UNDERGROUND STORAGE TANK ASSESSMENT REPORT FOR DAY TANK 2 AT SOUTH
FUEL FARM NAS CECIL FIELD FL
8/29/1997
ENVIRONMENTAL DETACHMENT CHARLESTON

DAY TANK 2 (TANK 342DT2)

SPORTENVDETHASN
SUPSHIP PORTSMOUTH ENVIRONMENTAL DETACHMENT CHARLESTON
1899 NORTH HOBSON AVENUE
NORTH CHARLESTON, S.C. 29405-2106
Underground Storage Tank (UST) Assessment Report

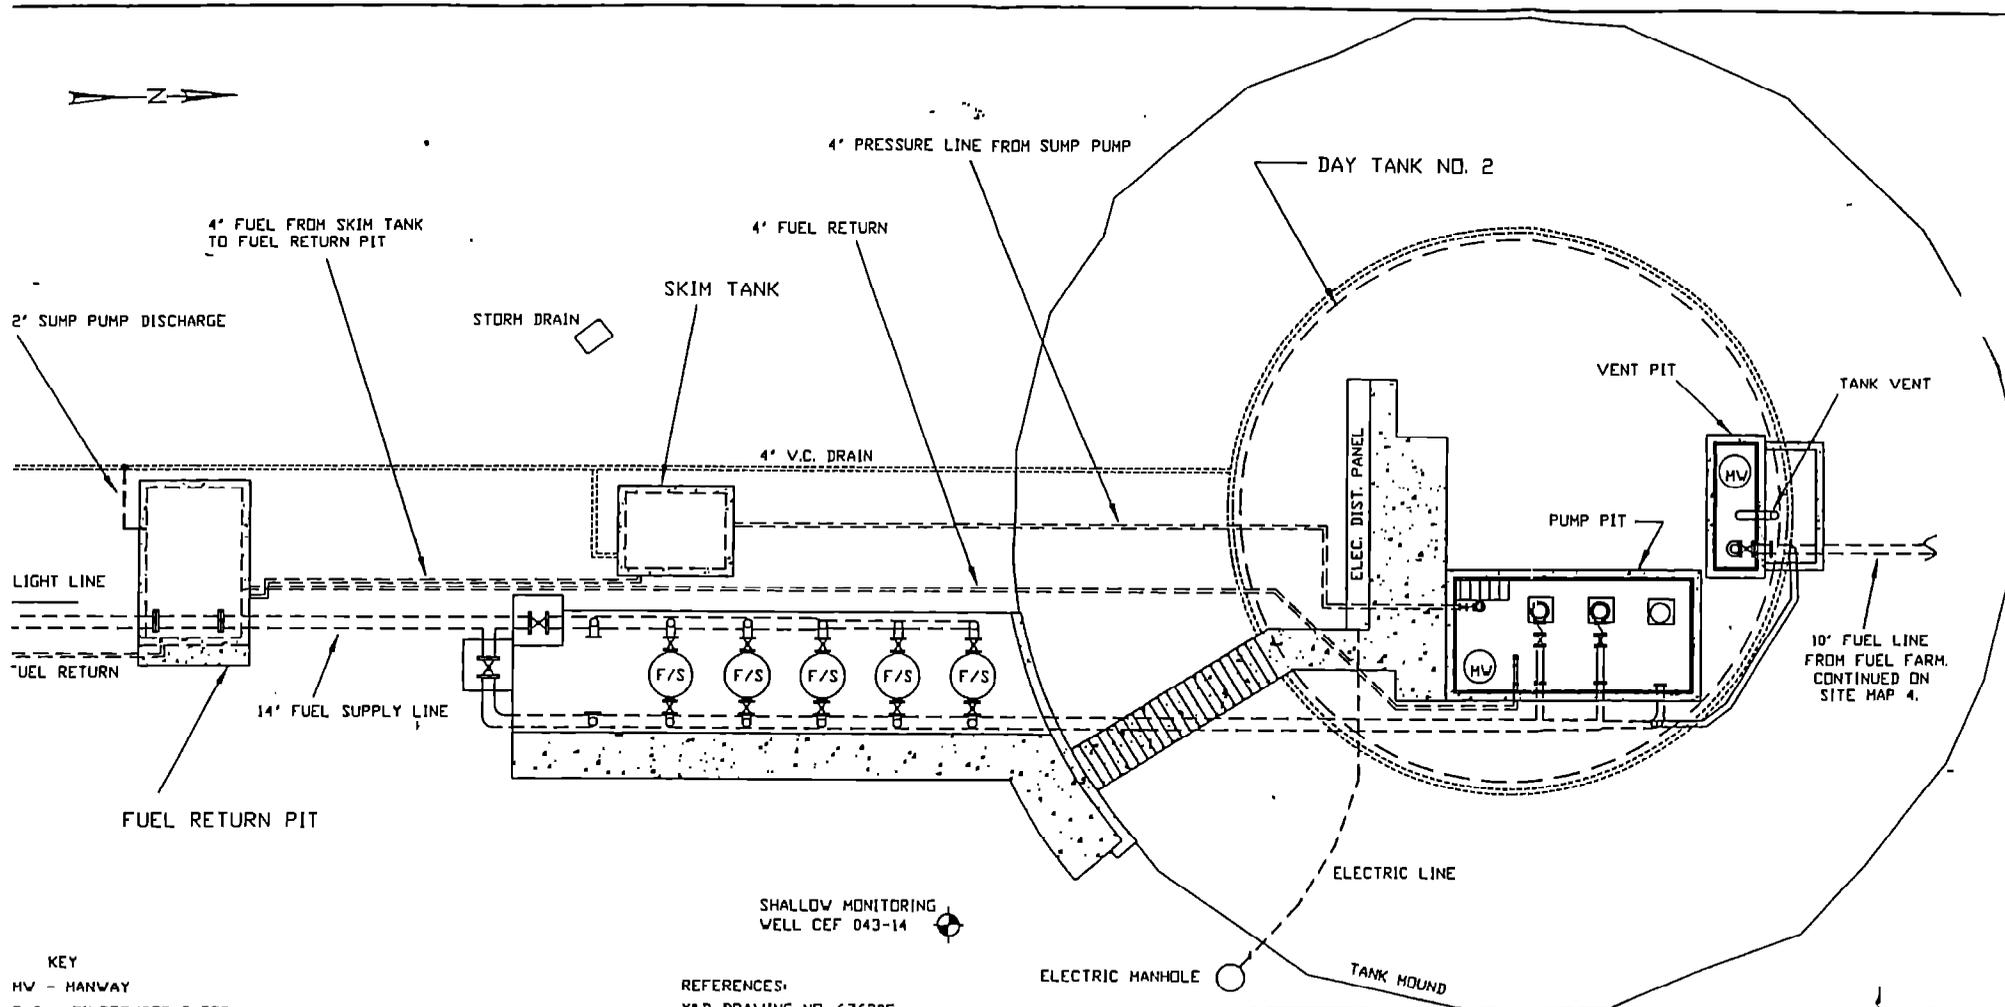
Site Map 1
 Day Tank 2 Site Layout
 Naval Air Station Cecil Field
 Jacksonville, FL

REFERENCES:
 YLD DRAWING NO. 676305
 HIGH SPEED REFUELING FACILITIES
 PIPELINE PROFILE
 YLD DRAWING NO. 676304 (FILE 12110-027)
 HIGH SP. REF. FAC.
 5,000 BBL DAY TANK PIPING
 SITE SURVEY CONDUCTED BY DET PERSONNEL

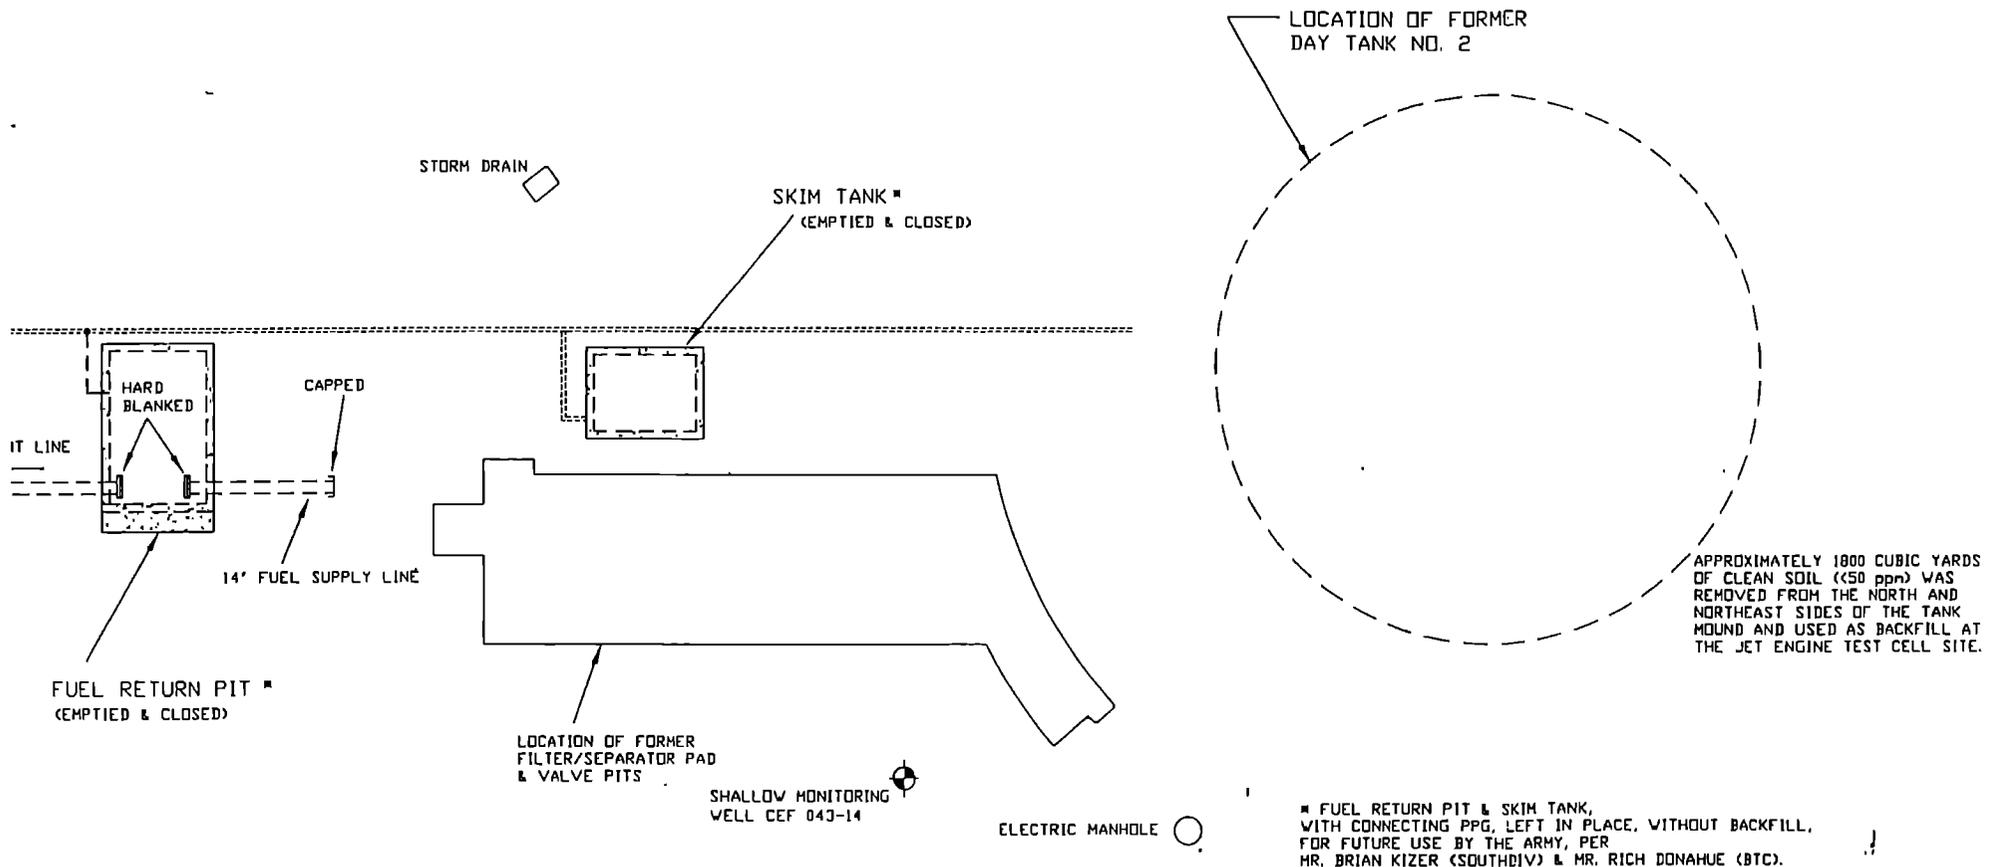
SPORTENVDETHASN 1099 North Hobson Ave. North Charleston, SC 29405-2106 Ph. (803) 743-6777	Site Map 2 Day Tank 2 Site After Demolition Naval Air Station Cecil Field Jacksonville, FL	
	DWG DATE: 2 DEC 97	DWG NAME: CF-DYTK2

APPROXIMATELY 1800 CUBIC YARDS OF CLEAN SOIL (<50 ppm) WAS REMOVED FROM THE NORTH AND NORTHEAST SIDES OF THE TANK MOUND AND USED AS BACKFILL AT THE JET ENGINE TEST CELL SITE.

■ FUEL RETURN PIT & SKIM TANK, WITH CONNECTING PPG, LEFT IN PLACE, WITHOUT BACKFILL, FOR FUTURE USE BY THE ARMY, PER MR. BRIAN KIZER (SOUTHDIV) & MR. RICH DONAHUE (BTC).

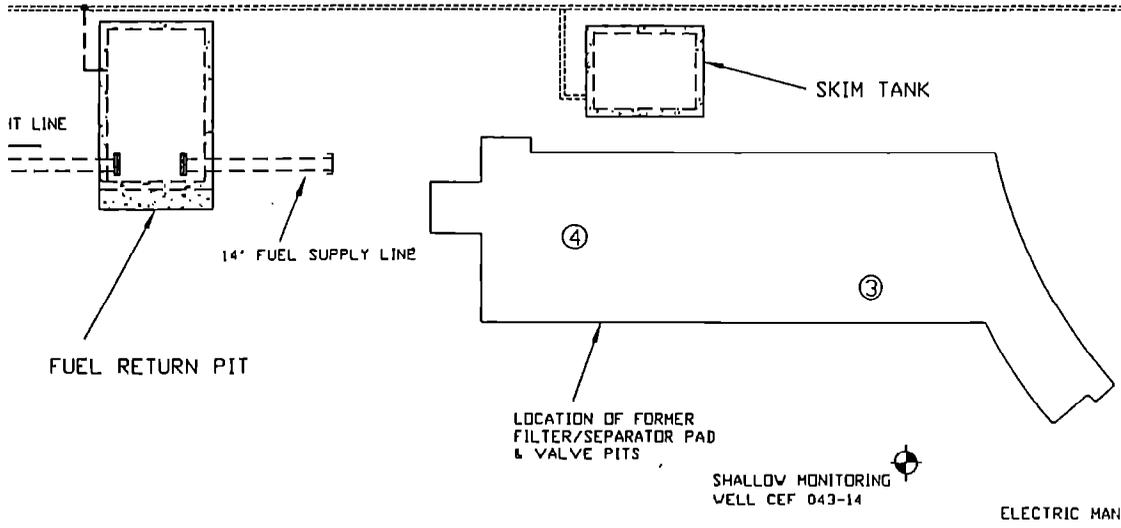
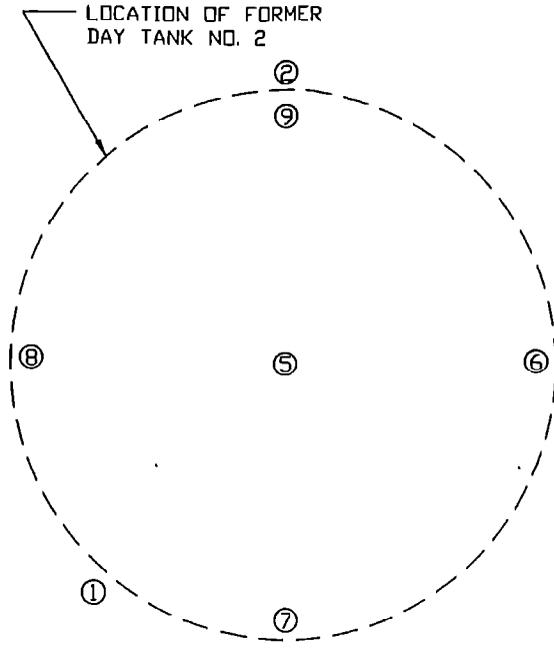
SPORTENVDECHASN 1899 North Hobson Ave. North Charleston, SC 29405-2106 Ph. (803) 743-6777	Site Map 3 Day Tank 2 OVA/FID Sample Loc. Naval Air Station Cecil Field Jacksonville, FL	
	DWG DATE: 2 DEC 97	DWG NAME: CF-DYTK3

SAMPLE #	DEPTH BGSL	DATE	TIME	READING (ppm)
1	1' 6'	8/13	1030	3,791
2	1' 6'	8/22	1430	250
3*	1'	8/24	1120	7,828
4*	1'	8/24	1130	7,350
5	4'	8/27	0815	385
6	4'	8/27	0820	6,583
7	4'	8/27	0825	6,563
8	4'	8/27	0830	3,639
9	4'	8/27	0835	4,529

* READINGS 3 & 4 WERE TYPICAL OF THE SOIL IN THE FUEL RETURN PIT/SKIM TANK AREA. ALL SOIL HAD A VERY STRONG PETROLEUM ODDOR.

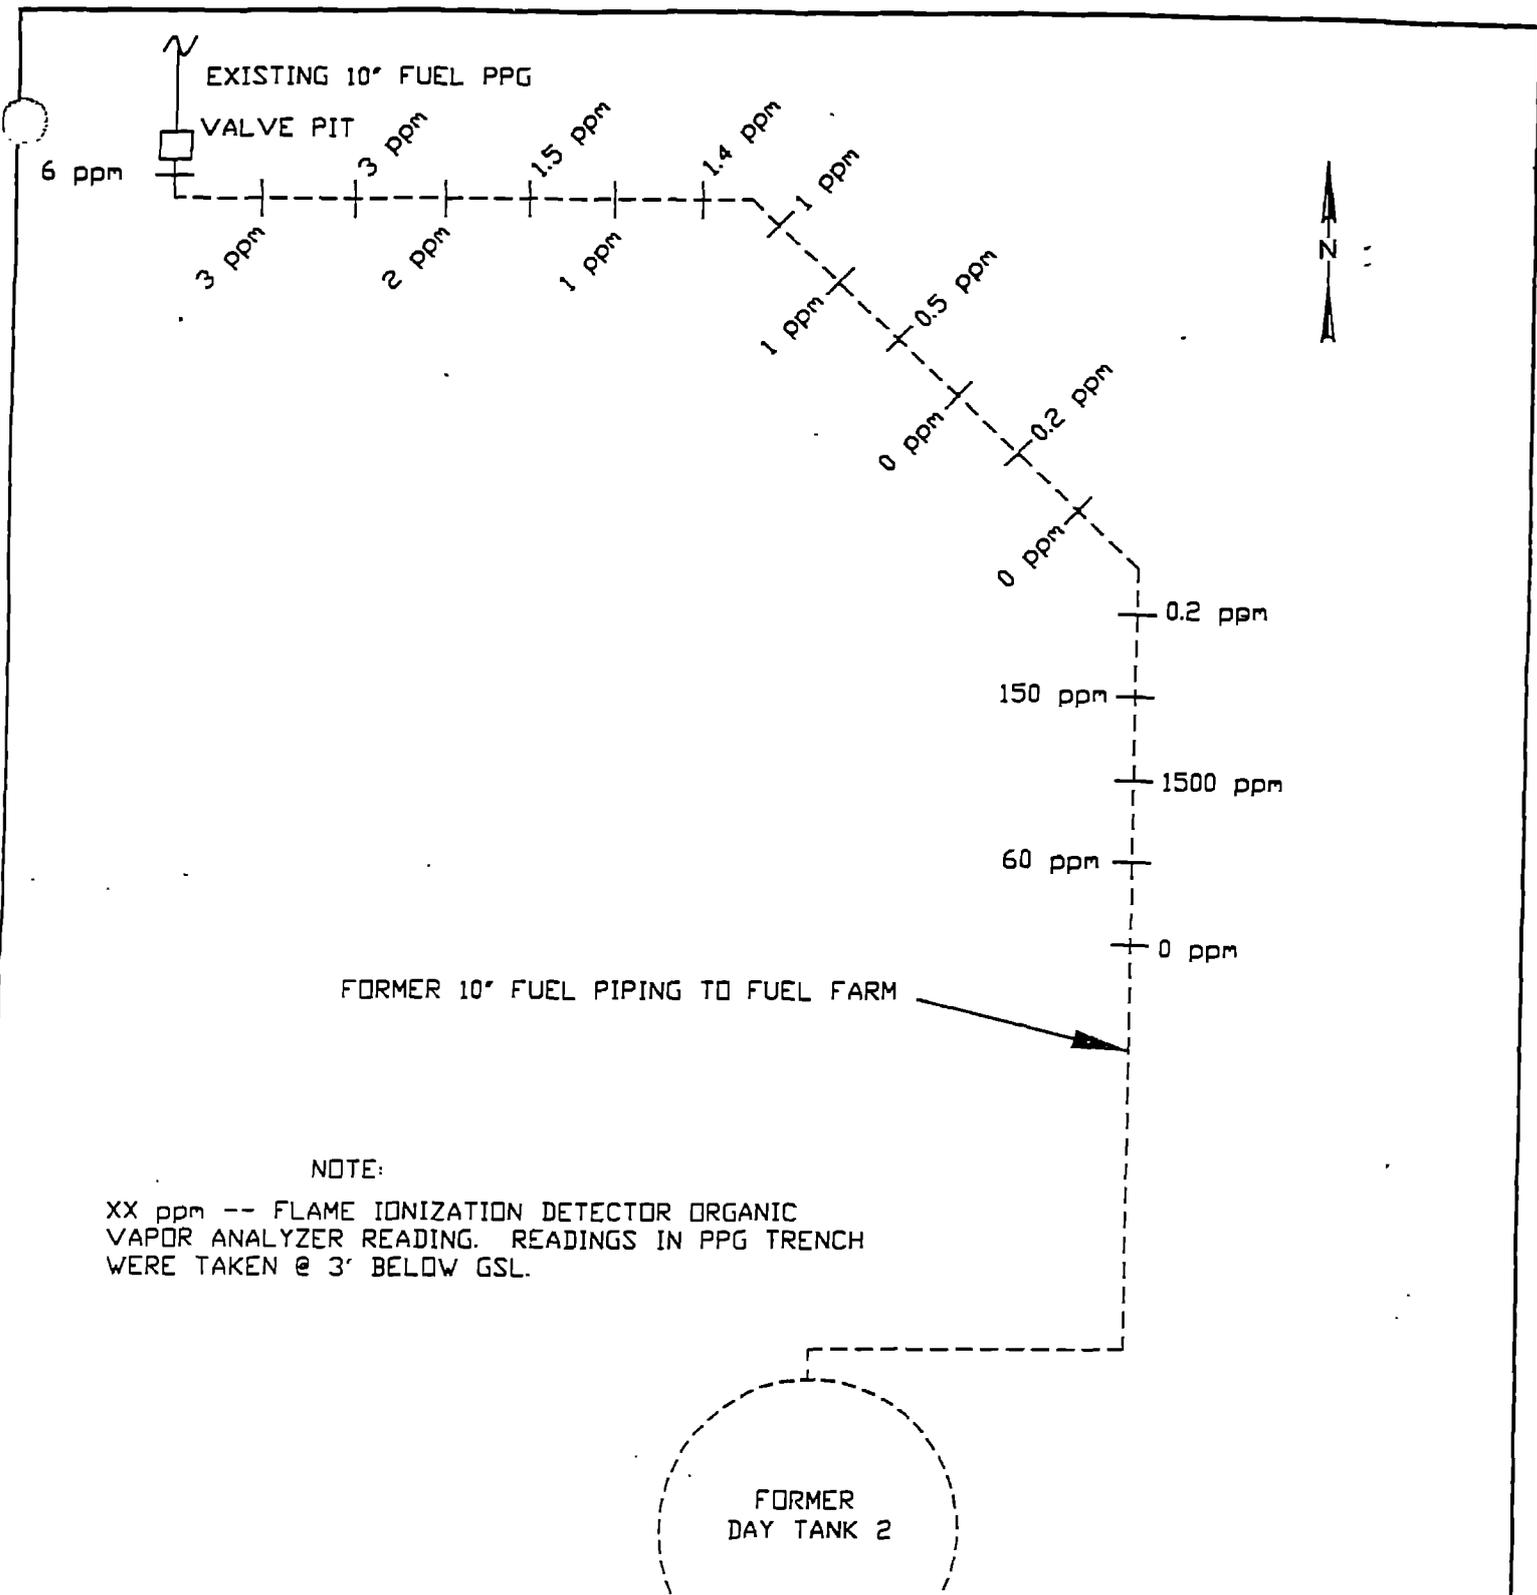
Site Map 4
Day Tank 2 Fuel PPG Removal
 Naval Air Station Cecil Field
 Jacksonville, FL

XX ppm -- FLAME IONIZATION DETECTOR ORGANIC VAPOR ANALYZER READING. READINGS IN PPG TRENCH WERE TAKEN @ 3' BELOW GSL.

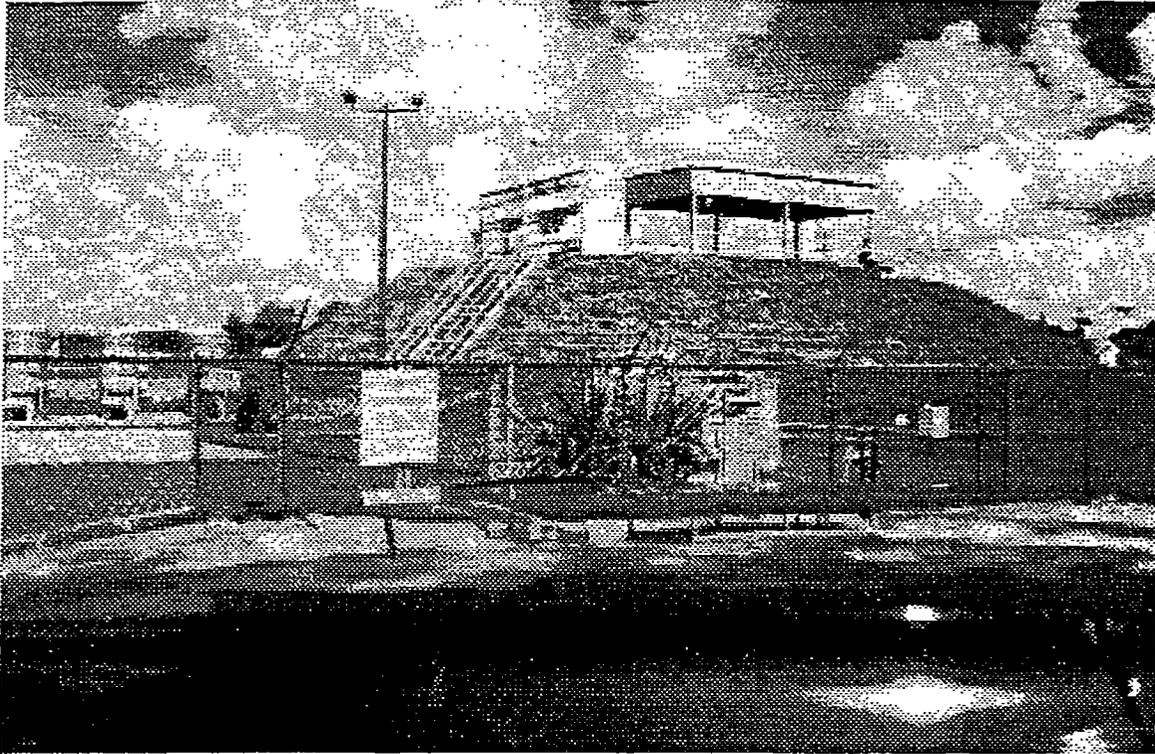
Photo 1: Day Tank #2 prior to commencement of work.

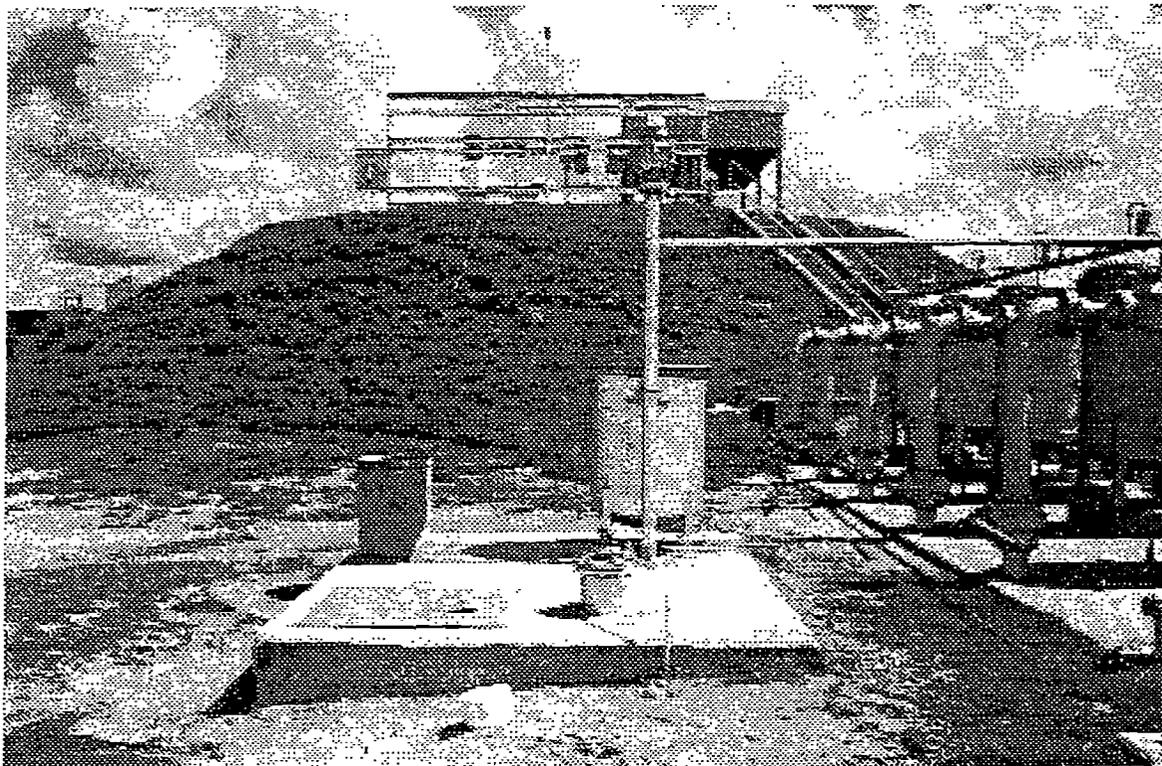
Photo 2: Day Tank Skim Tank and filter assembly. Skim tank was emptied, cleaned and abandoned in place (empty).

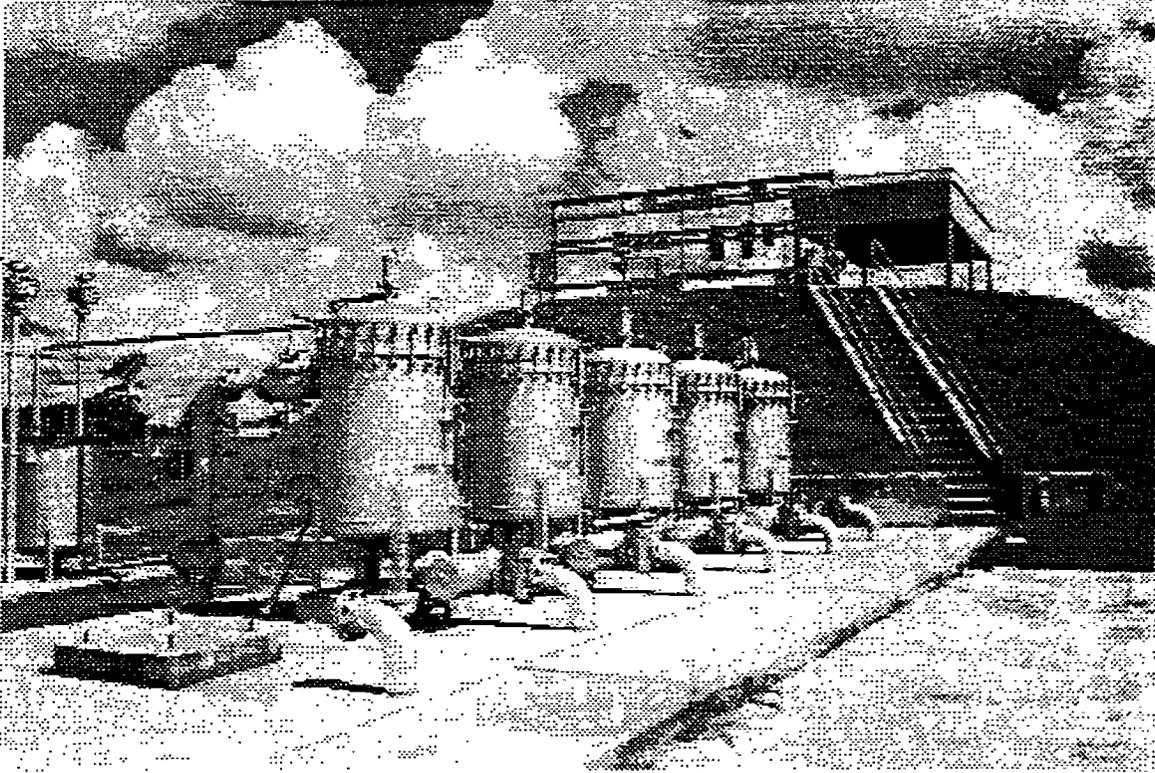
Photo 3: Day tank filters. Filters, concrete slab and piping were removed and recycled.

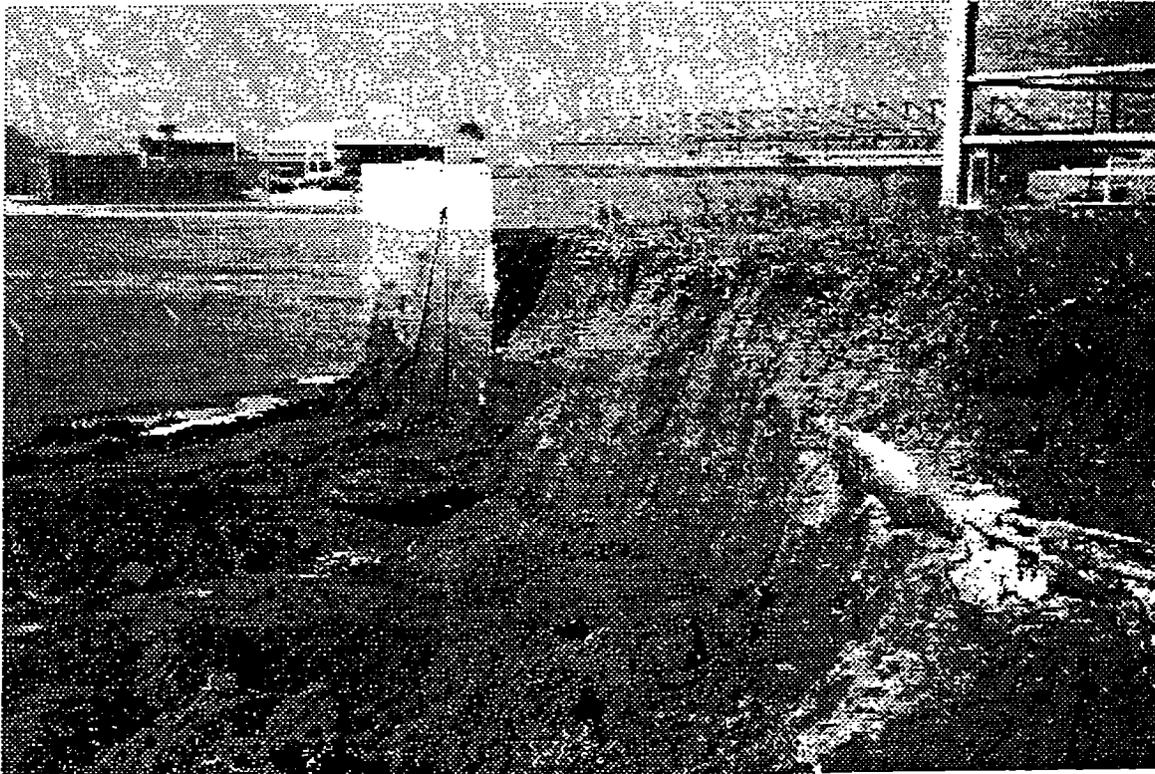
Photo 4: Additional manways under 4' of soil on top of Day tank. Concrete encased conduit ran from vent pit manway to electrical manifold.

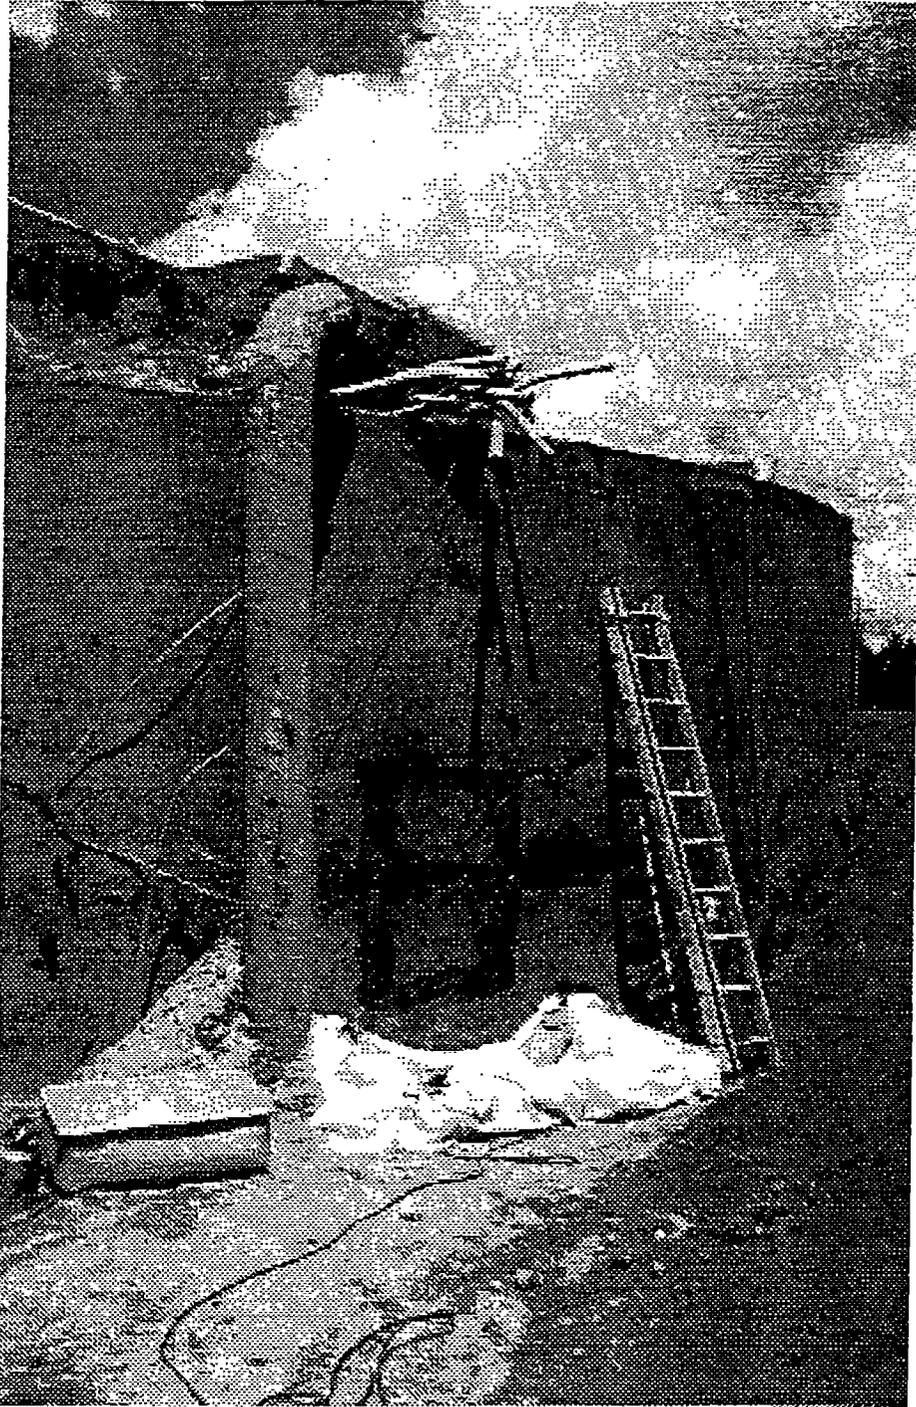
Photo 5: Southeast side of Day tank exposed. Note 14" fuel supply line from pump pit and area cleaned for tank access.

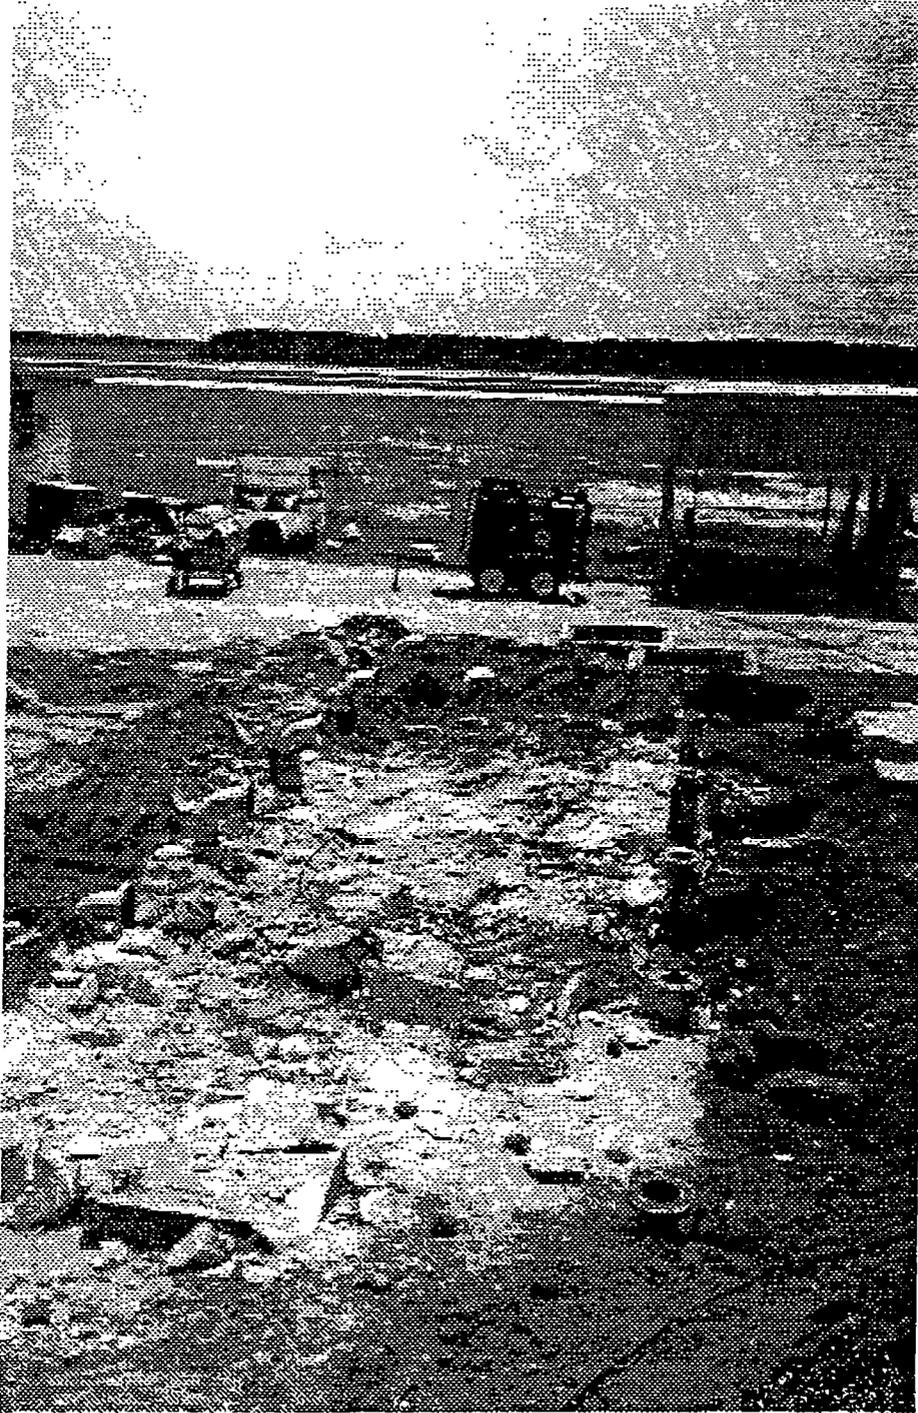
Photo 6: Demolition of Day tank concrete filter pad after filter removal. Note valve pits and pump pit cover over fuel return pit. Valve pits and valves were removed with piping.

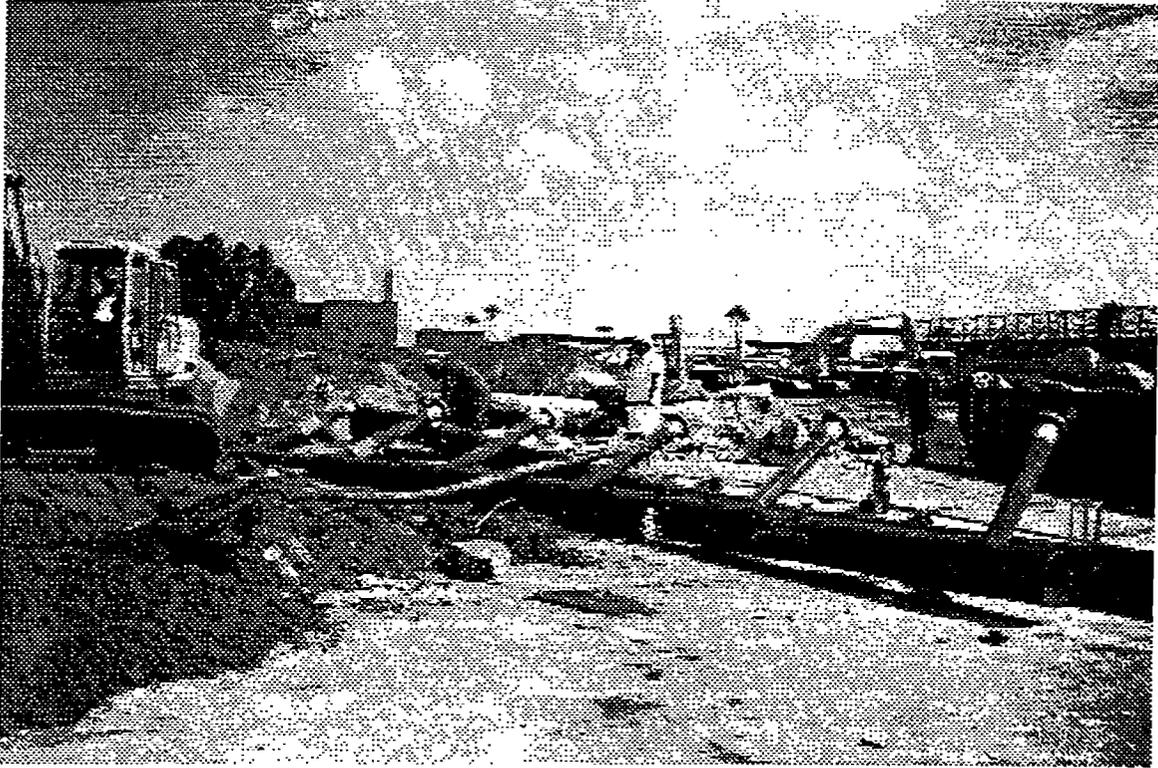
Photo 7: Demolition of Day tank filter piping after removal.

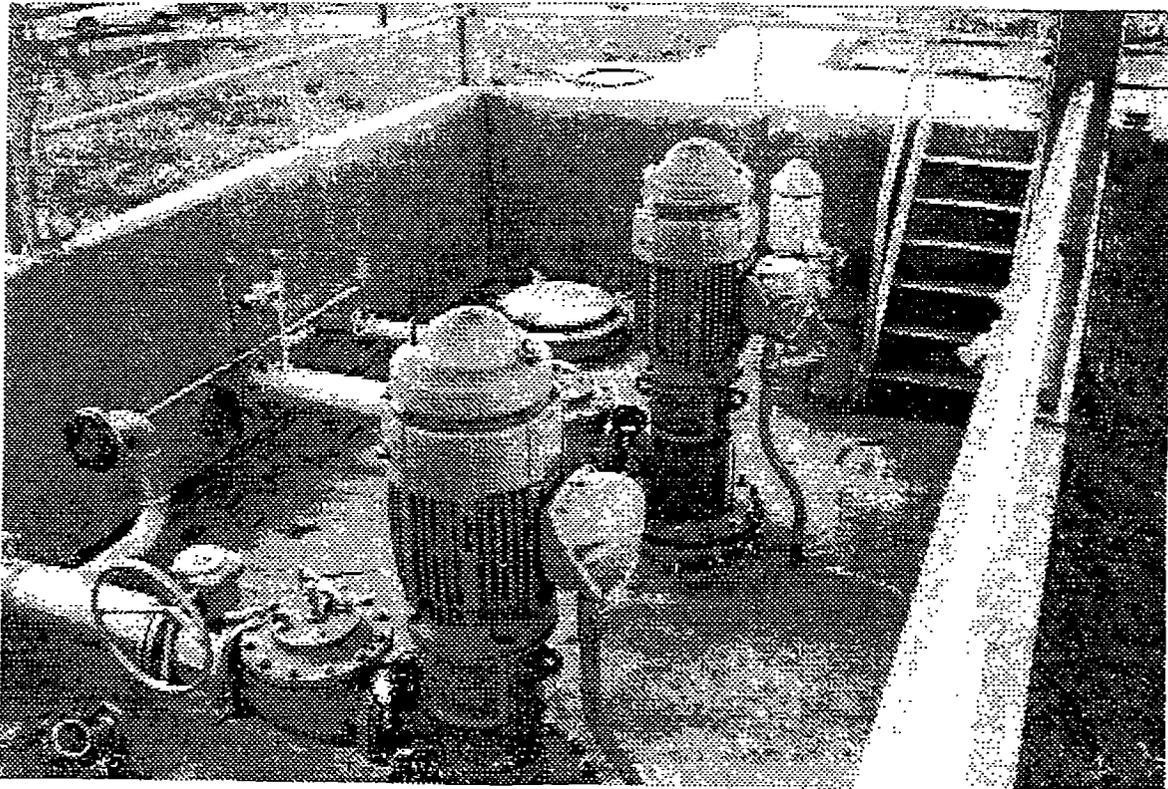
Photo 8: Day tank pump pit on top of tank prior to removal of cover, pumps and motors.

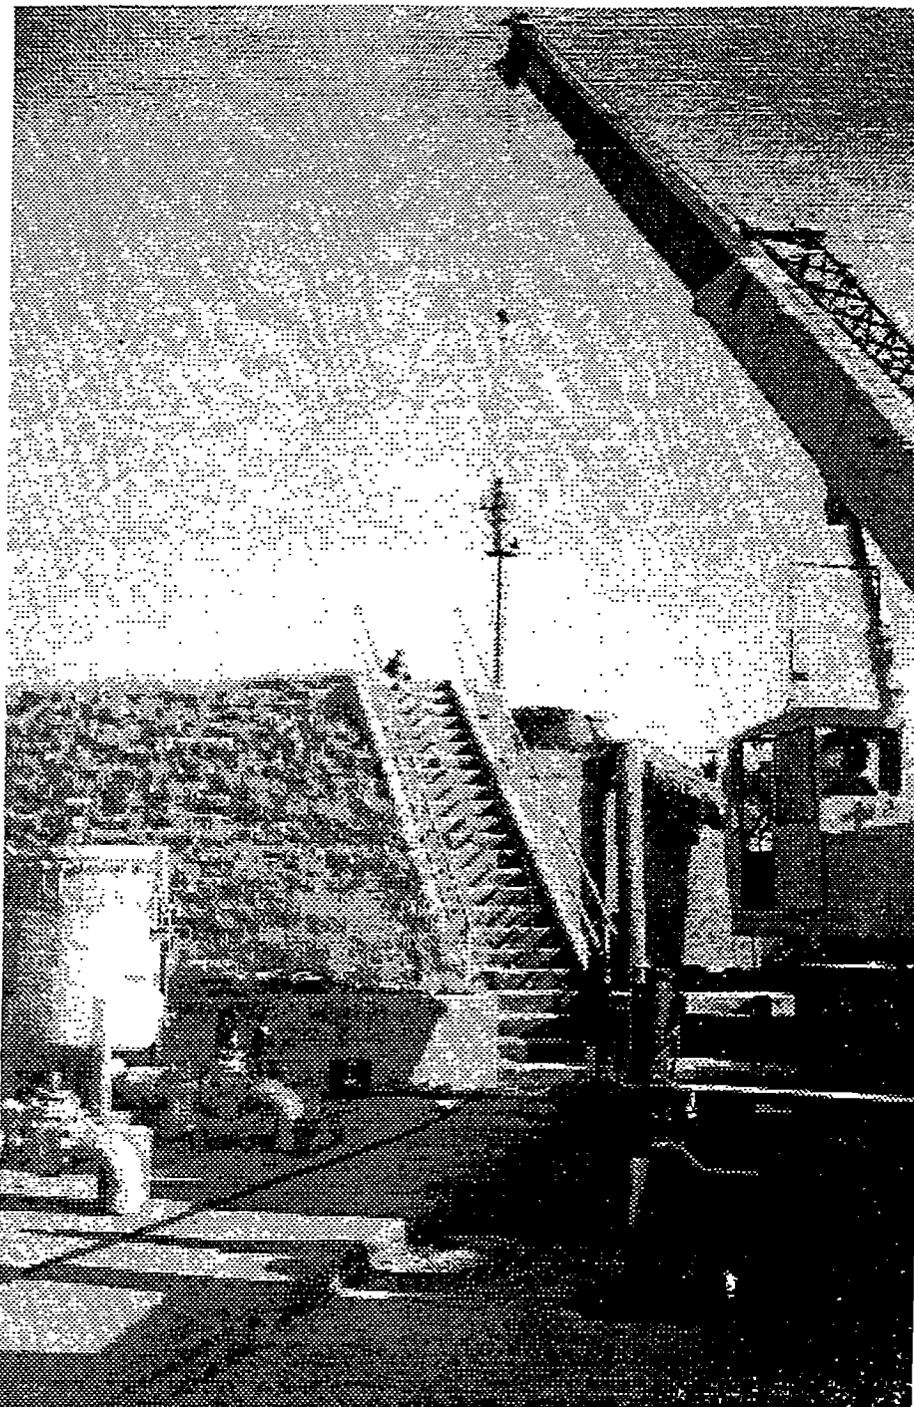
Photo 9: Removal of pump & motor from pump pit.

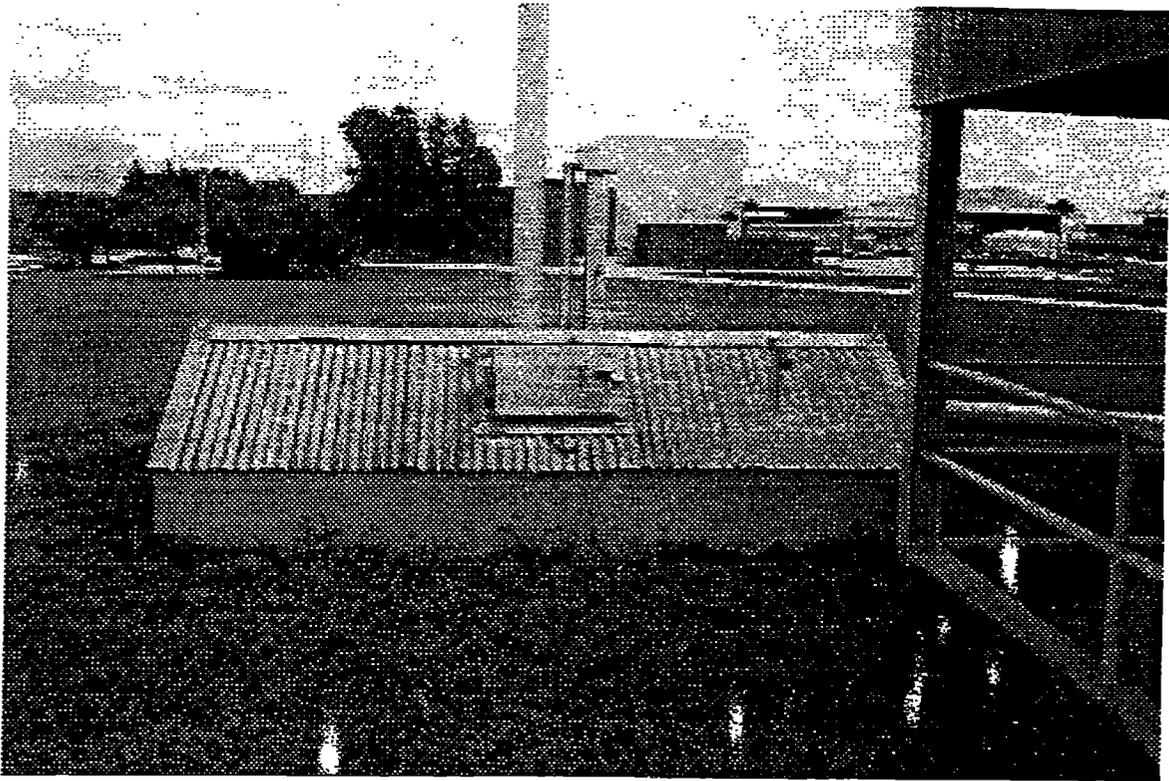
Photo 10: Vent pit with cover prior to commencement of work.

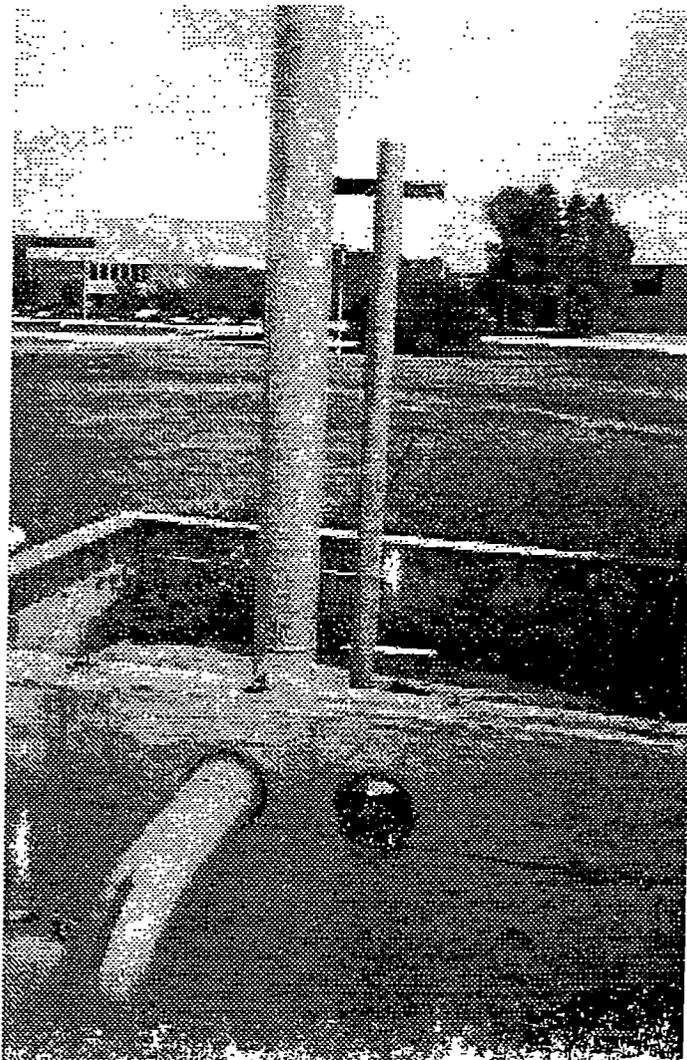
Photo 11: Vent pit after cover removal showing tank and pit vent piping.

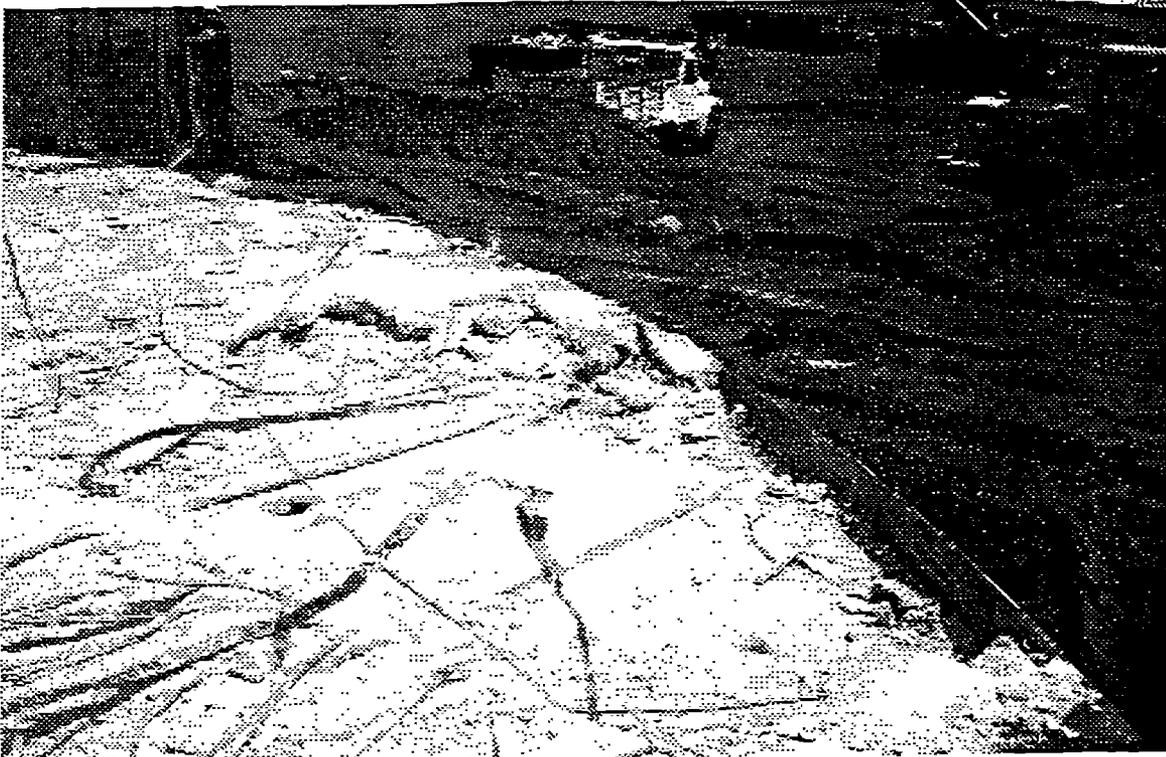
Photo 12: Demolition of 9" concrete slab on top of tank. Note 9" steel lip that extends above tank top. Flatbar was welded to tank top and concrete poured over it.

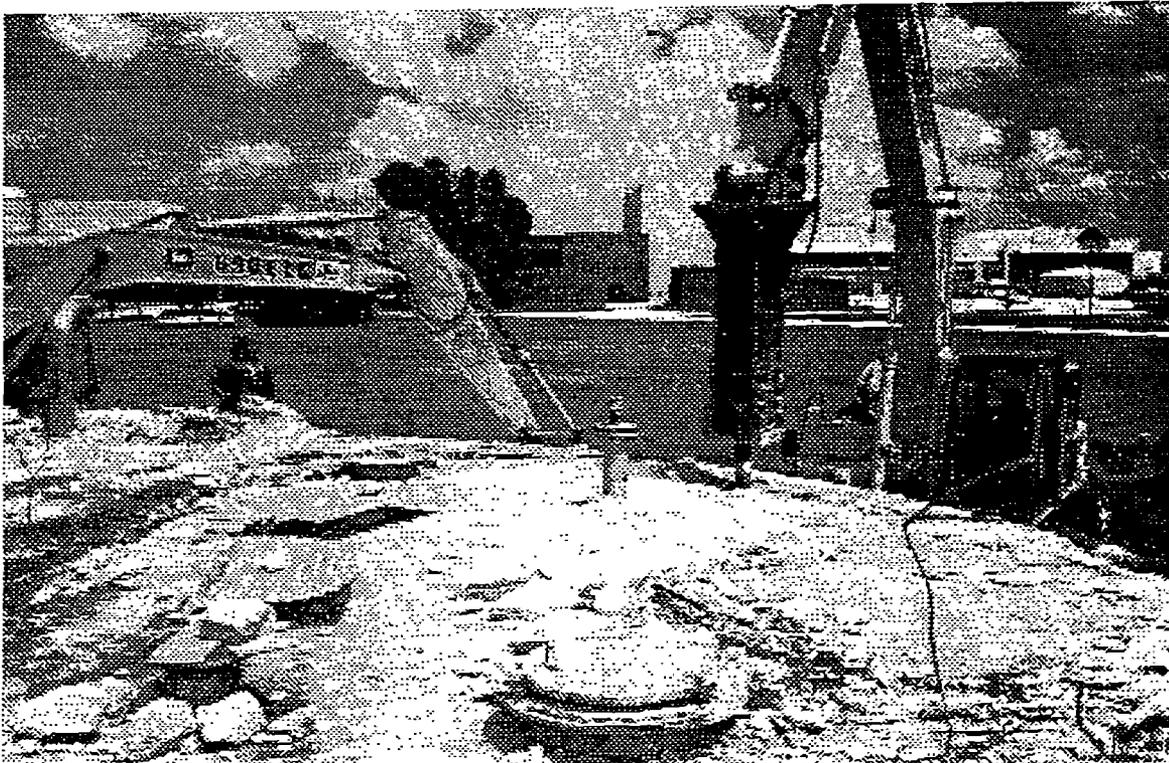
Photo 13: Continuation of 9" concrete slab demolition with hydraulic hammer. Manways shown were in pump pit.

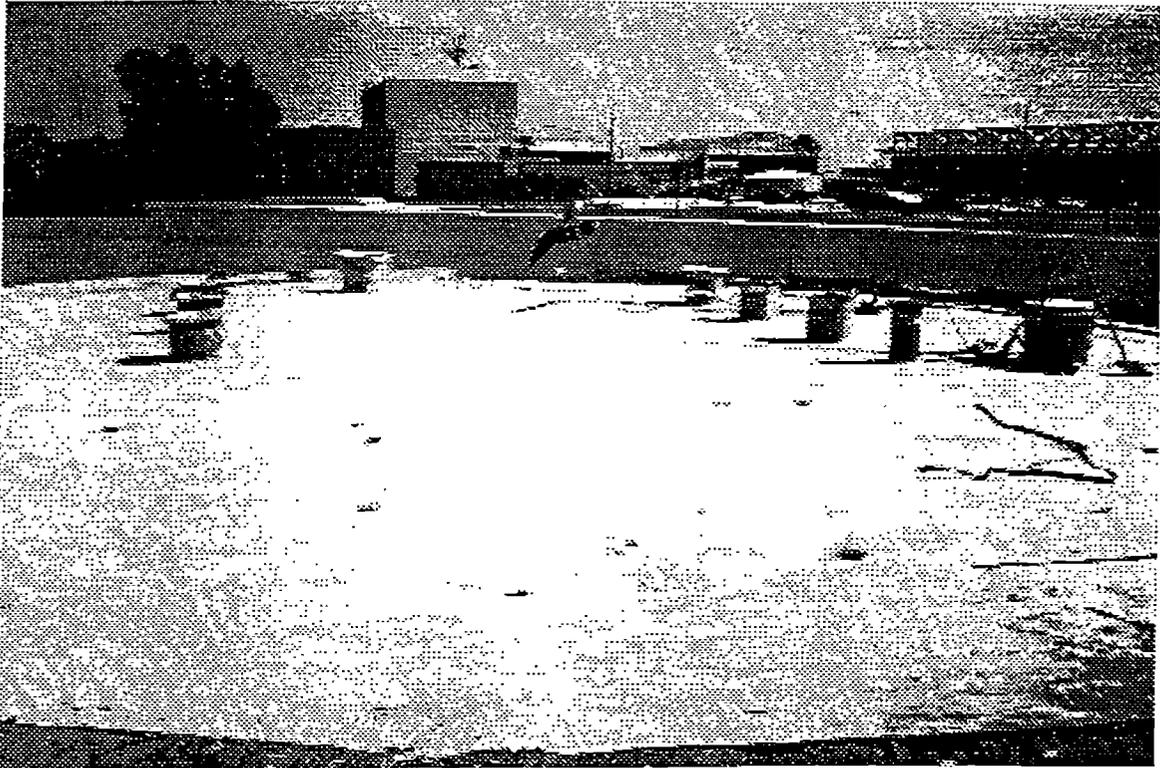
Photo 14: Day tank top after concrete removal.

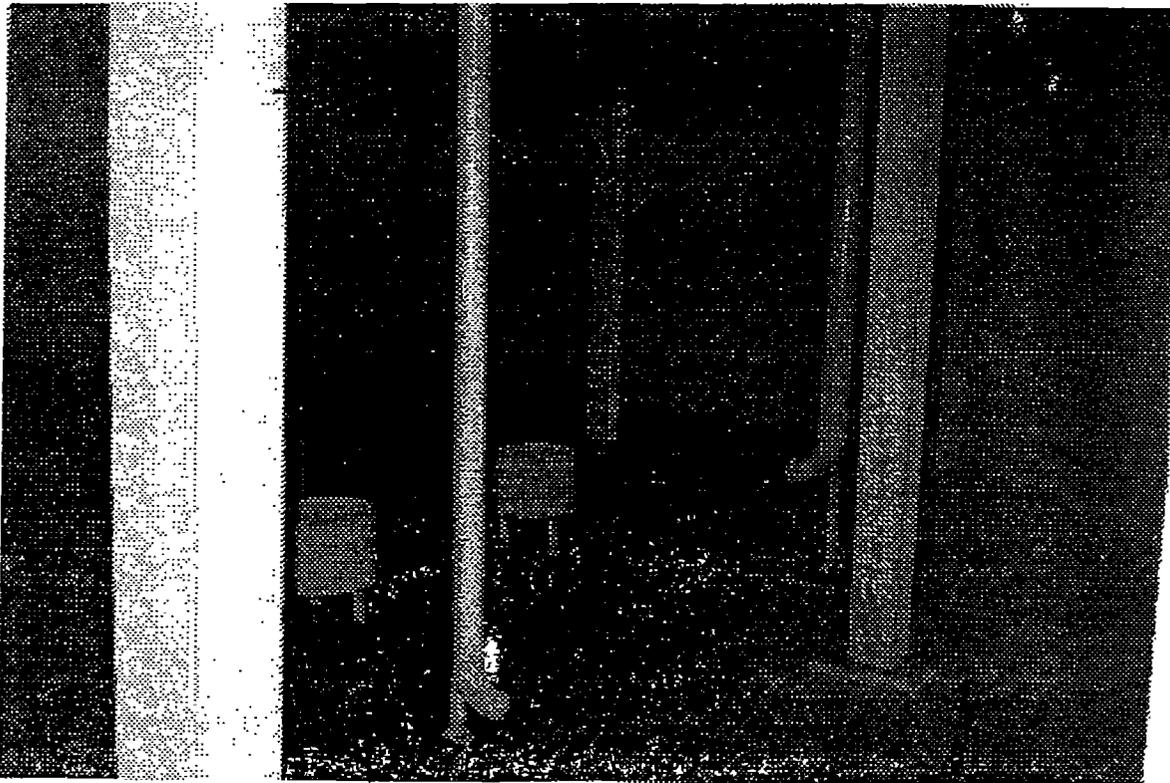
Photo 15: Day tank internals after access cut.
