UNDERGROUND STORAGE TANK ASSESSMENT REPORT FOR DAY TANK 2 AT SOUTH
FUEL FARM NAS CECIL FIELD FL
8/29/1997
ENVIRONMENTAL DETACHMENT CHARLESTON

DAY TANK 2 (TANK 342DT2)

SPORTENVDETHASN
SUPSHIP PORTSMOUTH ENVIRONMENTAL DETACHMENT CHARLESTON
1899 NORTH HOBSON AVENUE
NORTH CHARLESTON, S.C. 29405-2106
Underground Storage Tank (UST) Assessment Report

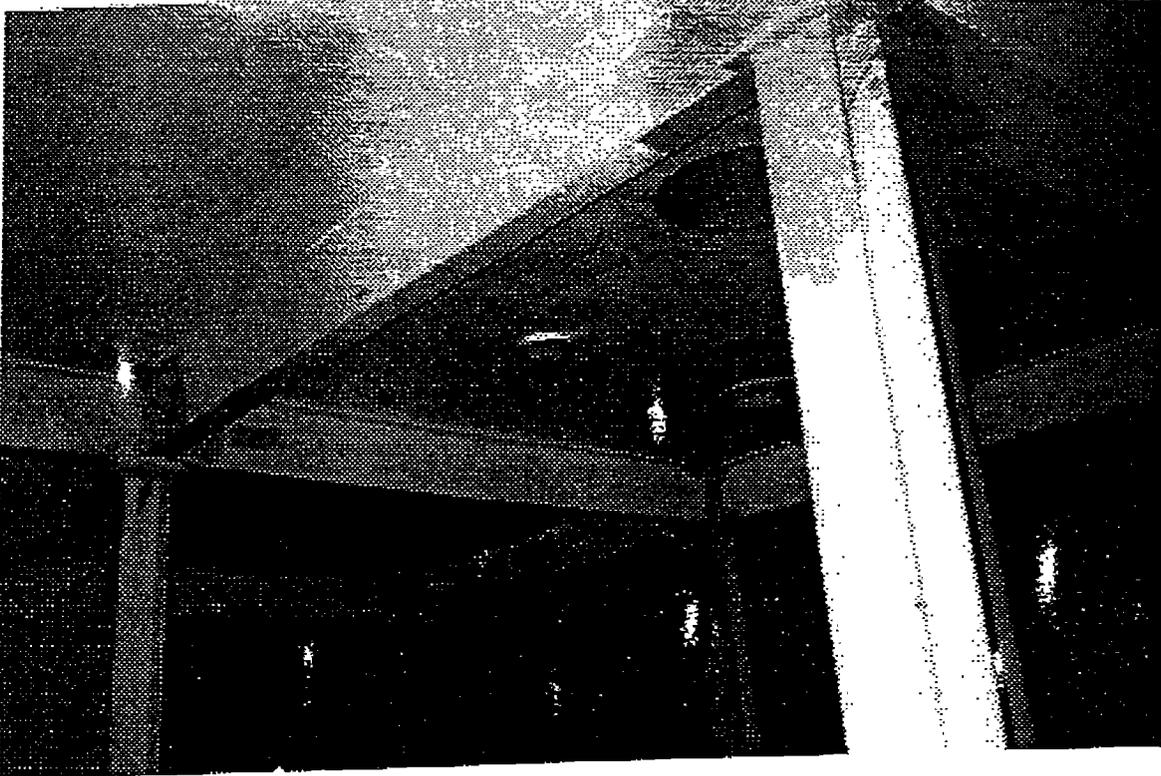
Photo 16: Day tank internal support structure. Note pump pit manway and pump/motor penetrations.

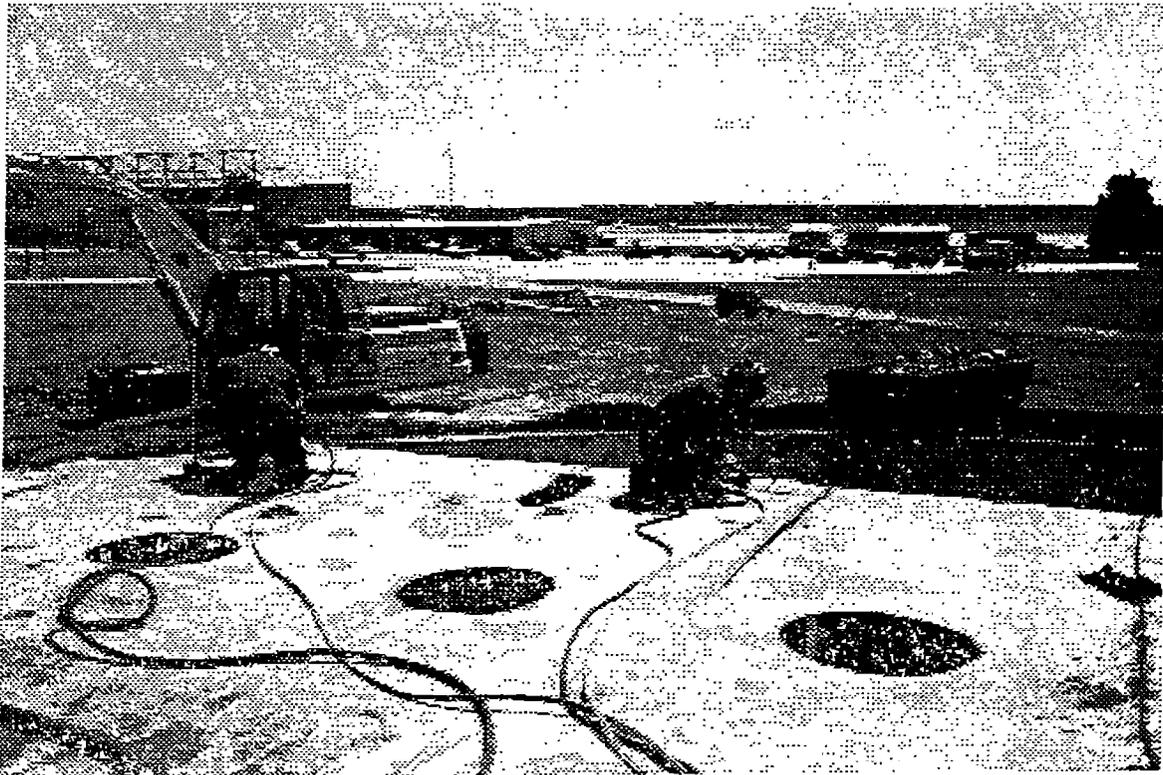
Photo 17: Day tank top removal.

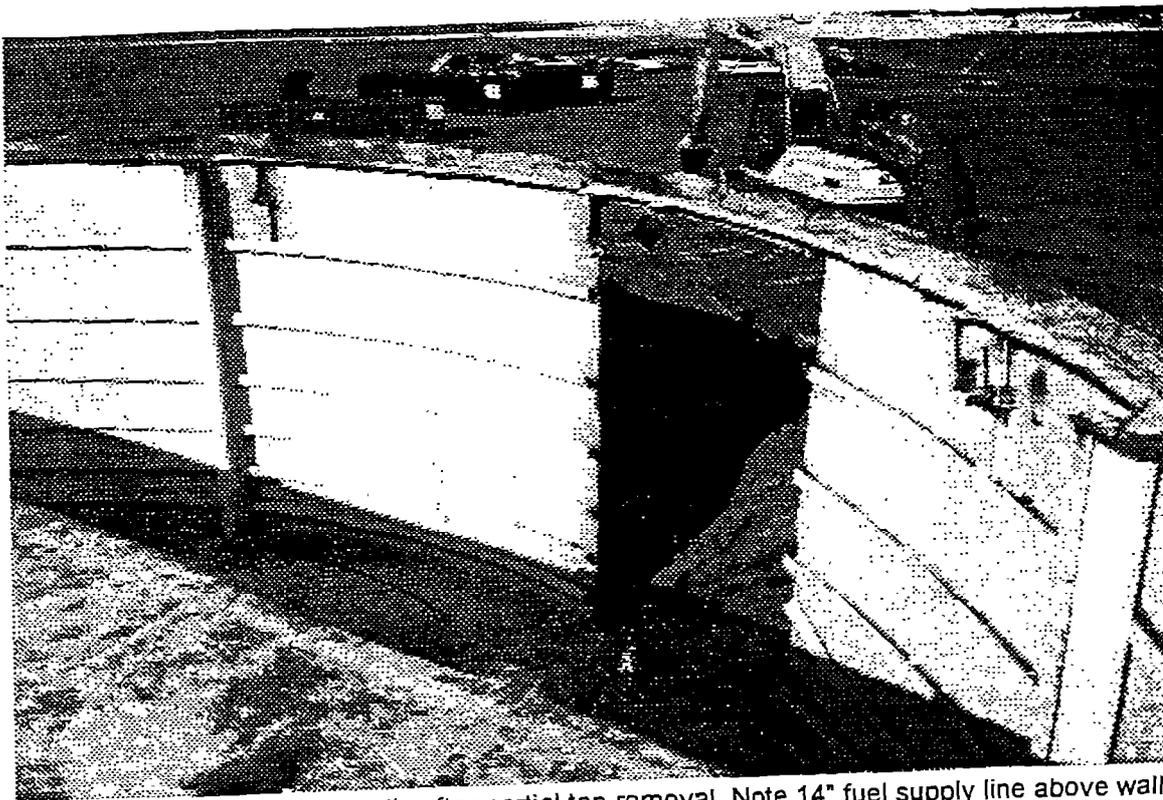
Photo 18: Day tank internal walls after partial top removal. Note 14" fuel supply line above wall near access.

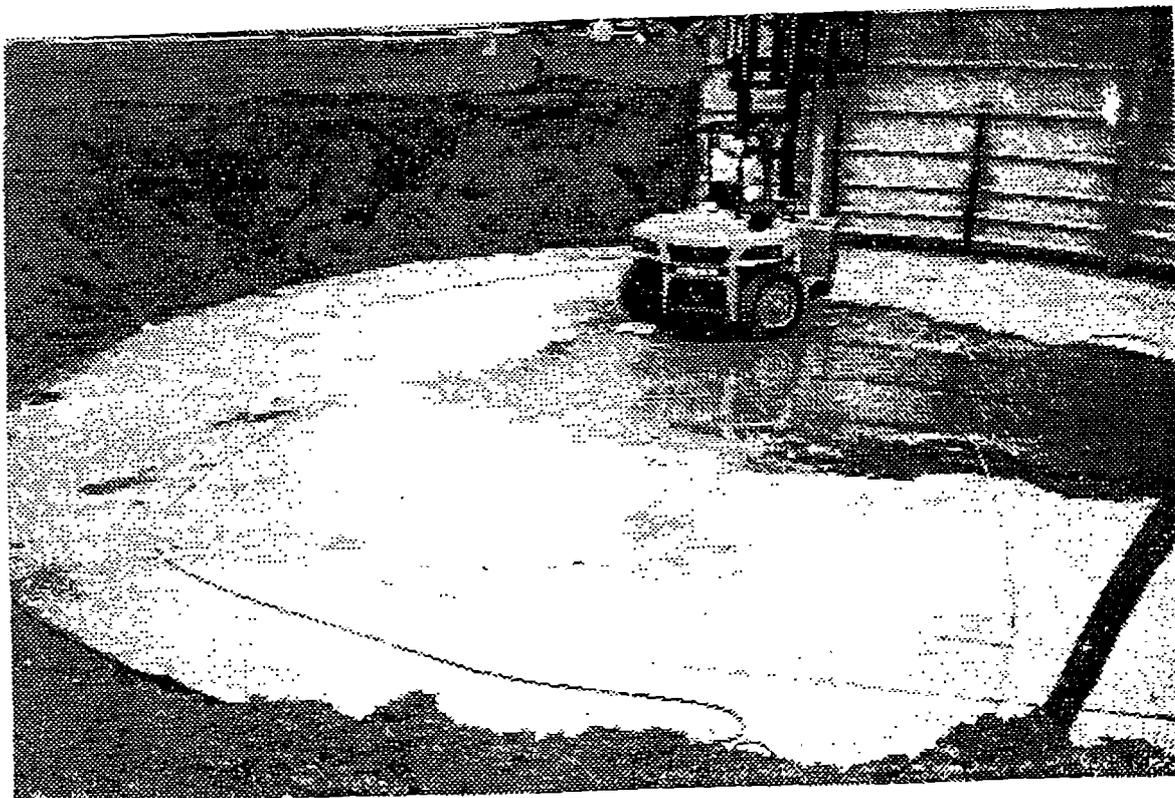
Photo 19: Steel bottom of Day tank prior to removal.

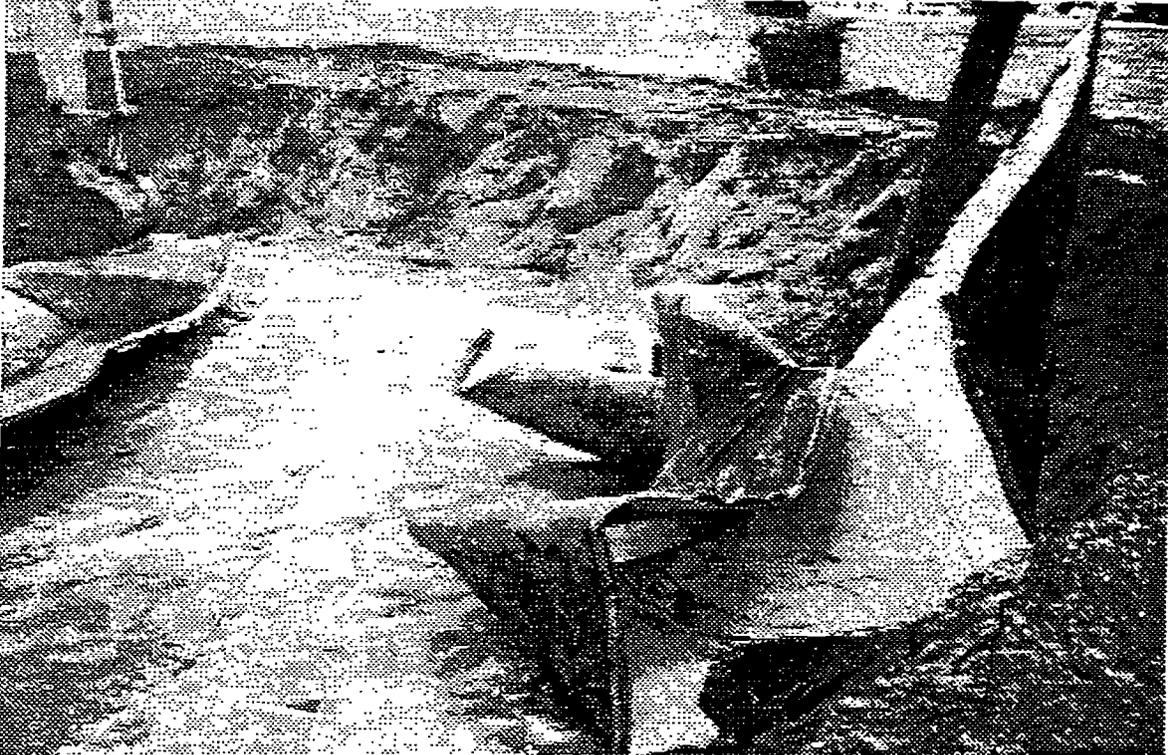
Photo 20: Steel tank bottom during removal.

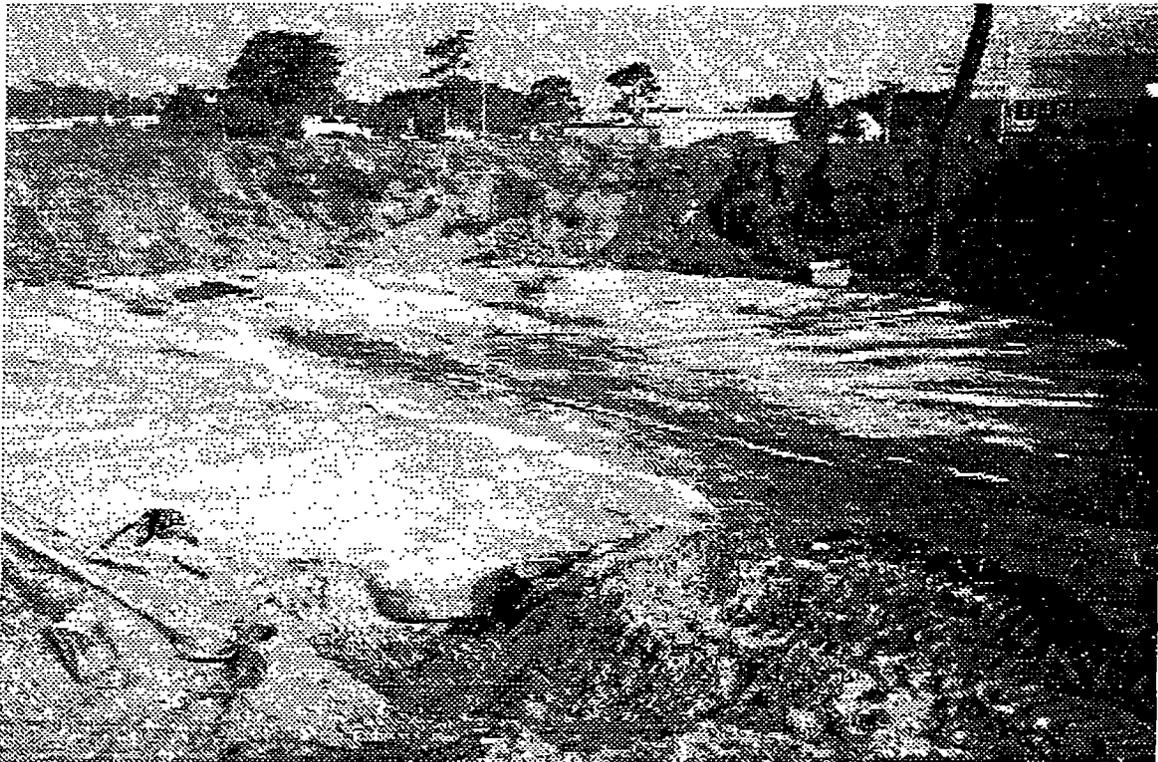
Photo 21: 15" concrete slab under Day tank. Note 14" fuel supply line cut off next to slab.

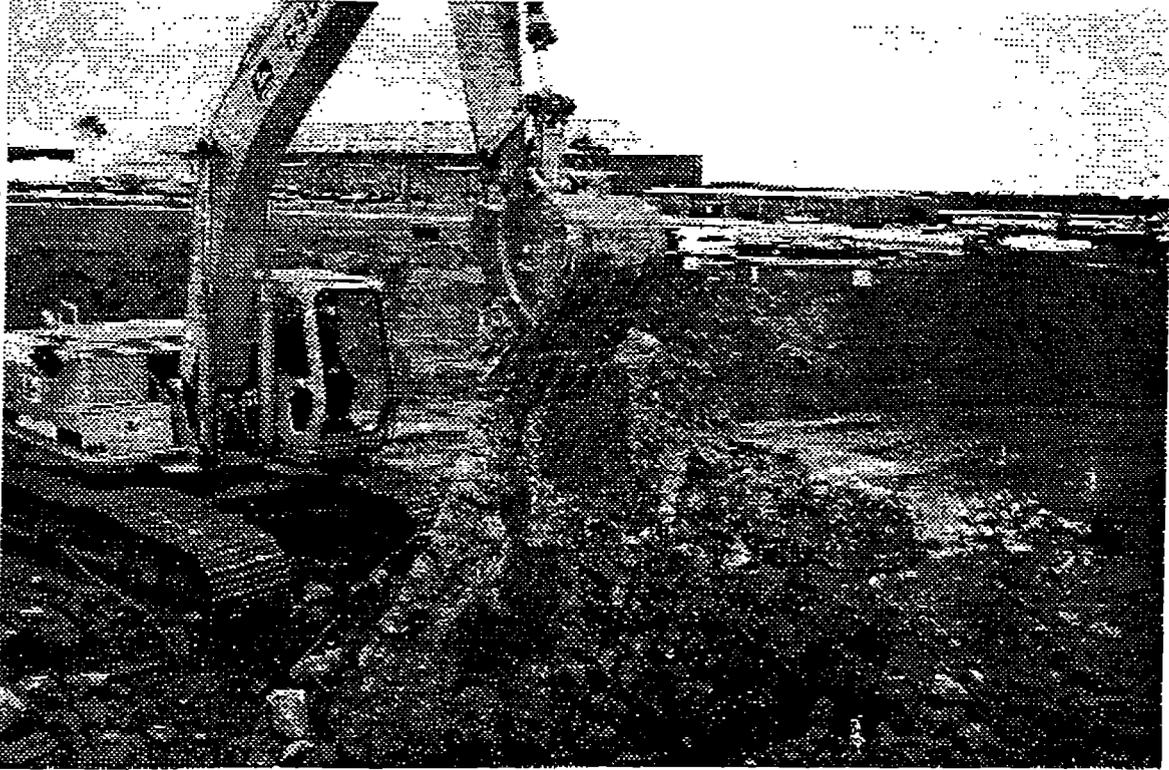
Photo 22: Day tank slab being removed from excavation.

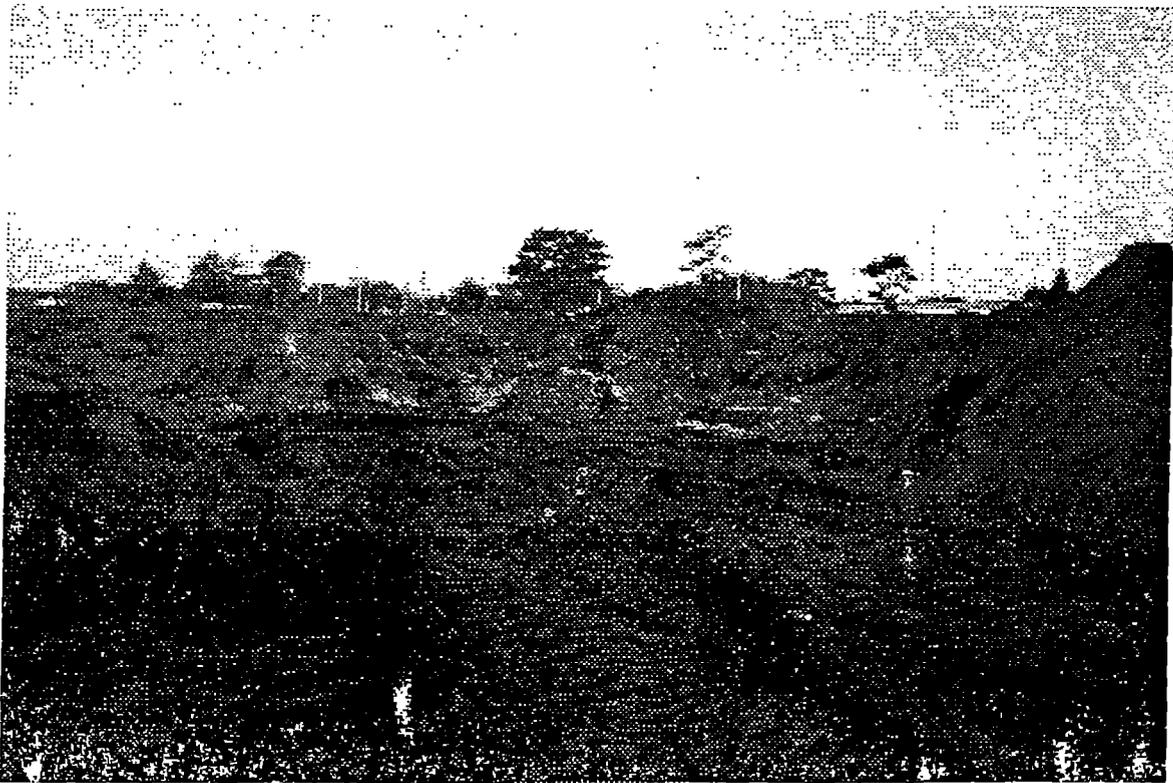
Photo 23: Excavation after concrete slab removal. Bottom of excavation was 3' below ground surface level.

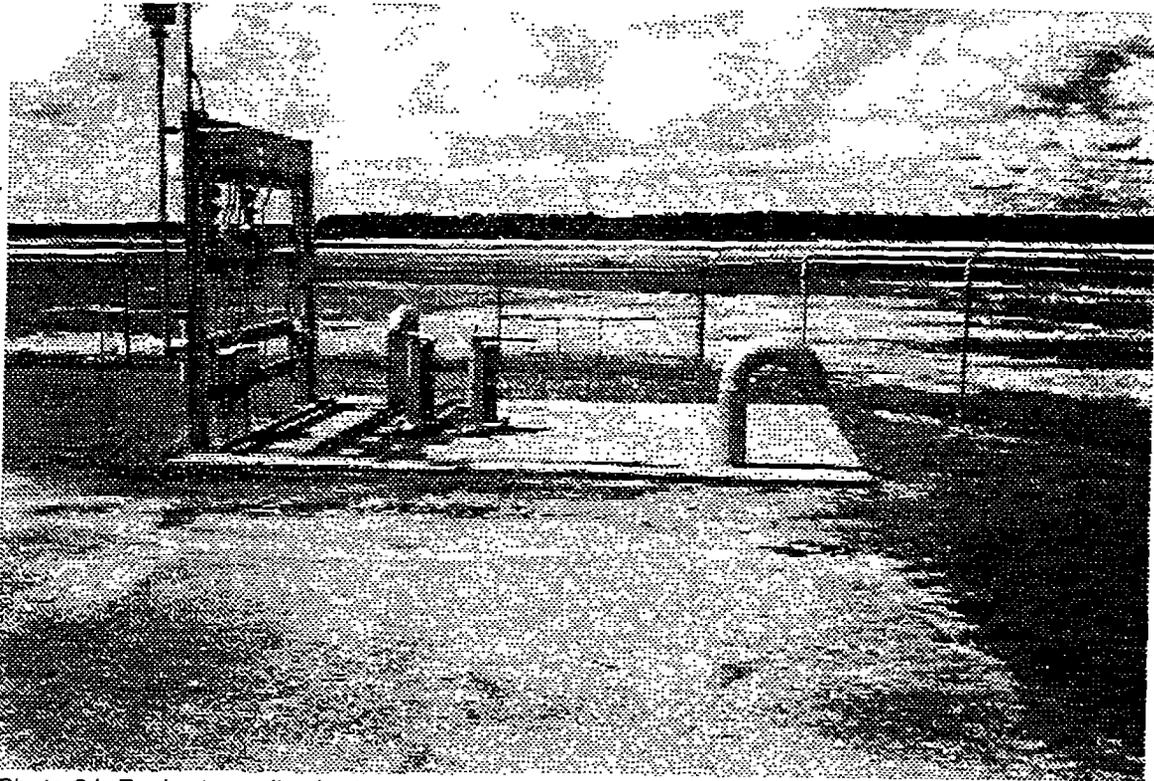
Photo 24: Fuel return pit prior to commencing work.

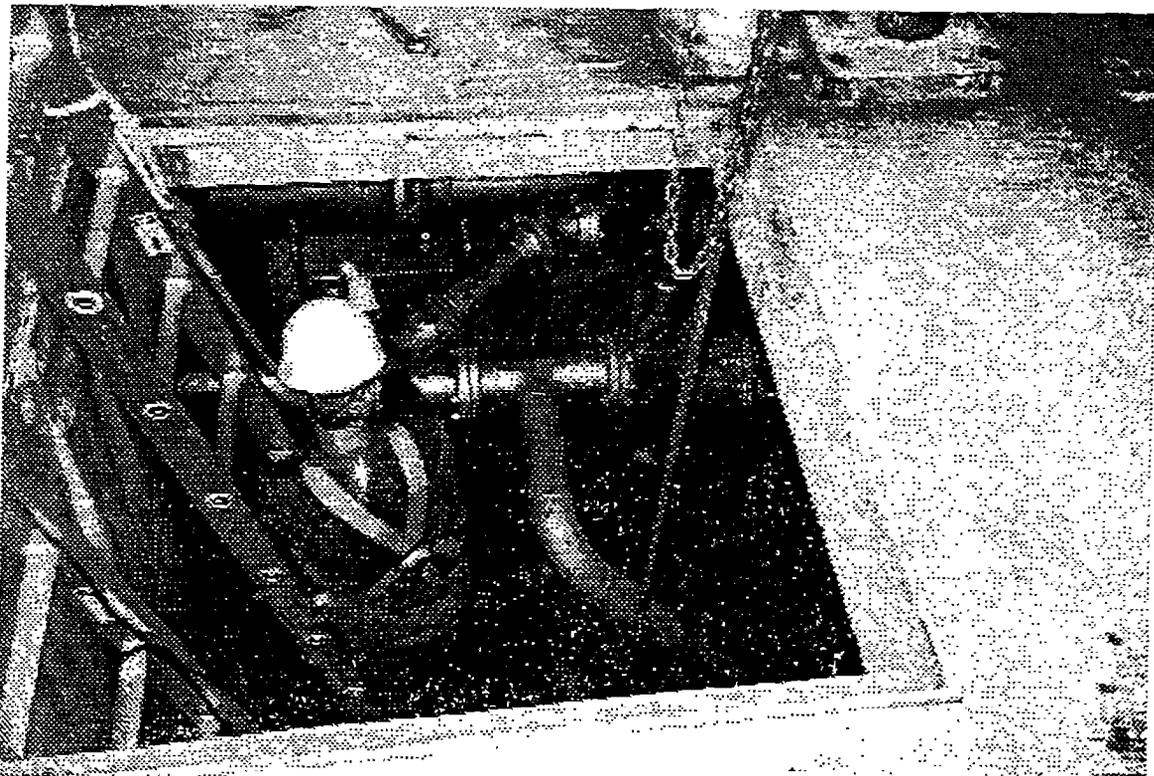
Photo 25: Removal of piping and components from fuel return pit.

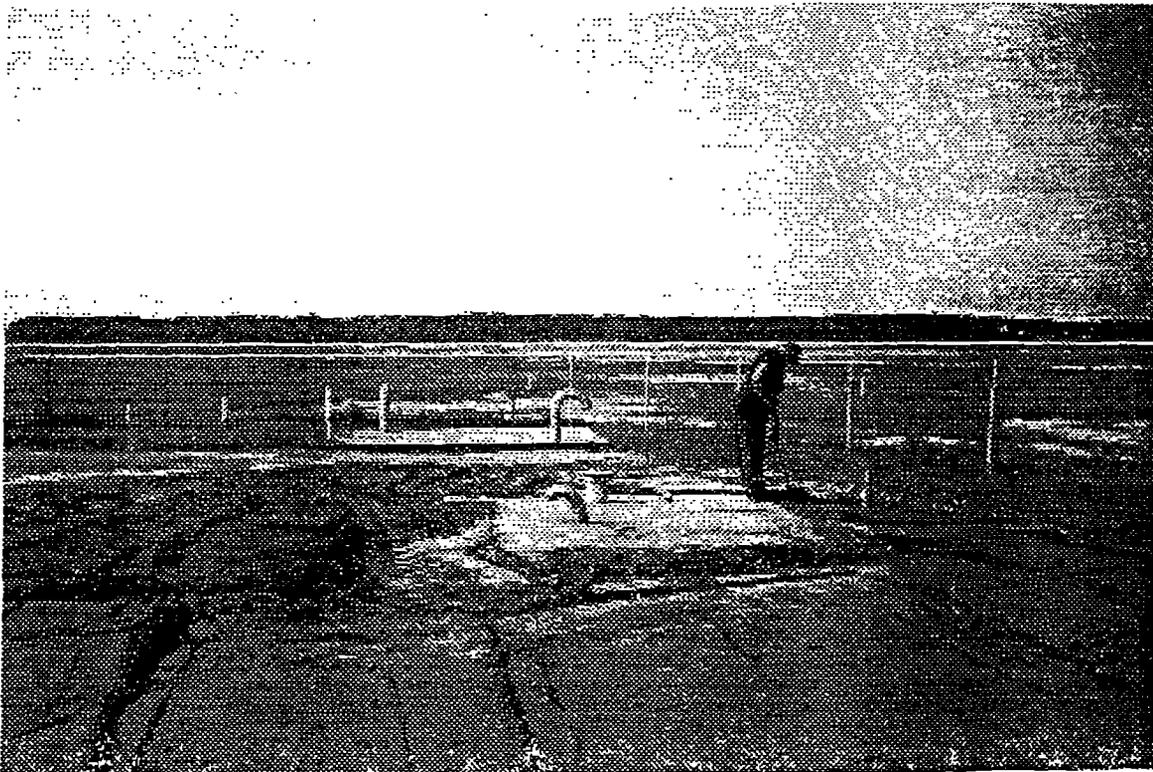
Photo 27: Skim tank and fuel return pit after closure and during site restoration.

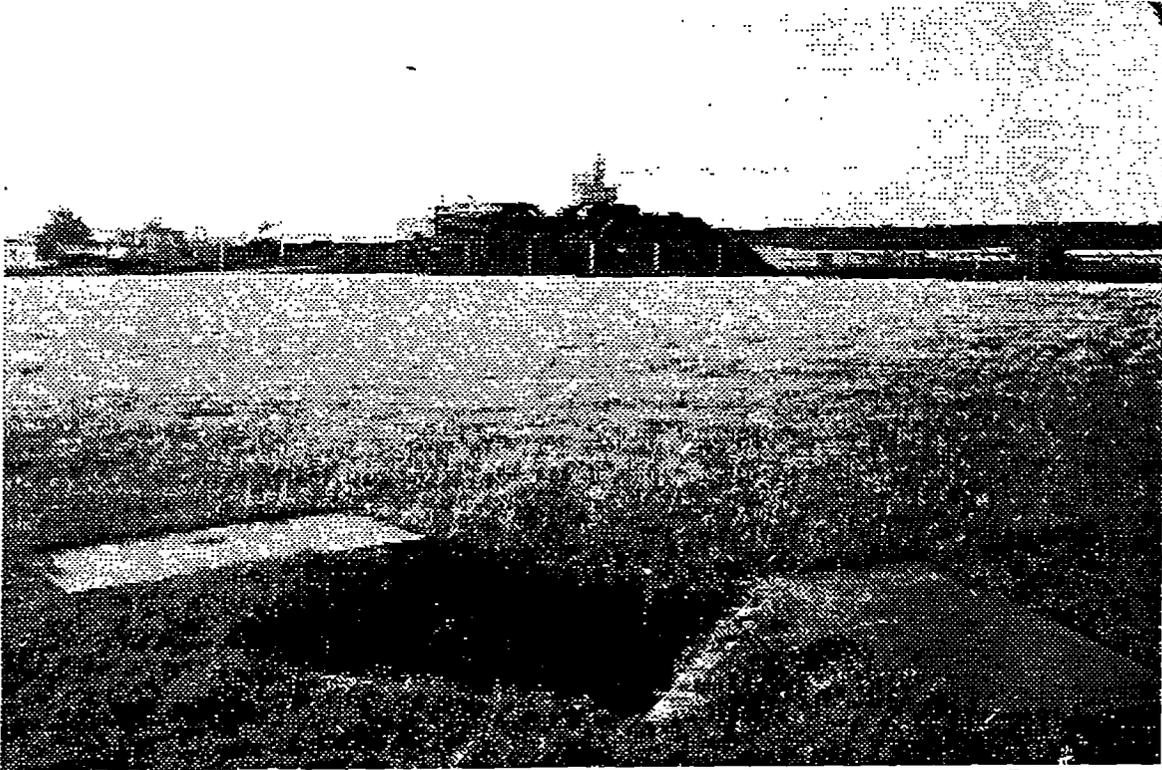
Photo 28: View of Day tank from 10" fuel line valve pit. 10" piping from valve pit to Day tank was removed.

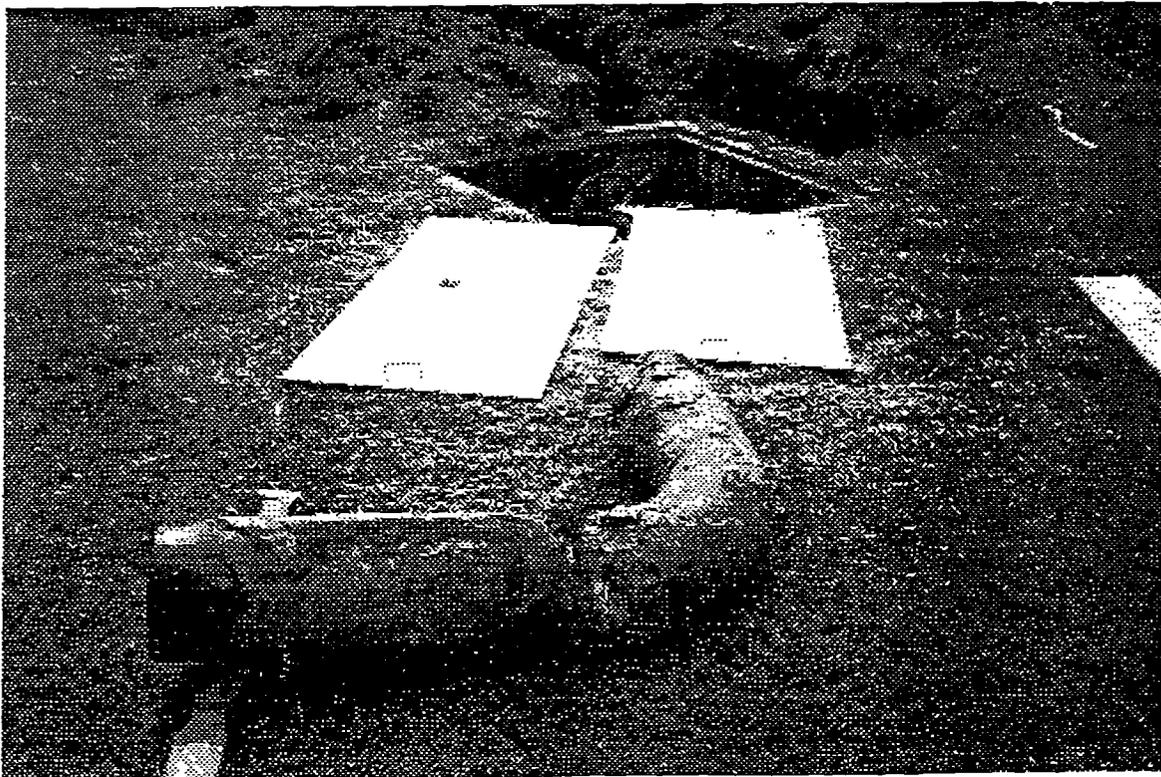
Photo 29: 10" coated steel pipe removed from valve pit and trench. Piping was in good shape.

The piping for Day Tank # 2 was in good condition and had no holes or pitting.

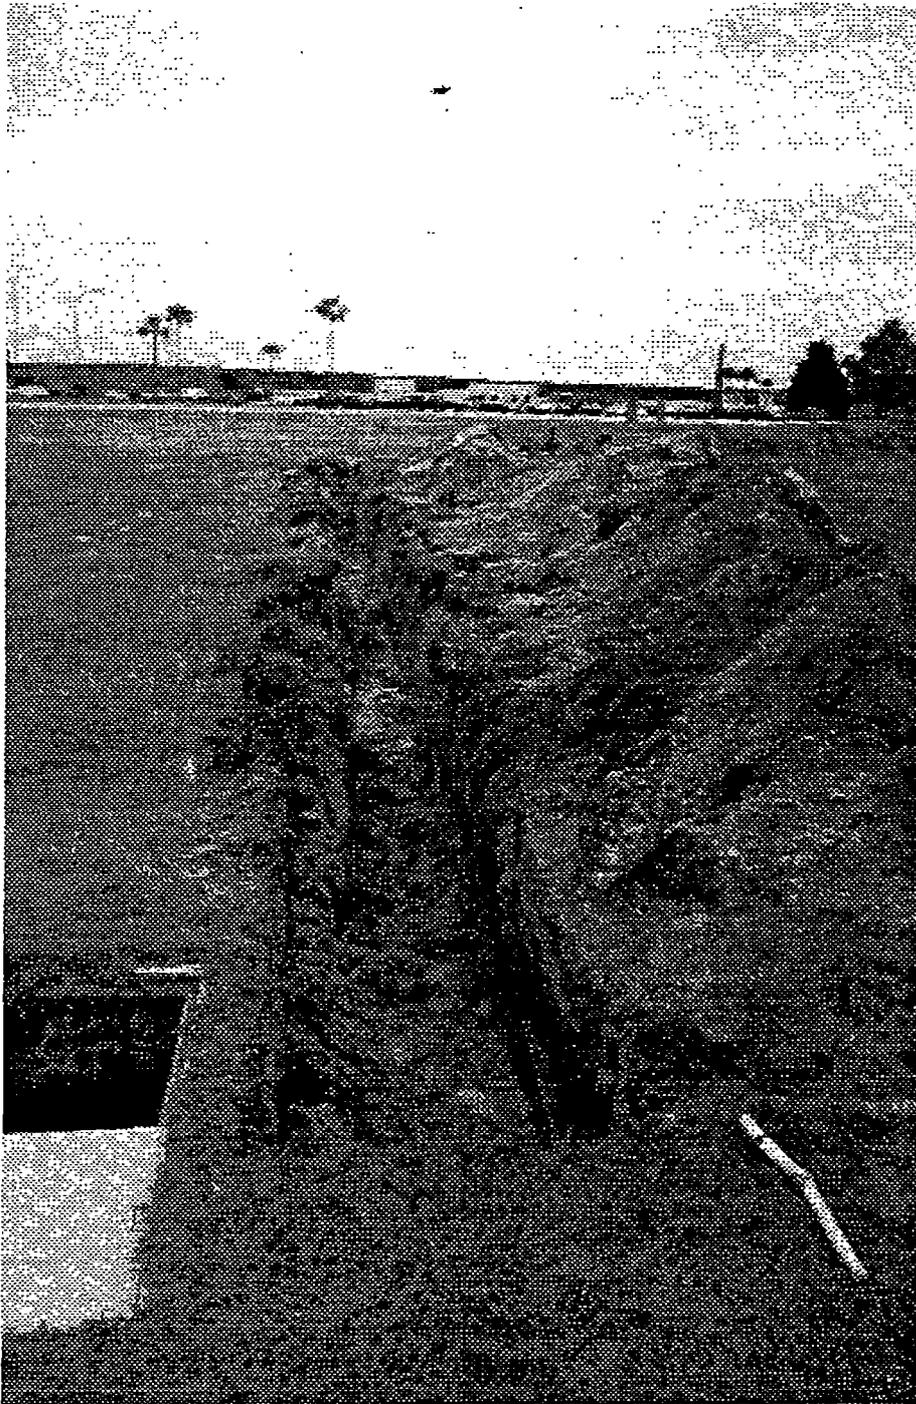
Photo 30: Piping trench heading east from valve pit. See Site Map 4 for FID readings in the trench.

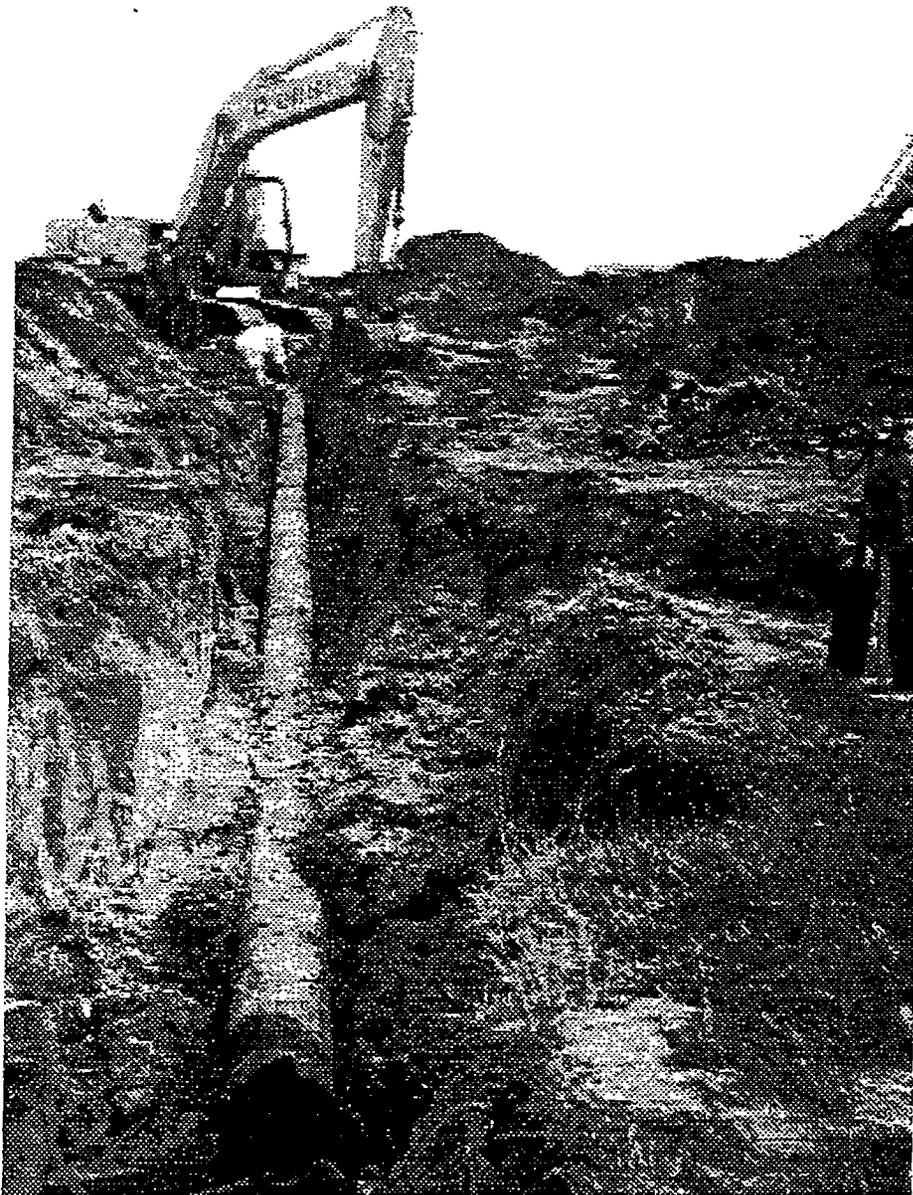
Photo 31: Removal of 10" fuel supply line heading south towards Day tank.
FID readings in this trench ranged from 60 ppm to 1500 ppm.

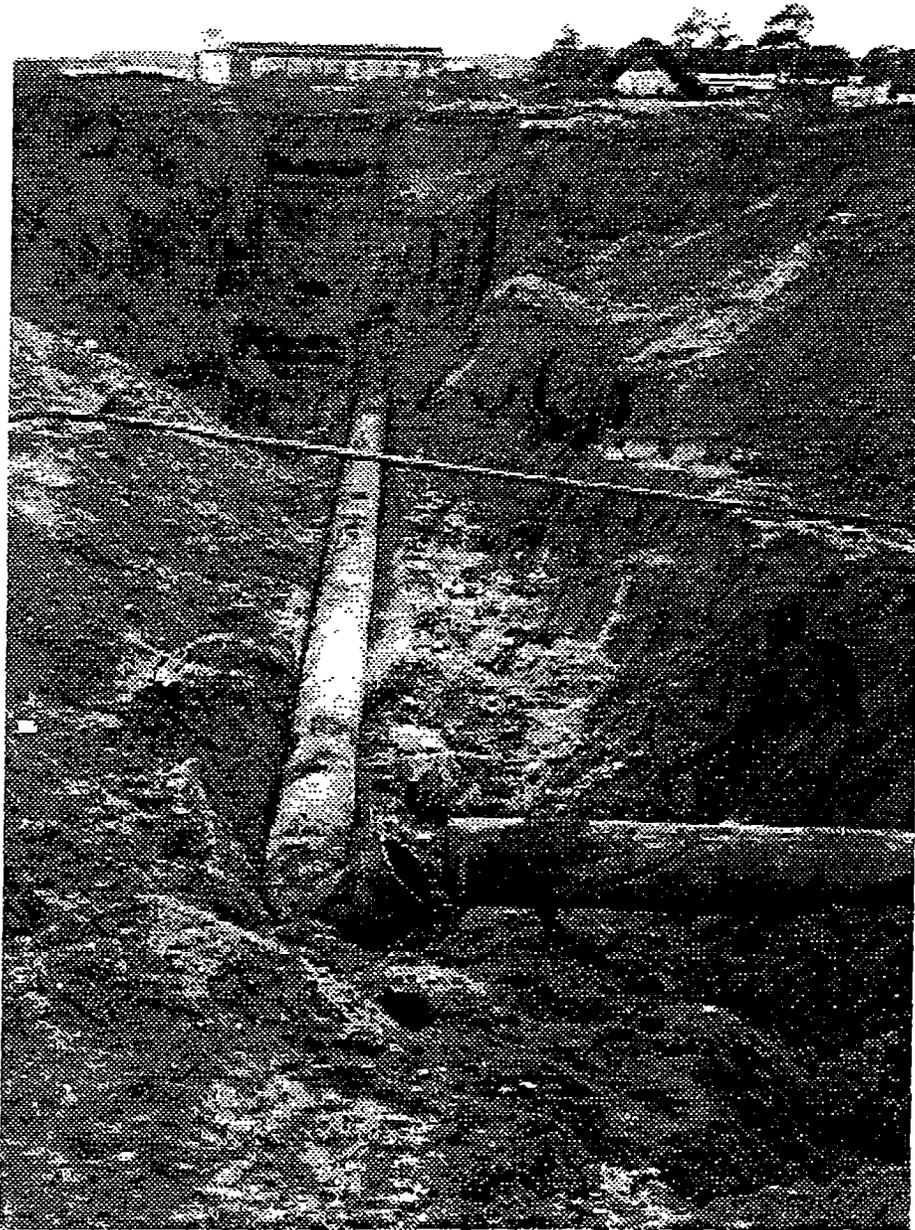
Photo 32: Removal of 10" fuel supply line heading west towards Day tank.

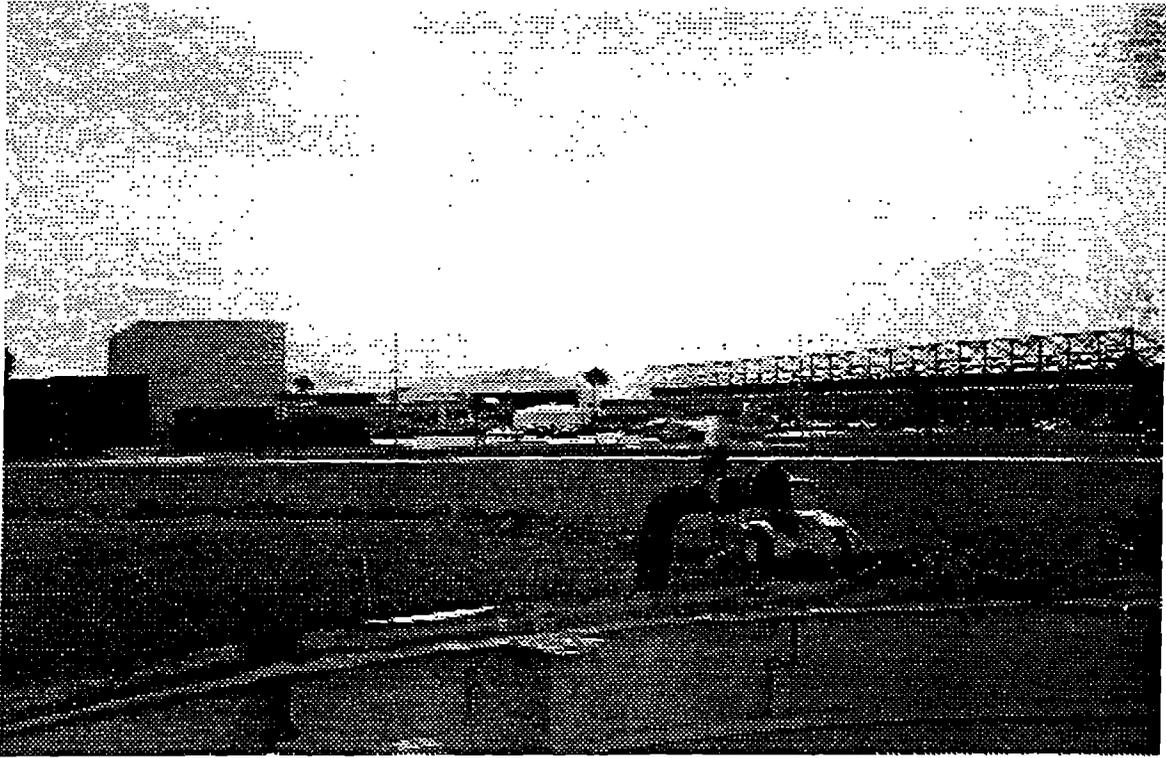
Photo 33: View of 10" piping over tank wall as well as piping trench in the background.

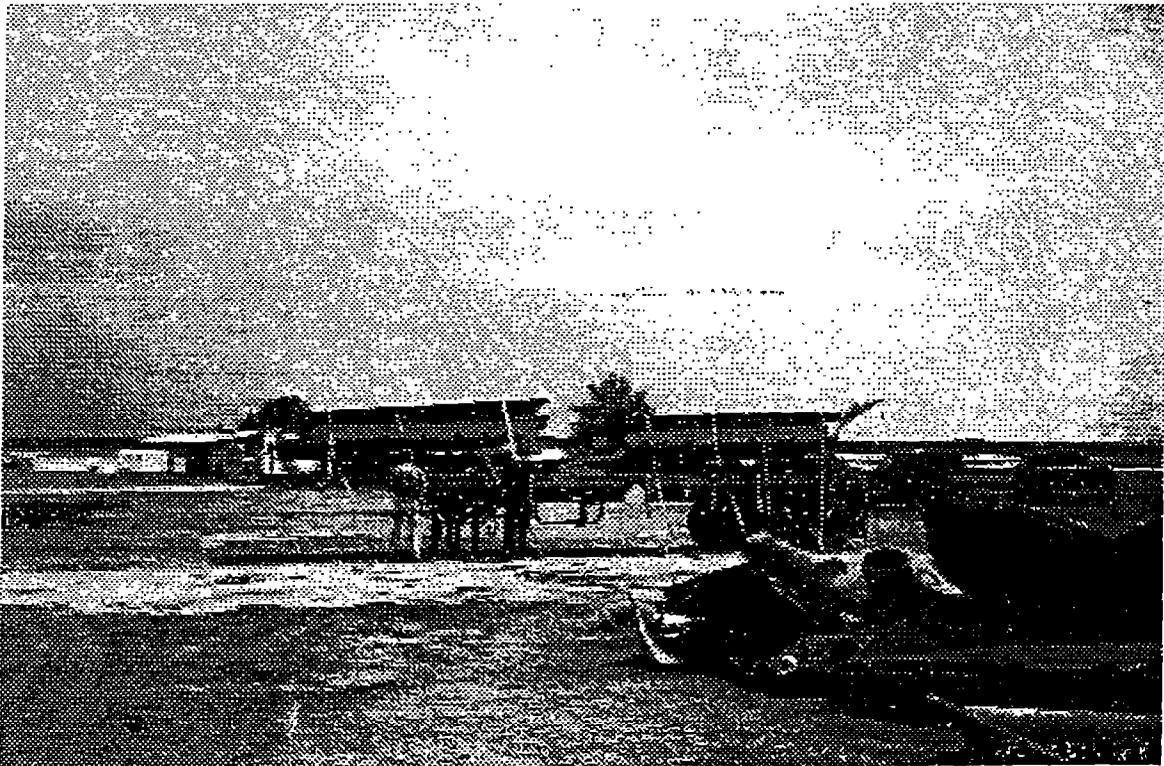
Photo 34: Steel sections of tank and piping being loaded on flatbeds for recycling.

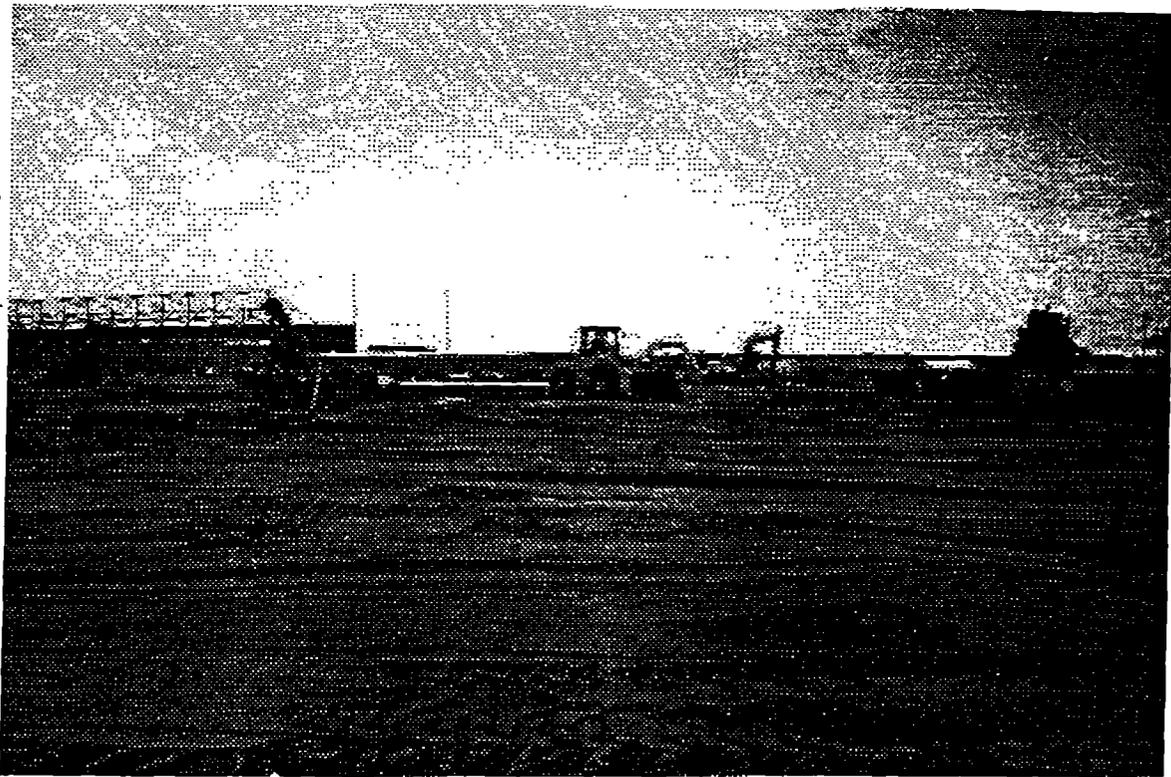
Photo 35: The Day tank site. looking northeast, during restoration.

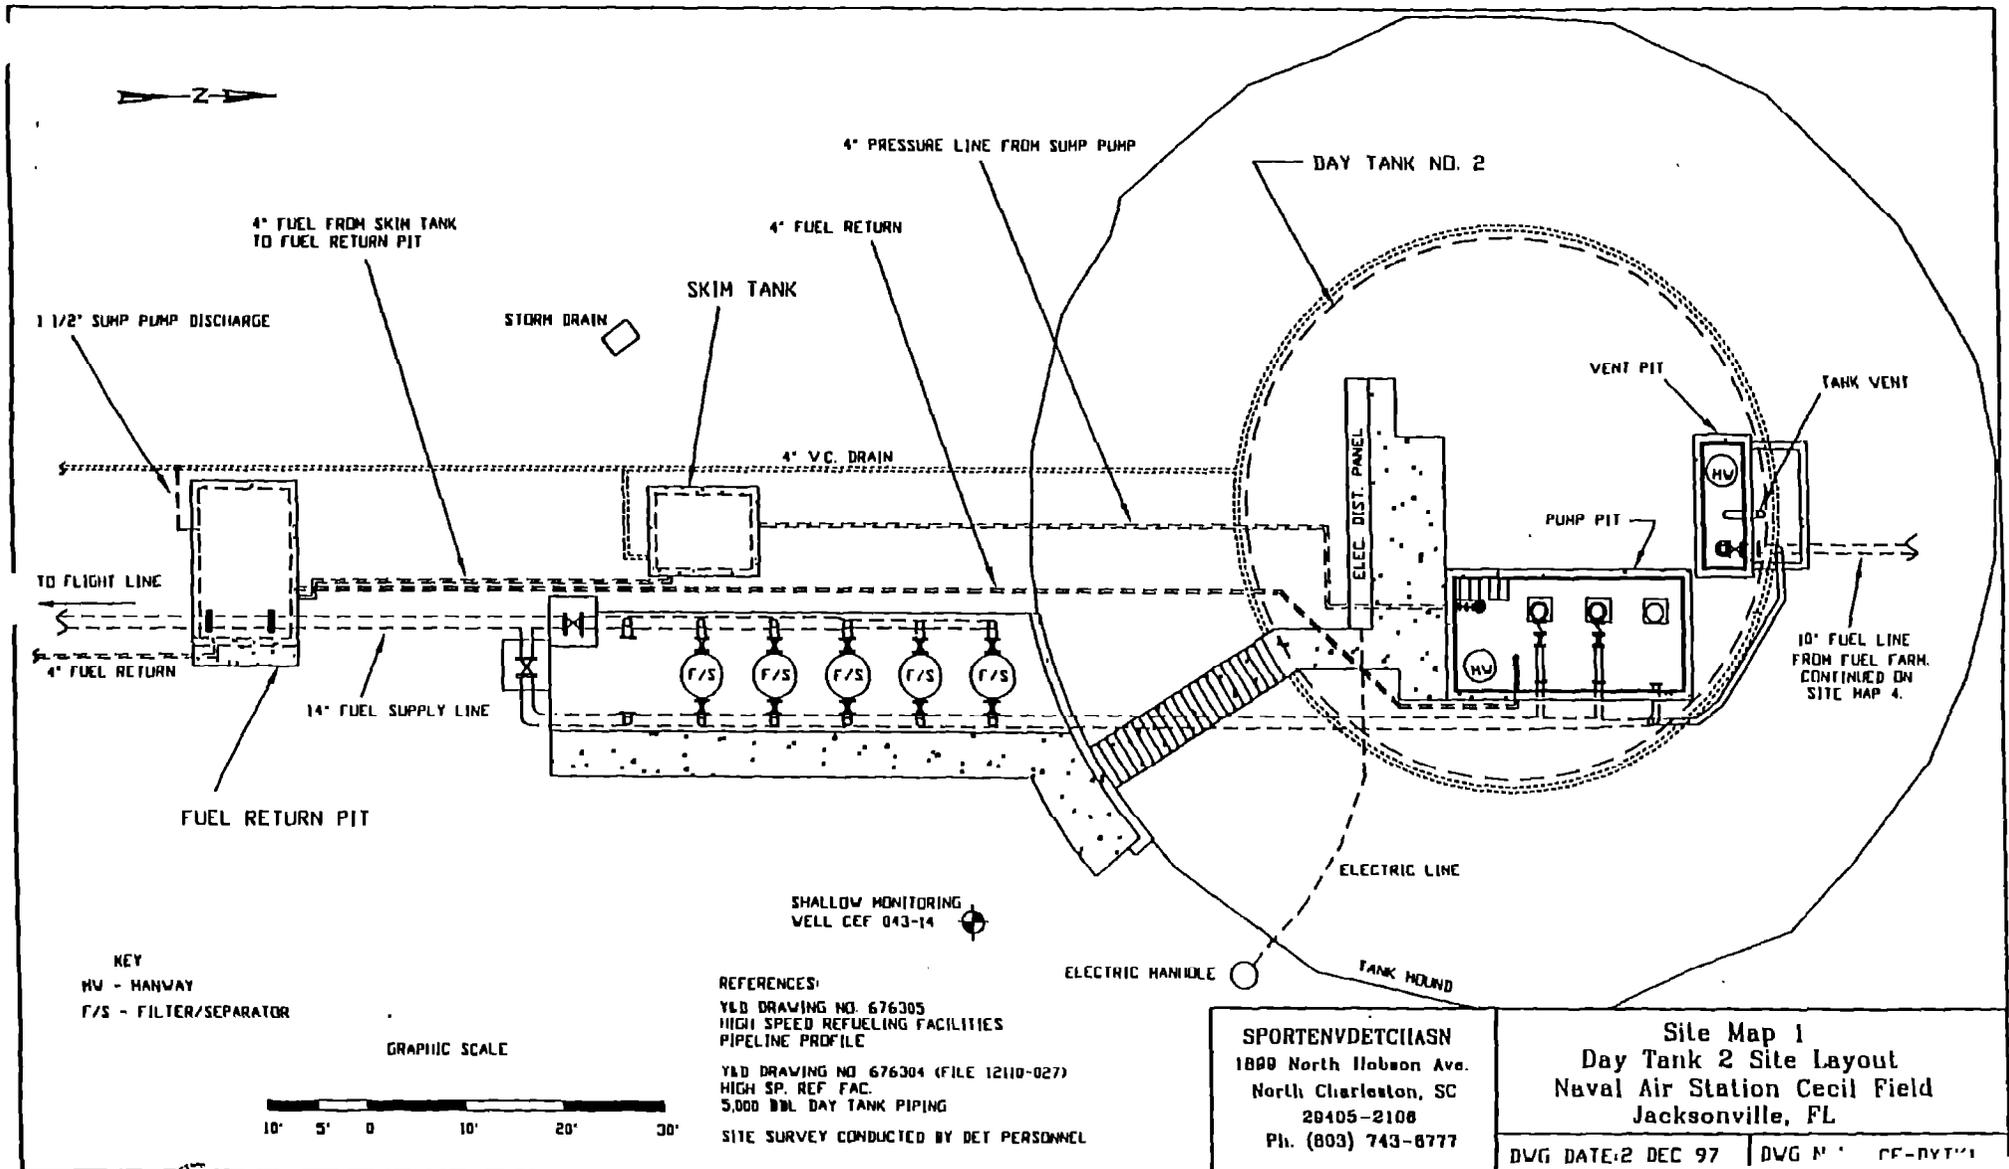
Site Map 1
Day Tank 2 Site Layout
Naval Air Station Cecil Field
Jacksonville, FL
DWG DATE: 2 DEC 97 | DWG NO: CE-DYT-1

10" FUEL LINE FROM FUEL FARM. CONTINUED ON SITE MAP 4.

14" FUEL SUPPLY LINE

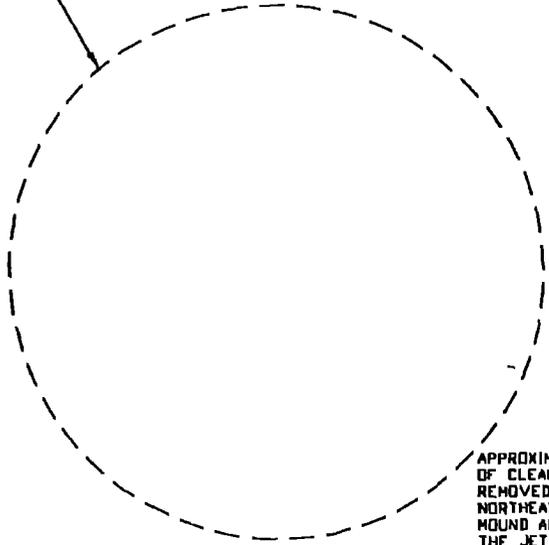
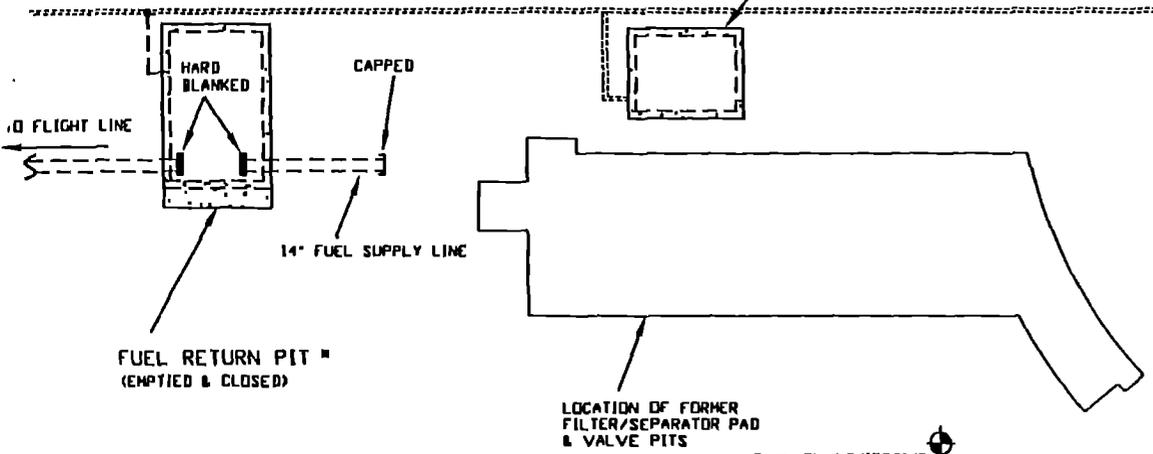
APPROXIMATELY 1800 CUBIC YARDS
OF CLEAN SOIL (<50 ppm) WAS
REMOVED FROM THE NORTH AND
NORTHEAST SIDES OF THE TANK
MOUND AND USED AS BACKFILL AT
THE JET ENGINE TEST CELL SITE.

* FUEL RETURN PIT & SKIM TANK,
WITH CONNECTING PPG, LEFT IN PLACE, WITHOUT BACKFILL,
FOR FUTURE USE BY THE ARMY, PER
MR. BRIAN KIZER (SOUTHDIV) & MR. RICH DONAHUE (BTC).

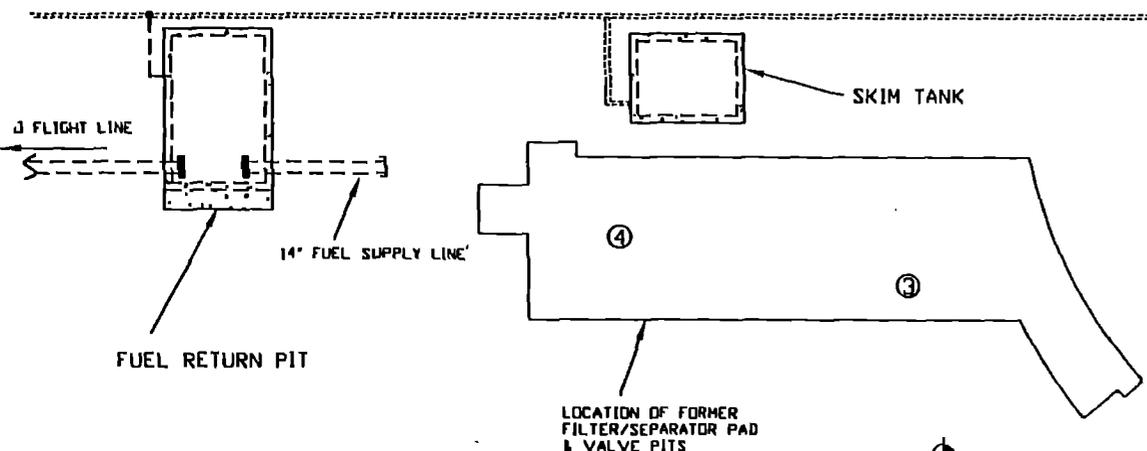
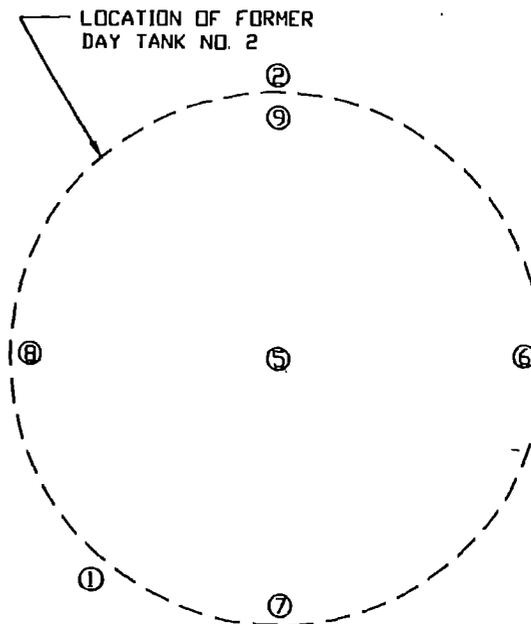
Site Map 3
Day Tank 2 OVA/FID Sample Loc.
Naval Air Station Cecil Field
Jacksonville, FL

SAMPLE #	DEPTH BGSL	DATE	TIME	READING (ppm)
1	1' 6"	8/13	1030	3,791
2	1' 6"	8/22	1430	250
3 ^m	1'	8/24	1120	7,828
4 ^m	1'	8/24	1130	7,350
5	4'	8/27	0815	385
6	4'	8/27	0820	6,583
7	4'	8/27	0825	6,563
8	4'	8/27	0830	3,639
9	4'	8/27	0835	4,529

* READINGS 3 & 4 WERE TYPICAL OF THE SOIL IN THE FUEL RETURN PIT/SKIM TANK AREA. ALL SOIL HAD A VERY STRONG PETROLEUM ODOR.
