UNDERGROUND STORAGE TANK ASSESSMENT REPORT FOR DAY TANK 2 AT SOUTH
FUEL FARM NAS CECIL FIELD FL
8/29/1997
ENVIRONMENTAL DETACHMENT CHARLESTON

DAY TANK 2 (TANK 342DT2)

SPORTENVDETHASN
SUPSHIP PORTSMOUTH ENVIRONMENTAL DETACHMENT CHARLESTON
1899 NORTH HOBSON AVENUE
NORTH CHARLESTON, S.C. 29405-2106
Underground Storage Tank (UST) Assessment Report

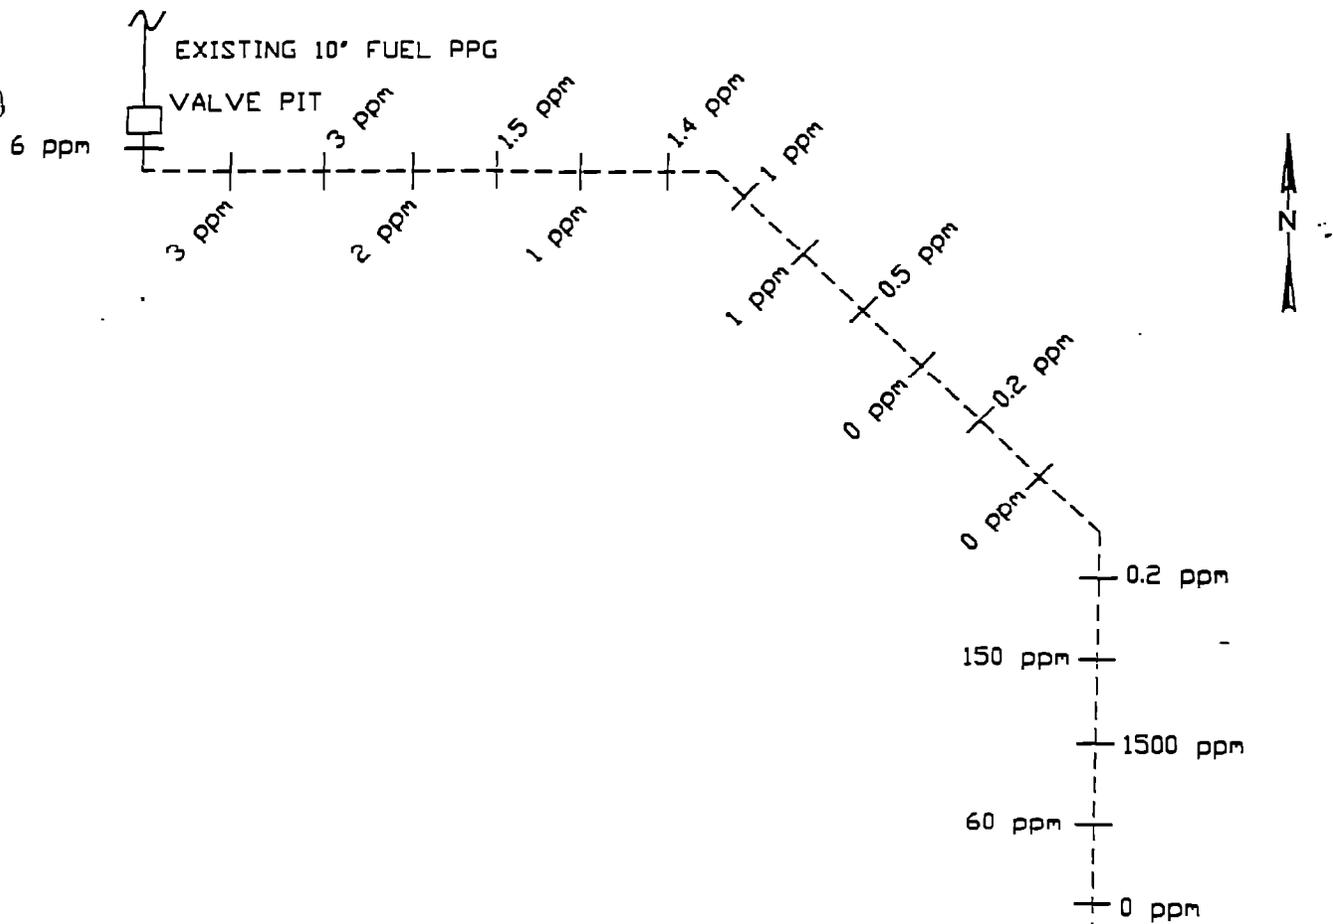
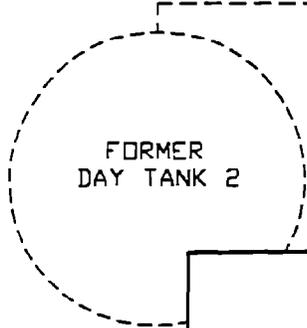
XX ppm -- FLAME IONIZATION DETECTOR ORGANIC VAPOR ANALYZER READING. READINGS IN PPG TRENCH WERE TAKEN @ 3' BELOW GSL.
