FINAL RESOURCE CONSERVATION AND RECOVERY FACILITY INVESTIGATION WORK  
PLAN ZONE J CNC CHARLESTON SC  
9/10/1996  
ENSAFE/ ALLEN AND HOSHALL

**COMPREHENSIVE LONG-TERM  
ENVIRONMENTAL ACTION NAVY  
NAVAL BASE CHARLESTON  
CHARLESTON, SOUTH CAROLINA  
CTO-029**

**FINAL  
ZONE J RFI WORK PLAN**

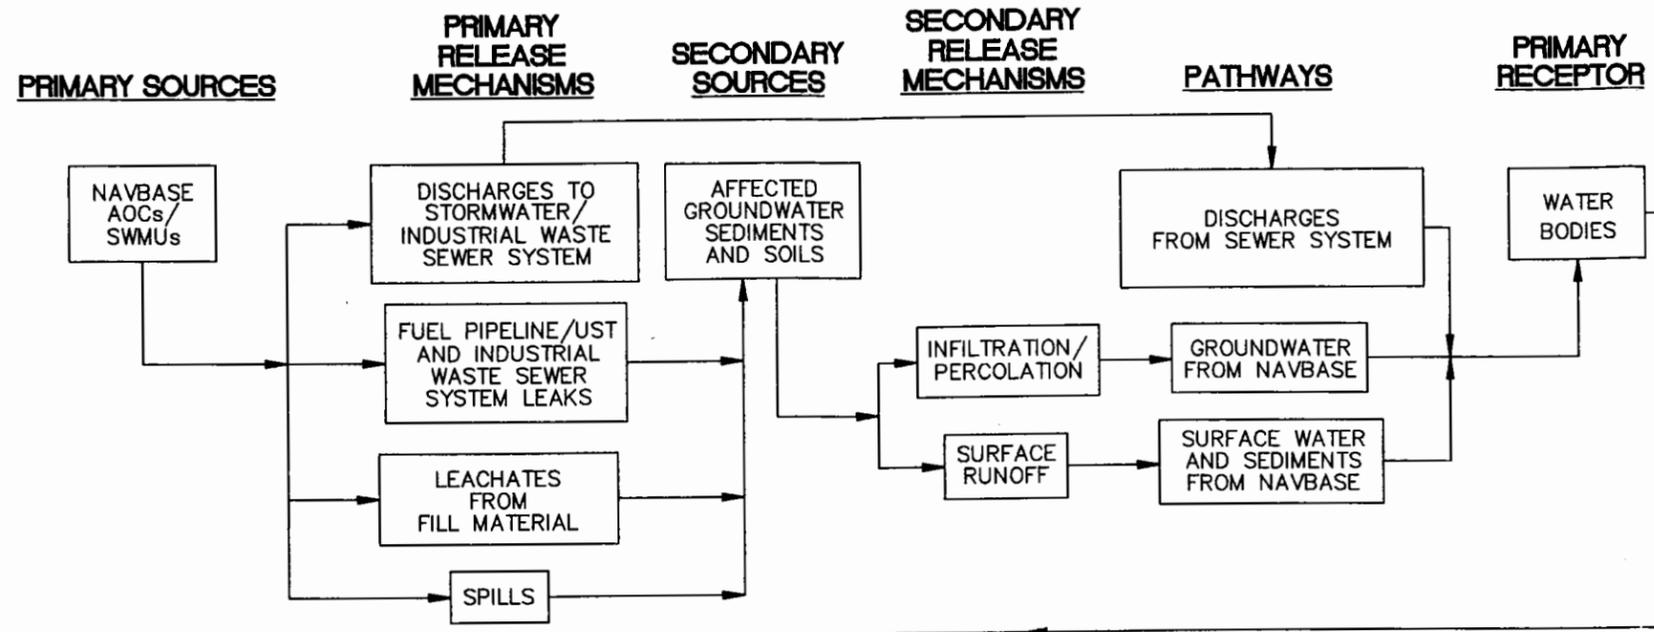
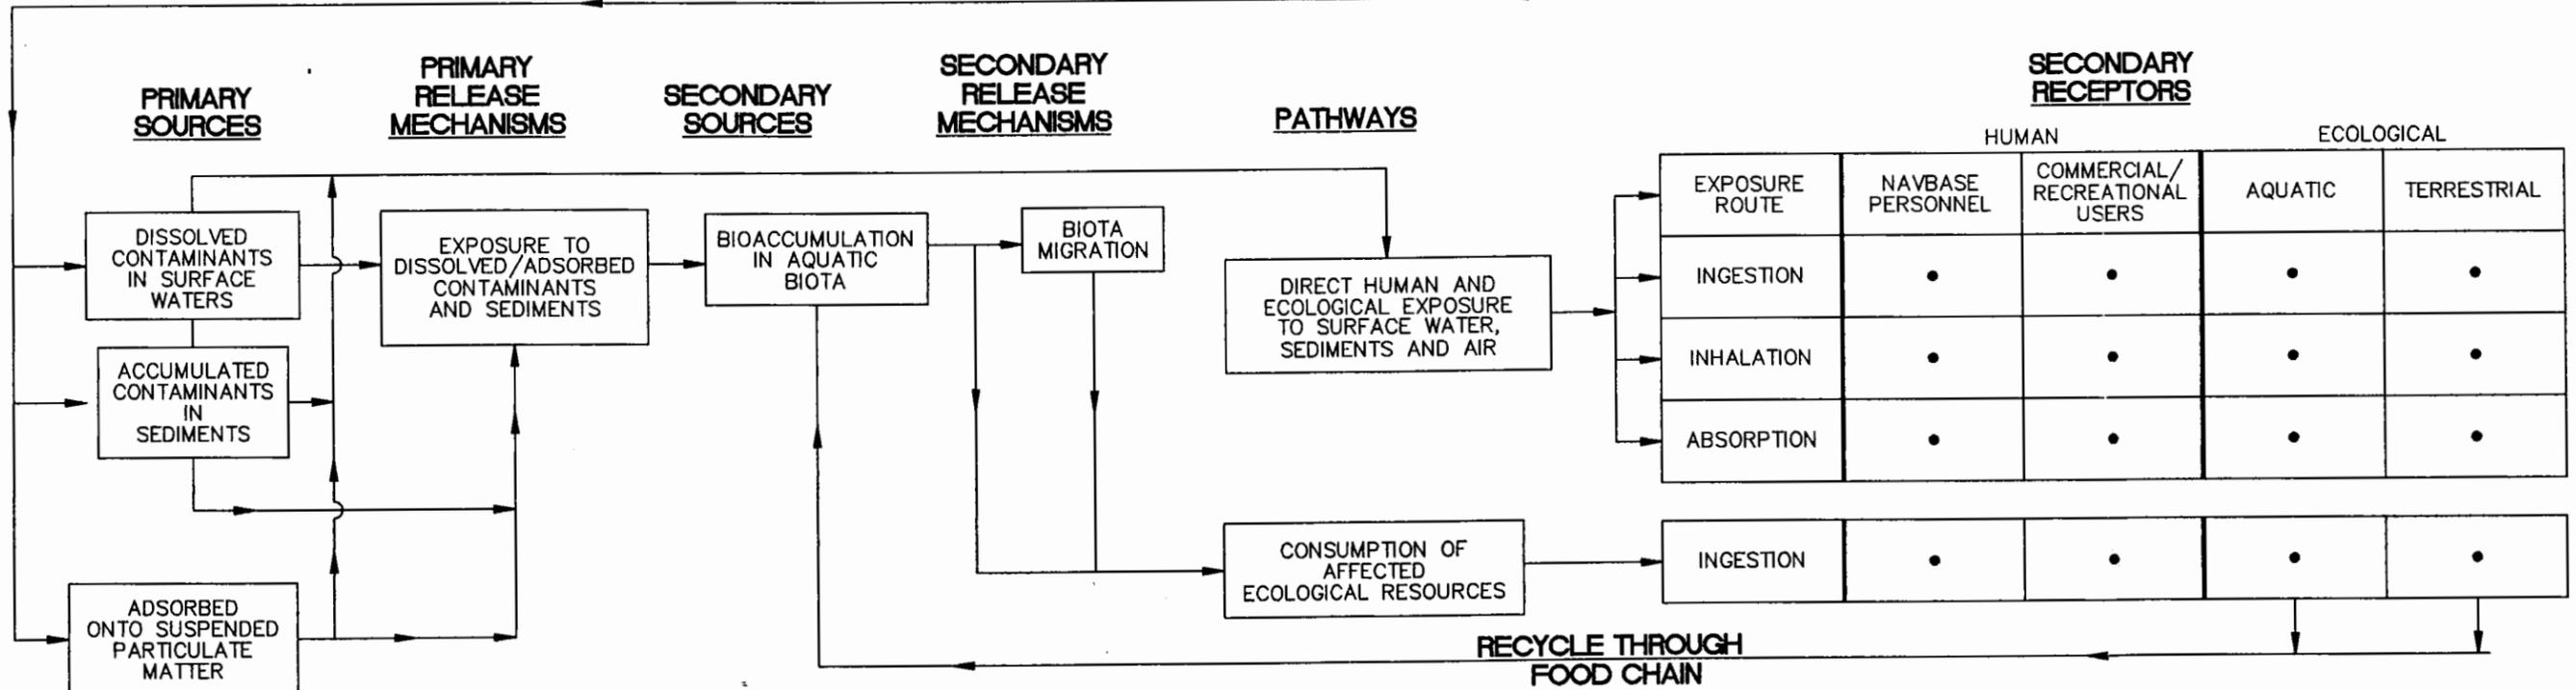
FIGURE 2-1  
CONCEPTUAL SITE MODEL  
WATER BODIES

Upon introduction of contaminants into the surface water system (through direct discharge at aquatic AOCs or indirect from land-based AOC/SWMUs), they may dissolve into the water column, adsorb onto suspended particulate matter in the water column, or accumulate in the benthic zone. The release mechanism is simply the exposure of receptors to these media. Currents, tides, and flushing actions of the water bodies also act as release mechanisms, transporting both the dissolved and adsorbed contaminants through the water and sediment.

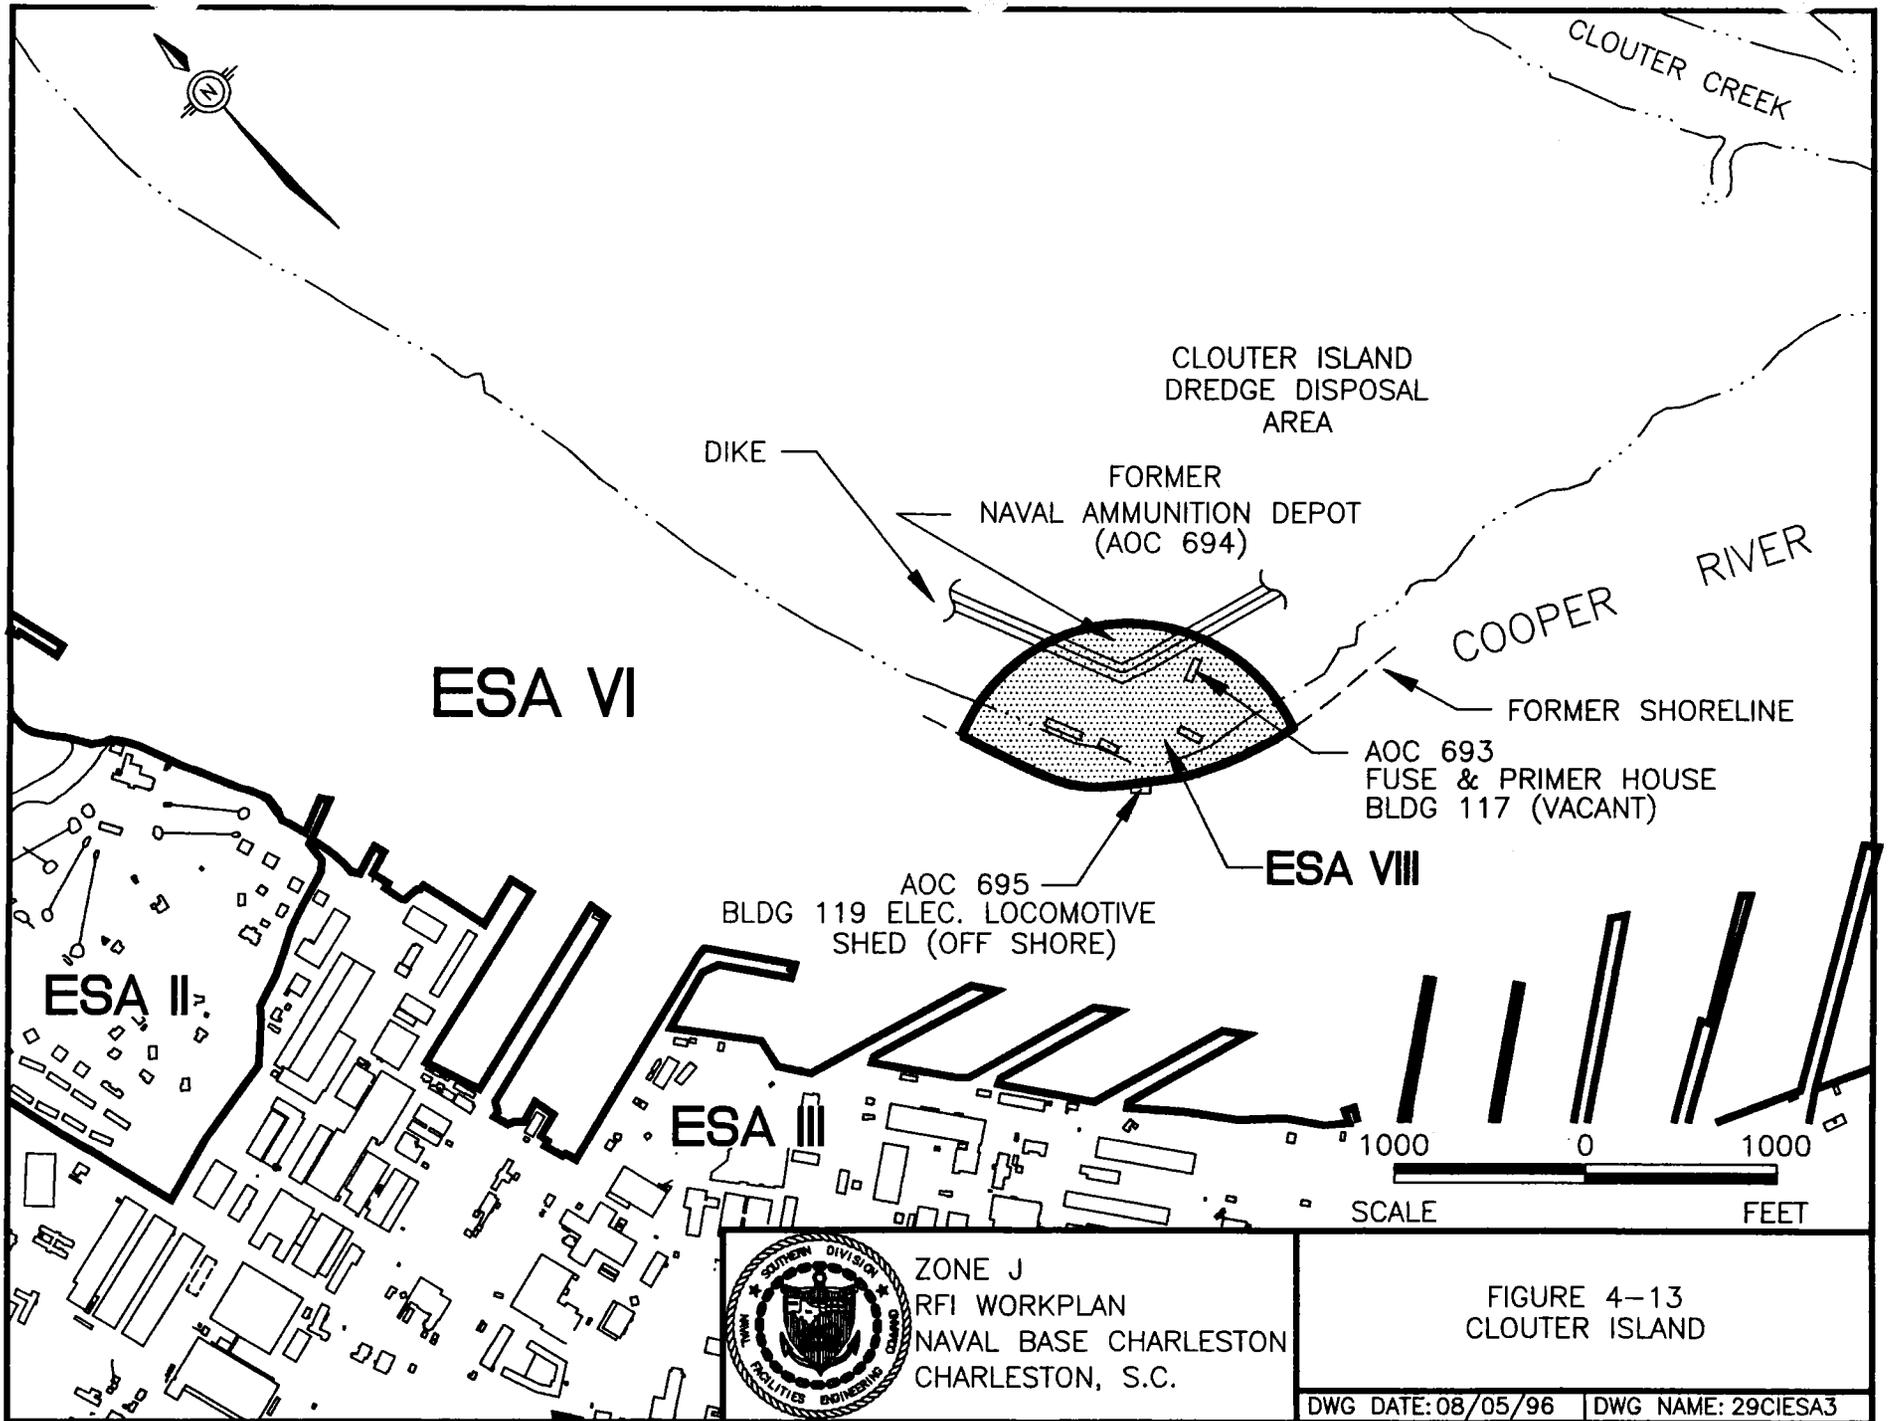
FIGURE 4-13  
 CLOUTER ISLAND

As a noncontiguous property, Clouter Island is the only ESA in which the scope of the ERA is limited to AOC-related habitats; therefore, a PSA of the entire island's ecology was not performed. Thus, the Zone J PSA of Clouter Island addressed only the ecological components associated with the three AOCs on the wooded southwestern portion of the island (AEC VIII; see Figure 4-13). These AOCs are all associated with the former Naval Ammunition Depot, (AOC 694/Zone K) and presently consists of one structure (Building 117), several large concrete foundations (from Buildings 102, 103, and 106), and a mound of demolition debris near Building 103, a former magazine. AOC 693, an abandoned Fuse and Primer House (Building 117), is the only structure associated with the former naval ammunition depot that remains intact. AOC 695, the former site of the Building 119 (Electric Locomotive Shed), is currently 50 feet offshore. Review of a 1939 map of the depot, this building was constructed on top of a railroad trestle which extended out from the shore apparently to allow rail access to supply and munition barges. The 1939 map shows the distance of Buildings 102 and 106 to the shoreline to be approximately 50 feet. The foundations of these buildings are now at the shoreline. The site of AOC 695 being underwater, it is uncertain if any of the structure and its associated wharf and trestle remains or if it was removed.

The ammunition depot's rail system, once servicing the entire complex, is no longer present. A portion of the railbed, however, is still evident as an unimproved shoreline road leading northward from the depot. Heavy earth-moving equipment, likely used for dike repair and maintenance, was parked on this road. Nearby, a second area was also used to stage such equipment as evidenced by two large diesel stains (soil had distinct diesel odor). A dredge line ran along side the unimproved road to the north and the base of the dike. Several truckloads of a dry, gray clay-like material, possibly dredge material from a dredge line maintenance event, have been dumped on and around the foundation of Building 102, the former Shell House, along with several discarded sections of dredge line. This foundation and the foundation of Building 106, the former Fixed Ammo Storehouse approximately 150 feet to the north, are more

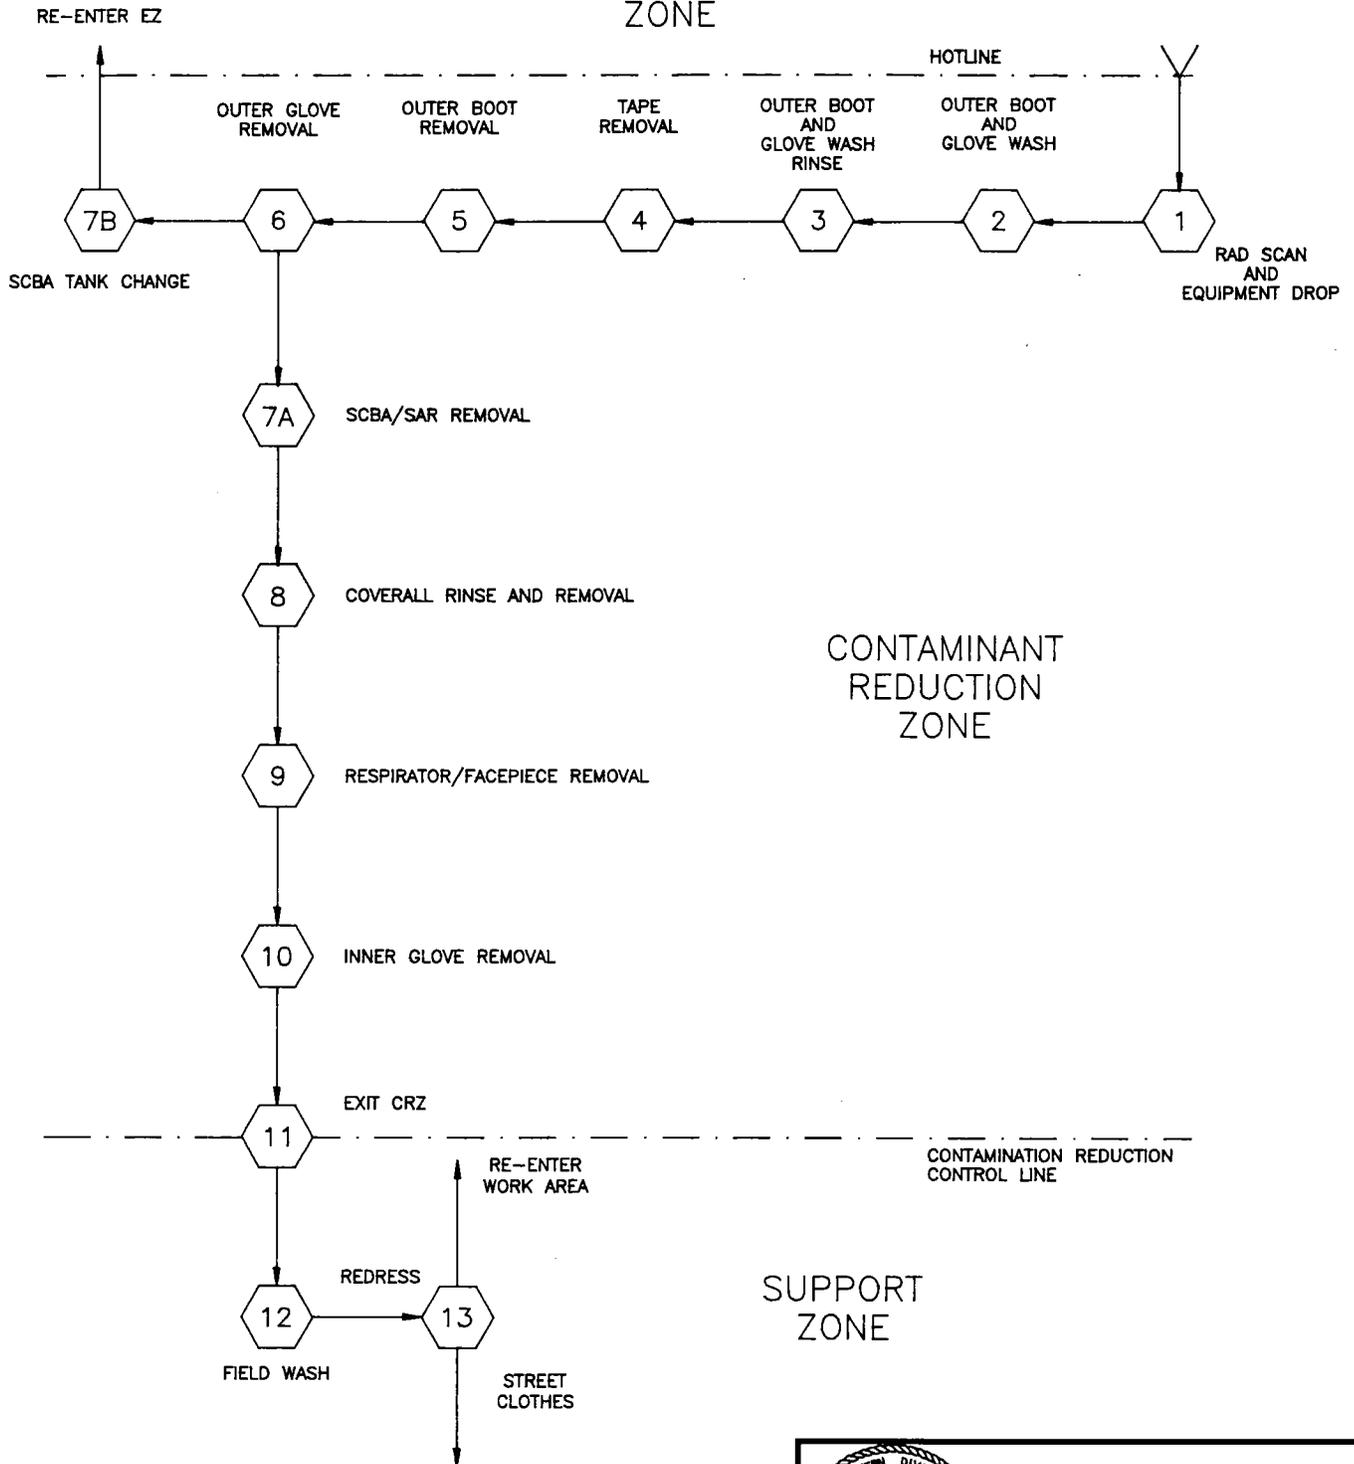
FIGURE 5-1  
FULL DECONTAMINATION LAYOUT  
LEVEL B PROTECTION

Workers shall use the following cleaning and decontamination procedures when exiting the EZ for lunch, at the end of their shift, or when work is completed for an EZ. Procedures for rest breaks, changing self-contained breathing apparatus (SCBA) tanks and cartridges are described
