RESOURCE CONSERVATION AND RECOVERY ACT FACILITY INVESTIGATION REPORT  
ADDENDUM CORRECTIVE MEASURES STUDY WORK PLAN COMBINED SOLID WASTE  
MANAGEMENT UNIT 23 (SWMU 23) ZONE E CNC CHARLESTON SC  
11/27/2002  
CH2M HILL

## RFI Report Addendum and CMS Work Plan Combined SWMU 23. Zone E

*Revision 0  
Contract N62467-99-C-0960  
158814.ZE.PR.01*

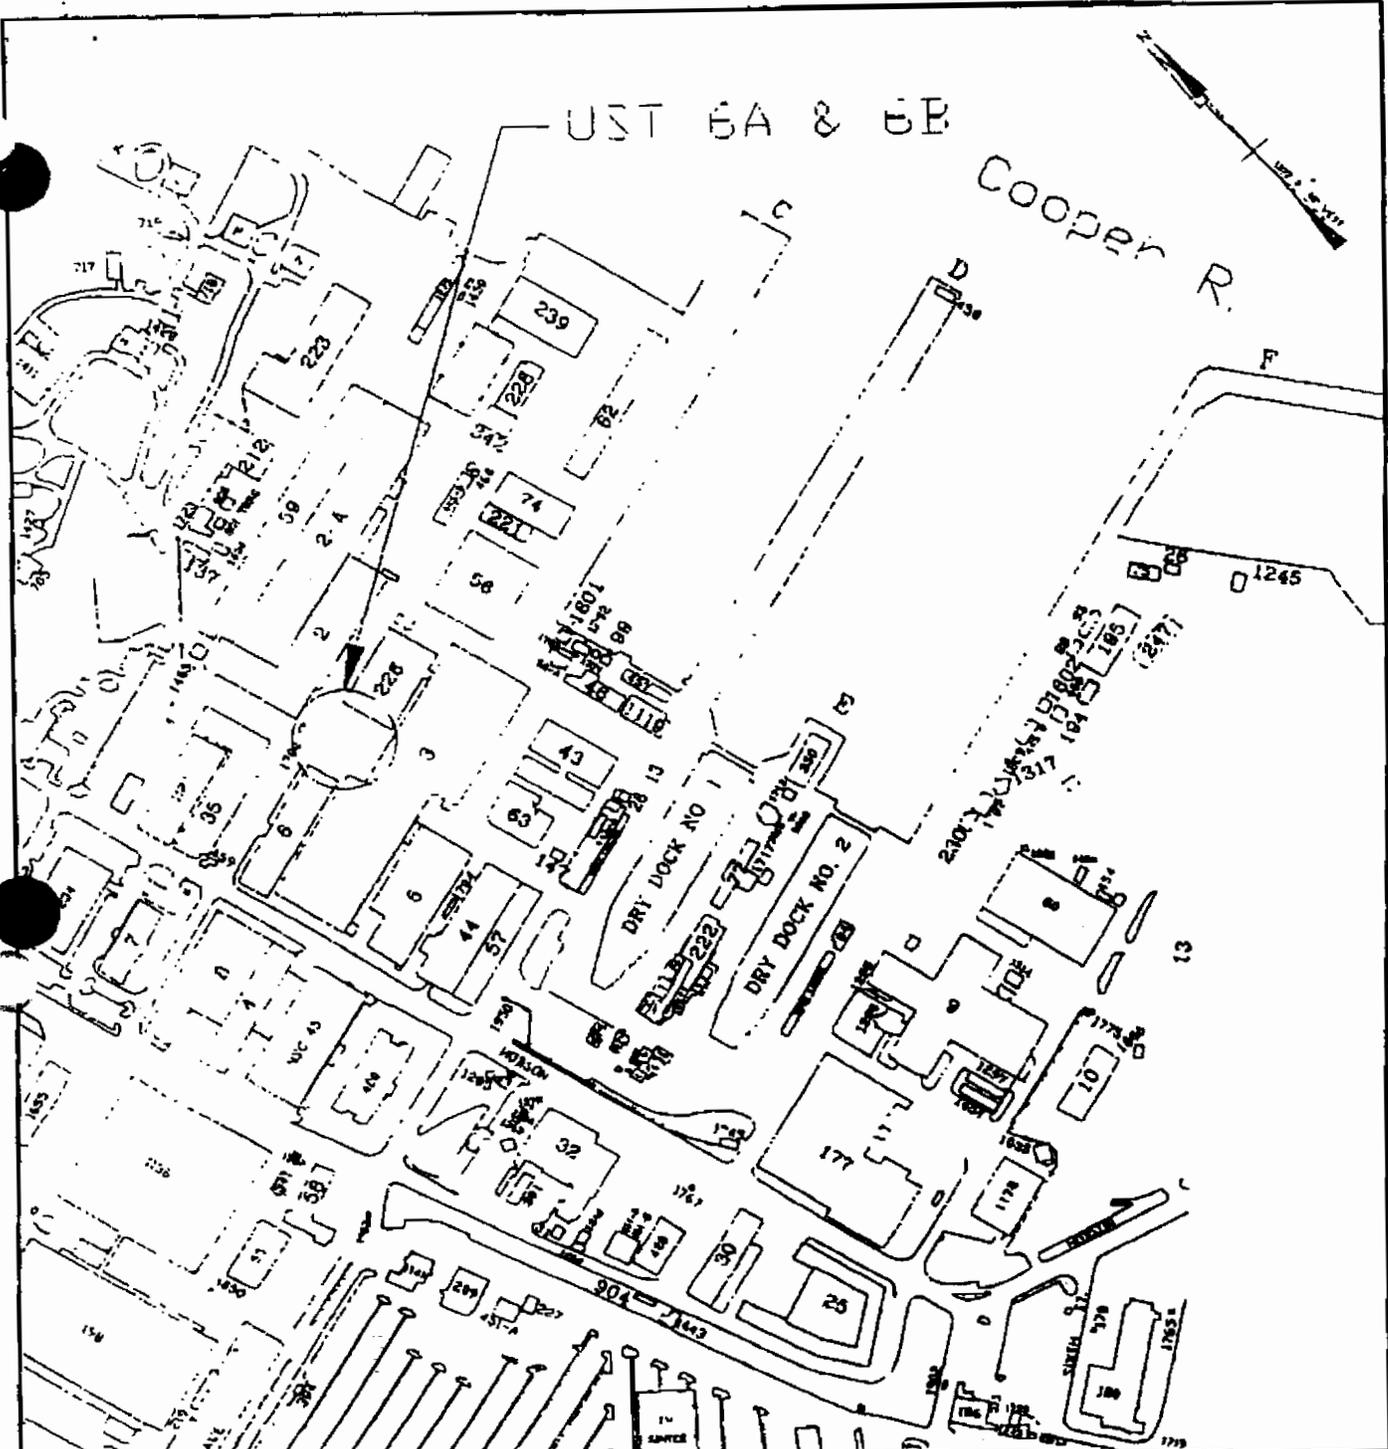
UST 6A & 6B

Several holes of 1/8" or less diameter were found in the upper portion of tanks 6A and 6B. The holes were not discernable until the tanks were cut open for cleaning and light was observed penetrating them from inside.

Although no holes were found in the pipe runs, they were heavily corroded throughout. Also, portions of pipe run excavation possessed a strong petroleum odor. See Map 3.
