INTERIM MEASURE WORK PLAN COMBINED SOLID WASTE MANAGEMENT UNIT 14  
(SWMU 14) ZONE H CNC CHARLESTON SC  
5/21/2001  
CH2M HILL

## Combined SWMU 14, Zone H

***Charleston Naval Complex  
North Charleston, South Carolina***

***Revision 1  
Contract N62467-99-C-0960***

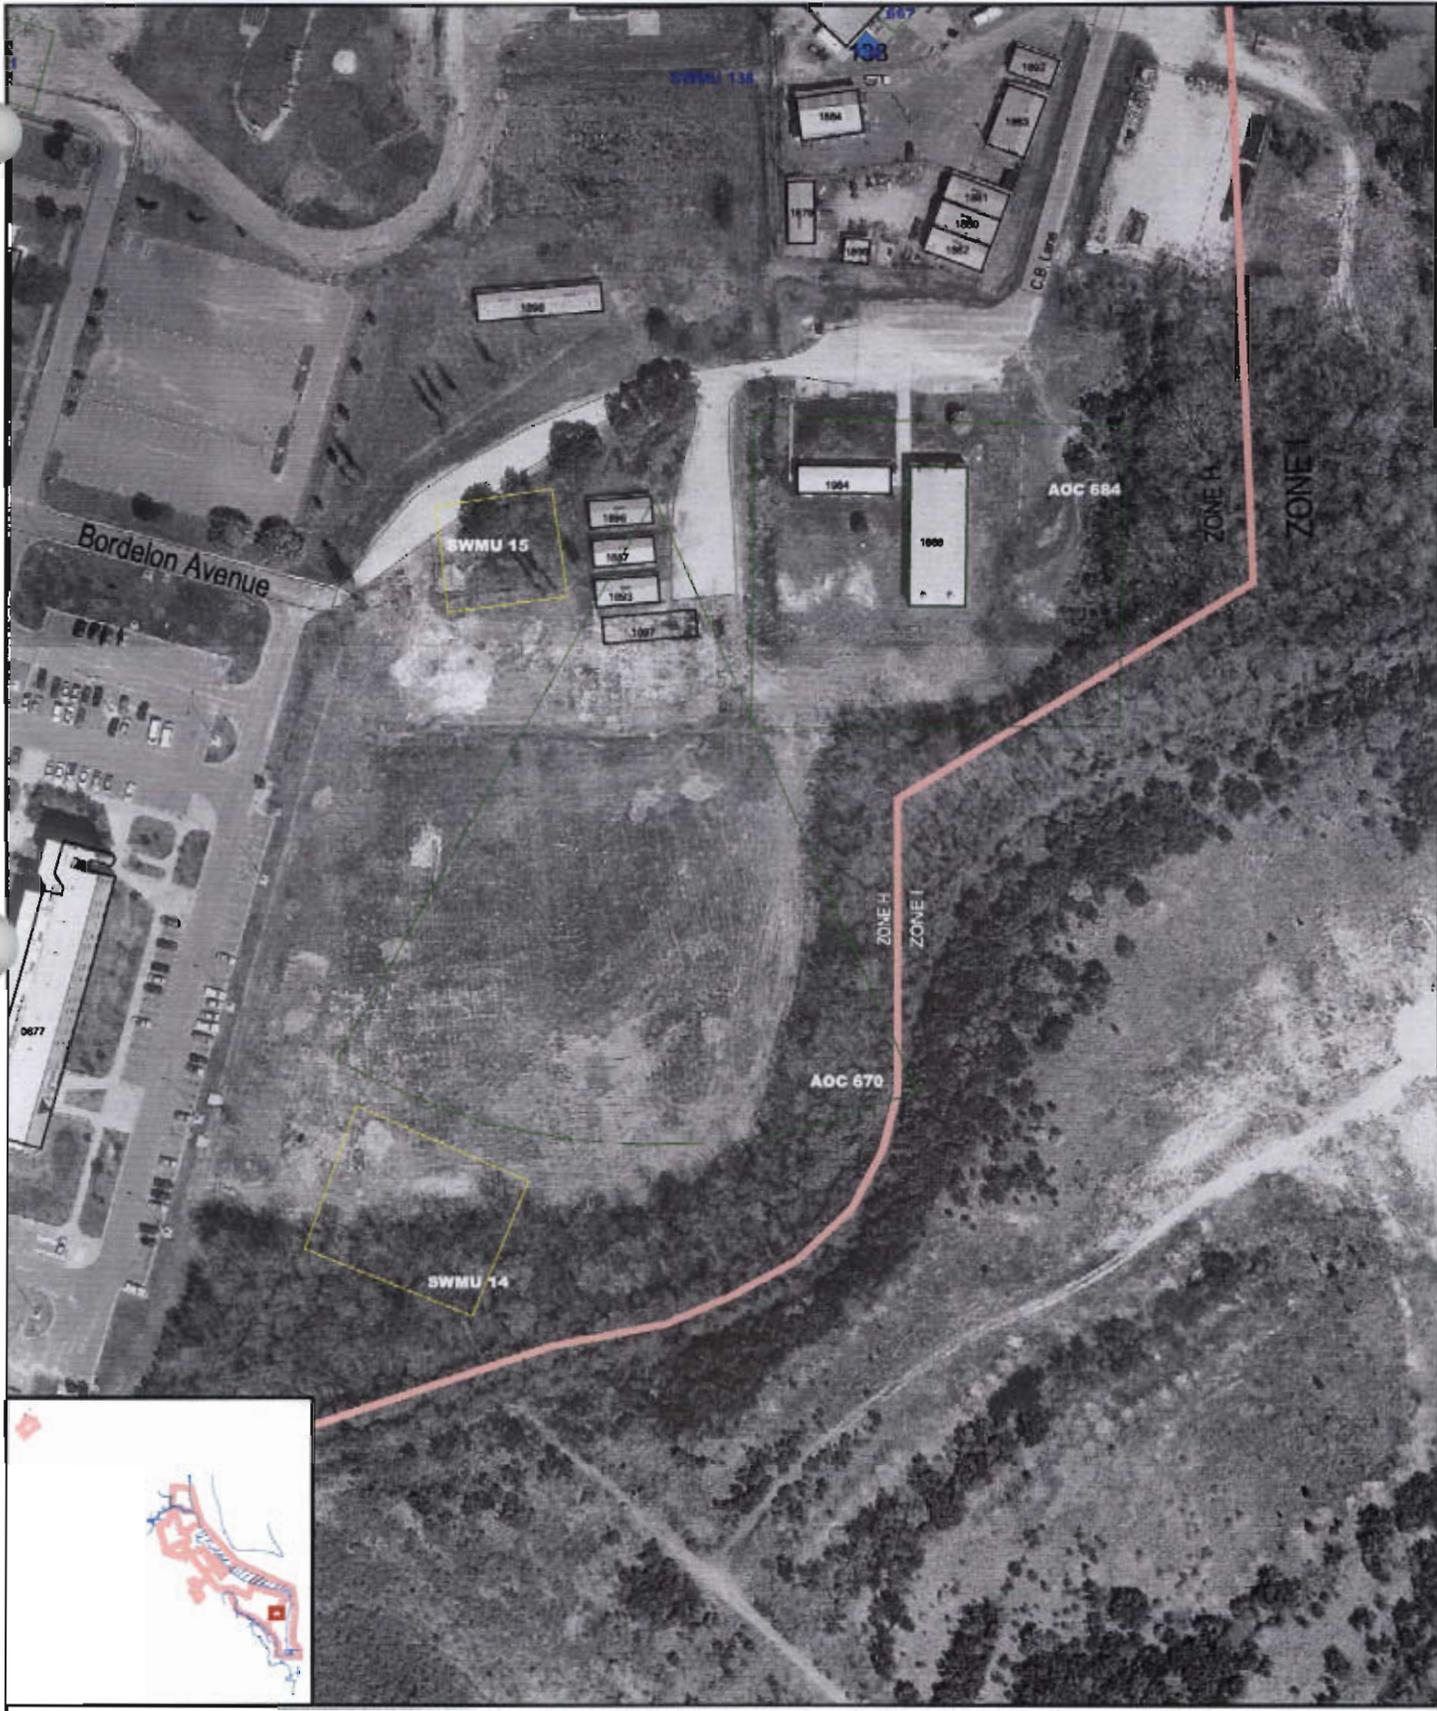
**Figure 1-1**  
 Site Location  
 Combined SWMU 14, Zone H  
 Charleston Naval Complex

Combined SWMU 14 is located in the eastern portion of Zone H at the CNC. The Combined SWMU 14 area encompasses SWMU 14, SWMU 15, Area of Concern (AOC) 670, and AOC 684. The locations of these SWMUs and AOCs are shown on Figure 1-1.

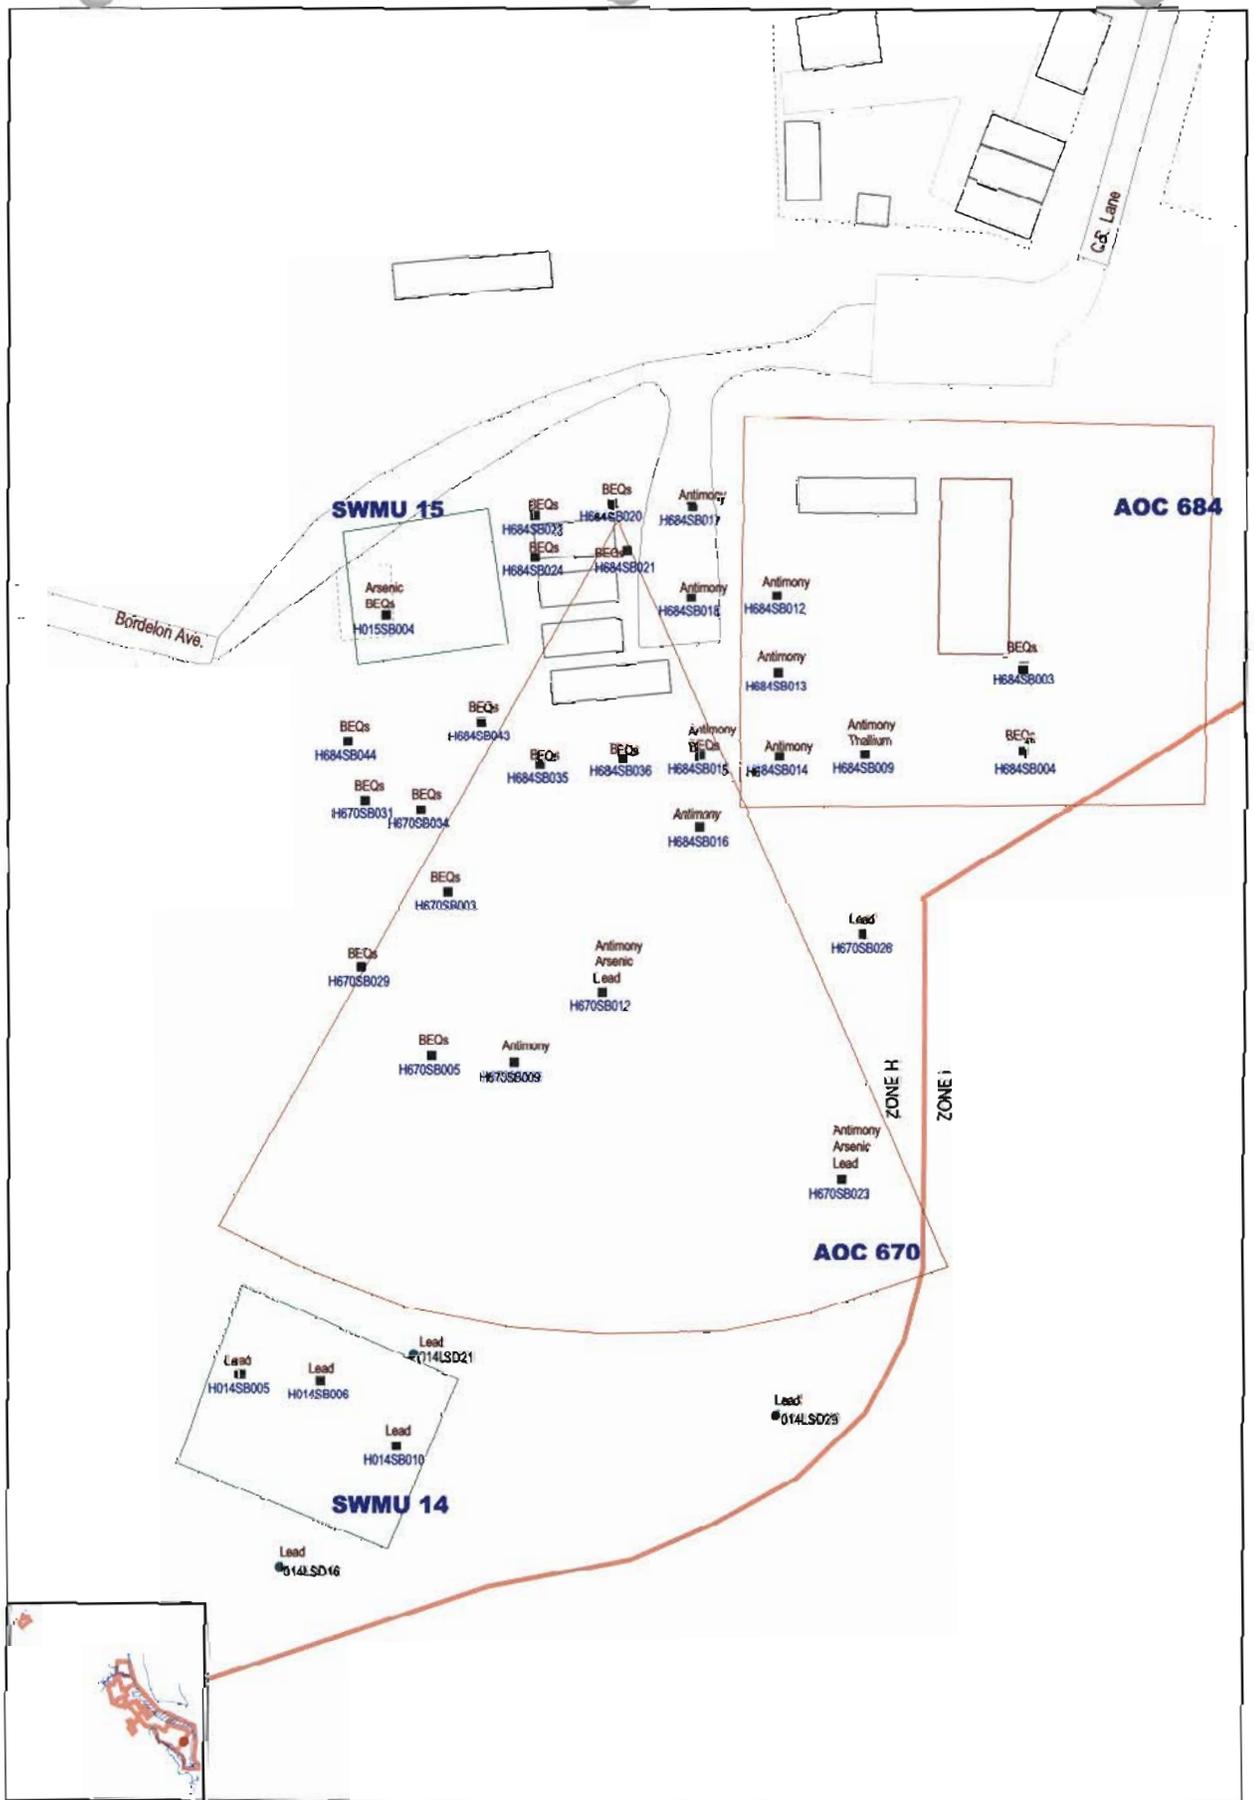
**Figure 1-3**  
 Soil COCs and Proposed IM Removal Locations  
 Combined SWMU 14, Zone H  
 Charleston Naval Complex

29 Figure 1-3 shows surface soil locations that indicate the presence of COCs which were  
30 identified during the RFI, the Draft CMS, and after supplemental lead shot distribution  
31 sampling conducted by EnSafe on the southern side of Combined SWMU 14.

Locations targeted for surface soil removal and the COCs that are targeted for removal at these locations are shown on Figure 1-3.

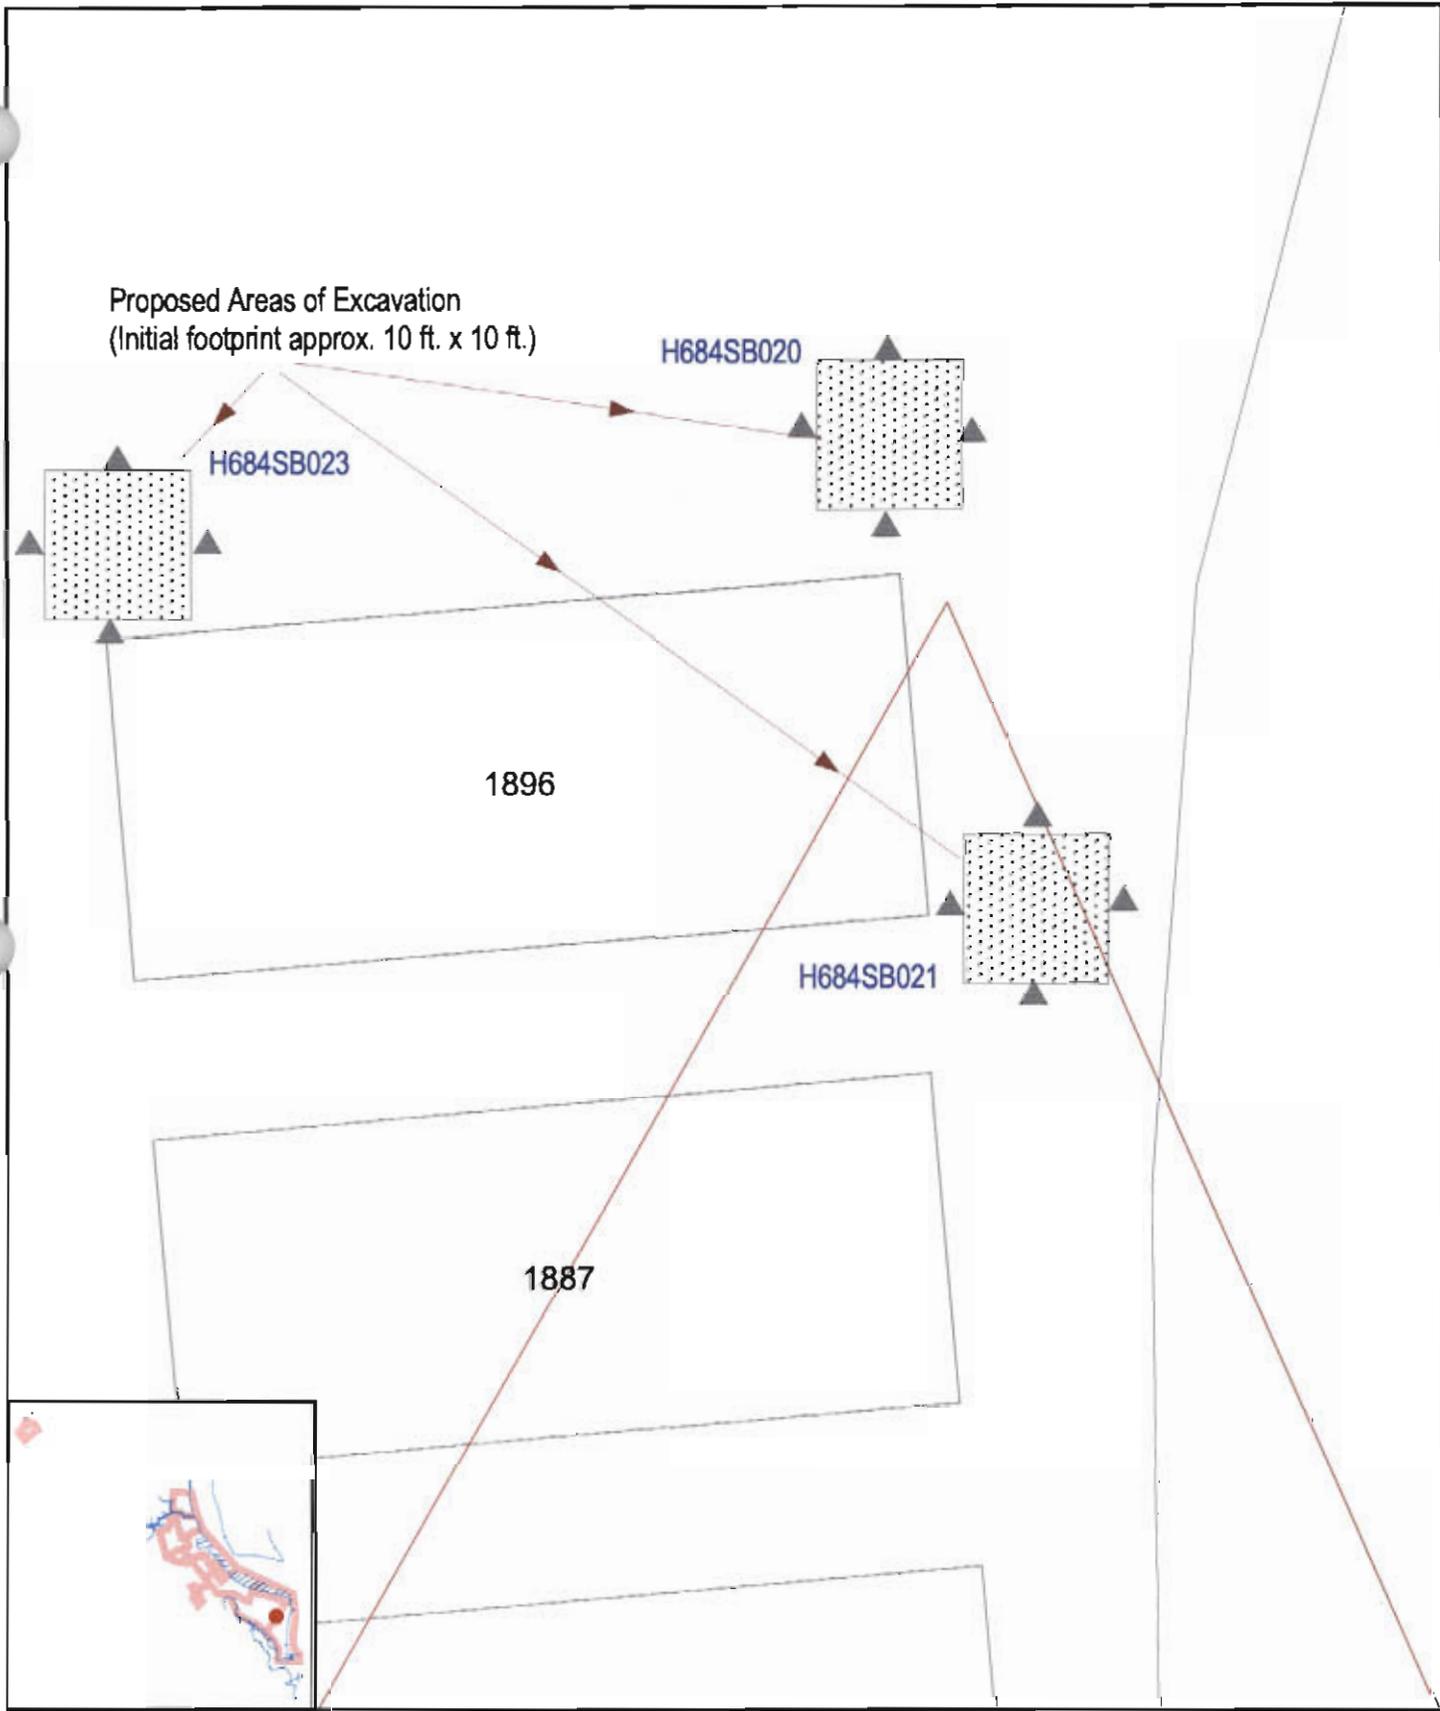
**Figure 2-1**  
Proposed Typical  
Excavation Footprint  
Combined SWMU 14, Zone H  
Charleston Naval Complex

21 Thirty-three surface soil samples were collected from the southern portion of Combined  
22 SWMU 14 as part of this sampling effort. Each sample location was excavated from a 1-foot  
23 (ft) x 1-ft x 4-inch deep excavation area, sieve-analyzed, and tested for lead. Three of the 33  
24 soil samples showed lead concentrations in excess of the 400 mg/kg goal. Figure 2.10 from  
25 the *Draft Zone H Combined SWMU 14 CMS Report* (see Appendix A) shows the locations of  
26 the lead shot distribution samples and the surface soil lead concentrations at these locations  
27 (EnSafe, 1999). The three sample locations that show lead concentrations in excess of the  
28 400 mg/kg are also shown on Figure 2-1 of this IM Work Plan.

1 At each location where surface soil excavation will be performed, a 10-ft x 10-ft excavation  
2 footprint will be laid out, and four delineation samples will be collected around each  
3 excavation footprint. These samples will be analyzed to verify the concentrations of the  
4 COCs being removed (BEQs or inorganics or both). Analytical results from the delineation  
5 sampling will be evaluated to determine the horizontal extent of excavation at each location.  
6 If any of these delineation samples exceeds the target cleanup levels for the COC being  
7 removed at that location, additional soil samples will be collected farther out to complete  
8 the delineation. The final excavation limits will be determined based on these analytical  
9 results. Typical initial excavation footprint and delineation sampling locations are shown on  
10 Figure 2-1.

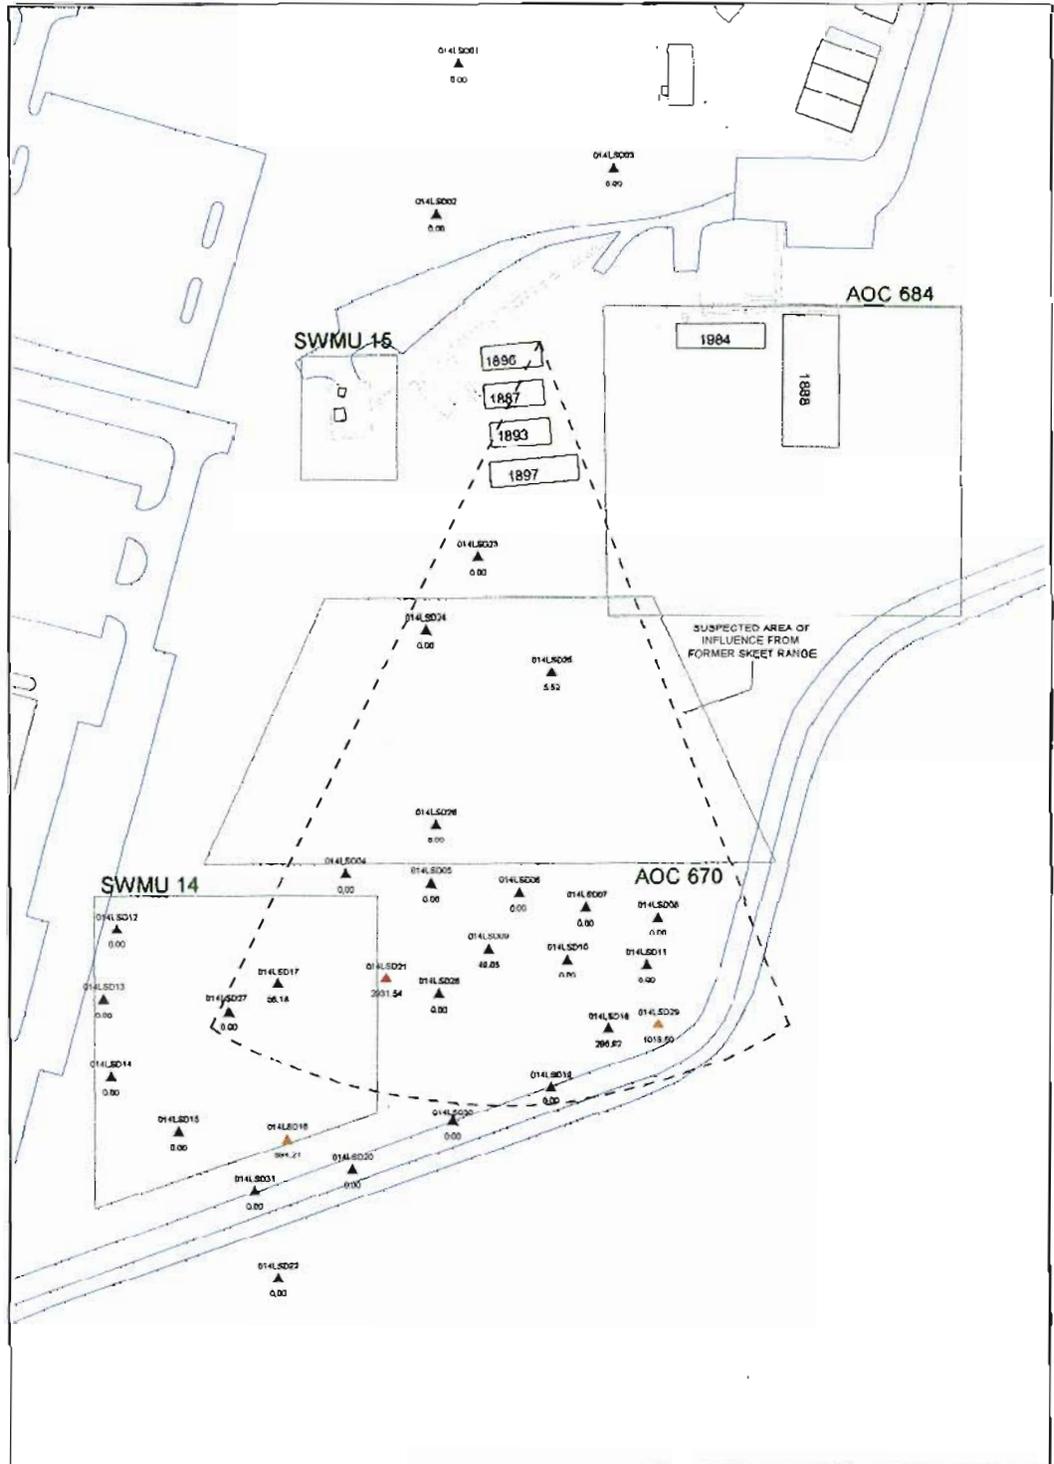
Figure 2.10  
Lead Shot Distribution

18 **Appendix A** — Presents Figure 2.10 of the Draft Zone H Combined SWMU 14 (EnSafe,  
19 1999).

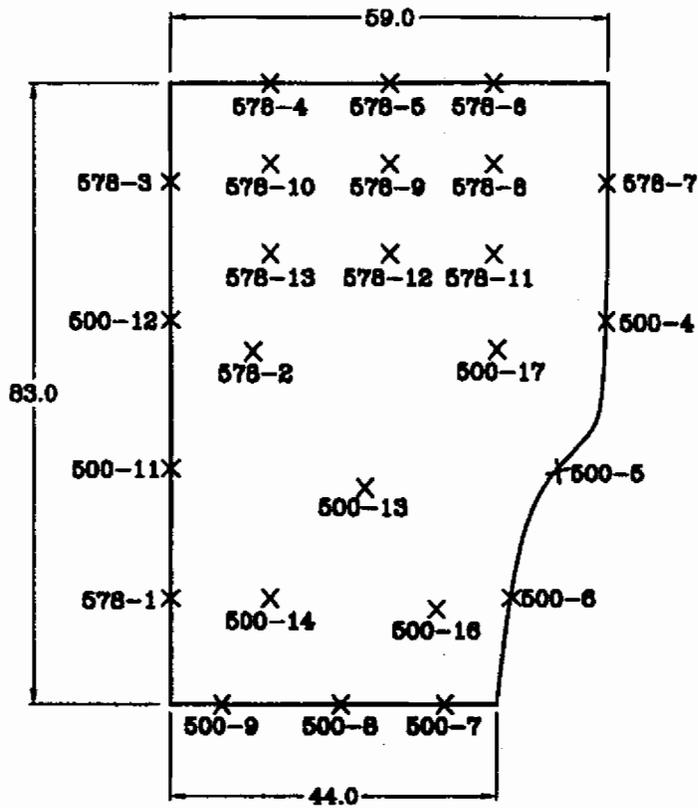
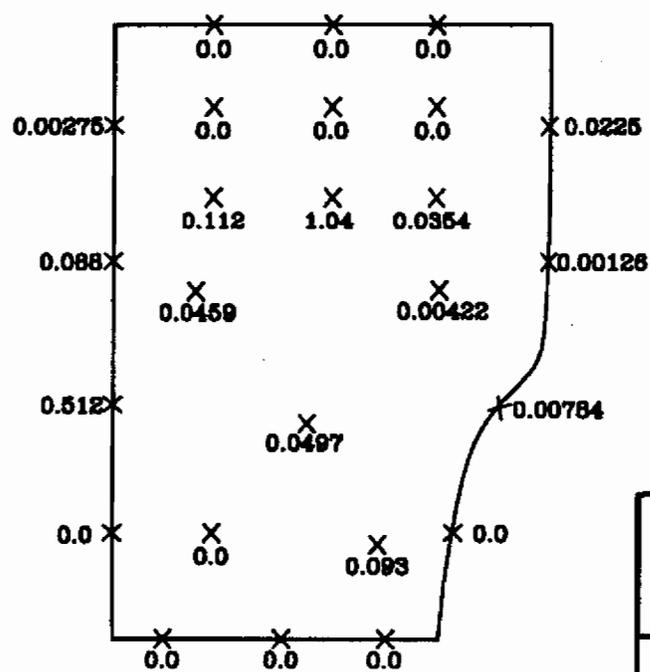
**Figure 4**  
**SWMU 14**  
**Confirmation Sample Location/Results**  
**Charleston Naval Base**  
**Charleston, SC**

14 The DET IM identified 25 additional anomalies (named anomalies A through Y). Figure 4  
15 from the *Completion Report, Interim Remedial Measure for SWMU 14* (DET, 1998), which is  
16 included in Appendix B, shows the locations of these geophysical anomalies and their  
17 identification numbers. The IM effort excavated all 59 anomalies and found miscellaneous  
18 non-hazardous metallic objects such as rebar, fence posts, strapping, welding rods, concrete  
19 footings, horseshoes, and one anomaly (Anomaly G) with DANC containers.

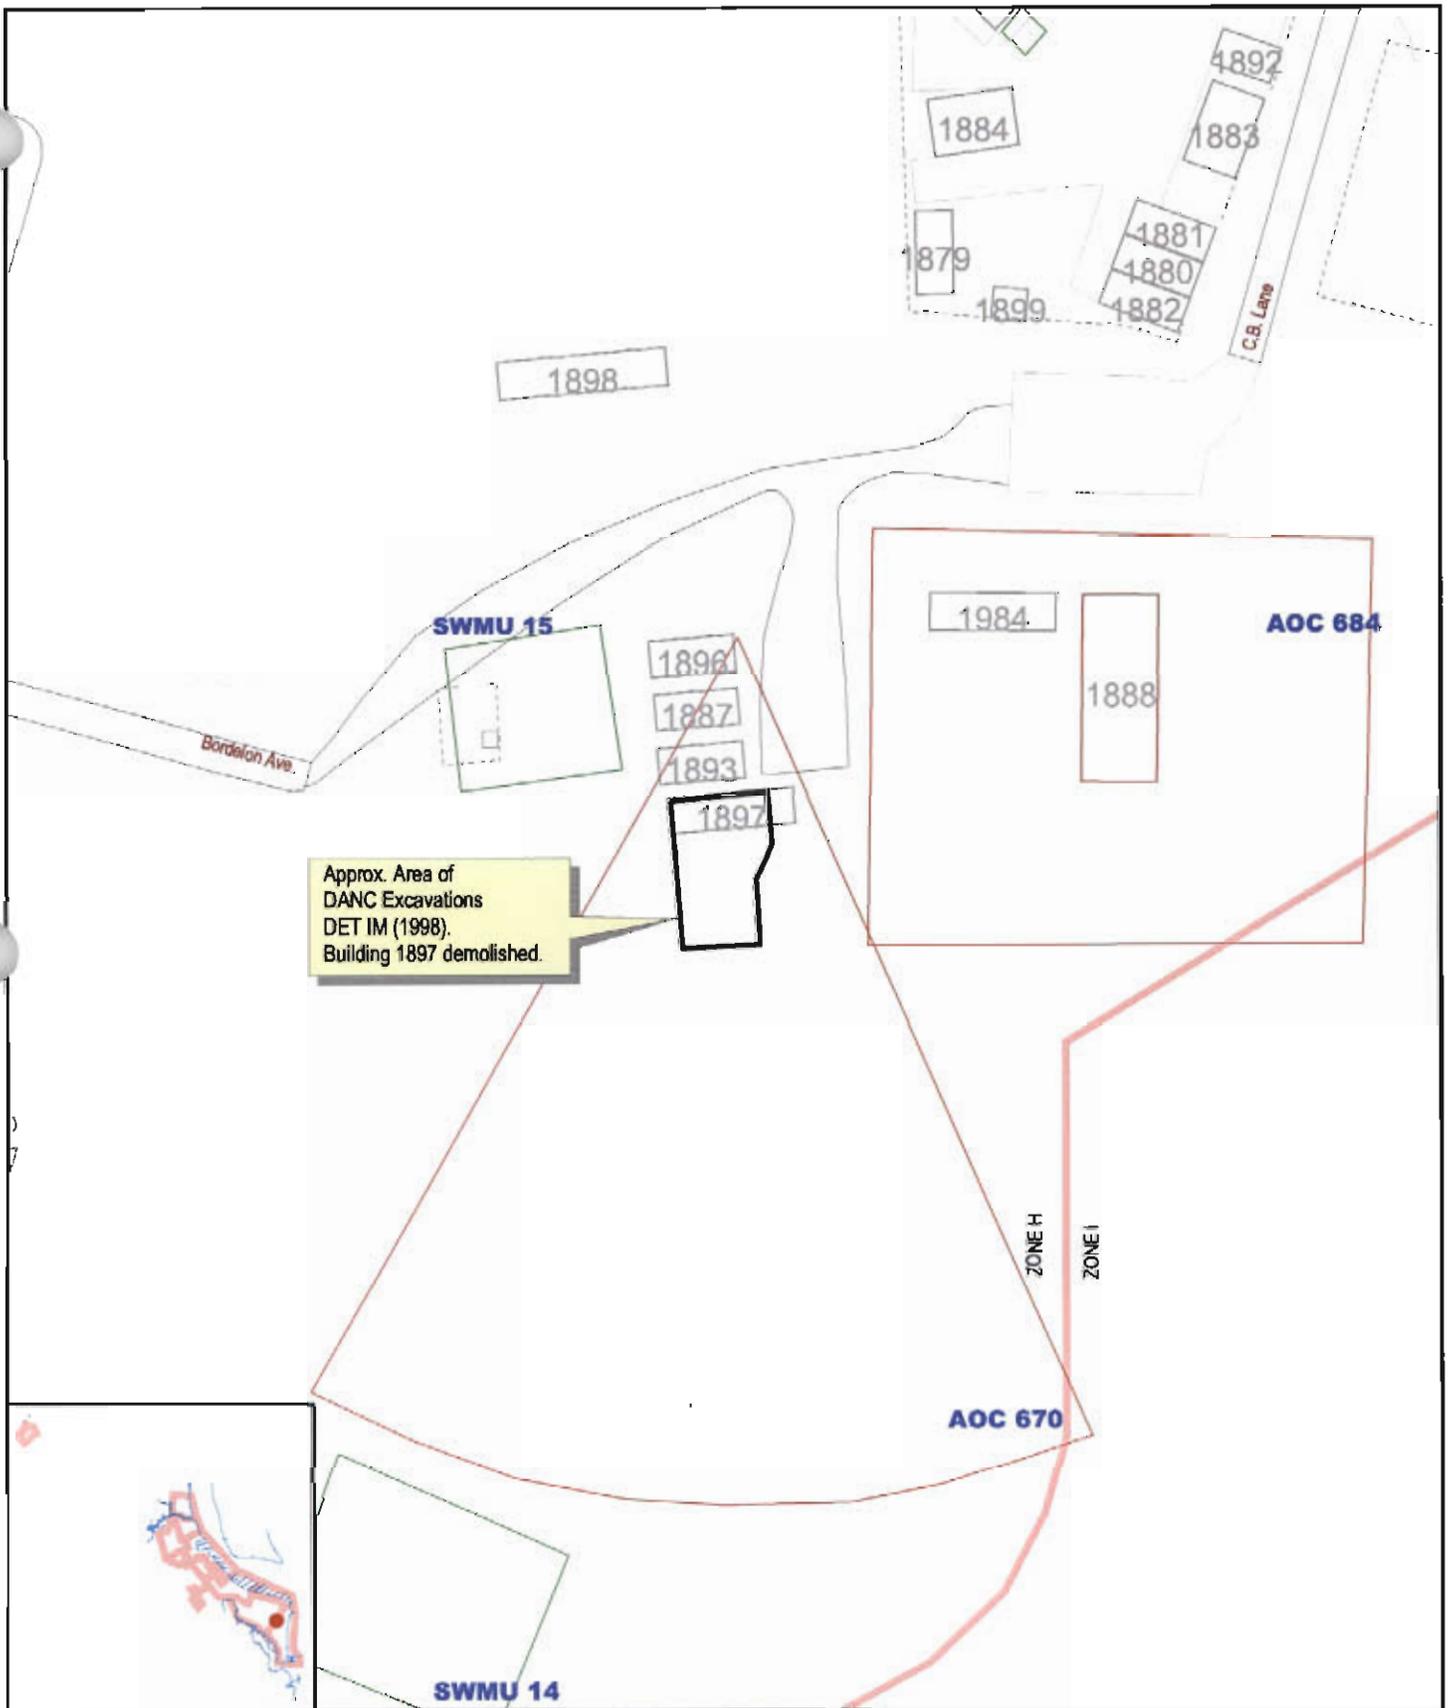
**Figure C-1**  
 Location of DANC Excavation  
 Area, DET IM (1998)  
 Combined SWMU 14, Zone H  
 Charleston Naval Complex

20 Anomaly G was detected within AOC 670, south of Building 1897. The Anomaly G  
21 excavation involved removal of 90 DANC containers (each container approximately 5  
22 gallons in volume). Building 1897 was demolished to allow excavation of an additional 50  
23 DANC containers from under the footprint of the building. DANC is a decontaminating  
24 agent primarily consisting of chlorinated compounds, and historic information indicated  
25 that DANC containers had been buried at Combined SWMU 14 (EnSafe, 1996). Tables 1 and  
26 2 from the DET IM Report (DET, 1998), also included in Appendix B, show the descriptions  
27 of the anomalies found in the excavations conducted at these locations. Figure C-1 in  
28 Appendix C shows the location of the DANC excavation at Combined SWMU 14.

21 **Appendix C** — Provides Figure C-1, which depicts the DANC excavation.
