RESOURCE CONSERVATION AND RECOVERY ACT FACILITY INVESTIGATION REPORT
ADDENDUM AREA OF CONCERN 558 (AOC 558) ZONE E CNC CHARLESTON SC
7/2/2002
CH2M HILL

RFI REPORT ADDENDUM

Area of Concern 558, Zone E

Re: RFI Report Addendum (Revision 0) – AOC 558, Zone E

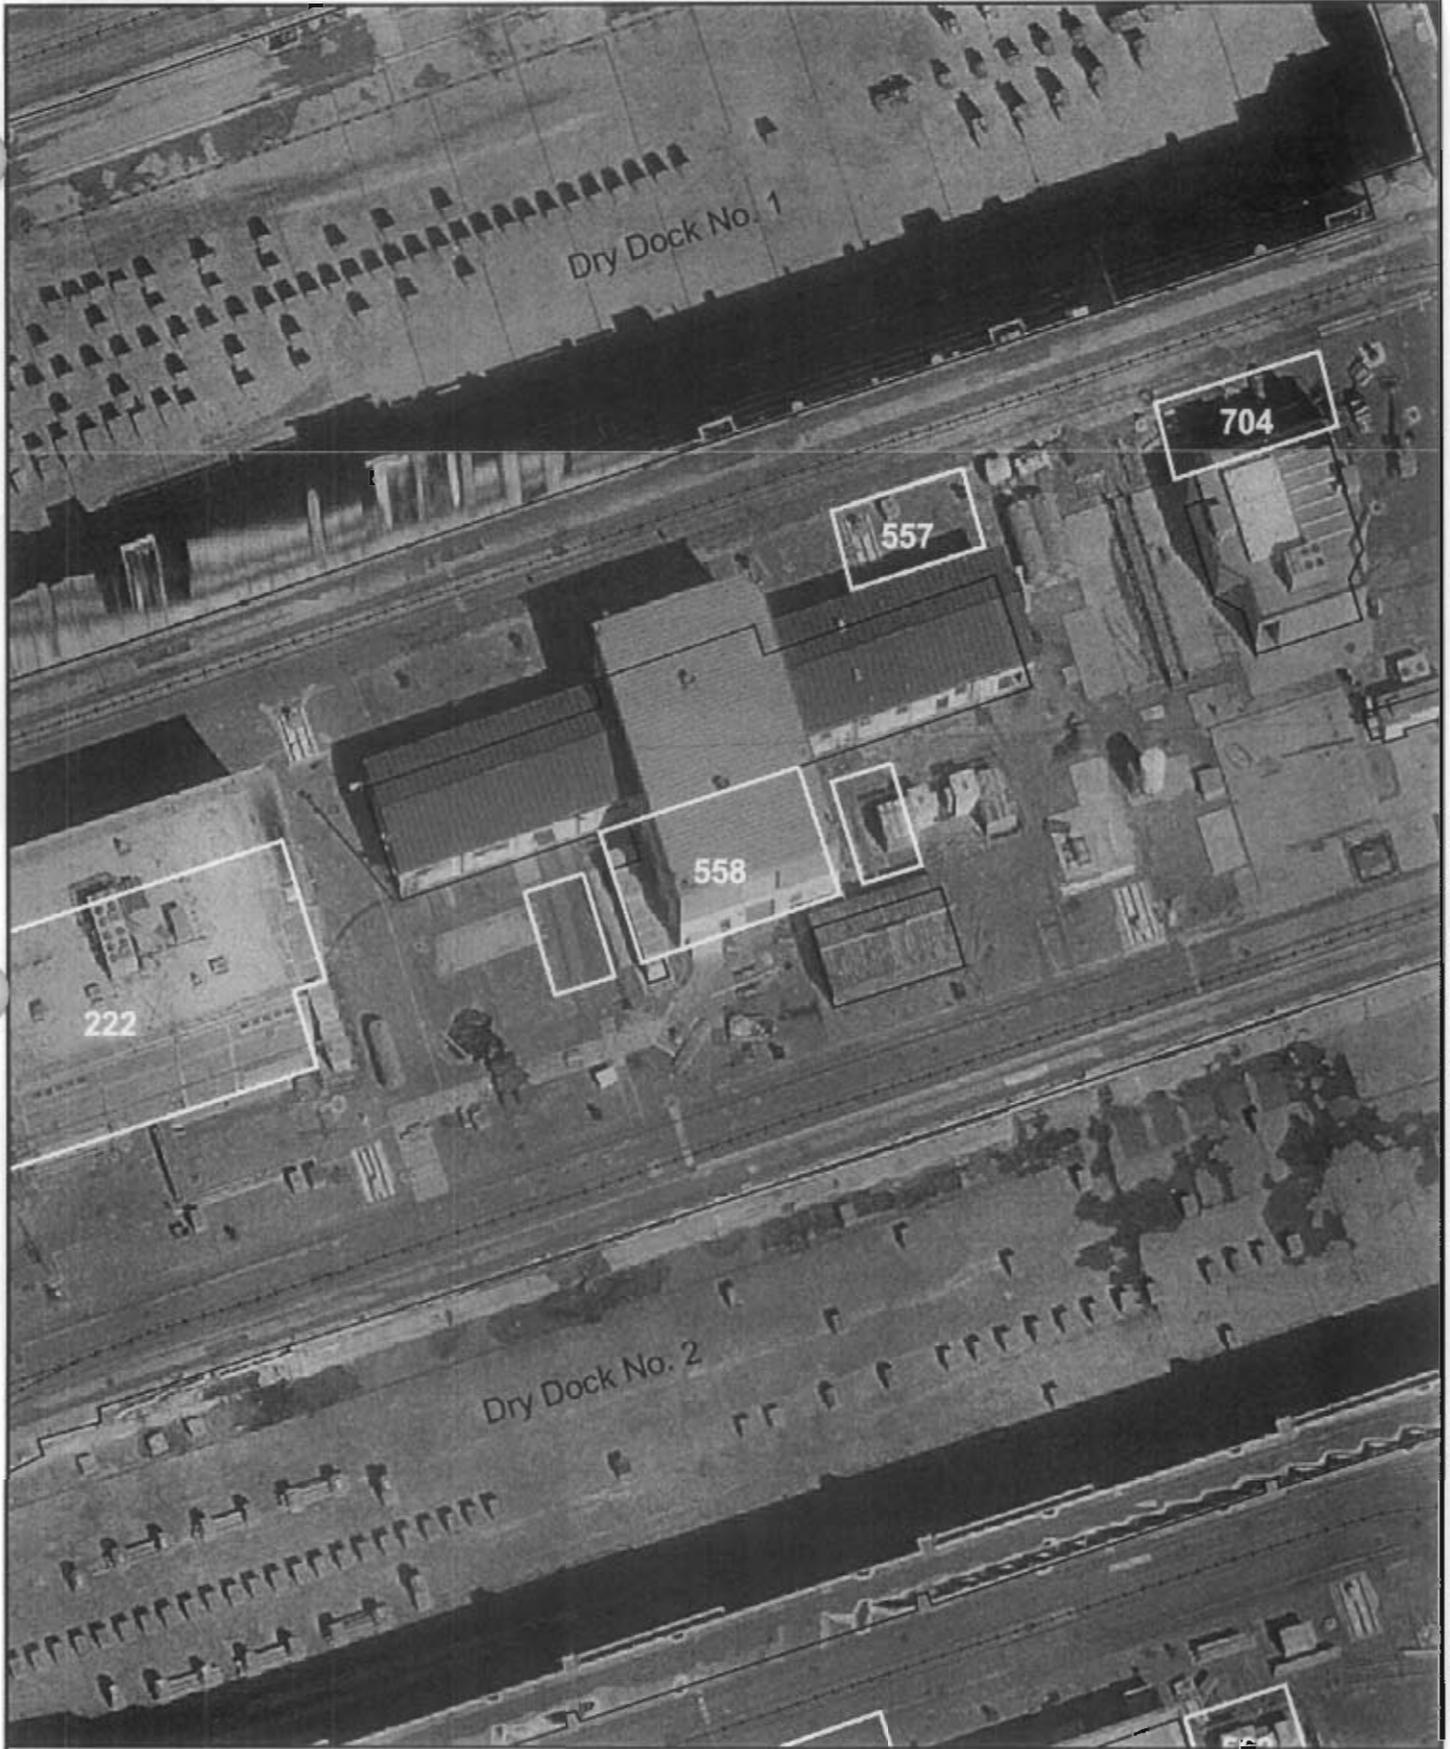
Figure 1-2
Site Map
AOC 558
Charleston Naval Complex

17 AOC 558 consists of an electrical substation in Building 77. Building 77 is located in the
18 working area between Dry Dock No. 1 and Dry Dock No. 2 in Zone E of the CNC. Building
19 77 is a two-story concrete structure built in 1942 that housed transformers, switches and
20 other electrical equipment. Building 77 is divided into three sections. The east section
21 contains a steam room, restrooms and shower facilities. The middle section contains nine
22 transformers and several switch stations. The west section contains a field office. The last
23 polychlorinated biphenyl (PCB)-containing equipment was removed in 1991. The RCRA
24 Facility Assessment (RFA) reported that the cable vaults leading from the substation were
25 cleaned in 1991 to remove PCBs and asbestos. Building 77 is currently vacant.

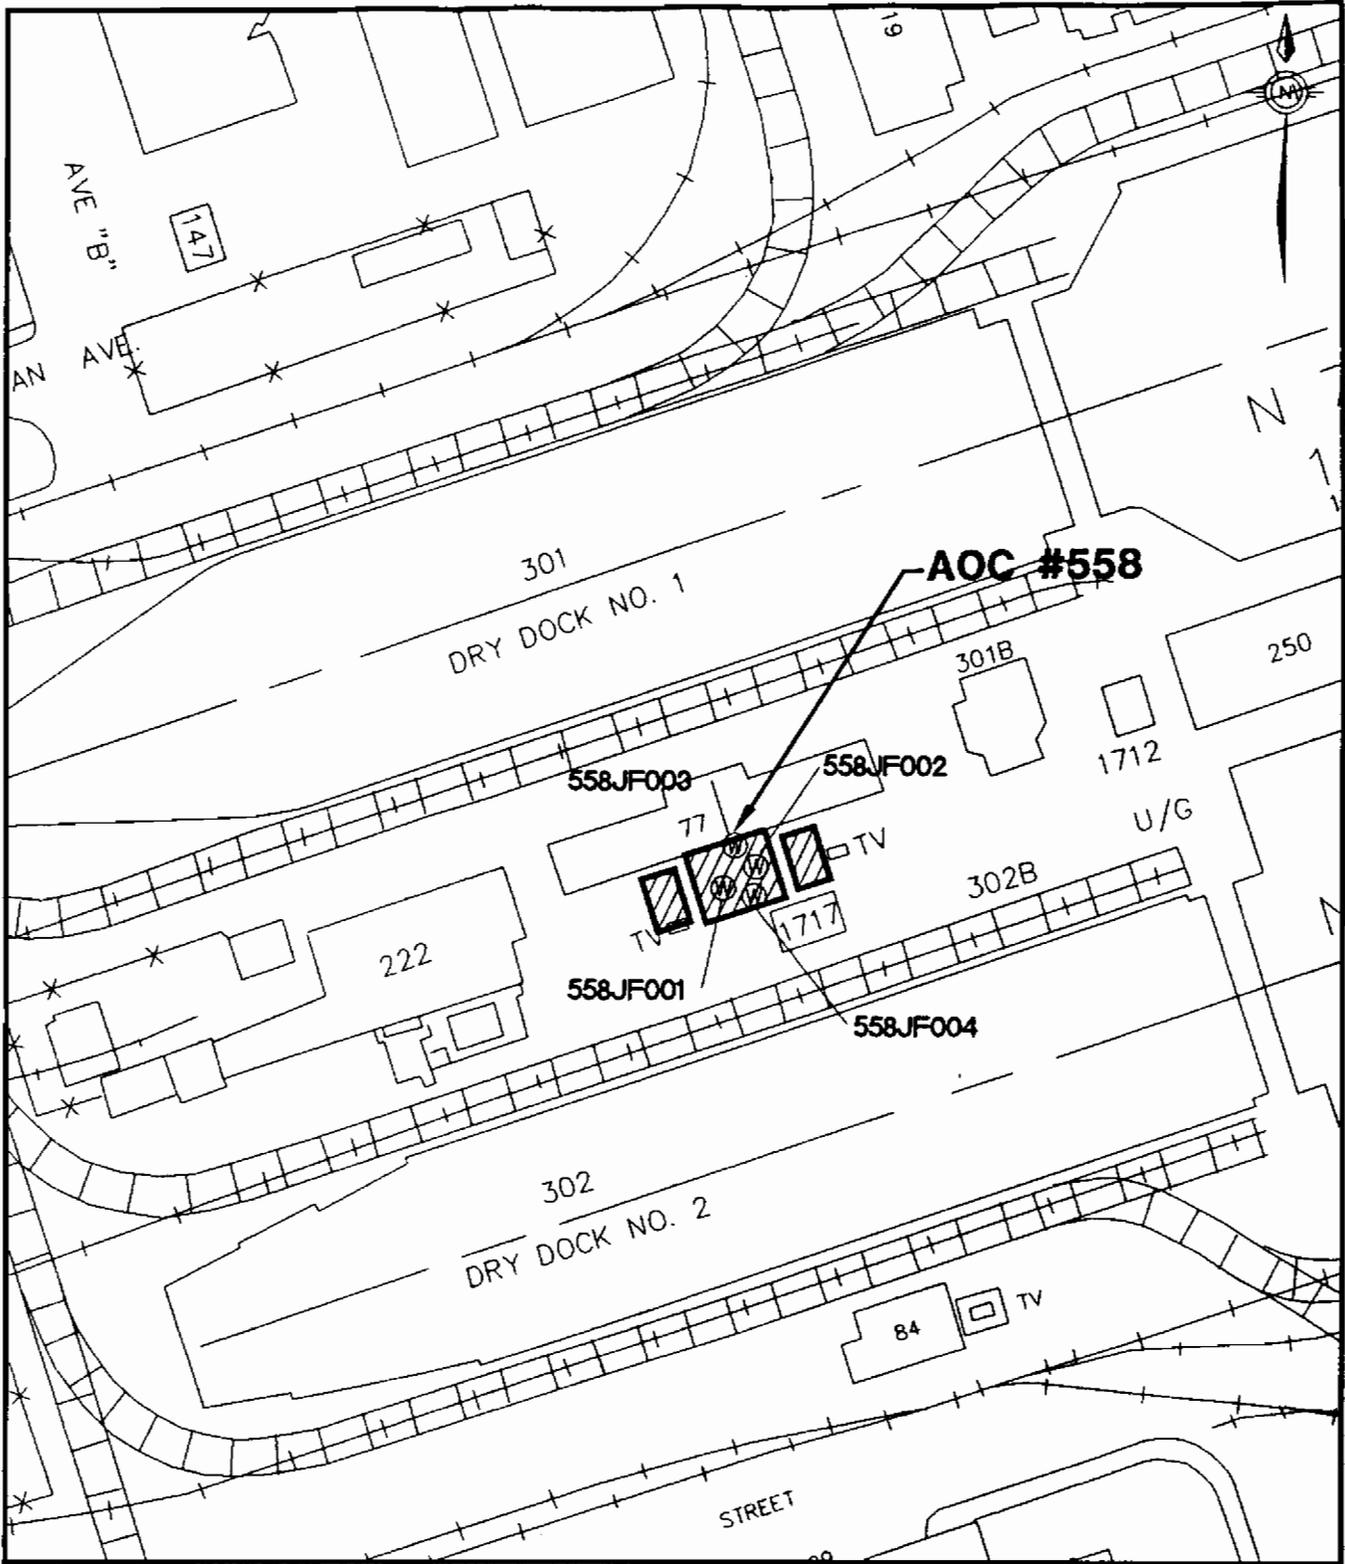
FIGURE 10.28.1
WIPE SAMPLE LOCATIONS
AOC #558
SUBSTATION
BUILDING 77

21 The RFI Work Plan for AOC 558 proposed collecting four wipe samples based on the
22 location of PCB-containing equipment and visual evidence of spills and leaks. Four wipe
23 samples were collected from the concrete floor at the locations shown in Figure 10.28.1 (see
24 Appendix A). Wipe samples were analyzed for PCBs.

- 26 • **PCBs:** PCBs were not detected above laboratory detection limits.

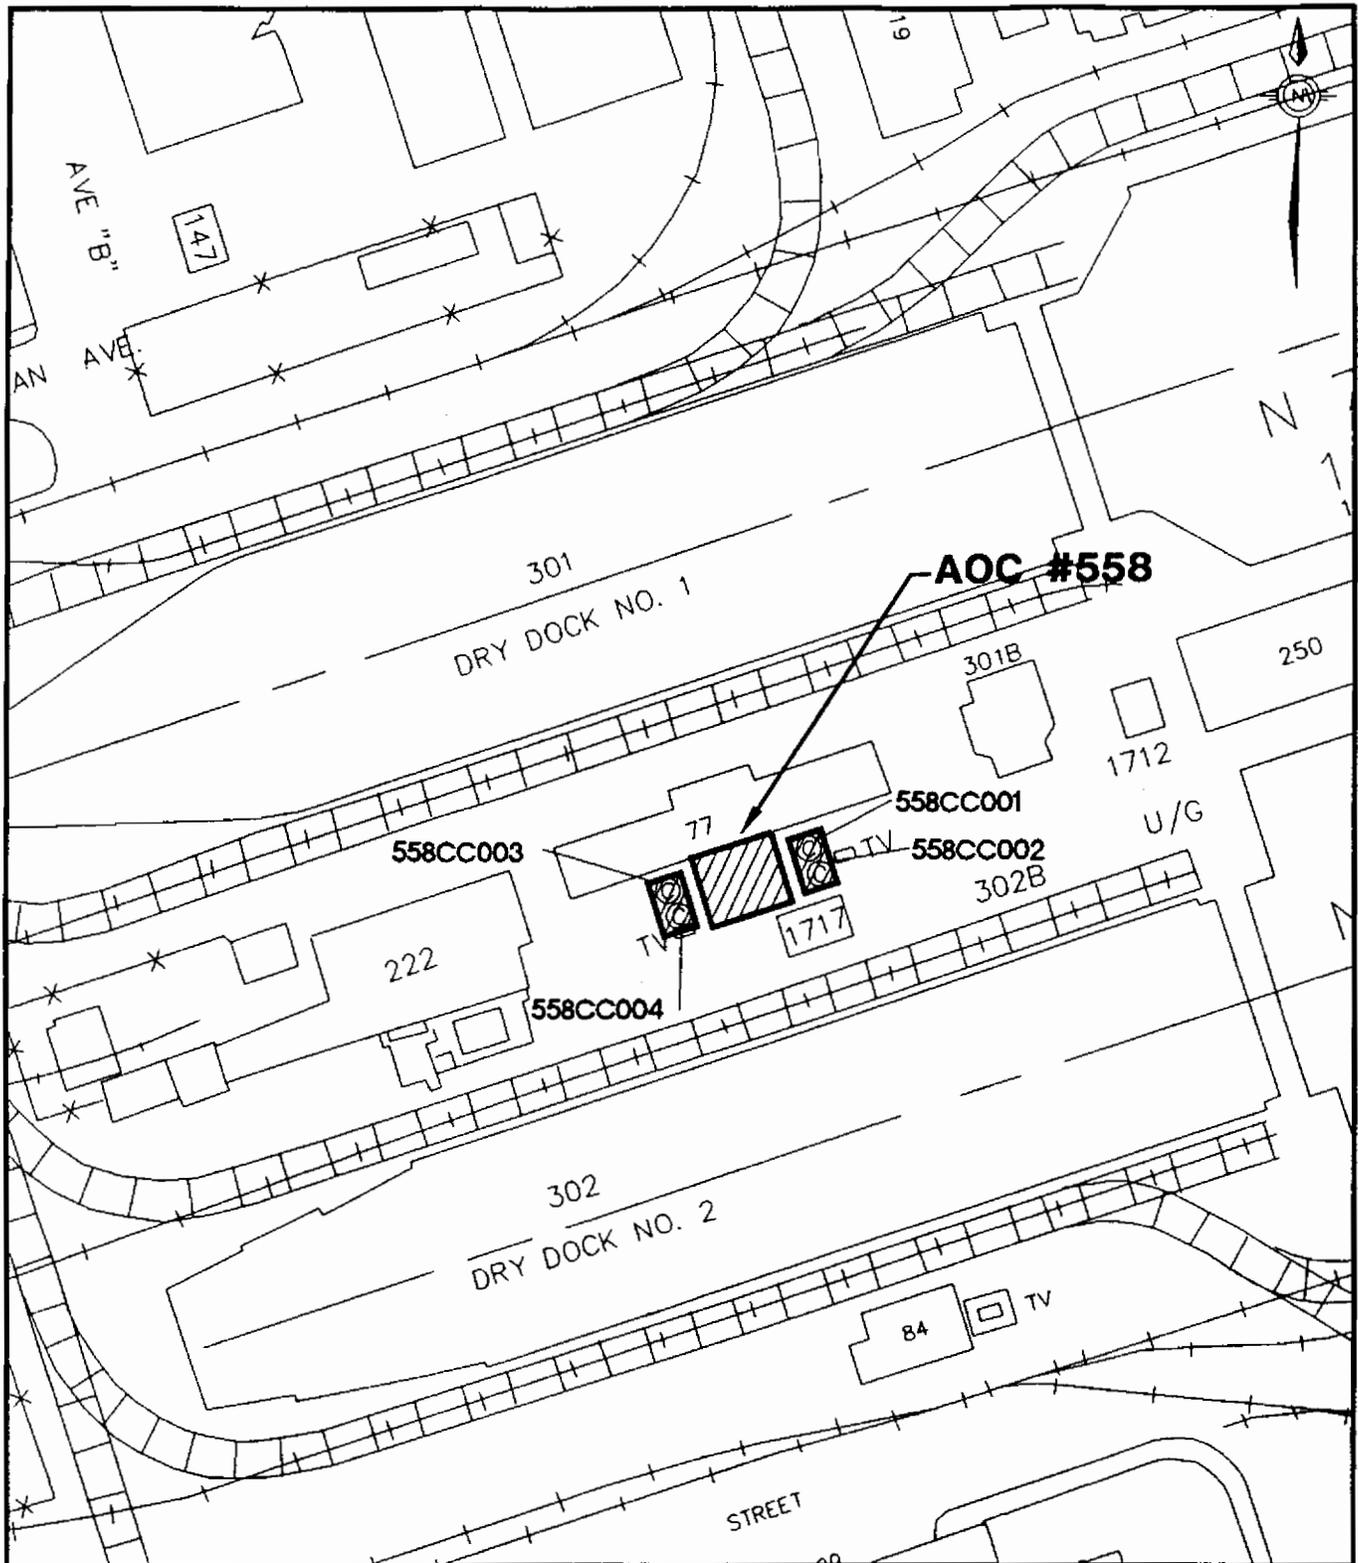
FIGURE 10.28.2
CONCRETE SAMPLE LOCATIONS
AOC #558
SUBSTATION
BUILDING 77

2 The RFI Work Plan for AOC 558 proposed collecting four concrete core samples from
3 Building 77. Four concrete core samples were collected from the east and west sections of
4 Building 77 at the locations shown in Figure 10.28.2 (see Appendix A). The concrete core
5 samples were analyzed for VOCs, SVOCs, pesticides, PCBs, metals and cyanide. Duplicate
6 samples were not collected.

- 9 • **VOCs:** VOCs were not detected in concrete core samples above the screening criteria.
10 Only one VOC, acetone, was detected in a single sample, at a concentration of 96J
11 µg/kg. COPC screening criteria have not been established for concrete samples, but the
12 result is well below the residential soil risk-based concentration (RBC) of 780 µg/kg
13 (hazard index (HI) = 0.1).

- 18 • **PCBs:** PCBs were not detected in the concrete core samples above laboratory detection
19 limits.
- 20 • **Inorganics:** As would be expected for concrete samples, metals were detected. COPC
21 screening criteria have not been established for concrete samples; however, the reported
22 concentrations were below industrial soil RBCs.

- 23 • **Cyanide:** Cyanide was detected in a single concrete sample at a concentration of 460J
24 µg/kg. This value is well below the industrial soil RBC of 410 mg/kg and well below
25 the residential soil RBC of 16 mg/kg (HI = 0.1).

Concrete samples were collected from the concrete pads associated with the switchgear located outside the building to investigate possible releases of dielectric fluid. Wipe samples were collected from the several areas within the transformer vault and included any stained areas inside the building to detect any possible migration pathway of released dielectric fluid.
