ASBESTOS-CONTAINING MATERIAL RE-INSPECTION FOR BUILDING NS46 VOLUME 9
CNC CHARLESTON SC
2/15/2000
BAT ASSOCIATES, INC.

**Asbestos-Containing Material Re-inspection
For Building NS46
Charleston Naval Shipyard
Charleston, South Carolina**

Contract No. N2467-96-D-0998
Delivery Order No. 0013

February 15, 2000

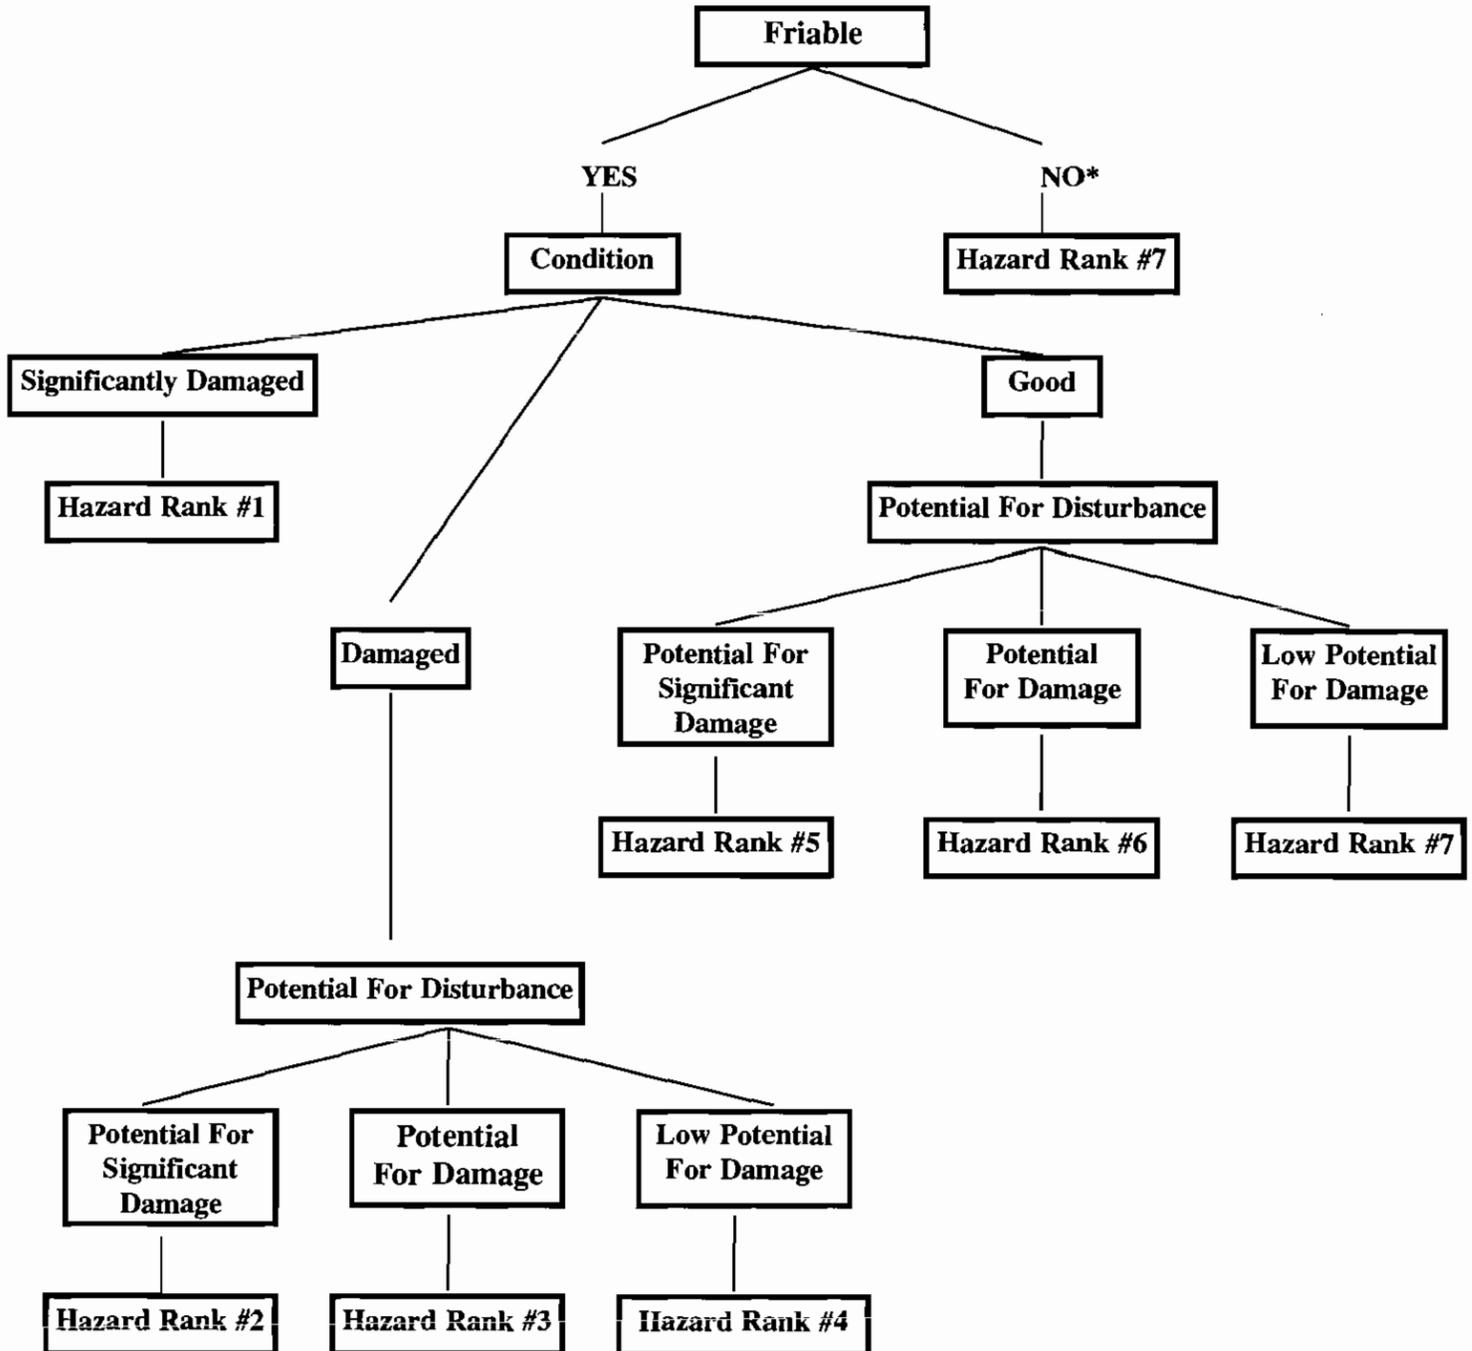
Figure 1.0 Decision Tree Diagram For Hazard Assessment

Hazard rank #1 are materials of highest concern, and hazard rank #7 are the materials least likely to release asbestos fibers to the work area.

*Miscellaneous materials that are considered non-friable were placed in the Hazard Rank #8 category, which is in good condition with a low potential for damage.

BAT adopted for this re-inspection one of the four general classes of hazard assessment models considered during the AHERA rule-making process. This method for hazard assessment is a modified decision tree as detailed in the USEPA, *Guidance for Assessing and Managing Exposure to Asbestos in Buildings*, or the *Pink Book*. Based on the physical assessment responses documented in the field, the BAT Management Planner proceeded through the decision tree process depicted in Figure 1.0 on the following page.

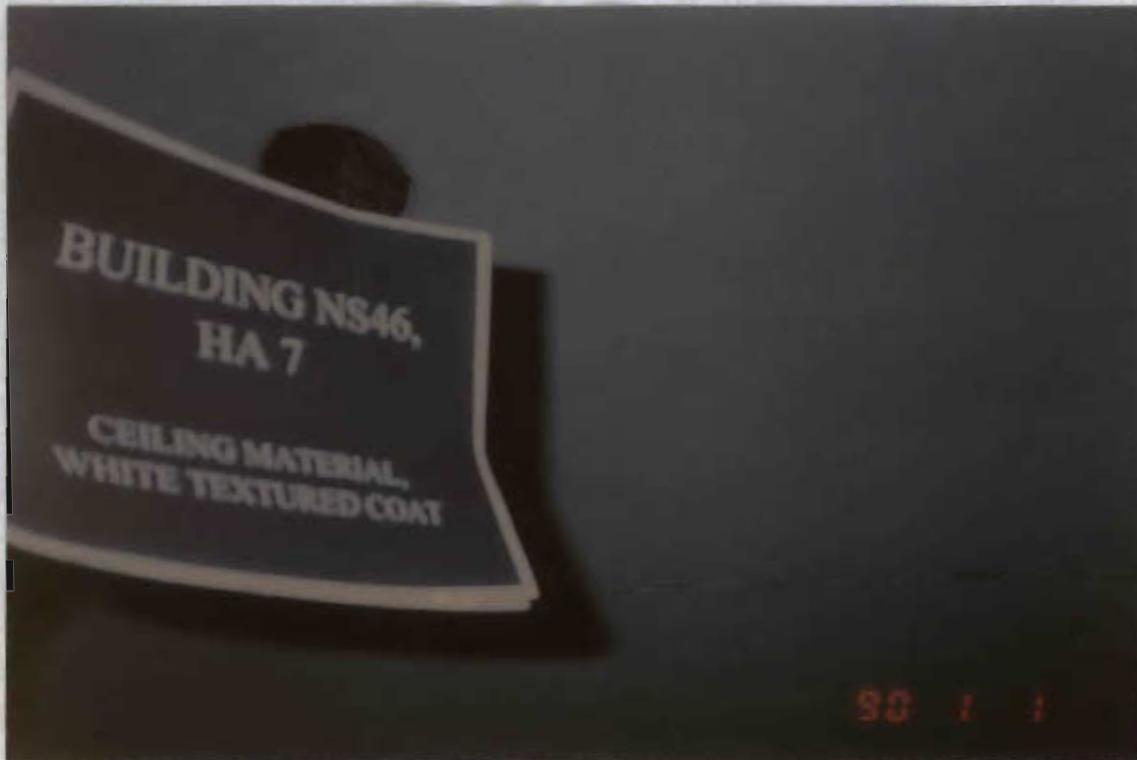
Spray-Applied Textured Finish and Plaster, on concrete, HA # 7

HA No.	Material Description	Recommended Response Action
7	Spray-Applied Textured Finish, on concrete	Removal Prior to Renovation or Demolition
14	Caulking, gray	O&M Plan
15	Mastic, black behind gray grouting on brown wall tile	O&M Plan
16	Mastic, black behind white grouting on brown wall tile	O&M Plan
