FINAL ASBESTOS INSPECTION REPORT BUILDING 2NS CNC CHARLESTON SC
10/1/1998
ENVIRONMENTAL DETACHMENT CHARLESTON

**BUILDING 2NS
CHARLESTON NAVAL COMPLEX
CHARLESTON, SC**

BUILDING 2NS: Degaussing Facility and Boat Pier (533)

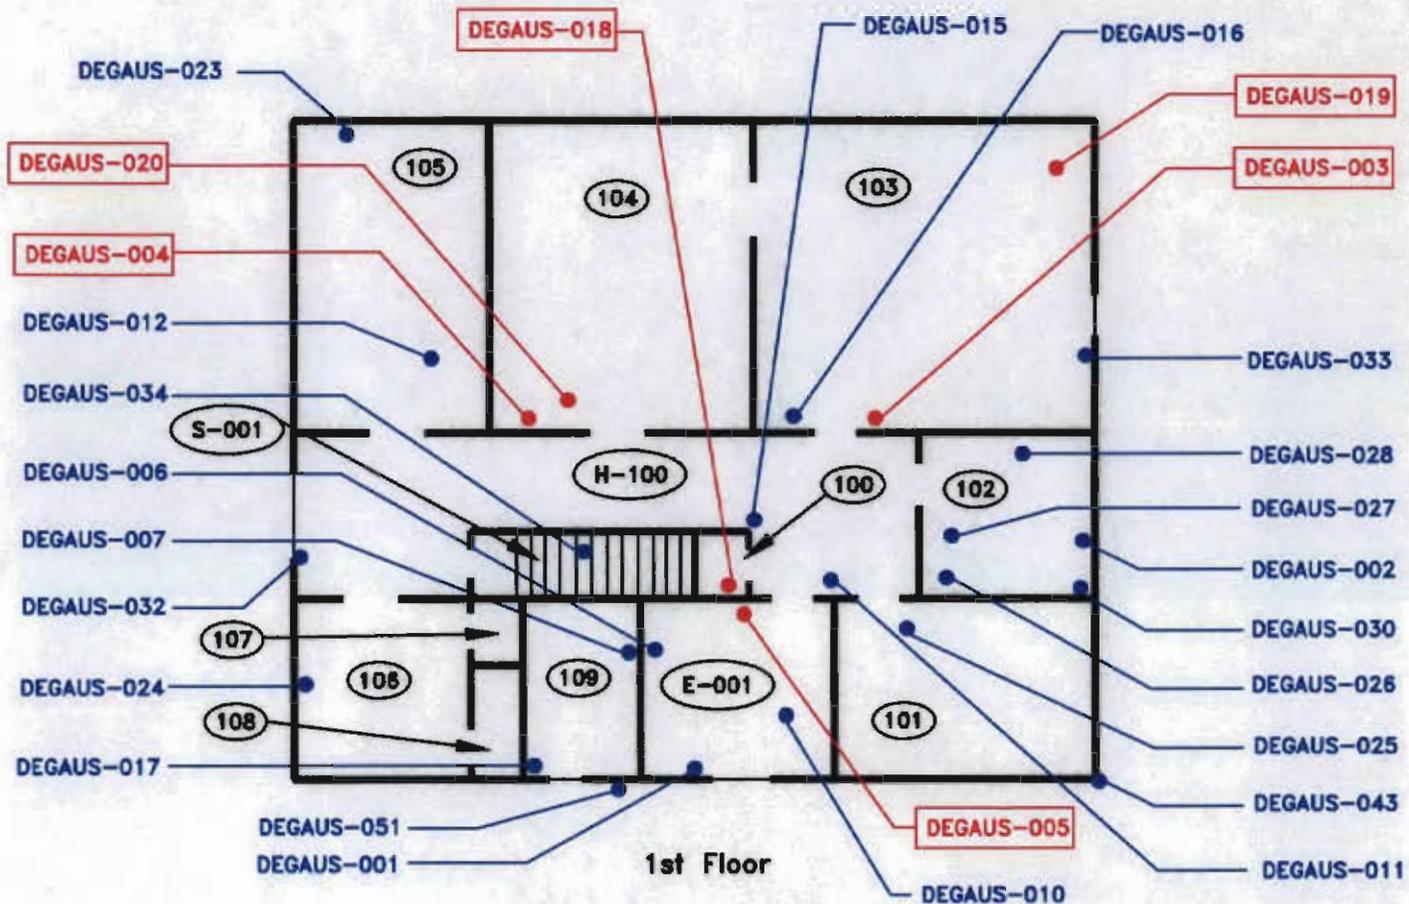
SHEET 1 of 4

XXXX-XXX — Indicates sample locations which tested positive for asbestos

SAMPLE LOCATIONS
2NS DEGAUSSING STATION
CHARLESTON NAVAL COMPLEX, CHARLESTON, SC

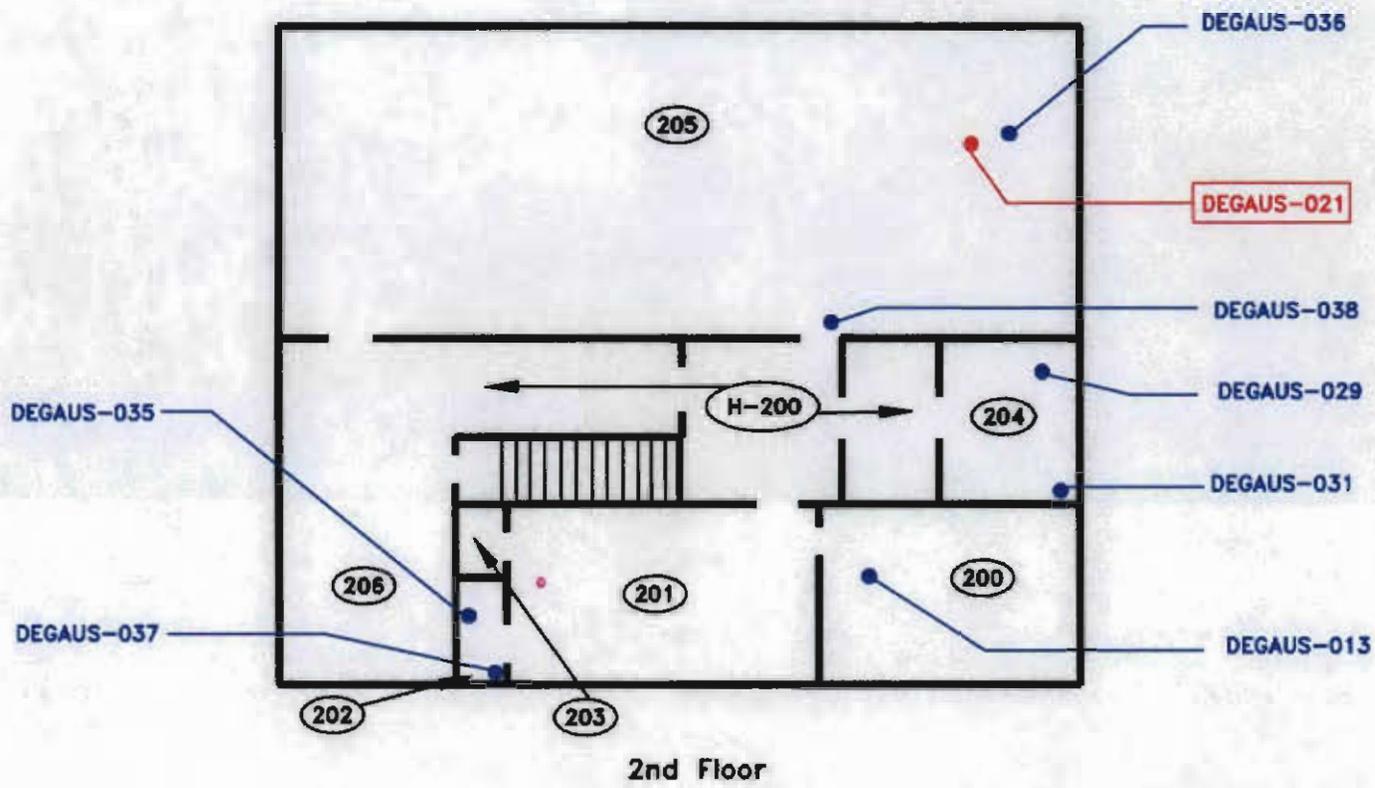
2nd Floor

xxxx-xxx — Indicates sample locations which tested positive for asbestos

SAMPLE LOCATIONS
 2NS DEGAUSSING STATION
 CHARLESTON NAVAL COMPLEX, CHARLESTON, SC

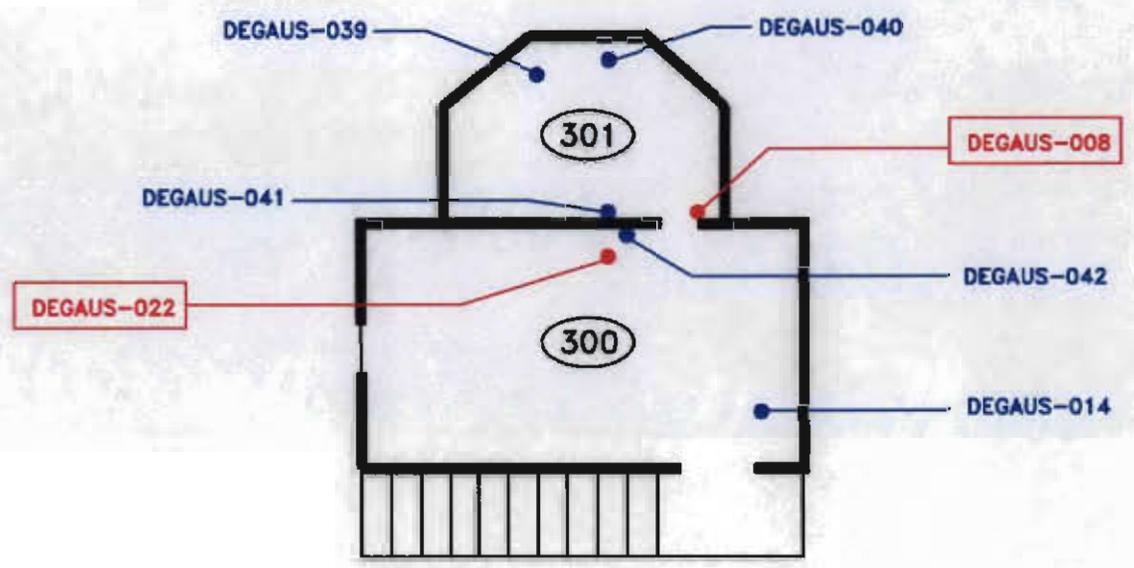
3rd Floor

XXXX-XXX — Indicates sample locations which tested positive for asbestos

SAMPLE LOCATIONS
 2NS DEGAUSSING STATION
 CHARLESTON NAVAL COMPLEX, CHARLESTON, SC
