PROJECT SURVEILLANCE SERVICES AND AIR MONITORING DURING REMOVAL OF  
ASBESTOS-CONTAINING MATERIAL QUARTER 760 CNC CHARLESTON SC  
10/1/2000  
BAT ASSOCIATES, INC.

**Project Surveillance Services and Air Monitoring  
During Removal of Asbestos-Containing Material  
at the  
North Charleston Naval Base: Quarter 760  
North Charleston, South Carolina**

**Subject: Closure Report for Project Surveillance and Air Monitoring  
North Charleston Naval Base: Quarter 760  
North Charleston, South Carolina**

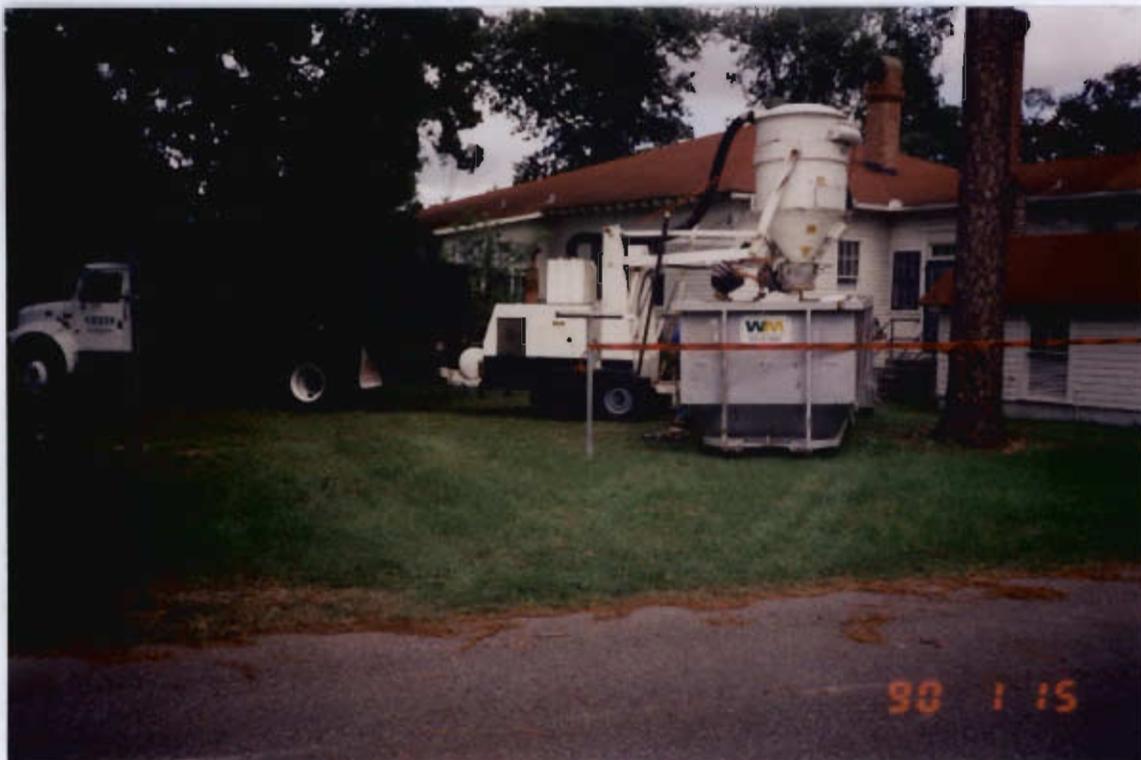
**PHOTO 1:** View of the HEPA Vac Machine prior to the beginning of the asbestos abatement.

The Contractor used a trailer-mounted vacuum (Vac truck) equipped with a HEPA filter to vacuum out approximately 1 inch to 4 inches of soil from within the crawl space. The soil was containerized in a three chambered non-permeable bladder bag which was lined inside a transport dumpster. Mr. Larry Hopkins, of Cross Construction Corp, operated the Vac truck.

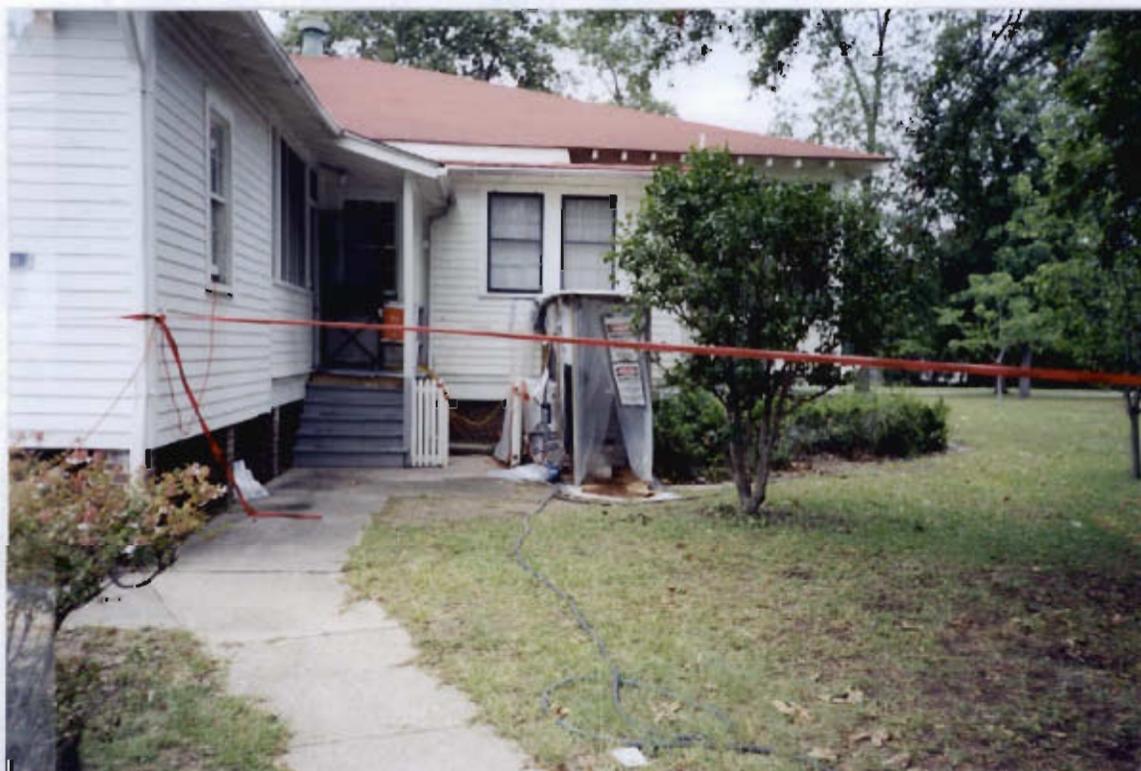
**PHOTO 2:** View of the PDF. Note the Danger signs posted, also the barrier tape demarcating the work area.

A personal decontamination facility (PDF) was constructed and used by the Contractor's workers and other work area visitors to dispose of used coveralls and rinse themselves of any dust or debris prior to leaving the clean side of the PDF. The PDF was located at the entrance to the work area and consisted of three primary chambers: 1) dirty room, 2) decontamination shower, and 3) clean room. Each chamber of the PDF was segmented via overlapping curtains constructed of 6-mil polyethylene sheeting.

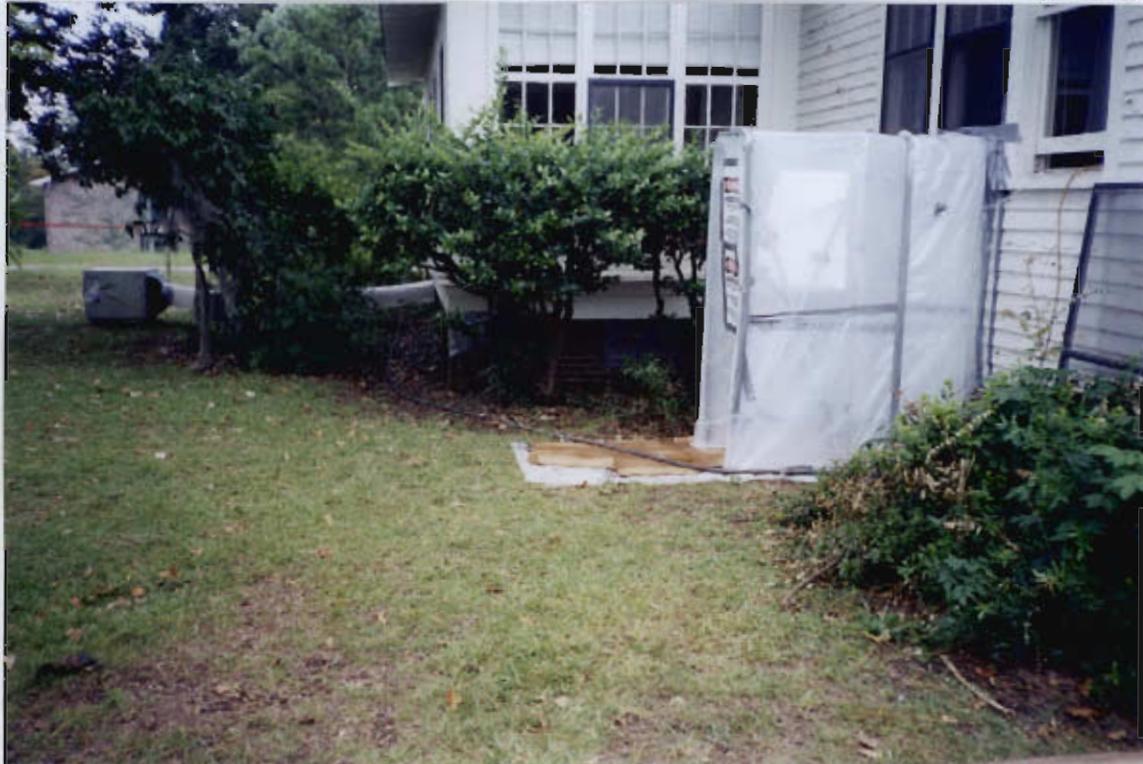
**PHOTO 3:** View of the waste load out located on the west side of the Project Site. Note Danger signs posted also one of the Negative Air Machine that was in use.

A waste load out was constructed and used by the Contractor's workers to rinse off any dust and debris off equipment prior to leaving the work area. The waste load out was located on the west side of the Project Site.

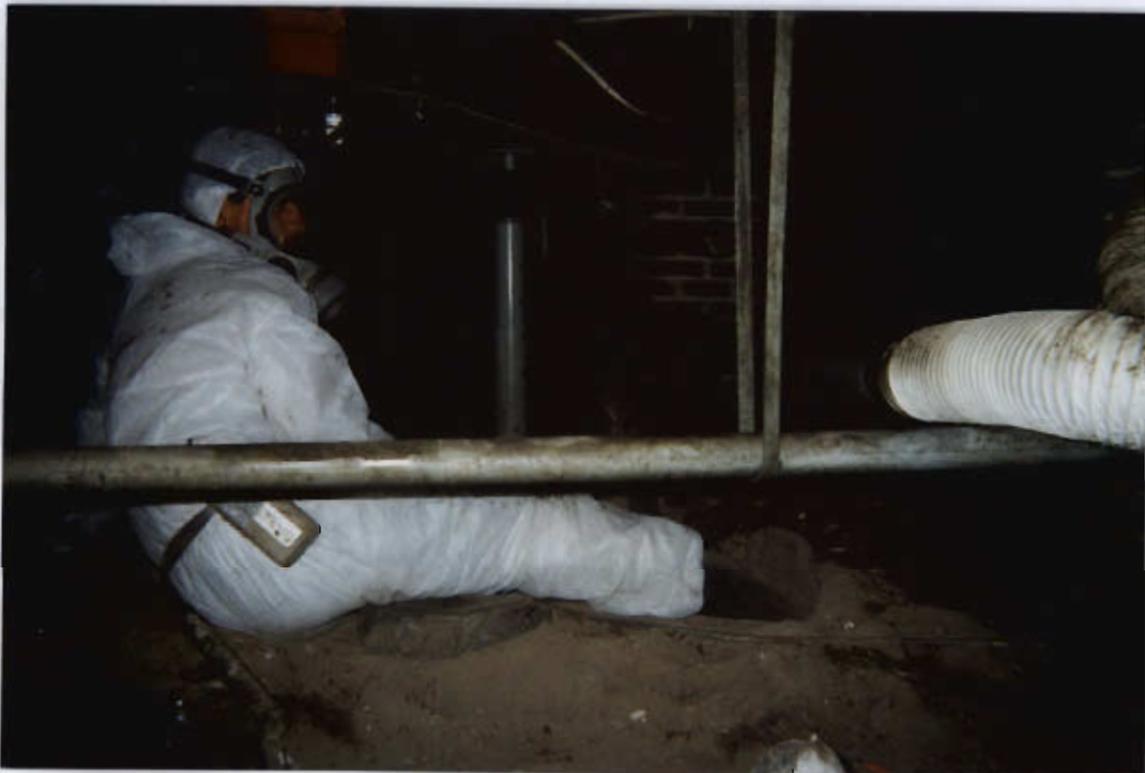
**PHOTO 4:** Pictured is one of the Contractor's workers wearing a full-faced PAPR, two disposable suit, rubber boots and gloves

The Abatement Contractor's workers donned full-face powered air purifying respirators (P.A.P.R.), hooded disposable cellulose suits with booties, protective footwear, and hand coverings during the gross removal of TSI. The Abatement Contractor's workers utilized hand-held tools to cut TSI wrapping and lowered the material from the substrate onto the plastic floor sheeting (drop cloth) below or directly into the 6-mil. Thick, properly labeled asbestos bags. In circumstances where the material had to be lowered a drop cloth, a worker promptly containerized the removed materials in 6-mil. Thick, properly labeled asbestos bags. Removed materials were kept in a wetted state prior to placing the materials in disposal bags.

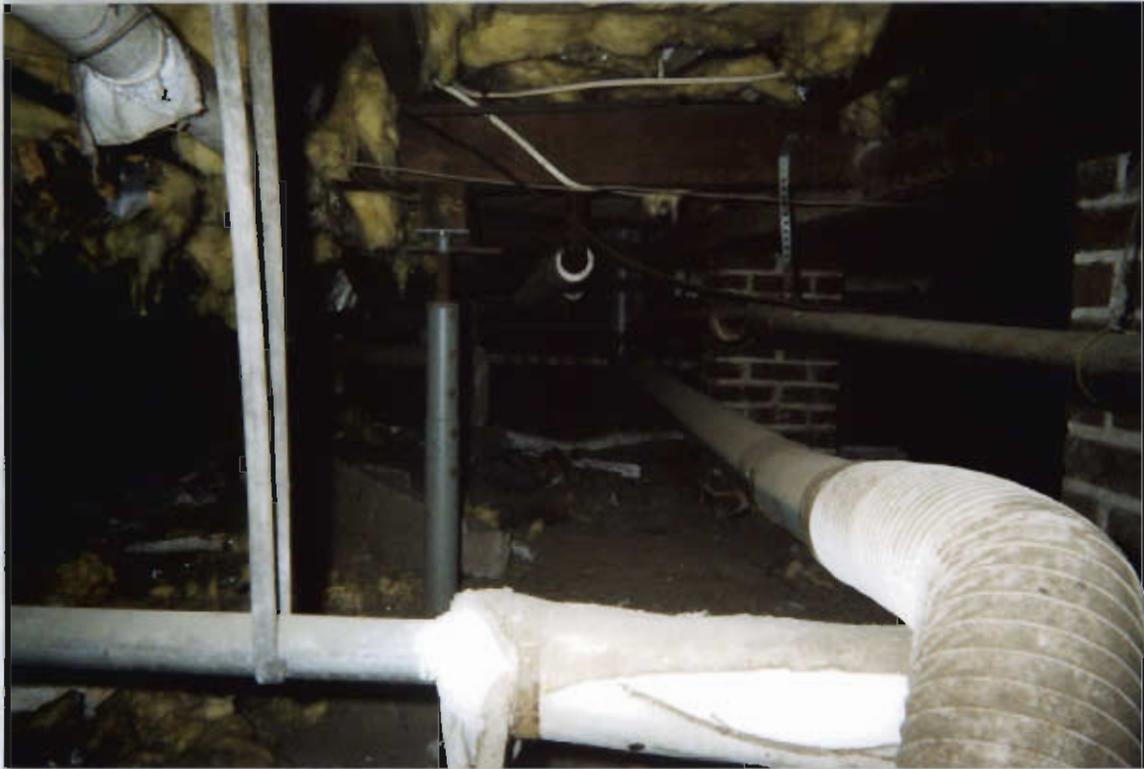
**PHOTO 5:** View of inside crawl space. Note the fiberglass insulation debris.

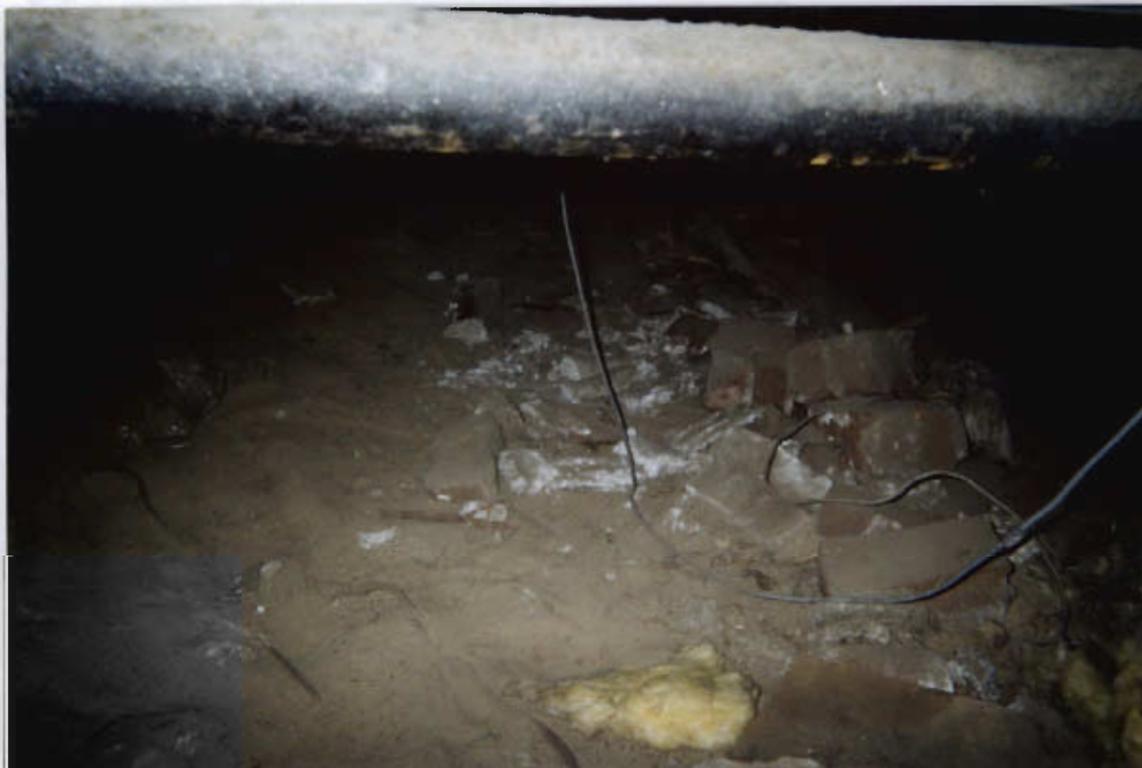
**PHOTO 6:** View of inside crawl space. Note the asbestos-containing material around the bricks on ground along with fiberglass insulation.

BAT required the Abatement Contractor to remove soil in a 12-inch radius around the area that the 3% asbestos-contaminated soil was collected. A visual re-inspection identified no suspect ACM.

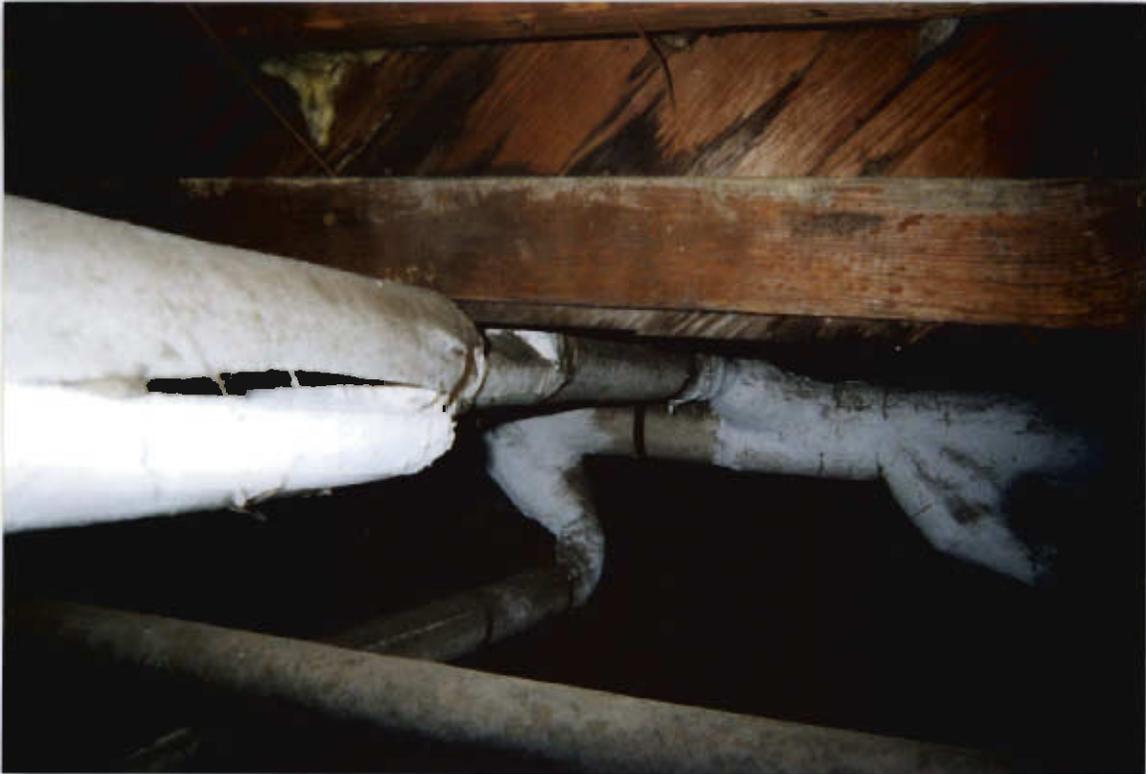
A previously performed asbestos survey of the Project Site identified asbestos-containing pipe insulation on inoperative pipes (Thermal Systems Insulation/TSI) and asbestos-contaminated soil inside the crawl space area of Quarter 760.

**PHOTO 7:** Piping insulated with asbestos-containing materials prior to abatement.

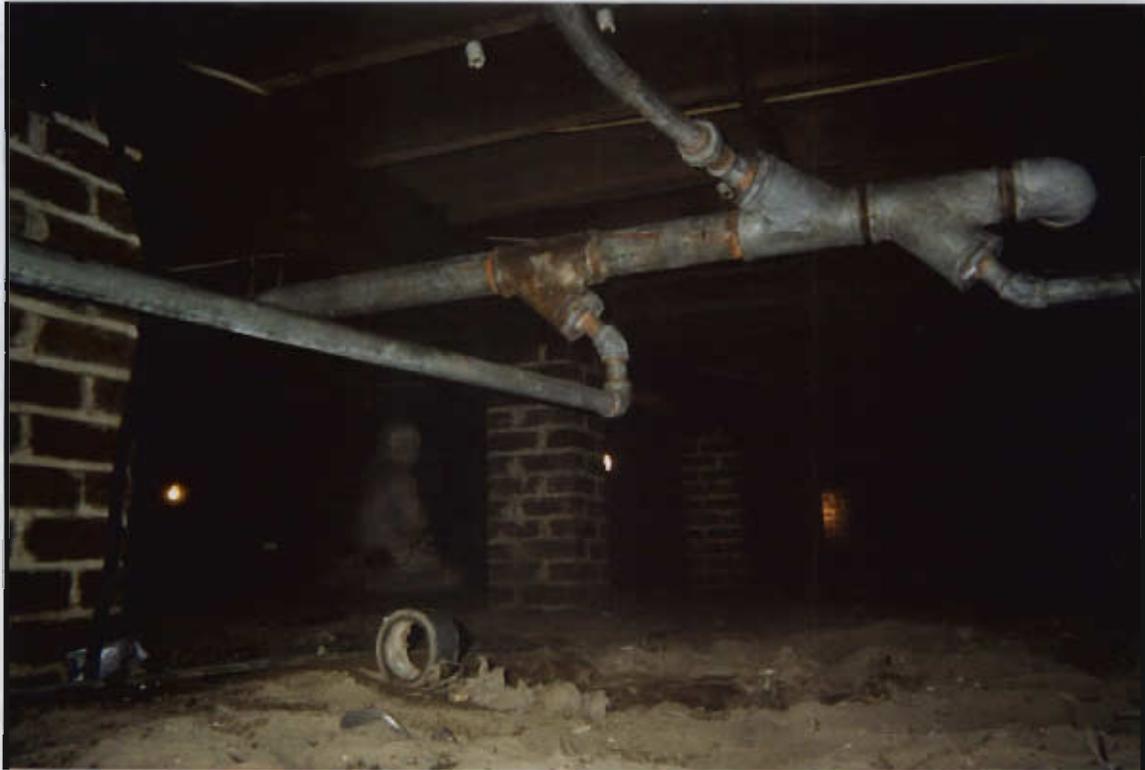
**PHOTO 8:** Piping after asbestos-containing material was abated.
