NAVAL NUCLEAR PROPULSION PROGRAM (NNPP)  
RADIOLOGICAL FINAL REPORT  
FOR THE DECOMMISSIONING OF  
CHARLESTON NAVAL SHIPYARD

(VOLUME II)  
SECTION C  
THRU  
SECTION E

Prepared by  
Radiological Engineering Division  
Charleston Naval Shipyard  
Charleston, South Carolina

April 1, 1996

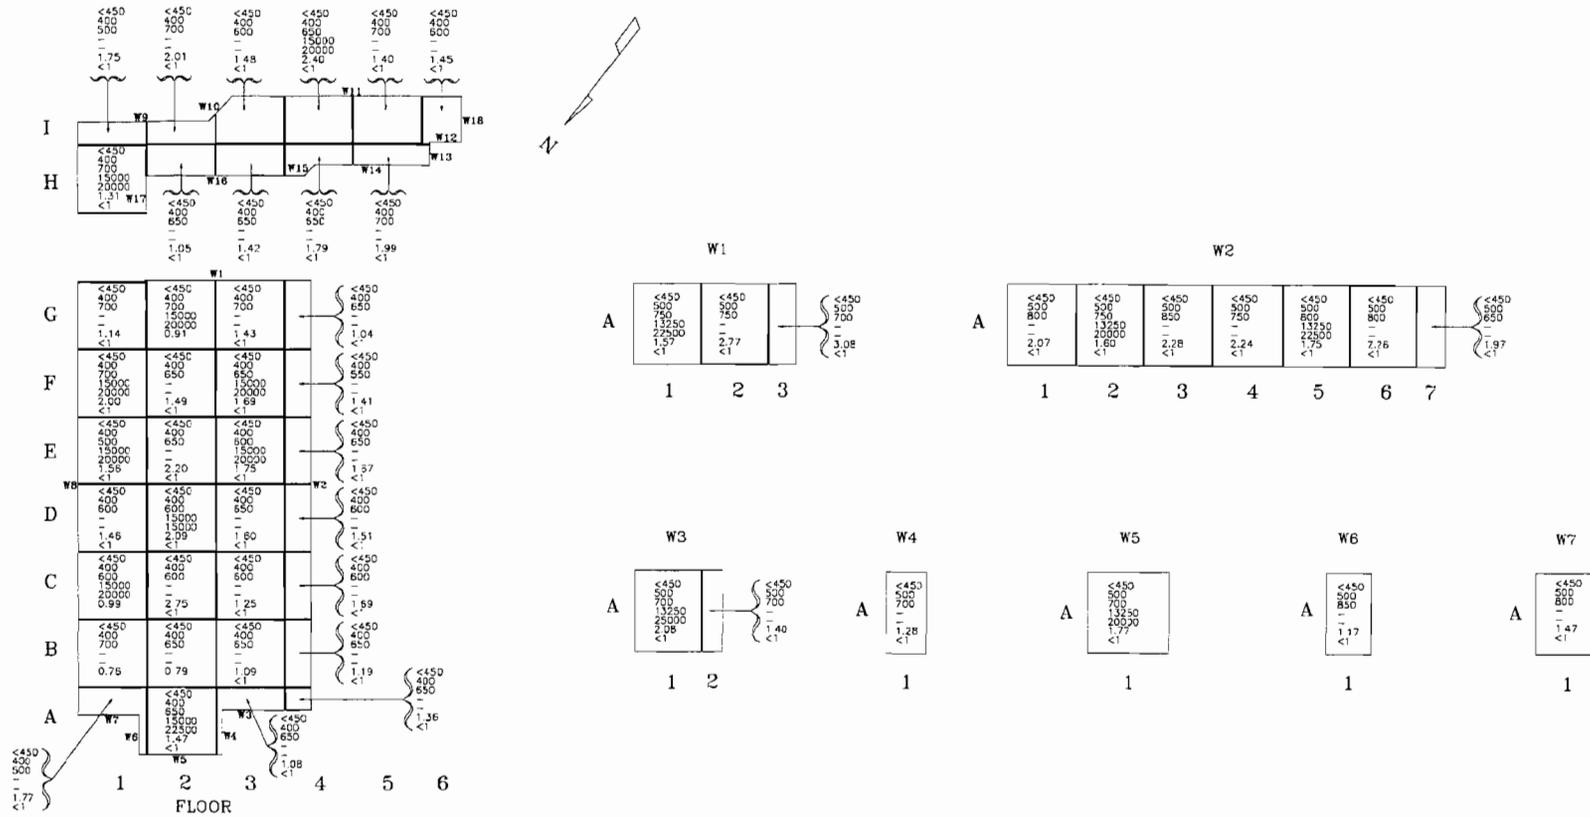
e. Localized Grid Maps, Radiography Room #1

**Sample Data**  
 <450 - IM-247/PD Results [ $\mu\text{Ci}/20\text{cm}^2$ ]  
 200 - IM-253/PD (HV-1 PHA) [Bqg]  
 300 - IM-253/PD (HV-1 PHA) [cpm]  
 7000 - IM-253/PD (HV-2 GROSS) [Bqg]  
 7300 - IM-253/PD (HV-2 GROSS) [cpm]  
 82 - MCA Gross Gamma Ec. Co-60 [pCi/g]  
 <1 - MCA Specific Co-60 Results [pCi/g]

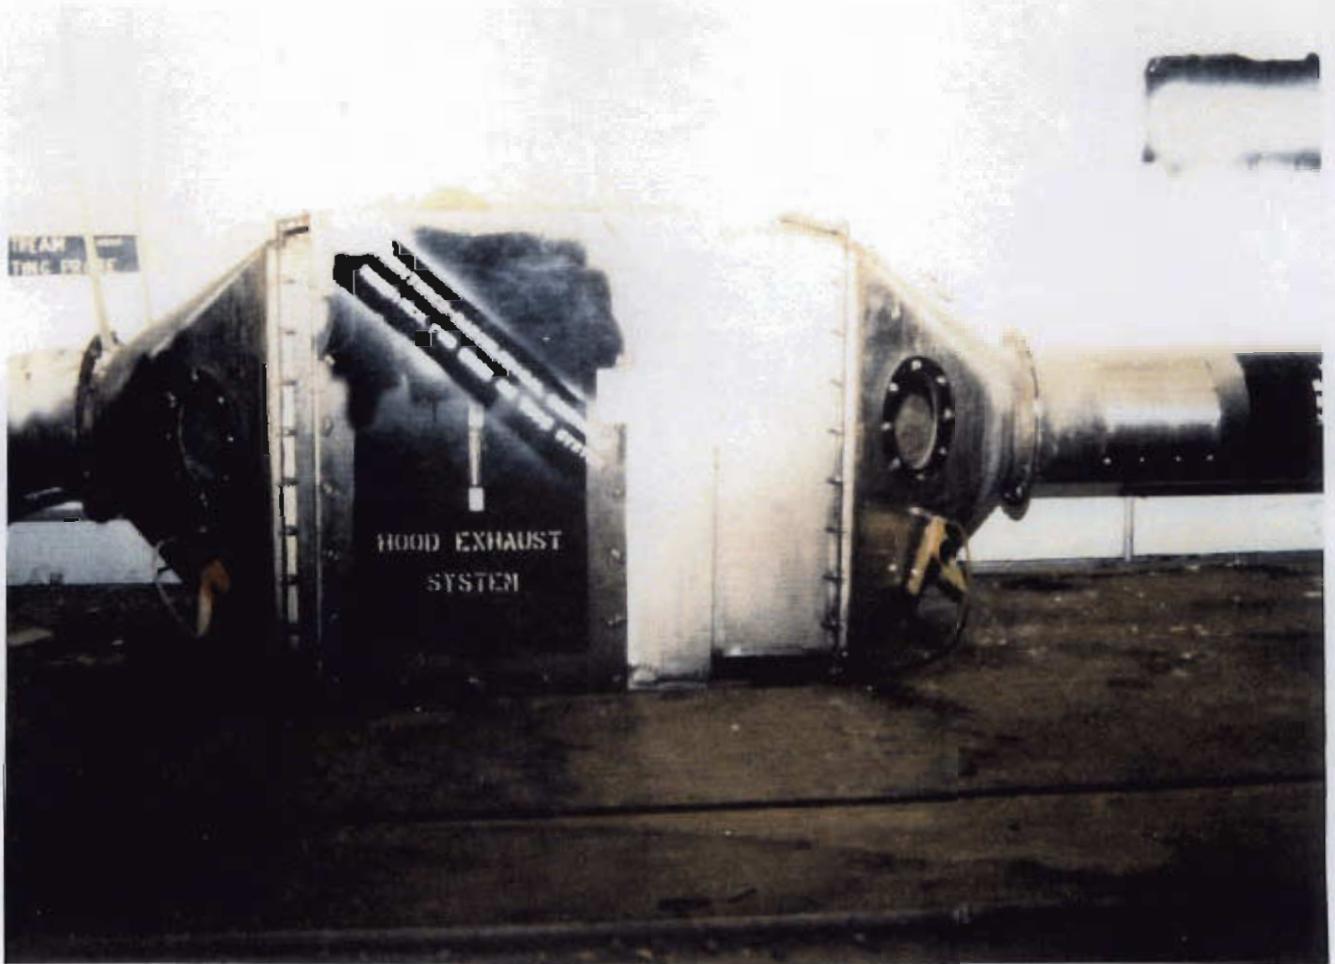
- 7. Bldg. 13A, Radiochemistry Lab Overhead, Mezz.
    - f. Prior to Photographs
-

Radiochemistry Lab hood exhaust system HEPA filter housing.

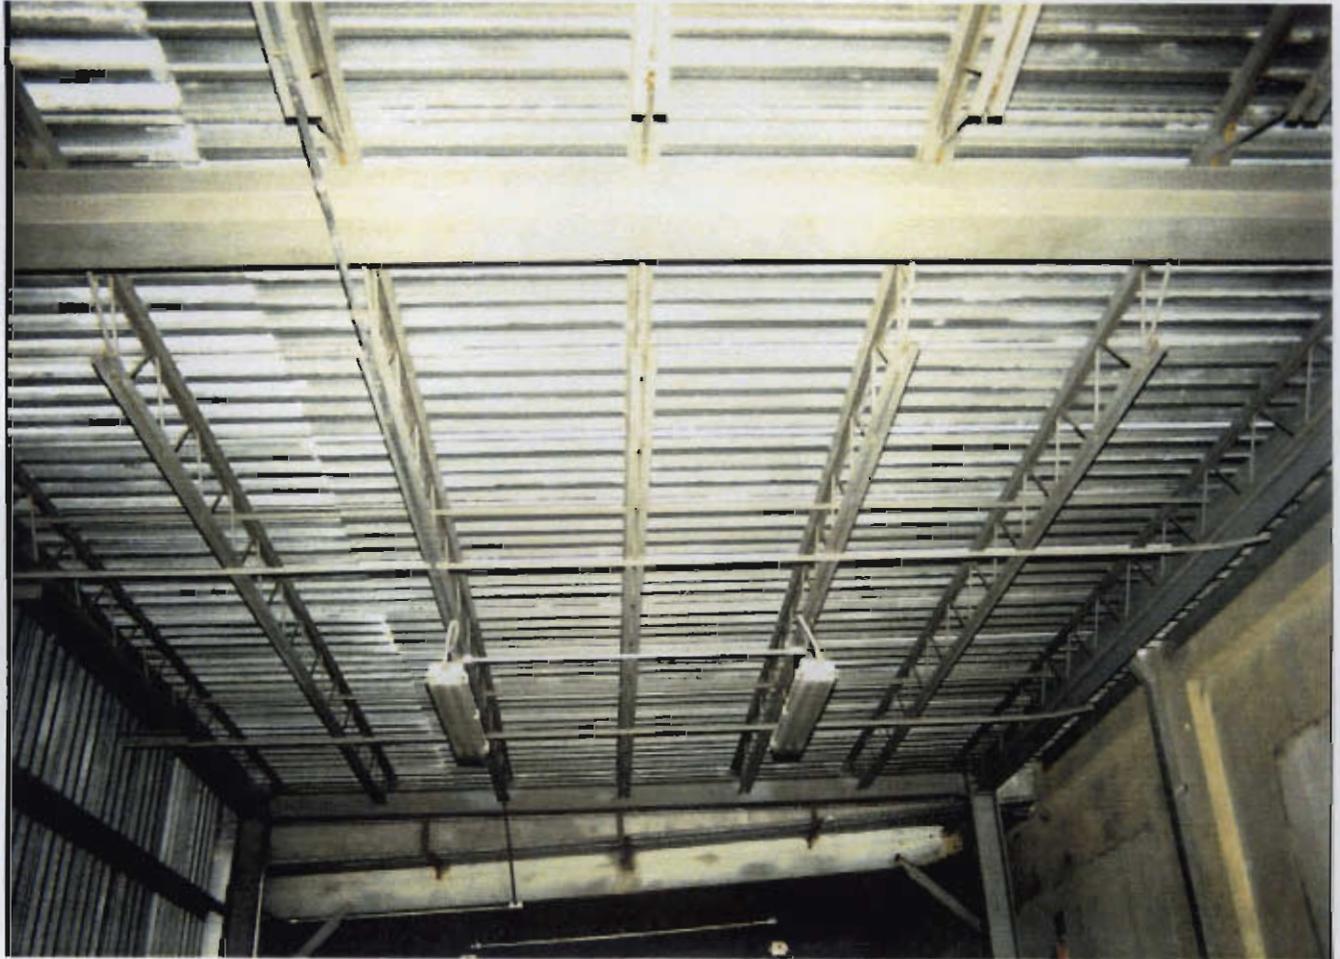
f. Prior to Photographs

Looking at ceiling of covered area.

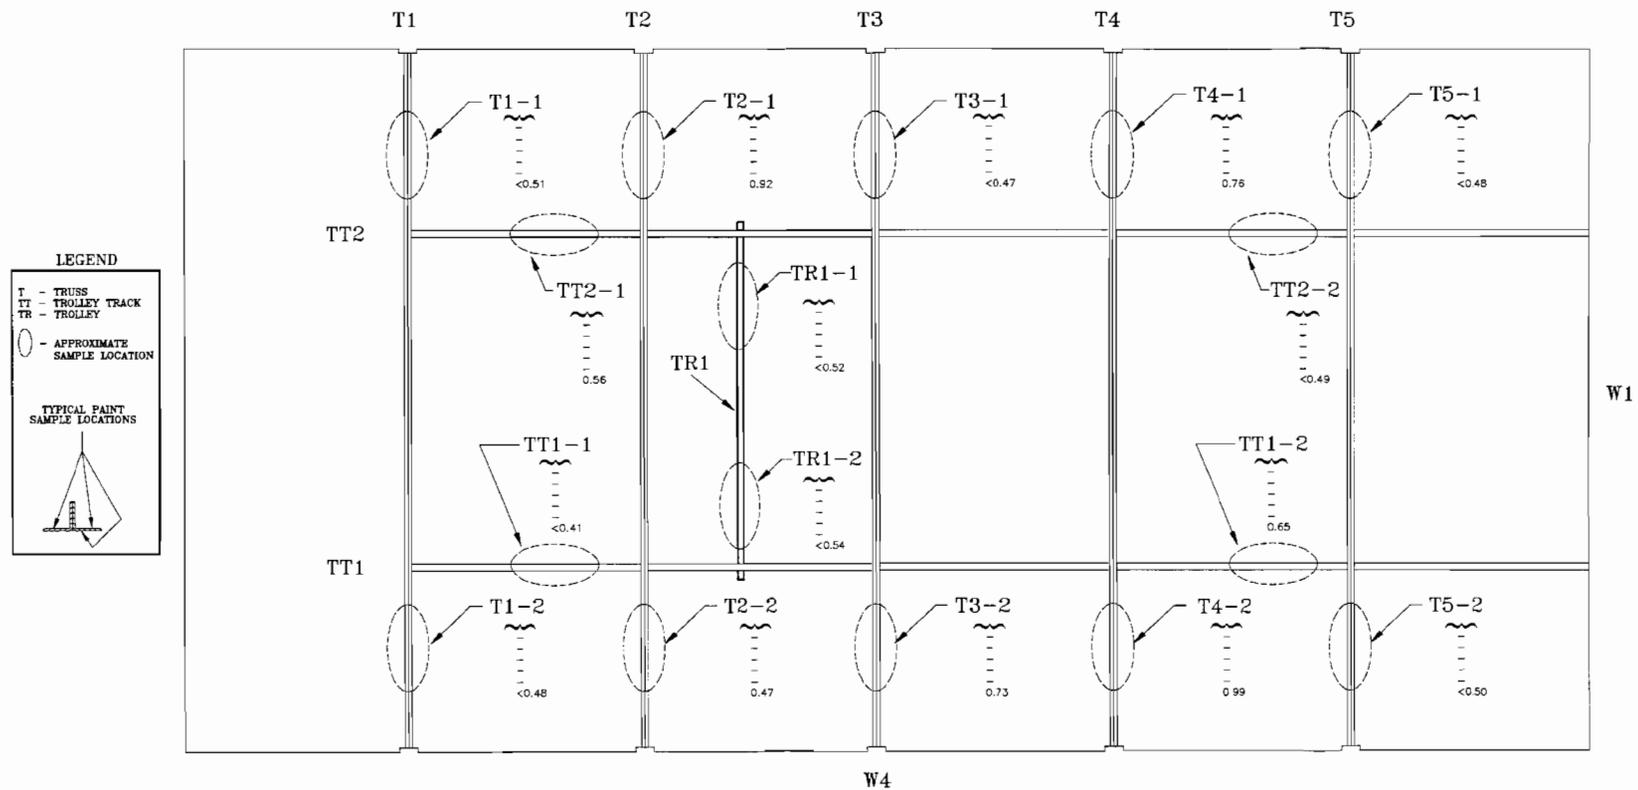
e. Localized Grid Maps

**Note:**  
All solid samples taken consist of paint and have a limit of 3 pCi/g.

**Sample Data**  
 <450 - IM-247/PD Results [ $\mu\text{g}/20\text{cm}^2$ ]  
 200 - IM-253PD (HV-1 PHA) [bkg.]  
 300 - IM-253PD (HV-1 PHA) [cpm]  
 7000 - IM-253PD (HV-2 GROSS) [bkg.]  
 7300 - IM-253PD (HV-2 GROSS) [cpm]  
 1.52 - MCA Gross Gamma Eq. Co-60 [pCi/g]  
 <1 - MCA Specific Co-60 Results [pCi/g]

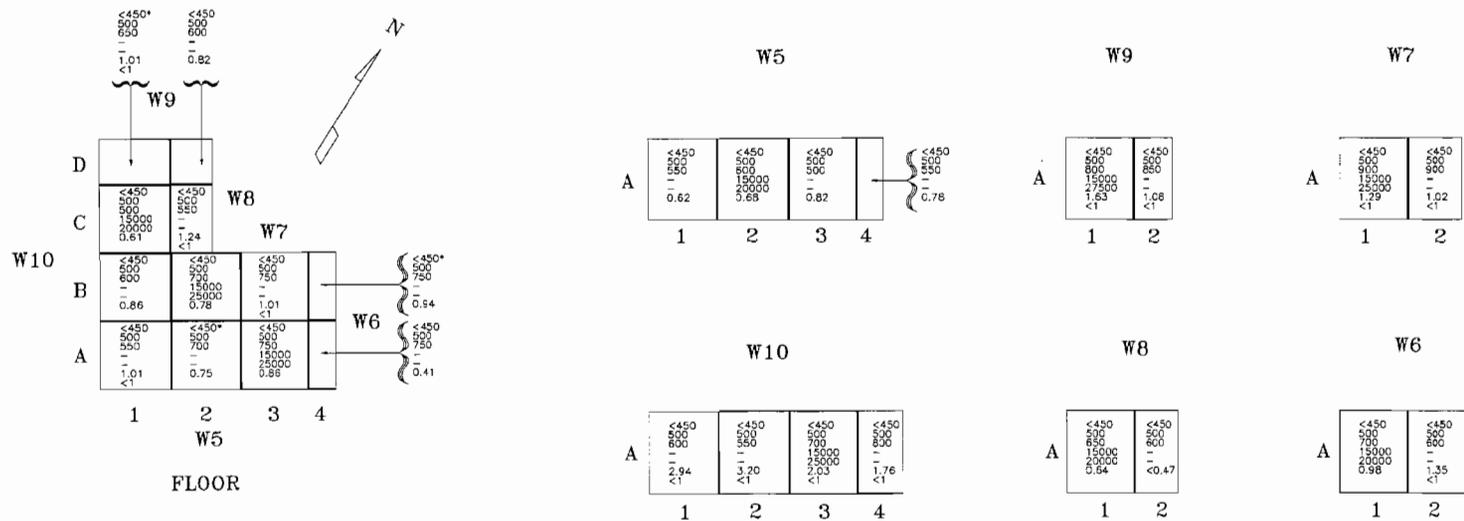
e. Localized Grid Maps

Note:  
\* Denotes grids which were surveyed with an AN/PDR-56 for Alpha radioactivity and no detectable activity was found.

**Sample Data**  
 <450 - IM-247/PO Results [ $\mu\text{Ci}/20\text{cm}^2$ ]  
 200 - IM-253/PD (HV-1 PHA) [Bq.]  
 300 - IM-253/PD (HV-1 PHA) [cpm]  
 7300 - IM-253/PD (HV-2 GROSS) [Bq.]  
 7300 - IM-253/PD (HV-2 GROSS) [cpm]  
 1.82 - MCA Gross Gamma Eq. Co-60 [ $\mu\text{Ci}/\text{g}$ ]  
 <1 - MCA Specific Co-60 Results [ $\mu\text{Ci}/\text{g}$ ]

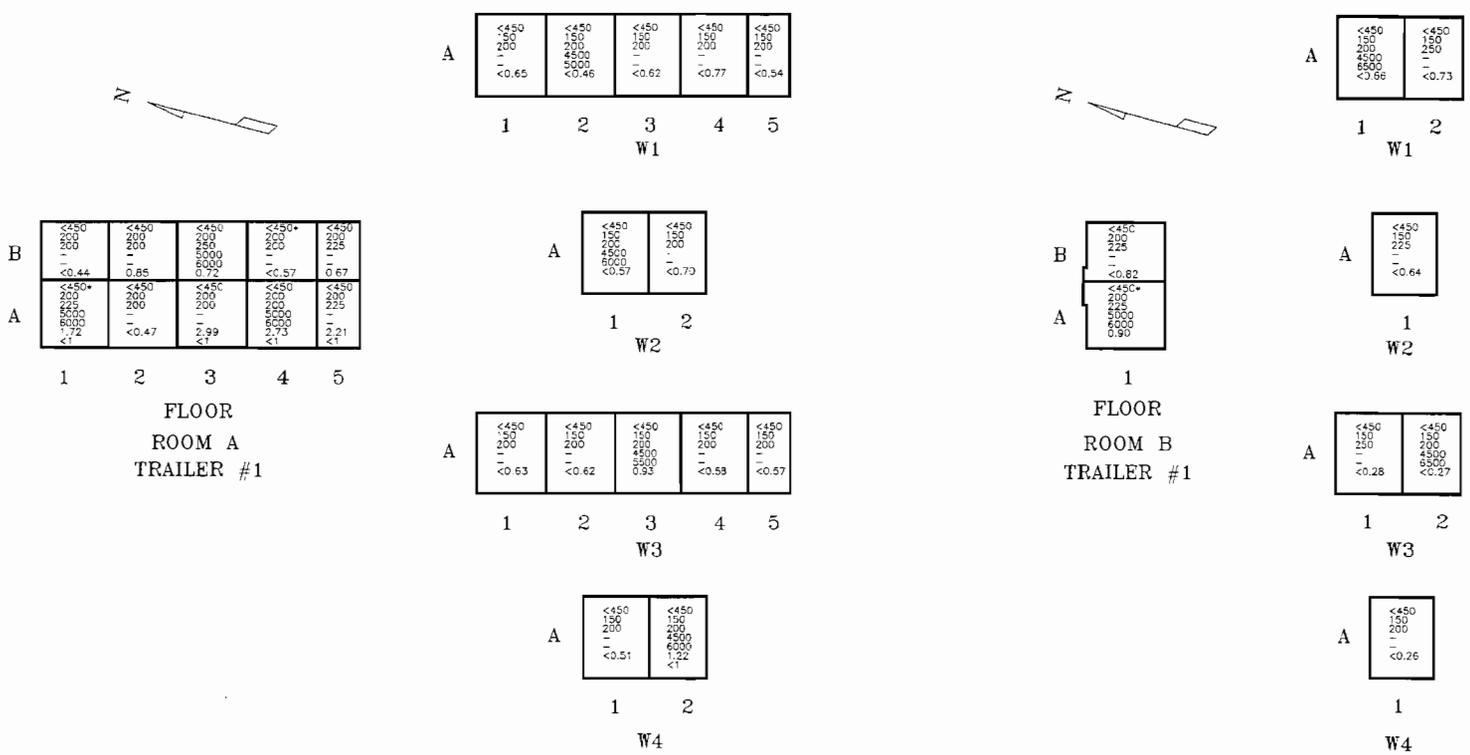
e. Localized Grid Maps

Note:  
\* Denotes grids which were surveyed with an AN/PDR-56 for Alpha radioactivity and no detectable activity was found.

Sample Data  
 <450 - IM-247/PD Results [ $\mu\text{Ci}/20\text{cm}^2$ ]  
 200 - IM-253/PD (HV-1 PHA) [bq]  
 300 - IM-283/PD (HV-1 PHA) [cpm]  
 7500 - IM-253/PD (HV-2 GROSS) [bq]  
 7500 - IM-253/PD (HV-2 GROSS) [cpm]  
 1.82 - MCA Gross Gamma Eq. Co-60 [pCi/g]  
 <1 - MCA Specific Co-60 Results [pCi/g]

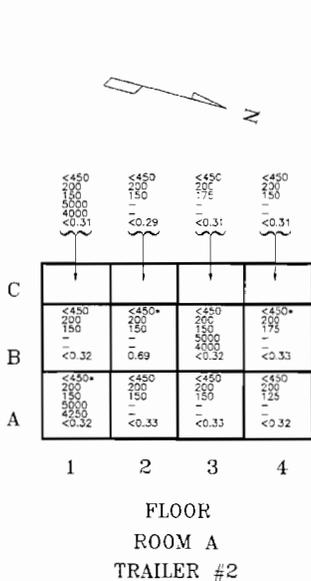
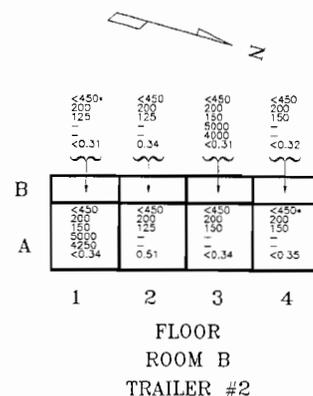
e. Localized Grid Maps

Note:  
 \* Denotes grids which were surveyed with an AN/PDR-56 for Alpha radioactivity and no detectable activity was found.

Sample Data  
 <450 - IM-247/PD Results [ $\mu\text{Ci}/20\text{cm}^2$ ]  
 200 - IM-253/PD (HV-1 PHA) [bkg.]  
 300 - IM-253/PD (HV-1 PHA) [cpm]  
 7000 - IM-253/PD (HV-2 GROSS) [bkg.]  
 7300 - IM-253/PD (HV-2 GROSS) [cpm]  
 1.32 - MCA Gross Gamma Eq. Co-60 [ $\mu\text{Ci/g}$ ]  
 < - MCA Specific Co-60 Results [ $\mu\text{Ci/g}$ ]

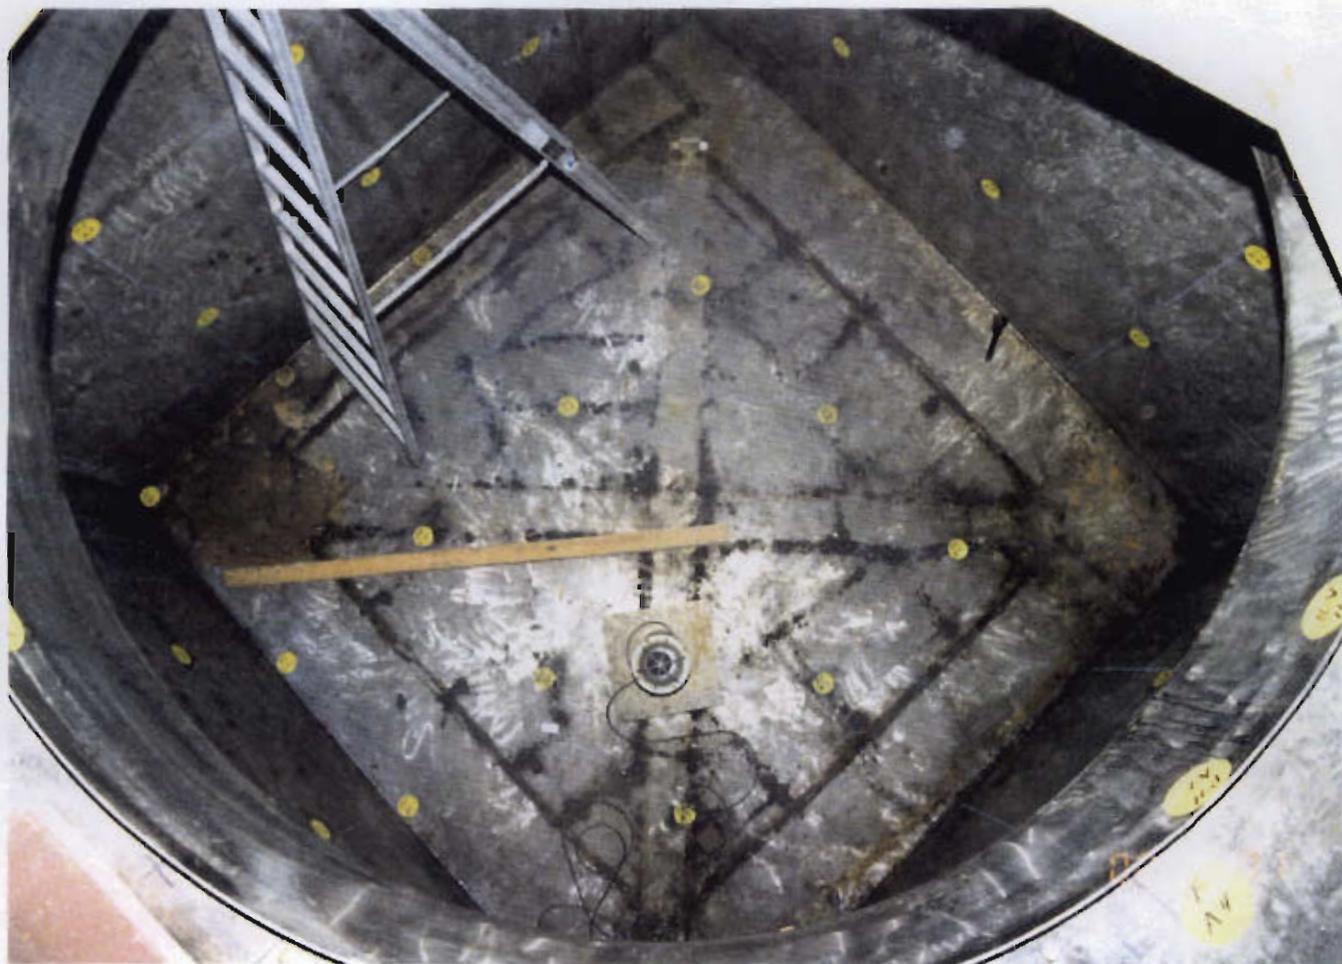
g. After Photograph

Center of IAF looking down into pit.
