STATEMENT OF BASIS CNC CHARLESTON SC
7/1/2004
CH2MHILL

Statement of Basis

**Charleston Naval Complex
North Charleston, SC**

Prepared for
**U.S. Navy Southern Division
Naval Facilities Engineering Command**

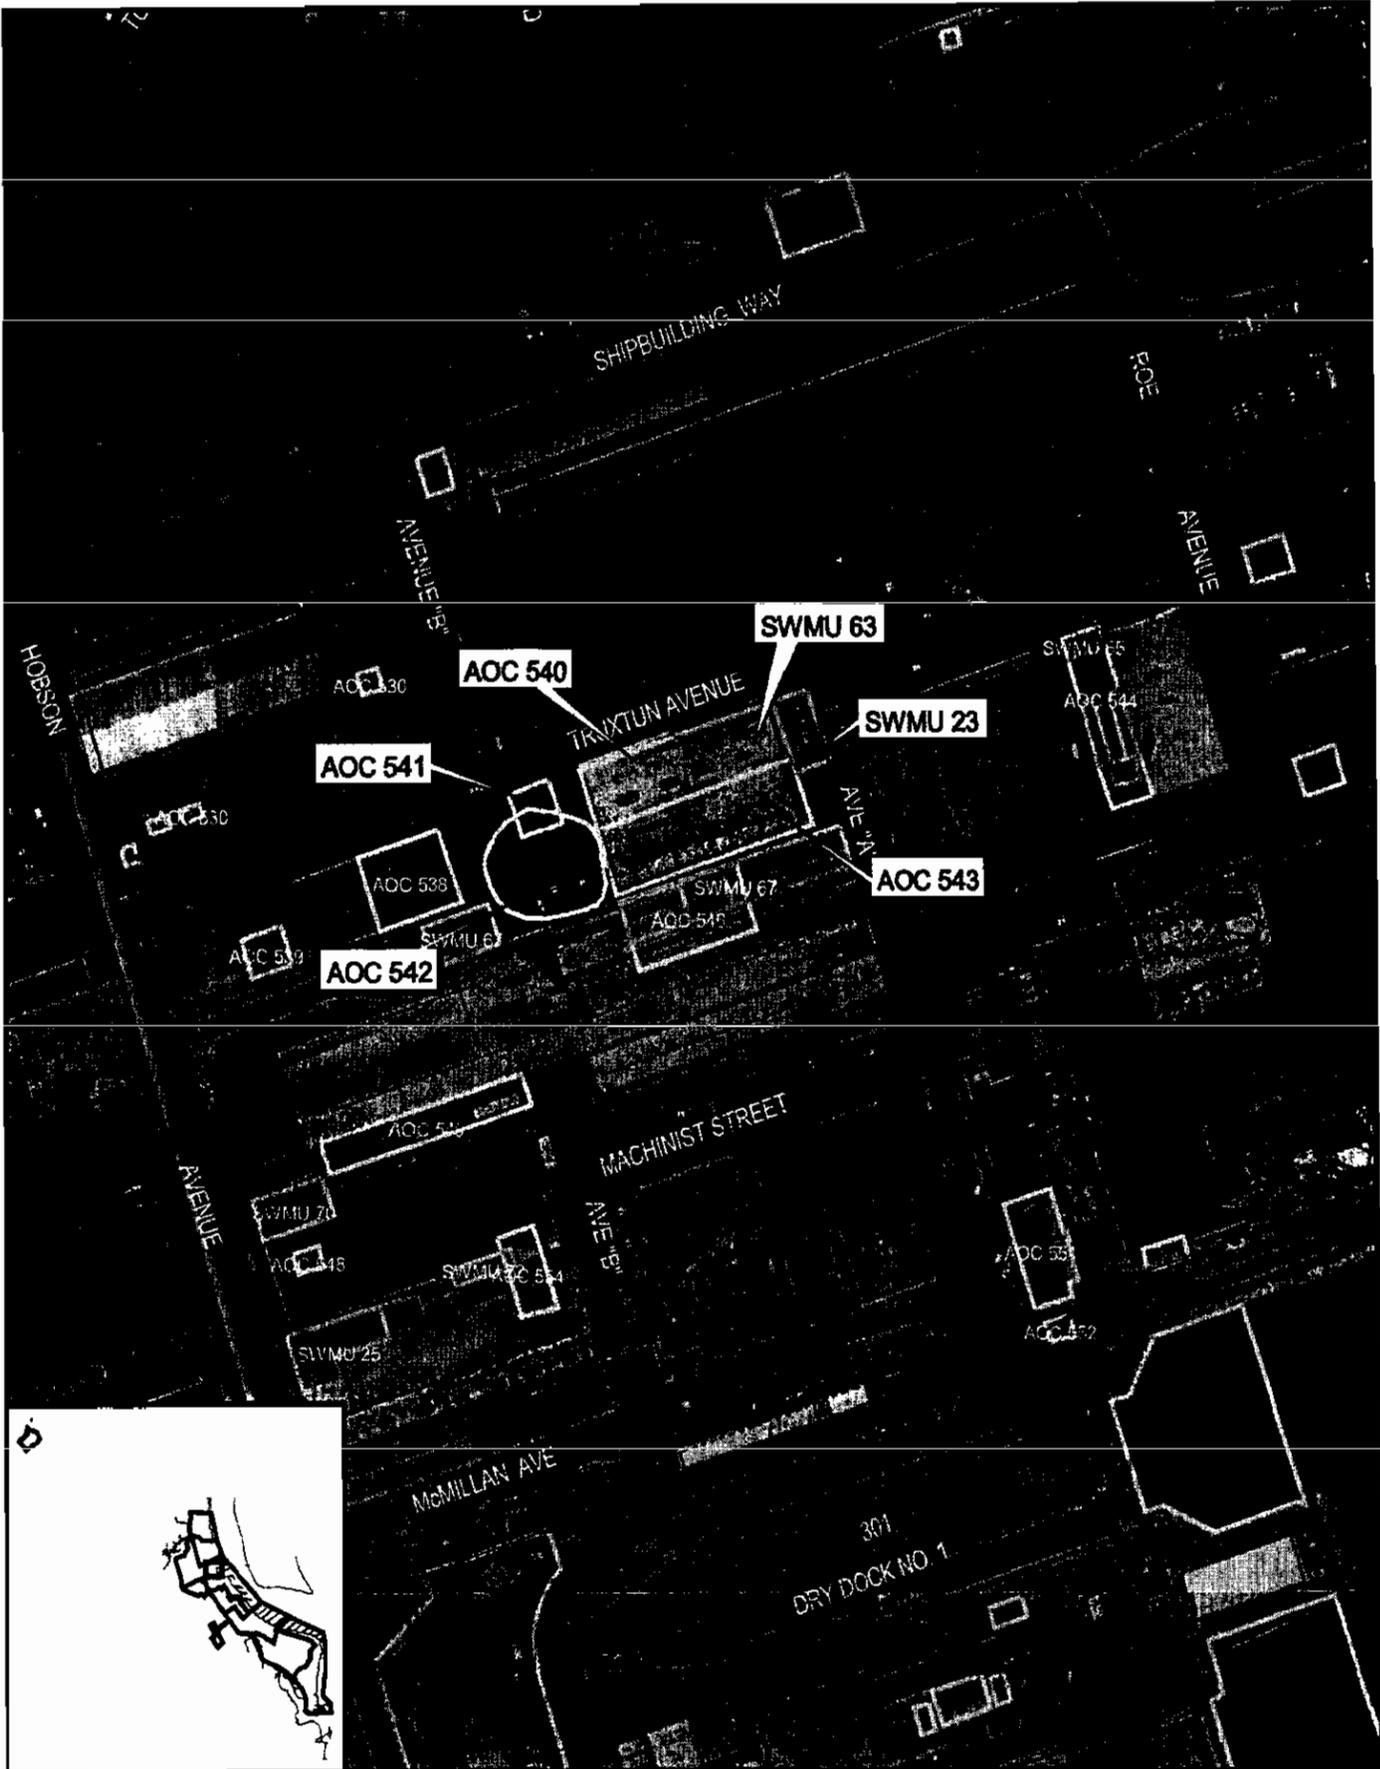
Figure 5
Aerial Photograph of Combined SWMU 23
Zone E
Charleston Naval Complex

15 SWMU 23 is located outside Building 226 on the northeast corner, and is the location of the
16 former wastewater treatment system (WWTS) associated with Building 226. The WWTS
17 building is a concrete structure built around 1983 to replace an older system. The newer
18 WWTS was installed to handle chrome effluent, acid/alkali effluent from metal plating, and
19 cadmium effluent. The WWTS consisted of rinse water pumps, holding tanks, transfer
20 pumps, a clarifier, a neutralization tank, and a plate and frame filter press. The WWTS is no
21 longer in use.

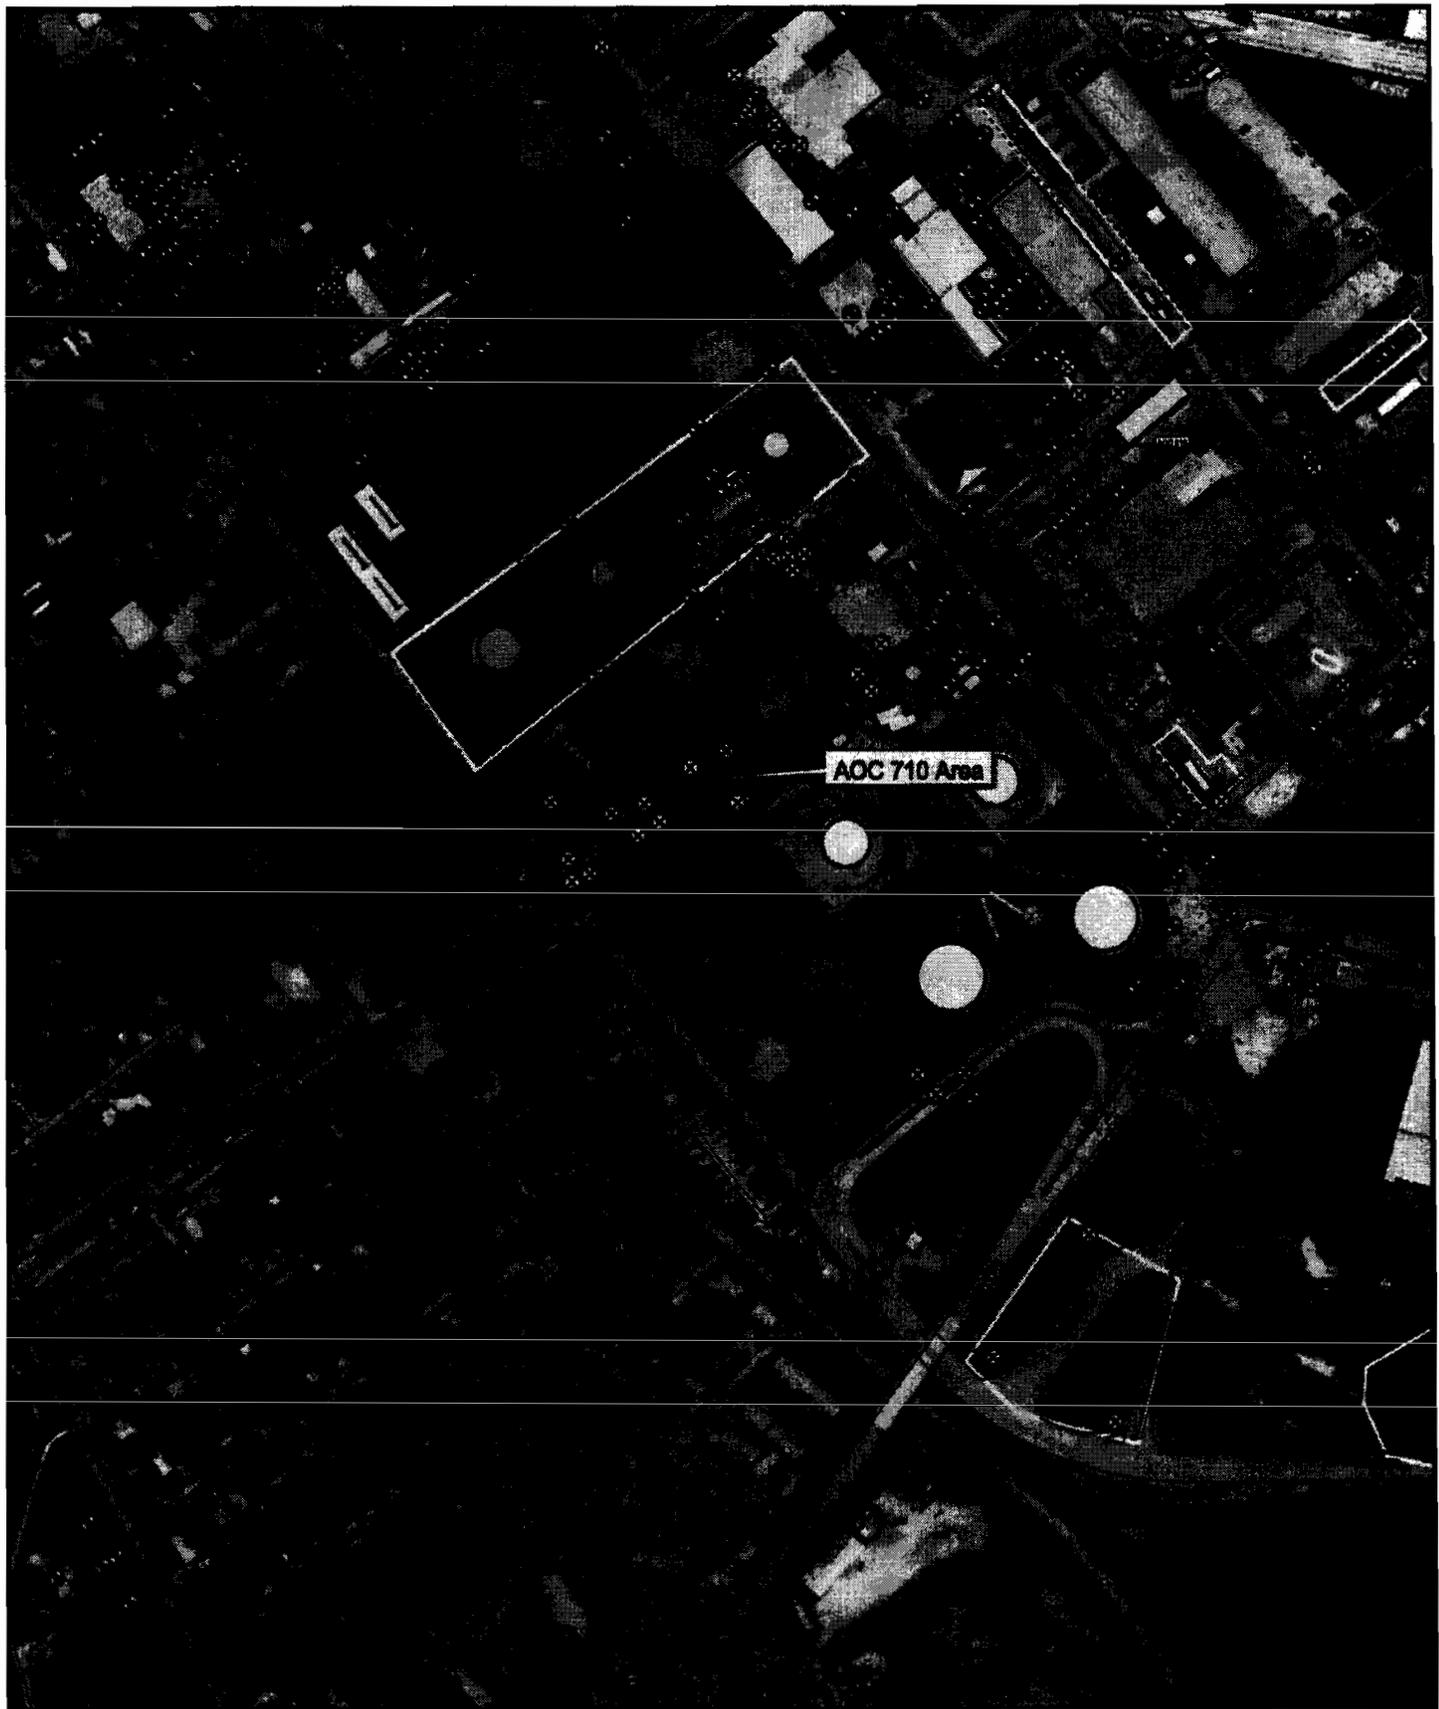
Figure 69
Site Location
AOC 710, Zone F
Charleston Naval Complex

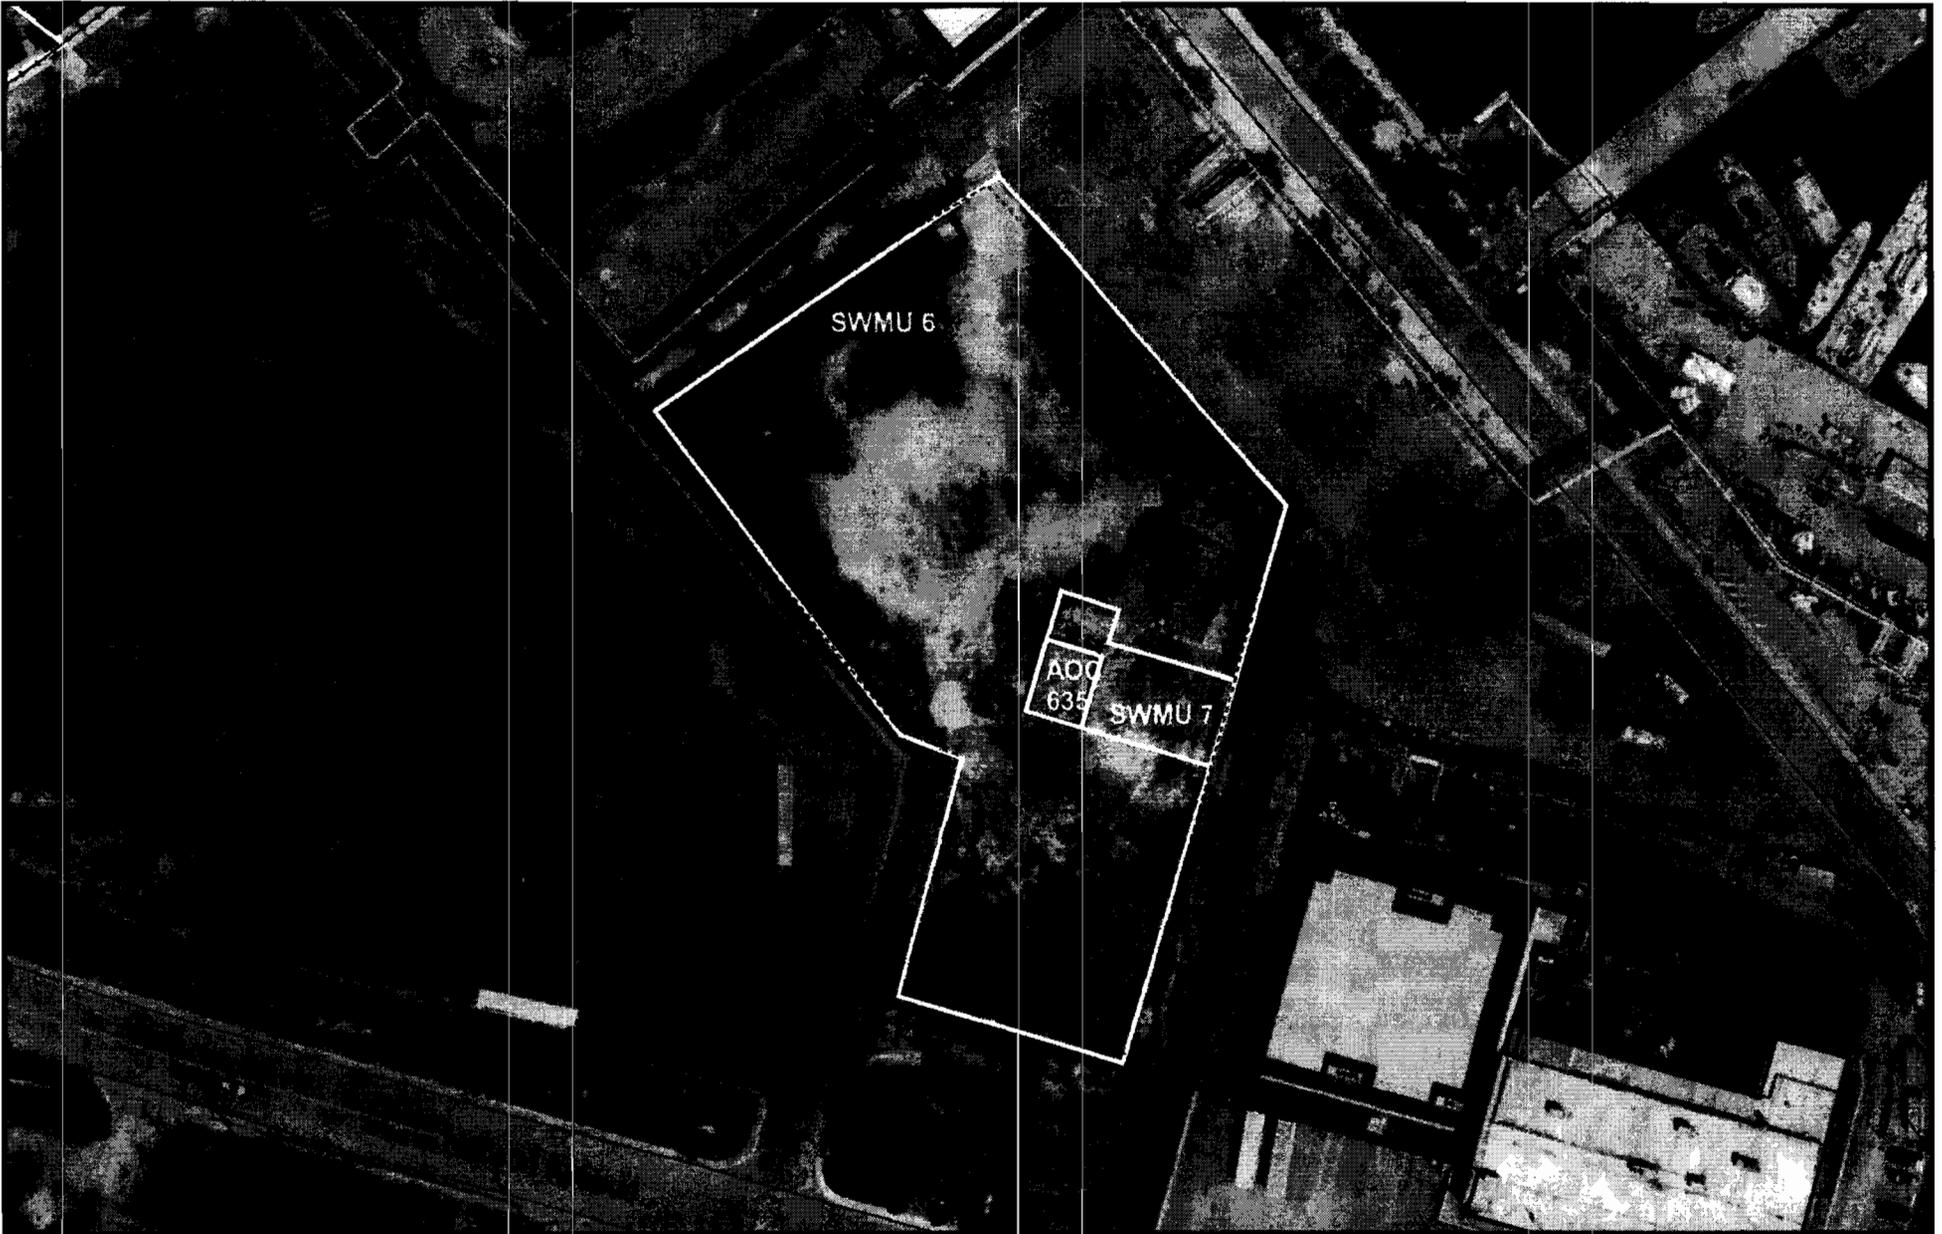
1 Figure 80

Figure 80
Aerial View
SWMU 6, Zone G
Charleston Naval Complex

3 SWMU 6 was recommended for an RFI under the current RCRA permit. Subsequent to the
4 RFI, activities at SWMU 6 included the removal of buildings, concrete slabs, and parking
5 lots. The SWMU 6 area is currently an unpaved, grassy field. Figure 80 shows the site
6 location.
