COMPLETION REPORT INTERIM MEASURE FOR AREA OF CONCERN 501 (AOC501) WITH
TRANSMITTAL CNC CHARLESTON SC
10/20/1998
CNC CHARLESTON

COMPLETION REPORT

INTERIM MEASURE FOR
AOC 501

NAVAL BASE CHARLESTON
CHARLESTON, SC

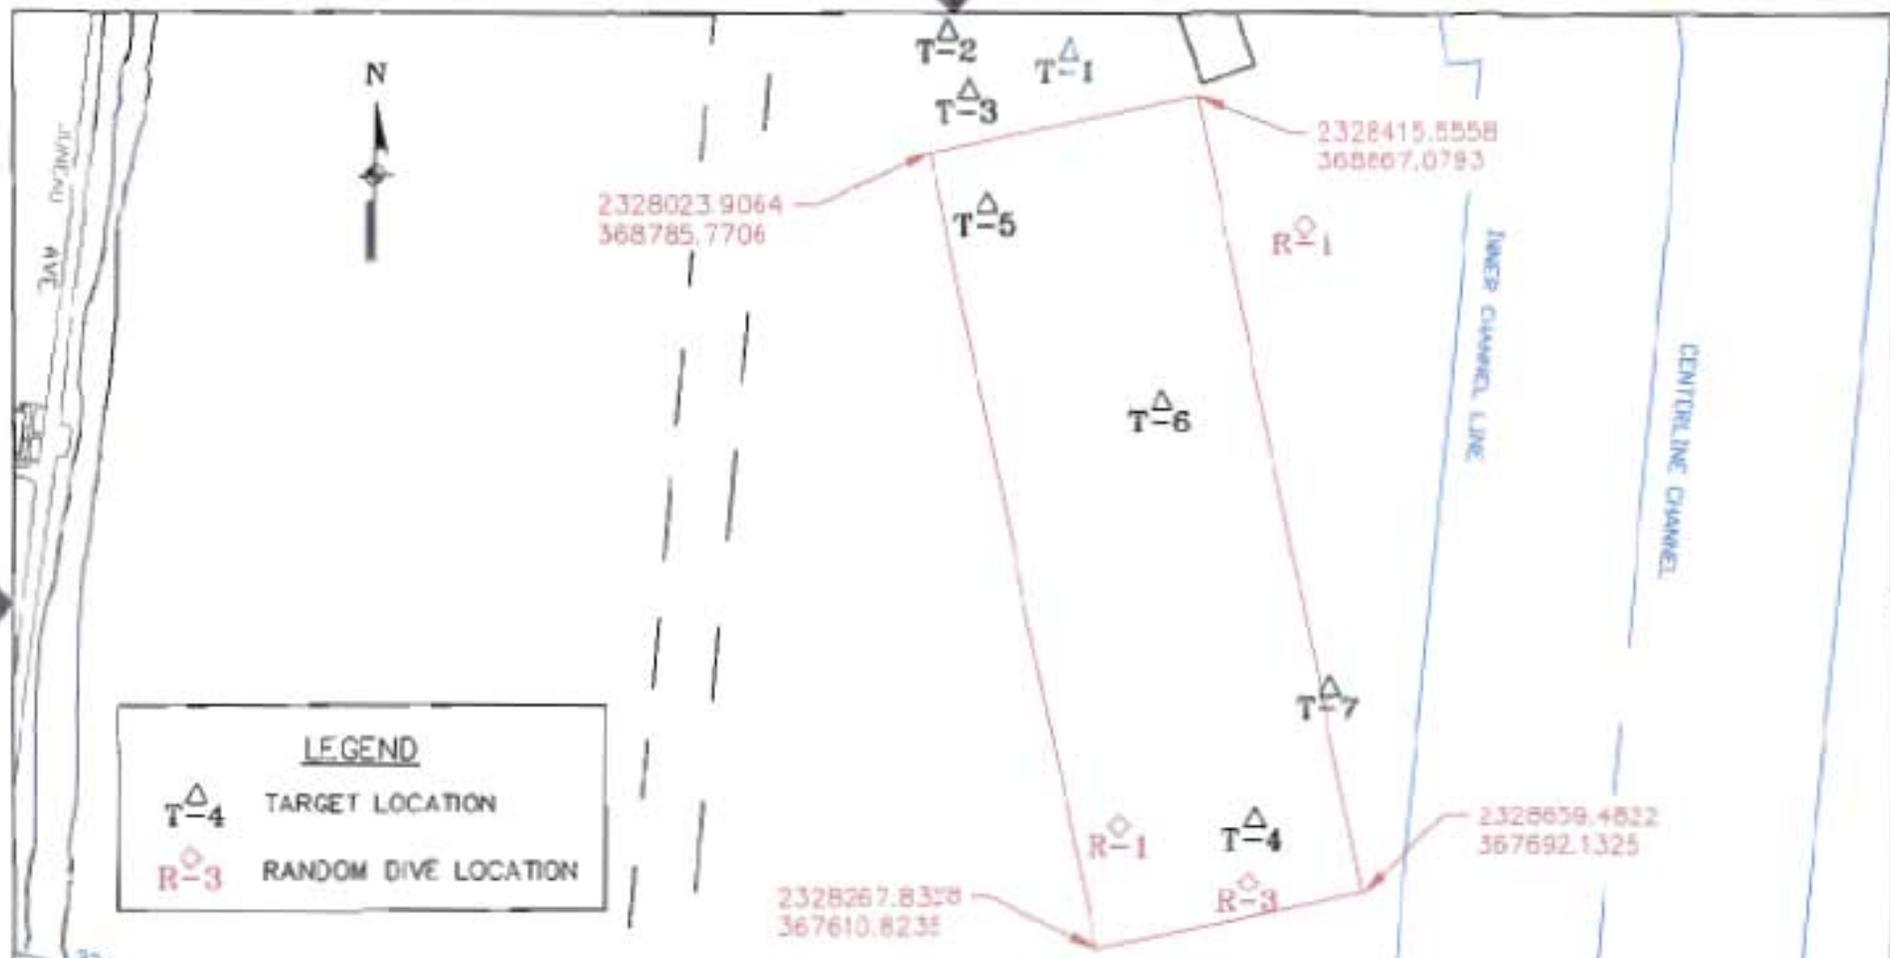
ENVIRONMENTAL DETACHMENT CHARLESTON 180 NORTH JOHNSON AVENUE - BUILDING 36 NORTH CHARLESTON, SOUTH CAROLINA 29405-5108			
FIGURE 2 ADC 501 COMPLETION REPORT SITE MAP WITH TARGET LOCATIONS, RANDOM DIVE LOCATIONS AND STATE PLANE COORDINATES			
DATE	DATE	PREPARED BY:	REV
10-11-98		TOMMY HARDIN	-
SCALE		SHEET	A-2

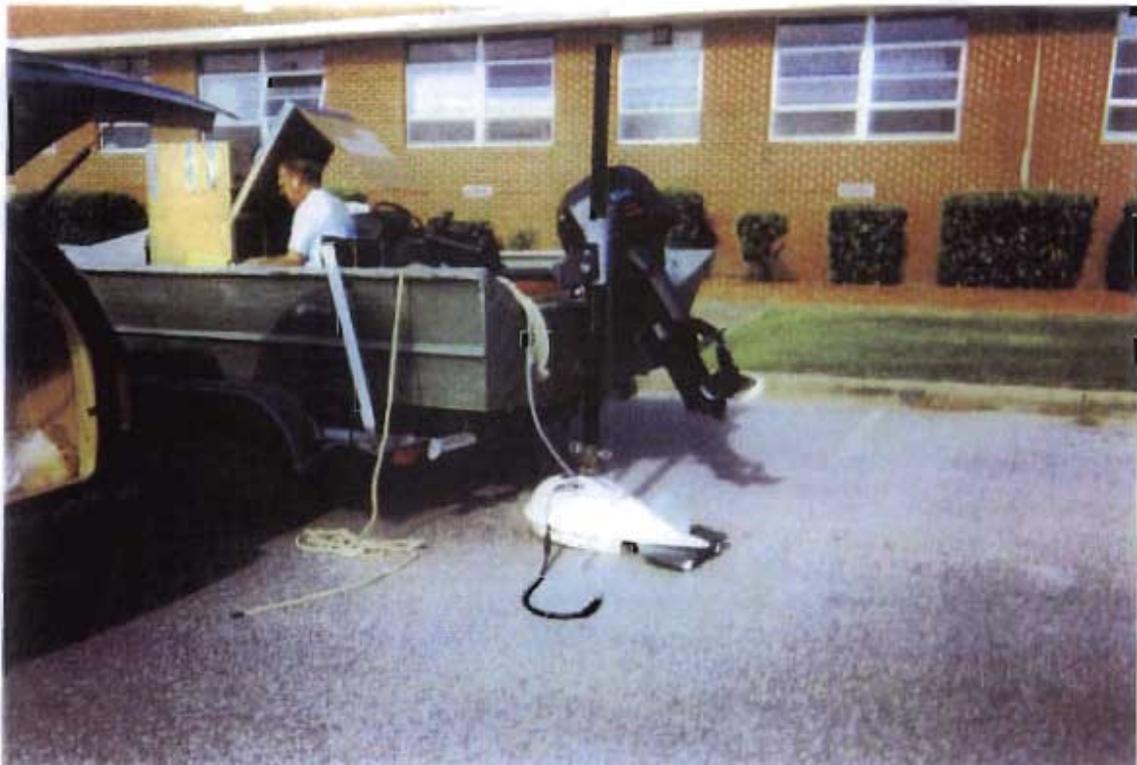
The CHIRP II mounted to the stern of the boat prior to launching the boat.

The CHIRP radiating element, or fish, and Global Positioning System (GPS) beacon, are mounted vertically on the stern of the boat. As the boat approaches a target, the return wave from leading edge of the emitted acoustic radiation is recorded. As the boat (actually the CHIRP emitting element) passes over the target, the returned energy shows an apparent change in location because the object is nearer the CHIRP. As the boat goes away from the target, the returned energy plot again shows the apparent change in location because the object is farther away from the CHIRP. The plot of the returned energy — approaching, near, receding — forms a curve or parabola with its center or focus being the location of the target. The GPS system records this location for future reference.

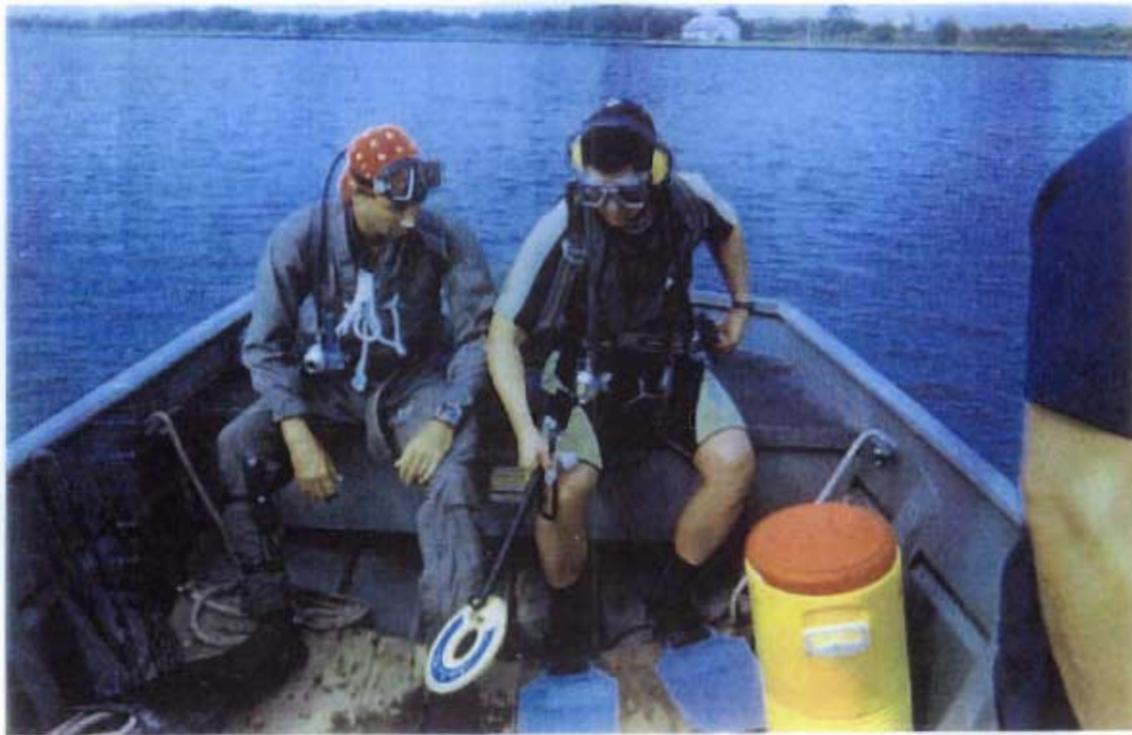
EOD divers testing the Surfmaster under water metal detector prior to a dive.

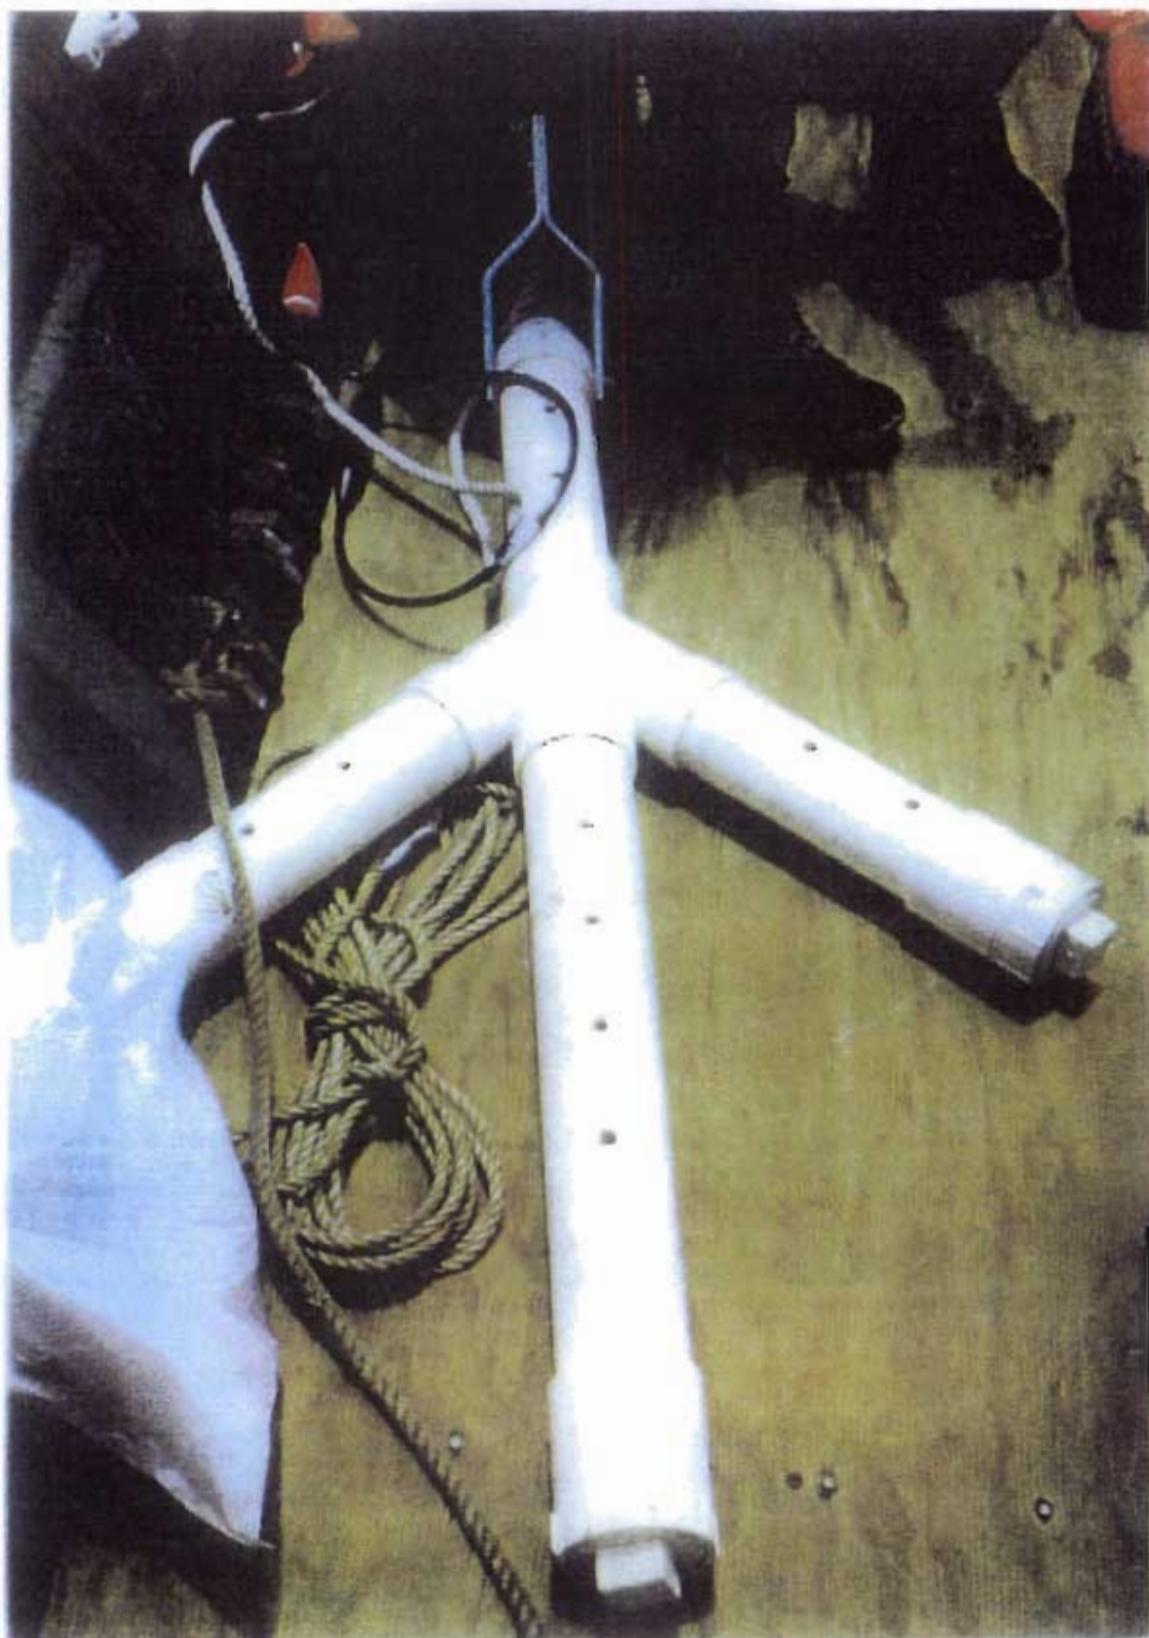
The DMG-50 Gradiometer, which is inside of the PVC towing container.

e. GRADIOMETER. The gradiometer used on this project was the Hydrographic Survey Products Digital Marine Gradiometer model DMG-50. The DMG-50 uses a pair of solid state magnetometers to detect changes in magnetic gradients and analyzes those changes with microprocessors. Using a magnetic gradiometer on this project provided two benefits. First, the gradiometer was used to help characterize density variations detected by the CHIRP II. Second, the magnetic gradiometer technique was used as a quality assurance check on the acoustic sub-bottom profiler, CHIRP II.

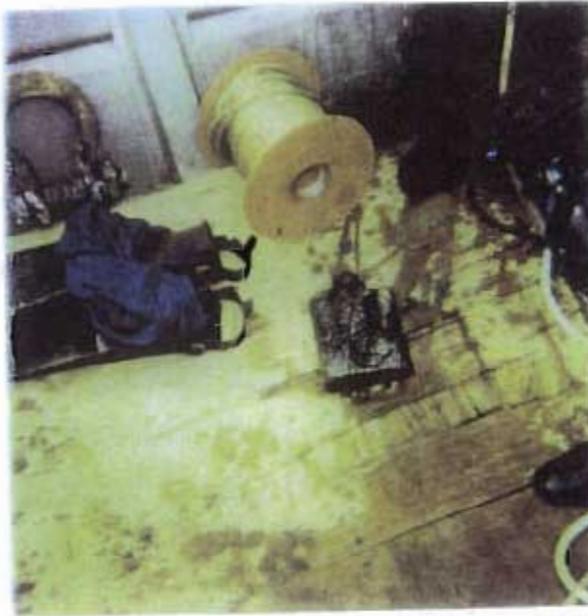
A badly corroded oxygen breathing apparatus was found at Target 1 (T-1).

Site	Located Items	
T01	Recovered:	<ul style="list-style-type: none"> • Badly corroded Oxygen Breathing Apparatus (OBA) canister, $\pm 2''$ x $\pm 8''$ x $\pm 8''$ • Two small shackles or chain links, badly corroded
T02	Recovered: Not Recovered:	<ul style="list-style-type: none"> • Beer can, wood with embedded nails, and pliers • Clump of angle iron welded or corroded together
T03	Not Recovered:	<ul style="list-style-type: none"> • $\pm 20'$ of cable in one piece (same cable as at T07)
T04	Nothing Detected	
T05	Recovered: Not Recovered:	<ul style="list-style-type: none"> • Rusty spike or pipe, $\pm 1''$ diameter x $\pm 30''$ long, weight ± 5 lbs • Large pipe, $\pm 3''$ diameter x more than 12' long
T06	Nothing Detected	
T07	Recovered: Not Recovered:	<ul style="list-style-type: none"> • Four (4) pieces of pipe or metal clad line, $\pm 1''$ diameter x $\pm 30''$ long, total weight ± 8 lbs • Numerous small magnetic pieces, both inside and outside dive circle

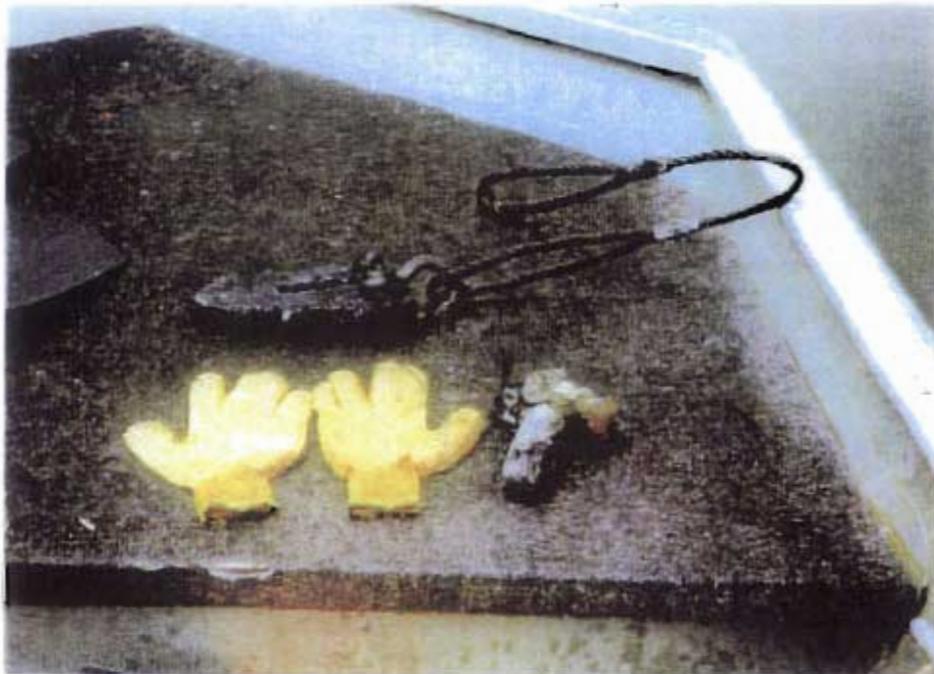
A shackle recovered at Target 1(T-1) location.

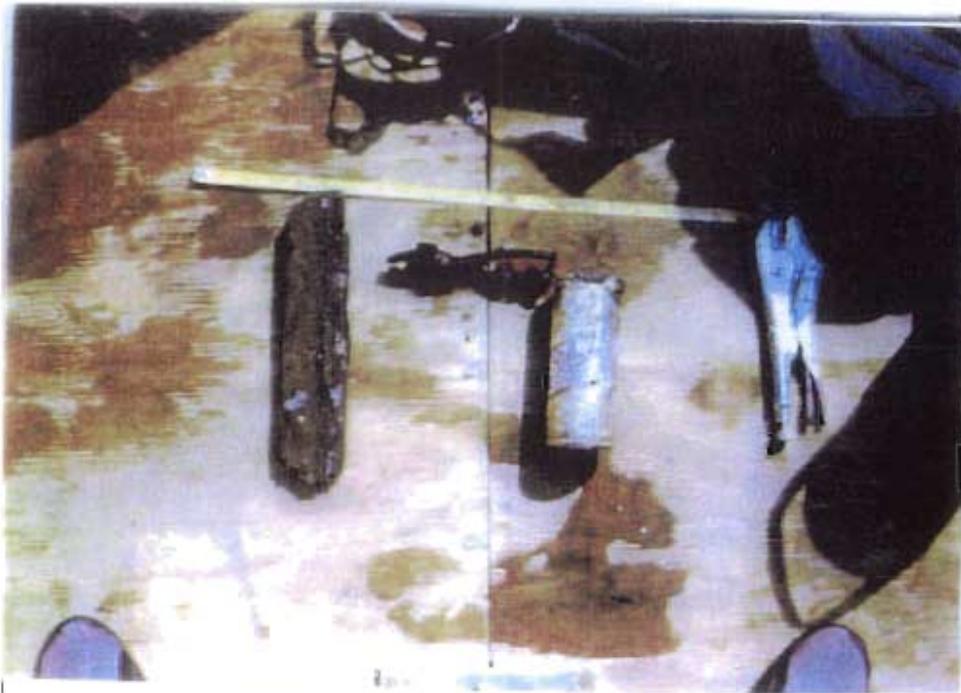
A piece of wood with embedded nails, beer can, and pliers are shown above was found at Target 2 (T-2) location. Also found but not recovered was a piece of angle iron.

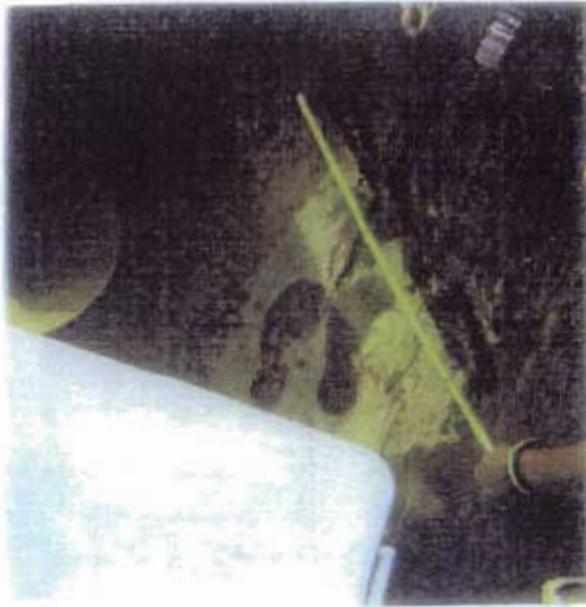
**A rusty pipe approximately 1" dia. x 30" long
was recovered at Target 5 location.**

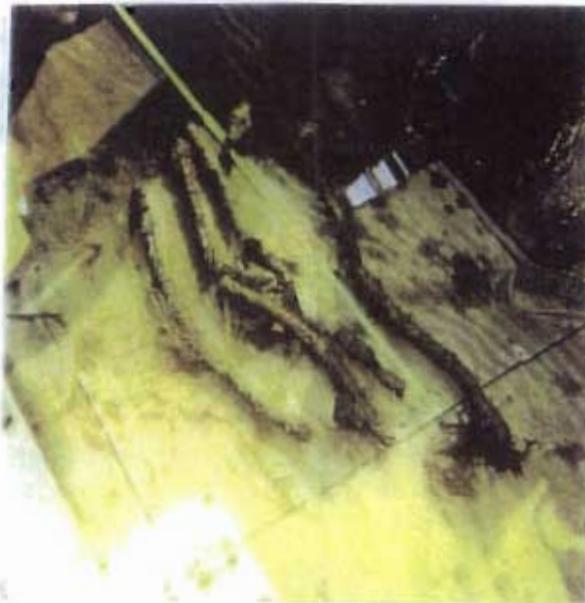
**Four pieces of pipe approximately 1" dia. x 30" long
was found at Target 7 (T-7) location.**

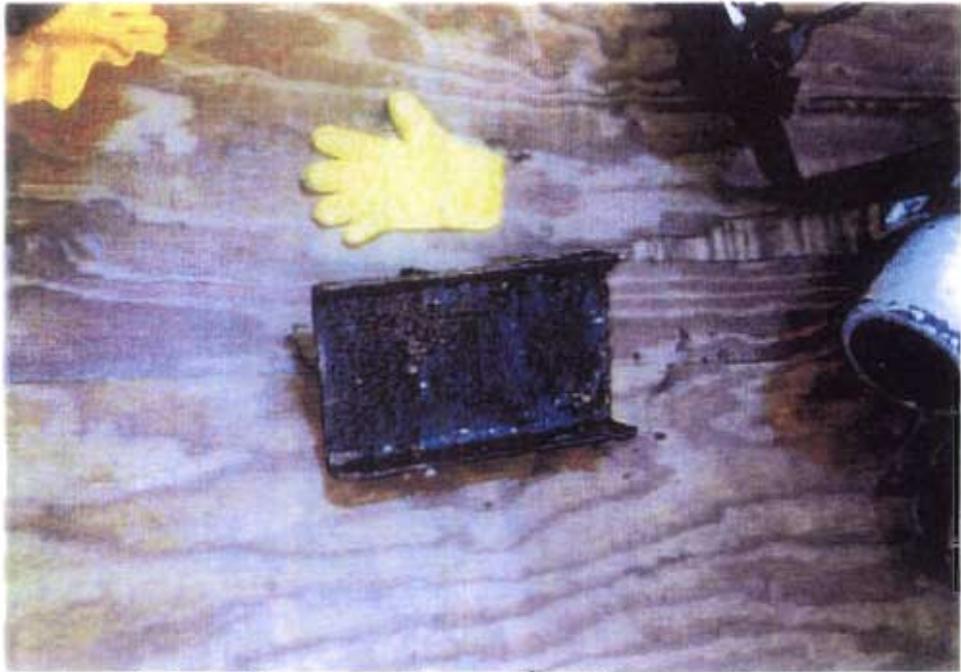
A piece of channel beam found at random dive 1 location (R-1).

R1	Recovered:	<ul style="list-style-type: none"> • Section of channel beam, $\pm 2''$ x $\pm 8''$ wide x 12" long, metal $\pm \frac{1}{2}''$ thick • One (of many) corroded three dimensional spike or bolt clumps $\pm 5''$ x $\pm 5''$ x $\pm 5''$
R2	Not Recovered:	<ul style="list-style-type: none"> • Tree limbs and branches
R3	Not Recovered:	<ul style="list-style-type: none"> • Tree limbs and branches

A short piece of channel beam was found at the random dive site R1. R1 is discussed on pages 6 through 8 in the Final Report. There is no strong or point-source target on the CHIRP recording. There are three reasons for this. First, the bottom at R1 was hard packed sand and was covered with three-dimensional ferrous objects, apparently bolts or spikes welded together and embedded in timbers. This background decreases the sensitivity of the CHIRP and produces a layering image on the recording. Second, the area in which

the small piece of channel beam was found was searched by the edge of the acoustic cone from the CHIRP. Again, this tends to decrease sensitivity and produces a faint parabola on the recording. Third, the size of the beam, given the background (hard sand, numerous ferrous objects) and the location near the edge of the cone, was small enough that it was at or near the limit of detection. This produced the faint parabola, layering, and numerous small points, not one strong parabola, on the recording. There are locations within the AOC where the bottom is literally covered with tree limbs and branches. R2 and R3 are two examples of this. When the CHIRP located larger pieces of these, or similar objects such as clay lenses or blocks of concrete, they were recorded like the objects at T04 and T06. T04 and T06 produced strong, well-defined targets on the CHIRP recording but contained no ferrous objects (and therefore no Mk-47 depth bomb). The CHIRP was used to define sites within the AOC that required specific, detailed, man-based magnetic searches. It was the best technique for this purpose and was used by a qualified geophysicist as intended.

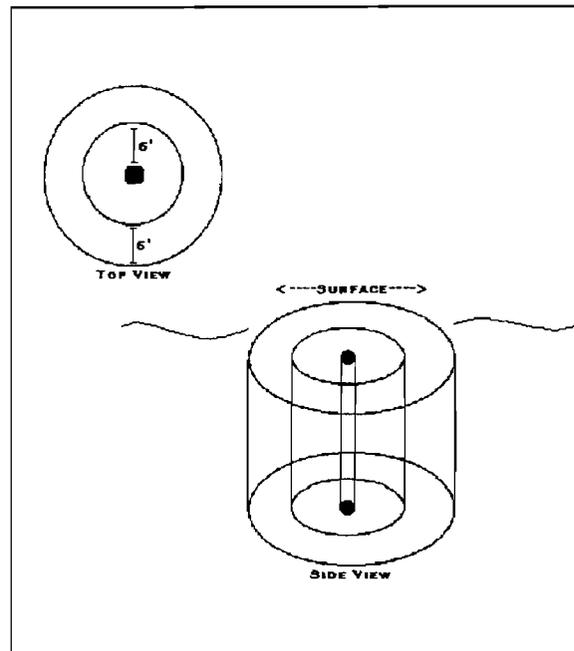
Figure 11 — Search Pattern

d. DIVE OPERATIONS. A weight (the clump) with a buoy line was set as near as possible to the target location, using a Garmin GPS III with integrating beacon to determine positions. The clump set was within three to five feet of the GPS mark determined by the CHIRP system. Exact positions were almost impossible to achieve due to the effect of the current on the buoy line and boat drift due to current and wind. Two divers would descend the buoy line. One diver, with a line attached to his equipment, would sit on the clump. The second diver would swim to the end of the line and cover the bottom from the clump to as far as he could reach with a hand-held White's Electronics, Inc. Surfmaster PI (Plus) metal detector. This inner circle was considered to be a six (6) foot search circle with its center the clump. When the search diver had completed one circle around the clump, the line would be extended an additional six feet. The search diver would then swim in another circle. That circle was considered to be a twelve (12) foot circle, with its center at the

center of the inner circle or clump. The 12 foot diameter for the outer circle was selected because it accounted for inaccuracies and vagaries in positioning the buoy and could be readily and reliably searched by one diver with a hand held instrument. If the diver did not detect anything within five or six fin kicks, he would check his ring or watch with the hand-held metal detector to insure it was functioning. The White's Surfmaster PI will detect both gold and silver rings and watches. If either the clump sitter or the search diver felt that visibility or current rendered the search unreliable, the operation was stopped and the area re-searched the next day. Figure 11 represents the search patterns at each target and random dive location. Figures 12 through 19 show divers preparing and recovering from dives.

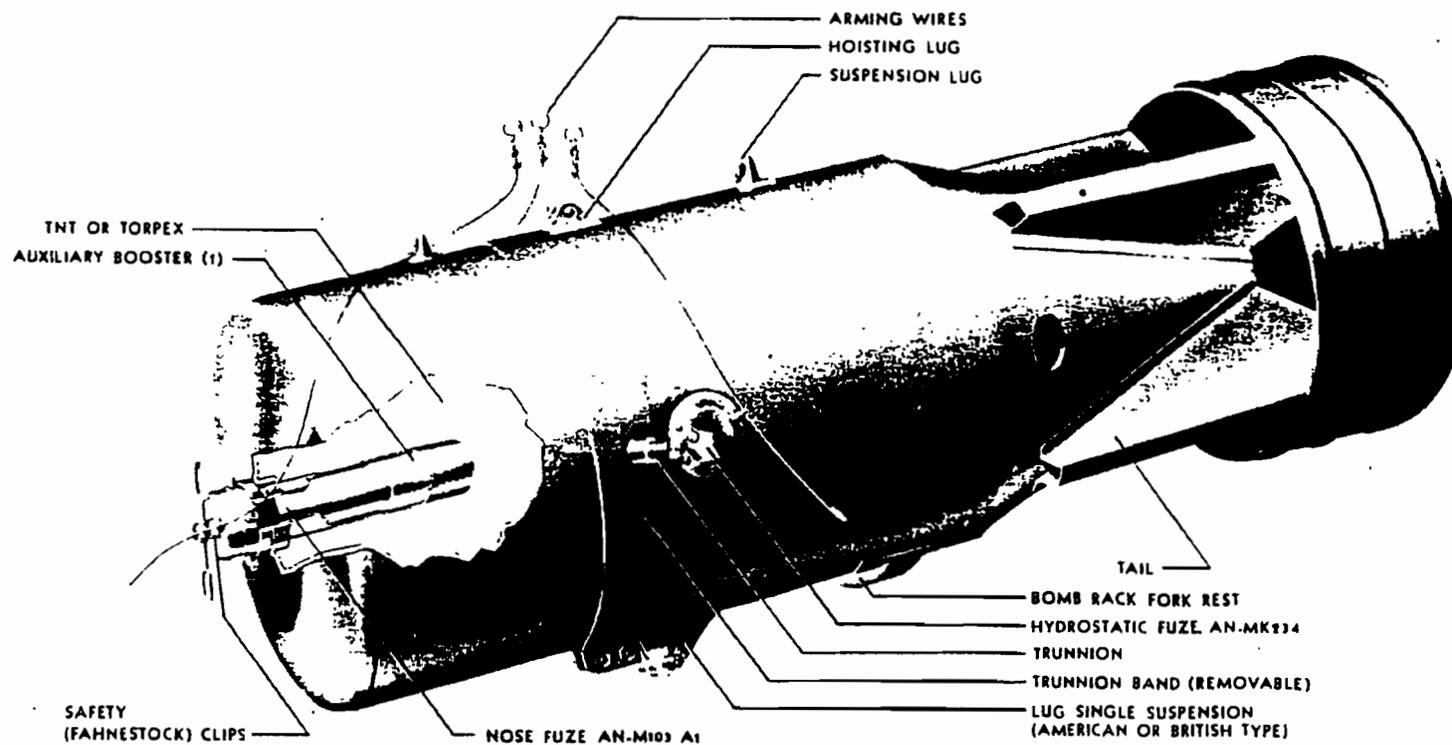
Figure 1: Mk-47 Depth Bomb

c. MK 47 DEPTH BOMB. The items of concern for this project were two Torpex loaded Mark 47 depth bombs. The Mk-47 is a cylindrical bomb with a flat nose and conical tail. The body consists of three pieces of metal tubing, welded together. There are both a nose fuze well and a transverse fuze well, welded in place 15 inches from the nose. The bomb is equipped with a drum tail. Looking from the tail toward the nose, the tail is circular and has four fins extending at right angles to each other. The fins are spot welded to a cone which fits over the aft end of the bomb and to the drum shroud. The fin assembly is bolted to the base of the bomb. As with many World War II era bombs, there are two suspension systems. A two lug suspension is diametrically opposite a one lug or banded suspension point. Torpex, the explosive filler, exists in several different forms. All forms are a mixture of RDX (approximately 41%), TNT (approximately 40 %), and aluminum powder (approximately 18%).

The bomb is shown in Figure 1. The general dimensions of a Mk-47 are:

325-pound Depth Bombs AN-Mk 41 and AN-Mk 47

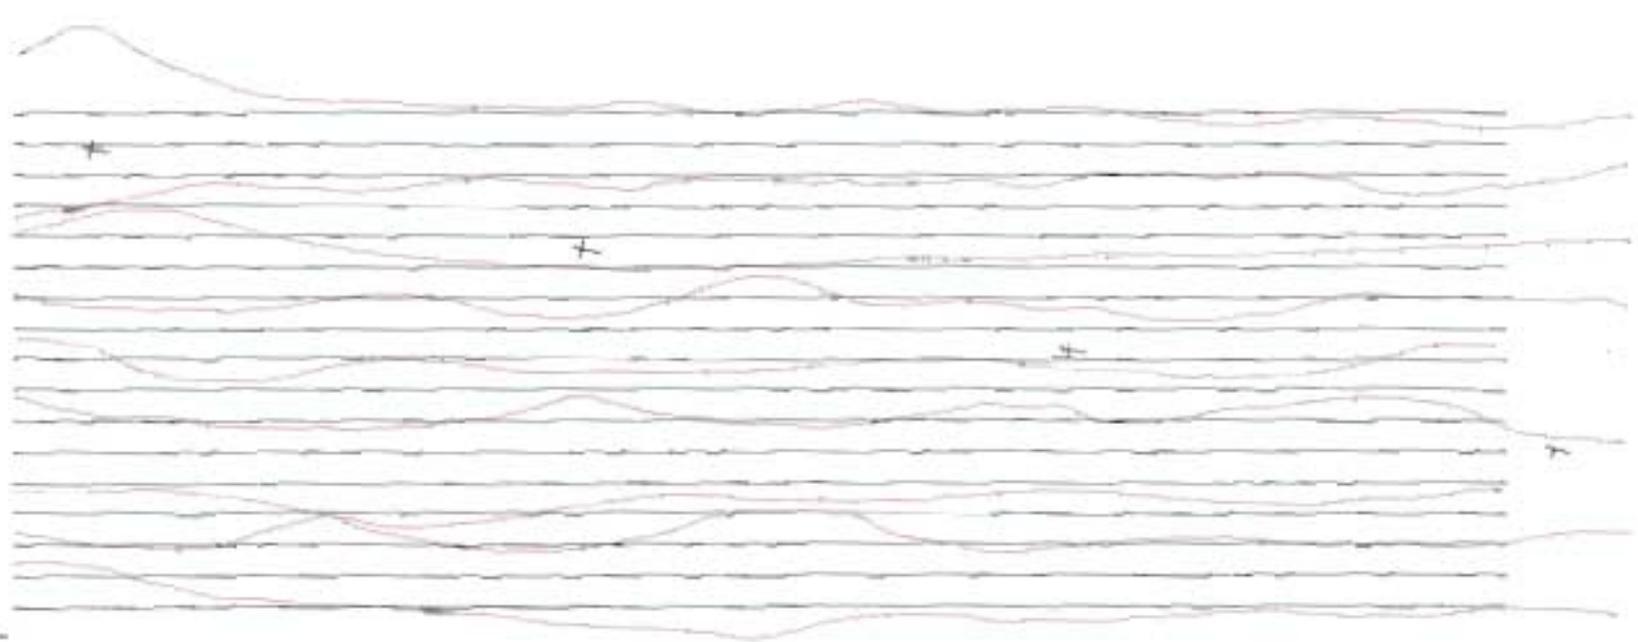
Chirp Acquisition Track

Boat track during CHIRP sub-bottom data
gathering operations, 28 July, 1998.

a. POSITION LOCATION. Locations during this project were determined by GPS equipment. The four corners of the search area were defined (see Figure 2). Initial search lanes within the area were established at 50 foot intervals. To insure better coverage and improve the quality of the data, secondary search lanes were established at 25 foot intervals. Because of real world limitations on the equipment, it was assumed that the CHIRP acoustic cone was only 80°, not the advertised 110°. The width of the cone on the bottom — the actual area searched — is listed in Table 1. The average water depth varied between location and tide state but was in the 20 to 35 feet range. The cone width or search width at these depths was approximately 48 to 85 feet. The 25 foot lane pattern therefore insured coverage of the bottom in the search area. Actual coverage of the search area is shown in Figure 3 through Figure 6.
