FINAL REPORT GEOPHYSICAL/INTRUSIVE SURVEY COMBINED SOLID WASTE
MANAGEMENT UNIT 9 (SWMU9) CLOSED LANDFILL WITH TRANSMITTAL CNC
CHARLESTON SC
1/25/1999
CNC CHARLESTON

**GEOPHYSICAL/INTRUSIVE SURVEY
COMBINED SWMU 9 CLOSED LANDFILL
NAVAL BASE CHARLESTON
CHARLESTON, SC**

Subj: SUBMITTAL OF FINAL REPORT FOR PROJECT NUMBER C98056; GEOPHYSICAL
SURVEYING SERVICES IN ZONE H AT SWMU 9, CHARLESTON NAVAL COMPLEX

Geophysical/Intrusive Survey for Combined SWMU 9 Closed Landfill Charleston Naval Complex, Charleston, SC

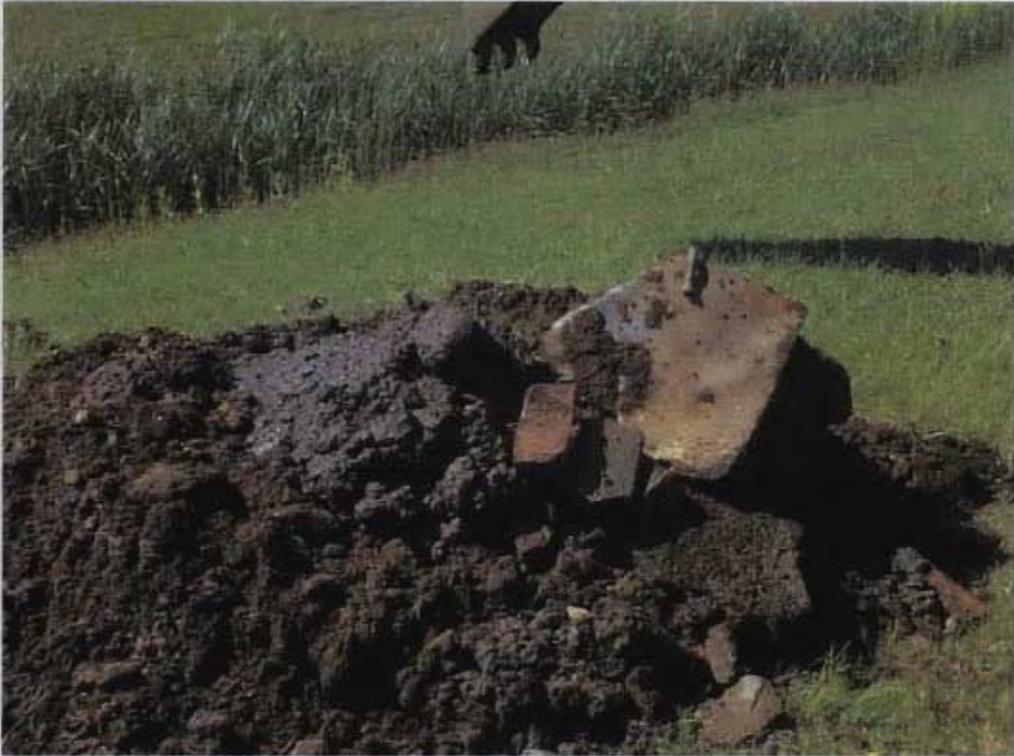
Test Pit #72

70	09/25/98	4	None*	*One small piece of glass and one small piece of wire
71	09/25/98	3.5	Broken concrete, broken tile, brick	
72	09/25/98	3.5	Broken concrete, iron, plating, brick	
73	10/21/98	4	Wire, steel scrap, broken tile	
74	10/21/98	2.5	Wire, wood, scrap metal, brick	
75	10/21/98	7	None	Layered soil

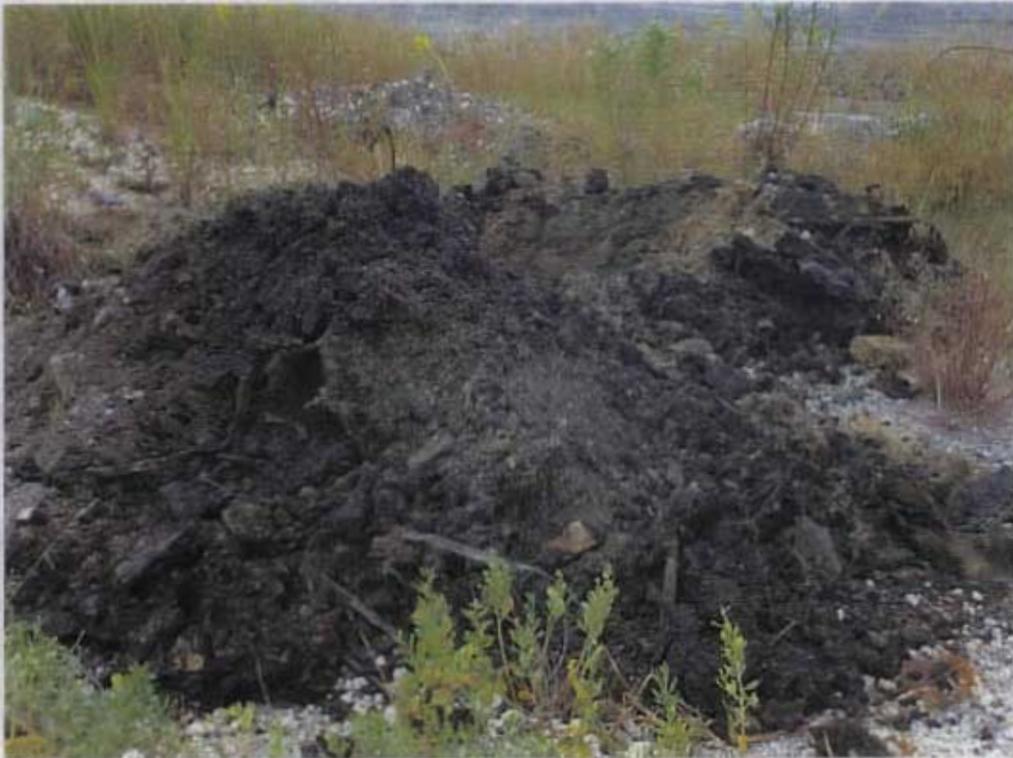
Test Pit #82

Test Pit Location	Excavation Date	Excavation Depth (Ft.)	Foreign Material	Remarks
76	10/21/98	7	None	
77	10/21/98	7	One 5' timber, one piece copper wire	Excavated thru asphalt, very strong fuel oil odor
78	10/21/98	6	None	
79	10/21/98	7	Very small amounts of rubber, glass & metal	Strong fuel oil odor
80	10/21/98	5	Timbers, broken concrete	Strong fuel oil odor
81	10/21/98	6	None	
82	10/21/98	3	Wire, scrap metal, wood, brick, strapping	Free product fuel oil
83	10/21/98	6.5	None	Strong fuel oil odor
84	10/21/98	6	Timbers, one piece broken concrete	Strong fuel oil odor
85	10/21/98	5	One piece wire cable & small amounts of broken concrete	Strong fuel oil odor
86	10/21/98	2	Wood, plastic, metal, paper, bottles, broken concrete	
87	10/21/98	1	Glass, broken concrete, brick, scrap metal	
88	10/21/98	5	None	Layered soil
89	10/22/98	6	None	
90	10/22/98	6	None	
91	10/22/98	6	None	
92	10/22/98	5	Wood, scrap metal, broken concrete, wire

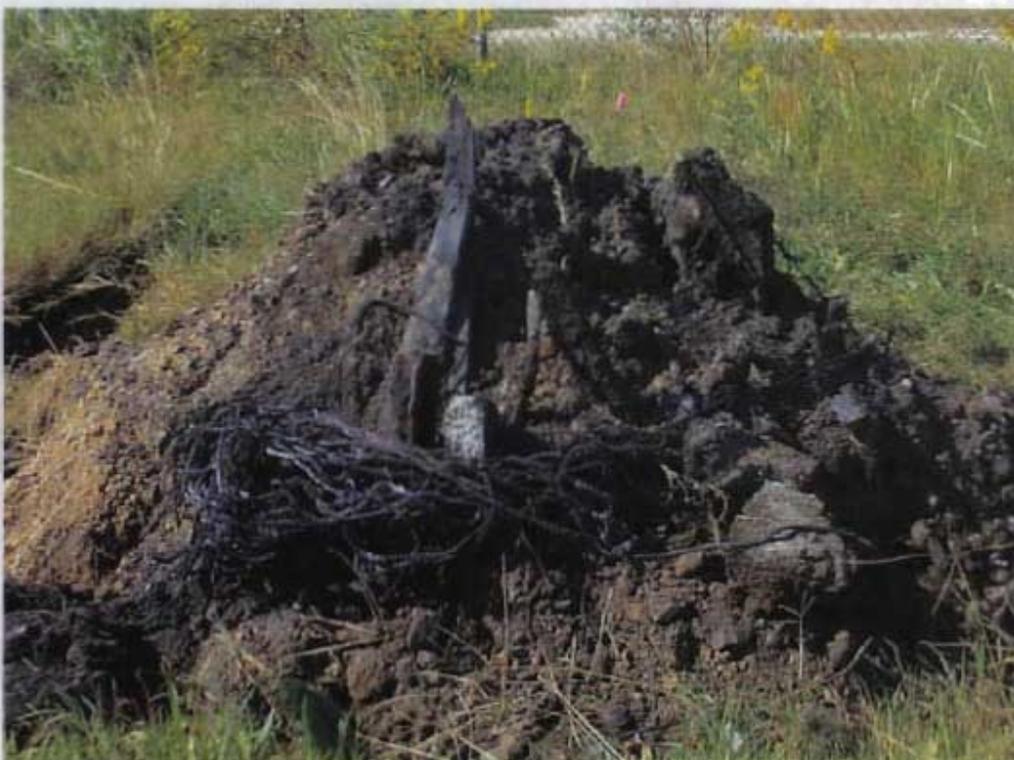
Test Pit #95

93	10/22/98	1.5	Concrete, wire, scrap metal, plastic	
94	10/22/98	1.5	Concrete, wire, scrap metal	
95	10/22/98	3	Concrete, wire, scrap metal, brick, wood, rope

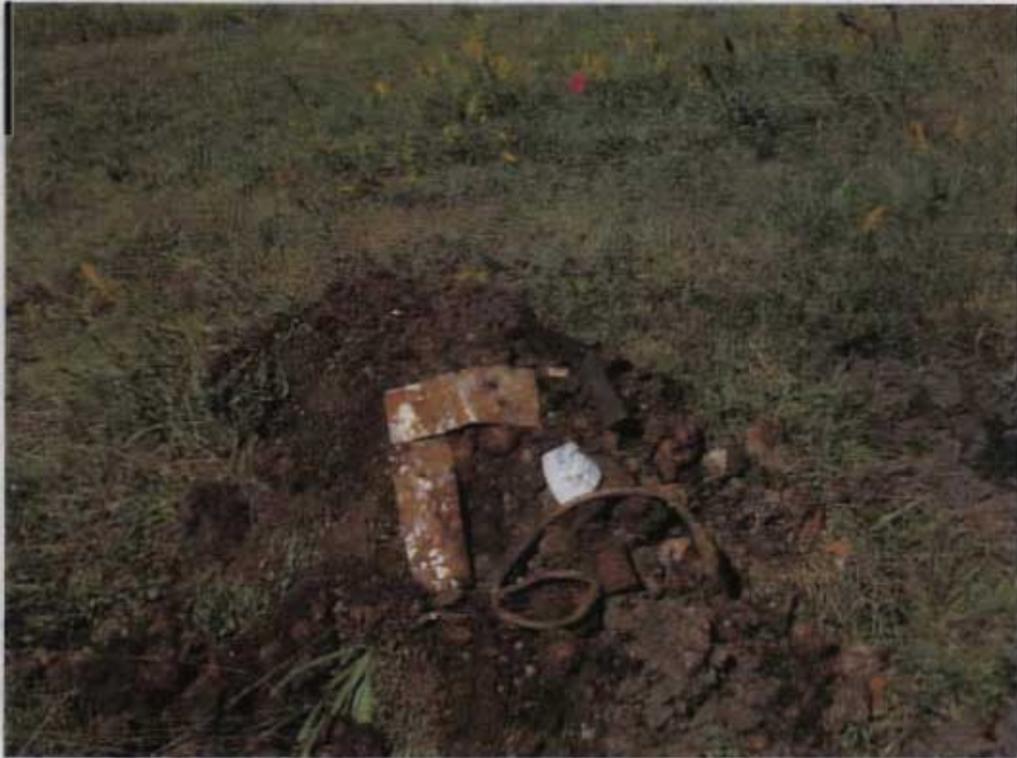
Test Pit #97

Test Pit Location	Excavation Date	Excavation Depth (Ft.)	Foreign Material	Remarks
96	10/22/98	4	scrap metal, brick, wood, glass	
97	10/22/98	1	Concrete, wire, scrap metal, brick, wood, glass, rubber, china	
98	10/22/98	1.5	Concrete, wire, wood, china	
99	10/22/98	6	Very small amounts of wood & plastic	
100	10/22/98	2.5	Scrap metal, china, wood, glass	
101	10/22/98	4	Scrap metal, plastic, tile, brick	
102	10/22/98	5	None	
103	10/22/98	5	Concrete, tile, brick, glass, metal, wood	
104	11/12/98	4.5	None*	*One small piece of broken concrete approx. 6" deep
105	11/12/98	5.5	None	
106	11/12/98	4.5	None	
107	11/12/98	5	None	
108	12/01/98	3	Wood, brick, concrete, plastic, wire, metal strapping, rubber	Odor of fuel oil
109	12/01/98	5	None	
110	12/01/98	5	None	
111	12/01/98	3	Scrap metal, china, glass, wire, rags, wood, bottles	
112	12/01/98	5	None	
113	12/01/98	6	None	
114	12/01/98	6	None	
115	12/01/98	7	None	
116	12/01/98	7	None
