ABOVE GROUND STORAGE TANK (AST) ASSESSMENT REPORT FOR BUILDING 32 CNC  
CHARLESTON SC  
6/1/2001  
ENVIRONMENTAL ENTERPRISE GROUP

**Aboveground Storage Tank (AST) Assessment Report**

Site I.D. #:	Unregulated		
Facility Name:	Charleston Naval Base Complex, Building 32		
Street Address:	1975 North Hobson Avenue		
City:	North Charleston, 29405	County:	Charleston

Site Map 1  
 AST 501  
 Charleston Naval Base  
 Charleston, SC

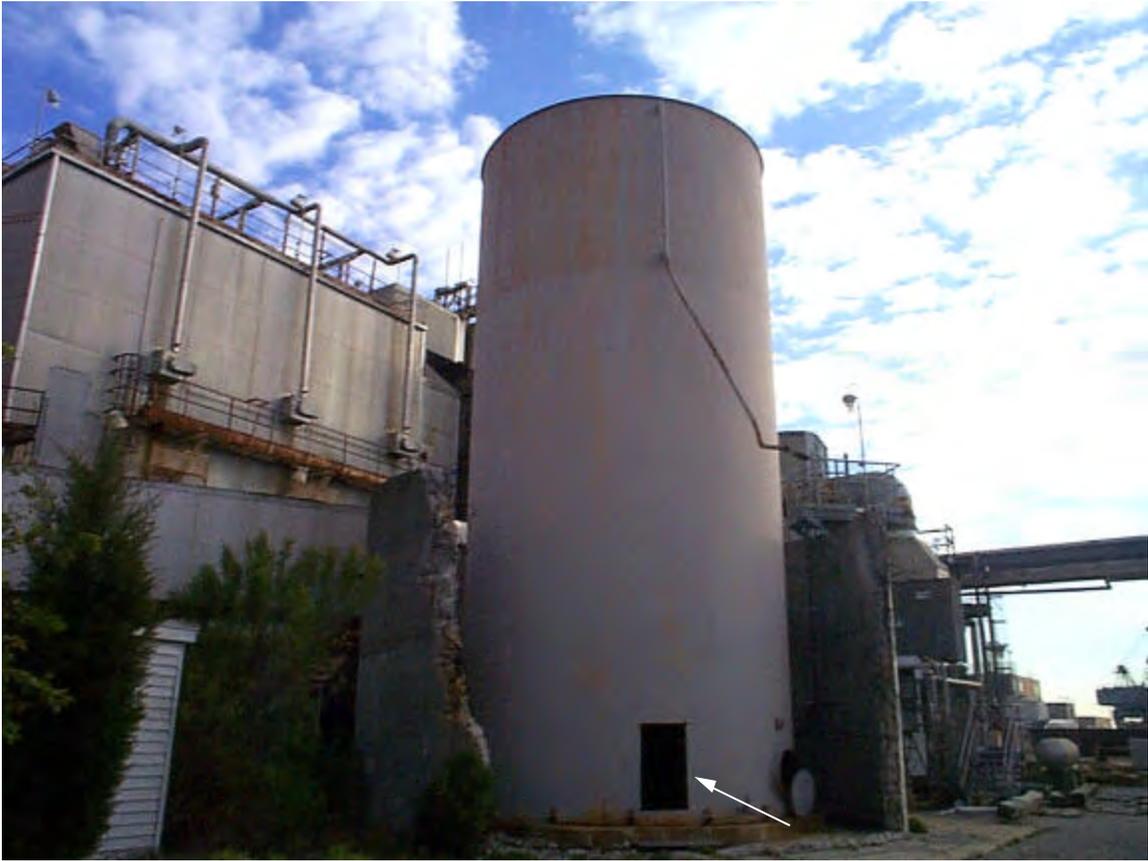
Photo A – AST 501 prior to commencing work. Note opening (arrow) already cut in the side and the partially removed berm.

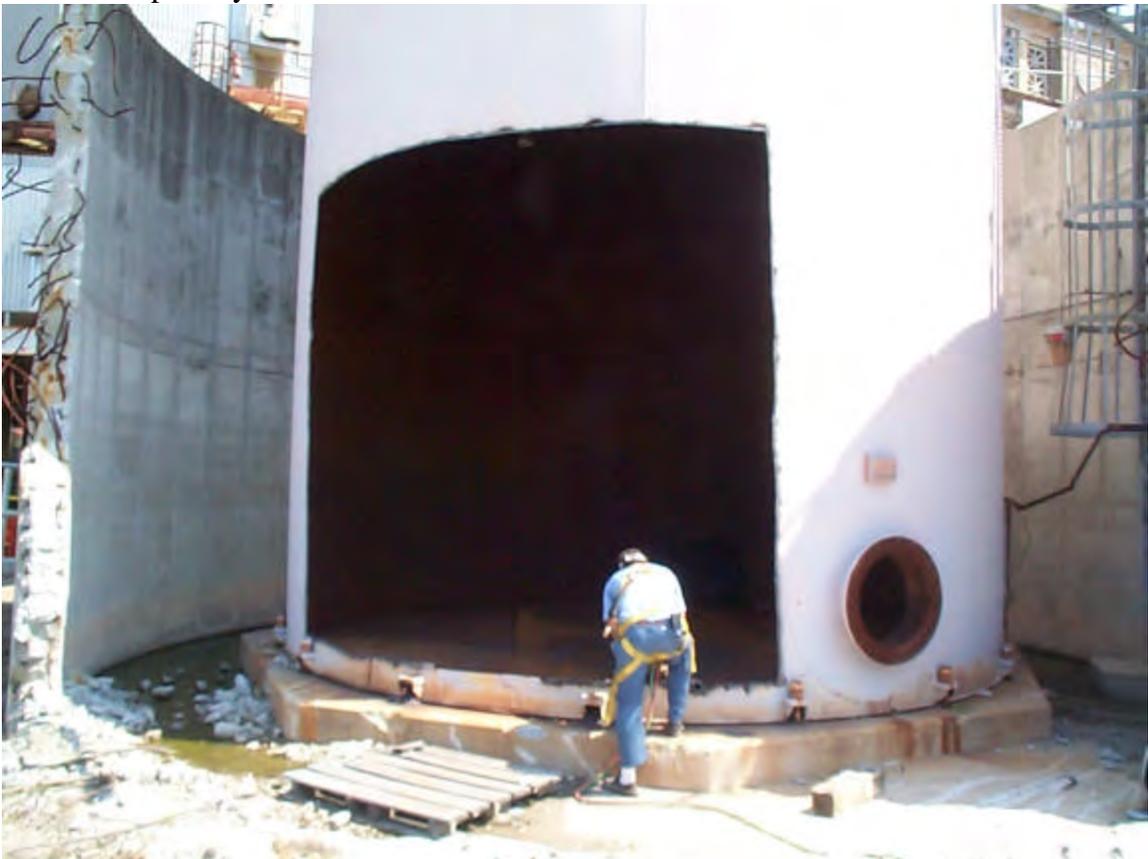
Photo B – Existing opening expanded to allow pieces cut from upper sections to be lowered inside the tank and removed.

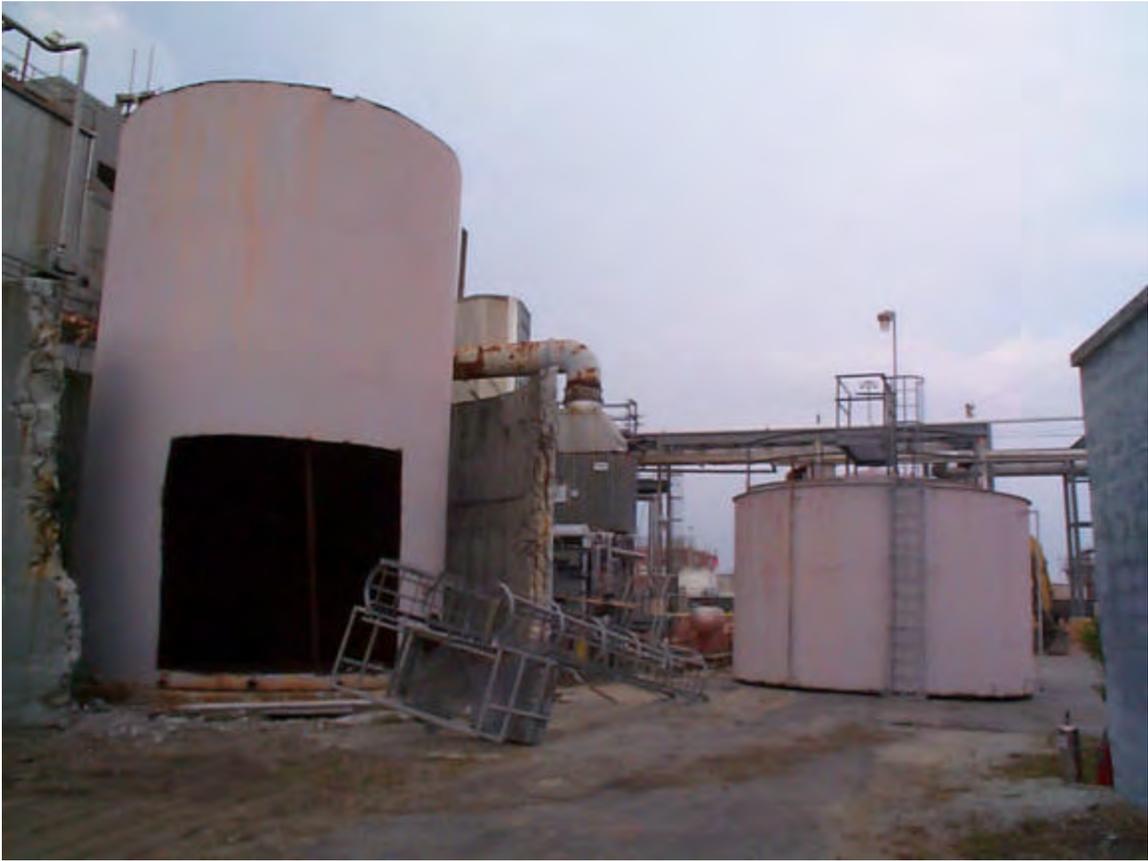
Photo C – Cut top section and lower ladder assembly (foreground) removed by crane.

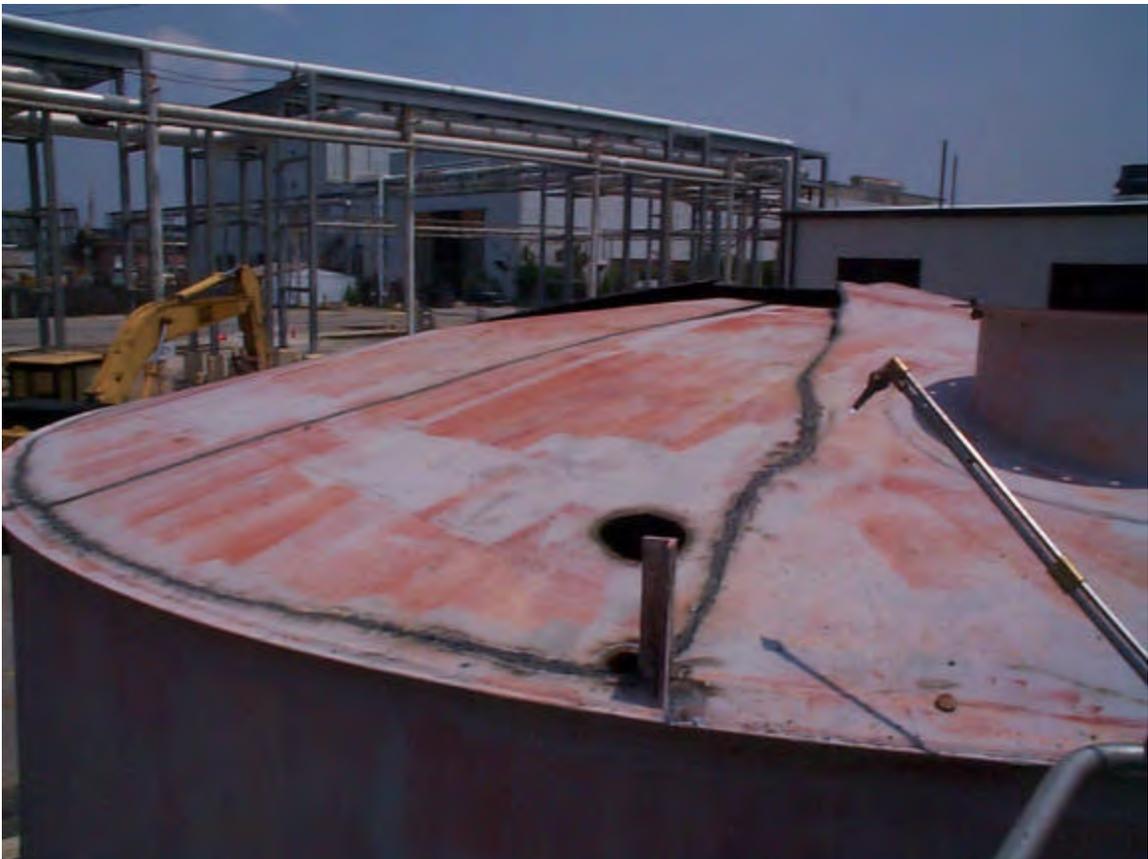
Photo D – AST roof being cut into pie shaped sections.

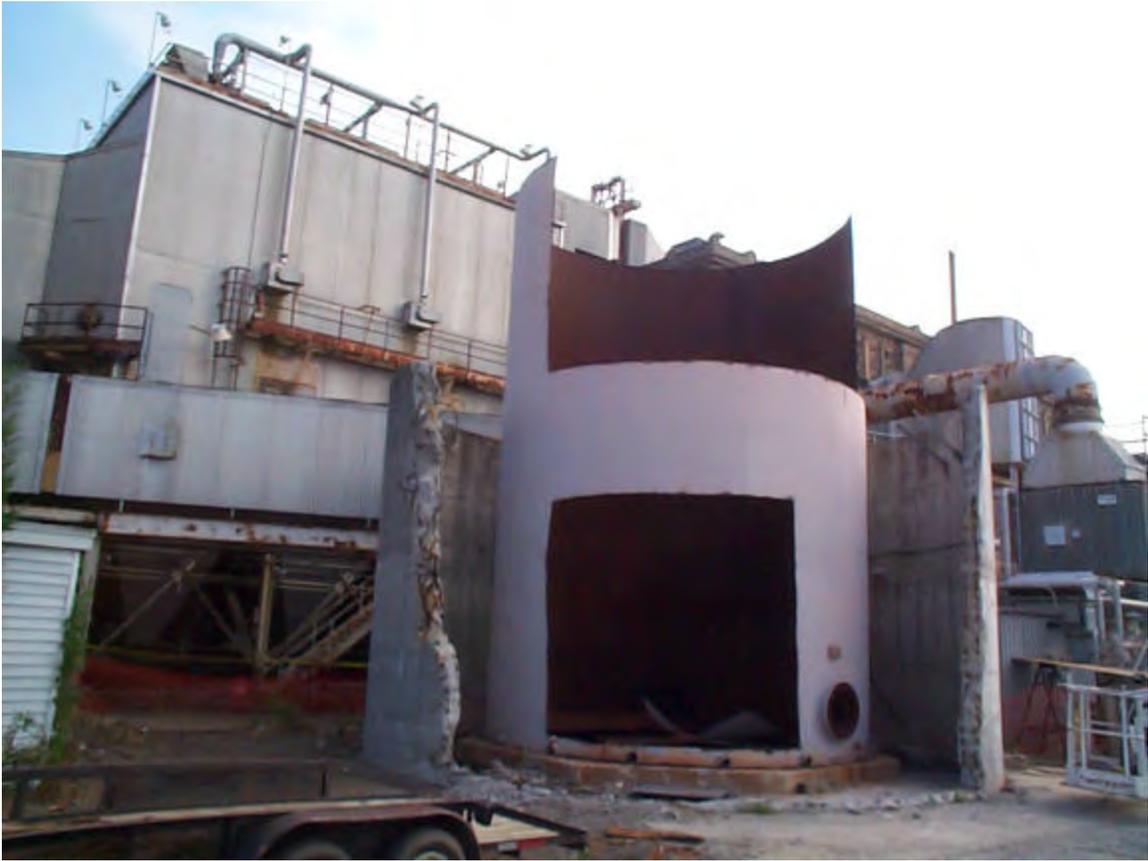
Photo E – Half of the middle section removed.

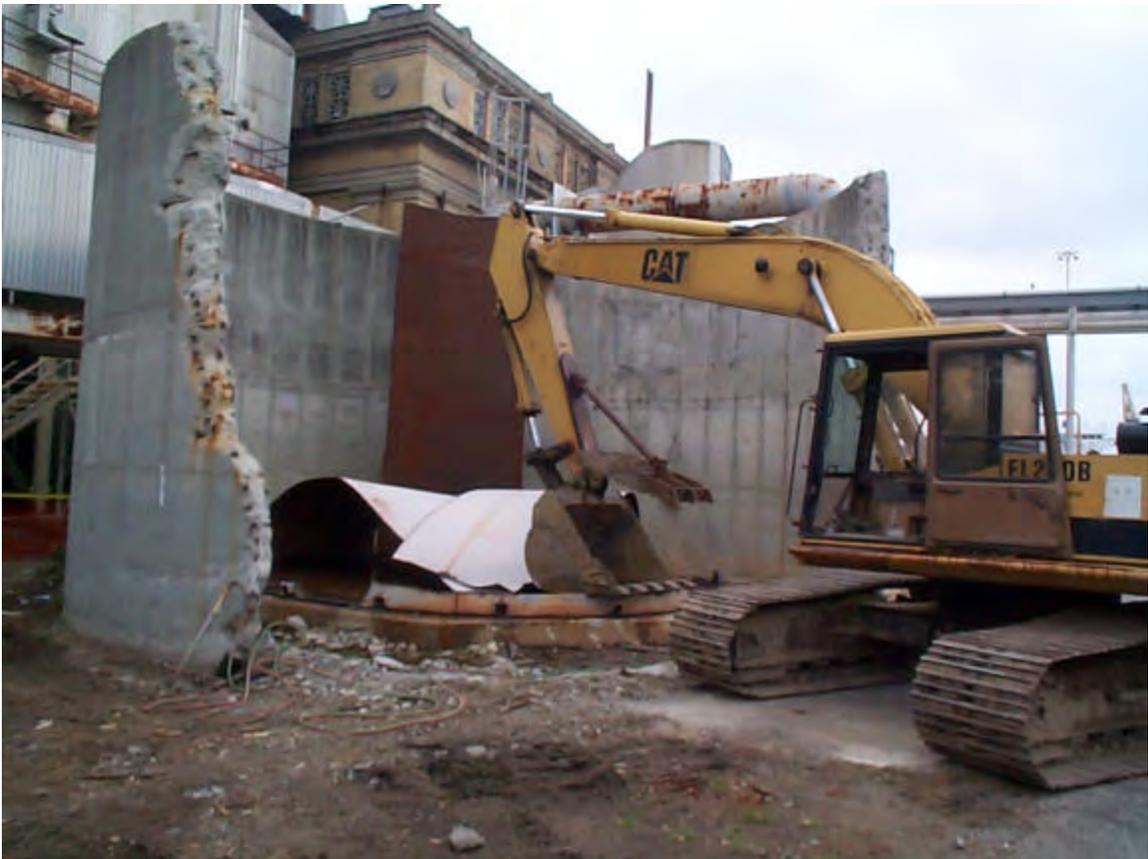
Photo F – Last of the AST vertical sections being removed.

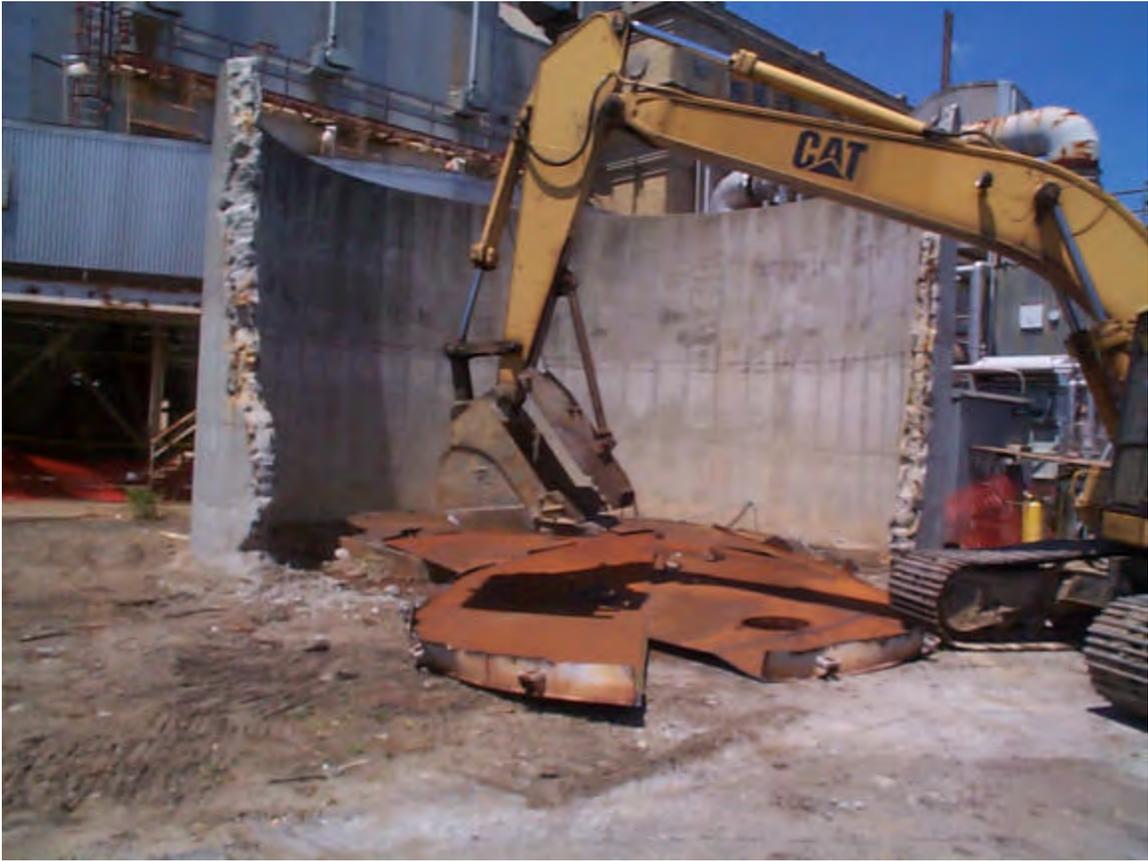
Photo G – AST bottom being removed from its elevated foundation.

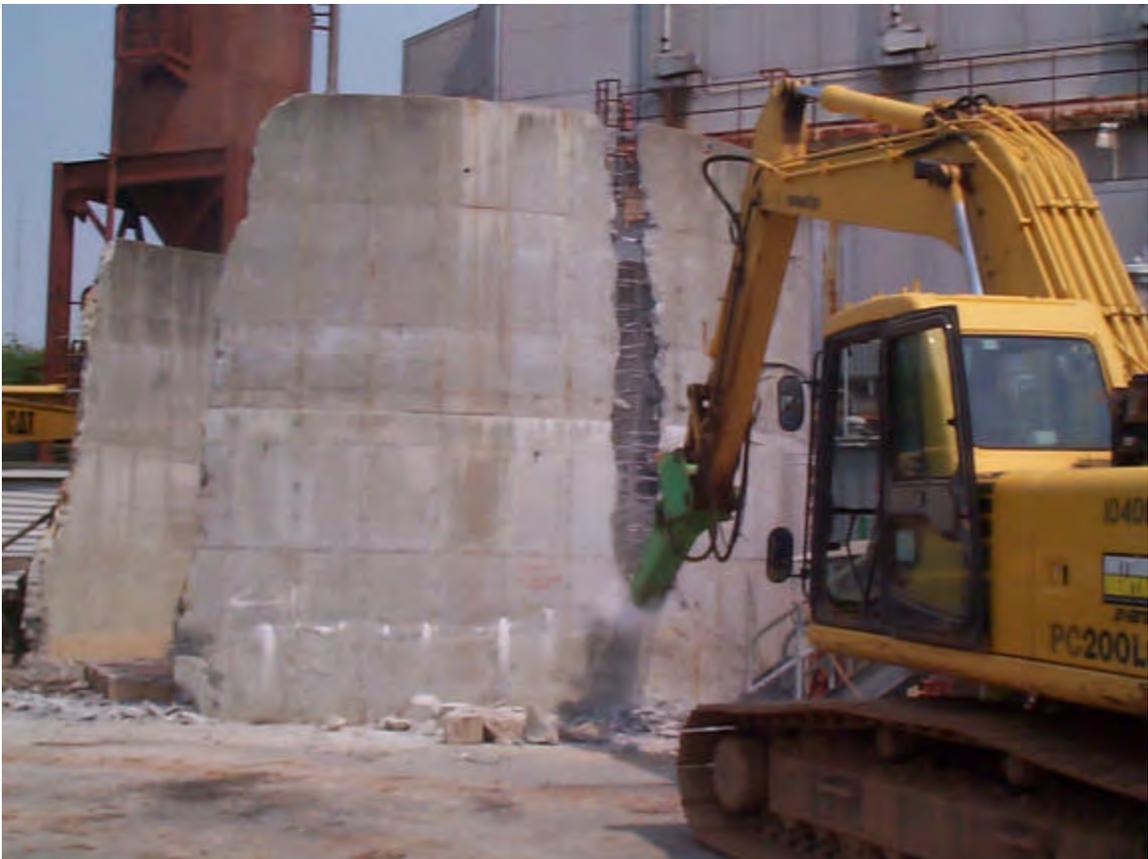
Photo H – Berm removal in progress.

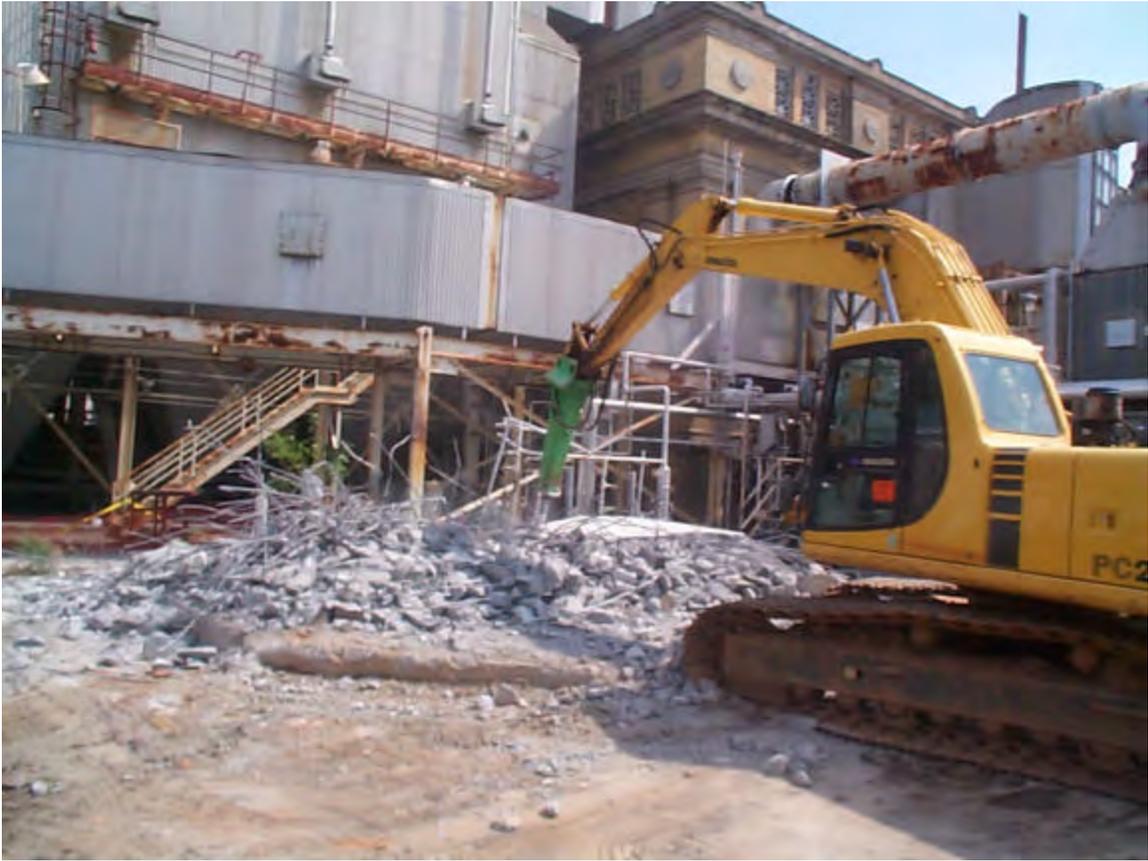
Photo I – Berm removal near completion.

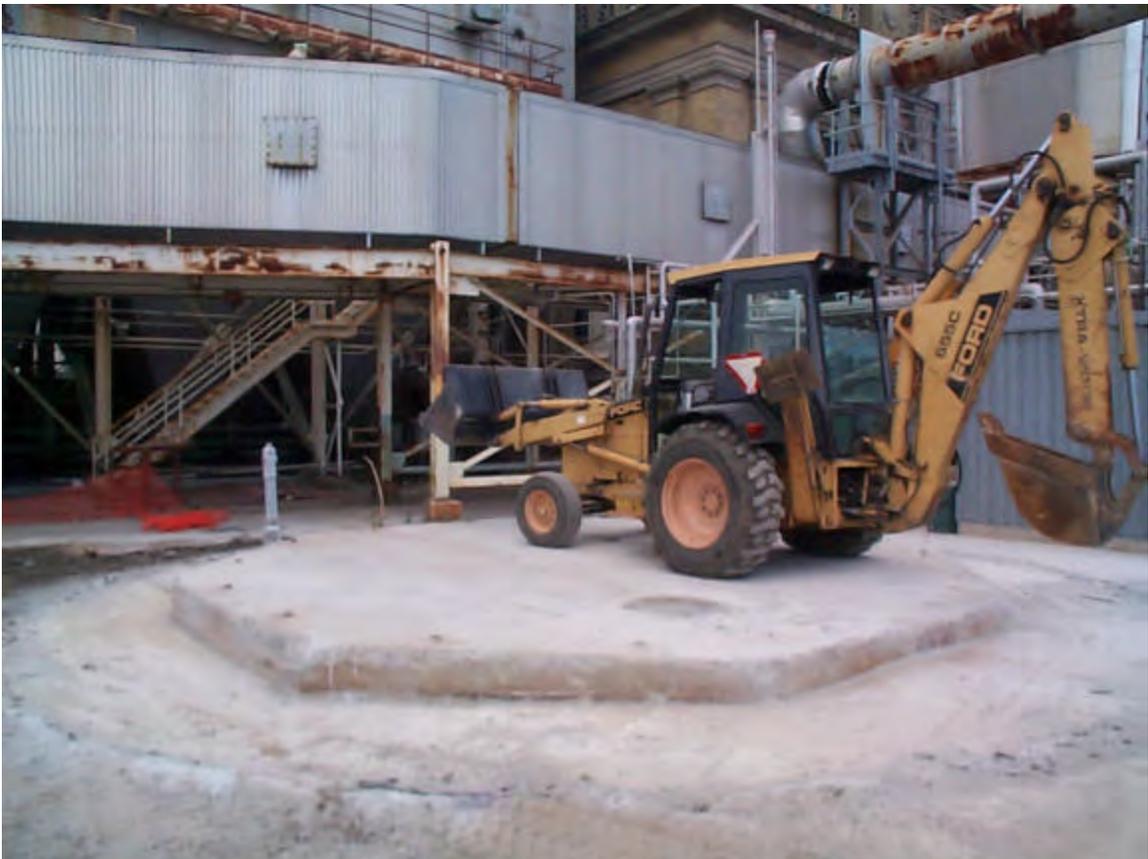
Photo J – AST 501 and berm removal complete.
