UNDERGROUND STORAGE TANK (UST) ASSESSMENT REPORTS FOR BUILDINGS NH-
23, NH-42, NH-61, NH-67, NH-68, NH- 1152, NH-1153, NH-1158, NH-1168, NH-1243,
AND NS-647 CNC CHARLESTON SC
10/02/1998
ENVIRONMENTAL DETACHMENT CHARLESTON

SUBJ: UST ASSESSMENT REPORTS FOR PROJECT NUMBER C98020

UST NH-23

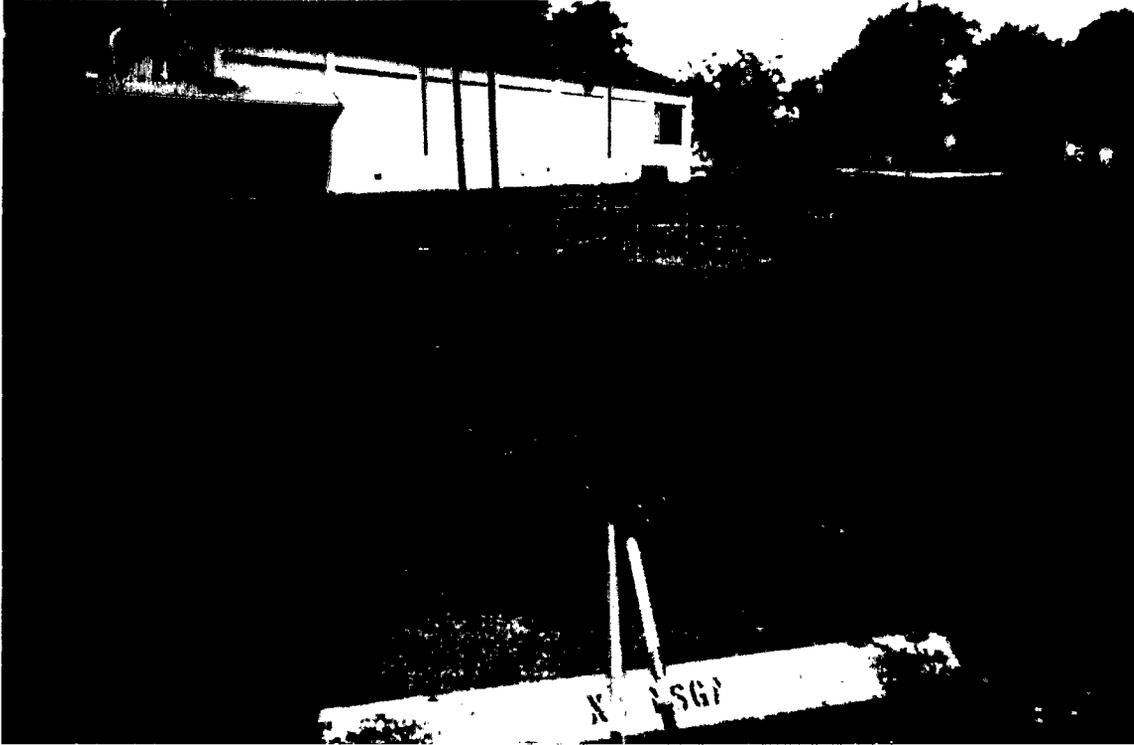
1. Charleston Naval Shipyard drawing PW-H1152-7, NH-1243-1, photographs, existing buildings NH-46 and NH-54 were used to locate the former site of building NH-1152 and UST NH-1152.

2. The site of former building NH-1152 was searched using an electronic ferrous metal indicator – Chicago Steel Tape, Magna-Trak 100 based on previous searches performed using a high-resolution time-domain Geonics EM-61 ferrous/non-ferrous metal detector. One anomaly was located in the general area where UST-NH-1152 was installed in the early 1940's. A site map for UST NH-1152 is included with this report as enclosure (2).

3. The site was excavated on 9-2-98 and a reinforced concrete pier (4' x 4' x 8' deep) was found at four feet below grade. The pier was probably base for a large radio antenna that was removed concurrently with demolition of building NH-1152. No UST was found at the site of former building NH-1152, the tank was probably removed during building demolition with retention of written documentation. There were no indications of fuel oil contamination, odors or stained soil. Soil samples were not taken.

4. Additional searches of the general area, using the Magna-Trak 100, revealed no additional indications of an underground storage tank.

5. The excavation was filled to grade and plugged with grass.

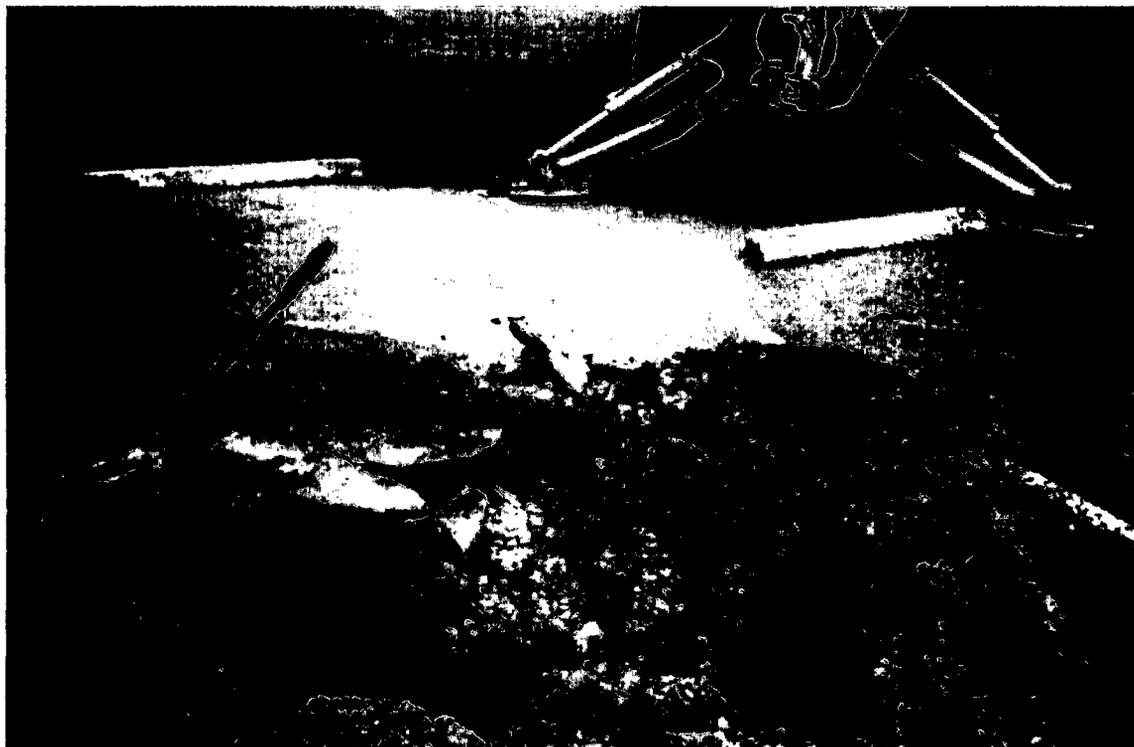
1. Charleston Naval Shipyard drawing PW-H1152-7, NH-1243-1, photographs, existing buildings NH-46 and NH-54 were used to locate the former site of NH-1153 and UST NH-1153.

2. The site of former building NH-1153 was searched using an electronic ferrous metal indicator – Chicago Steel Tape, Magna-Trak 100 based on previous searches using a high-resolution time-domain Geonics EM-61 ferrous/non-ferrous metal detector. One anomaly was located in the general area where UST-NH-1153 was originally installed in the early 1940's. A site map for UST NH-1153 is included with this report as enclosure (2).

3. The site was excavated on 9-2-98. A reinforced concrete and red brick foundation was found at two feet below grade. Additional excavation unearthed a deteriorated section tank fill pipe and other remnants of rusted carbon steel were found. No UST or other indications of a former UST were located at this site. Soil samples were not taken. The UST was probably removed during building NH-1153 demolition without retention of written documentation.

4. Additional searches using the Magna-Trak 100 revealed no additional indications of an underground storage tank.

5. The excavation was filled to grade and paved with asphalt.

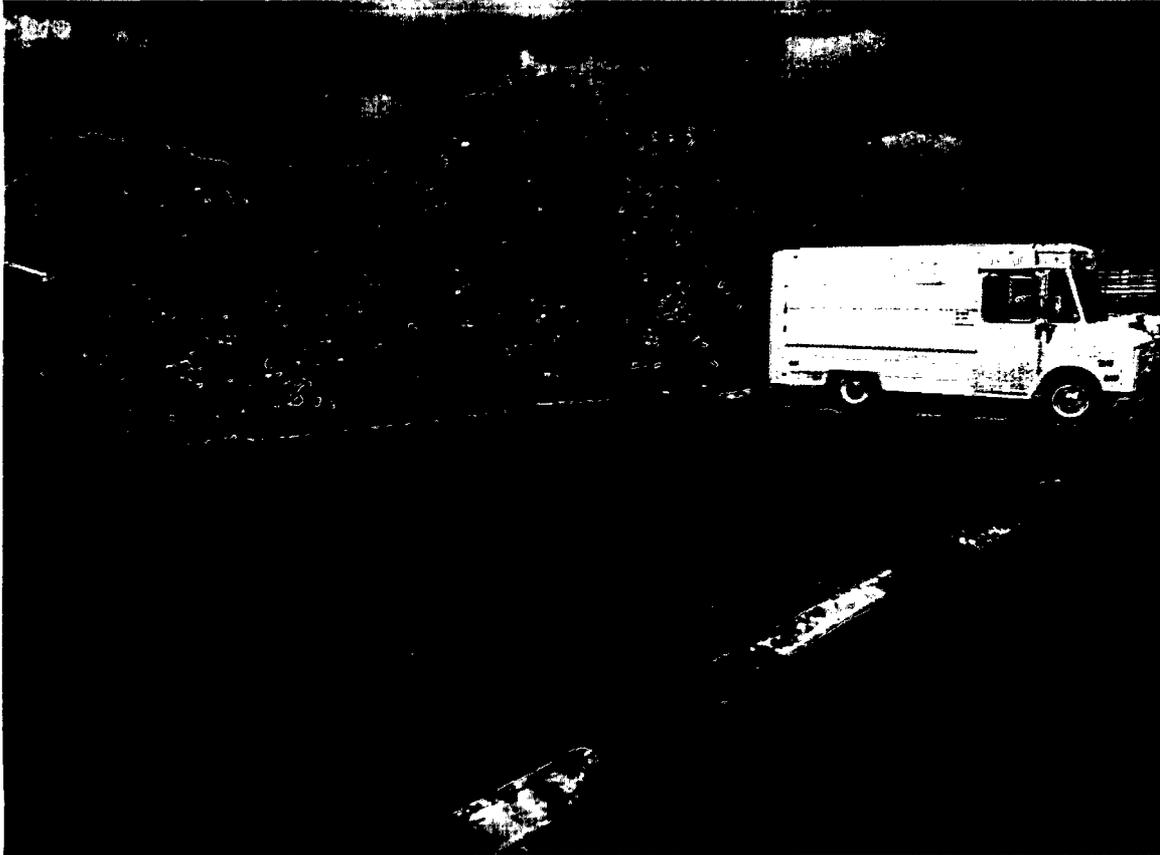
1. Charleston Naval Shipyard drawing PW-H1158-4, photographs and the current location of buildings NH-53 and NH-46 were used to locate the site of UST NH-1158 adjacent to the current parking lot North of NH-53. A Site Map for UST NH-1158 is included with this report as enclosure (2).

2. Only one location for UST NH-1158 adjacent to the asphalt parking lot of NH53 was laid out using an electronic ferrous metal indicator – Chicago Steel Tape, Magna-Trak 100 based on previous searches using a high-resolution time-domain Geonics EM-61 ferrous/non-ferrous metal detector. Survey of the entire parking lot area revealed no other indications of an underground storage tank.

3. Removal of topsoil and excavation of subsoil in the area suspected to contain UST NH-1158 revealed an 8-inch IPS steel sewer pipe, several assorted sections of corroded steel pipe and structural steel. Additional excavation and search with the Magna-Trak 100 revealed no indications of an underground storage tank.

4. The soil was fine to medium moist clay, light brown in color, having some sand content. Ground water was not encountered. Fuel oil odor, stained soils or other indications of fuel oil contamination were not found. Soil samples were not taken.

5. The excavation was filled to grade with clean fill. The existing topsoil and grass was spread to remove a depression that was existing prior to start of work.

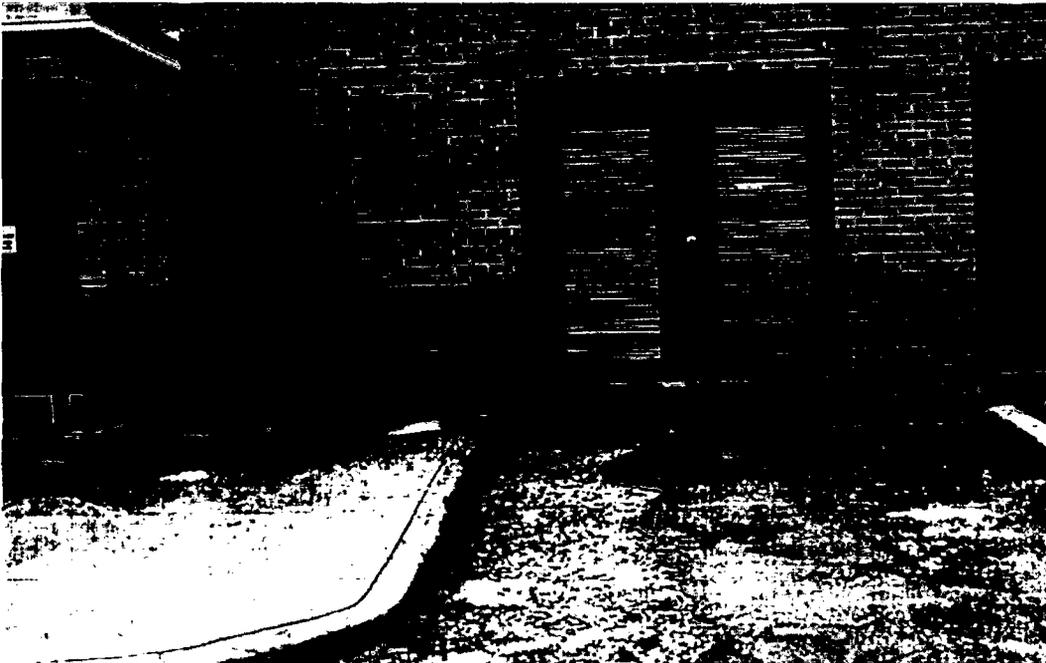
1. Charleston Naval Shipyard drawing NS647-62 and the current location of building NS-647 were used to locate the site of UST NS-647 adjacent to the current back alley door North of NS-647. The UST formerly supplied gasoline to an emergency generator that was removed prior to closure of the Base. A Site Map for UST NS-647 is included with this report as enclosure (2).

2. The probable location for UST NS-647 was laid out adjacent to the asphalt paving and under the edge of the alley door sidewalk. A high voltage electrical cable vault bound the probable location of UST NS-647 on the East Side and an 8-inch water main on the West Side. Existence of the high voltage electrical system and reinforcing steel in the concrete rendered magnetic locating devices useless. The UST fill pipe was penetrating the concrete pad adjacent to the building and was blocked or plugged about five feet into the pipe. A tank vent pipe was not existing, however the former location of the vent pipe is visible on the brick wall of building NS-647. Also a former Shipyard Public Works department employee verified that this location was correct for UST NS-647, the former Emergency Generator fuel supply tank.

3. Removal of asphalt and excavation of subsoil along the concrete in the area suspected to contain UST NS-647 revealed moist stained soil and gasoline odors at 2 feet below grade and 2 feet horizontally under the concrete, where the UST was thought to exist. Additional searching with a 4-foot long probe (vertically and horizontally in the excavation) revealed no UST or other large structure. The fill pipe terminal end could not be found since it was entrained in the thick concrete pad as verified by removal of soil from under the pad. The gas storage tank was apparently removed at an unknown date with out retention of written documentation.

- a. The soil was medium grain, moist clay, and light to dark gray in color, having some sand and organic content. Ground water was not encountered. Strong petroleum odors were noticed.
 - b. A soil sample was taken at 3 feet below grade and 2 feet horizontally under the concrete. Analysis of the soil sample SPORT0780-1 revealed moderate VOC contamination.
4. The excavation was filled to grade using the existing fill and paved with asphalt. The tank vent pipe was cut off at the concrete pad level and filled/covered with cement.
