ABOVEGROUND STORAGE TANK (AST) ASSESSMENT REPORT FOR BUILDING M-1123  
CNC CHARLESTON SC  
08/30/1999  
NAVFAC SOUTHERN

Aboveground Storage Tank (AST) Assessment Report

Site I.D. #: M1123, Unregulated  
Facility Name: Charleston Naval Base Complex, M1123  
Street Address: Truxtun Avenue  
City: North Charleston, 29405-2413 County: Charleston

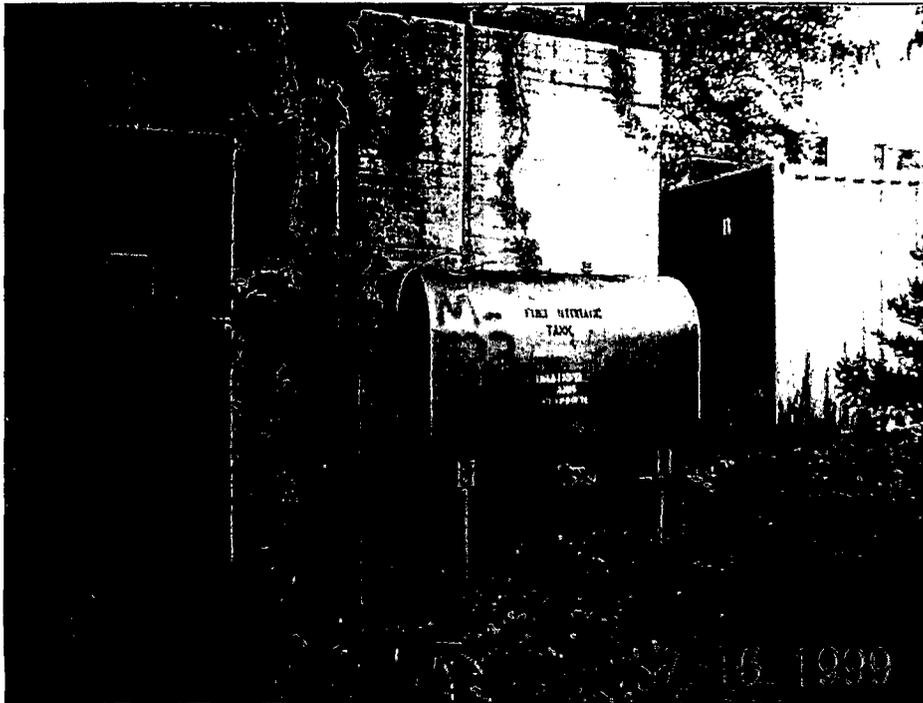
Corrosion of the painted AST M1123 was limited to a few localized areas of surface rust where the paint had deteriorated. No pitting or holes were observed.

Photo A: Prior to removal
