ABOVE GROUND STORAGE TANK (AST) ASSESSMENT REPORT BUILDING 590A CNC
CHARLESTON SC
09/29/1997
ENVIRONMENTAL DETACHMENT CHARLESTON

Aboveground Storage Tank (AST) Assessment Report

Site I.D. #:	Unregulated	# 01026
Facility Name:	Charleston Naval Base Complex, Building 590-A	
Street Address:	River Road	
City:	North Charleston, 29405-2413	County: Charleston

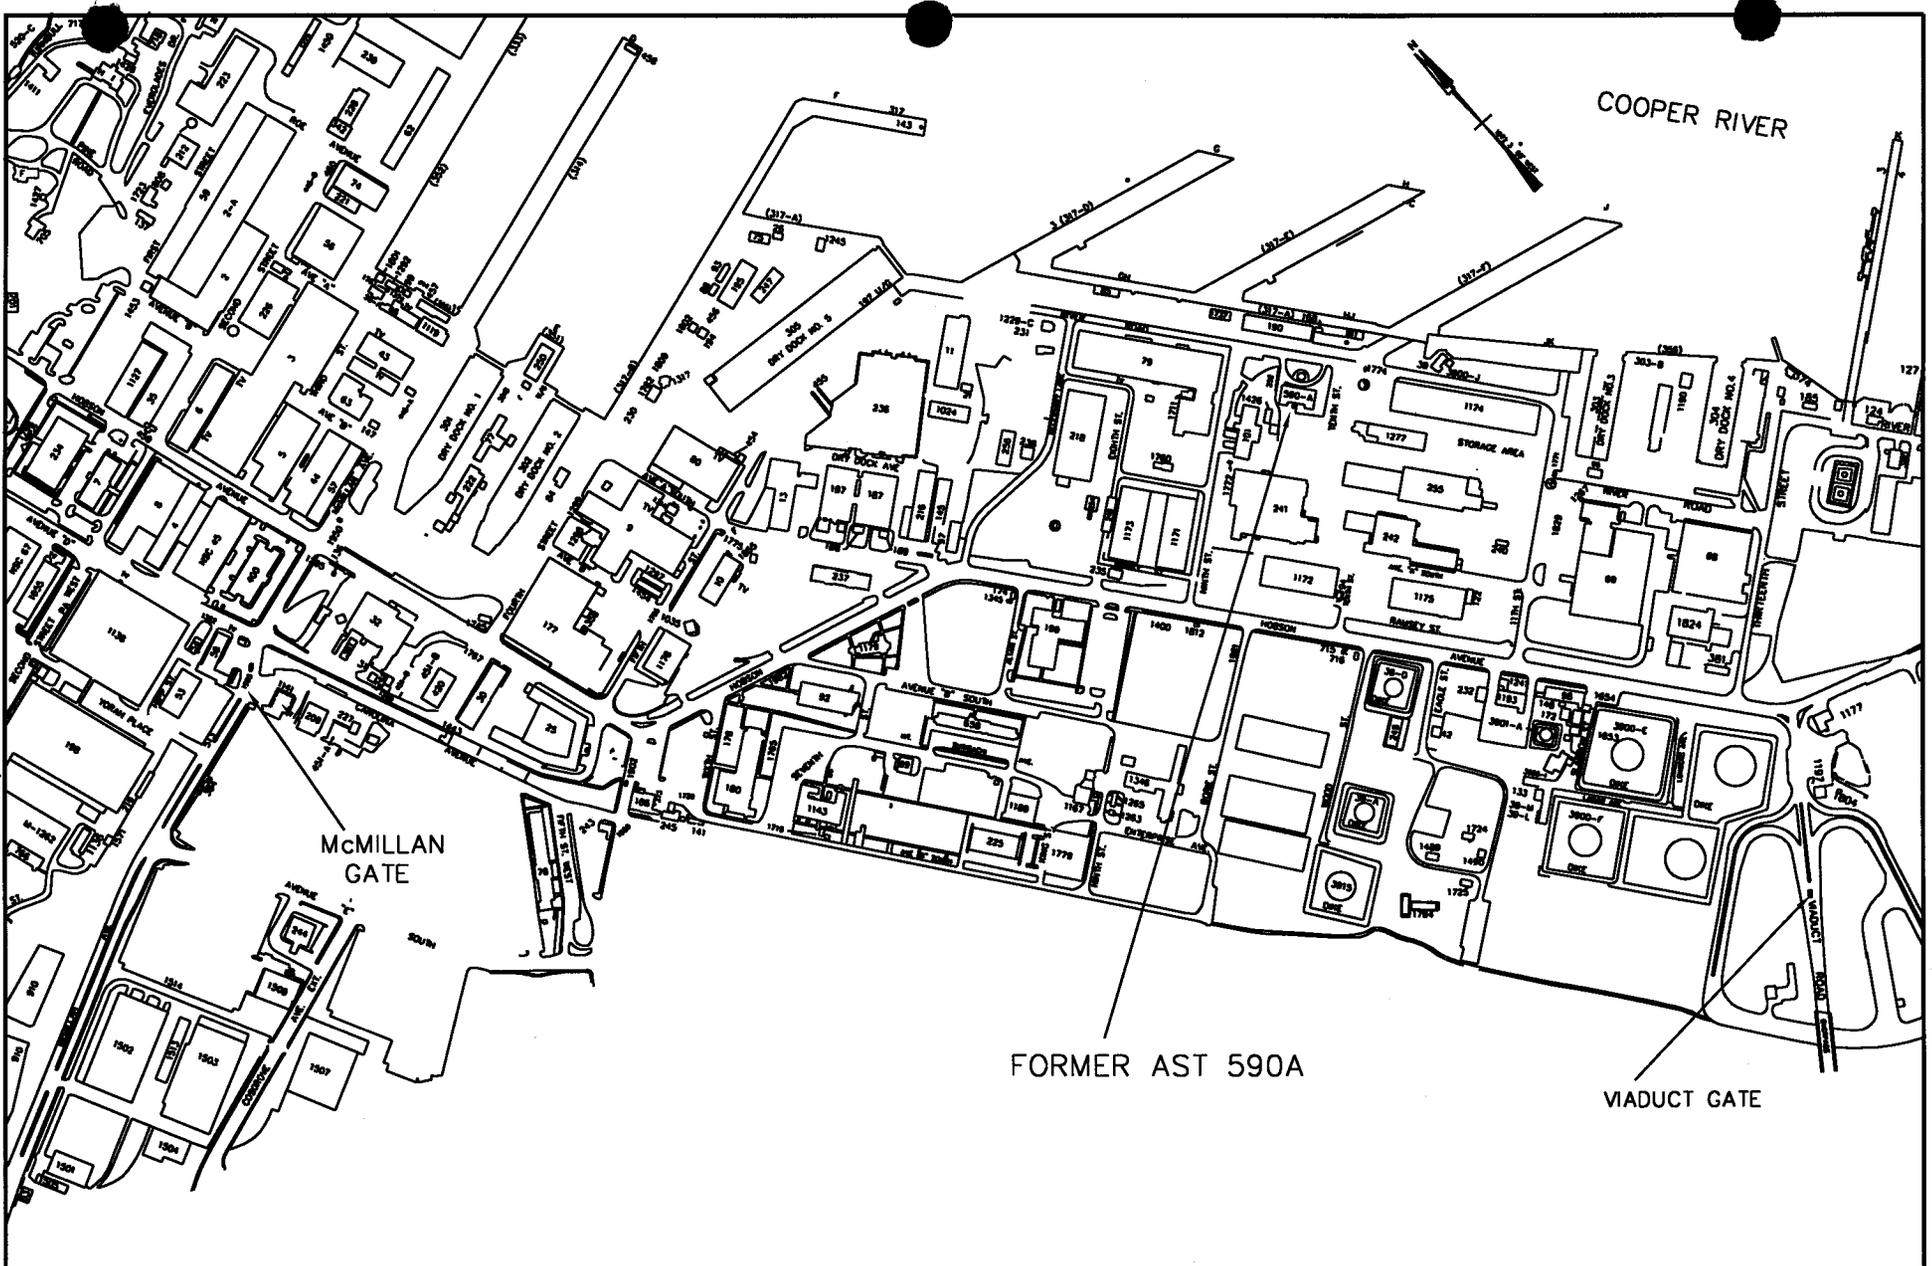
Site Map 1 AST 590A Charleston Naval Base Charleston, SC	
DWG DATE: 20 NOV 97	DWG NAME: A590A_1

COOPER R. ~ 320'
FROM AST 590A

FORMER AST 590A

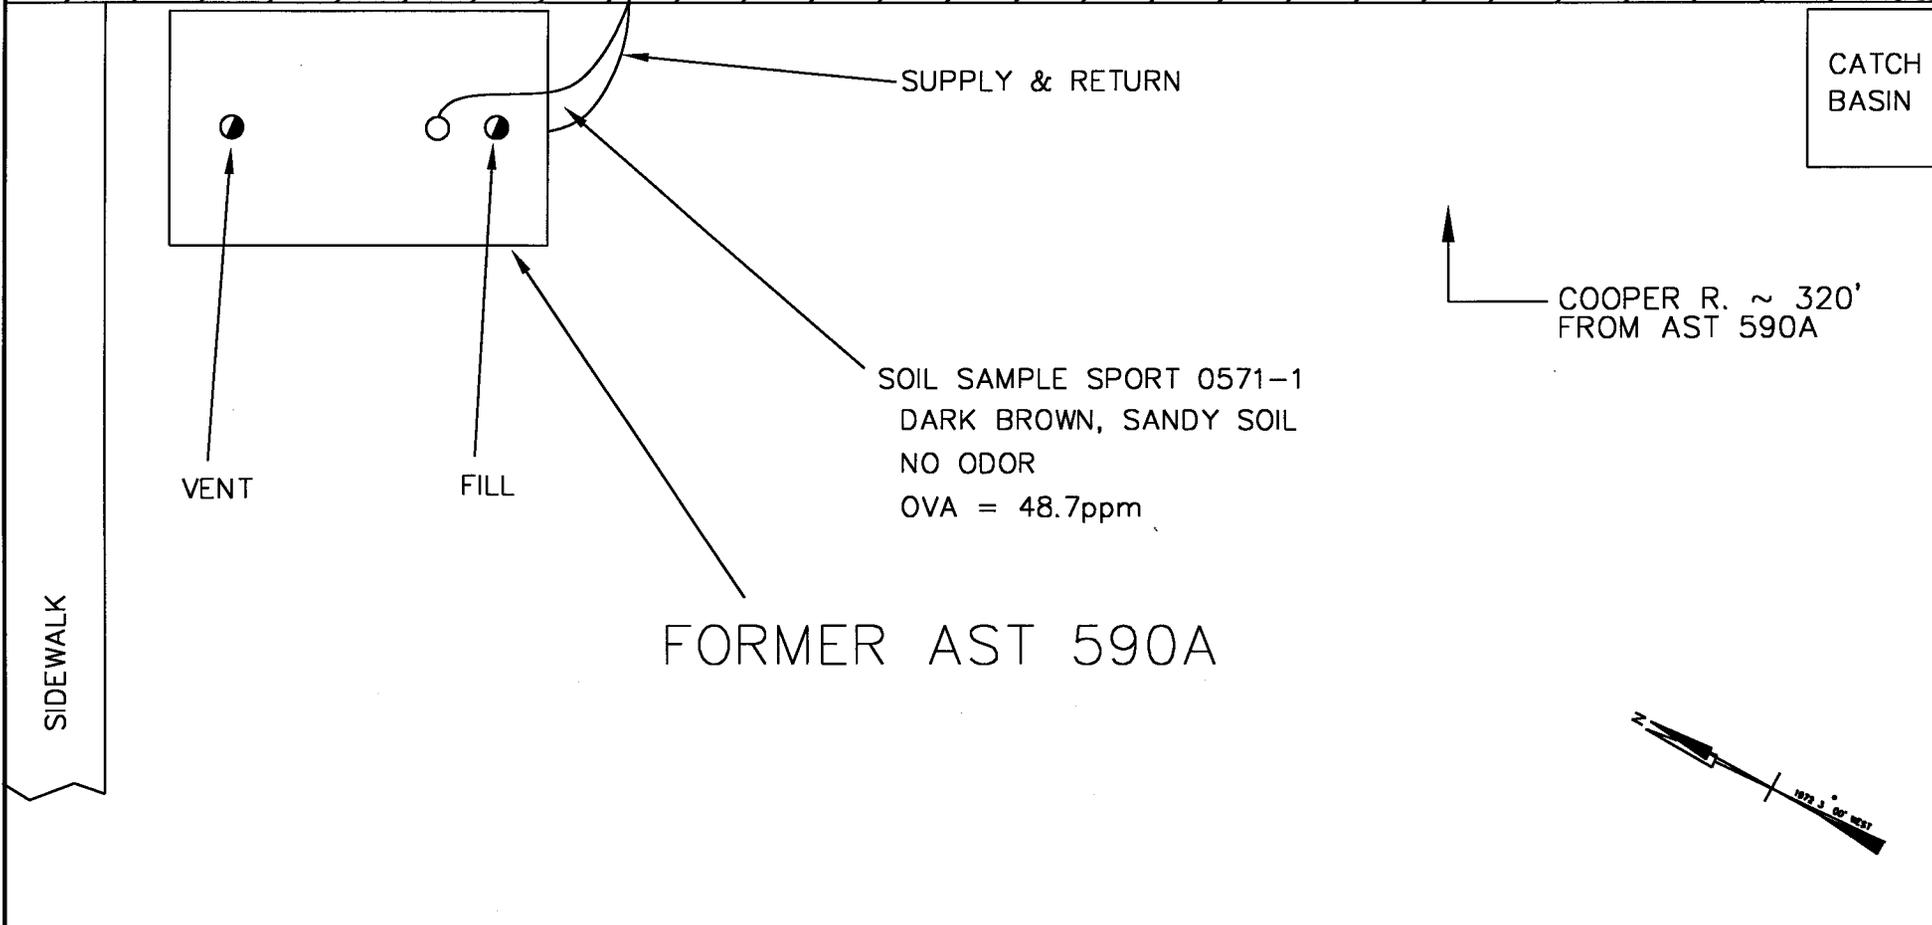
Site Map 2
 AST 590A
 Charleston Naval Base
 Charleston, SC

SUPPLY & RETURN

SOIL SAMPLE SPORT 0571-1
DARK BROWN, SANDY SOIL
NO ODOR
OVA = 48.7ppm

FORMER AST 590A

Sample jars were prepared by the testing laboratory. The grab method was utilized to fill the sample containers leaving as little head space as possible and immediately capped. The soil sample was extracted at the tank end closest to the fill pipe and beneath the supply and return piping.

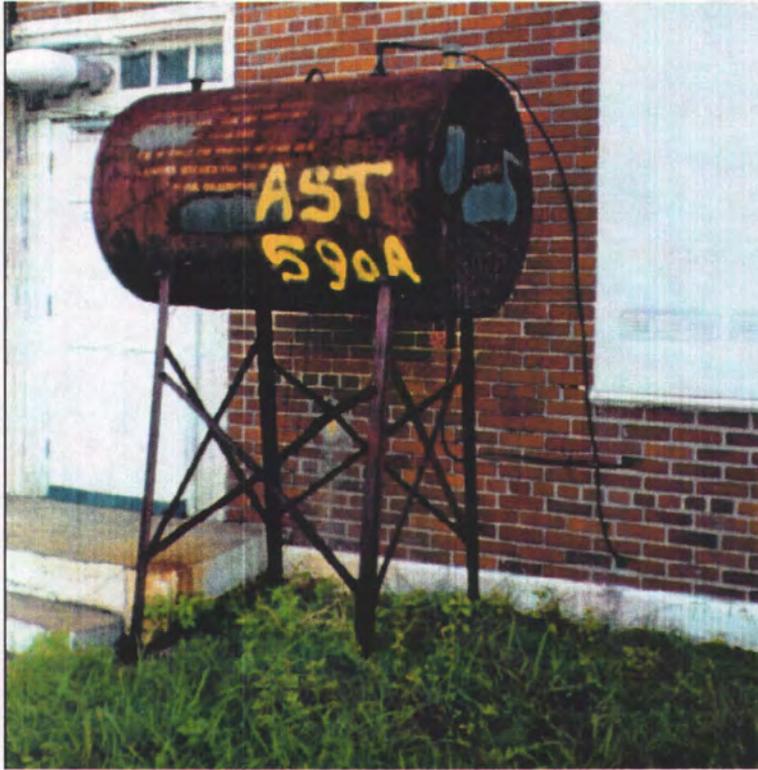
Photo 1: AST 590A prior to removal.

AST 590A was covered with patches of flaking paint and surface rust, but no holes were found.

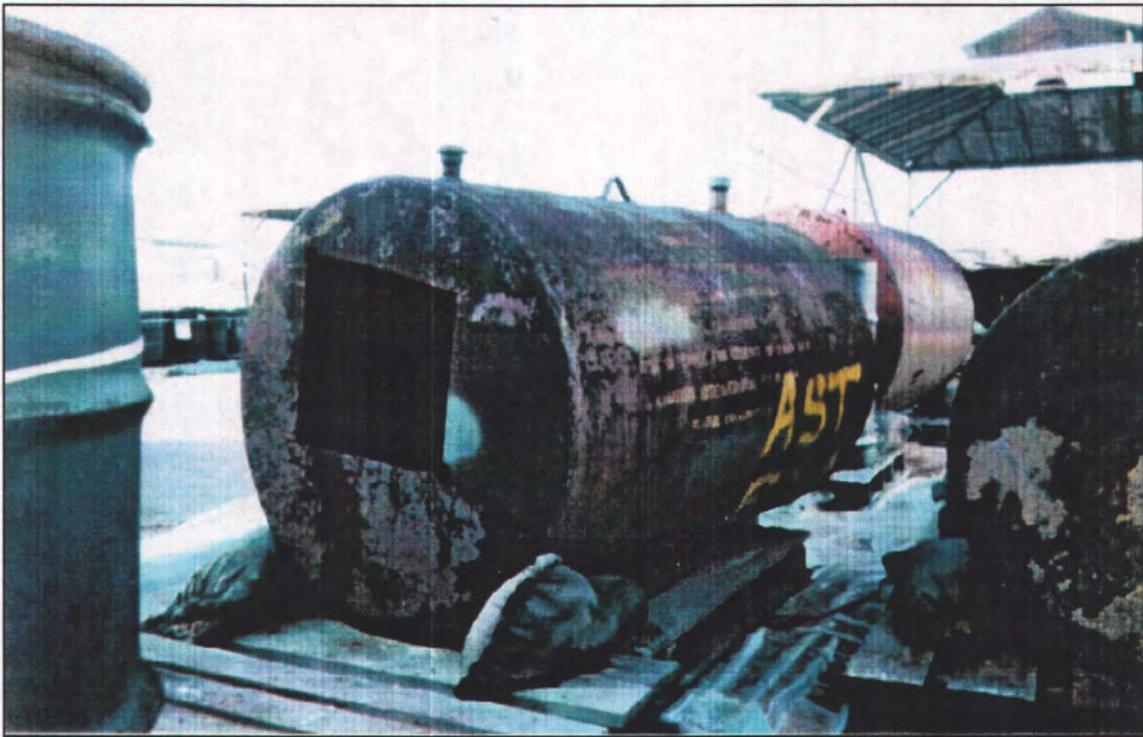
Photo 2: AST 590A being cleaned and cut up as scrap metal.

AST 590A was removed, drained, cut open at both ends, and cleaned with a steam cleaner. It was then cut up for recycling as scrap metal. (See Attachment III.)

The tank was cut open on both ends, cleaned with a steam cleaner, cut into sections, and disposed of as recyclable scrap metal.
