ABOVE GROUND STORAGE TANK (AST) ASSESSMENT REPORT AST TANK 3909 CNC
CHARLESTON SC
01/05/1998
ENVIRONMENTAL DETACHMENT CHARLESTON

Aboveground Storage Tank (AST) Assessment Report

Site Map 1
 AST 3909
 Charleston Naval Base
 Charleston, SC

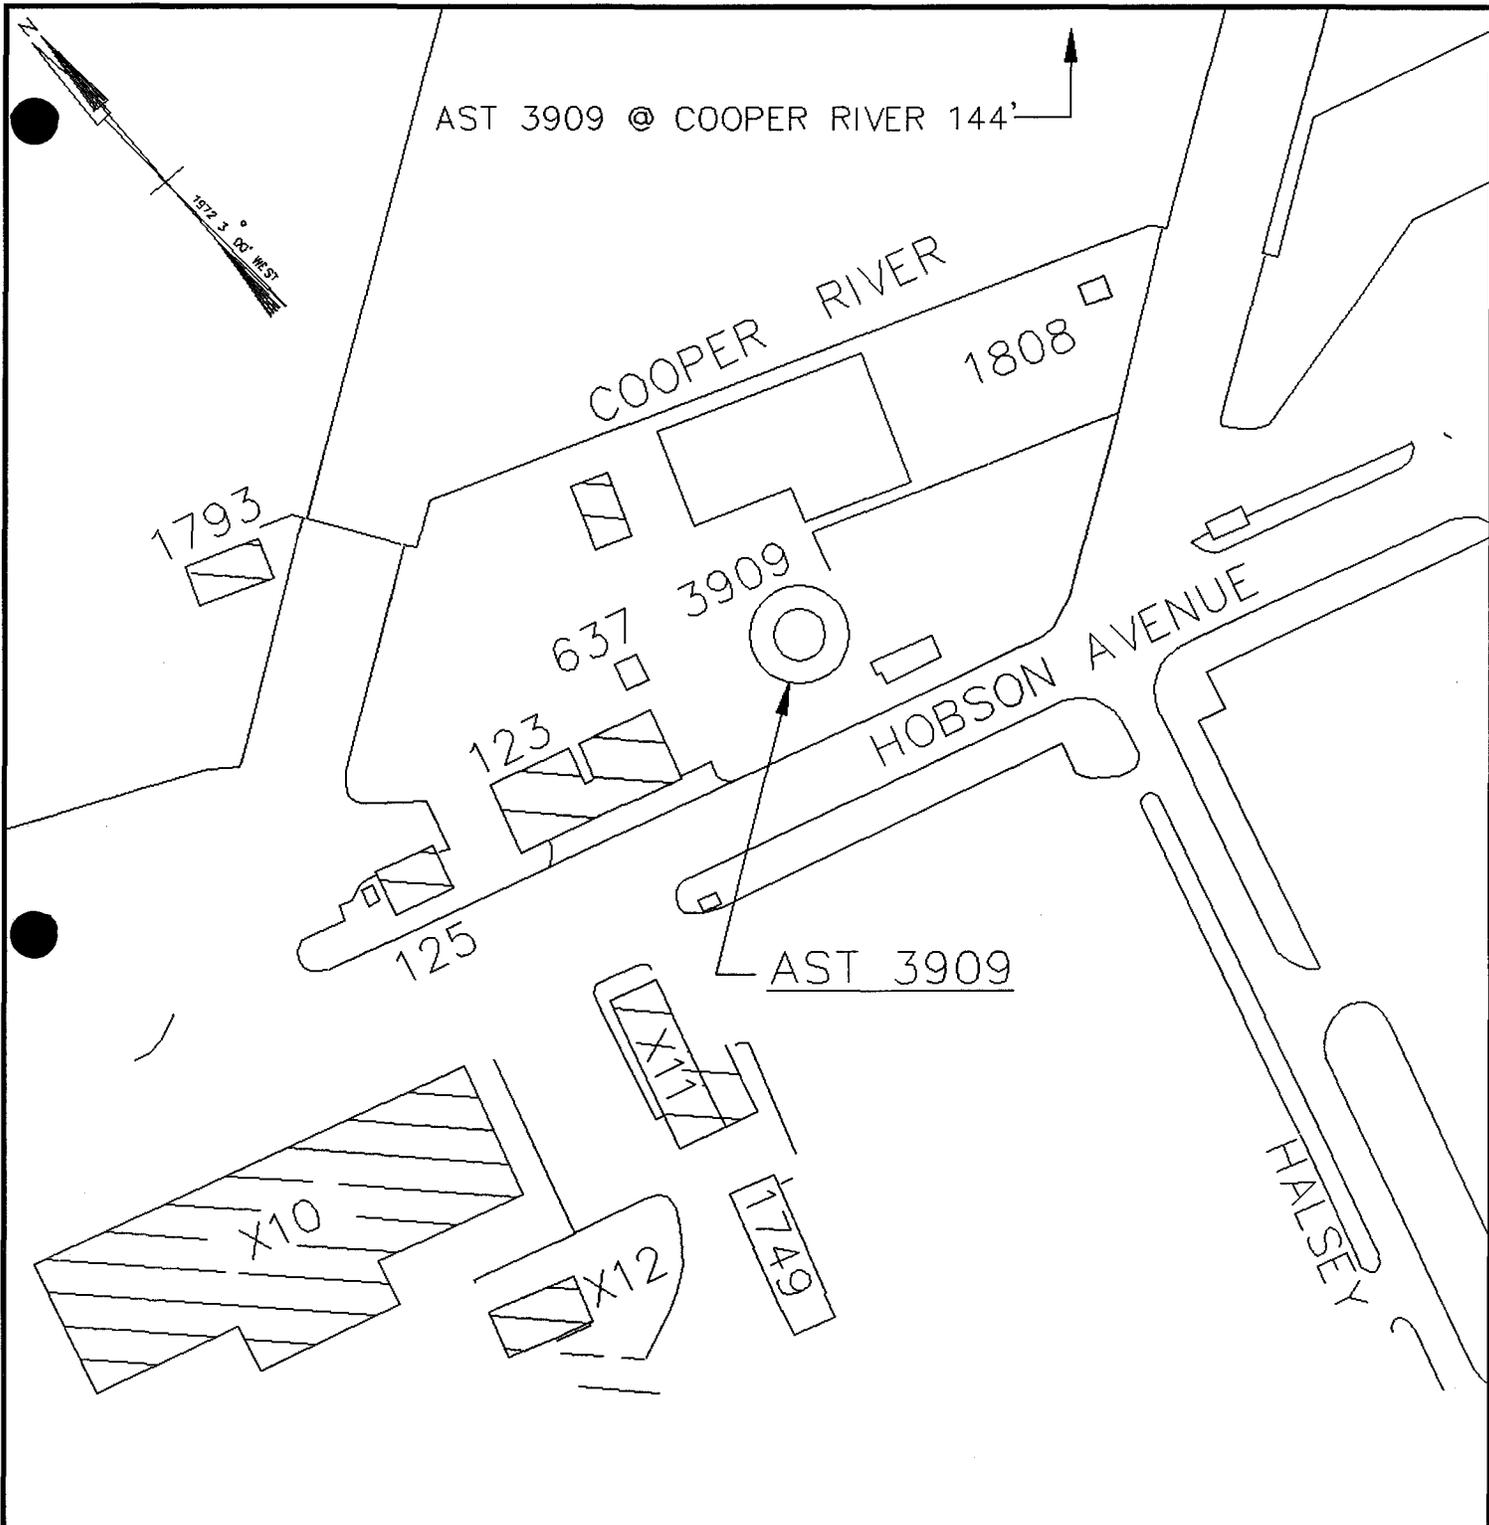
AST 3909 @ COOPER RIVER 144'

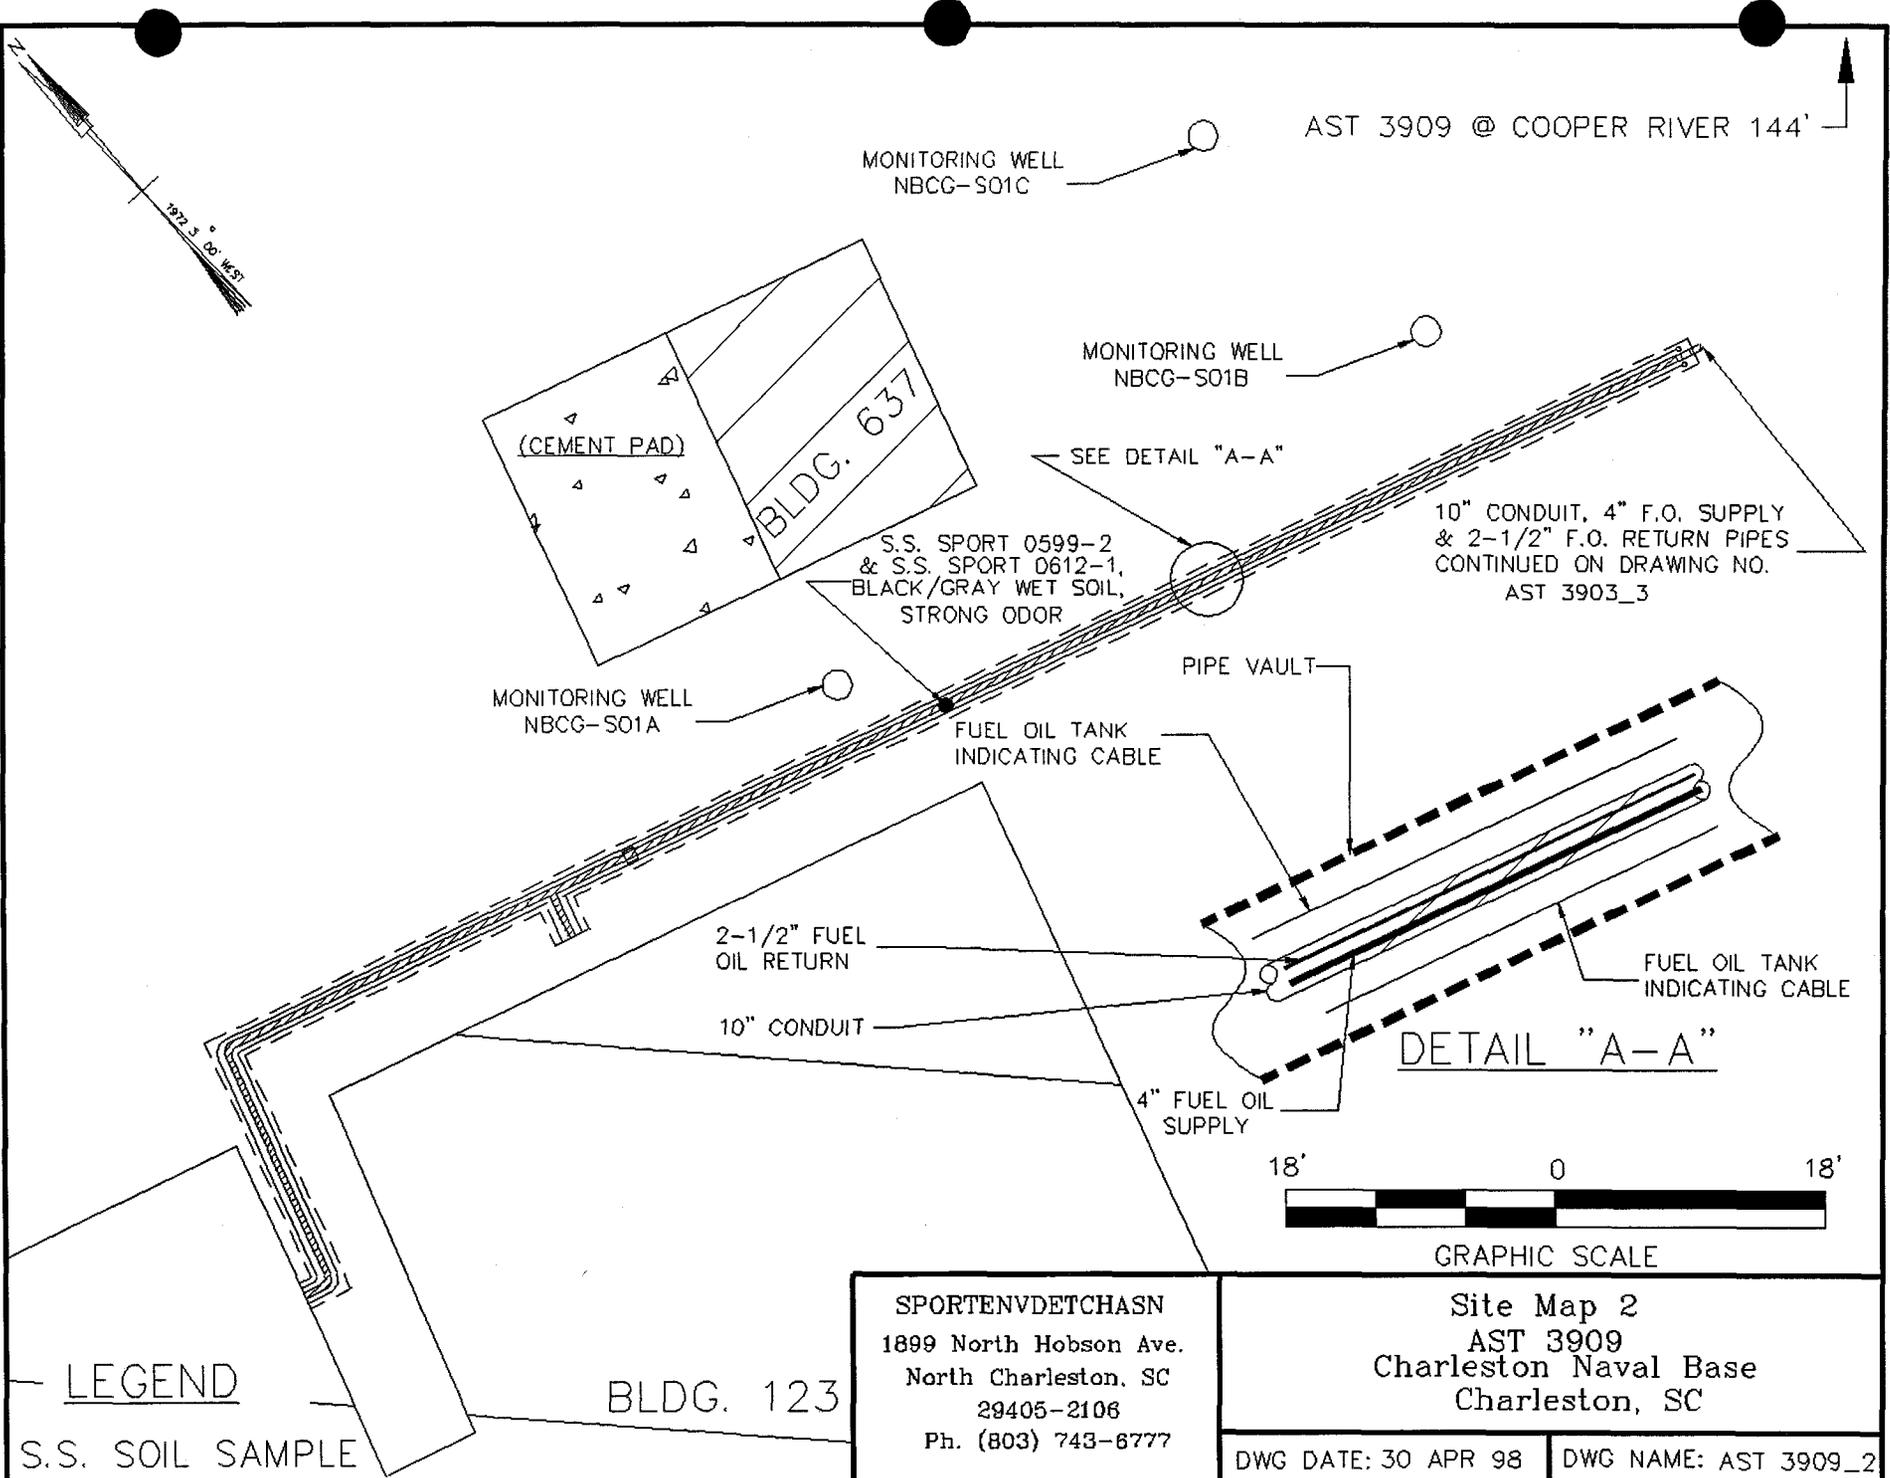
Site Map 2
AST 3909
Charleston Naval Base
Charleston, SC
DWG DATE: 30 APR 98 | DWG NAME: AST 3909_2

S.S. SPORT 0599-2
& S.S. SPORT 0612-1,
BLACK/GRAY WET SOIL,
STRONG ODOR

10" CONDUIT, 4" F.O. SUPPLY
& 2-1/2" F.O. RETURN PIPES
CONTINUED ON DRAWING NO.
AST 3903_3

DETAIL "A-A"

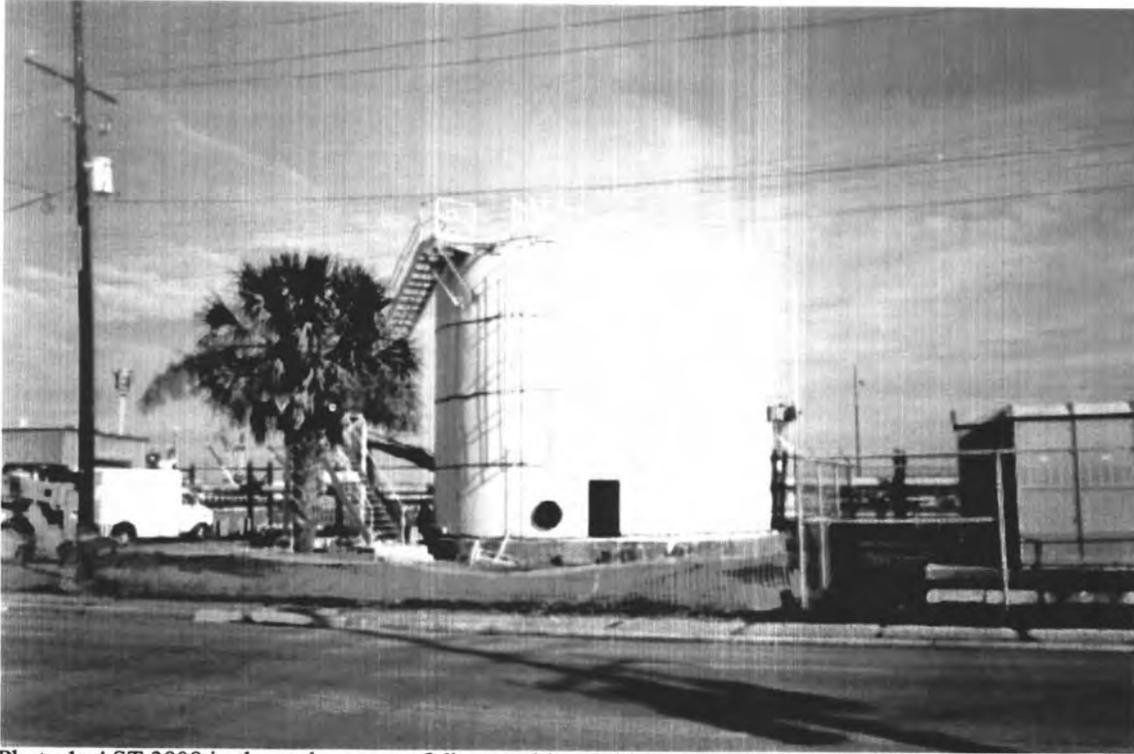
Photo 1: AST 3909 in the early stages of disassembly. Grid work is where the lead base paint was removed prior to cutting.

AST 3909 was cleaned with a steam cleaner, cut into sections, and recycled as scrap metal. (See Attachment III.)

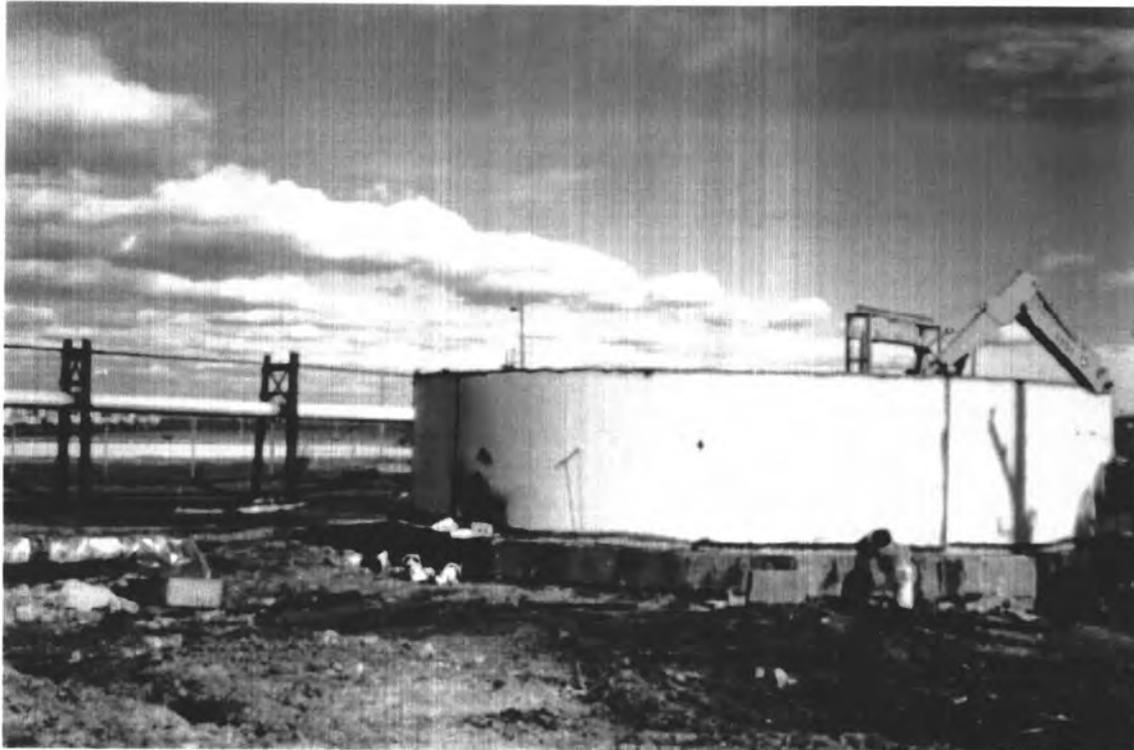
Photo 2: The last stages of the dismantling operation for the tank.

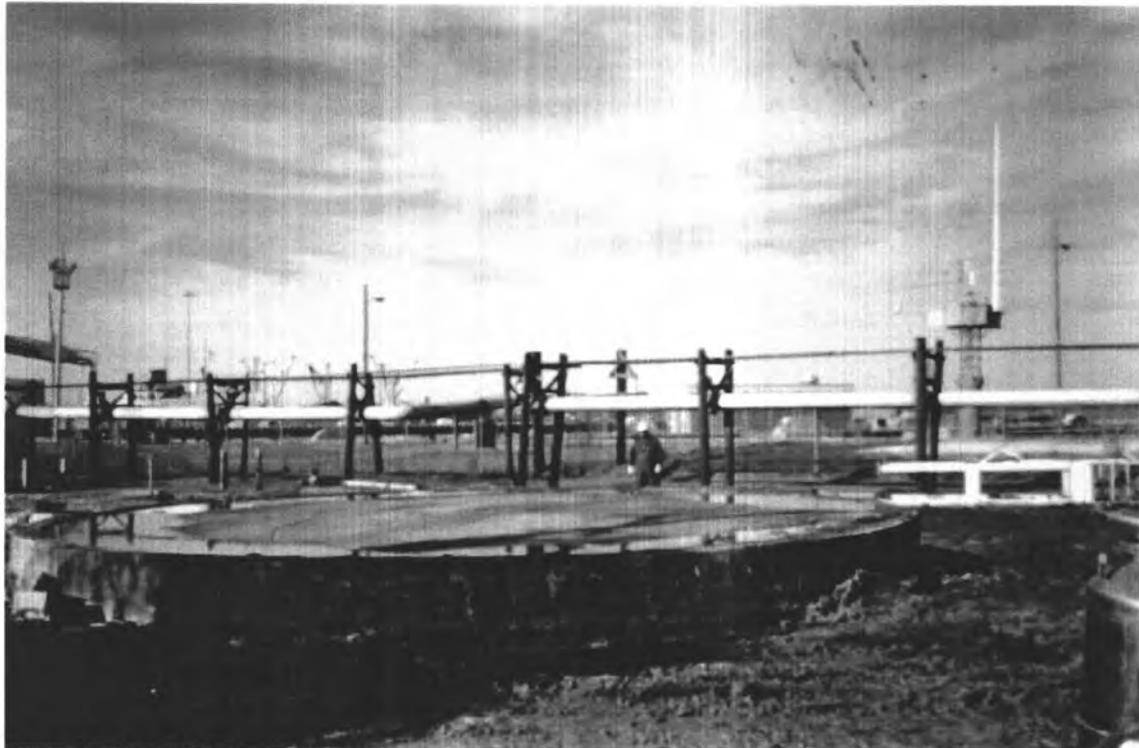
AST 3909 was constructed on site in 1964 to supply fuel oil to the boilers of auxiliary boiler house Building 123. The tank sat on a concrete foundation filled with approximately 18" of sand. The sand served as a soft pad for the tank bottom. Some sand pads on other tanks were found to be oil impregnated. Samples SPORT 0590-1 & 2 and SPORT 0599-2 & 3 were taken to determine if AST 3909's sand pad was oil impregnated and if it had to be disposed of as petroleum contaminated waste. Although the total petroleum hydrocarbon results were elevated, it appears that the sand was not impregnated and a release did not occur; therefore, the sand was left in place.

Photo 3: AST 3909 foundation.

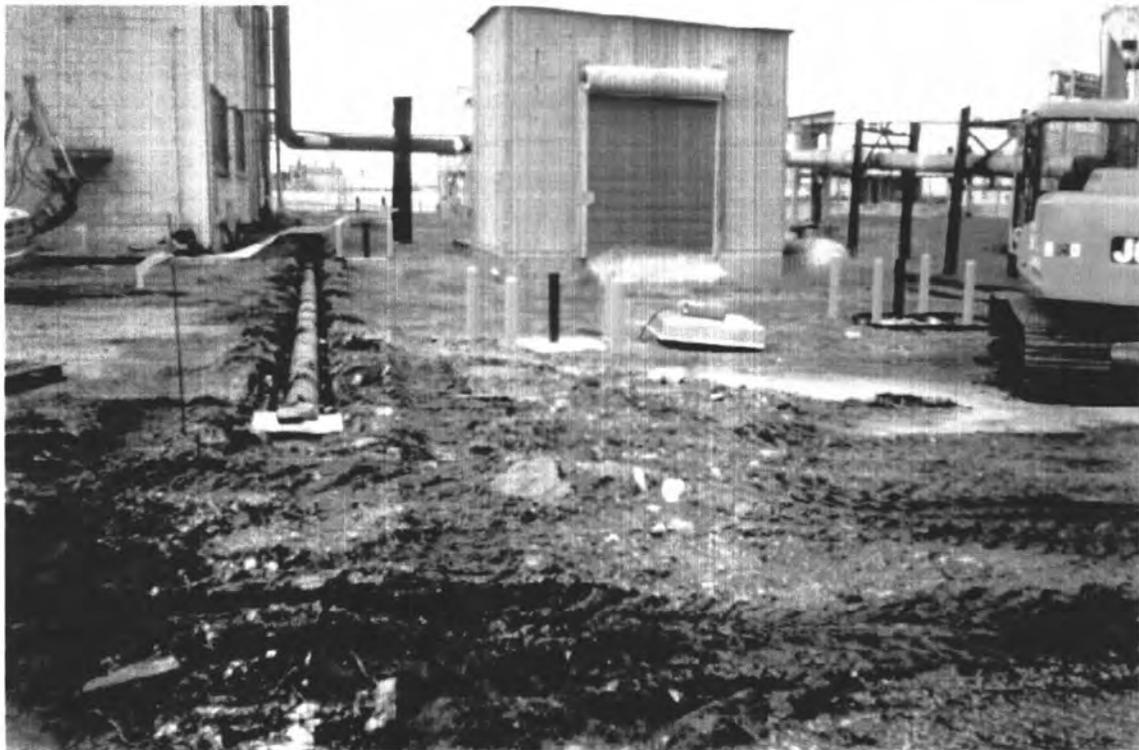
The steel supply and return piping for AST 3909 was protected by a 10" steel conduit which ran through a concrete pipe trench with removable covers.

The piping was corroded throughout its length, but severely corroded where it entered Building 123, where it was unprotected and covered with an oily film. Oily sludge was found inside the steel conduit (see photos), but its source was not determined.

Photo 4: AST 3909 pipe trench.

Further, appropriate consideration to the destruction and removal of the concrete piping trench should be incorporated with the above requested work.

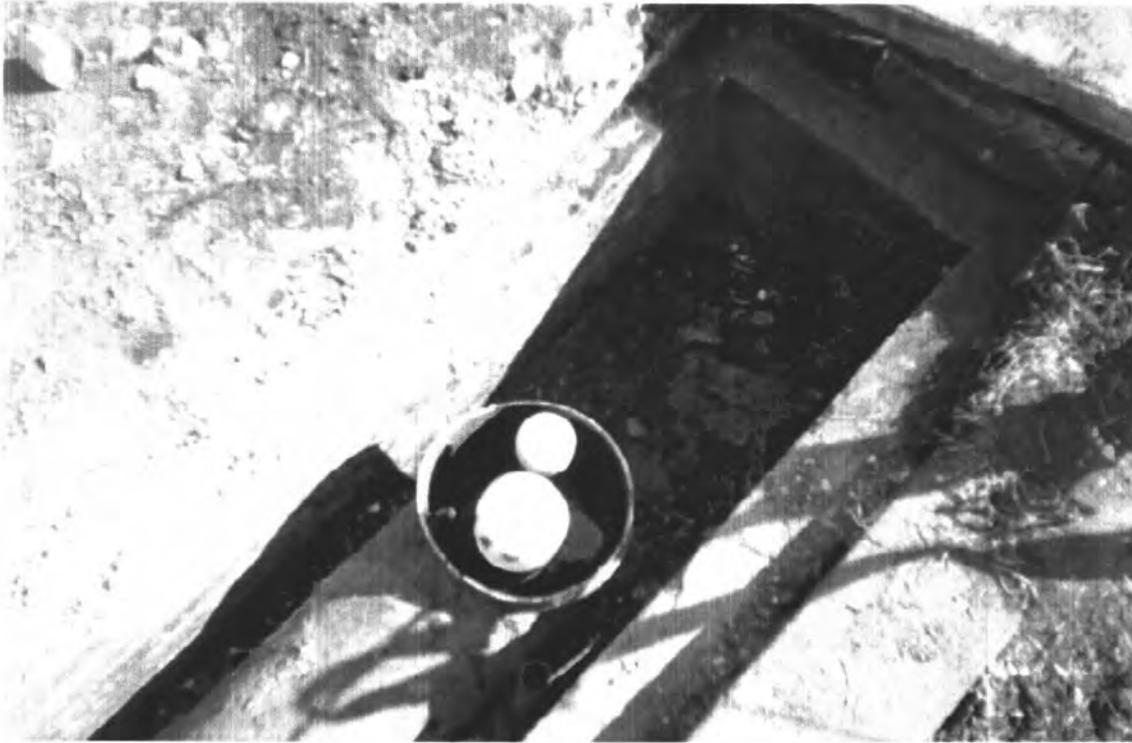
Photo 5: Close-up of AST 3909 pipe trench arrangement.

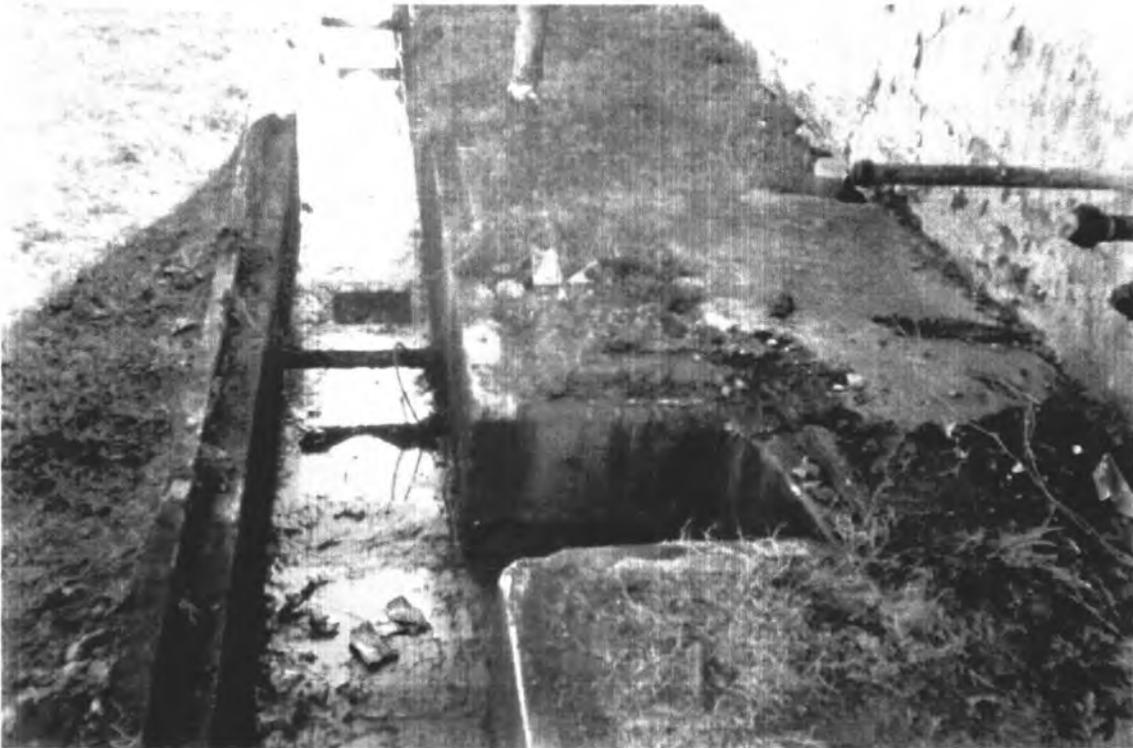
Photo 6: Pipe trench after removal of piping.
