ABOVE GROUND STORAGE TANK (AST) ASSESSMENT REPORT ASTK 86 CNC  
CHARLESTON SC  
10/06/1997  
ENVIRONMENTAL DETACHMENT CHARLESTON

Re: Aboveground Storage Tank Assessment Report dated March 9, 1998  
Bldg. 86 (AST 86) (Site Identification # 15405-General File)  
Charleston Naval Complex/Charleston Naval Base  
Charleston, SC  
Charleston County

**Aboveground Storage Tank (AST) Assessment Report**

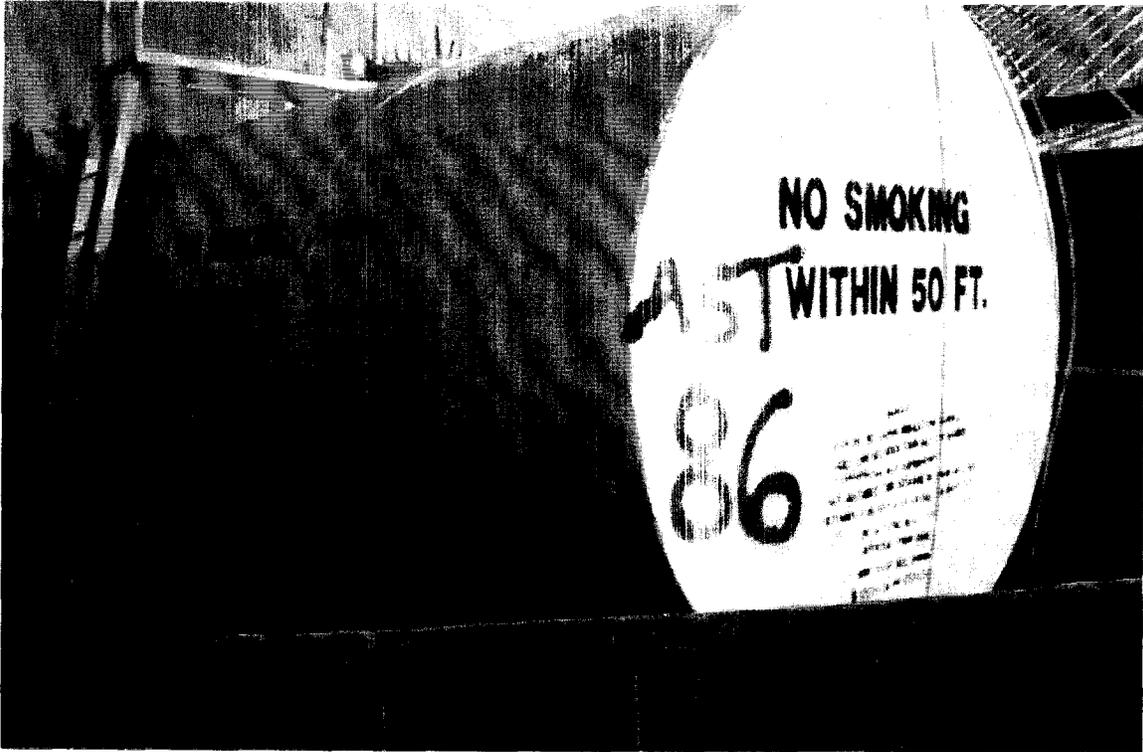
AST 86 was in good condition. No holes, pitting, or corrosion were found.

Photo 1: AST 86 in the berm, prior to removal.

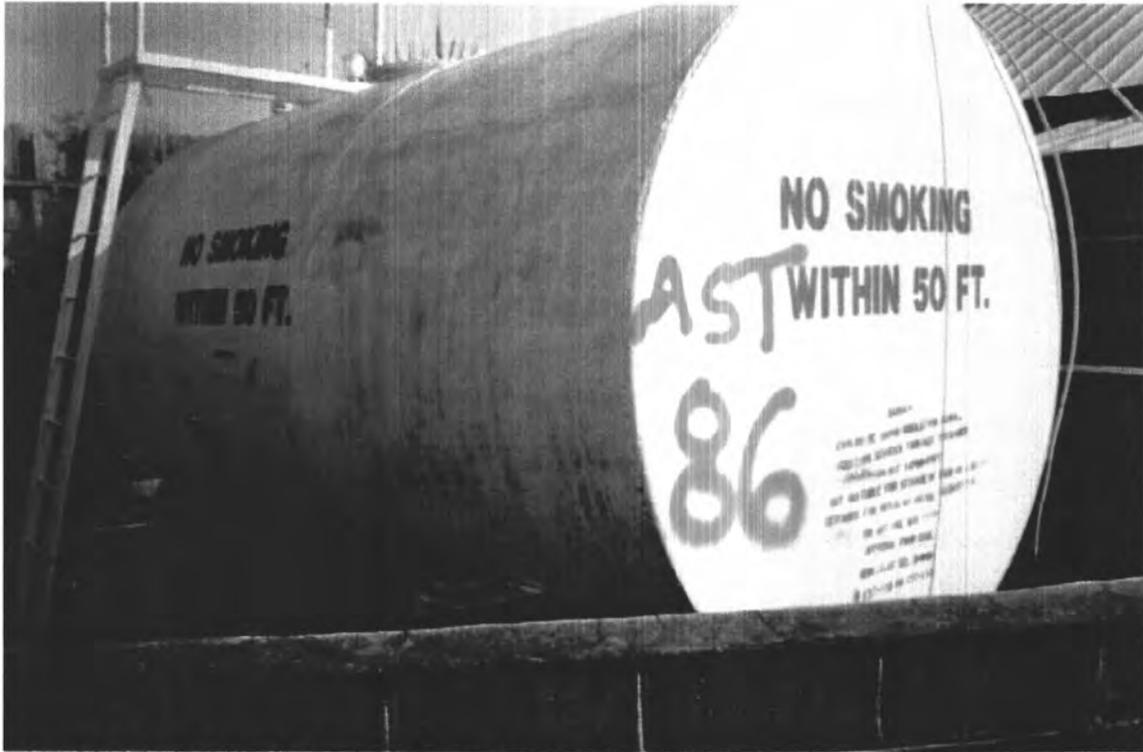
Photo 1: AST 86 in the berm, prior to removal.
