CONTAMINATION ASSESSMENT REPORT FOR UNDERGROUND STORAGE TANK 708
(UST 708) CNC CHARLESTON SC
05/22/1998
ENVIRONMENTAL DETACHMENT CHARLESTON

**CONTAMINATION ASSESSMENT REPORT FOR UST 708 (SCDHEC GWPD
SITE ID # 17665)**

UST 708
(SCDHEC GWPD SITE ID # 17665)
NAVAL BASE CHARLESTON
CHARLESTON SC

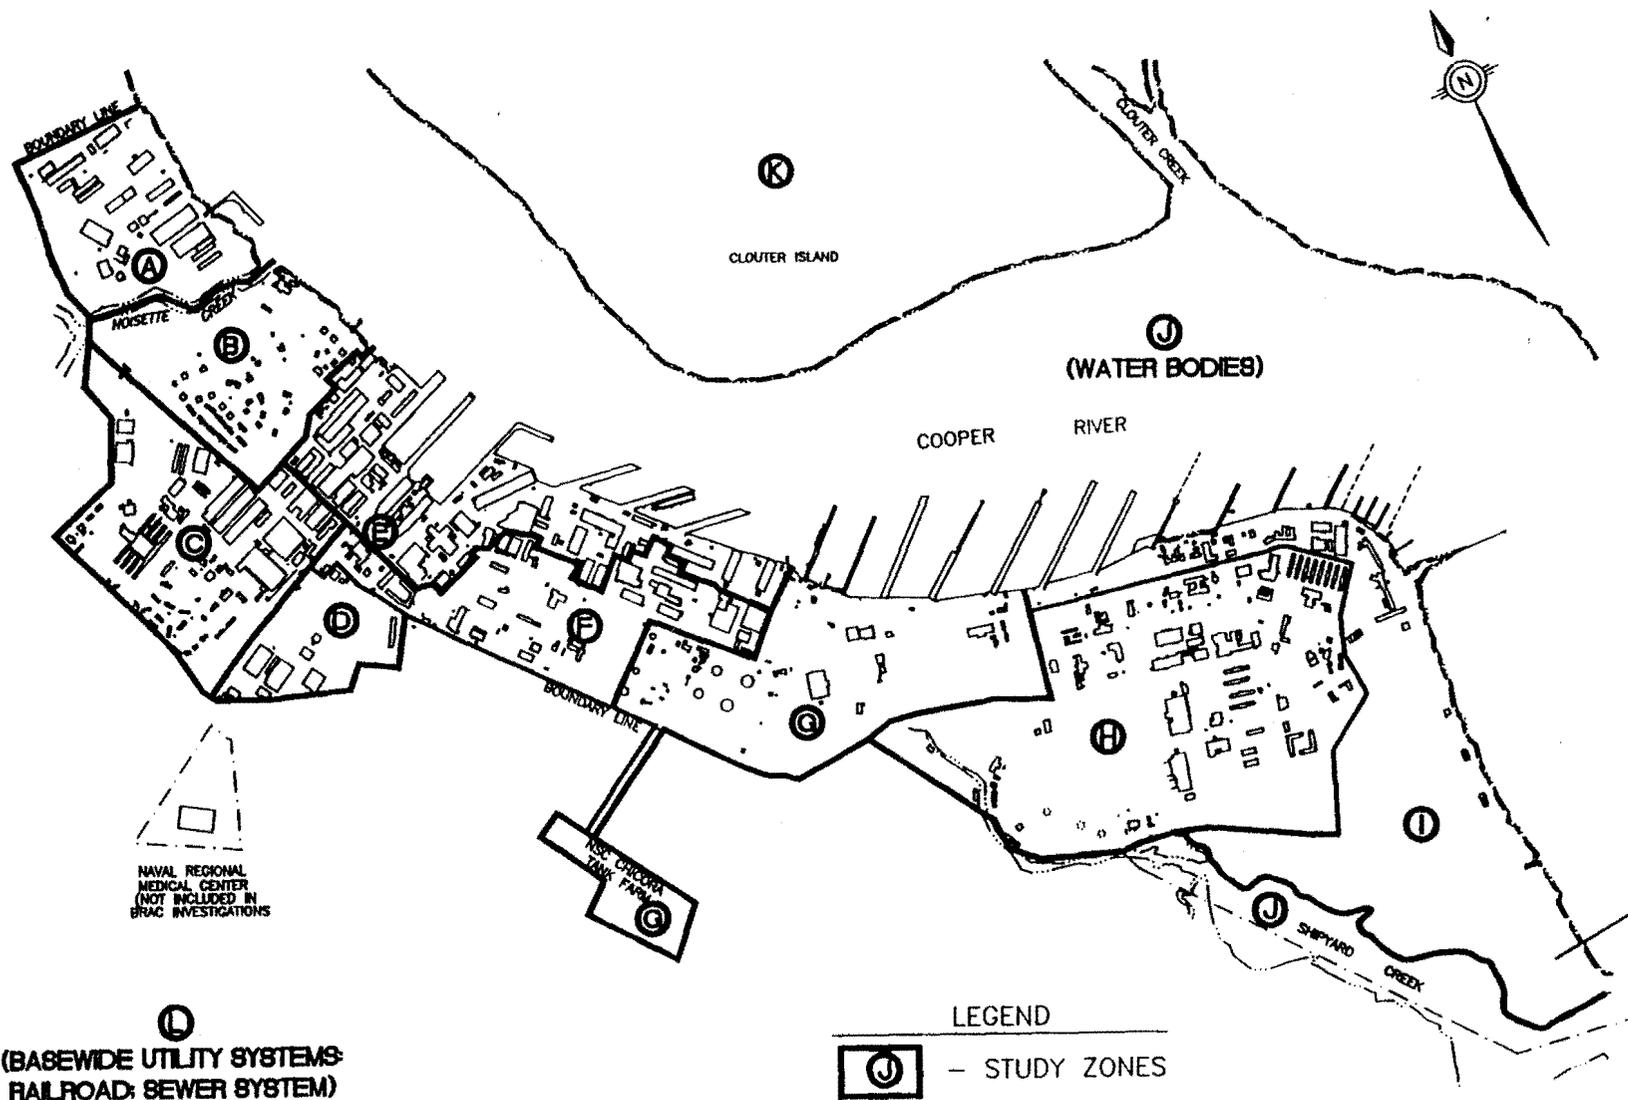
Figure 1-1
RFI Zone Boundaries
Charleston Naval Base
Charleston, SC

The former UST 708 site is in RFI Zone B in the northern portion of the NAVBASE. Zone B consists of a golf course and housing area located immediately south of Noisette Creek. Building 708 is a single family dwelling located in the western half of Zone B at 1468 Hobson Avenue. Building 708 is located on the east side of Hobson Avenue. The former UST location is in front of Building 708 beside the driveway.

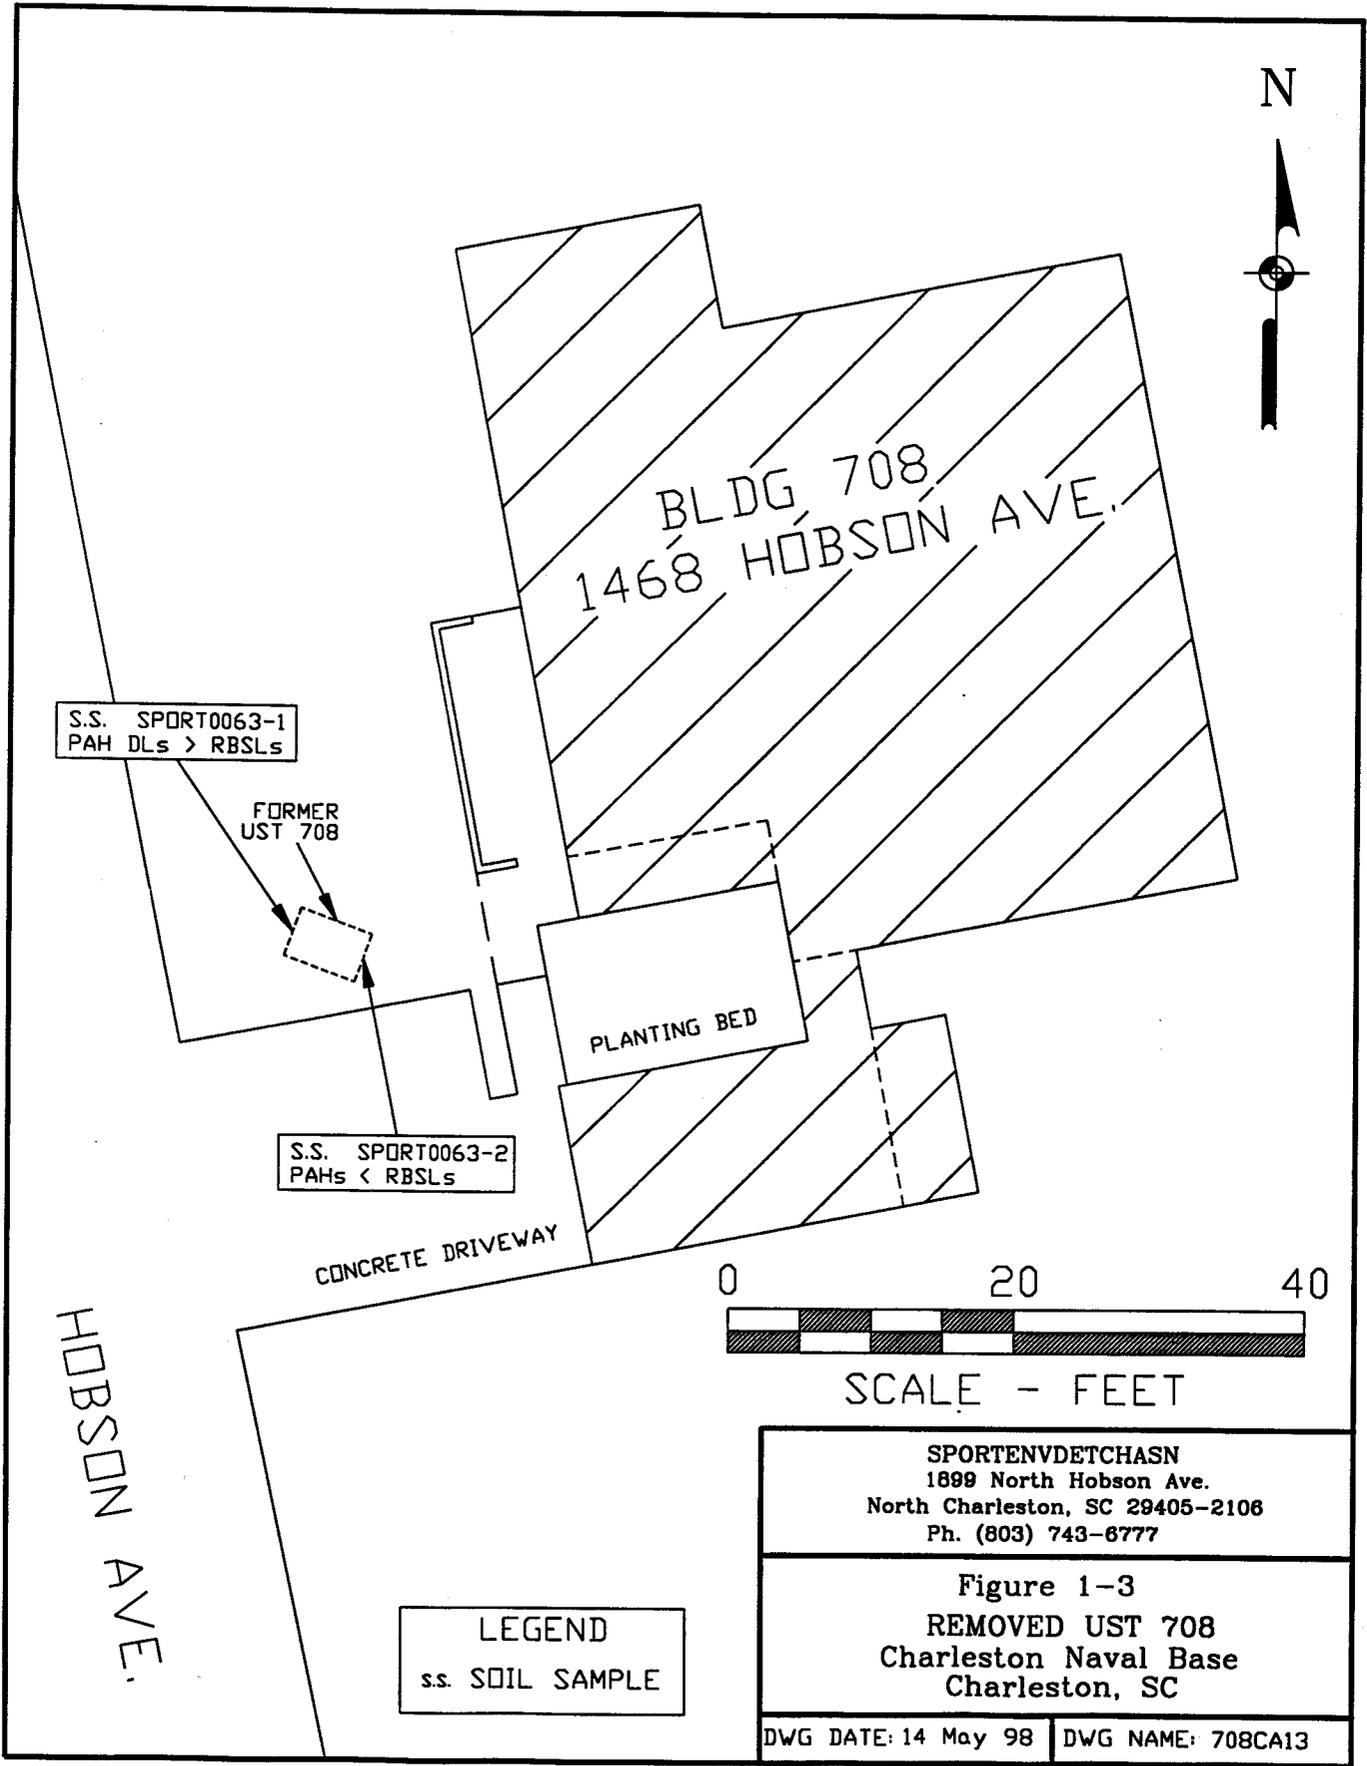
Figure 1-3
REMOVED UST 708
Charleston Naval Base
Charleston, SC

S.S. SPORT0063-1
PAH DLs > RBSLs

FORMER
UST 708

S.S. SPORT0063-2
PAHs < RBSLs

BLDG 708
1468 HOBSON AVE.

CONCRETE DRIVEWAY

Two soil samples were taken at the base of the excavation before it was filled and analyzed for PAHs and BTEX + Naphthalene. Sample SPORT0063-1 taken at the west end of the tank contained matrix interferences, which elevated detection levels (DLs) for PAHs above SCDHEC RBSLs for Benzo(b)fluoranthene and Chrysene. Sample SPORT0063-2 contained concentrations of PAHs less than RBSLs. See Figure 1-3.

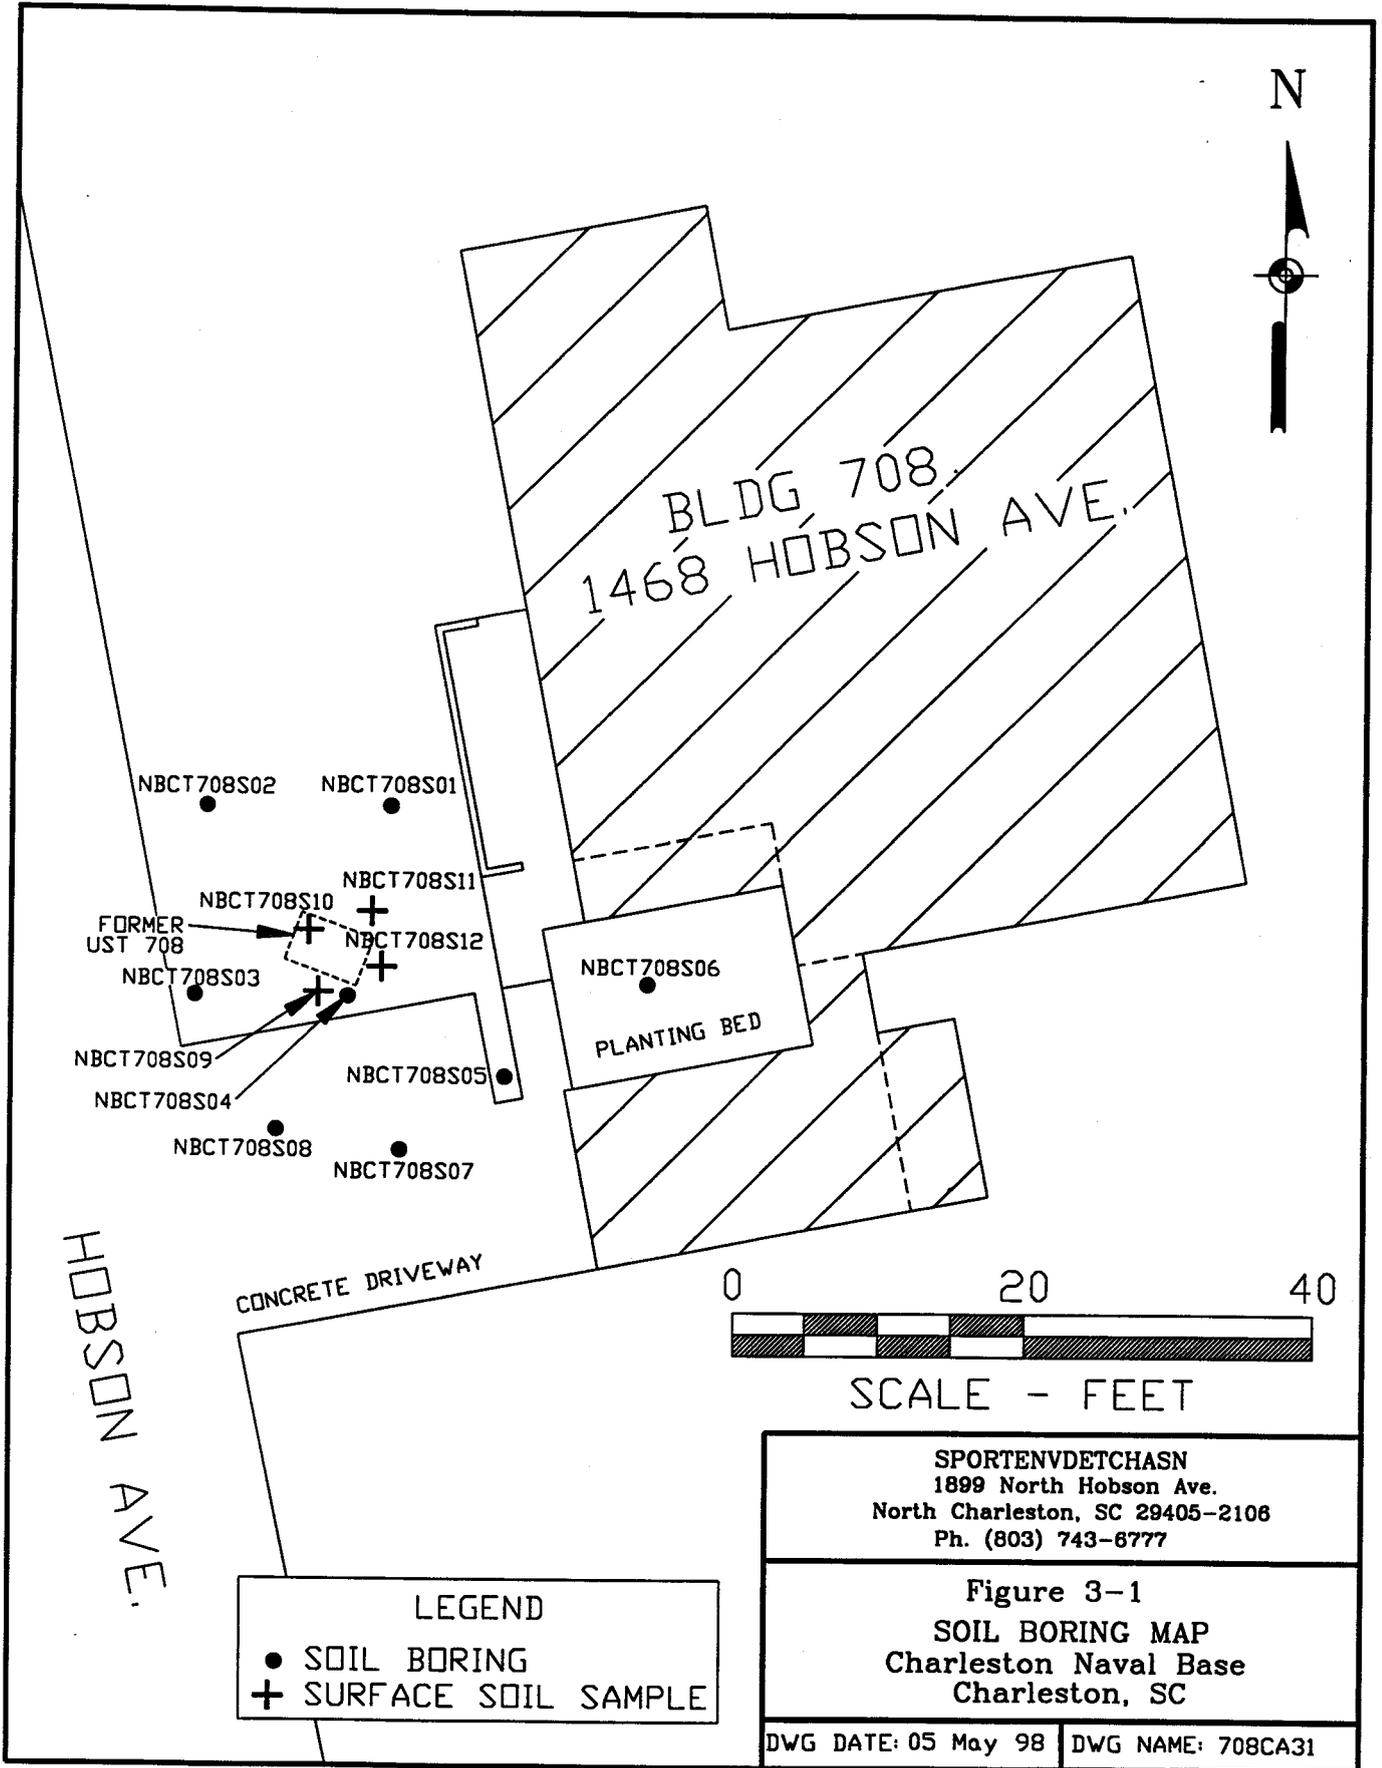
3.1.1 Soil Boring Program. A soil boring program was performed at Quarters Building 708 to assess the horizontal and vertical extent of hydrocarbon contamination in the vadose zone at the site. A total of eight soil borings were advanced toward the water table using stainless steel hand augers. Figure 3-1 shows soil boring locations.

The locations of the soil borings performed differ from those proposed in the Sampling and Analysis Plan - UST NS708 dated July 23, 1997. Soil Boring NBCT708S02 was relocated toward Hobson Avenue when a creosote timber was found near the surface at the proposed location. In addition, soil boring NBCT708S05 was terminated short of the water table when an obstruction was encountered at 5 feet bgs.

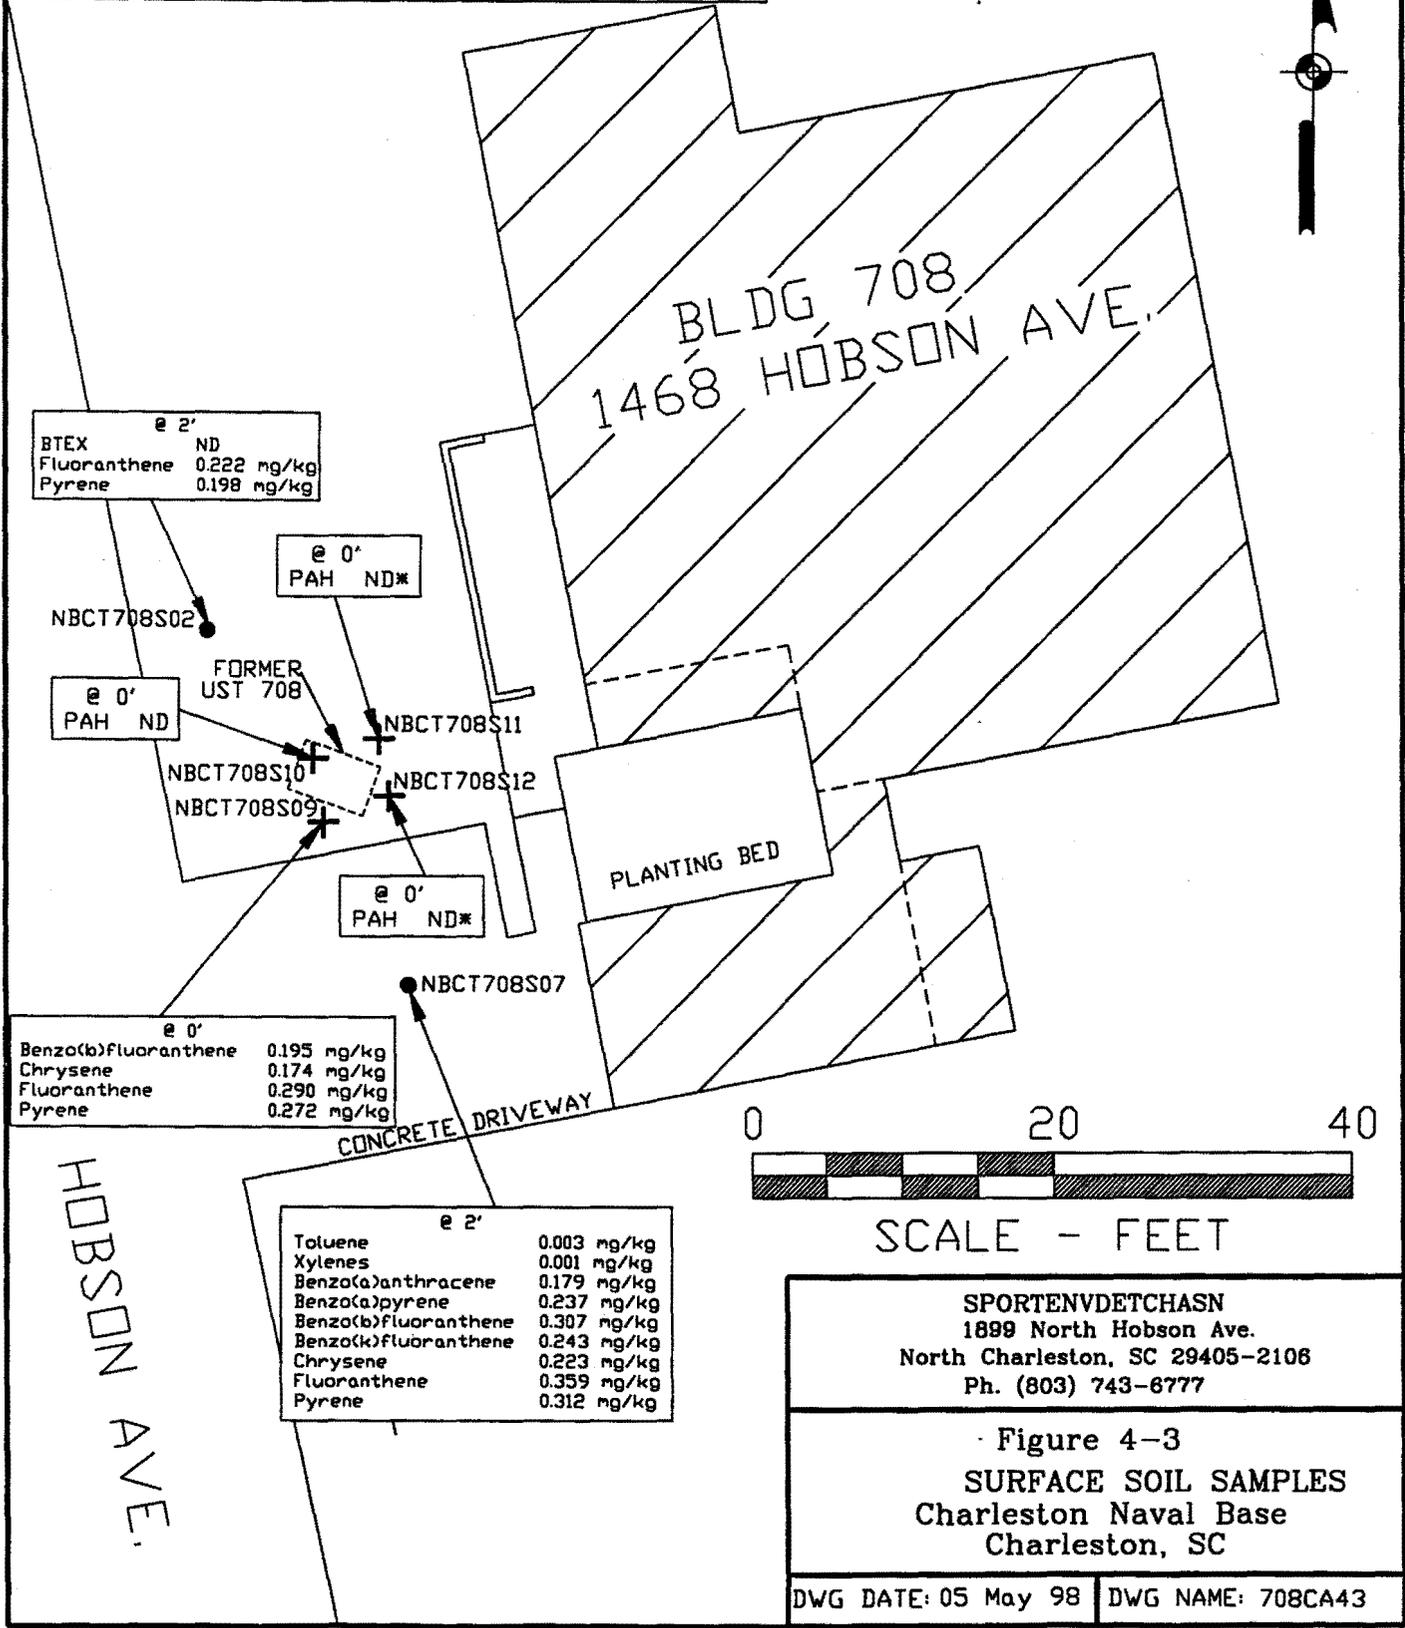
Figure 4-3
SURFACE SOIL SAMPLES
Charleston Naval Base
Charleston, SC

- SOIL BORING
- + SURFACE SOIL SAMPLE
- ND NON-DETECT
- ND* NON-DETECT, BUT DLs ELEVATED ABOVE SOME RBSLs - SEE SECTION 4.2.2.2

BTEX	ND
Fluoranthene	0.222 mg/kg
Pyrene	0.198 mg/kg

PAH	ND*
-----	-----

PAH	ND
-----	----

Benzo(k)fluoranthene	0.195 mg/kg
Chrysene	0.174 mg/kg
Fluoranthene	0.290 mg/kg
Pyrene	0.272 mg/kg

Toluene	0.003 mg/kg
Xylenes	0.001 mg/kg
Benzo(a)anthracene	0.179 mg/kg
Benzo(a)pyrene	0.237 mg/kg
Benzo(k)fluoranthene	0.307 mg/kg
Benzo(k)fluoranthene	0.243 mg/kg
Chrysene	0.223 mg/kg
Fluoranthene	0.359 mg/kg
Pyrene	0.312 mg/kg

4.2.2.2 Surface Soil Sampling Results Laboratory analysis was performed on four surface soil samples taken the soil surrounding the UST excavation. The results of the analysis are presented in Table 4-2. Sample NBCT708S090101 contained concentrations of Benzo(b)fluoranthene, Chrysene, Fluoranthene and Phenanthrene below SCDHEC Residential Ingestion/Dermal Contact RBSLs or USEPA residential soil ingestion RBCs. Both sample NBCT708S090101 and soil boring sample NBCT708S020101 where COCs were detected in the two foot depth interval are located between the excavation and Hobson Avenue. COC concentrations in sample NBCT708S020101 are less than soil ingestion RBSLs or RBCs. Also, surface soil samples NBCT708S110101 and NBCT708S120101 contained matrix interferences which raised DLs for PAHs to 0.333 milligrams per kilogram (mg/kg), which exceeds the SCDHEC Residential Ingestion/Dermal Contact RBSL for Dibenzo(ah)anthracene and the residential soil ingestion RBC for Benzo(a)pyrene (both 0.088mg/kg). Figure 4-3 illustrates the analytical results for surface soil samples. Copies of the analytical reports are contained in Appendix C.

- The greatest number of COCs and the highest COC concentrations were detected immediately underneath the driveway in sample NBCT708S070101. None of the detections under the driveway exceeded groundwater protection RBSLs or SSLs. Concentrations of Benzo(a)pyrene exceeded the USEPA Region III residential soil ingestion RBC, but this presents no threat to site residents because this area is capped by a concrete driveway.

- The presence of COCs in soil boring sample NBCTS708S020101 and surface soil sample NBCT708S090101 suggest that an area of minimally contaminated surface soil exists between the former tank site and Hobson Avenue. All detected concentrations are less SCDHEC soil ingestion/dermal contact RBSLs or residential soil ingestion RBCs, so this area presents no treat to site residents.

- Surface soil samples NBCT708S110101 and NBCT708S120101 had DLs elevated above residential ingestion/dermal contact RBSLs for Dibenzo(ah)anthracene and the residential soil ingestion RBC for Benzo(a)pyrene. However, detection of Dibenzo(ah)anthracene at the NAVBASE has been extremely rare. Benzo(a)pyrene, while fairly common at the NAVBASE, is usually accompanied by other COCs, particularly Pyrene and Phenanthrene, at higher concentrations. With no PAH detected in any surface soil sample, the possibility that Dibenzo(ah)anthracene or Benzo(a)pyrene is present in surface soils at the former UST 708 site is negligible. Surface soils at the former UST 708 site are not a threat to site residents.
