RCRA FACILITY ASSESSMENT FOR NAVAL BASE CHARLESTON FOR VOLUME I CNC
CHARLESTON SC
05/31/1994
ENSAFE ALLEN AND HOSHALL

**RCRA FACILITY ASSESSMENT
NAVAL BASE CHARLESTON
VOLUME I**

**Department of the Navy
Southern Division
Naval Facilities Engineering Command
North Charleston, South Carolina**

May 31, 1994

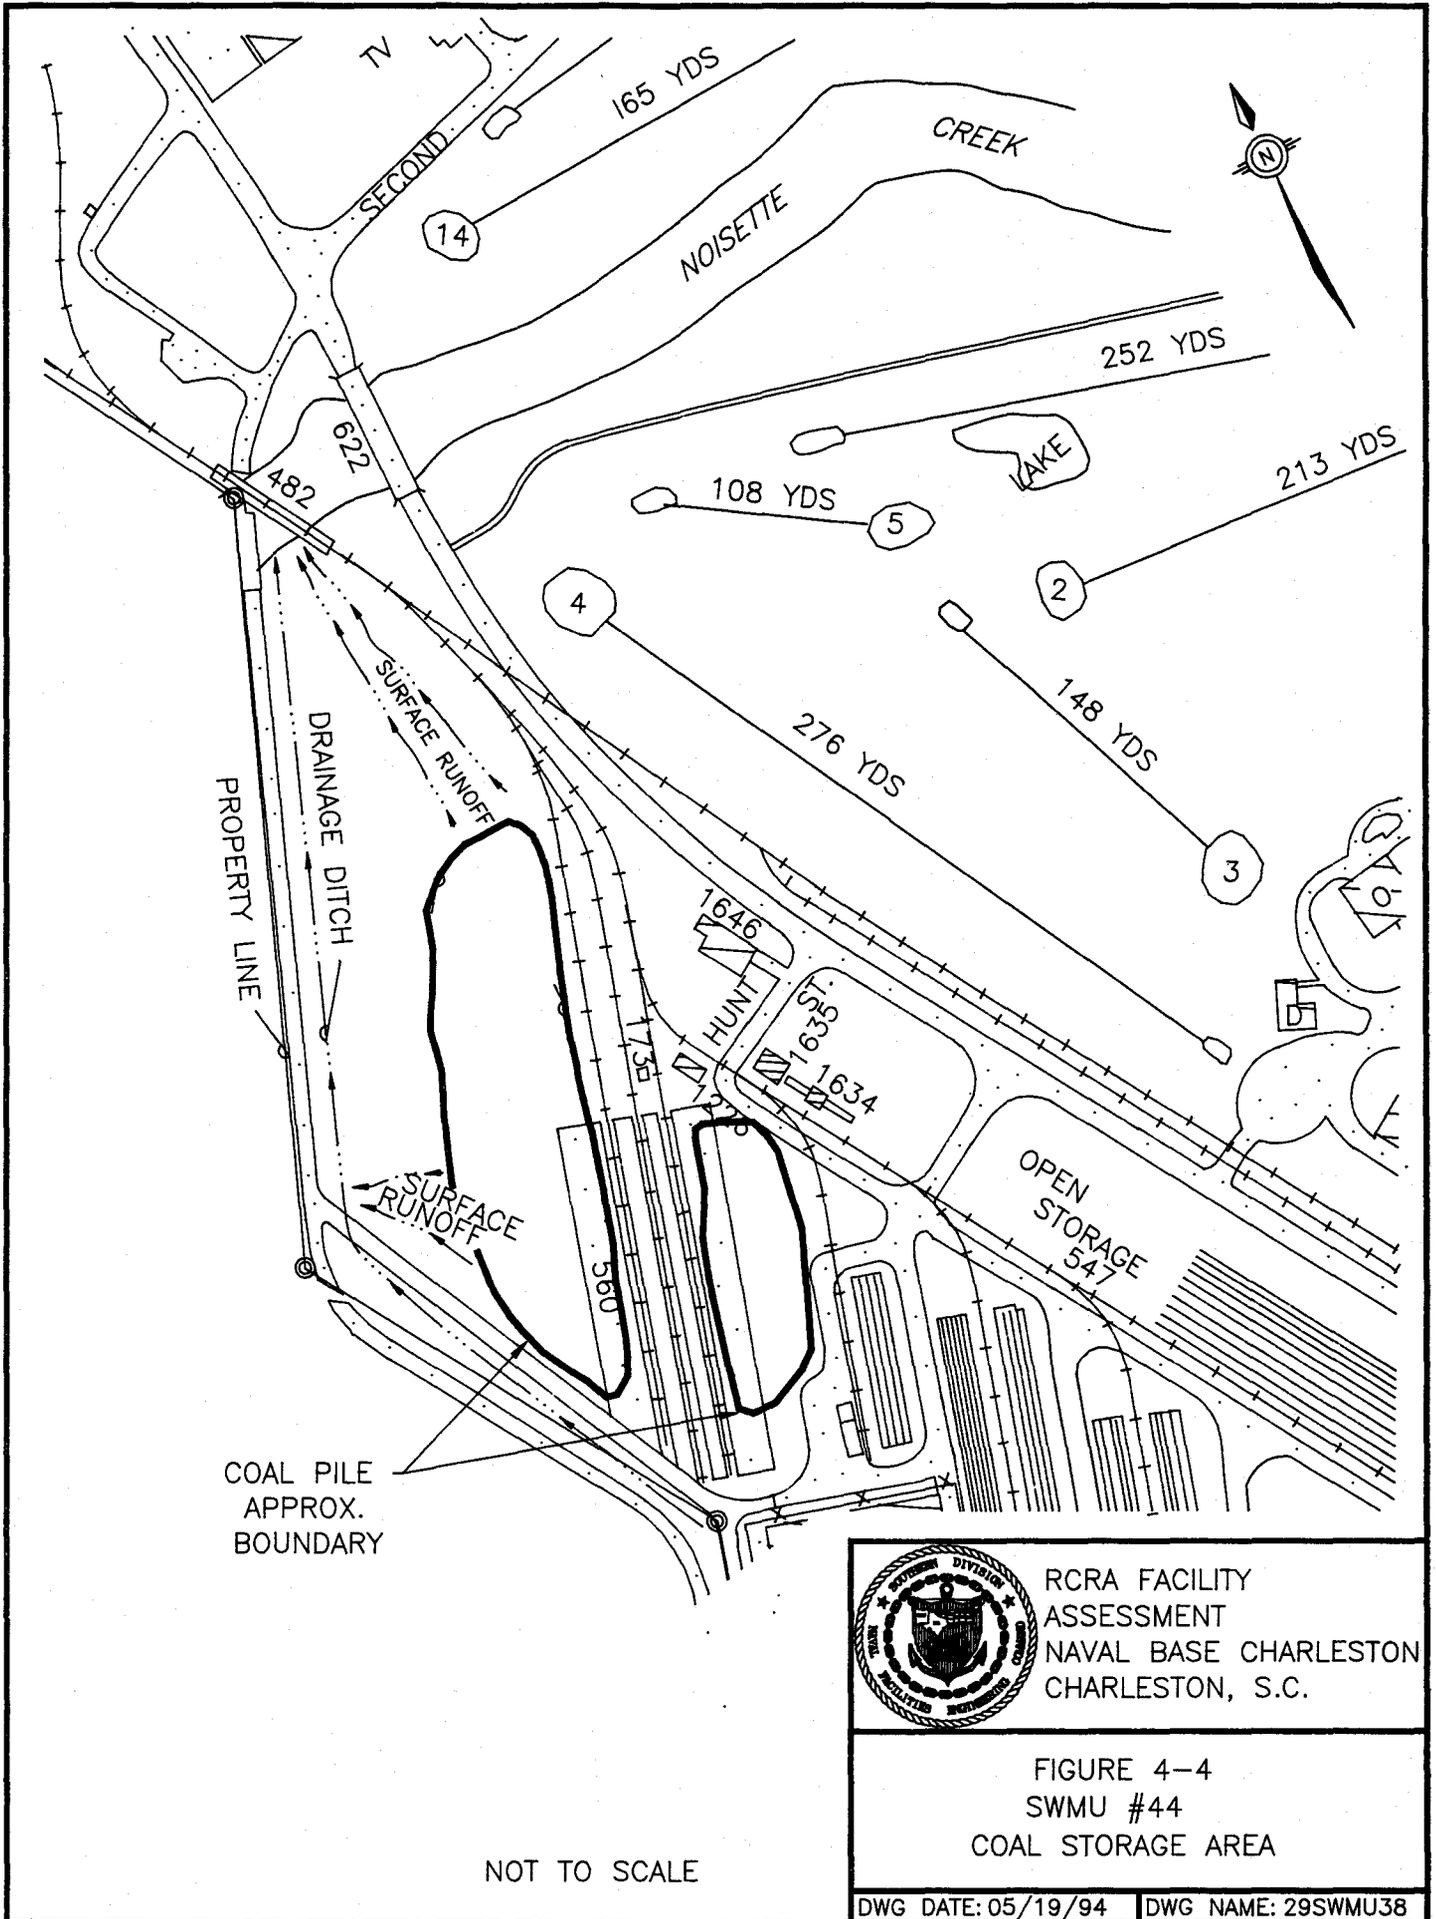
The stored coal itself is not considered hazardous, but rainwater percolating through the coal produces runoff water which has been very acidic (pH average as low as 2.5) and has had elevated total suspended solids and total metals. The pH of the runoff varies with the sulfur content of the coal.

A RCRA Facility Investigation is recommended.

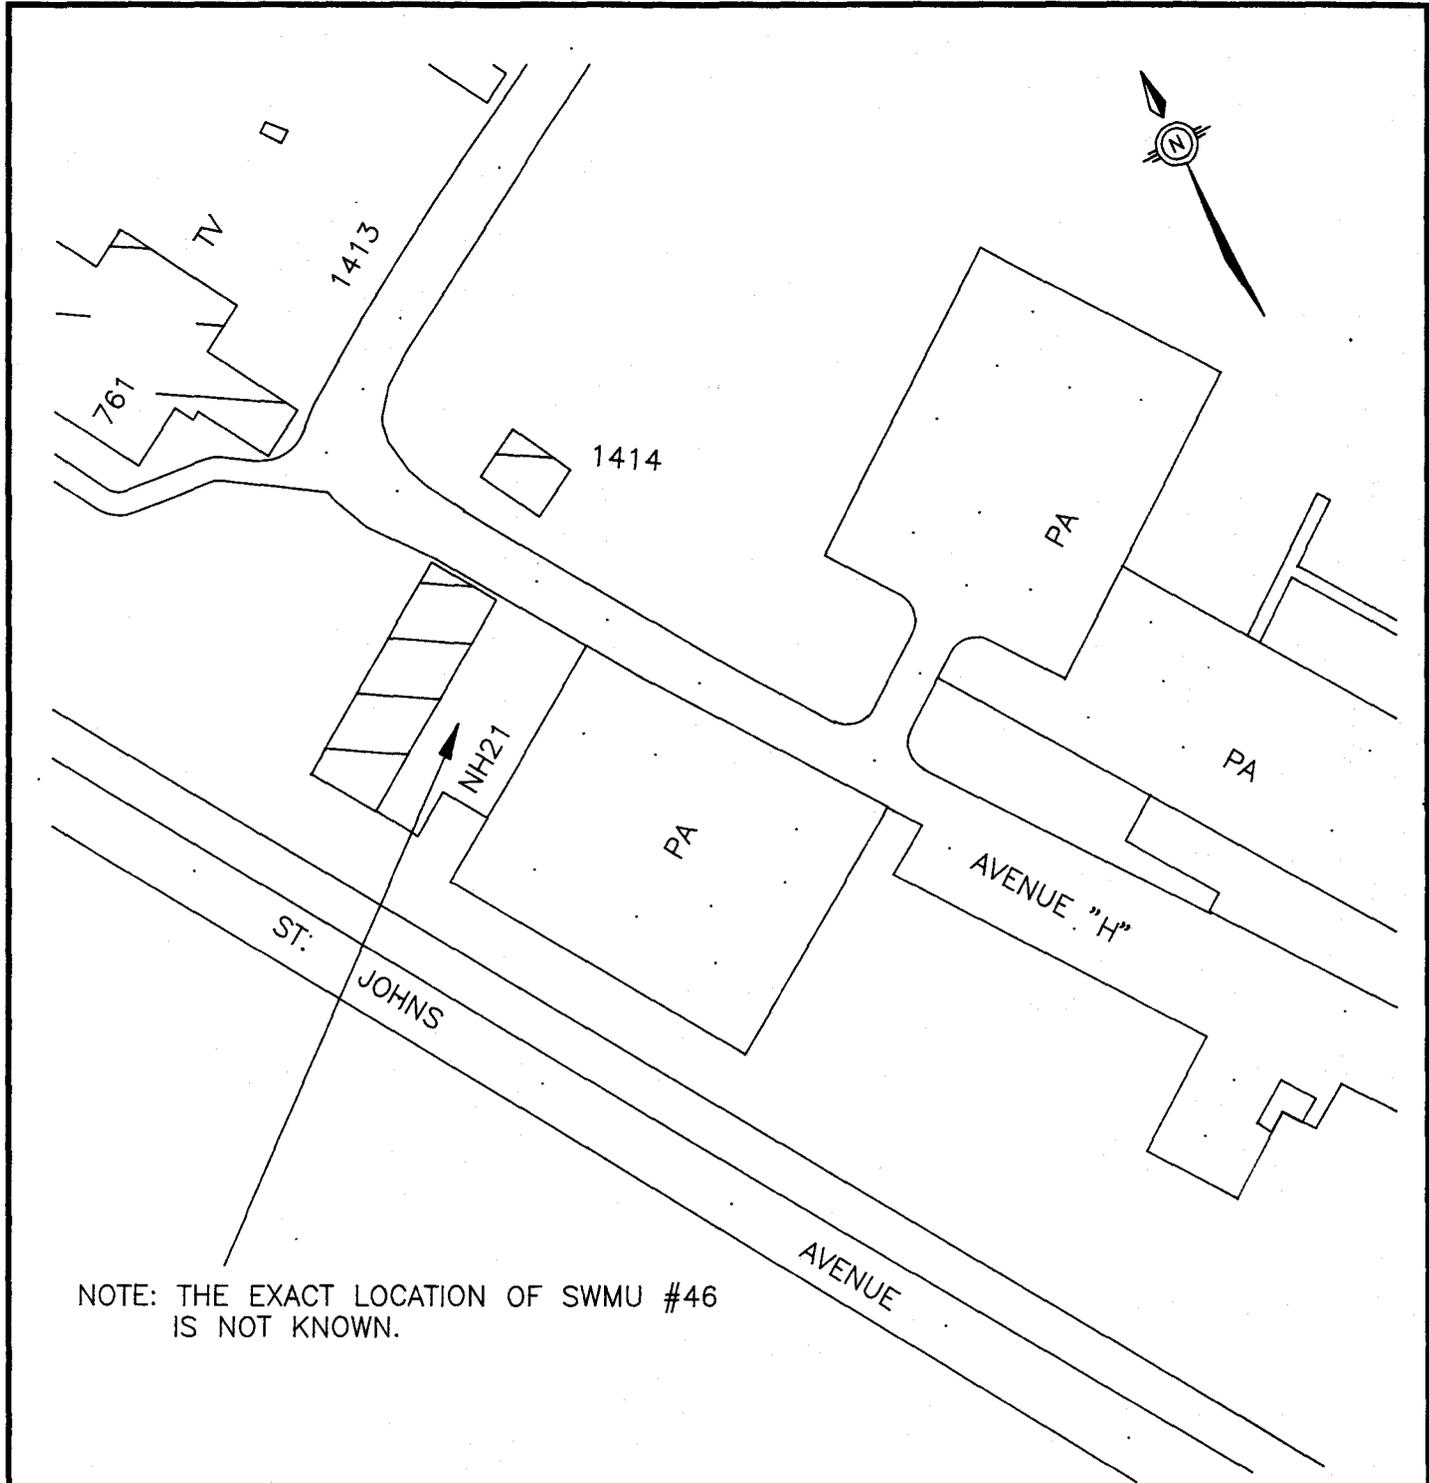
NOTE: THE EXACT LOCATION OF SWMU #46 IS NOT KNOWN.

This SAA is no longer operational. Per 40 CFR 262.34(a)(1), certification of closure is required in accordance with 40 CFR 265.111 and 114.

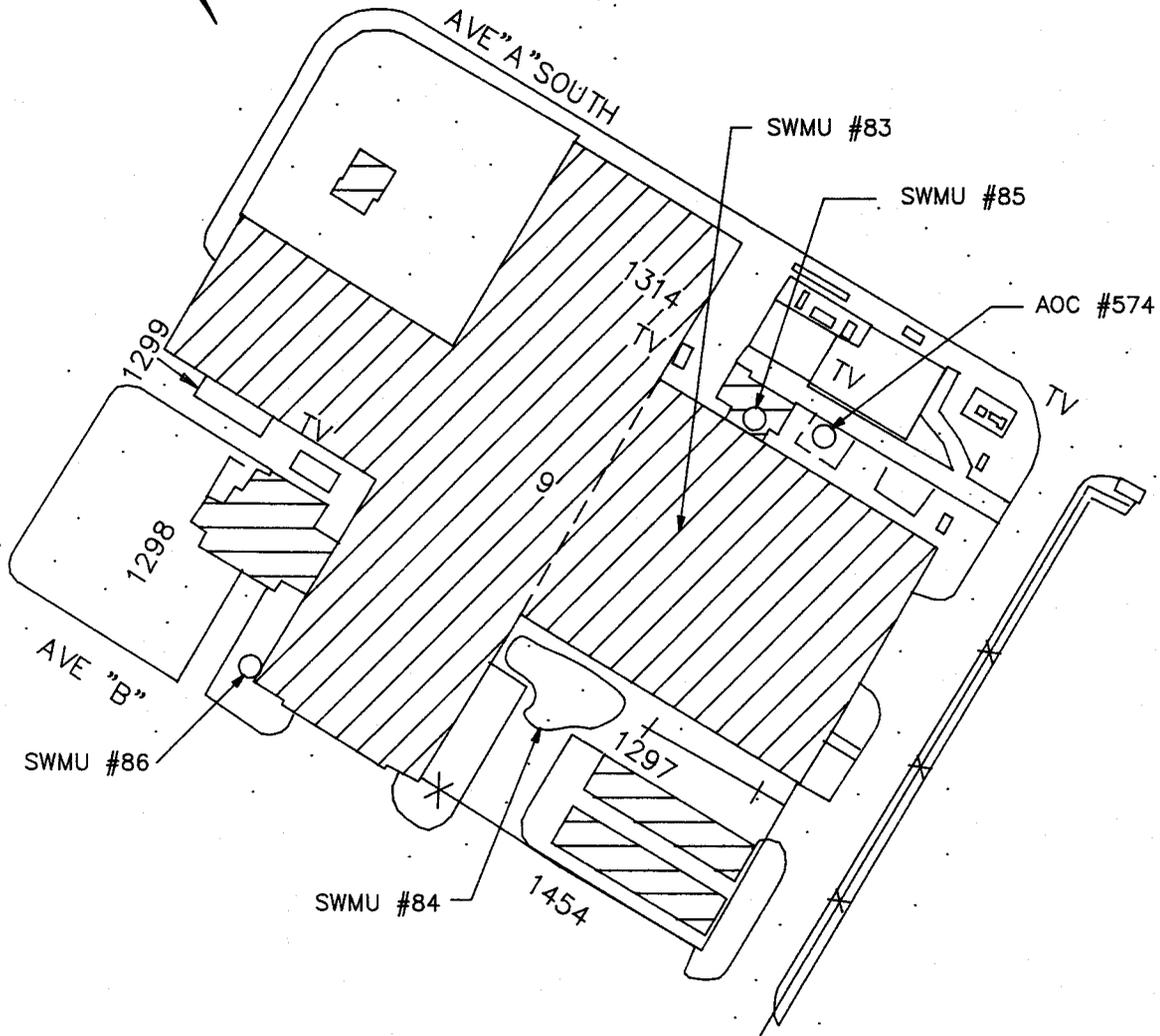
An abandoned oven in the foundry area is posted with a sign indicating that it contains PCBs. An approximately 10 cubic foot pit filled with soot and metal scrap was observed below an electric furnace in the foundry. Electrical panels in the former foundry area are intact. The smoldering pots contain friable asbestos.

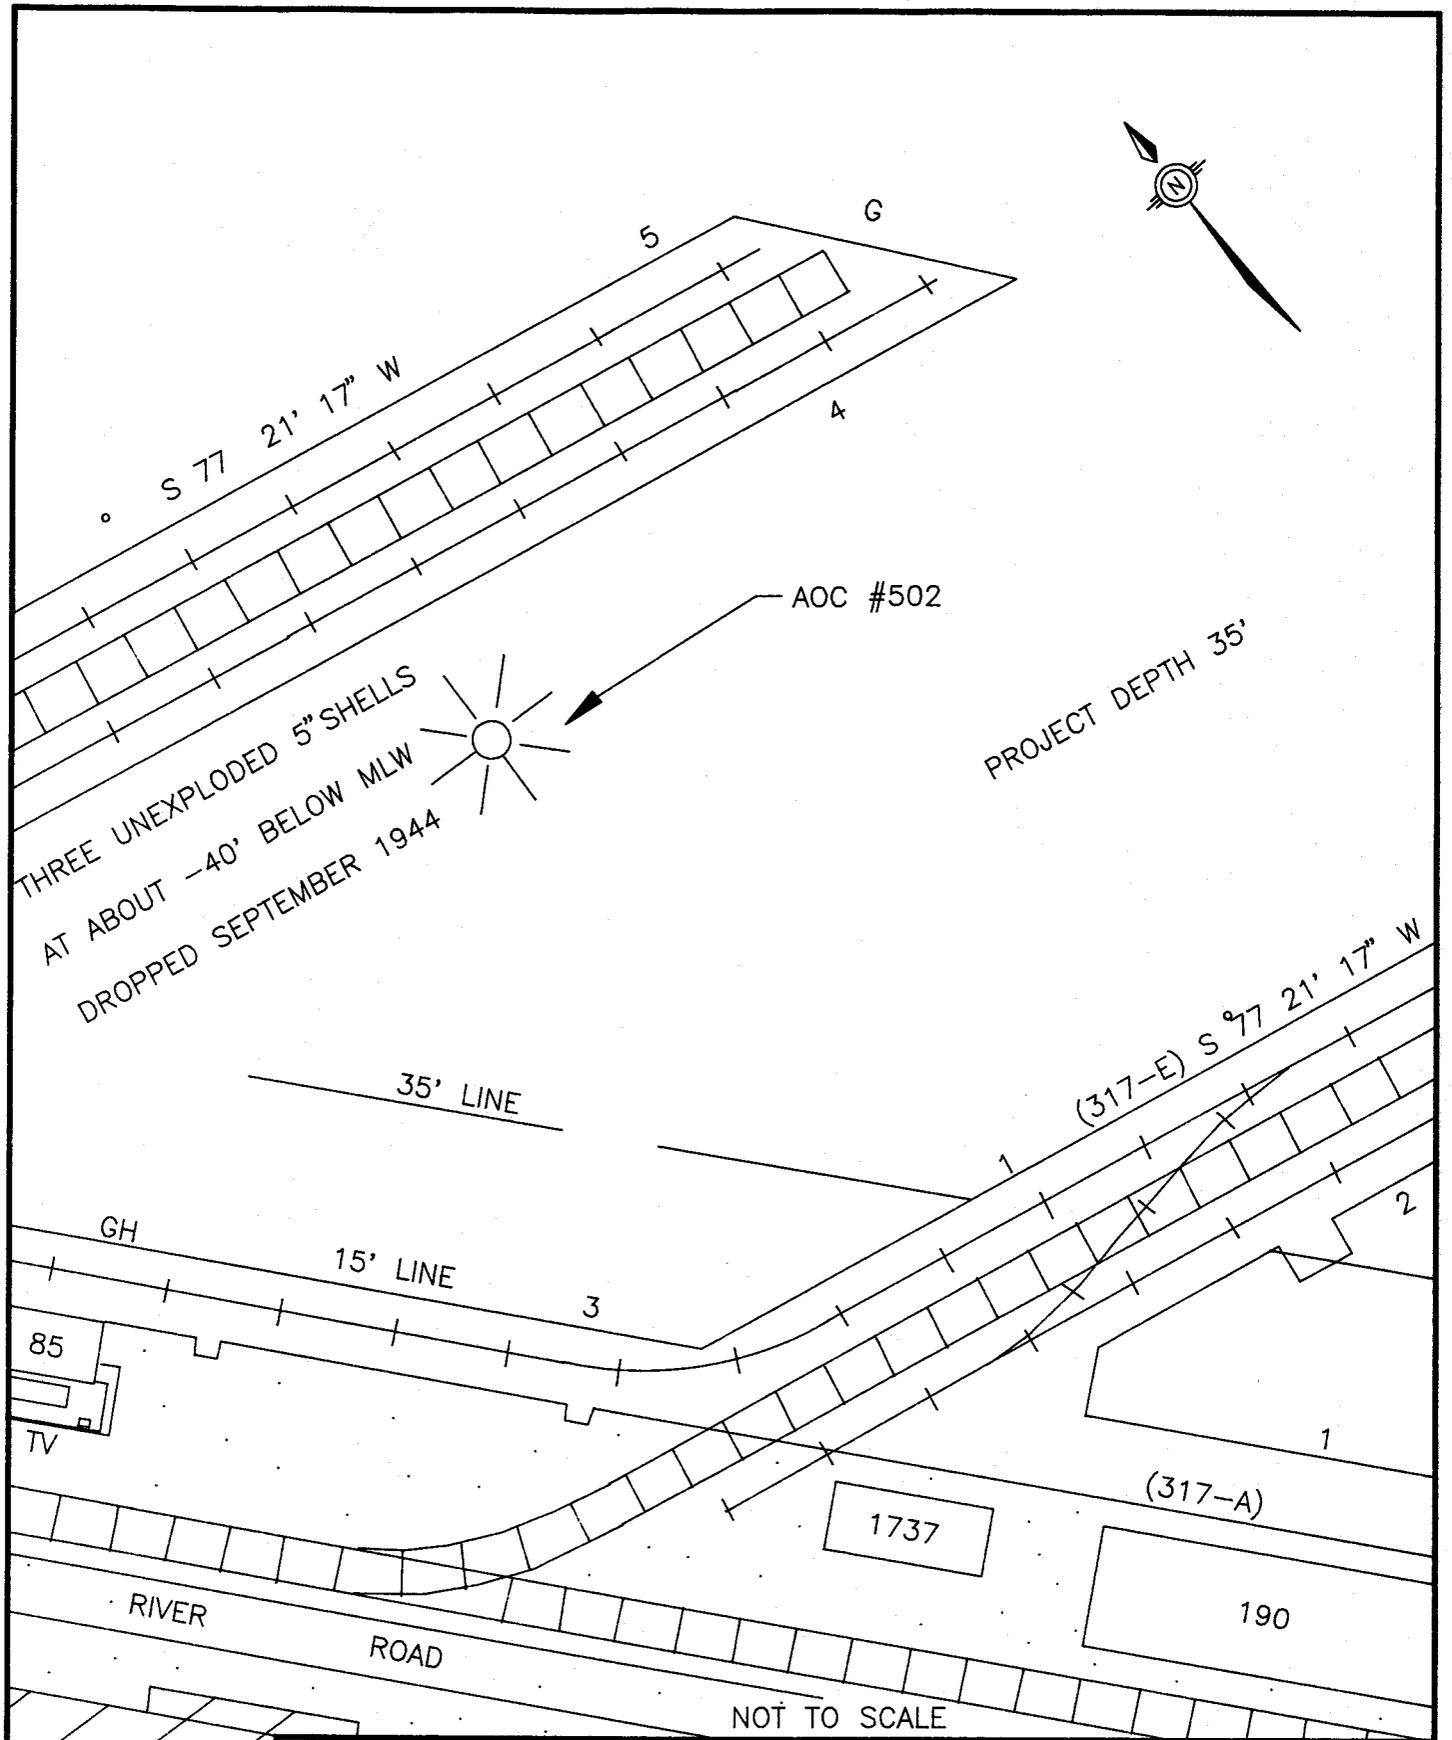
THREE UNEXPLODED 5" SHELLS
 AT ABOUT -40' BELOW MLW
 DROPPED SEPTEMBER 1944
