ABOVE GROUND STORAGE TANK (AST) ASSESSMENT REPORT DATED 9 MARCH 1998
AND NO FURTHER ACTION (NFA) FOR BUILDING 226 ABOVE GROUND STORAGE TANKS
226-1 AND 226-2 (AST 226-1 AND 226-2) WITH SOUTH CAROLINA DEPARTMENT OF
HEALTH AND ENVIRONMENTAL CONTROL REVIEW LE
05/14/1998
SOUTH CAROLINA DEPARTMENT OF HEALTH AND ENVIRONMENTAL CONTROL

Re: Aboveground Storage Tank Assessment Report dated March 9, 1998
Bldg. 226 (AST 226-1/226-2) (Site Identification # 15405-General File)
Charleston Naval Complex/Charleston Naval Base
Charleston, SC
Charleston County

Aboveground Storage Tank (AST) Assessment Report

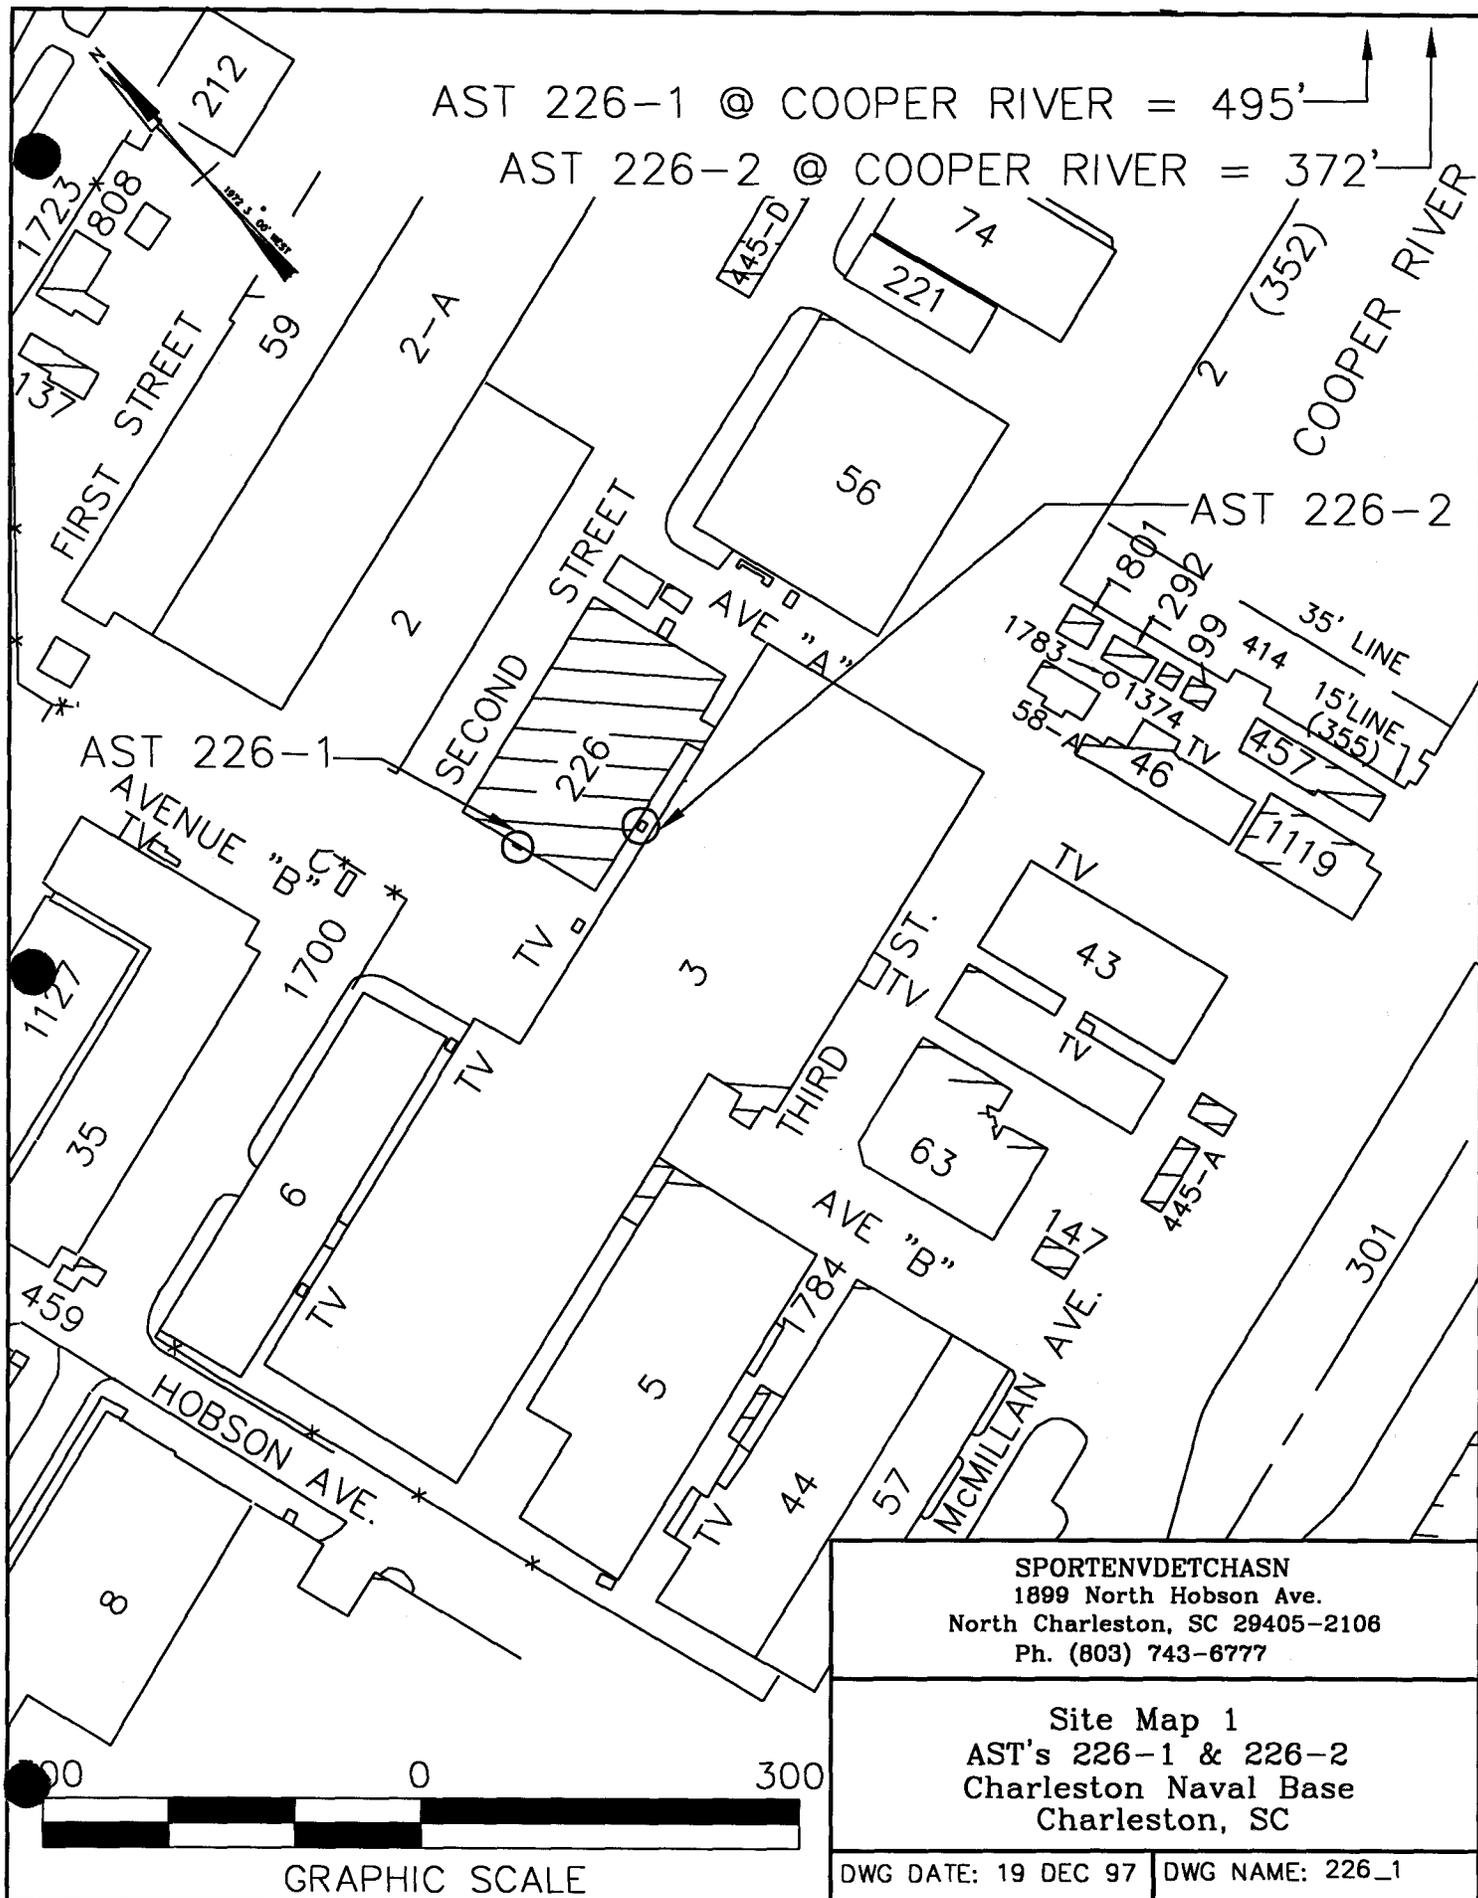
Site Map 1
AST's 226-1 & 226-2
Charleston Naval Base
Charleston, SC

AST 226-1 @ COOPER RIVER = 495'

AST 226-2 @ COOPER RIVER = 372'

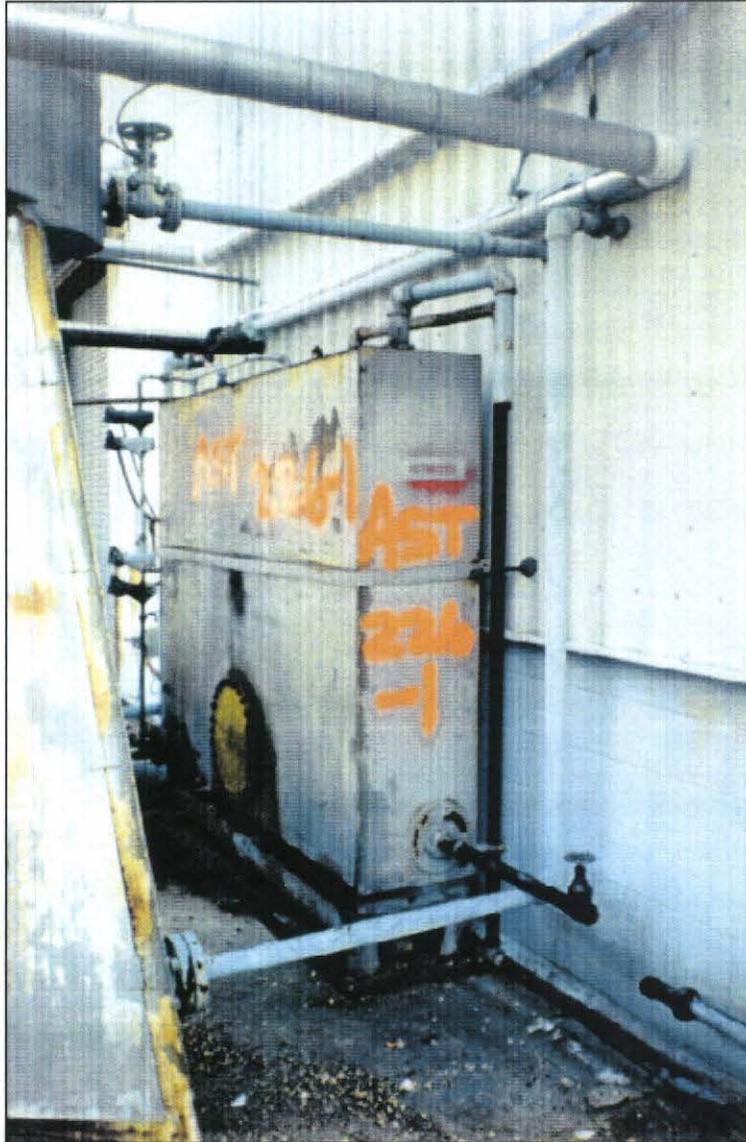
No corrosion, pitting, or holes were found on either AST 226-1 or 226-2.

Photo 1: AST 226-1 prior to removal.

ASTs 226-1 and 226-2 were removed, drained, cut open at both ends, and cleaned with a steam cleaner. They were then cut up for recycling as scrap metal. (See Attachment III.)

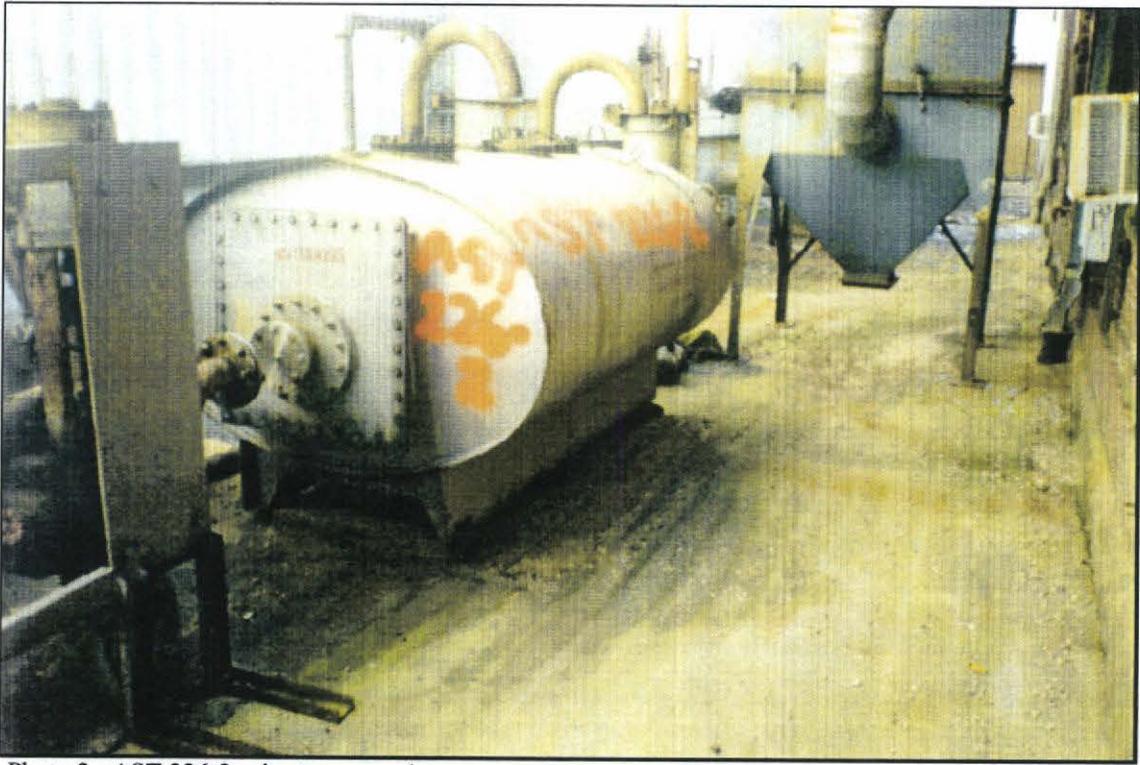
Photo 2: AST 226-2 prior to removal.
