LETTER REGARDING SOUTH CAROLINA DEPARTMENT OF HEALTH AND
ENVIRONMENTAL CONTROL REVIEW OF ASSESSMENT REPORT DATED 17 OCTOBER
1996 FOR BUILDING 9 ABOVE GROUND STORAGE TANK 9B AND 9C (AST 9B AND 9C)
CNC CHARLESTON SC
12/31/1996
SOUTH CAROLINA DEPARTMENT OF HEALTH AND ENVIRONMENTAL CONTROL

Re: Assessment Report dated October 17, 1996
Charleston Naval Base Building # 9 AST 9B/9C (Site Identification # 17684)
Charleston County

ASSESSMENT REPORT
AST 9B & 9C
NAVAL BASE CHARLESTON
CHARLESTON SC

Aboveground Storage Tank (AST) Assessment Report

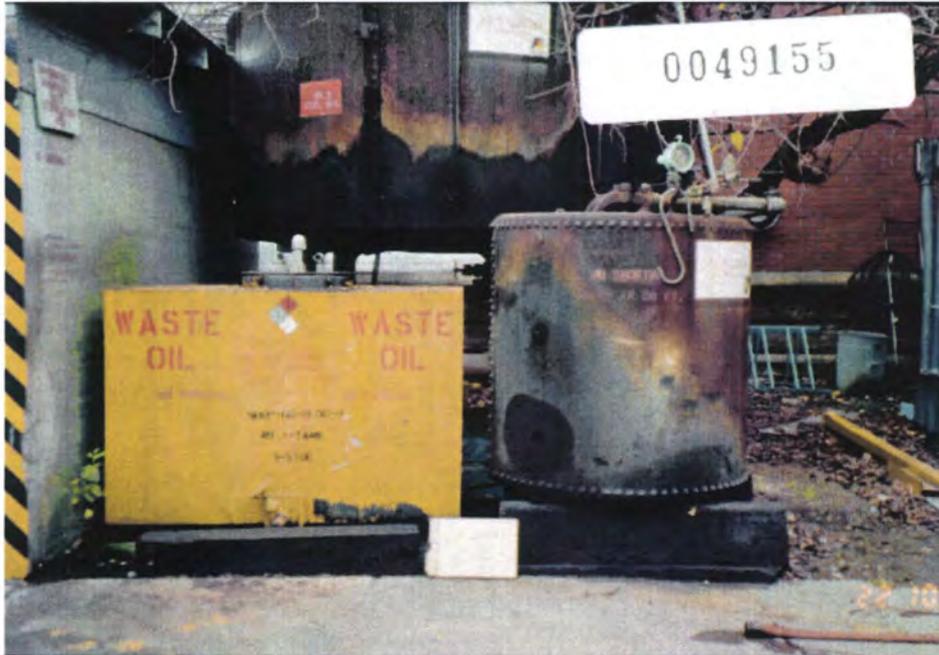
Photo 1: Building 9 waste oil tank, AST 9C, and AST 9B from left to right. This photo was taken before the waste oil tank was removed, prior to base closure.

Building 9 is located inside the Controlled Industrial Area of the Charleston Naval Shipyard. ASTs 9B and 9C provided #2 fuel oil to Building 9's foundry furnaces and torches. This location is designated as Area of Concern (AOC) #574 in the Naval Base Resource Conservation and Recovery Act (RCRA) Facility Assessment. The site also contained a waste oil tank which was removed prior to base closure. See photograph, Attachment I.

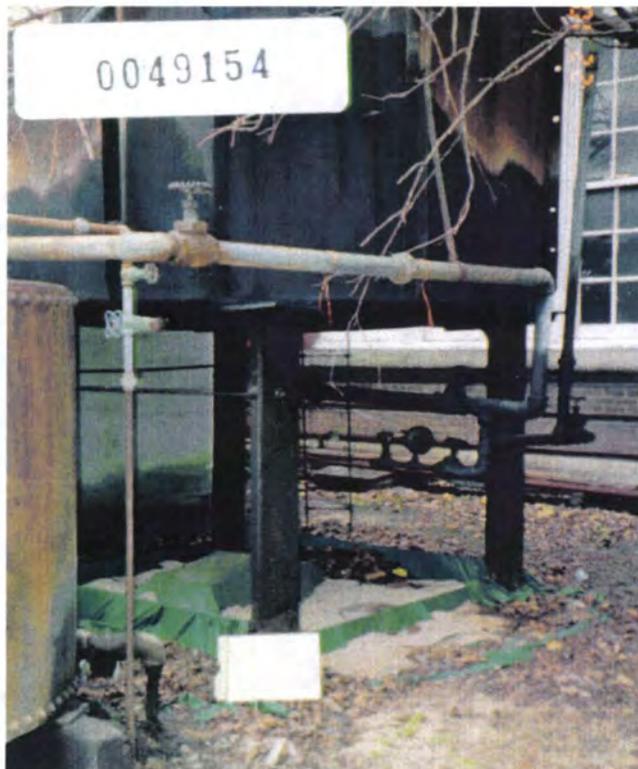
Photo 2: ASTs 9B and 9C, taken prior to base closure.

The ASTs were in poor condition. Oil was leaching out of the sides of the tanks. See photographs in Attachment I.

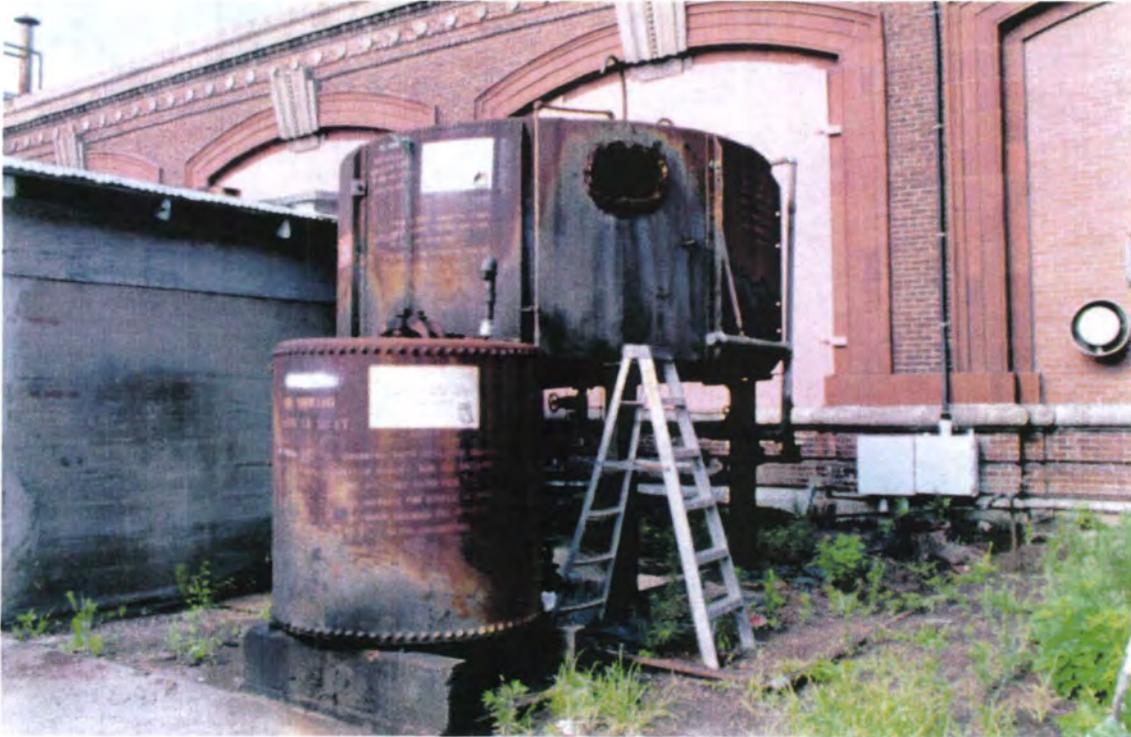
Photo 3: ASTs 9B and 9C, taken prior to removal.

The condition of the tanks and the available documentation support the conclusion that the tanks had been leaking for many years. Prior to base closure, Public Works planned to replace ASTs 9B and 9C because of their poor condition.

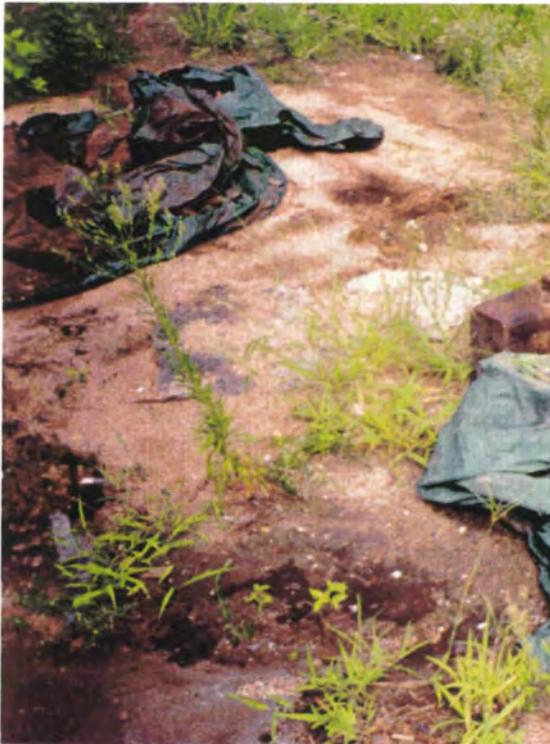
A. Were any petroleum-stained or contaminated soils found near the AST?	X		
B. Were any petroleum odors detected? If yes, indicate location on site map and describe the odor (strong, mild, etc.) [*mild, from contaminated soil beneath ASTs]	*X

Photo 4: AST 9B foundation soil staining.

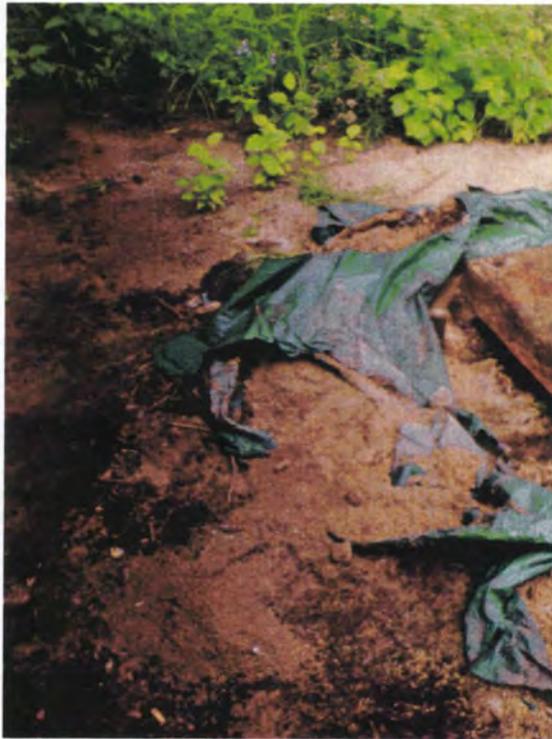
Photo 5: AST 9C foundation soil staining.
