UNDERGROUND STORAGE TANK (UST) ASSESSMENT REPORT FOR QUARTERS N CNC
CHARLESTON SC
04/27/1998
SOUTH CAROLINA DEPARTMENT OF HEALTH AND ENVIRONMENTAL CONTROL

South Carolina Department of Health and Environmental Control (S.C.D.H.E.C.)
Underground Storage Tank (UST) Assessment Report

Facility Name: Charleston Naval Base Complex, Housing Quarters N

Site Map 1
 UST Quarters N
 Charleston Naval Base
 Charleston, SC

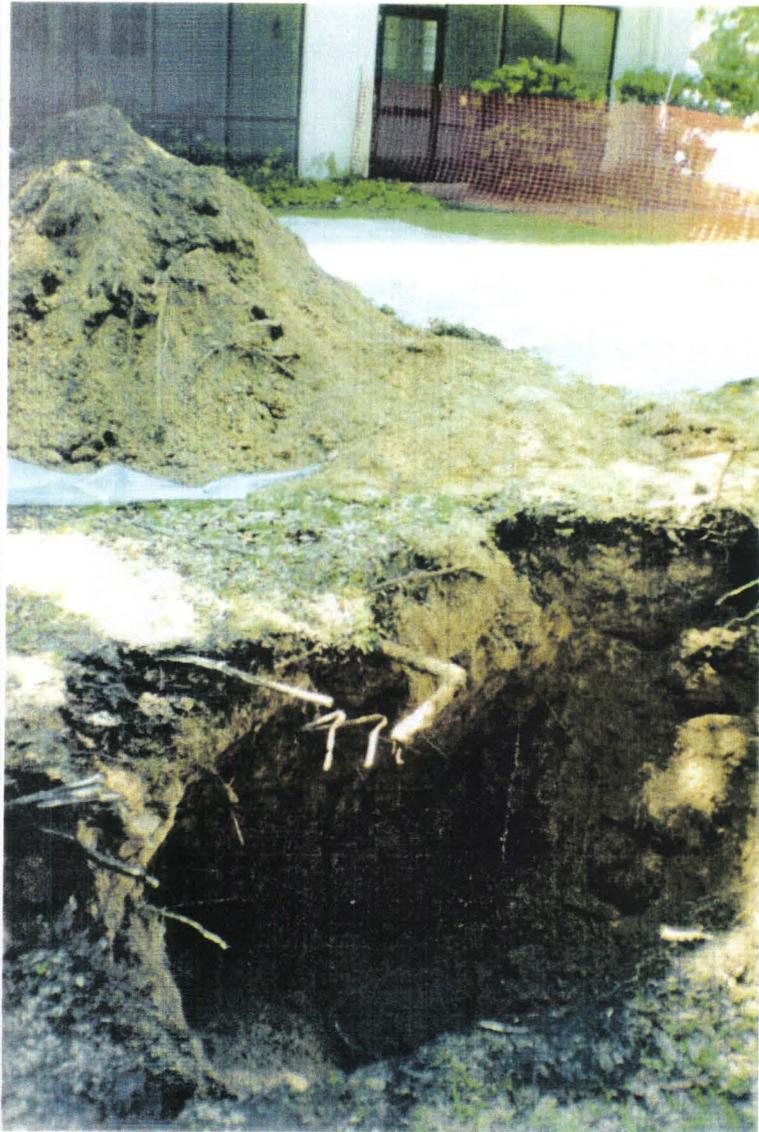
Photo 1: UST Quarters N excavation. The steel ventilation and copper supply and return piping are in the center of the photo. This photo was taken before the piping was removed

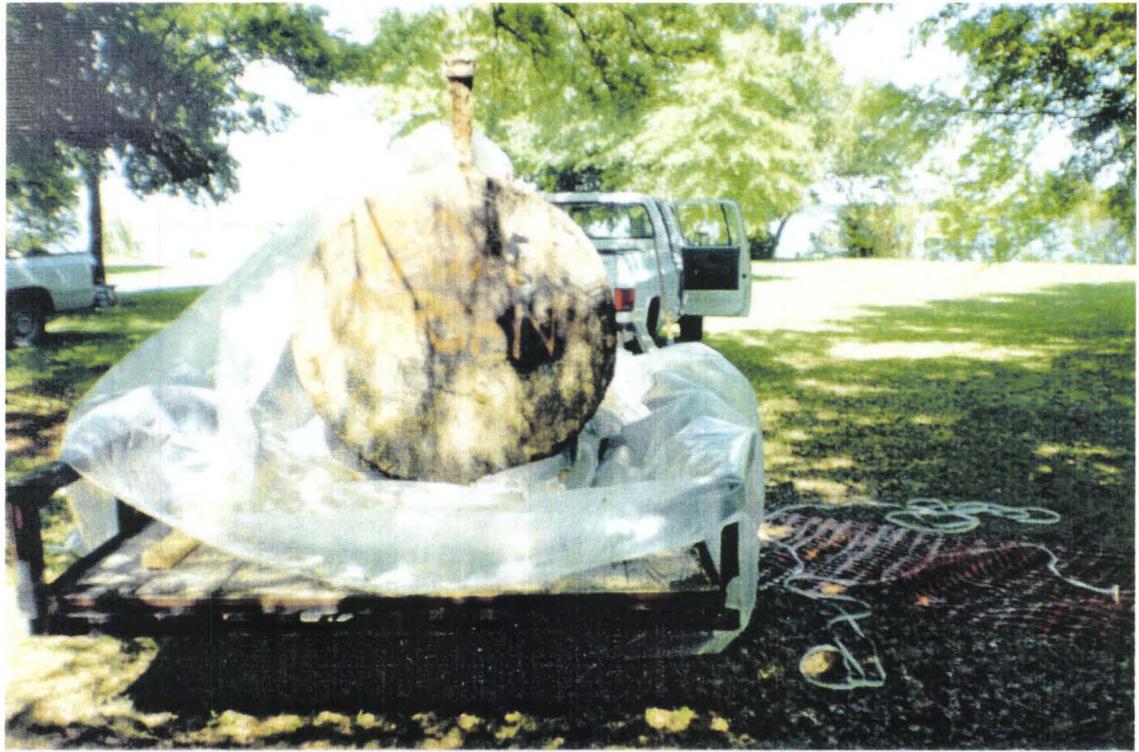
UST Quarters N was covered with a protective coating of pitch. The tank was in good condition. Patches of corrosion were present, but no holes or pitting were found.

Photo 2: UST Quarters N being readied for transport to the cutting and cleaning pad.

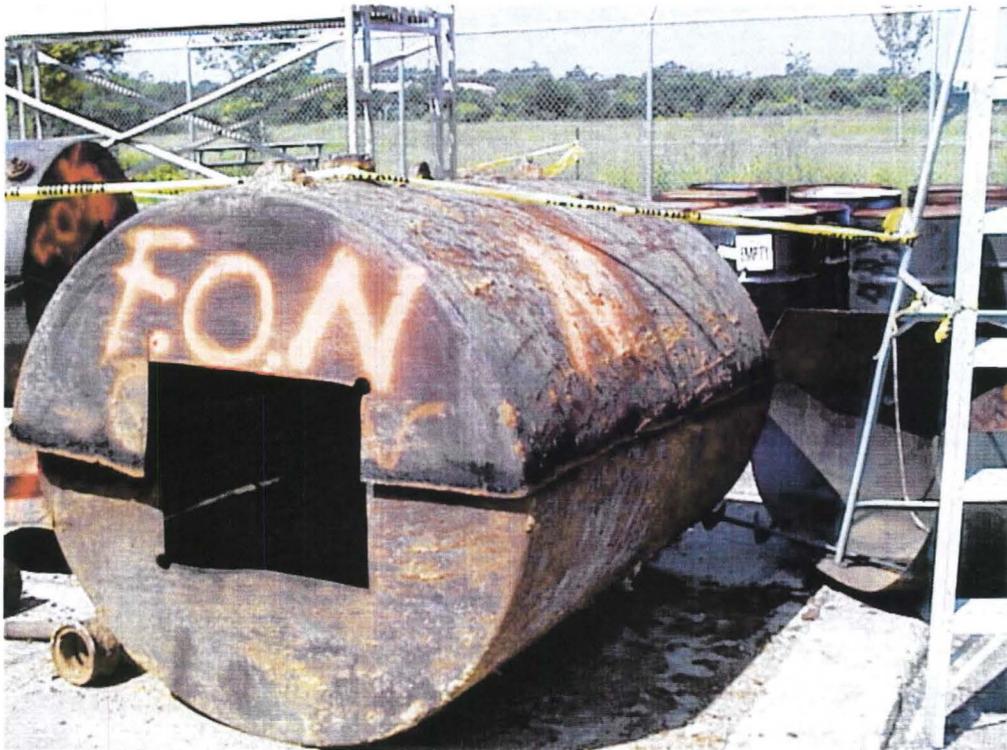
Photo 3: UST Quarters N after cleaning and cutting.

UST Quarters N was removed, drained, cut open at both ends, and cleaned with a steam cleaner. It was then cut up for recycling as scrap metal. (See Attachment III.)

The tank was cut open on both ends, cleaned with a steam cleaner, and disposed of as recyclable scrap metal.
