UNDERGROUND STORAGE TANK (UST) ASSESSMENT REPORT FOR UST 56 CNC
CHARLESTON SC
09/03/1996
ENVIRONMENTAL DETACHMENT CHARLESTON

UST ASSESSMENT REPORT
UST 56
NAVAL BASE CHARLESTON
CHARLESTON SC

South Carolina Department of Health and Environmental Control (S.C.D.H.E.C.)
Underground Storage Tank (UST) Assessment Report

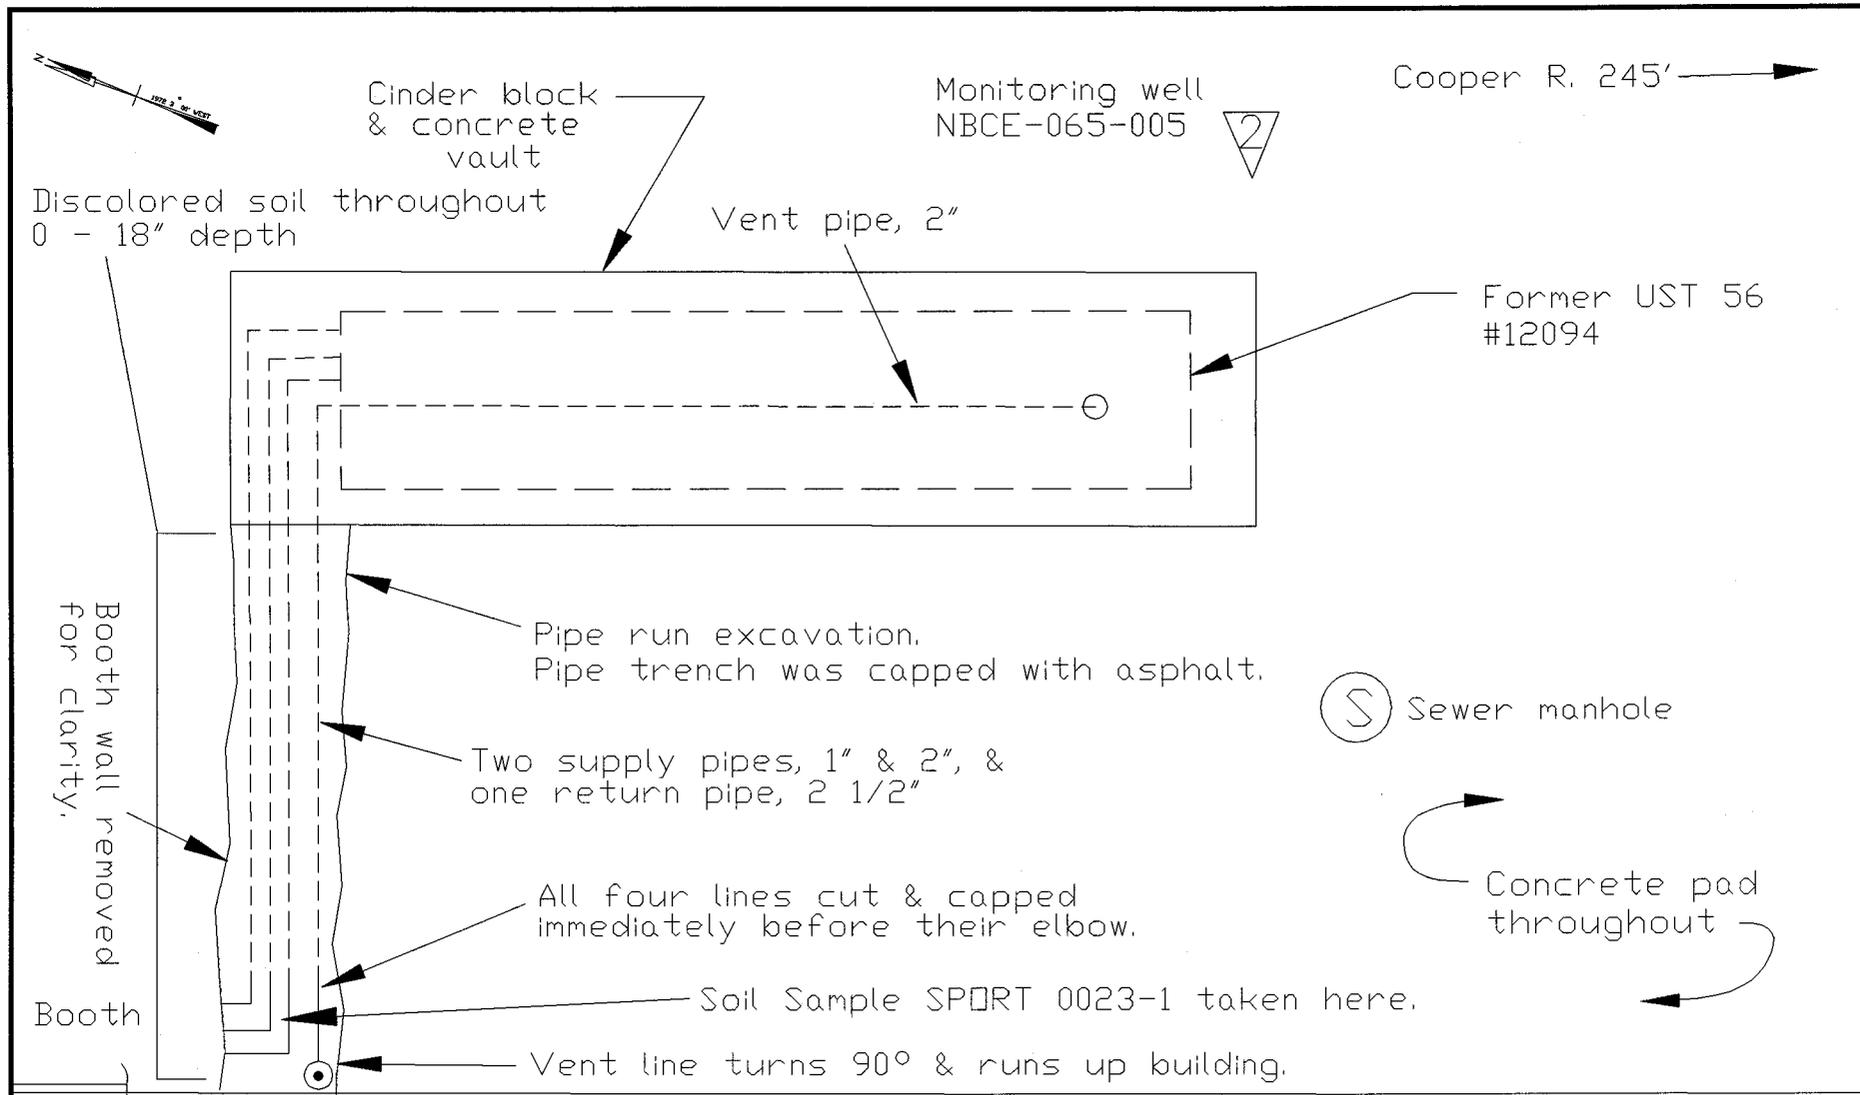
Figure: Site Map 2
 UST Bldg 56
 Charleston Naval Shipyard
 Charleston, SC

The booth adjacent to the pipe run housed the fuel pump for UST 56. Evidence indicates that this pump leaked, making it the most probable source of the contamination found in the pipe run excavation.

No soil samples were taken from beneath UST Bldg 56 because the tank rested in a concrete vault. A soil sample was taken from beneath the piping as indicated on Site Map 2. Sampling was performed in accordance with SC DHEC R.61-92 Part 280 and SC DHEC UST Assessment Guidelines.

Cinder block & concrete vault

Former UST 56
#12094

Pipe run excavation

Booths Leaky suction pump.

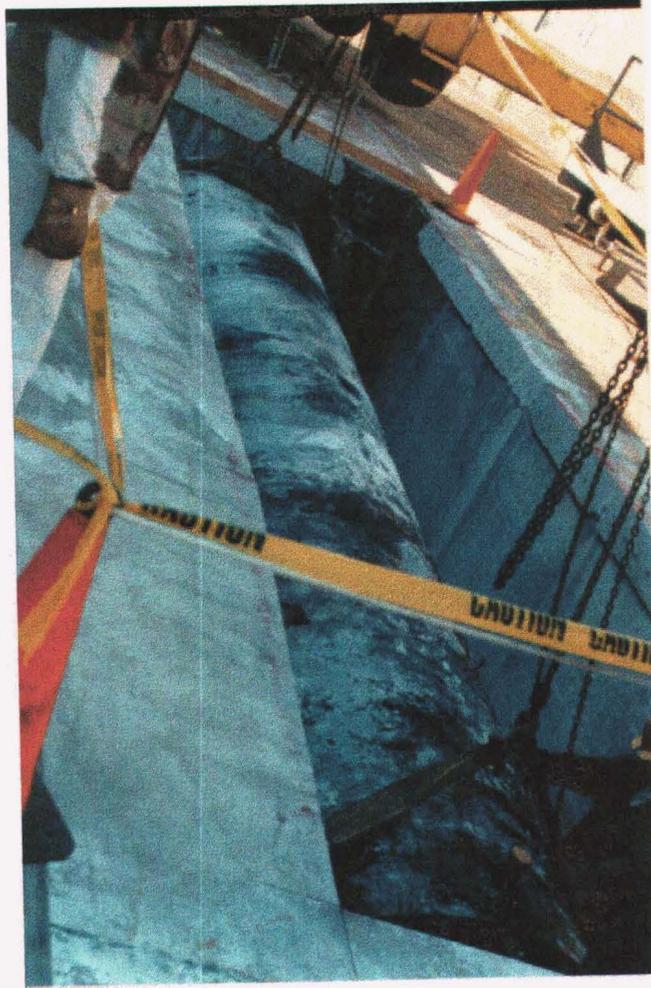
The entire UST was coated in rust. The rust, however, had no appreciable depth or pitting, and the tank had no holes or leaks.

UST 56 IN VAULT

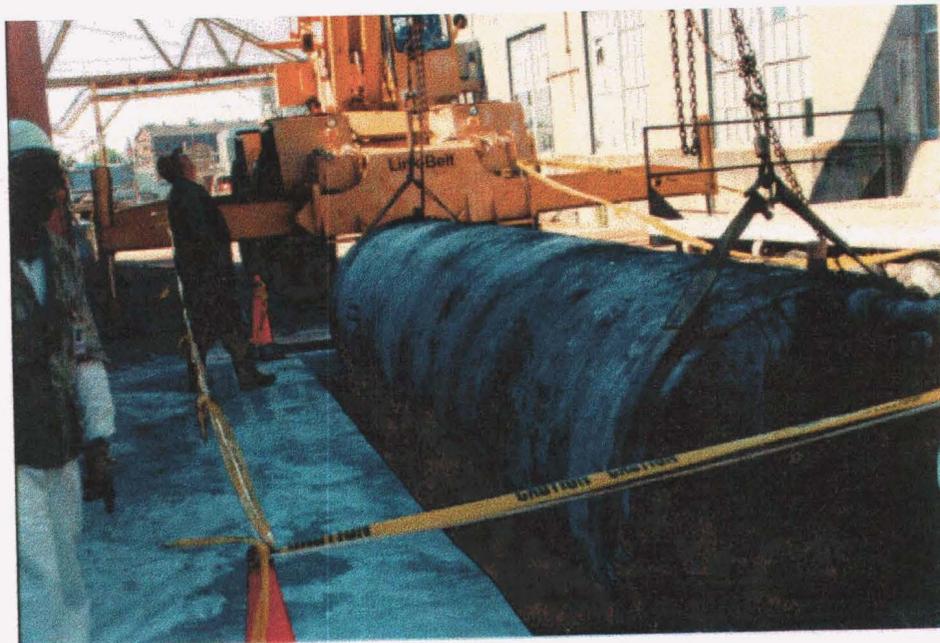
The UST was removed from its vault, drained and cleaned. It was then cut up for recycling as scrap metal. See Attachment III.

UST 56 RIGGING AND REMOVAL
