UNDERGROUND STORAGE TANK (UST) ASSESSMENT REPORT DATED 22 MAY 1998  
AND NO FURTHER ACTION (NFA) FOR QUARTERS J WITH SOUTH CAROLINA  
DEPARTMENT OF HEALTH AND ENVIRONMENTAL CONTROL REVIEW LETTER CNC  
CHARLESTON SC  
07/14/1998  
NAVFAC SOUTHERN

Re: Underground Storage Tank Assessment Report dated 22 May 1998  
Quarters "J" Housing (Site Identification # 15405-General File)  
Charleston Naval Complex/Charleston Naval Base  
Charleston, SC  
Charleston County

South Carolina Department of Health and Environmental Control (S.C.D.H.E.C.)  
Underground Storage Tank (UST) Assessment Report

Site Map 1  
 UST Quarters J  
 Charleston Naval Base  
 Charleston, SC

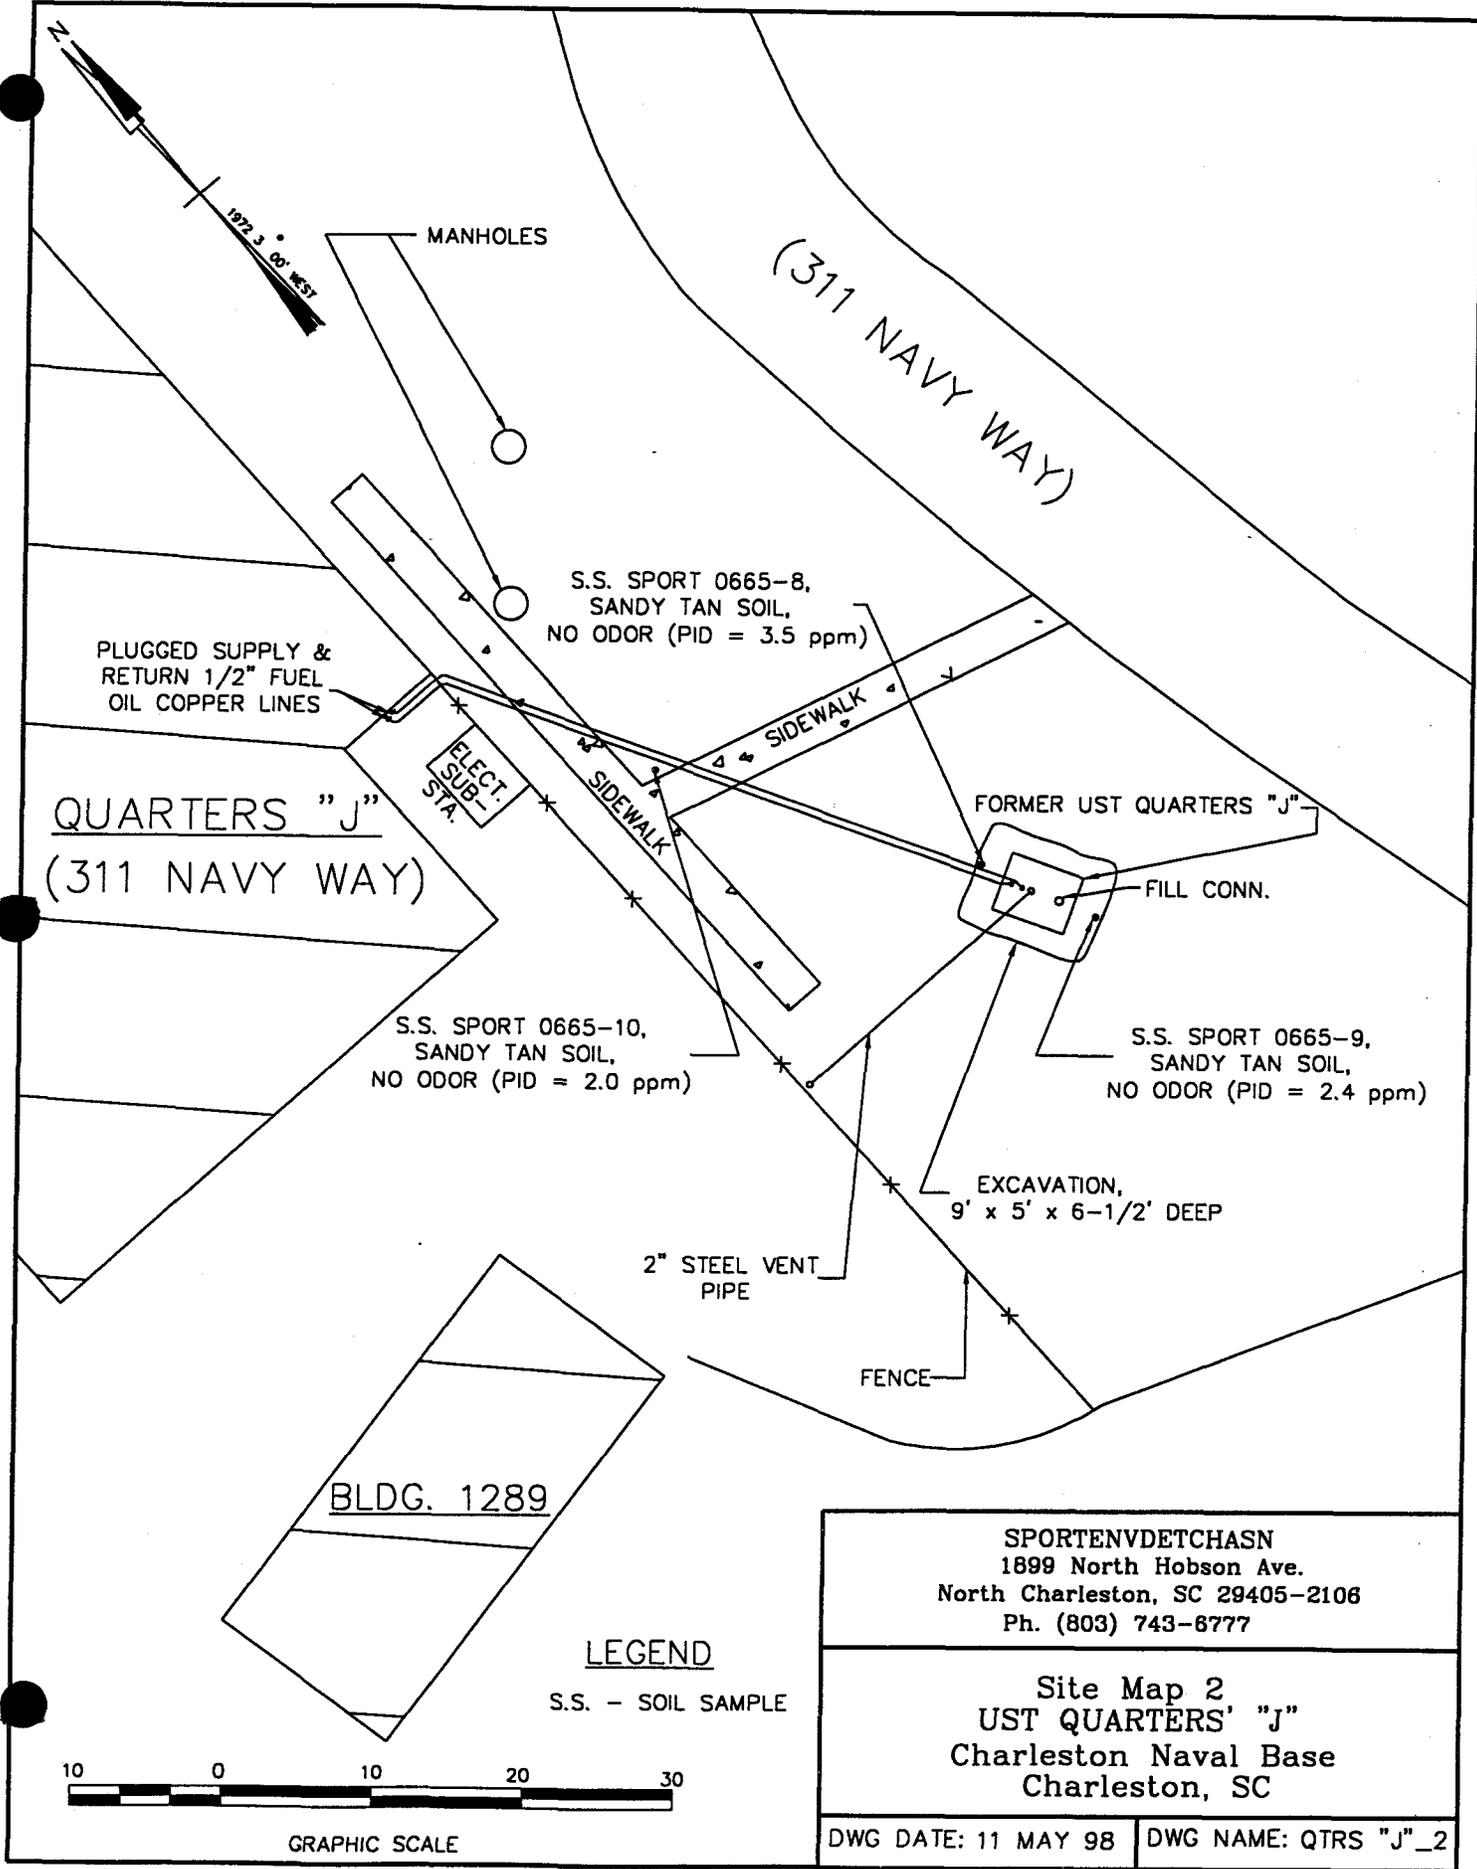
Site Map 2  
UST QUARTERS' "J"  
Charleston Naval Base  
Charleston, SC

S.S. SPORT 0665-8,  
SANDY TAN SOIL,  
NO ODOR (PID = 3.5 ppm)

PLUGGED SUPPLY &  
RETURN 1/2" FUEL  
OIL COPPER LINES

S.S. SPORT 0665-10,  
SANDY TAN SOIL,  
NO ODOR (PID = 2.0 ppm)

S.S. SPORT 0665-9,  
SANDY TAN SOIL,  
NO ODOR (PID = 2.4 ppm)

EXCAVATION,  
9' x 5' x 6-1/2' DEEP

2" STEEL VENT  
PIPE

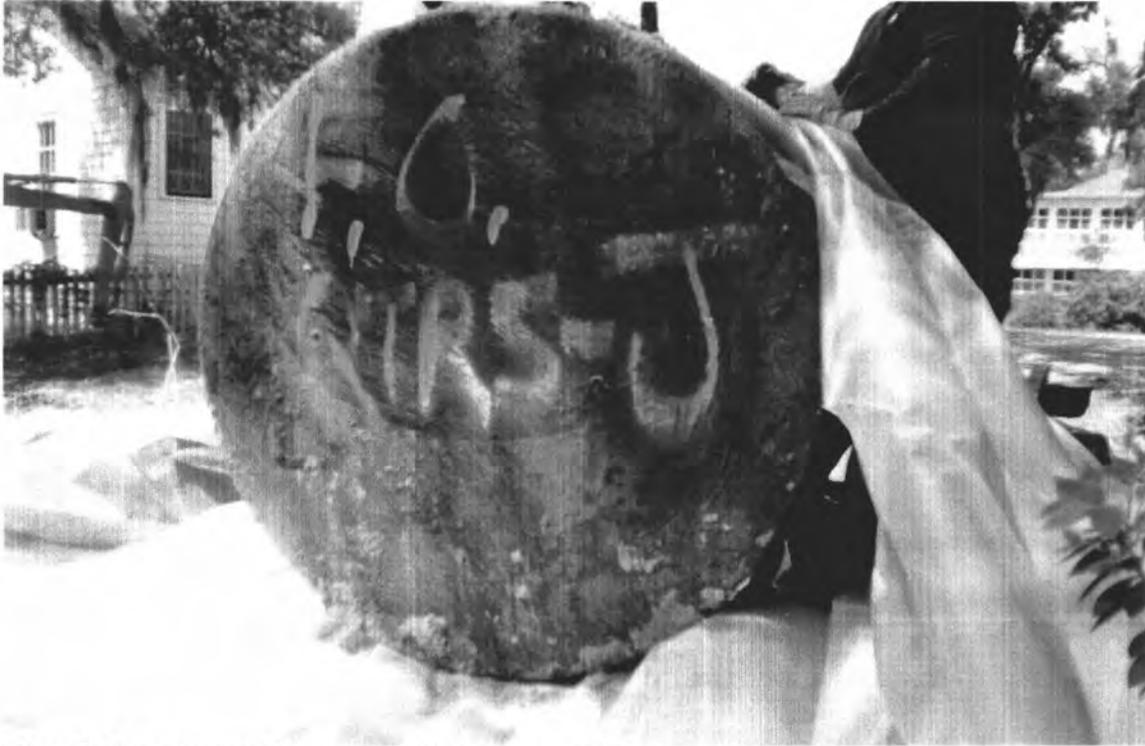
UST Quarters J was covered with a protective coating of pitch. The tank was in good condition. It had only patches of surface corrosion.

Photo 1: UST Quarters J being readied for transport to the cutting and cleaning pad.

UST Quarters J was removed, drained, cut open at both ends, and cleaned with a steam cleaner. It was then cut up for recycling as scrap metal. (See Attachment III.)

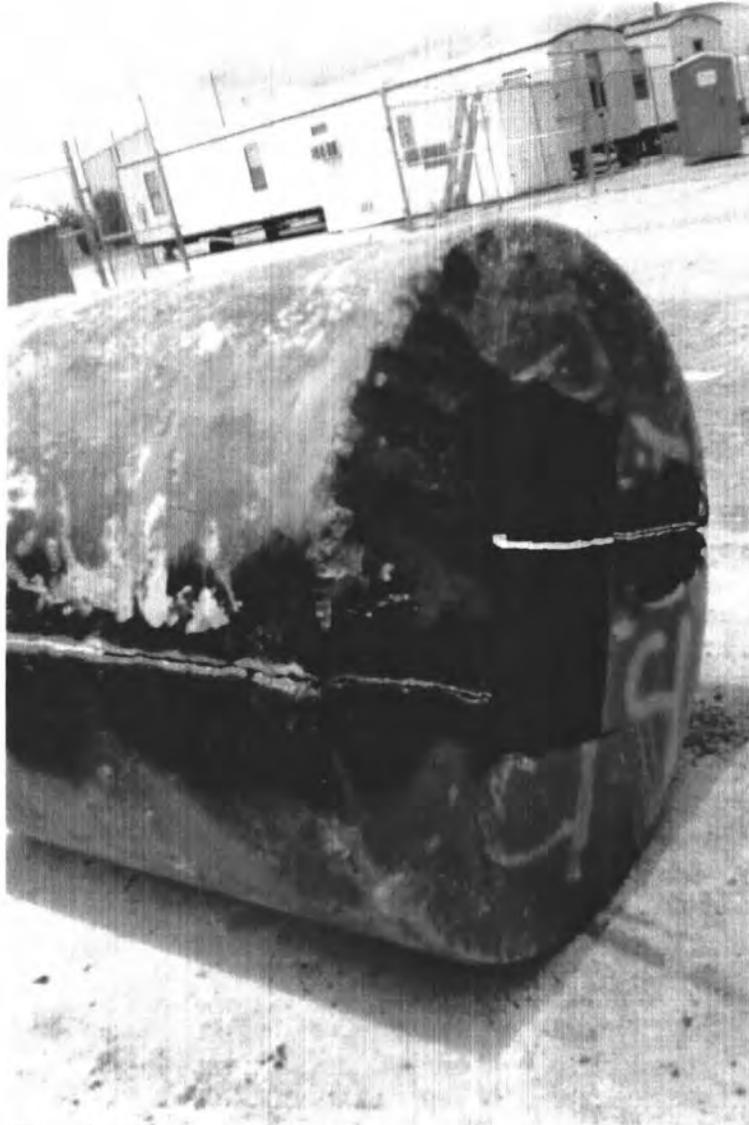
Photo 2: UST Quarters J after cutting and cleaning.
