UNDERGROUND STORAGE TANK (UST) ASSESSMENT REPORT DATED 19 OCTOBER
1998 FOR BUILDING 224 WITH SOUTH CAROLINA DEPARTMENT OF HEALTH AND
ENVIRONMENTAL CONTROL REVIEW LETTER CNC CHARLESTON SC
12/07/1998
NAVFAC SOUTHERN

Re: Underground Storage Tank Assessment Report dated 19 October 1998
Building 224 (Site Identification # 15405-General File)
Charleston Naval Complex/Charleston Naval Base
Charleston, SC
Charleston County

South Carolina Department of Health and Environmental Control (S.C.D.H.E.C.)
Underground Storage Tank (UST) Assessment Report

Site I.D. #:	Unregulated		
Facility Name:	Charleston Naval Base Complex, Building 224		
Street Address:	Hobson Avenue		
City:	North Charleston, 29405-2413	County:	Charleston

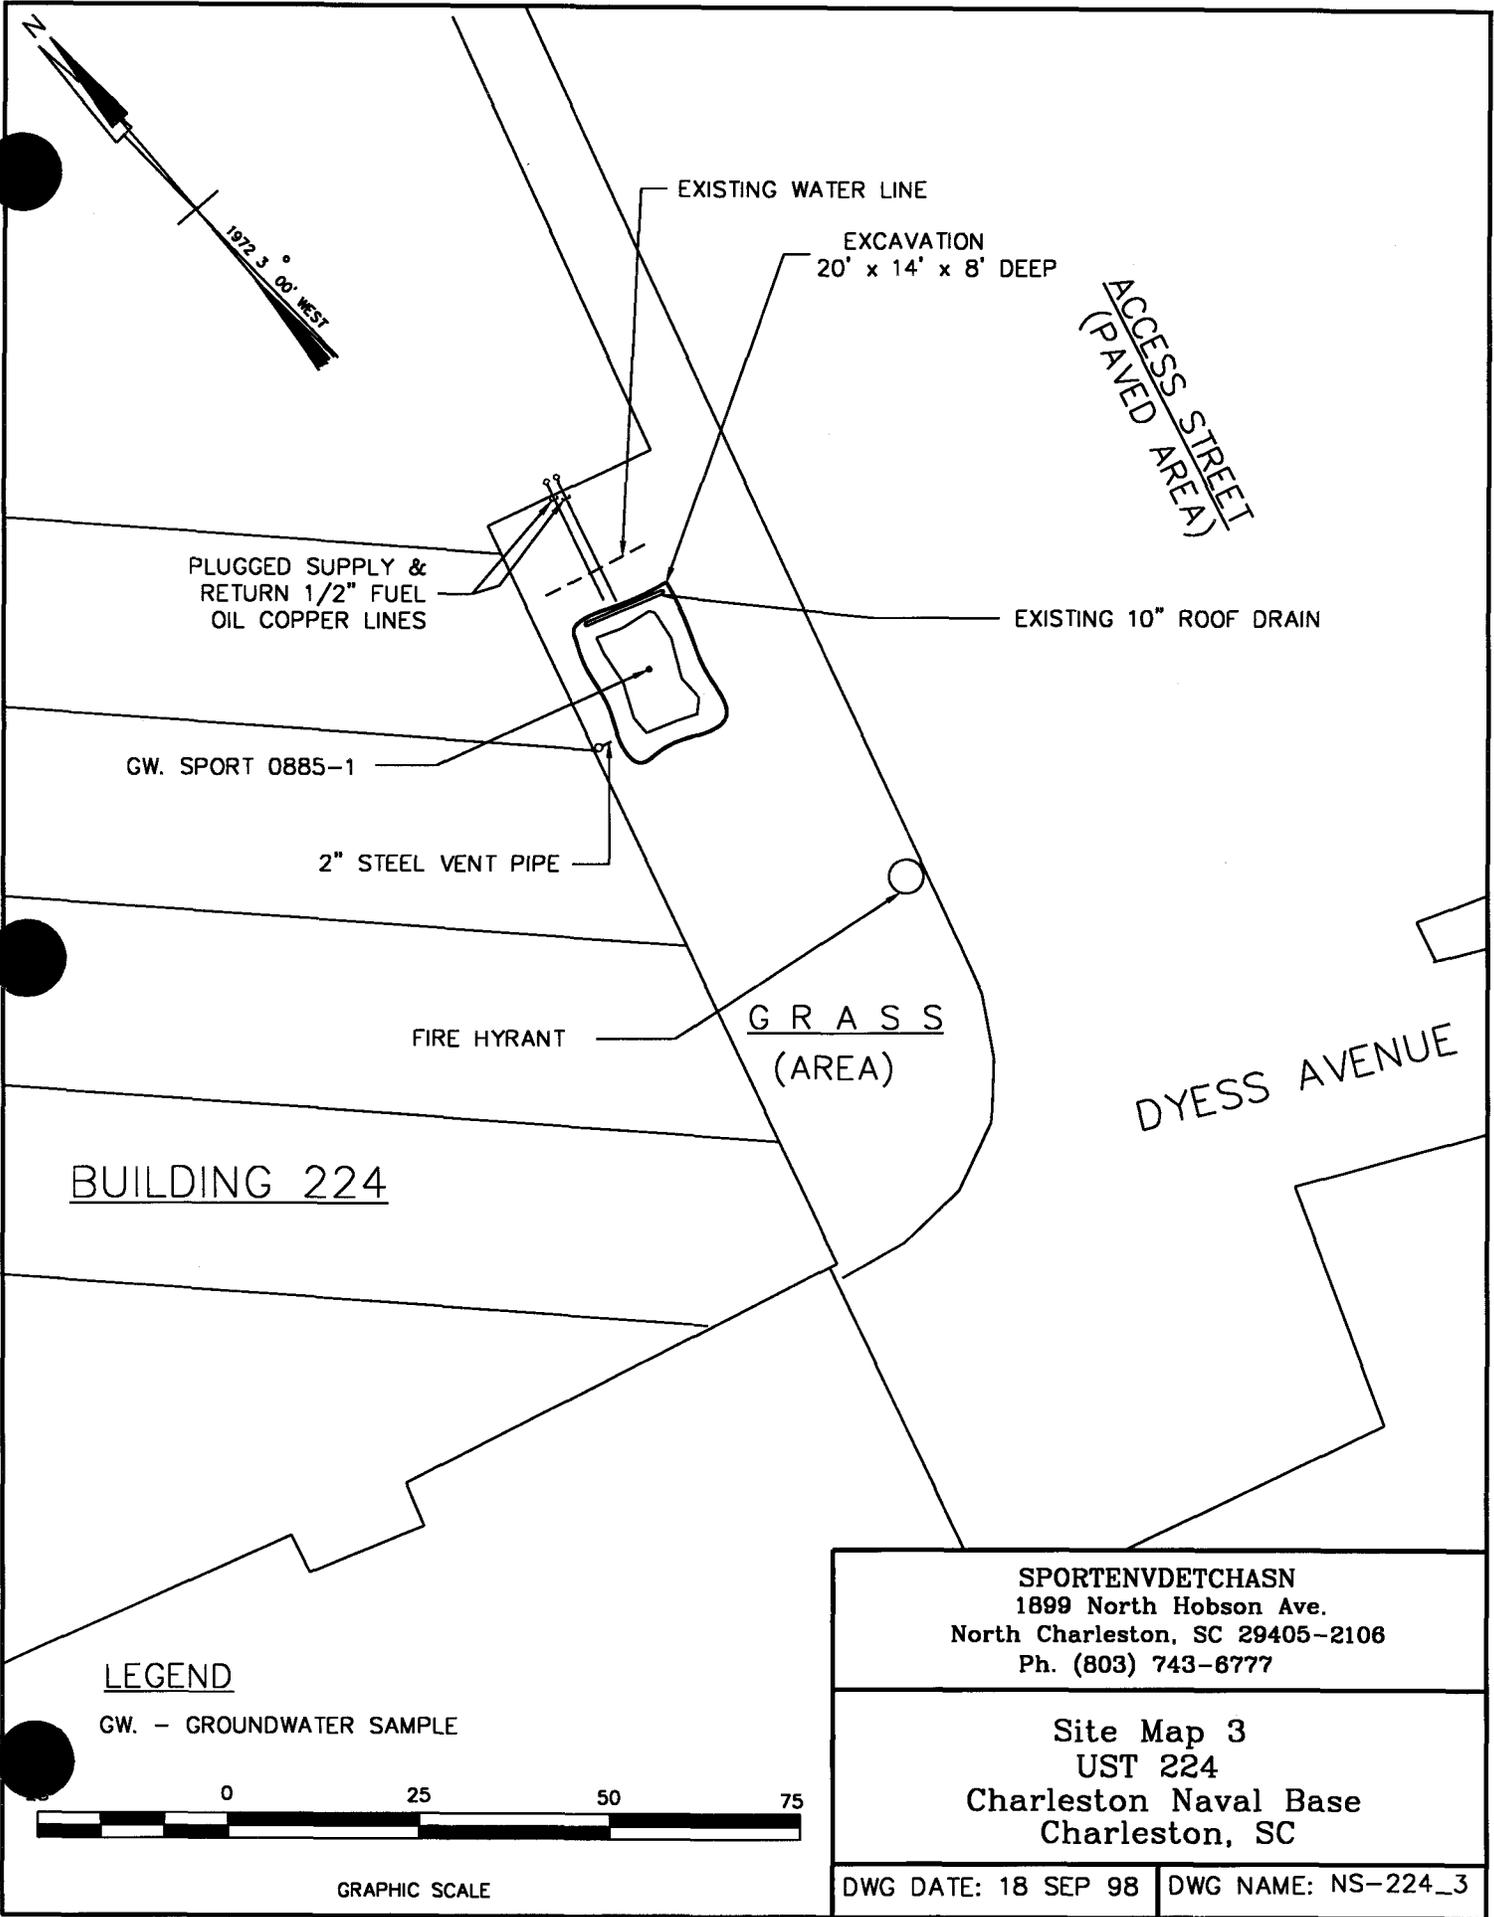
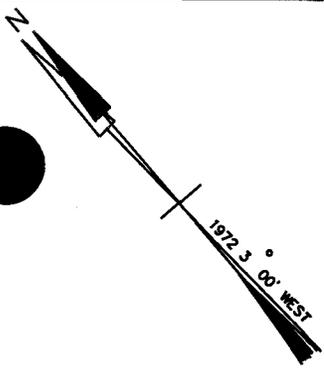
Site Map 3
UST 224
 Charleston Naval Base
 Charleston, SC

BUILDING 224

DYESS AVENUE

GW. - GROUNDWATER SAMPLE

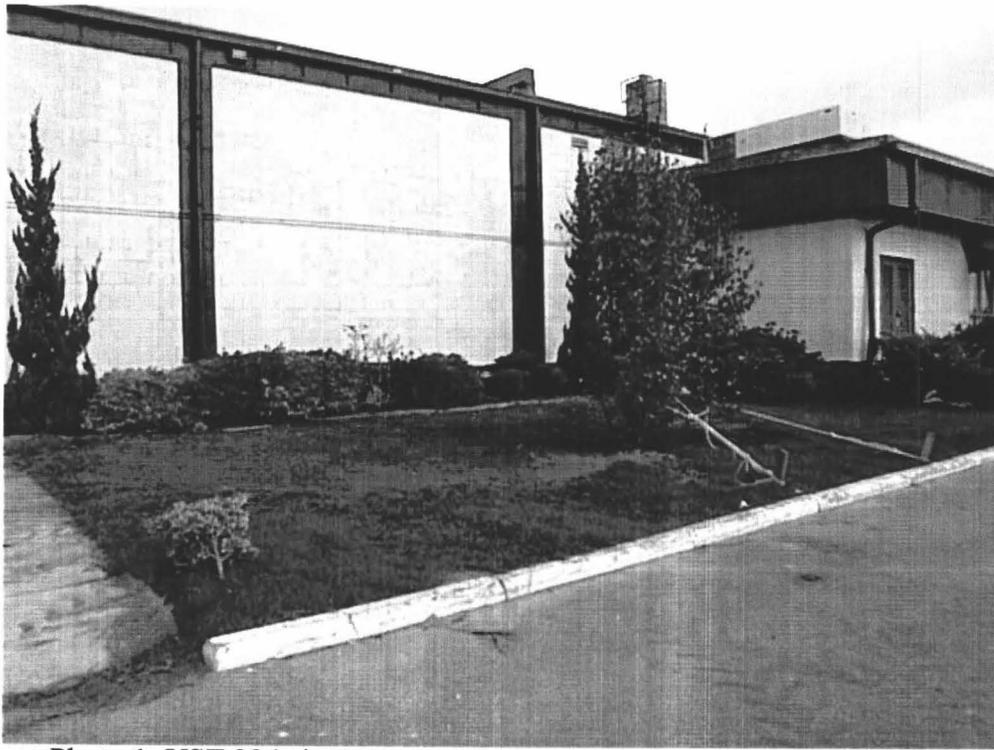
Photo 1: UST 224 site.

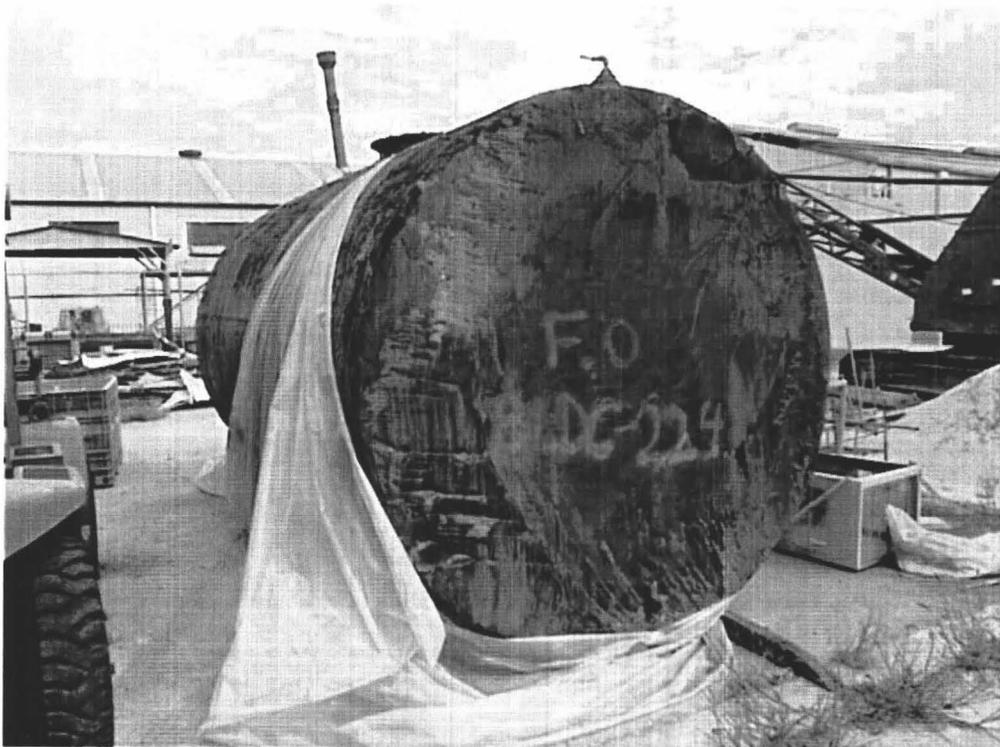
UST 224 was covered with a 3/8" thick protective coating. The tank was in good condition, no pitting or holes were found.

Photo 2: UST 224

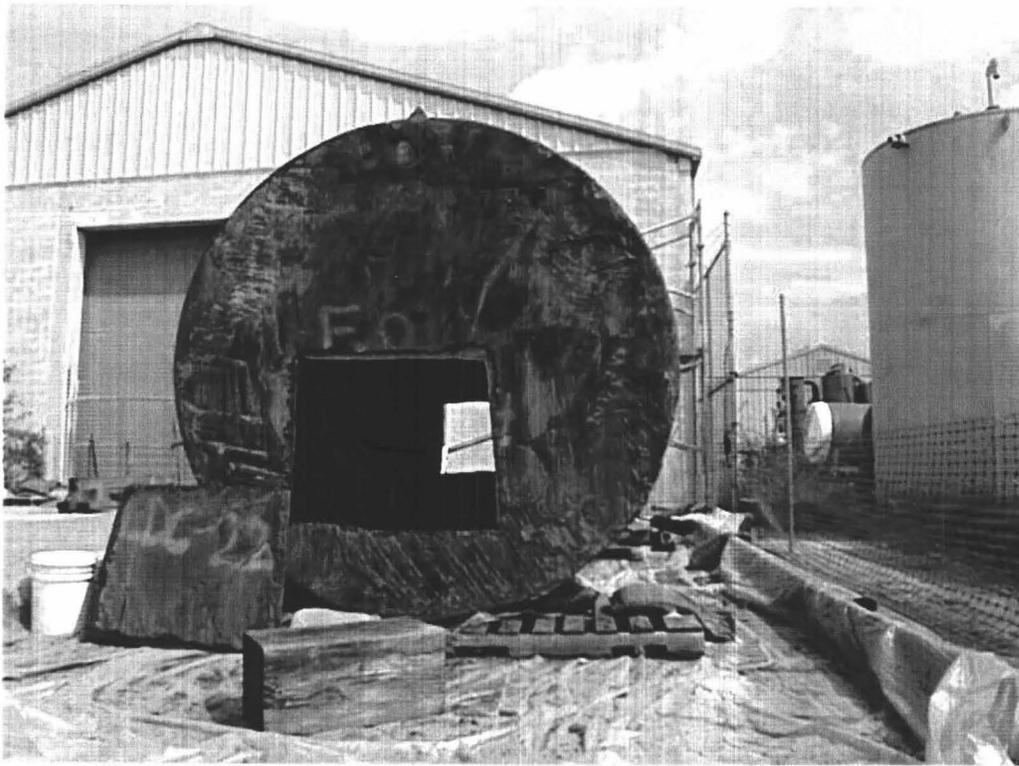
Photo 3: UST 224 during cutting and cleaning.

UST 224 was removed, drained, cut open at both ends, and cleaned with a steam cleaner. It was then cut up for recycling as scrap metal. (See Attachment III.)
