UNDERGROUND STORAGE TANK (UST) ASSESSMENT REPORT FOR TANK NS4 CNC
CHARLESTON SC
09/13/1996
SOUTH CAROLINA DEPARTMENT OF HEALTH AND ENVIRONMENTAL CONTROL

South Carolina Department of Health and Environmental Control (S.C.D.H.E.C.)
Underground Storage Tank (UST) Assessment Report

| Facility Name: | Charleston Naval Base Complex, NS4-TNK-1 (AKA NS4) | |

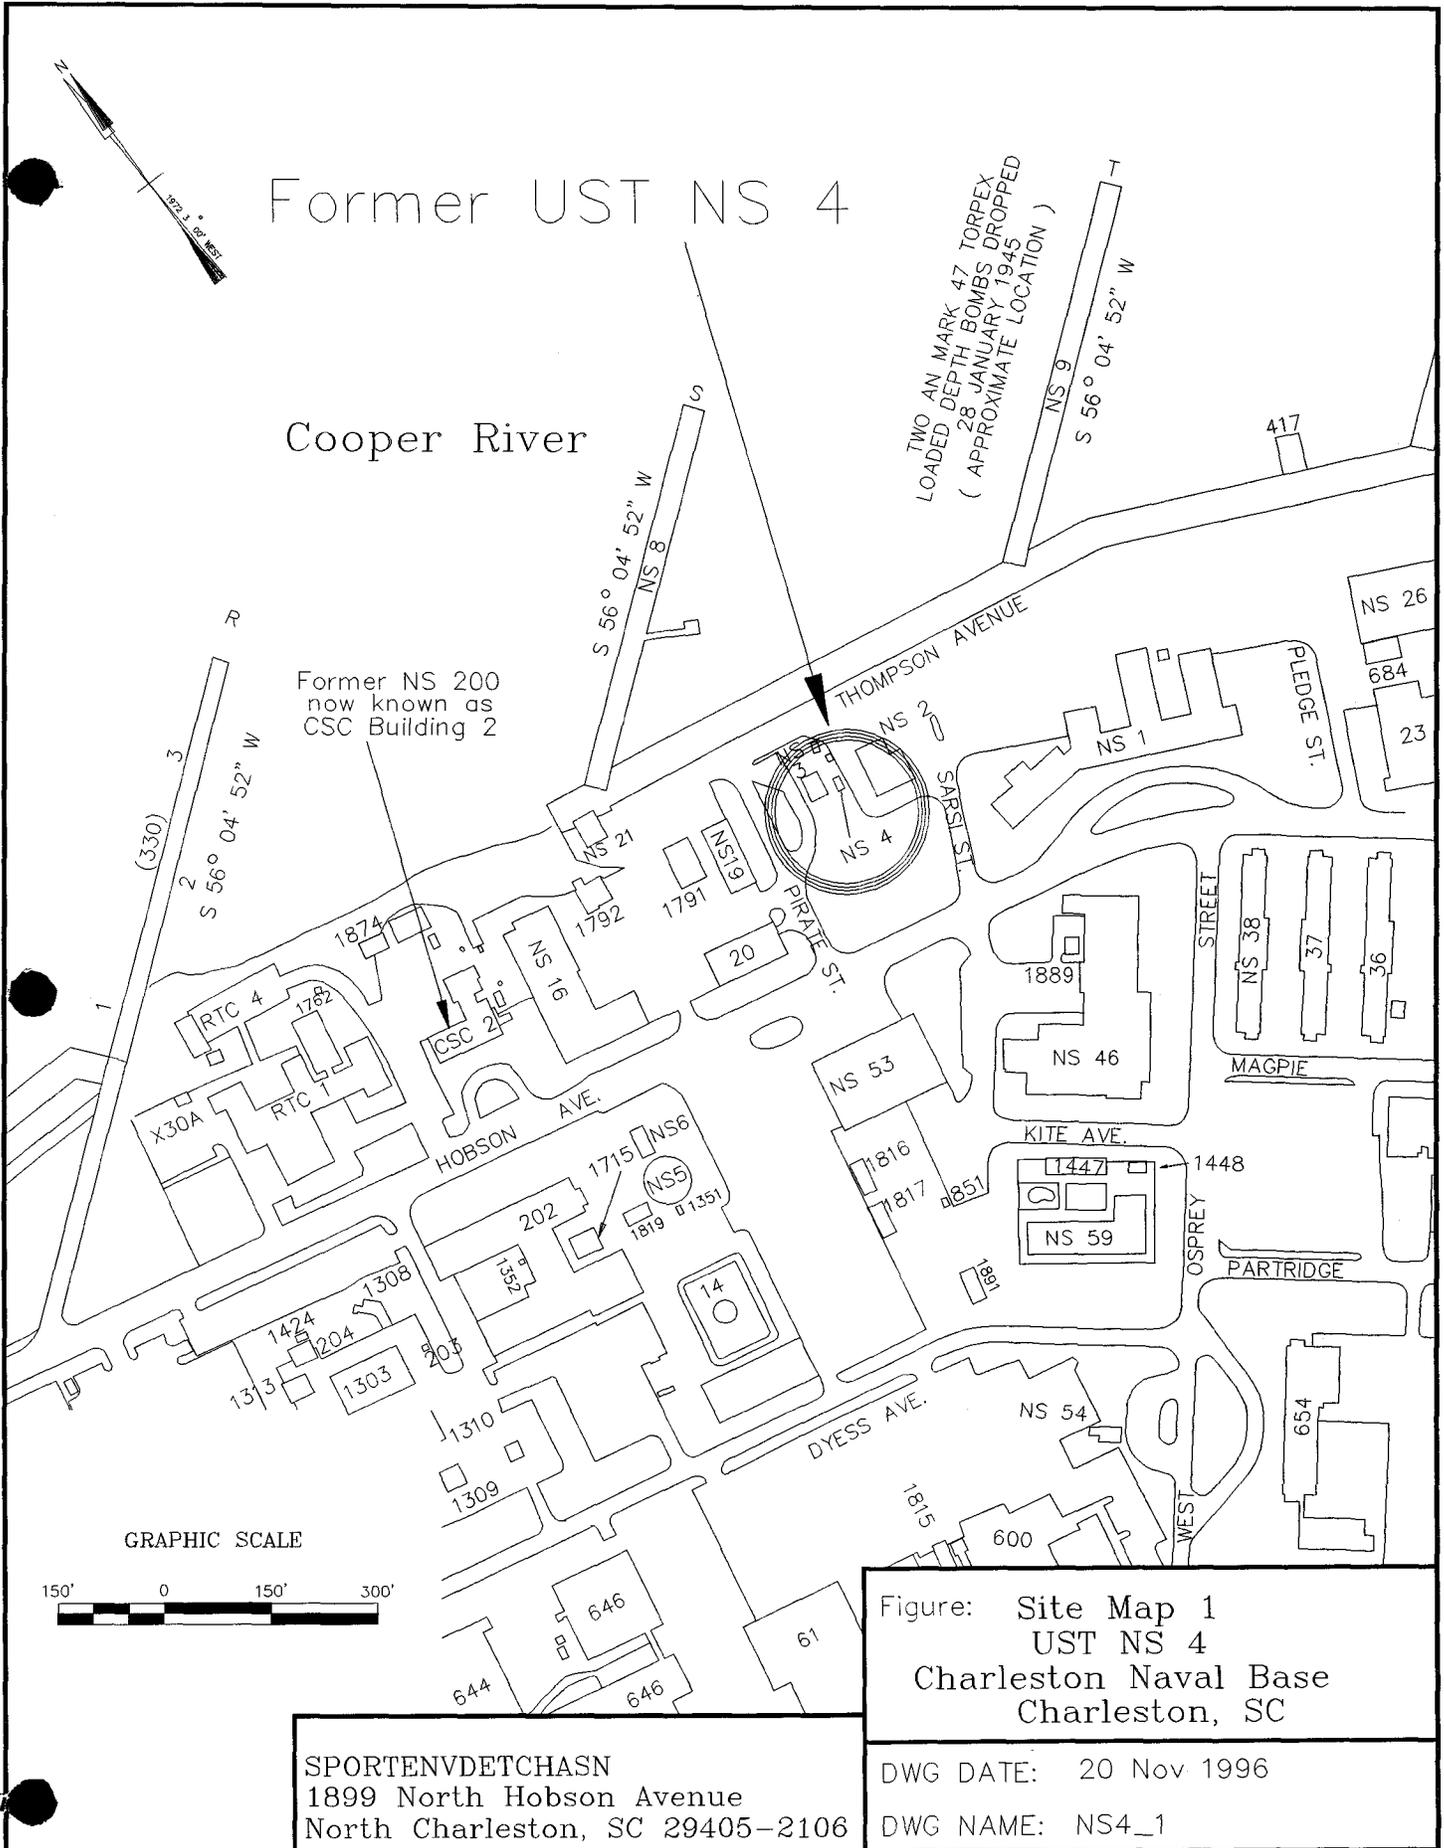
Figure: Site Map 1
UST NS 4
Charleston Naval Base
Charleston, SC

Former UST NS 4

Cooper River

TWO AN MARK 47 TORPEX
LOADED DEPTH BOMBS DROPPED
28 JANUARY 1945
(APPROXIMATE LOCATION)

Former NS 200
now known as
CSC Building 2

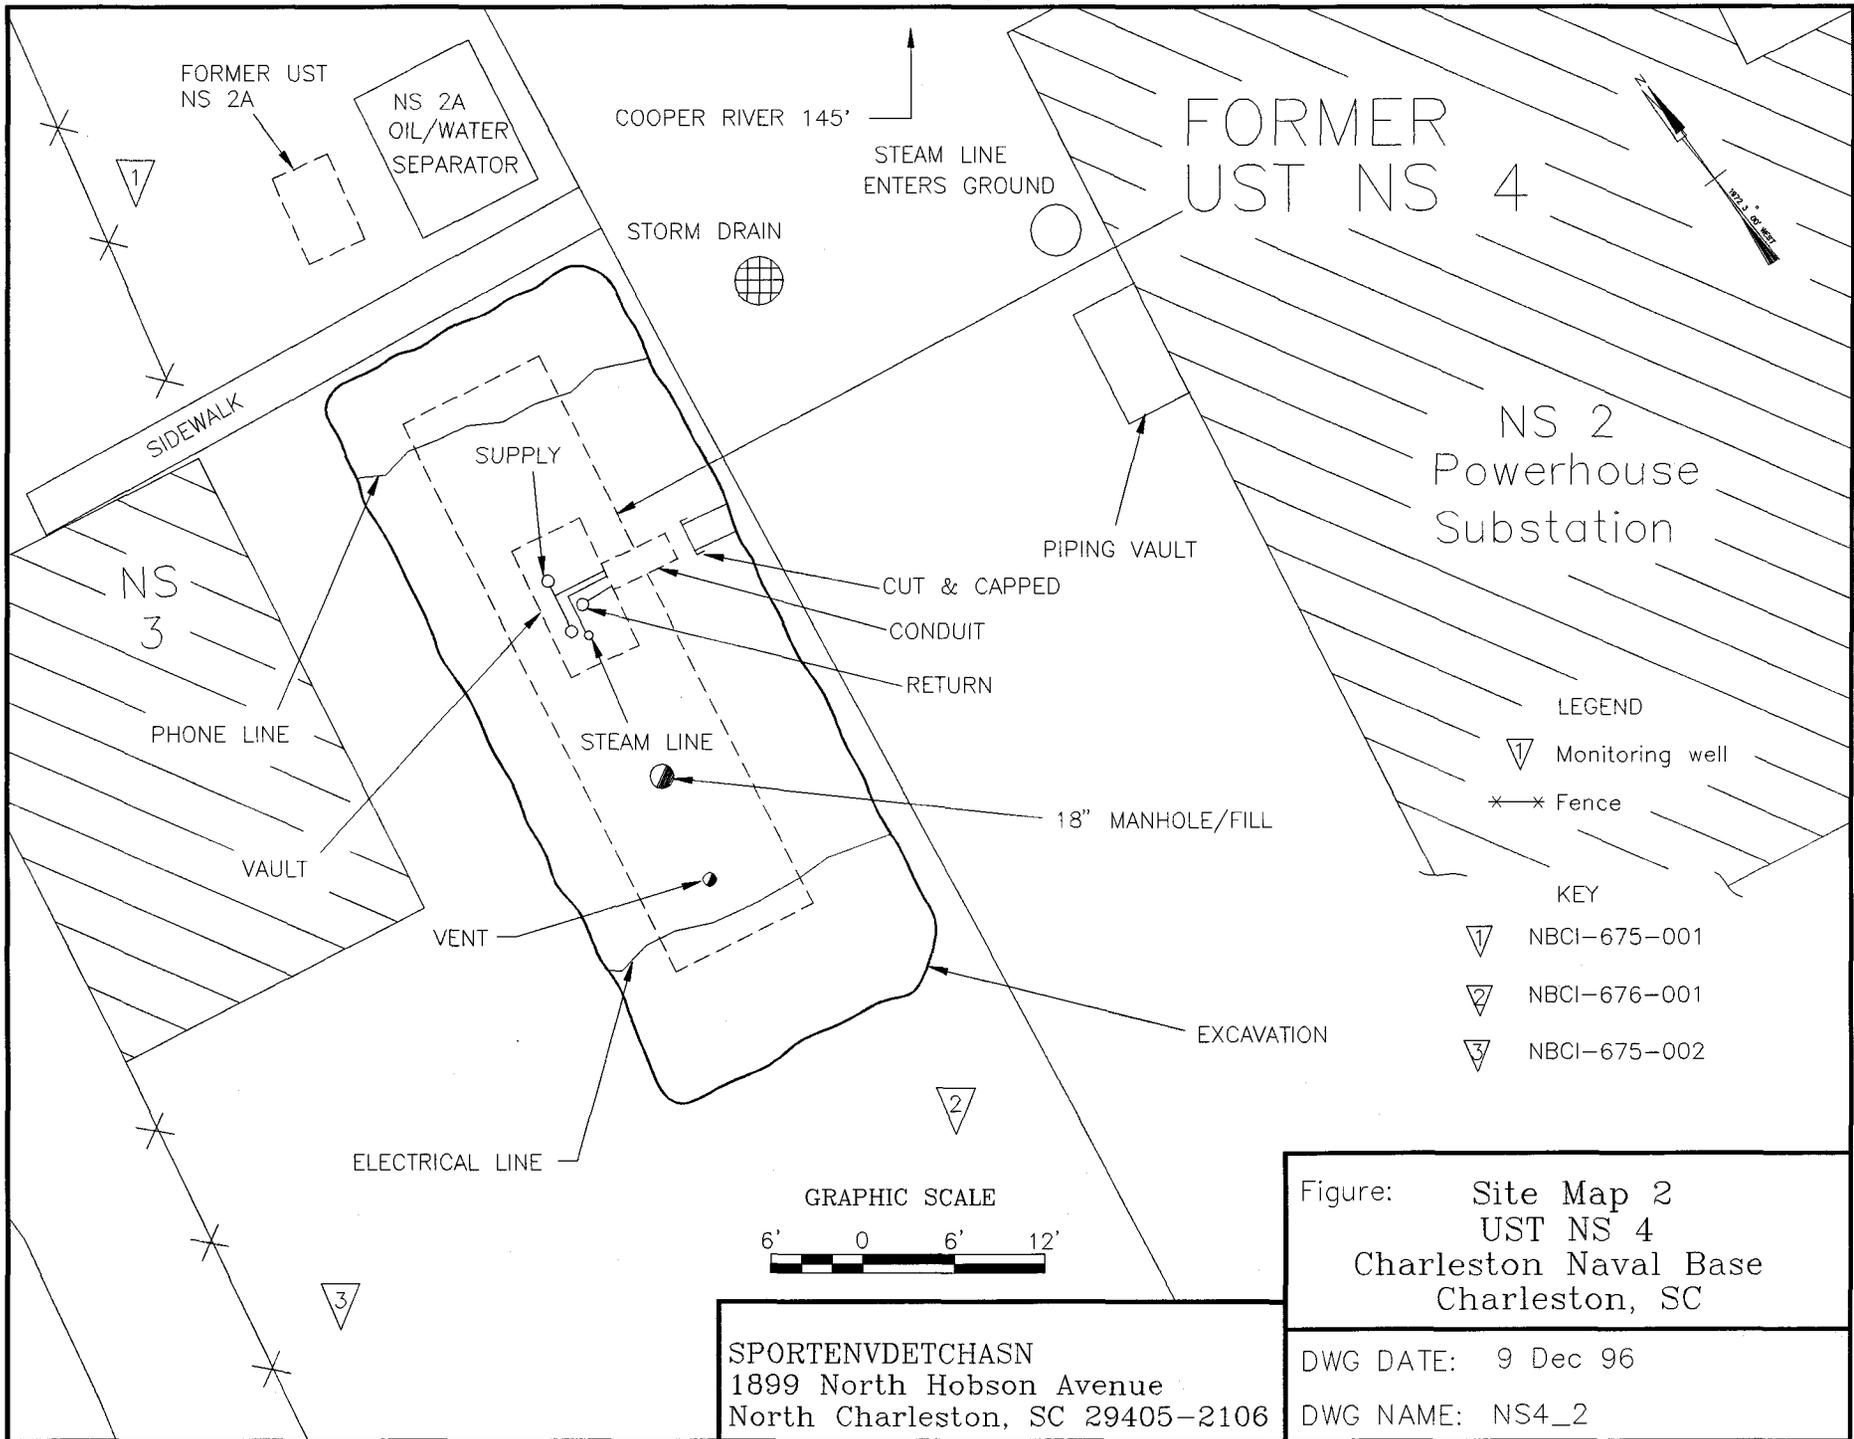
Figure: Site Map 2
 UST NS 4
 Charleston Naval Base
 Charleston, SC

The tank piping went from a concrete vault at the top of the tank and ran through a 13.5" pipe under asphalt pavement to another piping vault at building NS2. The piping was cut and capped as indicated on site map 2.

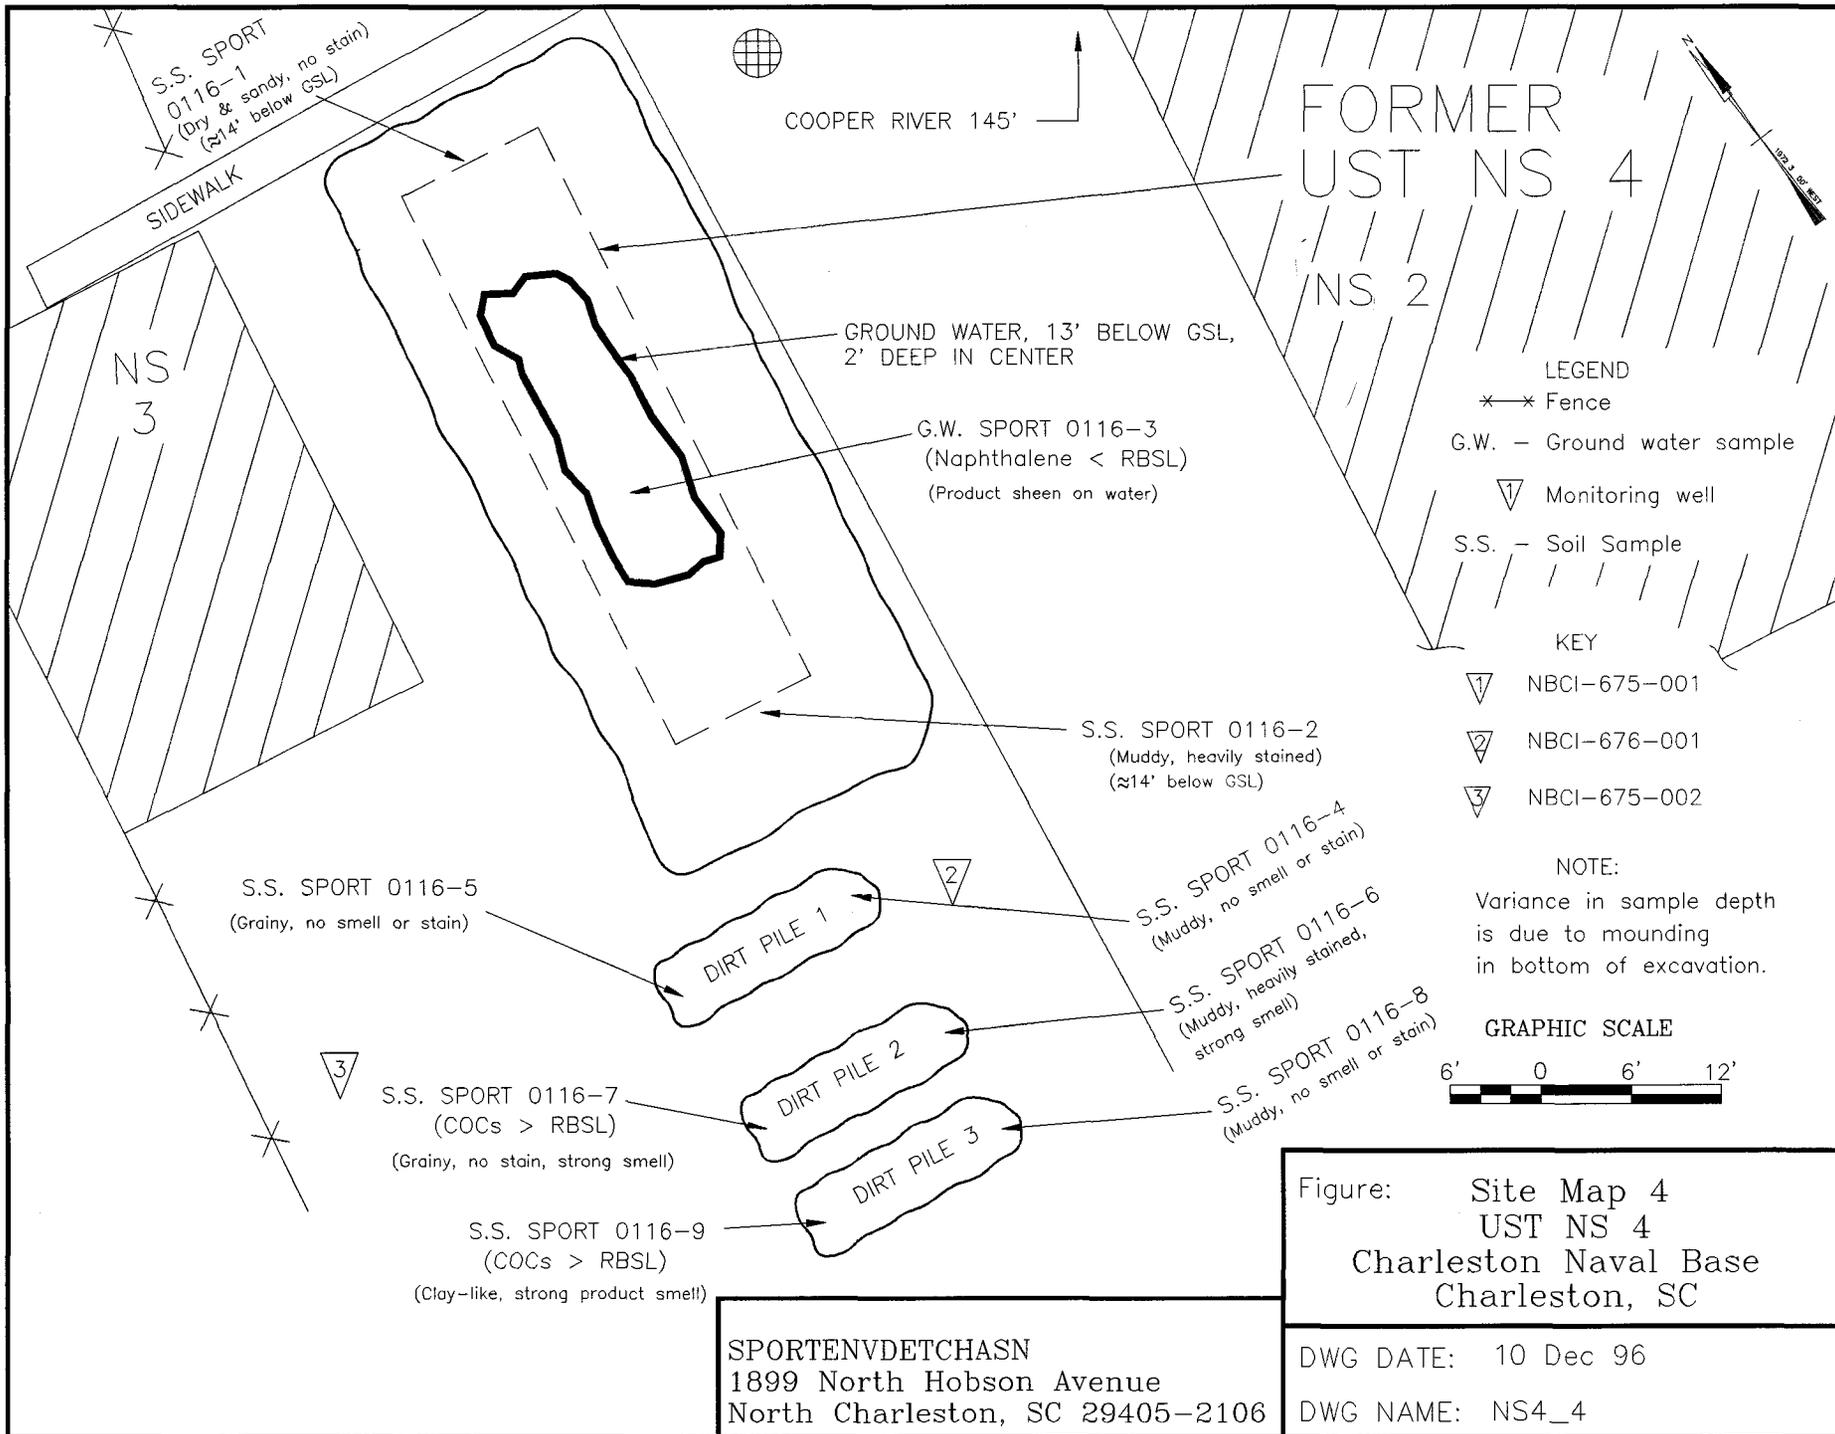
Figure: Site Map 4
 UST NS 4
 Charleston Naval Base
 Charleston, SC

| <p>A. Were any petroleum-stained or contaminated soils found in the UST excavation, soil borings, trenches, or monitoring wells? [*various, see site map 4] If yes, indicate depth and location on the site map.</p> | *X | | |
| <p>B. Were any petroleum odors detected in the excavation, soil borings, trenches, or monitoring wells? If yes, indicate location on site map and describe the odor (strong, mild, etc.) [*strong]</p> | *X | | |
| <p>E. Was a petroleum sheen or free product detected on any excavation or boring waters? [*sheen] If yes, indicate location and thickness on the site map.</p> | *X | | |

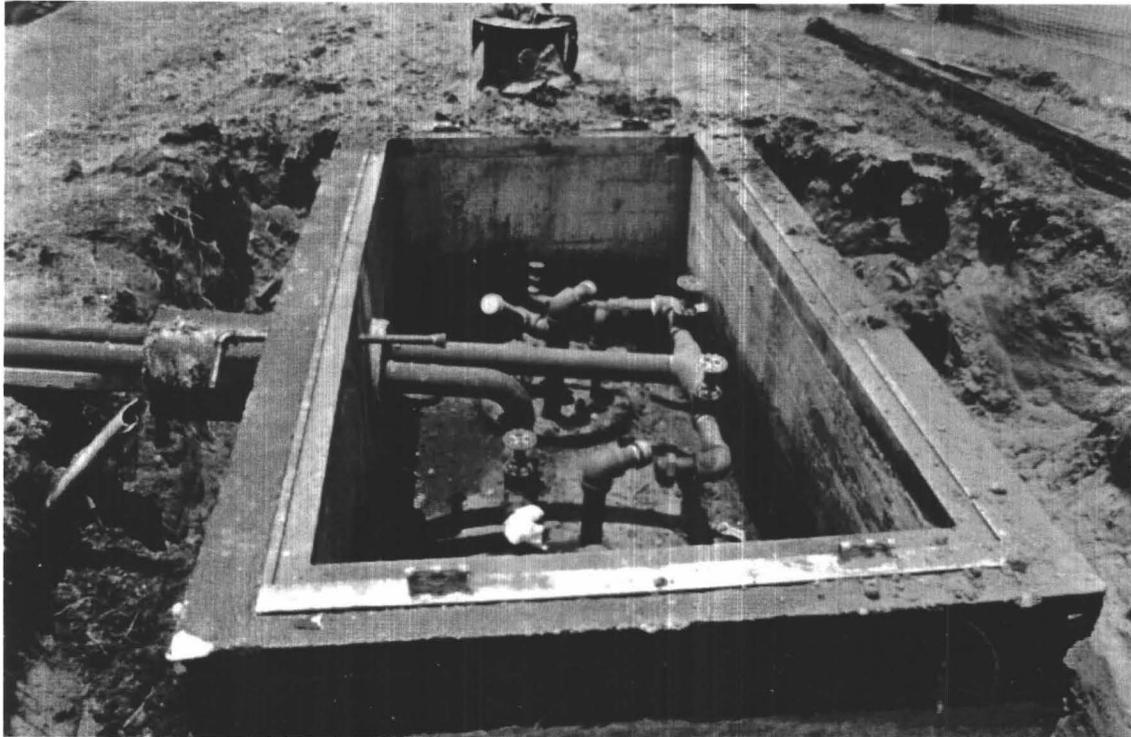
Photo 1: UST NS 4 pipe vault.

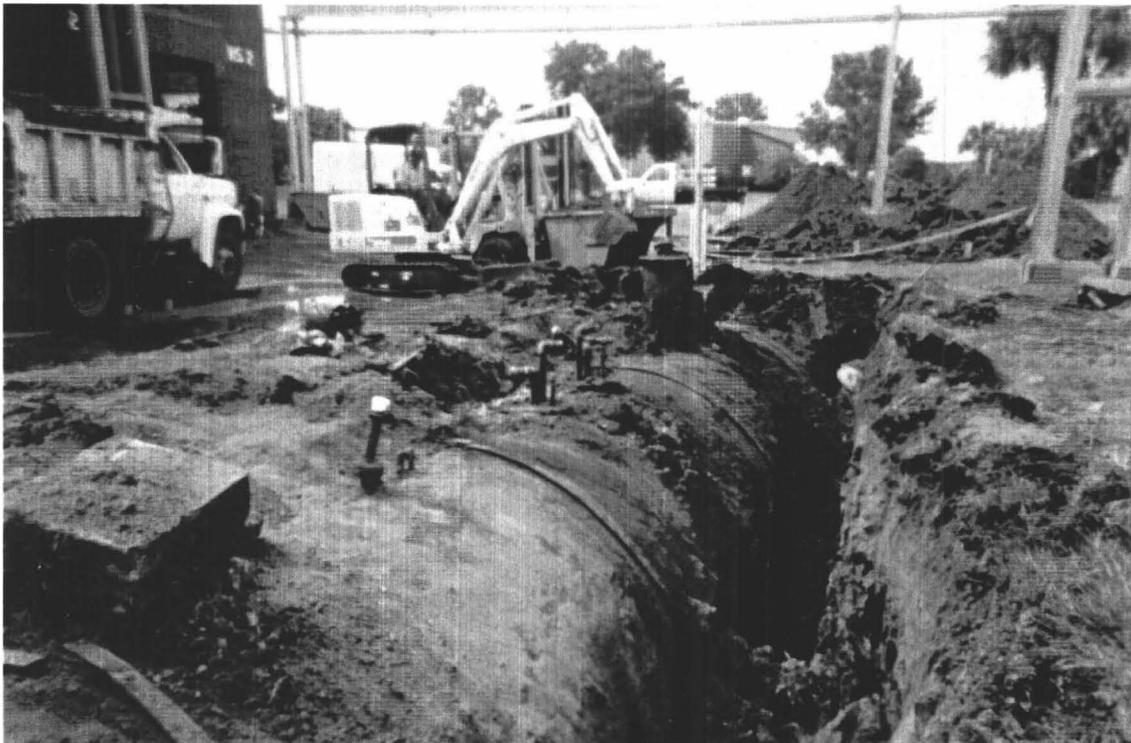
Surface corrosion was found throughout the exterior of the tank.

Photo 2: UST NS 4 being exposed. Note that the pipe vault has been removed.

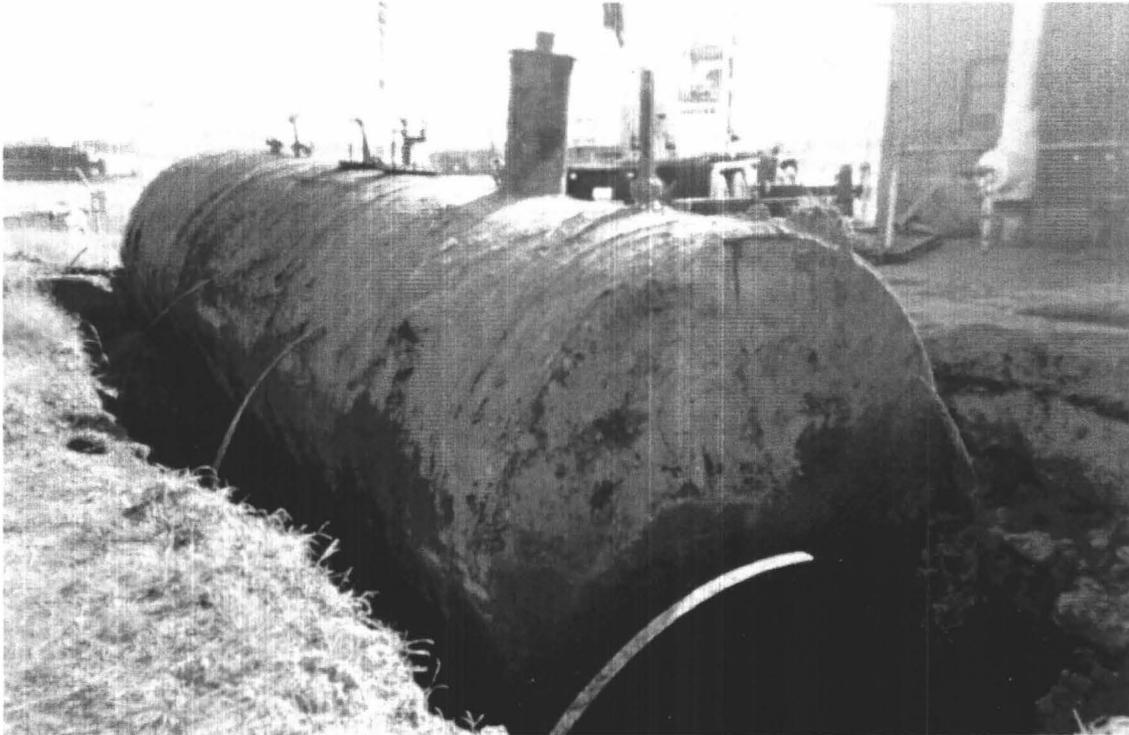
Photo 3: UST NS 4 being raised from the excavation.

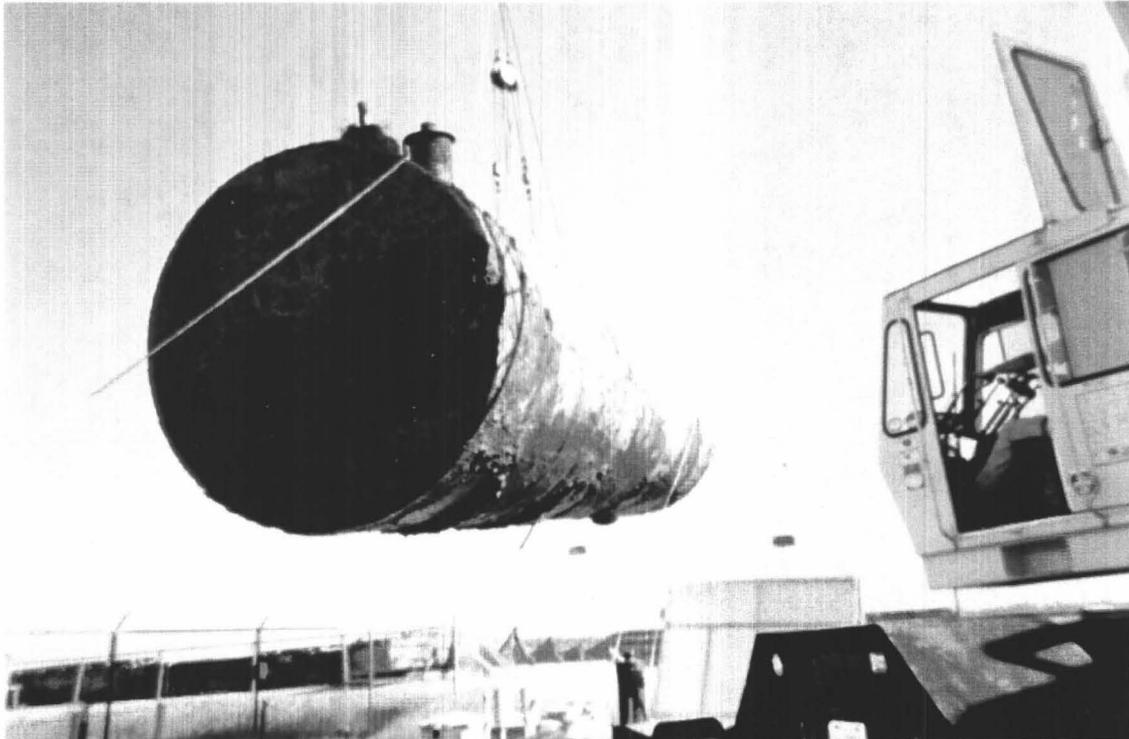
Photo 4: UST NS 4 being lifted clear of the excavation.

UST NS 4 was removed, drained, cut open at both ends, and cleaned with a steam cleaner. It was then cut up for recycling as scrap metal. (See Attachment III.)
