CONFIRMATORY SAMPLING WORK PLAN AREA OF CONCERN 726 (AOC 726) ZONE H
REVISION 1 CNC CHARLESTON SC
05/01/2006
CH2M HILL

CONFIRMATORY SAMPLING WORK PLAN
AOC 726, Zone H

**Charleston Naval Complex
North Charleston, South Carolina**

May 2006

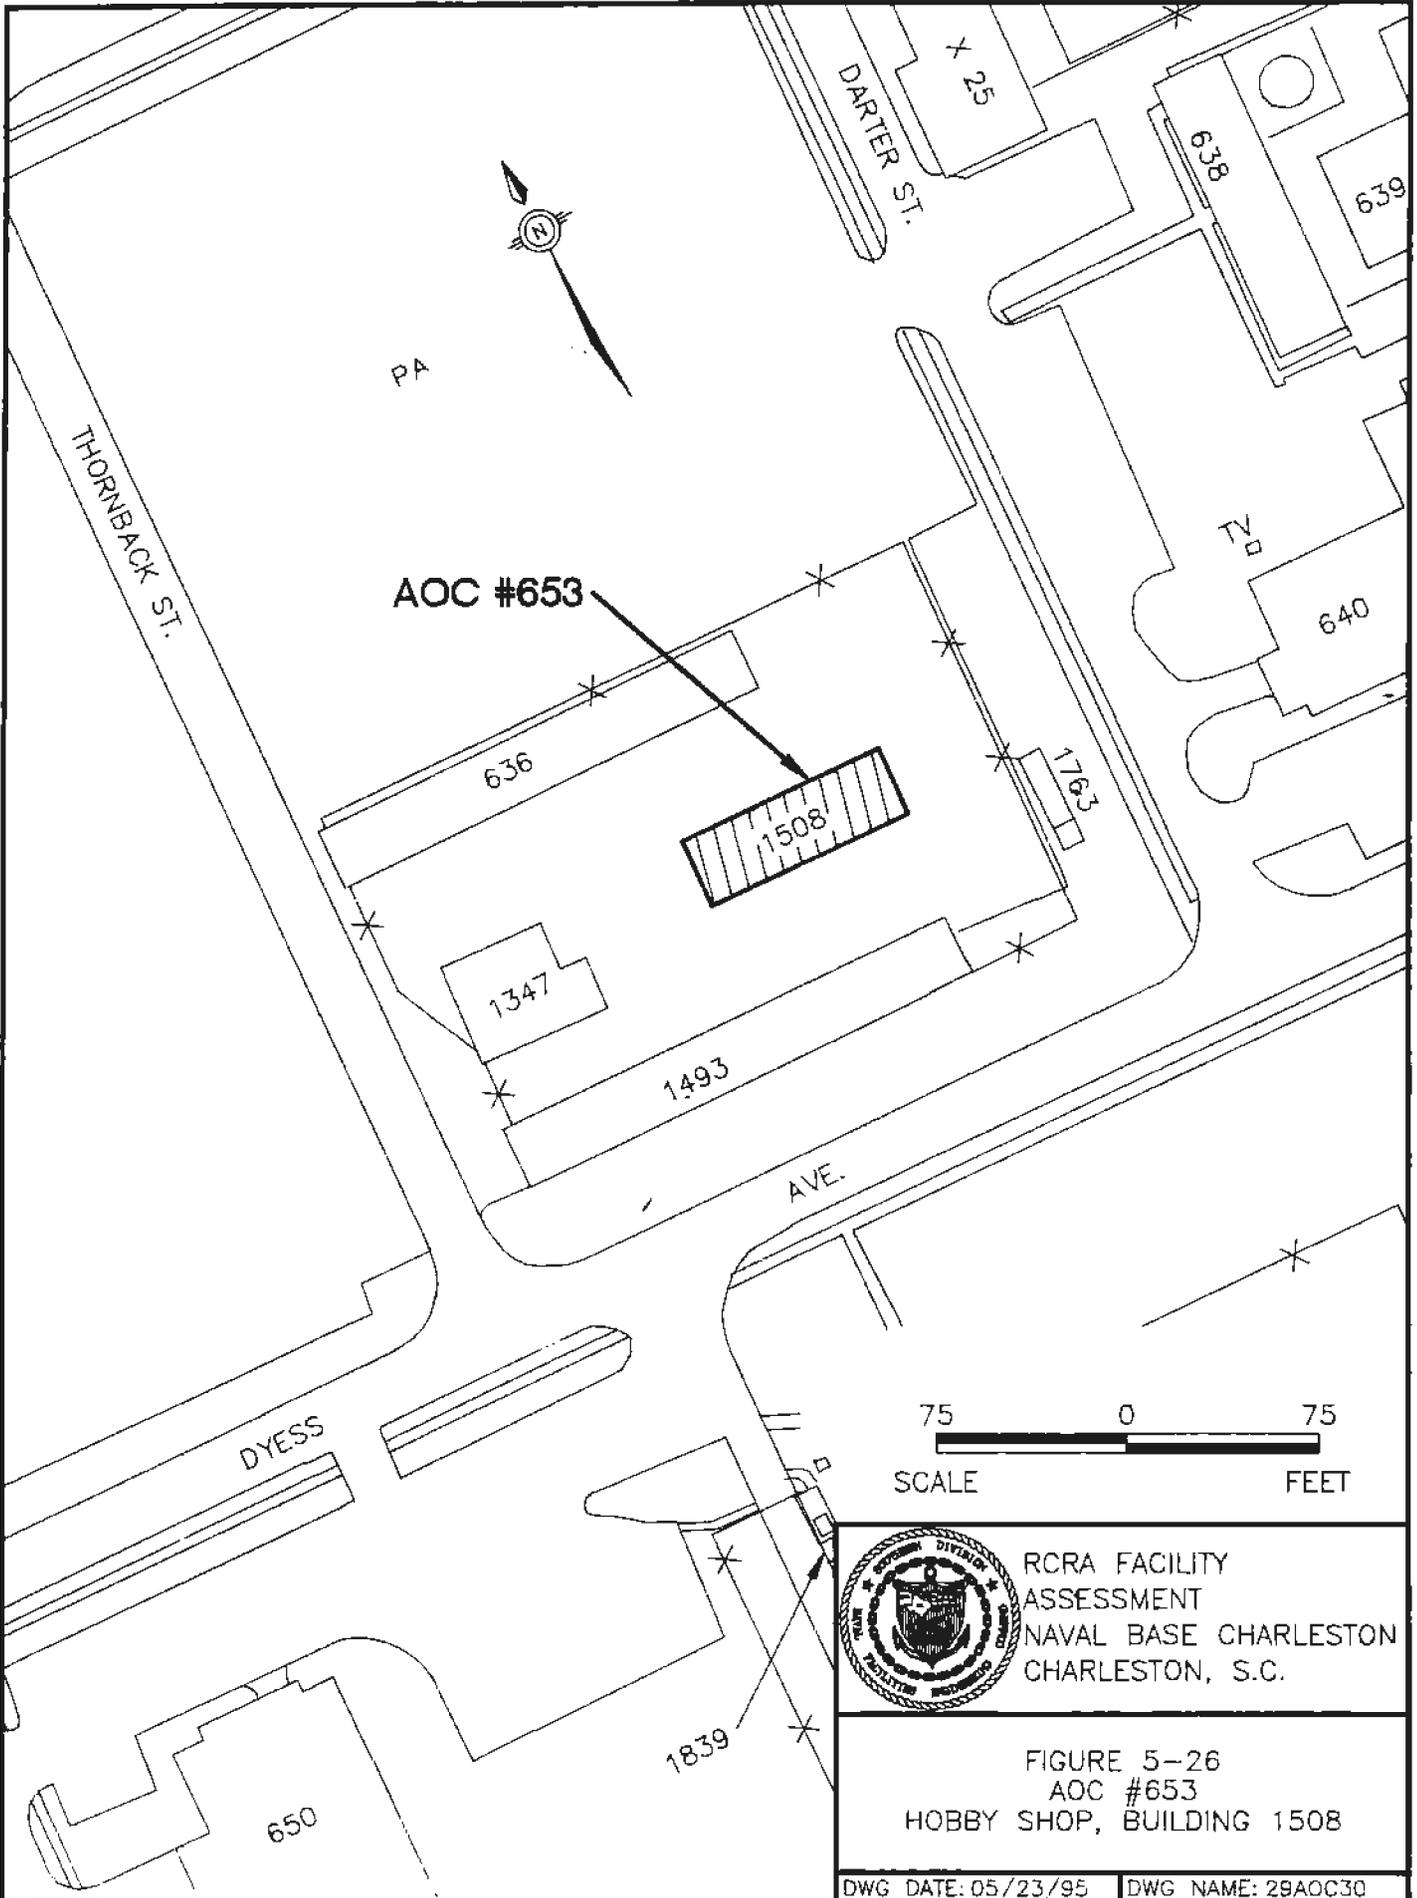
FIGURE 5-26
 AOC #653
 HOBBY SHOP, BUILDING 1508

AOC #653 consists of the Morale, Welfare, and Recreation Department hobby shop located in Building 1508. The hobby shop was constructed in 1972, and is used by both civilian and military personnel to perform automotive maintenance activities for their personal vehicles. The hobby shop has also been used for automotive steam cleaning and painting activities. Building 1508 is constructed of cinder block walls, with a metal roof and a concrete floor. The building paint, which may contain lead, is in poor condition. Two hydraulic lifts are located inside the building; one hydraulic lift is located outside. A two-bay car wash is also attached to the building. Three 40-gallon steel hydraulic fluid storage tanks are also located at the facility. The tanks are approximately 22 years old and are used in operating the hydraulic lift located at the north end of the facility. No floor drains or sumps are known to have been associated with this unit. According to the 1983 Initial Assessment Study of Naval Base Charleston by Environmental Science and Engineering, Inc., Building 1508 was constructed on fill material. The building is constructed on a concrete foundation; the surrounding pavement is asphalt. Building 1508 is located at map coordinates H-20 on Figure 5-D. The AOC location is shown in Figure 5-26.

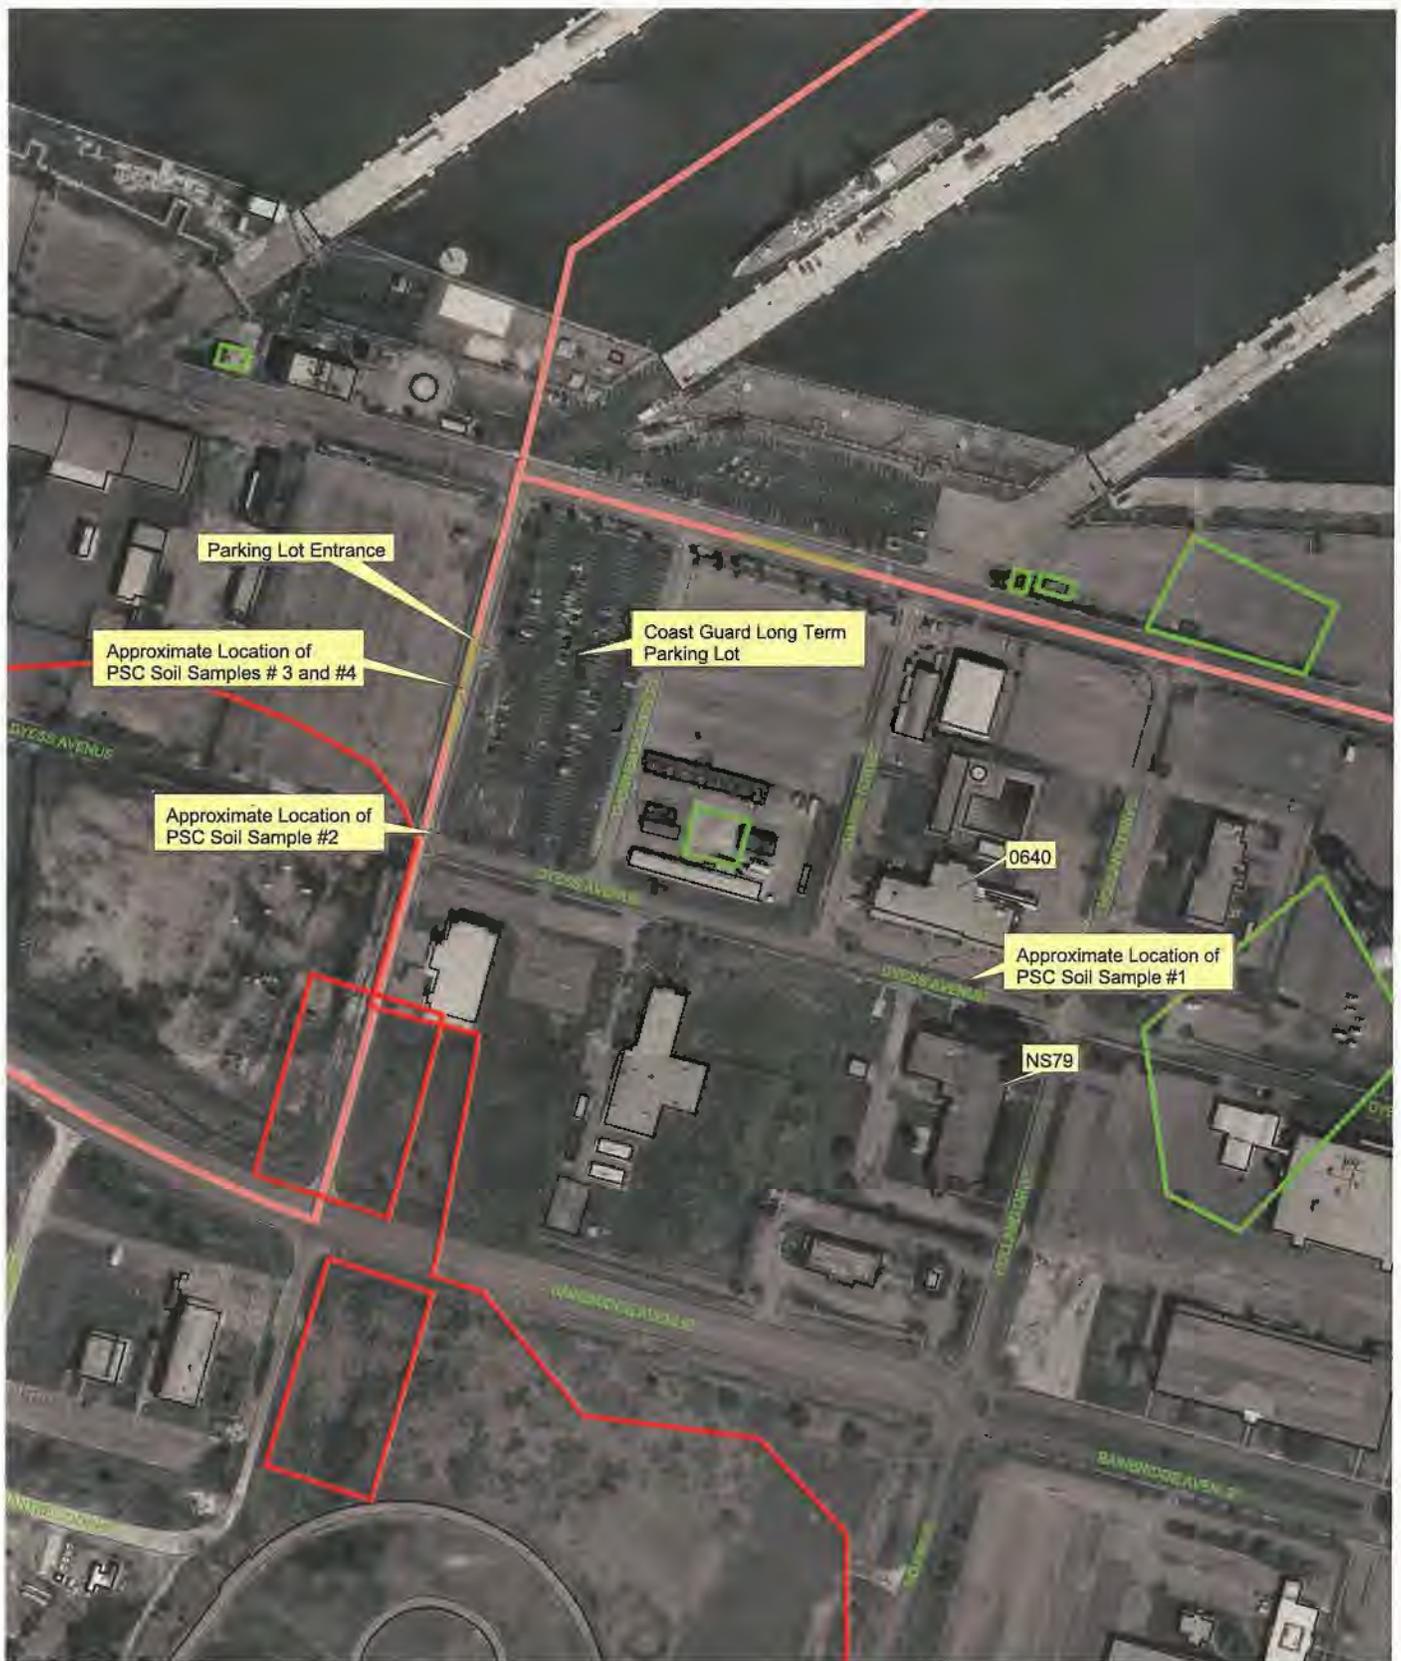
FIGURE 2-1
 PSC Soil Sampling Locations
 Based on *Industrial Hygiene Sampling Report (PSC, 2003)*
 AOC 726, Zone H, Charleston Naval Complex

6 On June 11, 2003, PSC Safety and Health Services, Inc. (PSC) conducted an industrial
7 hygiene survey for Wyatt and Wyatt, which included the collection and analysis of soil
8 samples from four locations in the vicinity where Wyatt and Wyatt believed potential
9 exposure of its workers to hazardous chemicals may have occurred. The following
10 information is based on the *Industrial Hygiene Sampling Report* prepared by PSC, dated June
11 27, 2003 (PSC, 2003). A copy of this report is provided in **Appendix C**.

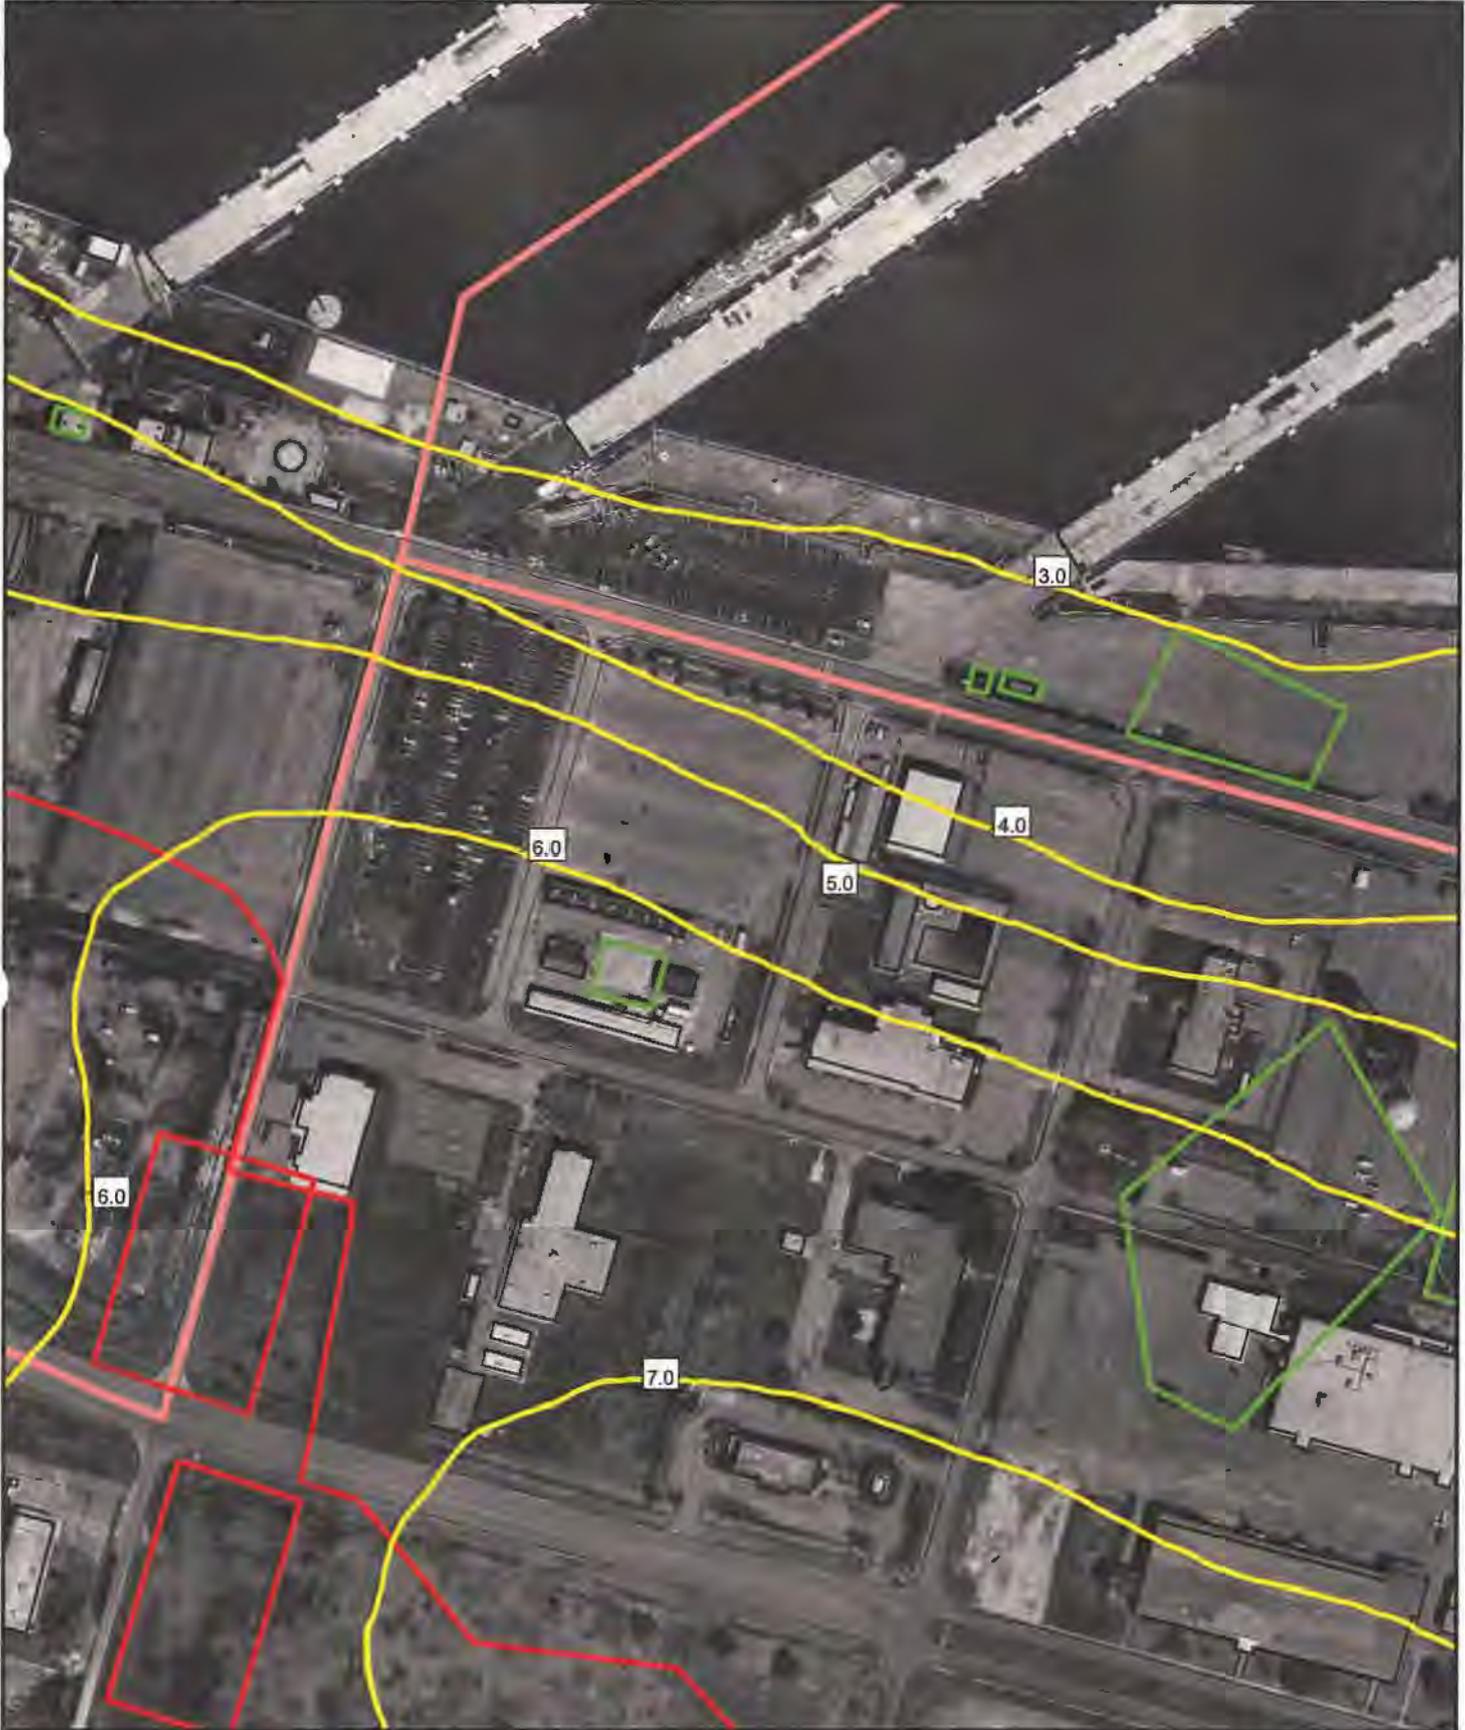
FIGURE 2-2
 Approximate Locations of New Sewer Line and Manholes
 AOC 726, Zone H, Charleston Naval Complex

2 Based on the available data, the location of AOC 726 is assumed to include the general route
3 of the new sewer line along Dyess Avenue, starting at the approximate location of PSC soil
4 sampling Location 1, extending up Dyess Avenue to Halsey Street, then extending up
5 Halsey Street to the entrance to the Coast Guard long term parking lot. The general
6 alignment of the new sewer line that was installed in this area is shown on **Figure 2-2**.

7 Areas of particular interest include PSC soil sampling Locations 1 and 4, at which detections
8 of VOCs were reported. In addition, according to the Wyatt and Wyatt "daily log," obtained
9 from SCDHEC (see **Appendix C**), the workers' reported symptoms were indicated to be
10 particularly significant during work between manholes 6 and 5, and between manholes 6
11 and 7. The approximate manhole locations are shown on **Figure 2-2**.

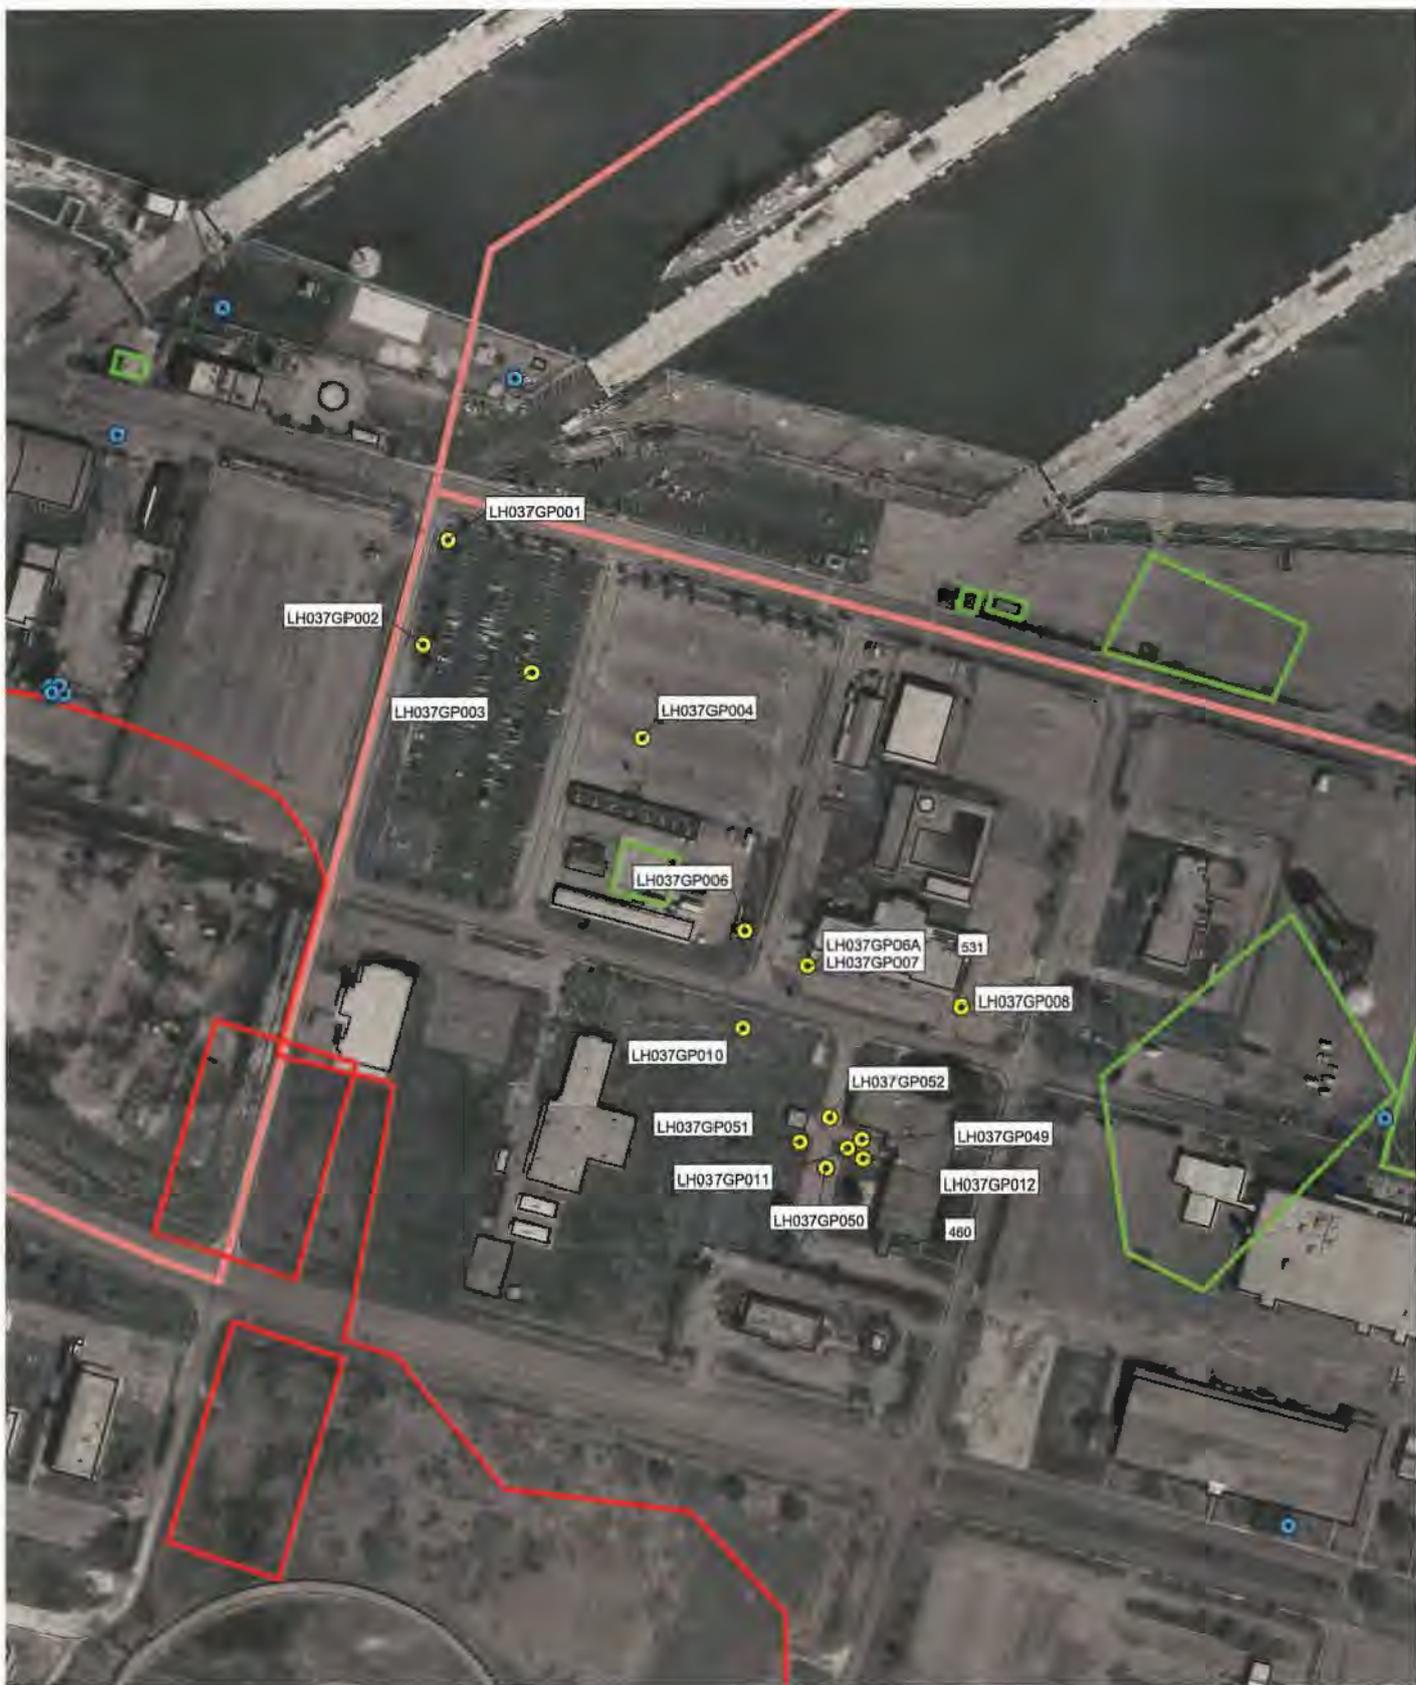
FIGURE 3-1
 DTP Groundwater Sampling Locations Near AOC 726
 AOC 726, Zone H, Charleston Naval Complex

- Groundwater Probe
- SEWER-LINE/MANHOLE-NS
- SEWER-LINE/MANHOLE
- SEWER-FLOW-ARROW

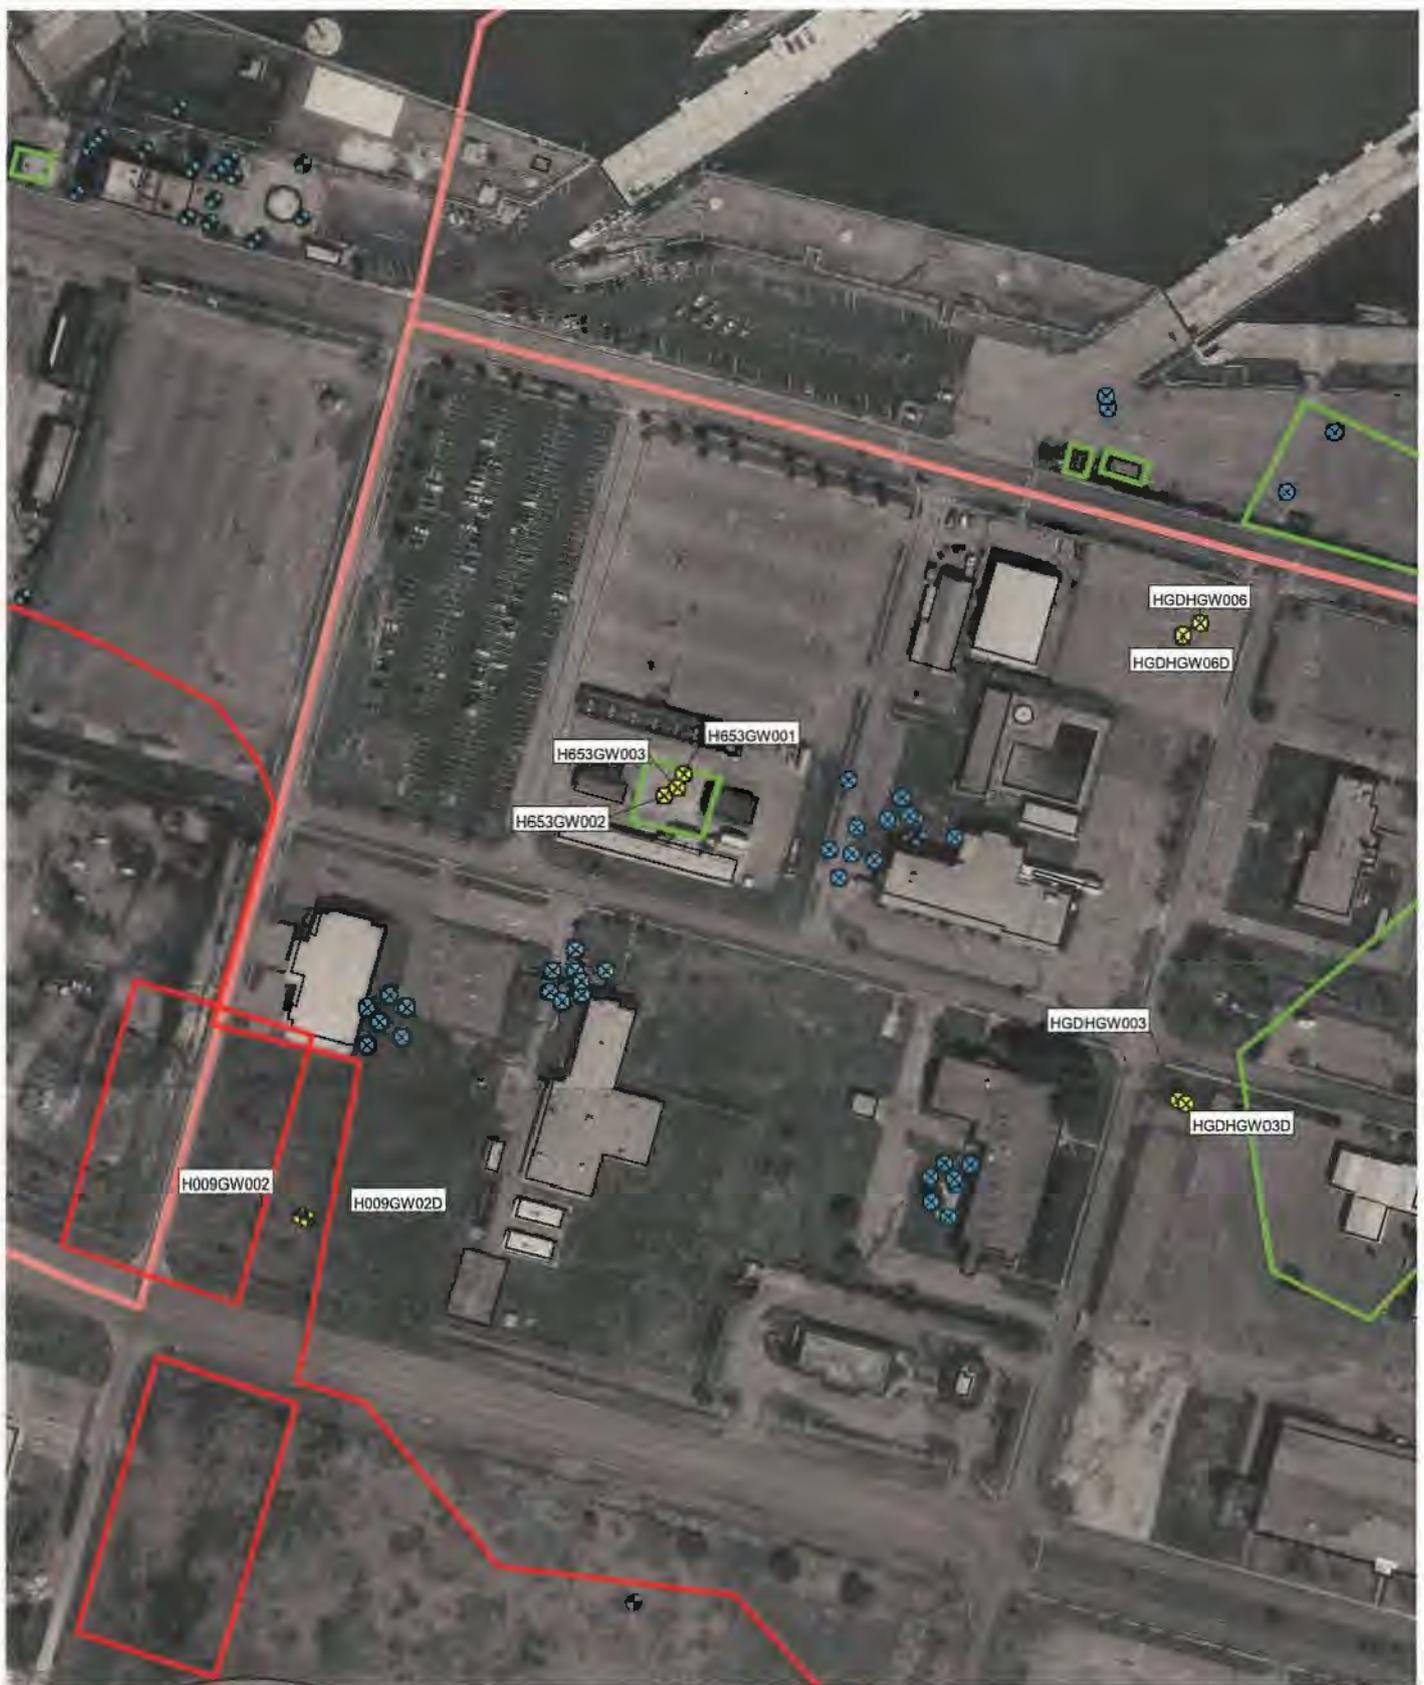
FIGURE 3-2
 RCRA-related Groundwater Wells Analyzed for VOCs in the Vicinity of AOC 726
 AOC 726, Zone H, Charleston Naval Complex

13 **Figure 3-2** shows the locations of monitoring wells installed as part of the RFI in the vicinity
14 of AOC 726. Only those monitoring wells that are labeled in **Figure 3-2** were installed as
15 part of the RFI. These wells include monitoring wells installed to investigate AOC 653 as
16 well as several grid wells installed in Zone H to assess the background groundwater quality.
17 **Table 3-1** shows the results of detections of VOCs from those samples. Several detections of
18 acetone, a common laboratory contaminant, were noted. One detection of trichloroethene
19 (TCE) above its drinking water MCL of 5 $\mu\text{g}/\text{L}$ was noted in well HGDHGW003.

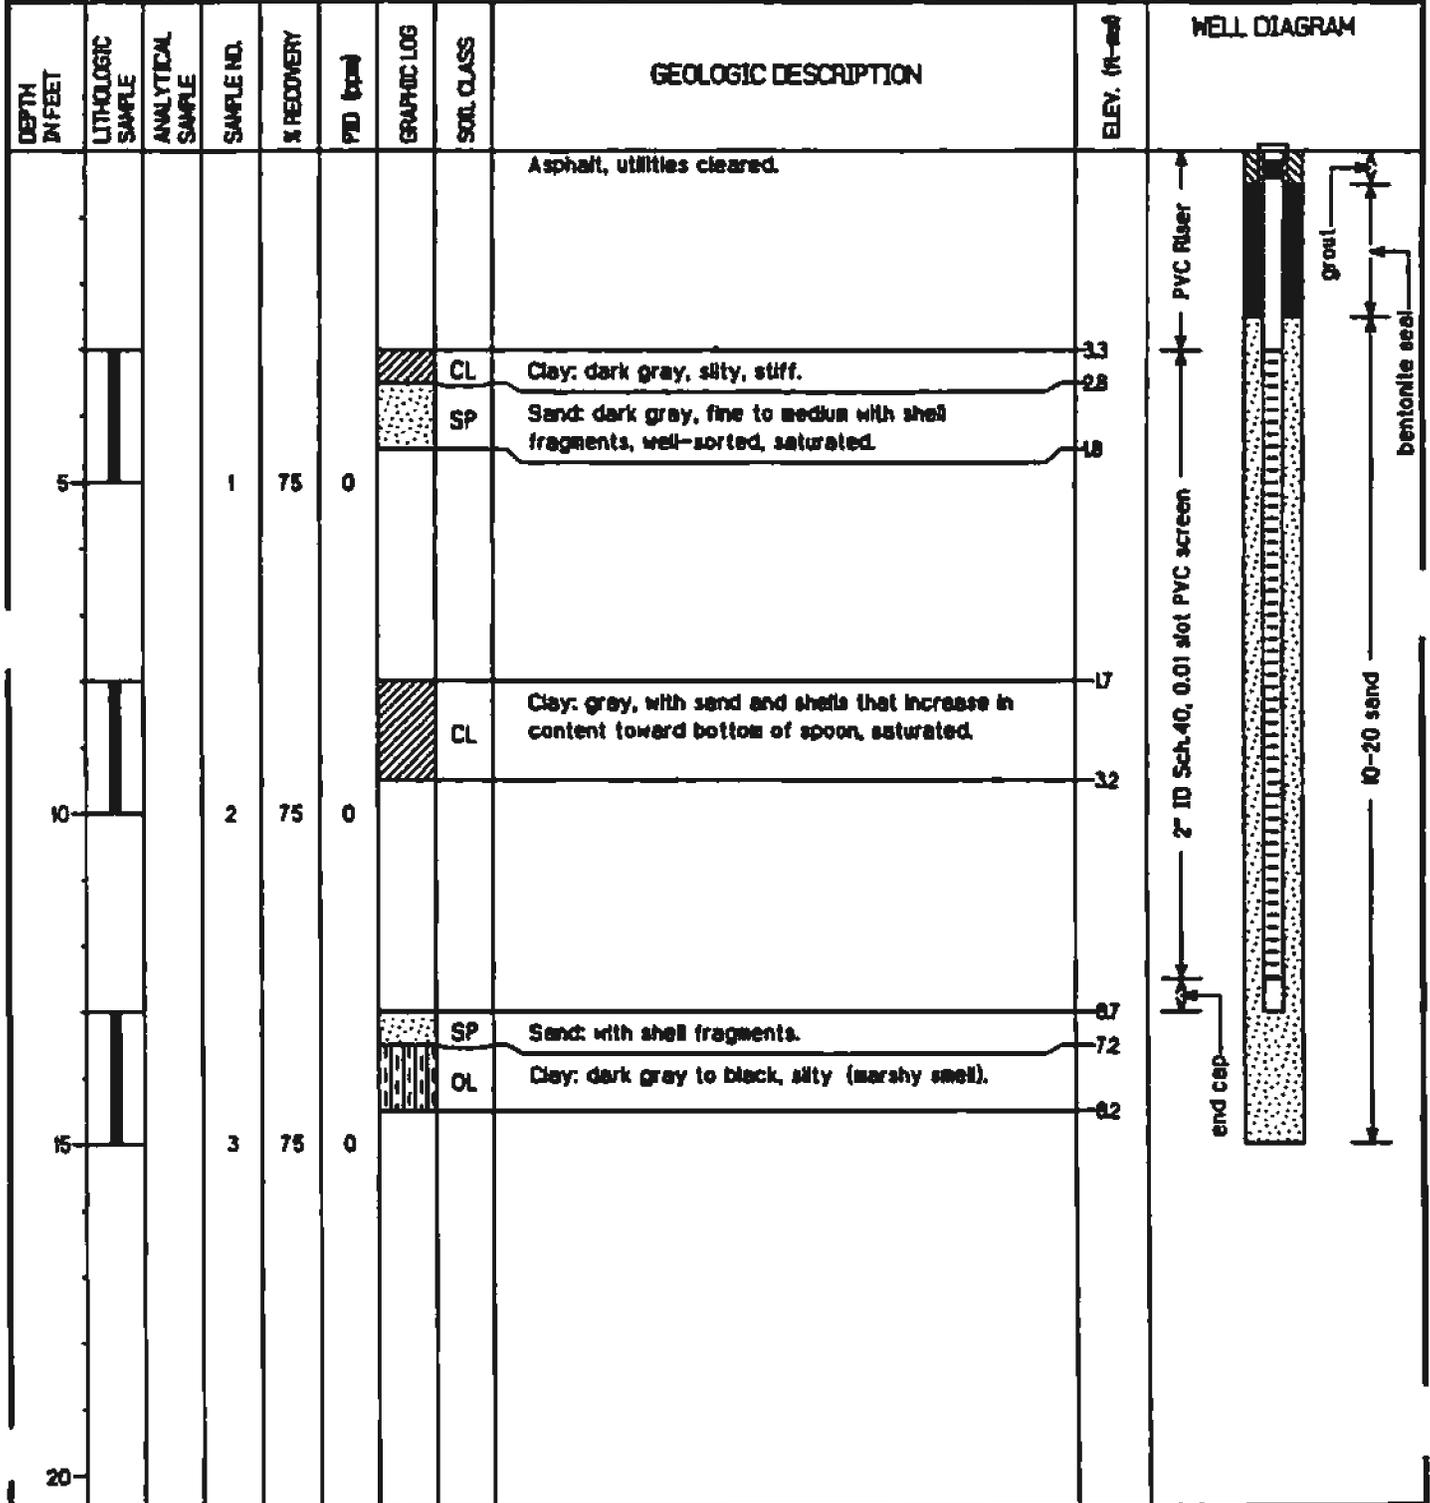
Monitoring Well NBCH853002

Well Screen: 3 to 12.5 feet bgs
