FINAL PHASE II SITE ASSESSMENT REPORT NALF CABINISS NAS CORPUS CHRISTI TX
9/16/1993
ENSAFE

**FINAL
PHASE II SITE ASSESSMENT
NALF CABINISS
NAS CORPUS CHRISTI, TEXAS**

September 16, 1993

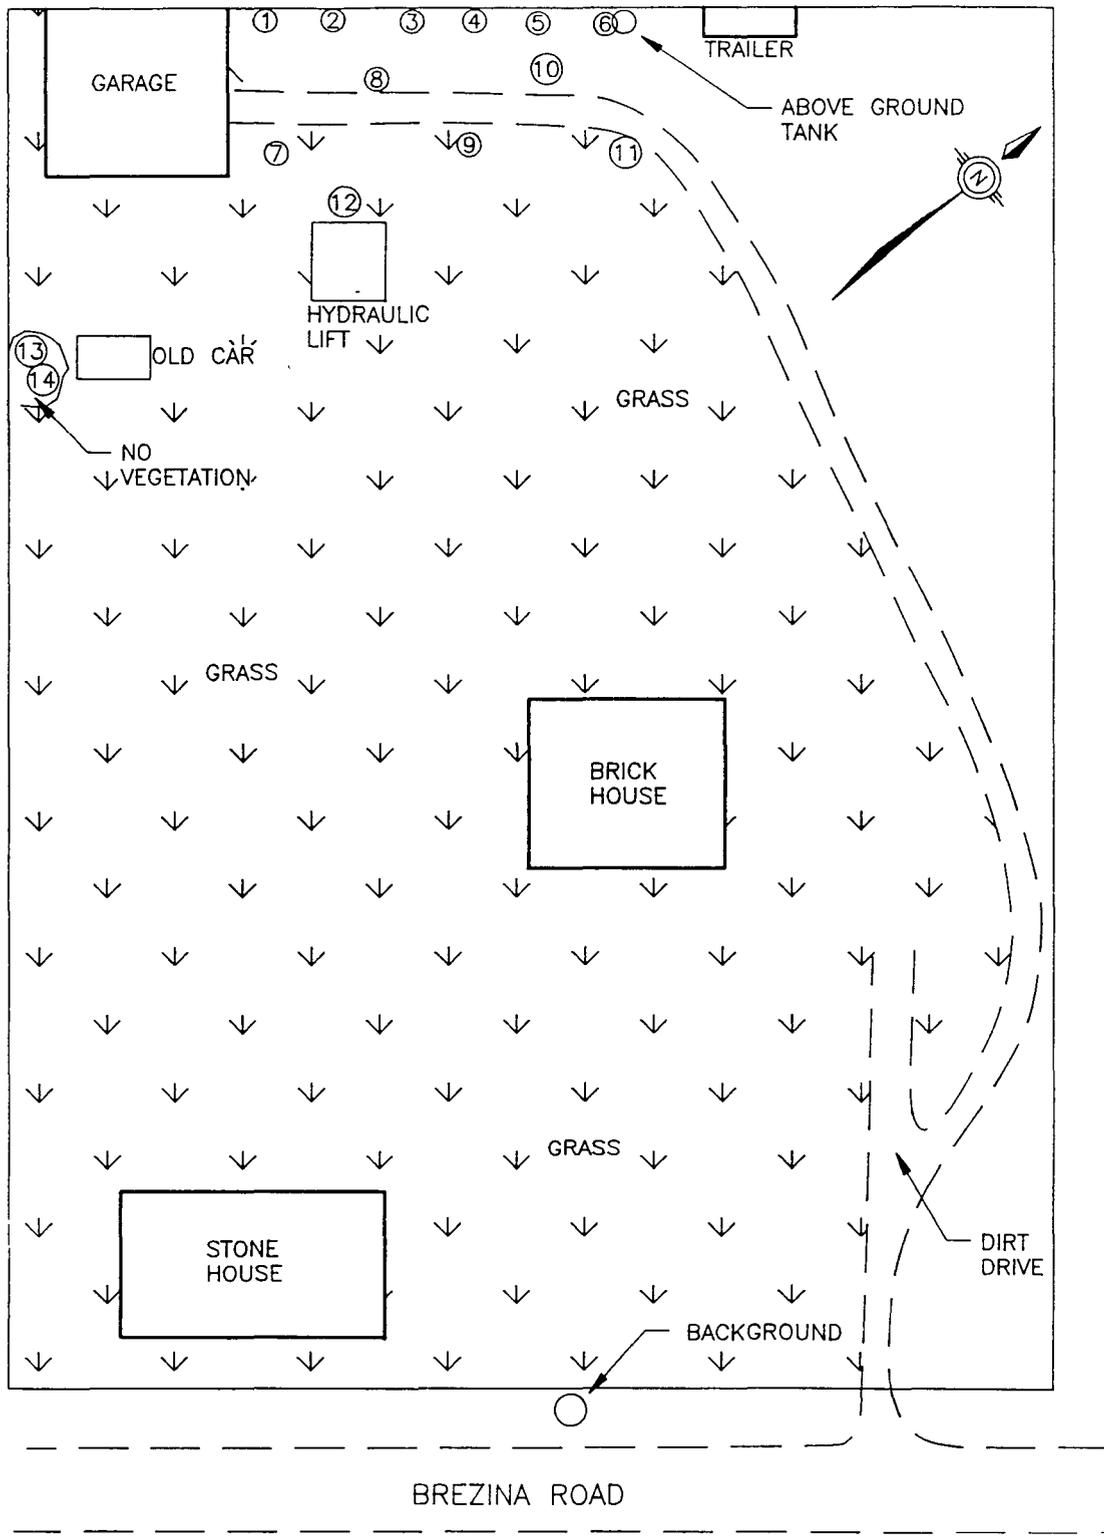
FIGURE 2
 SITE MAP AND SAMPLE LOCATIONS
 PARCEL C-15

All surface soil samples at this parcel were collected with a stainless-steel hand auger (see Figure 2). Except for sample 15-5, all samples were analyzed for TPH (total petroleum hydrocarbons) and BTEX (benzene, toluene, ethylbenzene, and xylene). Samples 15-1 through 15-11 were collected adjacent to the garage in the back corner of the residential parcel where petroleum products have supposedly been disposed. Sample 15-12 was collected adjacent to the hydraulic lift. Samples 15-13 and 15-14 were collected next to an old car in an area uncharacteristically devoid of vegetation. A background sample collected near the front of the parcel between the fence and the small ditch adjacent to Brezina Road was submitted for total RCRA metals analysis.

Sample 15-5 had the highest PID reading and was submitted for VOC (volatile organic compounds), SVOC (semi volatile organic compounds), total metals, TPH, and pesticide analysis as required in the plan of action.

TPH exceeded 100 ppm in samples 15-2 through 15-9, which were collected between the garage and the above-ground tank and the trailer. See Table 1 for results.

Sample 15-5 had concentrations of arsenic, cadmium, chromium, and lead at or above background and the GWP-Res. Arsenic was detected at 5 ppm, cadmium at 1.3 ppm, chromium at 16.0 ppm, and lead at 40.0 ppm. The GWP-Res. values for these metals in ppm are, respectively, 5.0, 0.5, 10.0, and 1.0. This sample was collected between samples 15-4 and 15-6 south of the above-ground tank and trailer.

High concentrations of TPH were found within the surface soil in samples 15-2 through 15-9. These samples were collected between the garage and the above ground tank and trailer.

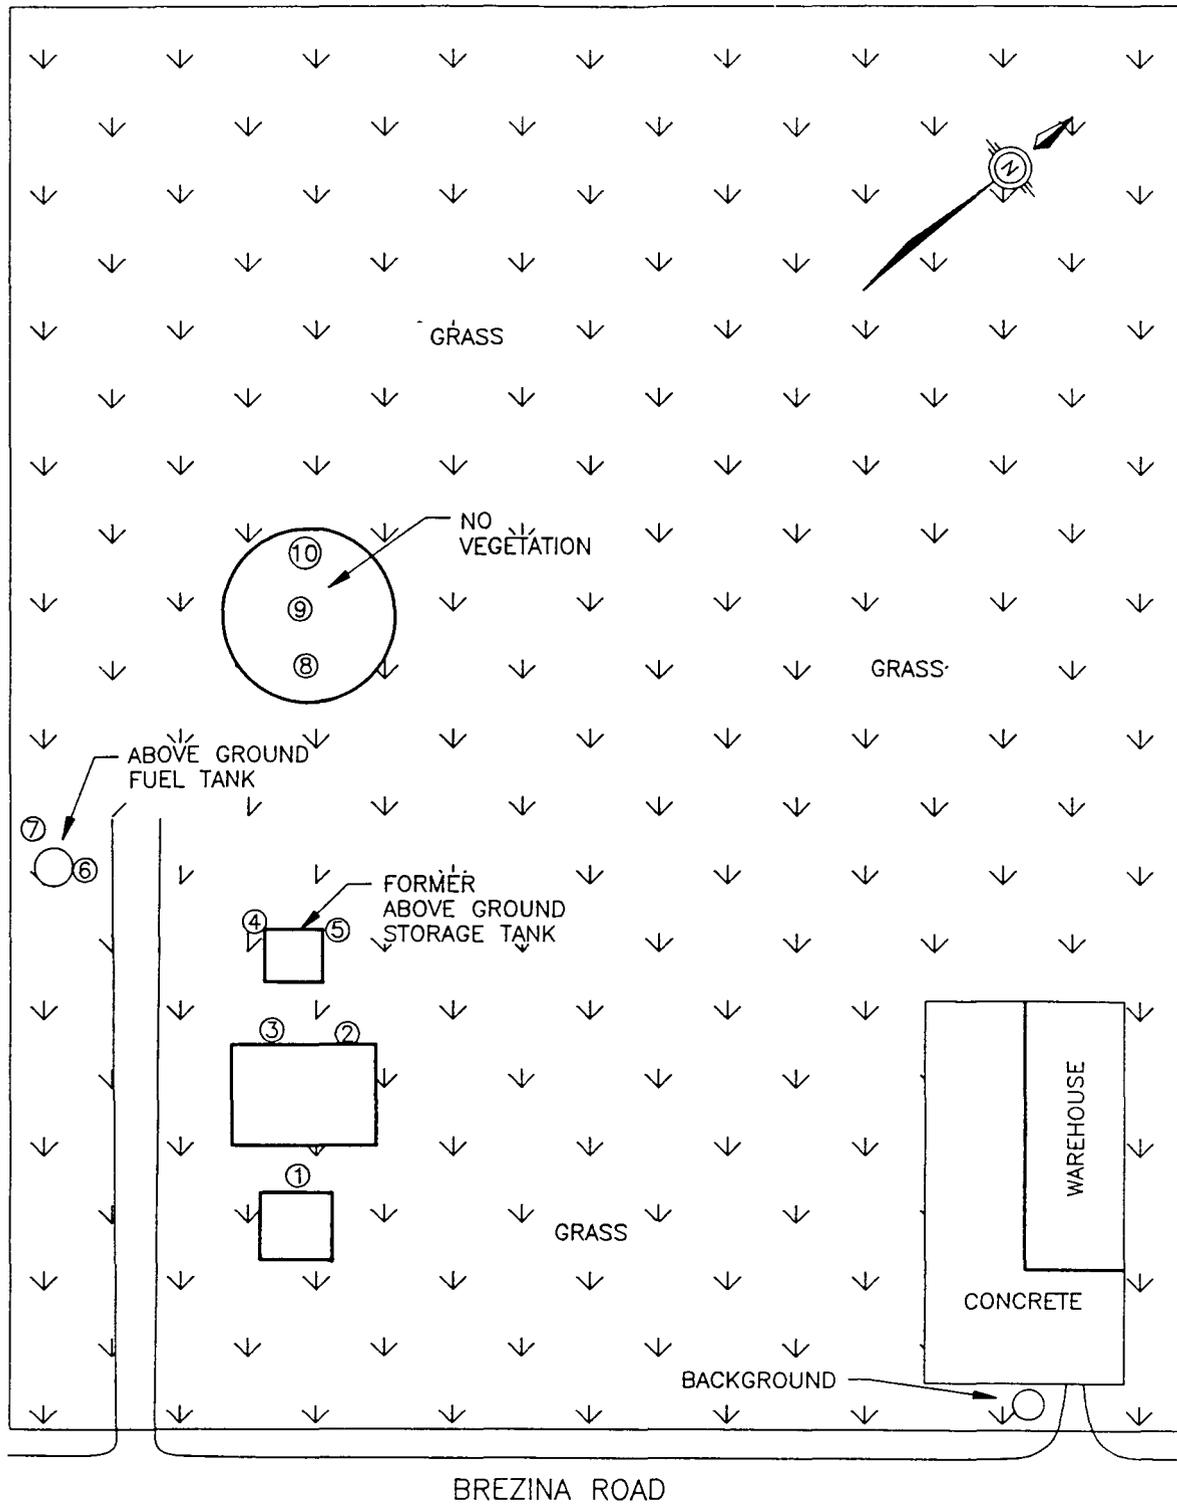
FIGURE 3
 SITE MAP AND SAMPLE LOCATIONS
 PARCEL C-16

Surface soil samples at this parcel were collected with a stainless-steel hand auger (see Figure 3). Samples 16-1 through 16-3 were collected adjacent to the two storage buildings and were analyzed for TPH, VOC, and pesticides. Samples 16-4 and 16-5 were collected next to the former location of the above-ground storage tank and were analyzed for TPH and BTEX.

Samples 16-6 and 16-7 collected next to the above-ground fuel tank and were also analyzed for TPH and BTEX. Samples 16-8 through 16-10 were collected within an area uncharacteristically devoid of vegetation where it is believed the 5400-gallon fiberglass tank was located and were analyzed for TPH, VOC, and pesticide analysis. A background sample was collected adjacent to the driveway leading to the storage facility and was analyzed for total RCRA metals analysis.

TPH exceeded 100 ppm at samples 16-2 and 16-4 through 16-10. These samples were collected from the northern most storage area, the former above ground storage tank location, the area adjacent to the fuel tank, and the area devoid of vegetation. See Table 2 for results.

High concentrations of TPH were found in the soil in samples 16-2 and 16-4 through 16-10. These samples were collected adjacent to the storage buildings, next to the former location of the above ground storage tank, next to the above ground fuel tank, and the area devoid of vegetation where it is believed the 5400 gallon fiberglass tank was located.

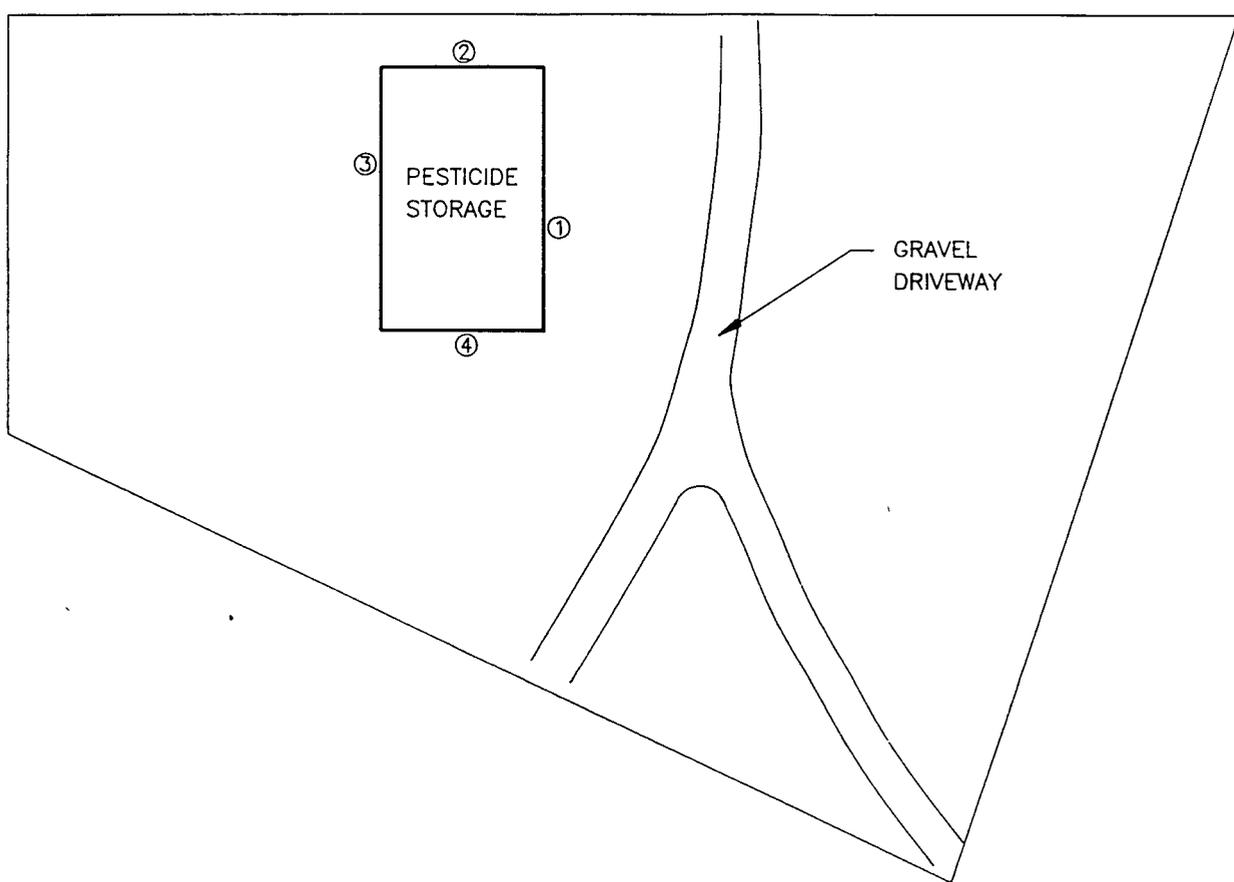
FIGURE 4
SITE MAP AND SAMPLE LOCATIONS
PARCEL C-17

Surface soil samples 17-1 through 17-4 were collected with stainless-steel spoons and analyzed for pesticides (see Figure 4). One sample was collected from each side of the pesticide storage building.

Samples from this parcel were analyzed for pesticides only. Several pesticides were detected, but none of the samples exceeded GWP-Res. values.

No pesticide samples showed contamination above the GWP-Res. values.

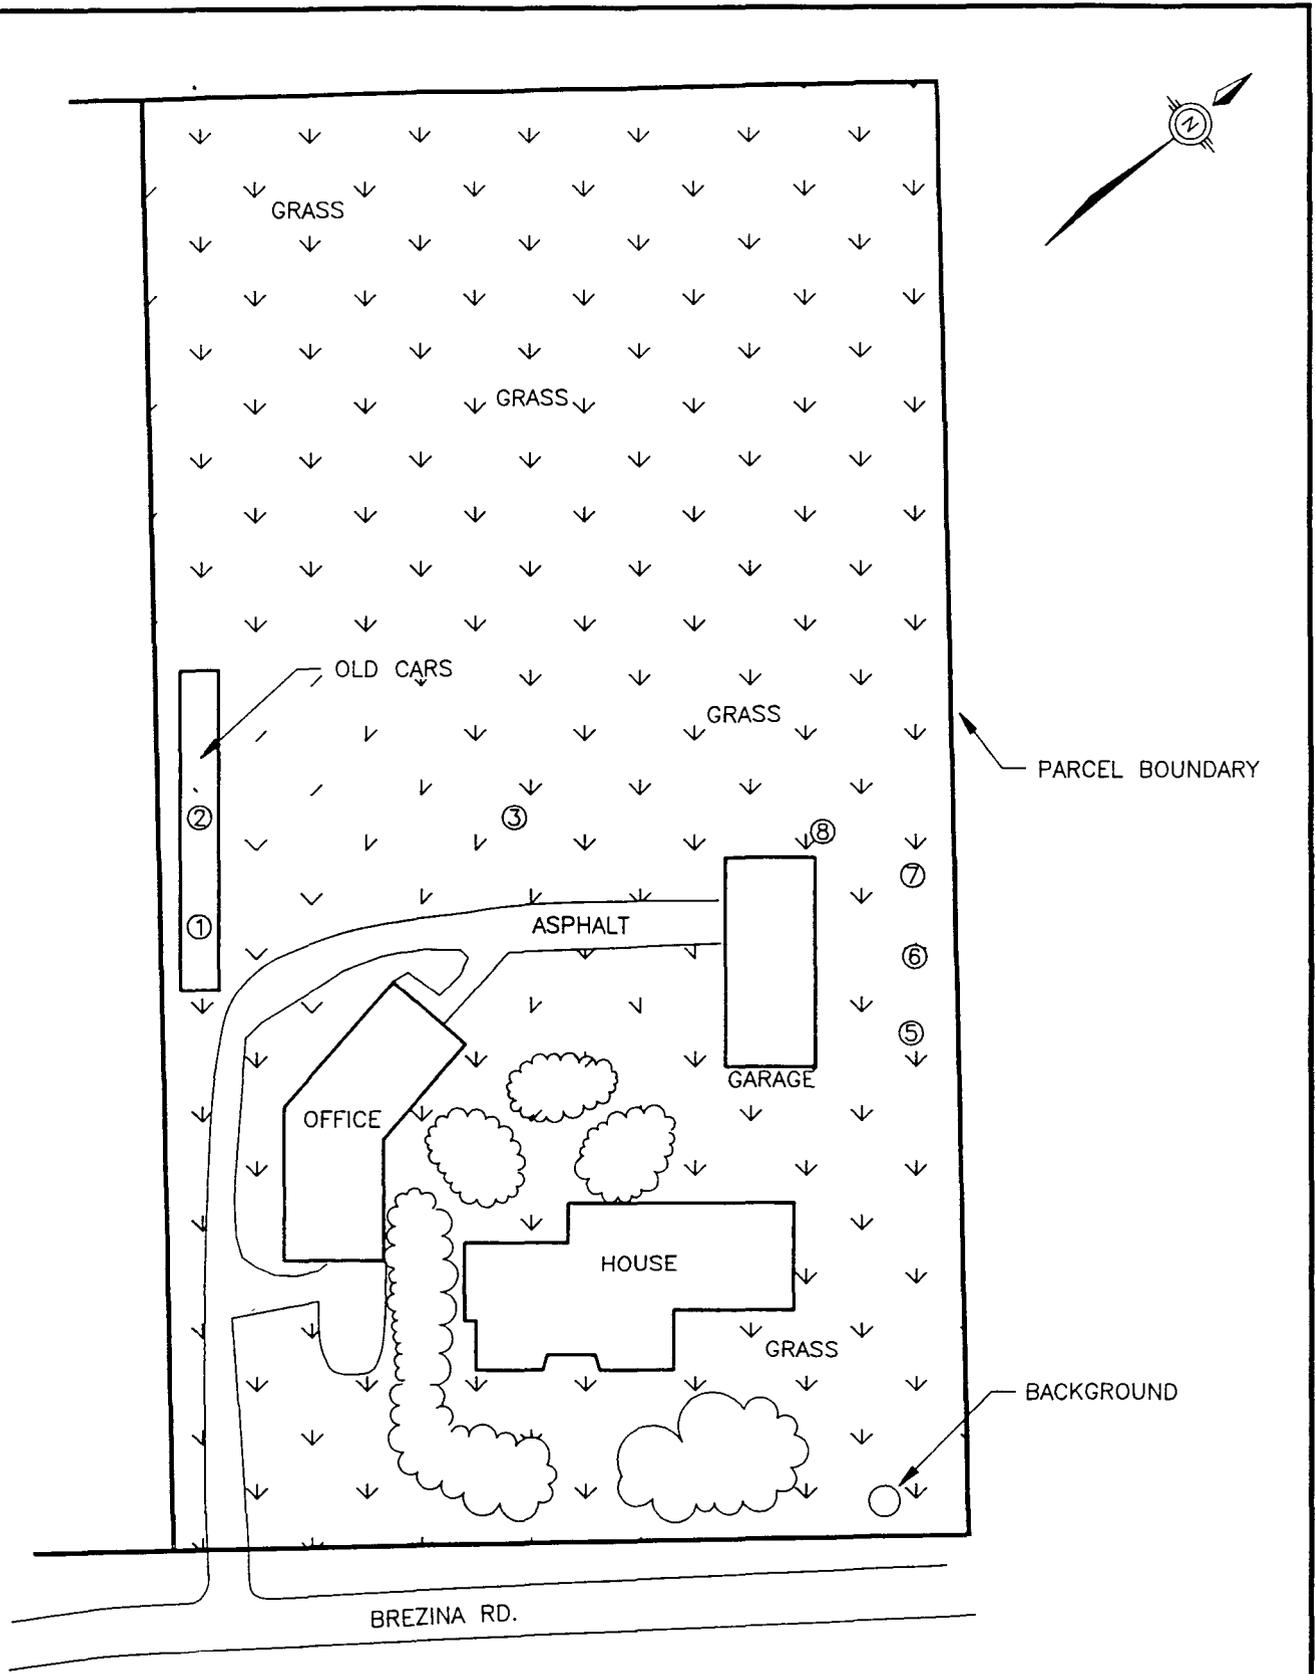
FIGURE 5
 SITE MAP AND SAMPLE LOCATIONS
 PARCEL C-18

A total of 7 surface soil samples were collected with a stainless-steel hand auger (see Figure 5). Samples 18-1 and 18-2 were collected within the area of the old cars and were analyzed for TPH and BTEX. Sample 18-3, collected north of the asphalt road, was also analyzed for TPH and BTEX. Sample 18-4 was not collected. Samples 18-5 through 18-7 were collected north of the garage and were analyzed for TPH, VOC, and RCRA metals. Sample 18-8 was also collected north of the garage and was analyzed for RCRA metals and TCLP metals. A background sample was collected near the corner of the property adjacent to the residence on the parcel and was submitted for RCRA metals analysis.

Two samples were supposed to be collected from an oil-stained area in the center of the site. However, E/A&H personnel were unable to locate the oil stain. Sample 18-3 was collected from an area of dark soil in the presumed vicinity of the oil stain, but sample 18-4 was not collected at a lower depth because the presence of oil could not be confirmed.

No VOC or BTEX compounds were detected at any sampling location. TPH exceeded 100 ppm in samples 18-3, 18-4, and 18-7 which were collected from north of the asphalt road and northeast of the garage. See Table 3 for results.

Samples 18-5, 18-6, and 18-8 were all collected north of the garage and all contained metals above background and the GWP-Res. values. See Table 4 for results.

High concentrations of TPH were found in samples 18-3, 18-5 and 18-7 located north of the asphalt road and northeast of the garage. Samples 18-5, 18-6, and 18-8 also had elevated levels

of barium, chromium, and lead. These samples were collected from north of the asphalt and northeast of the garage.
