REMOVAL OF SOIL DEBRIS ACTIVITY AT OFF SITE WEAPONS STORAGE AREA NAS
FORT WORTH TX
10/1/1993
METCALF AND EDDY

REPORT OF SOIL/DEBRIS REMOVAL ACTIVITY

OFF-SITE WEAPONS STORAGE AREA

CARSWELL AFB, TEXAS

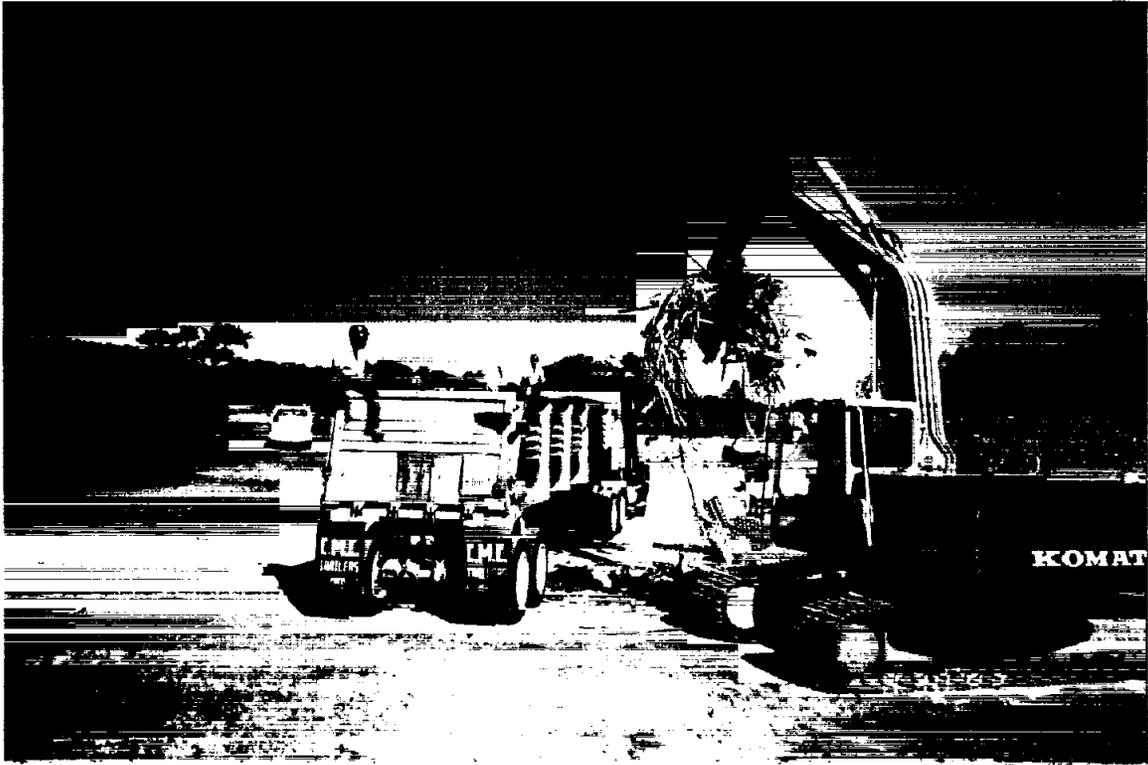
PHOTOGRAPH 3 Loading Debris into the Dump Trucks

The removal action took place on September 30, 1993. Eagle Construction & Environmental Services provided the track-hoe, the 20 cubic yard (yd³) dump trucks, and manpower to perform the removal. The track hoe was positioned on the edge of the limestone ledge and used its bucket to load the debris into the dump trucks. Chains were used to draw larger pieces to within reach of the track hoe. Smaller pieces which had migrated within 300 feet downstream were picked up by hand and brought to the collection point. The trackhoe was used to dig under the lip of the limestone. Smaller pieces were picked up by hand. A total of six truckloads were taken to the Westside Sanitary Landfill, Ft. Worth, Texas (a Waste Management facility).

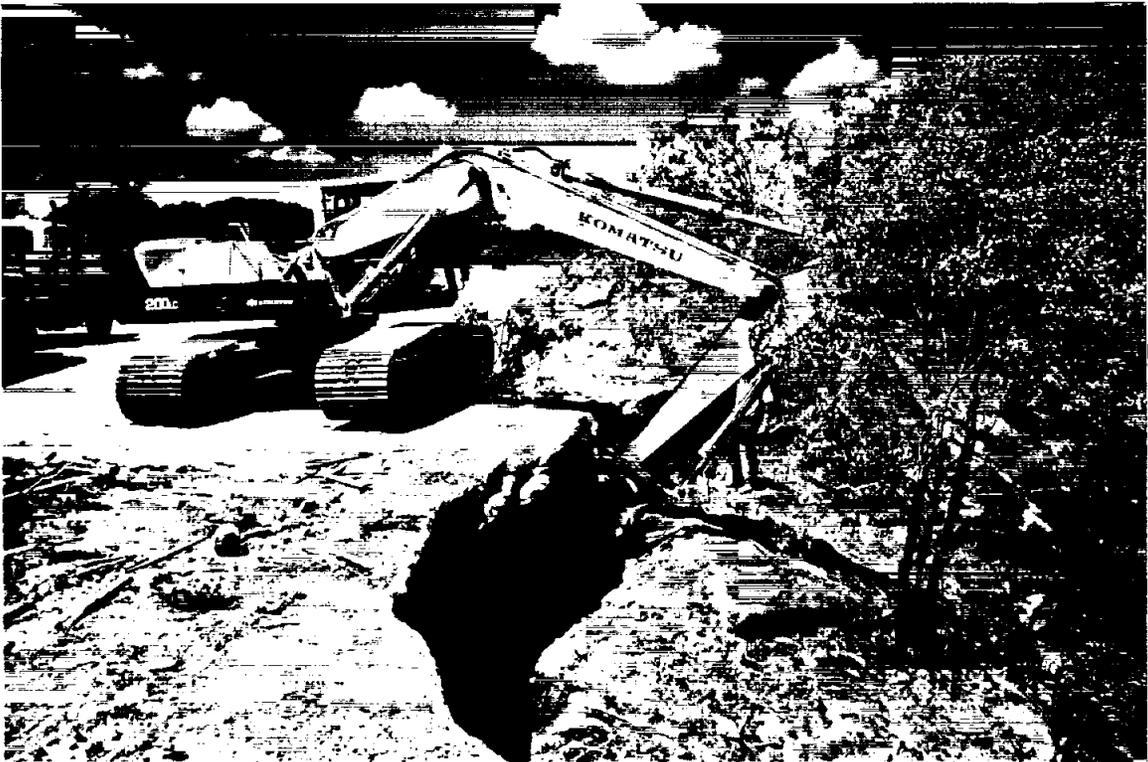
PHOTOGRAPH 4 Excavation under the Limestone Ledge

A closure sample was taken from the soil under the limestone ledge. The sample procedures for this soil sample are the same as described previously in Section 3. The analytical parameters are the same as described in Section 4. All of the analytical results (see Tables 5-1 and 5-2) for volatile organic compounds, BTEX, and semi-volatile compounds were not detected above the method detection limits with the exception of tetrachloroethene which was detected at 4.9 $\mu\text{g}/\text{kg}$. This is a trace amount present less than 3 ppb above the method detection limit. If one employs the same methodology of dividing by 20 to obtain the TCLP concentration, this trace amount would be non-hazardous. Given the highly volatile nature of this compound and the semi-arid conditions which exist in this portion of Texas, it is doubtful that resampling would be able to detect this compound at this location of the debris to the landfill.

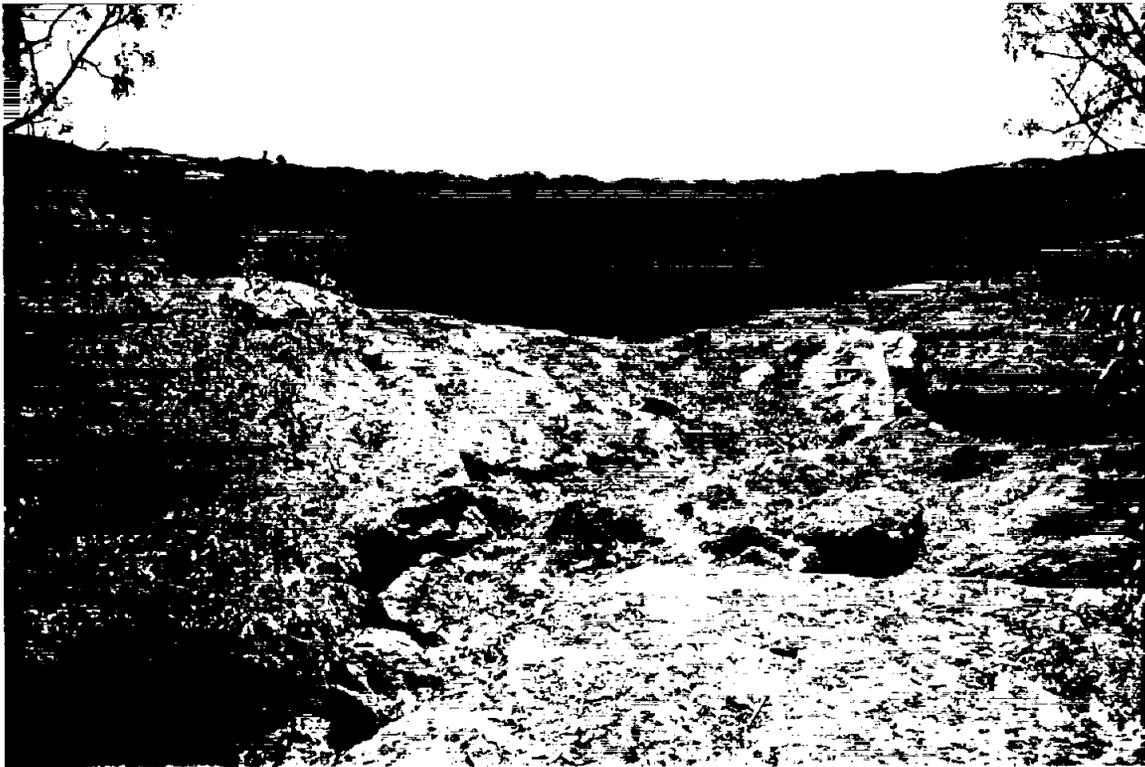
PHOTOGRAPH 7 View of Cleaned Area up towards the Limestone Ledge

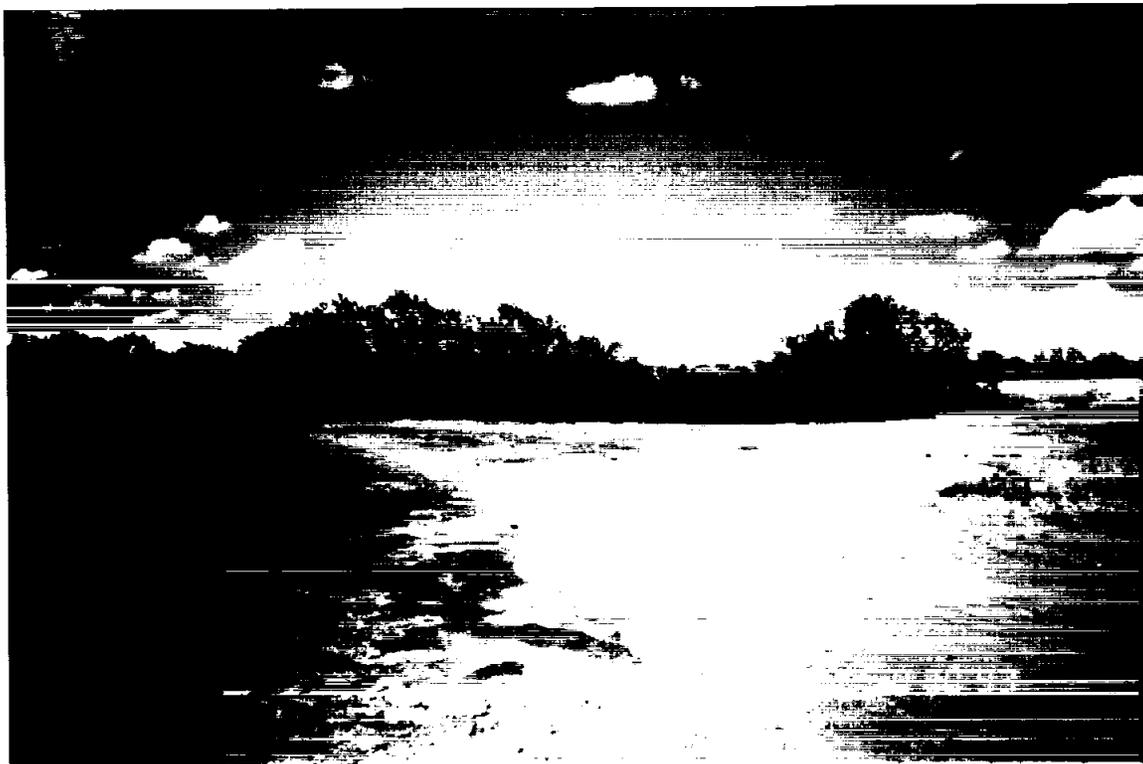
PHOTOGRAPH 8 View of Area Prior to Departure
