POSTER MATERIALS PRESENTED AT THE NOVEMBER 2014 RESTORATION ADVISORY  
BOARD MEETING AND PUBLIC AVAILABILITY SESSION FOR RUBBLE DISPOSAL AREA  
(SITE 7) NCBC GULFPORT MS  
11/3/2014  
NAVFAC SOUTHERN

# REMEDIAL INVESTIGATION AT THE RUBBLE DISPOSAL AREA (SITE 7)

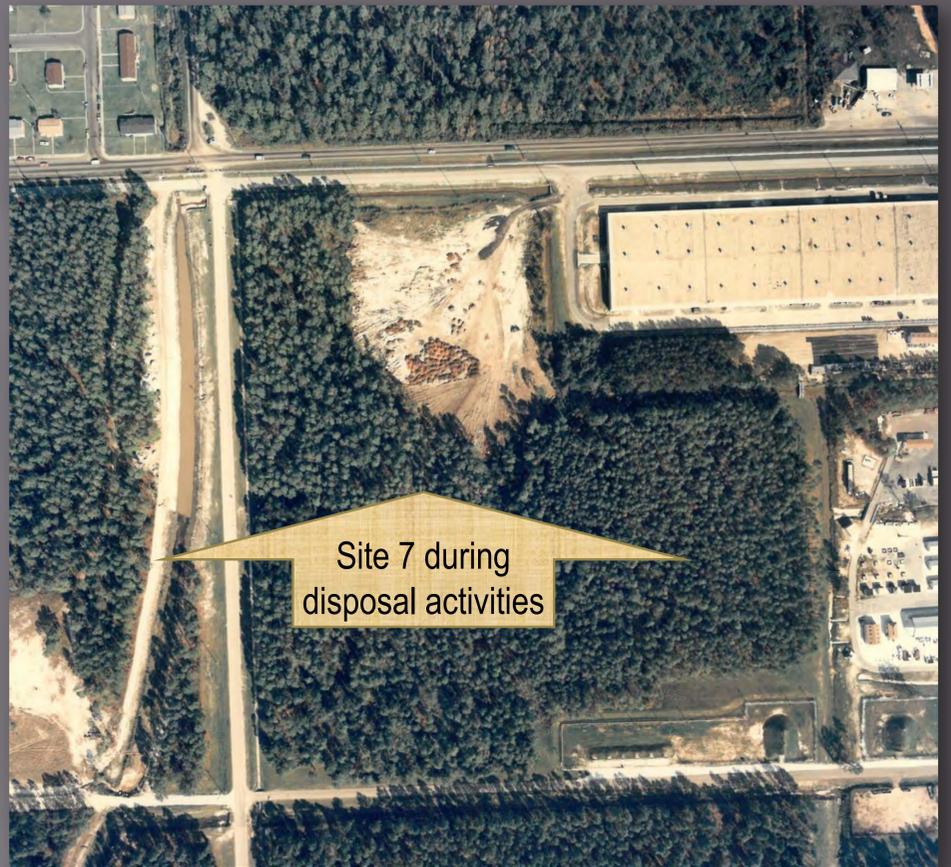
Initial Site 7 boundaries as identified in the 1985 Initial Assessment Study.

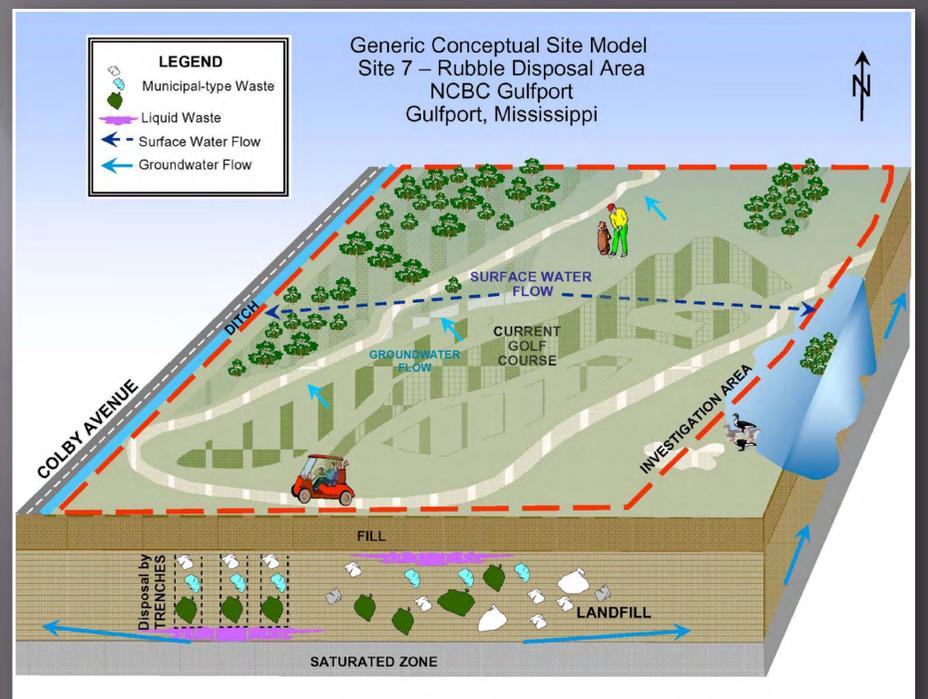
This Site Conceptual Model shows the Navy's understanding of Site 7. This model may be slightly modified based on new findings.

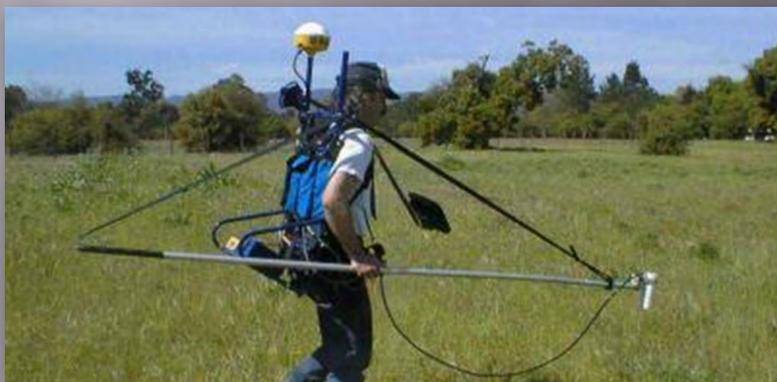
A typical magnetometer survey instrument

- ▣ Geophysics helped define the boundaries of the site by locating disposal “cells.”
- ▣ A series of 3-foot deep borings were completed on a 100-foot grid to visually identify buried waste.
- ▣ Soil gas studies showed that methane gas, volatile organic compounds, and hydrogen sulfide were below the appropriate action level.

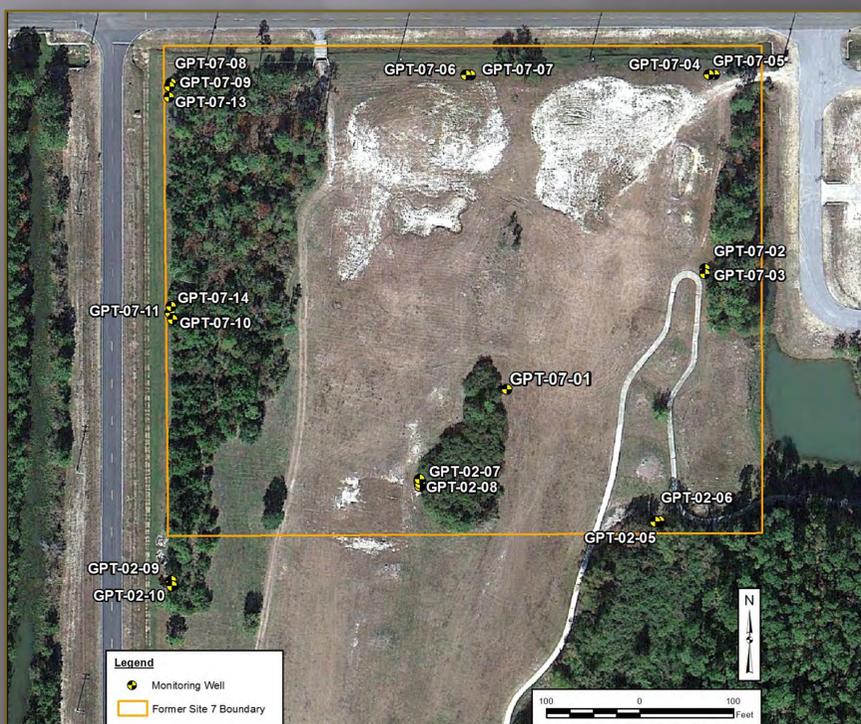
Monitoring Well Locations at Site 7

- ▣ Seventeen (17) groundwater monitoring wells were installed along the perimeter of Site 7.
- ▣ Low concentrations of contaminants found in the groundwater are being evaluated as part of the human health risk assessment.

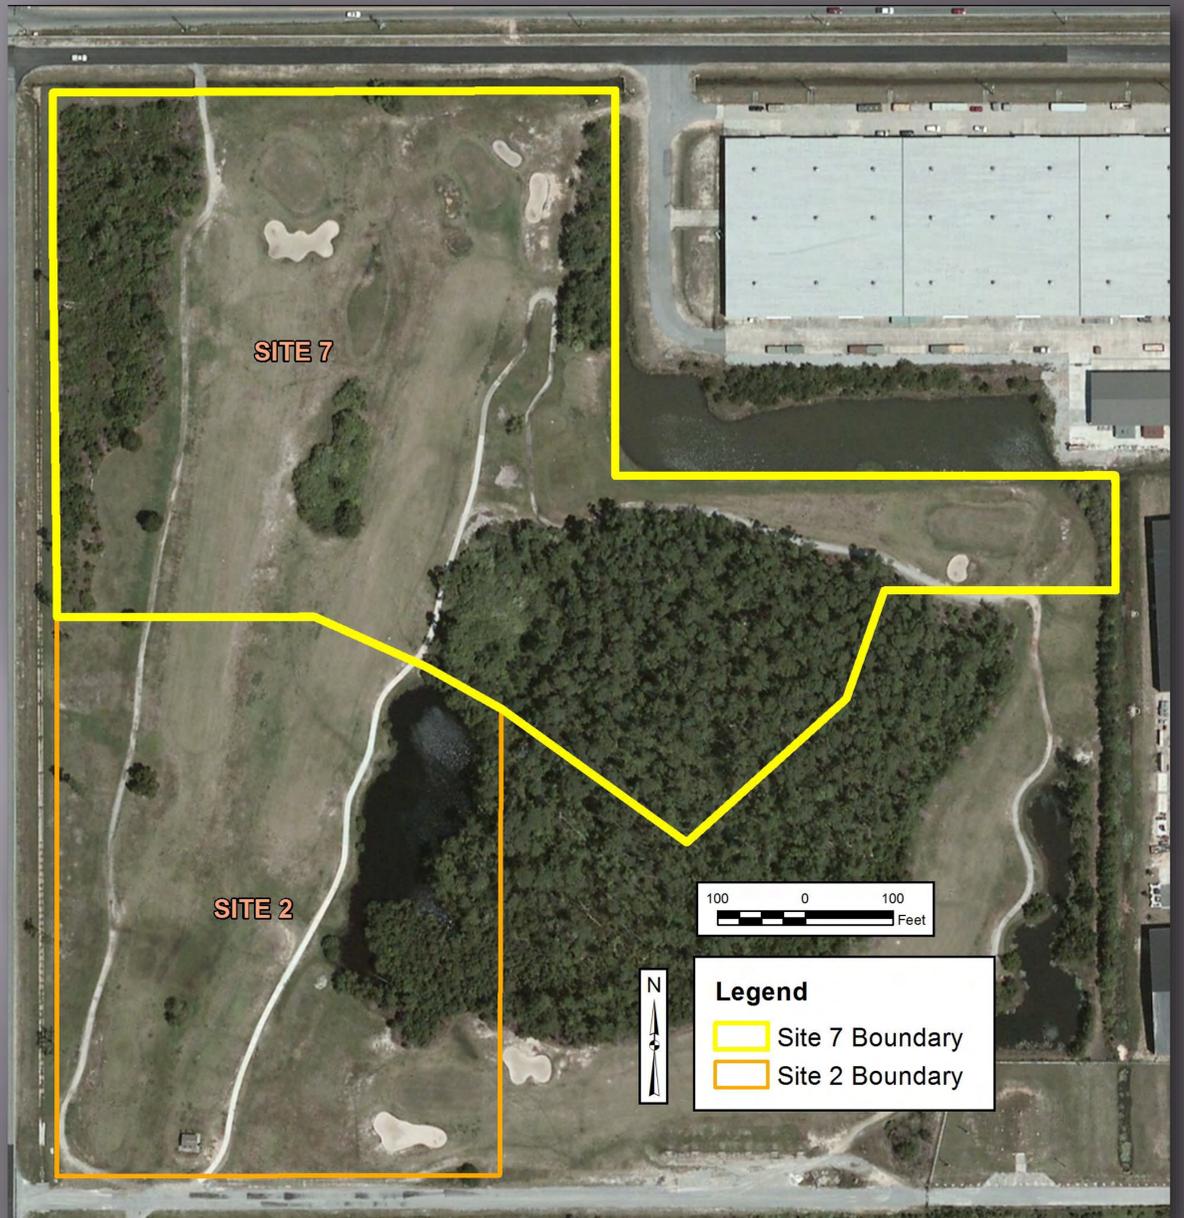
New boundaries of Site 7 based on investigation results.

- ▣ Additional sampling was completed to determine the depth and areal extent of contamination.
- ▣ The types of dioxins found during Phase 3 indicate that Herbicide Orange may be the source.
- ▣ The site was found to be larger than previously understood.

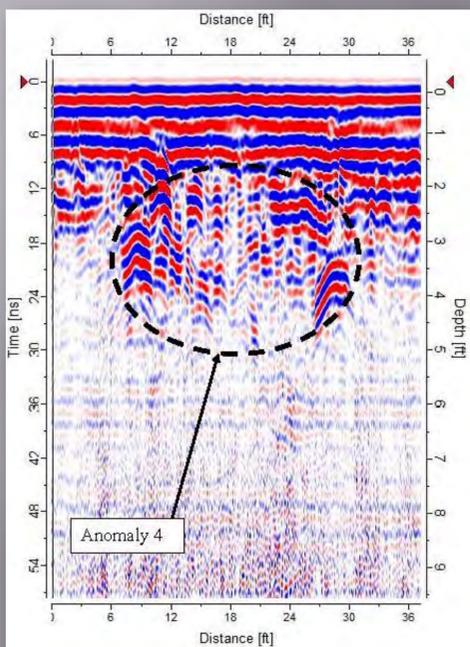
A ground penetrating radar (GPR) result indicating a buried metal item.

- ▣ Ground Penetrating Radar (GPR) was used to look for possible drums-sized objects.
- ▣ Trenching of the area was completed to identify the objects found with the GPR.
- ▣ Items targeted by the GPR were identified as construction rubble, as previously reported.

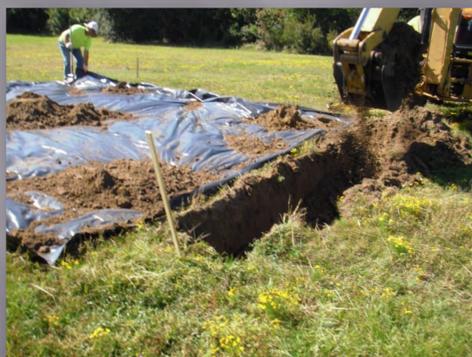
Trenching at Site 7

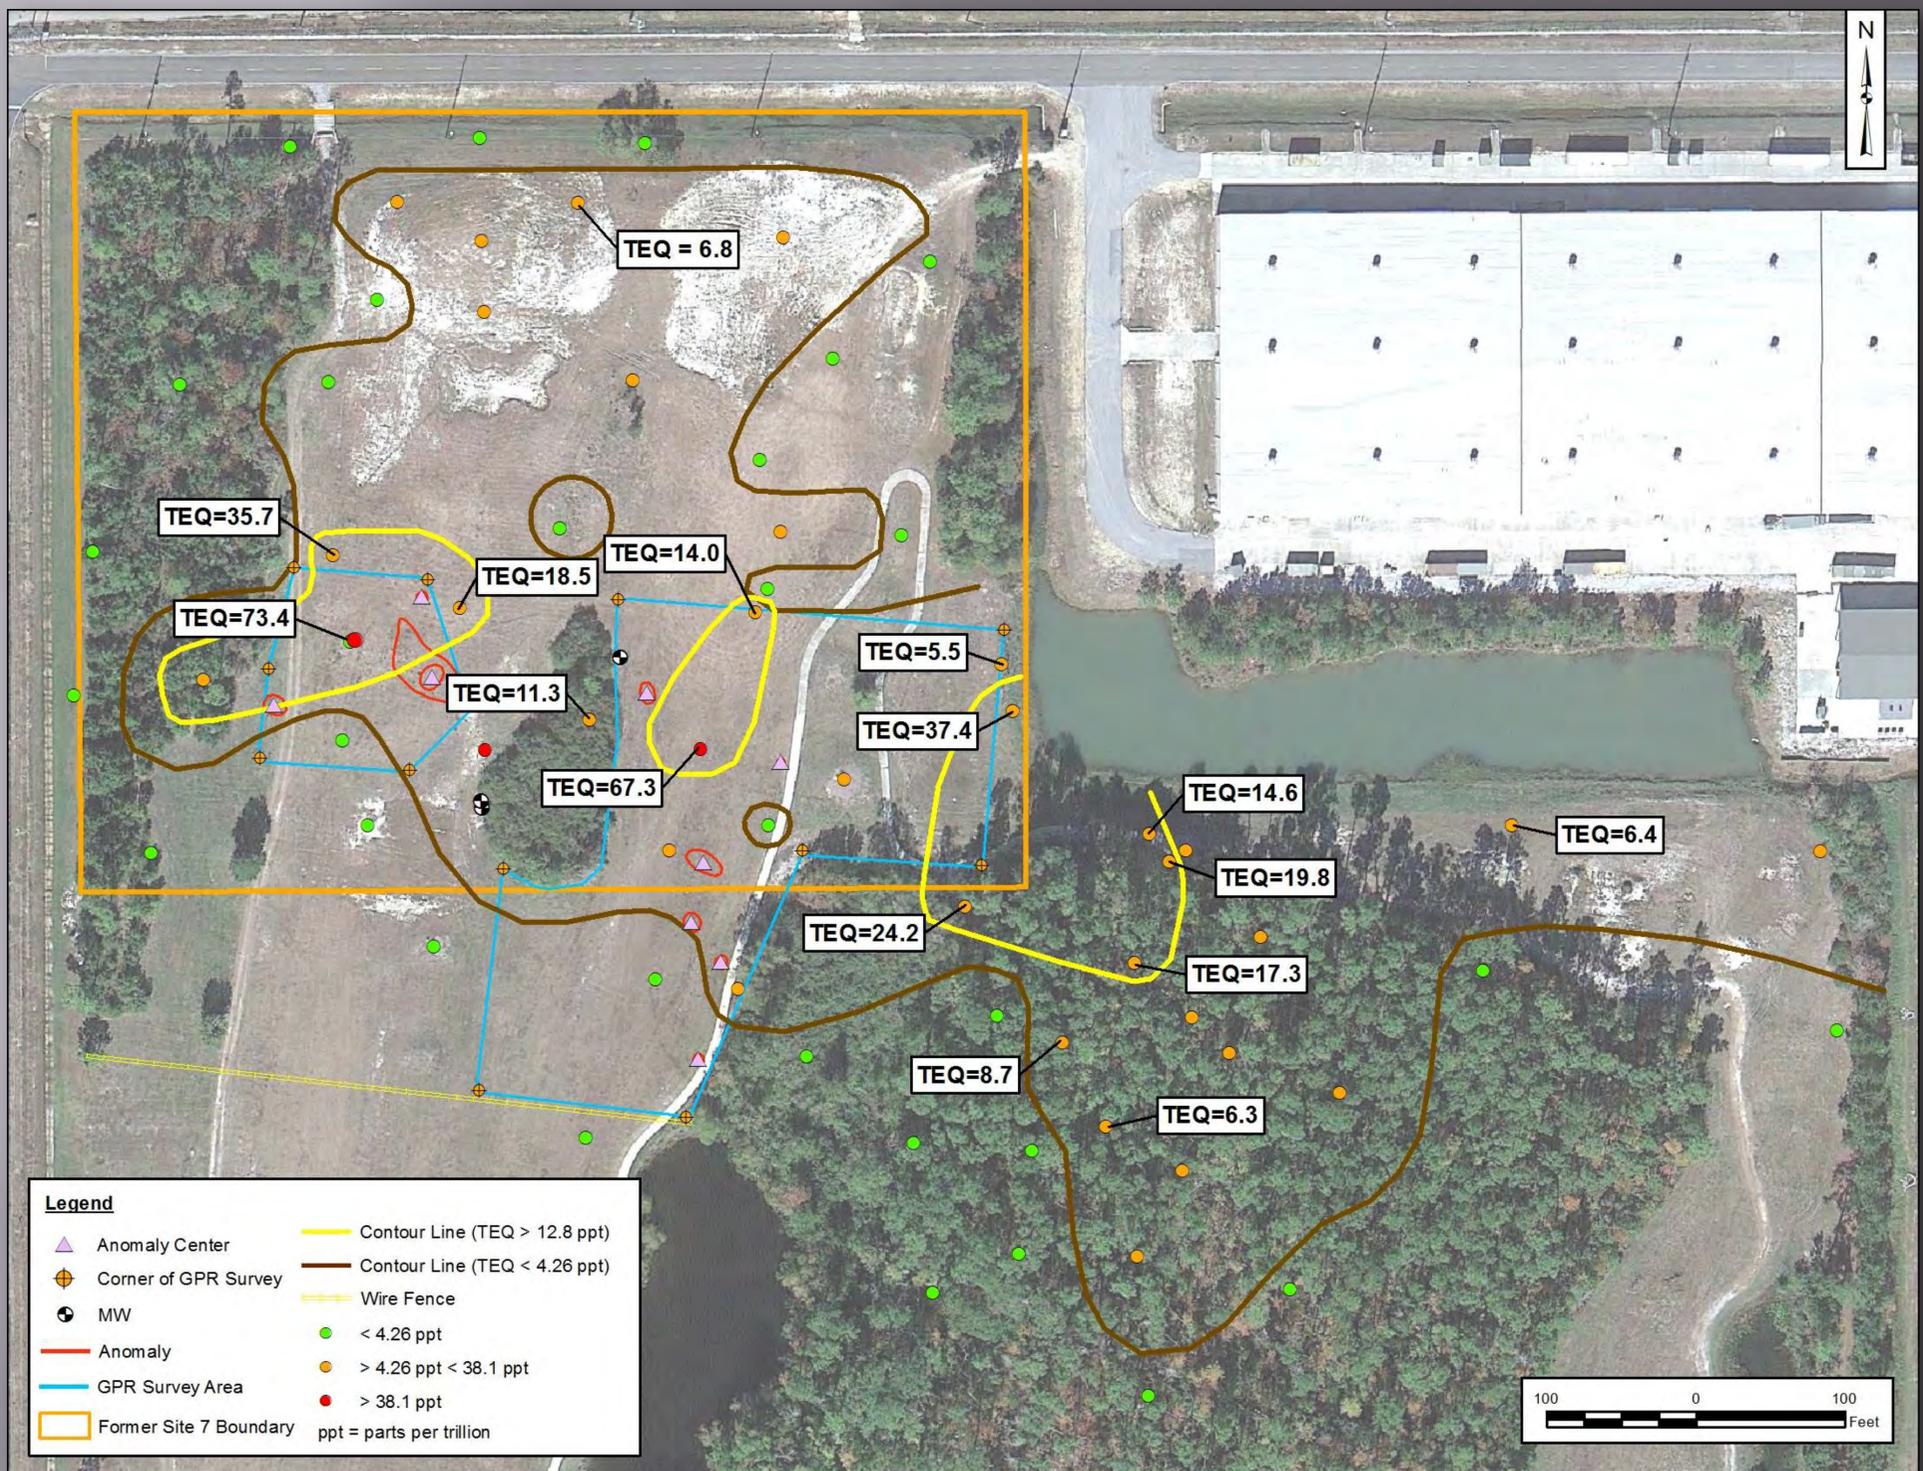
Surface Soil Sampling Results (0 – 2 Feet)

- Sixty-three (63) surface soil samples were collected.
- Thirty-two (32) samples contained dioxins at levels higher than MDEQs screening level of 4.26 ppt.
- Forty-eight (48) of these samples contained TCDD, the type of dioxin we often use to indicate that the source is Herbicide Orange.
- Dioxin concentrations ranged from 0.25 ppt to 73.4 ppt.

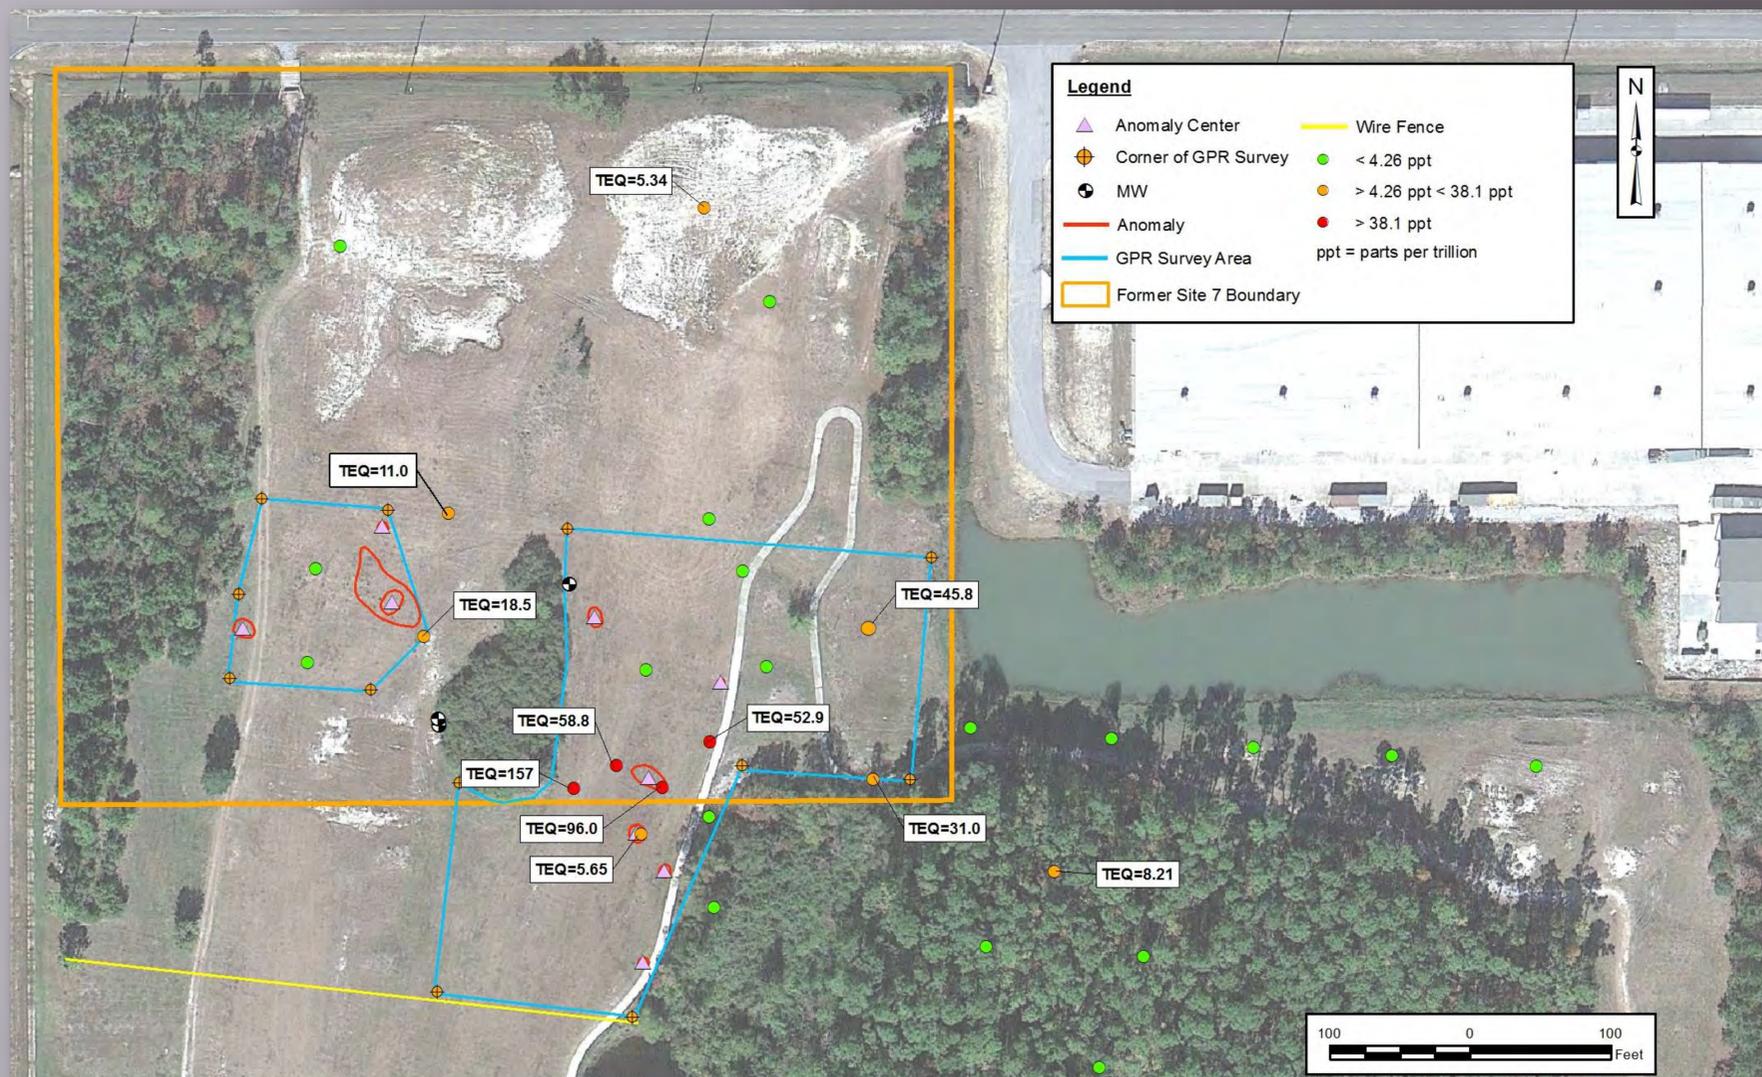
Subsurface Soil Sampling Results (3 - 5 Feet)

- ▣ Twenty eight (28) soil samples were collected from 3 to 5 feet below ground surface.
- ▣ TCDD was found in 16 samples.
- ▣ Thirteen (13) samples contained dioxins at levels higher than MDEQ's screening level of 4.26 ppt.
- ▣ Dioxin concentrations ranged from 2.1 to 157 ppt.

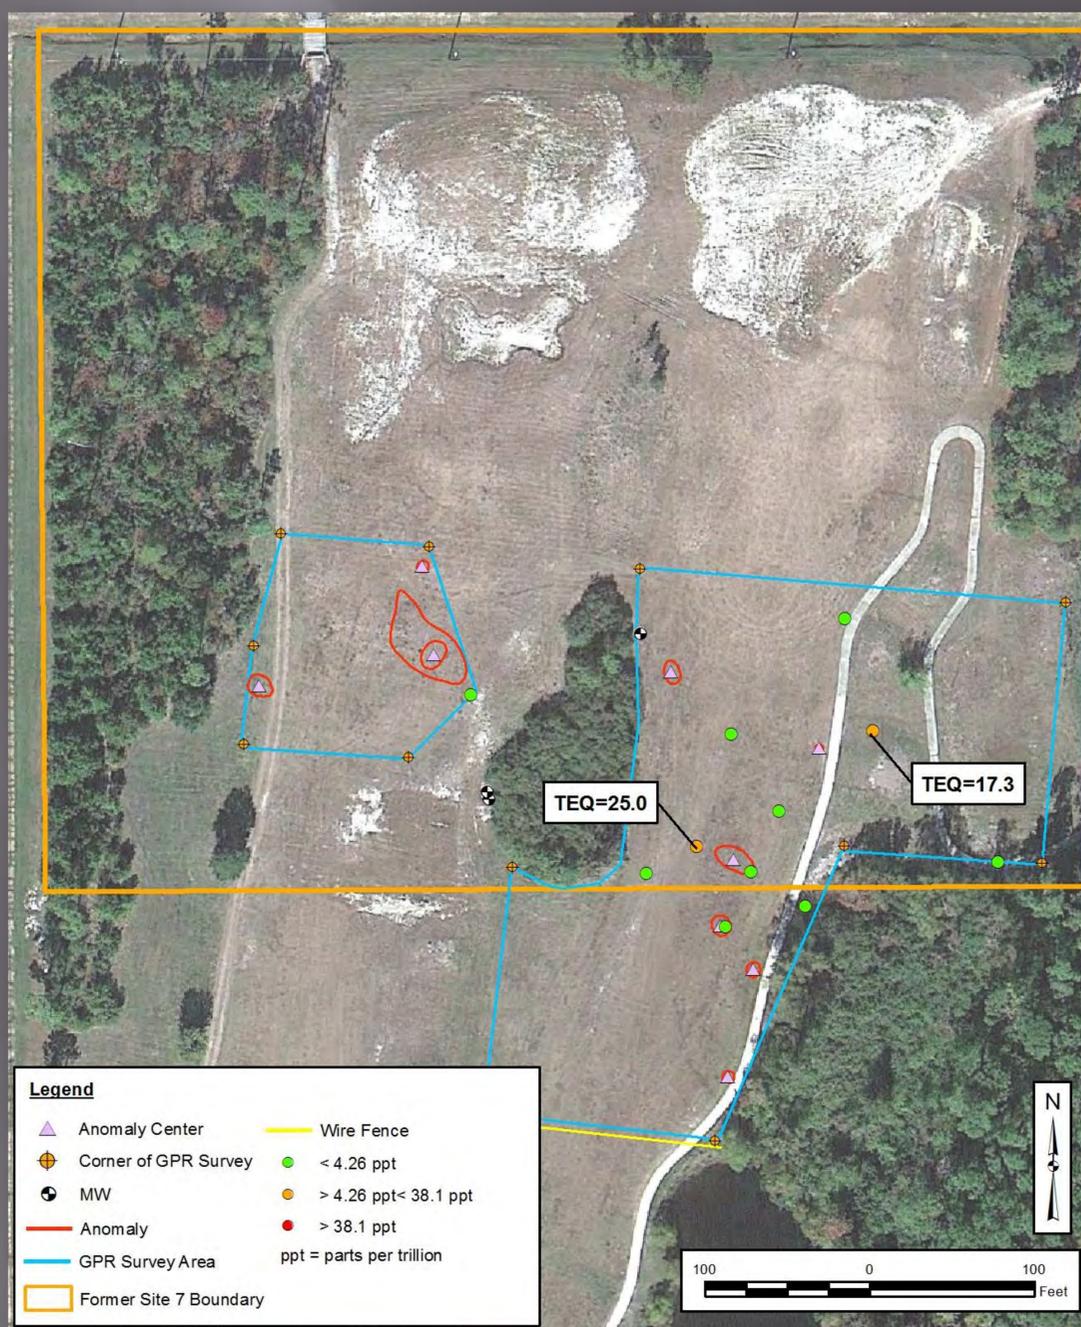
- ▣ Twelve (12) soil samples were collected at 6 to 8 feet below ground surface.
- ▣ TCDD was found in 2 samples.
- ▣ Two (2) samples contained dioxins at levels higher than MDEQ's screening level of 4.26 ppt.
- ▣ Dioxin concentrations ranged from 1.91 to 25.0 ppt.

Subsurface Soil Sampling Results (6 - 8 Feet)
