OUTFALLS 4 AND 5 HERBICIDE ORANGE INVESTIGATION NCBC GULFPORT MS
3/3/2006
TETRA TECH

Outfalls 4 and 5 Herbicide Orange Investigation

Naval Construction Battalion Center
Gulfport, Mississippi

Subject: **Final Outfalls 4 and 5 Herbicide Orange Investigation**

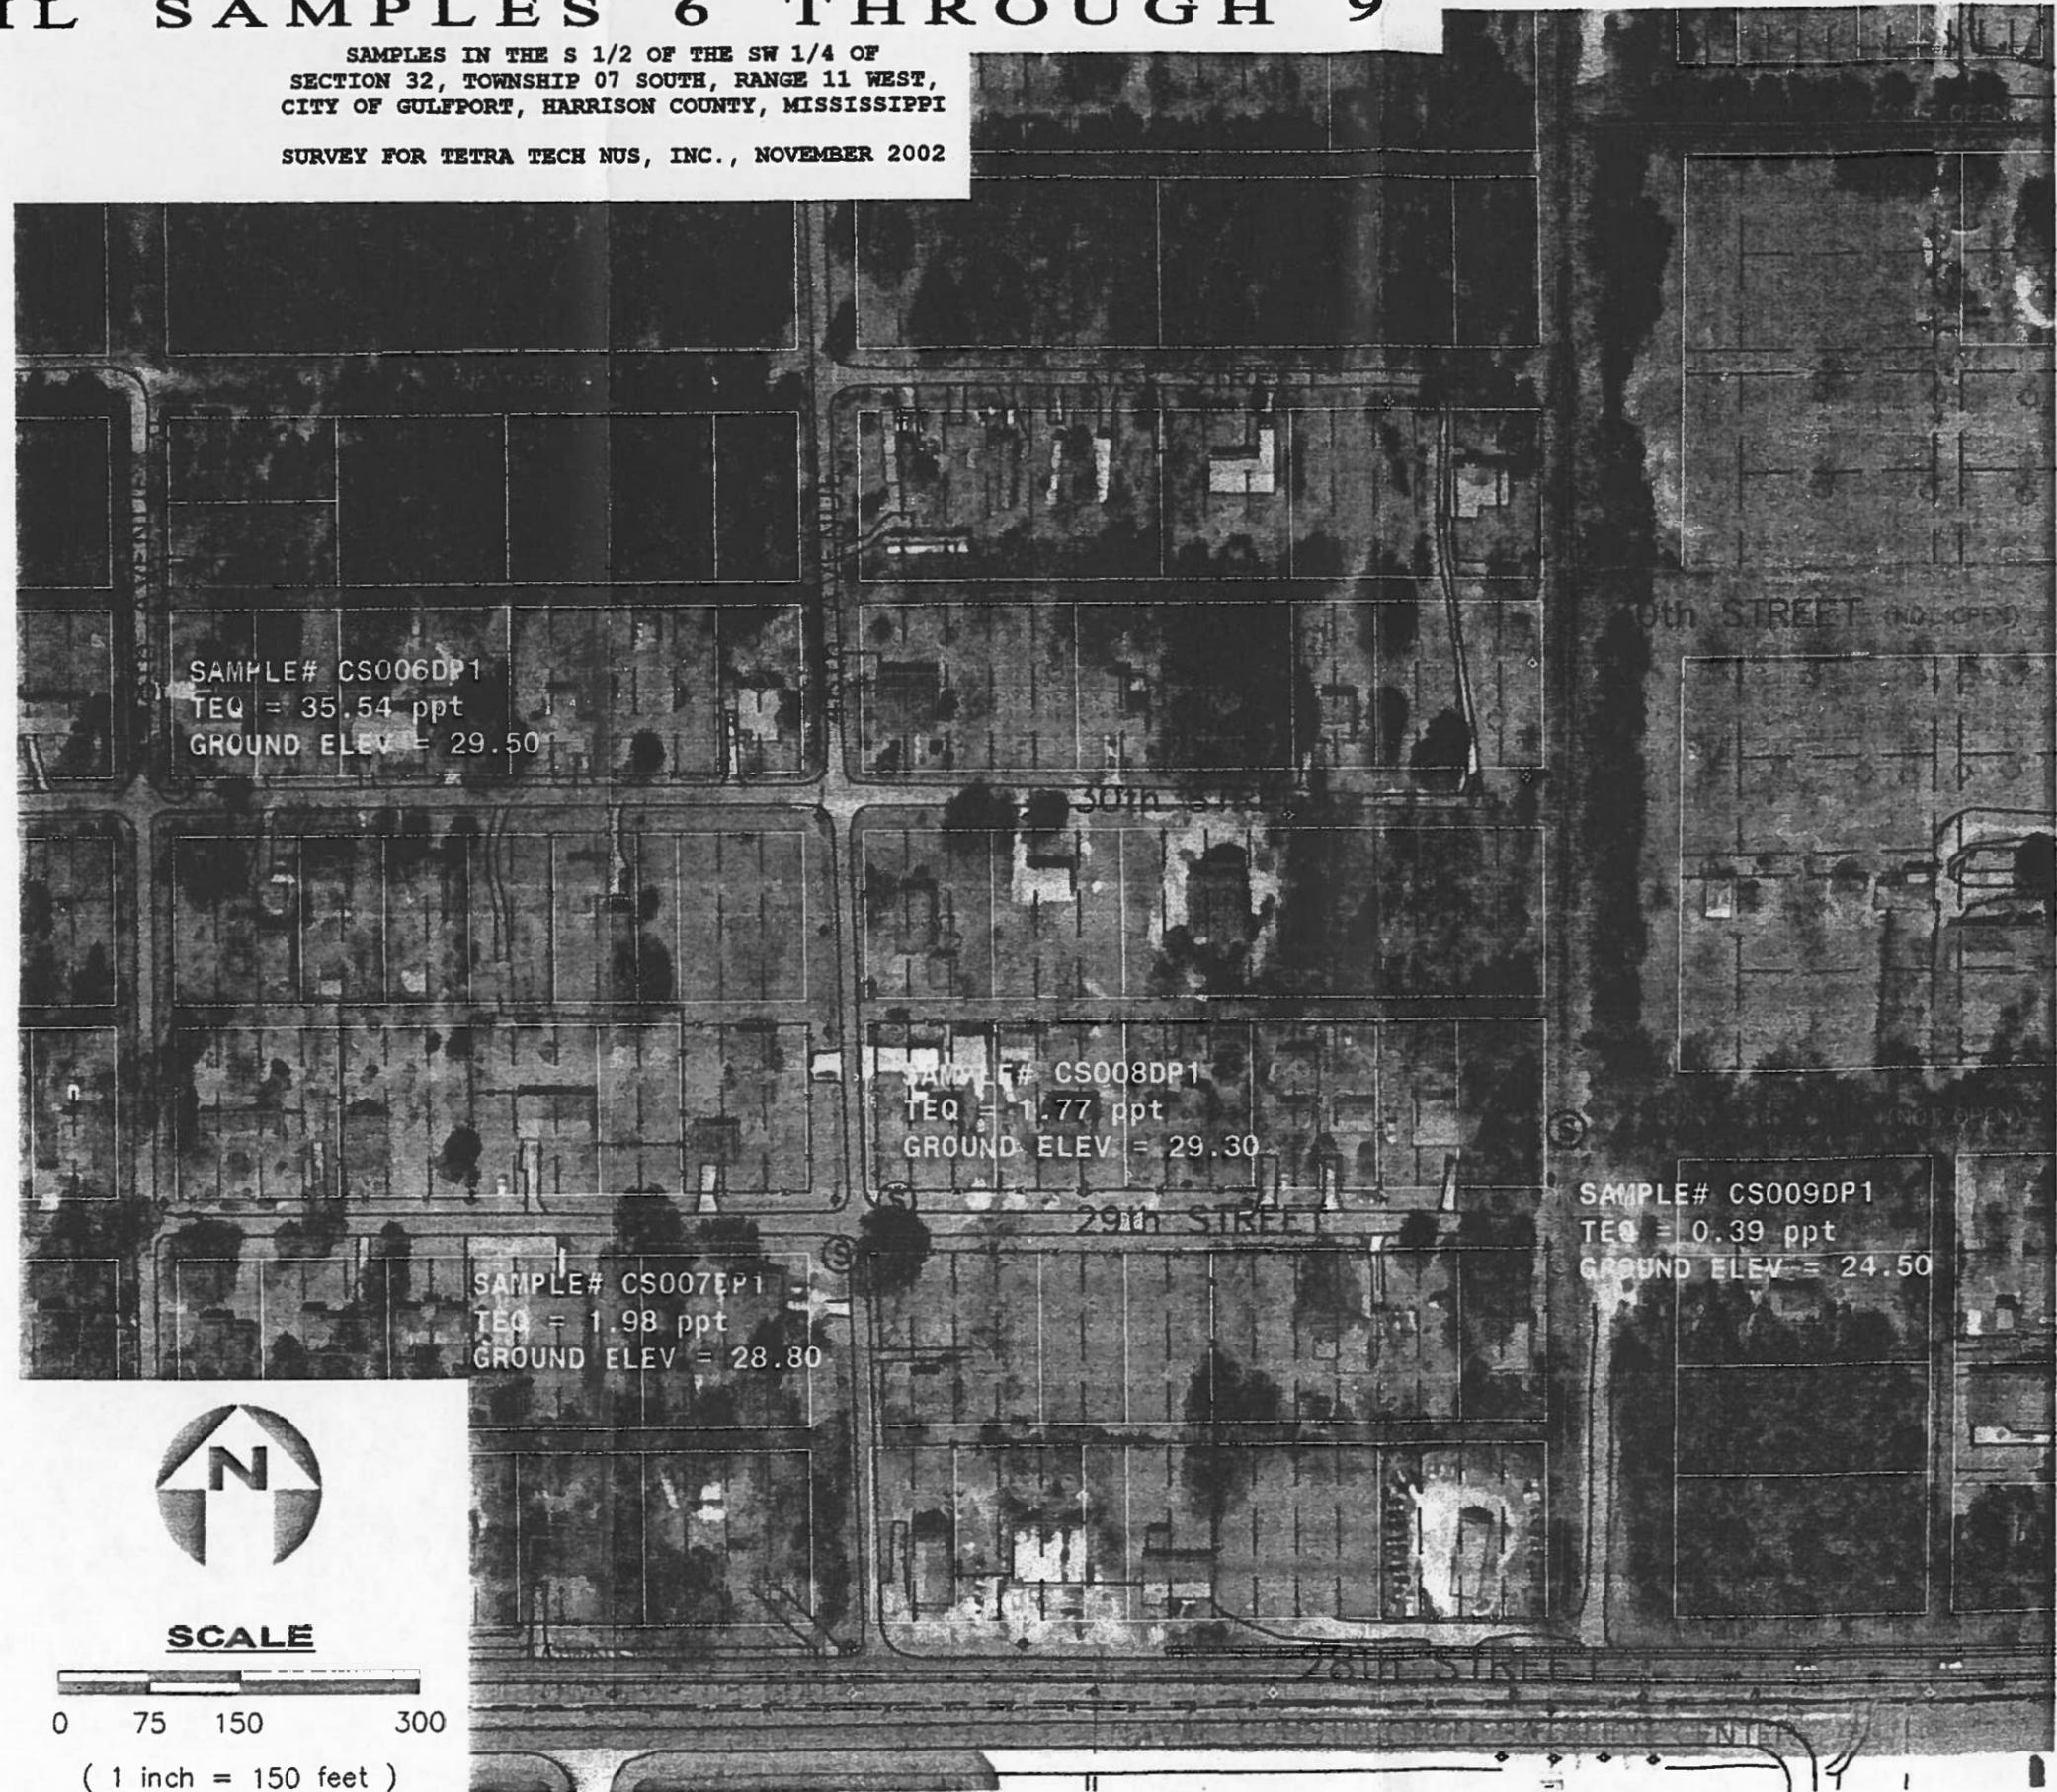
FIGURE 2

SOIL SAMPLES 6 THROUGH 9

SAMPLES IN THE S 1/2 OF THE SW 1/4 OF
SECTION 32, TOWNSHIP 07 SOUTH, RANGE 11 WEST,
CITY OF GULFPORT, HARRISON COUNTY, MISSISSIPPI
SURVEY FOR TETRA TECH NUS, INC., NOVEMBER 2002

SAMPLE LOCATION DATA SHOWN DEVELOPED FROM INFORMATION PROVIDED BY TETRA TECH, N.U.S. PROPERTY TAX MAP INFORMATION OBTAINED FROM HARRISON COUNTY TAX MAPS, DATED AUGUST 2002. AERIAL PHOTOGRAPHY SHOWN OBTAINED FROM HARRISON COUNTY, CIRCA 1996. COORDINATES SUPPLIED WERE DERIVED FROM A COMBINATION OF FIELD MEASUREMENTS, AERIAL MAP AND HARRISON COUNTY BASE MAP CORRELATION. THIS SURVEY IS REFERENCED IN FEET TO STATE PLANE COORDINATES SUPPLIED BY HARRISON COUNTY ENGINEERING DEPARTMENT, DATUM NAD-1983.

THE INTENT OF THIS SURVEY IS TO SHOW SAMPLE LOCATIONS AS INSTALLED OR COLLECTED BY TETRA TECH, NUS. A COPY OF THIS PLAT IS VALID ONLY IF IT IS COMPLETE AND INTACT, HAS AN ORIGINAL SIGNATURE AND DATE, AND HAS THE ORIGINAL EMBOSSED OR COLORED (NOT BLACK) STAMPED SURVEYOR'S SEAL.
