LEAD-BASED PAINT SURVEY FOR HARRY S TRUMAN ANIMAL IMPORT CENTER NAS  
KEY WEST FL  
6/1/1999  
HANSON ENGINEERS

# LEAD-BASED PAINT SURVEY

**HARRY S. TRUMAN ANIMAL IMPORT CENTER  
FLEMING KEY, FLORIDA**

JOB NO. 98FB048

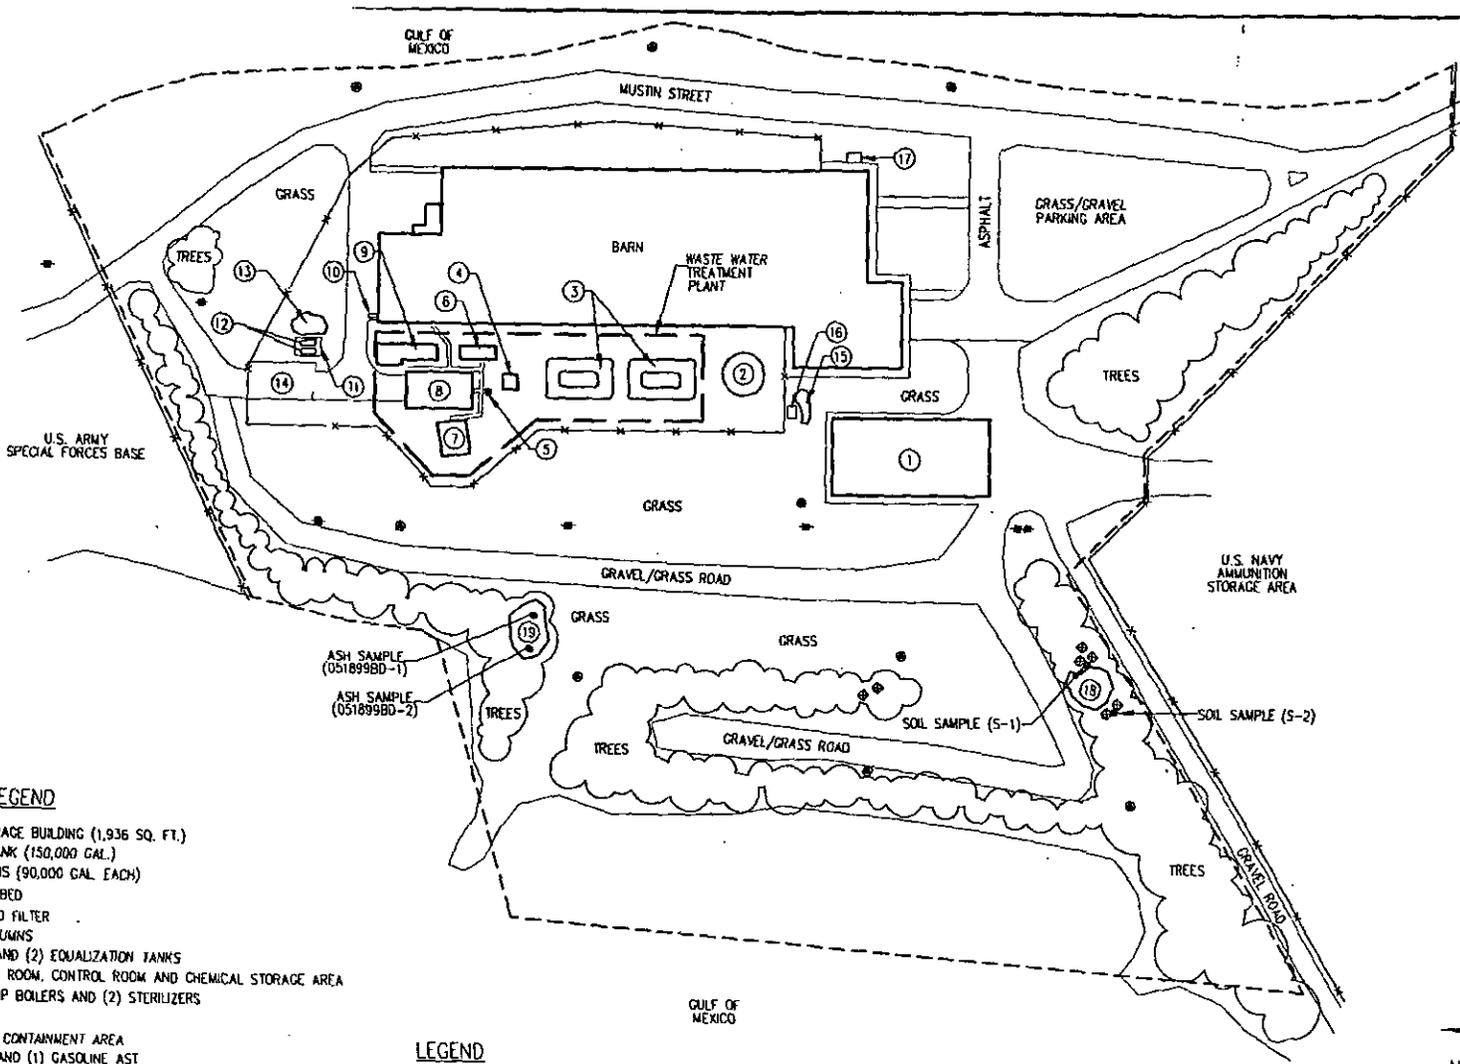
FIGURE 1.2

The HSTAIC Quarantine Facility USDA Animal Import Center is located on Fleming Key and covers approximately 30 acres in the northern portion of Fleming Key (see Figure 1.2). The facility was constructed in 1977 with a total footage of about 140,368 sq. ft.

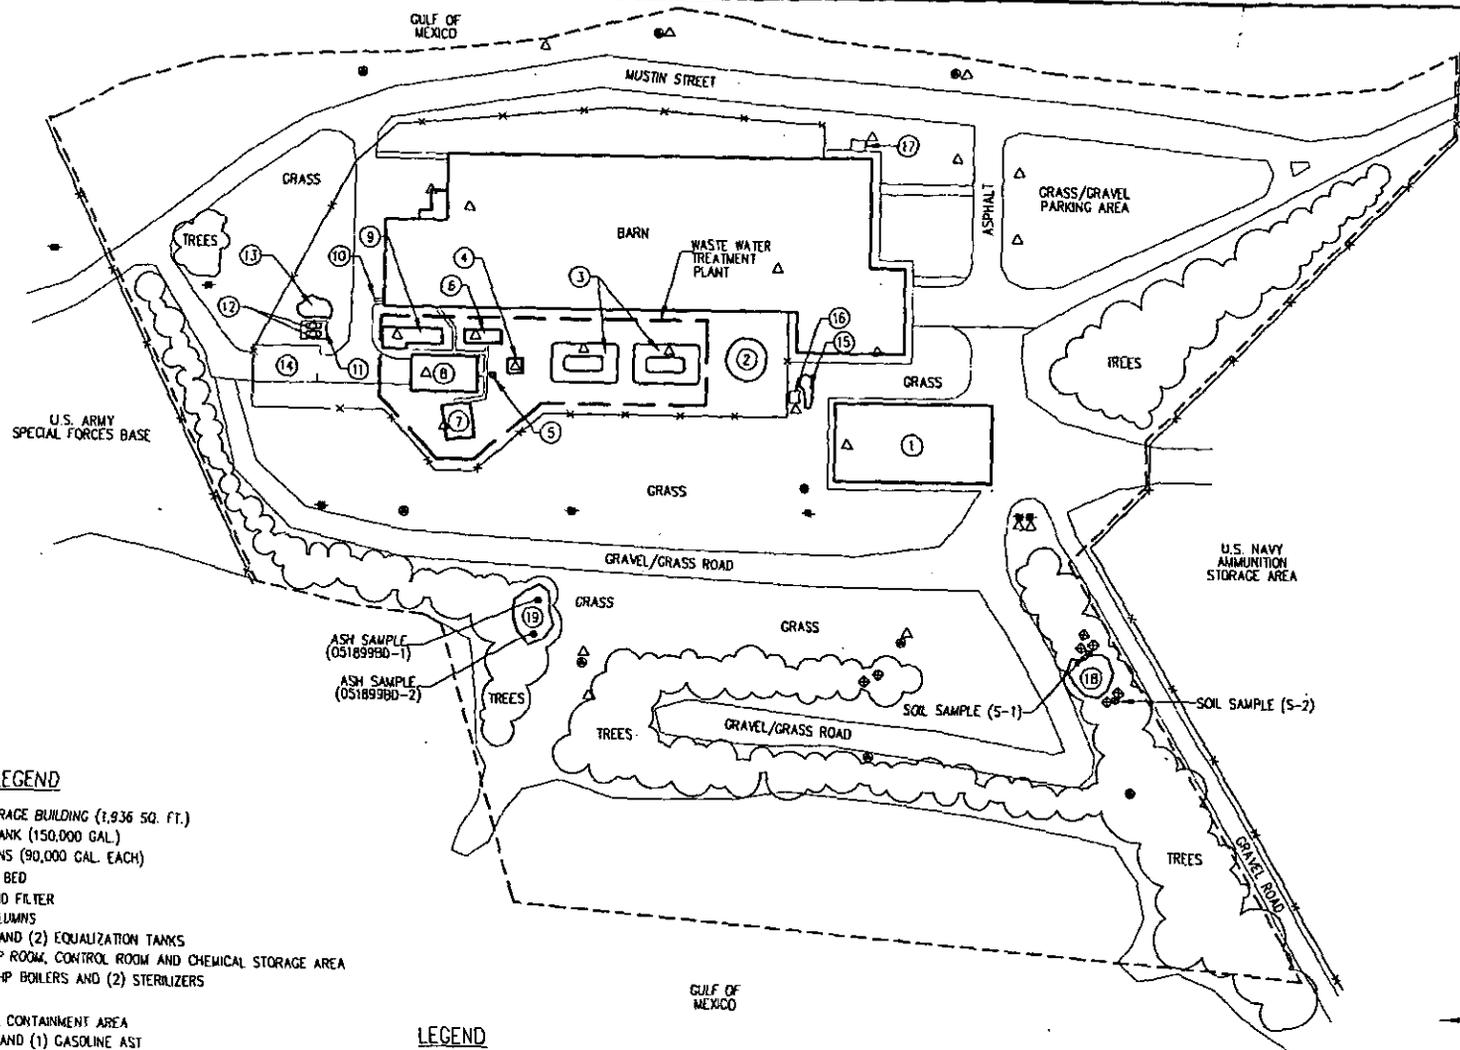
<b>POSITIVE LEAD SAMPLE LOCATIONS</b>	
	LEAD-BASED PAINT SURVEY HARRY S. TRUMAN ANIMAL IMPORT CENTER FLEMING KEY, FLORIDA	
	JOB NO. 98FB048	FIGURE 3.1

From the survey results, there are about 22 sq. ft of component surfaces that contain lead-based paint. The primary areas where lead-based paint was found were the parking lot bumper strips, shore line warning sign, west property well casing, and the water treatment building compressor room tank support.

- PROPERTY LINE
- - - FENCE
- POWER POLE
- MONITORING WELL
- DRUMS
- MOSQUITO CATCHER
- △ POSITIVE LEAD SAMPLE LOCATIONS

If the facility is to remain in place, the primary recommendation for the building management related to lead-based paint is the development of an operations and management program (O&M). In addition, some areas that contain lead-based paint are peeling (well casing) and should be abated or encapsulated. An O&M program can be defined as a formulated plan of training, cleaning, work practices, and surveillance to maintain lead-based paint containing materials in good condition. An O&M program may also provide an effective, less costly alternative to removal operations.

If the buildings are to be demolished, the lead-contaminated components should be disposed of as hazardous waste.

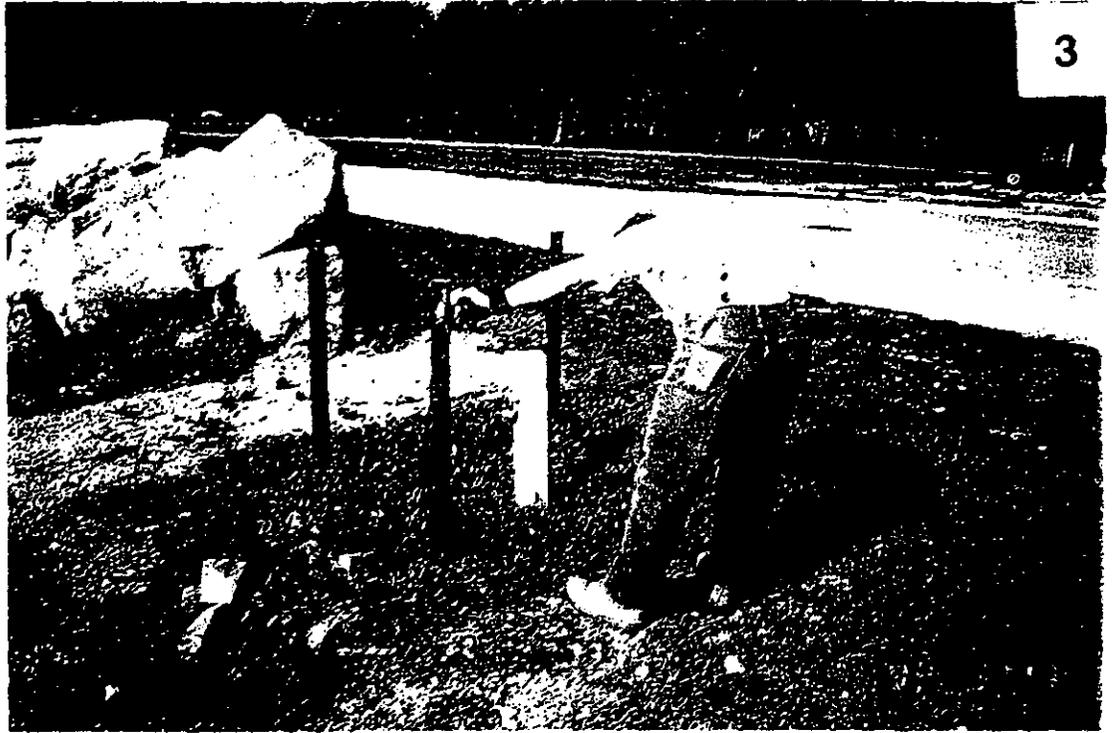
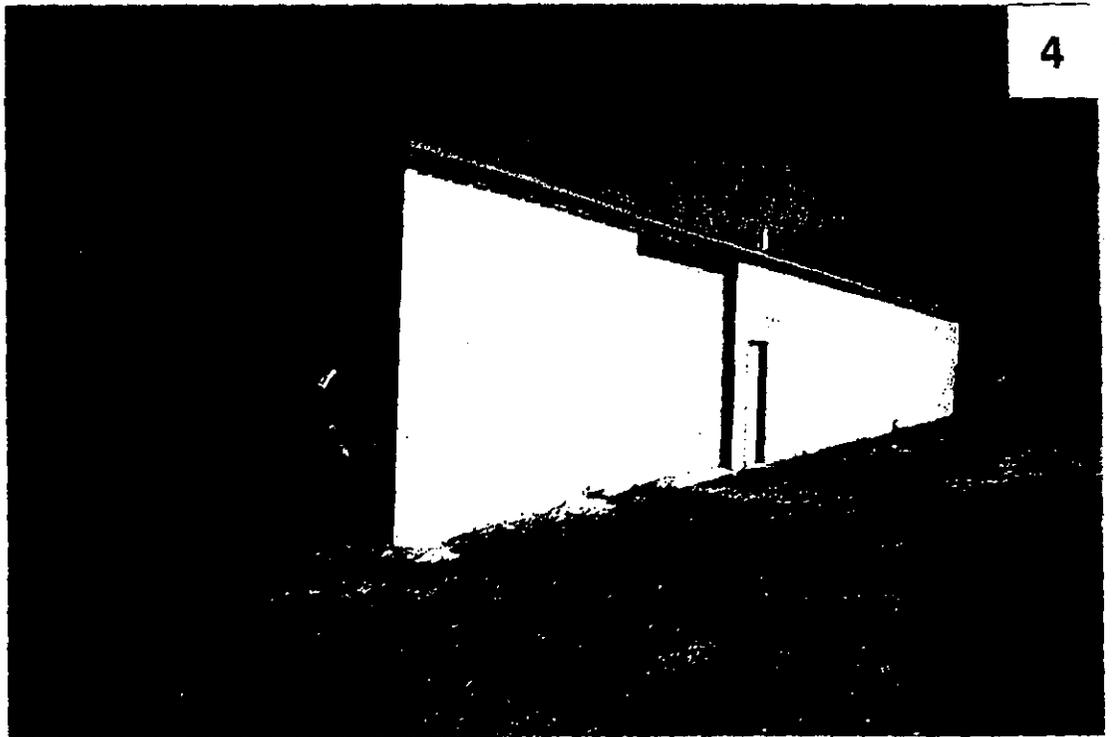
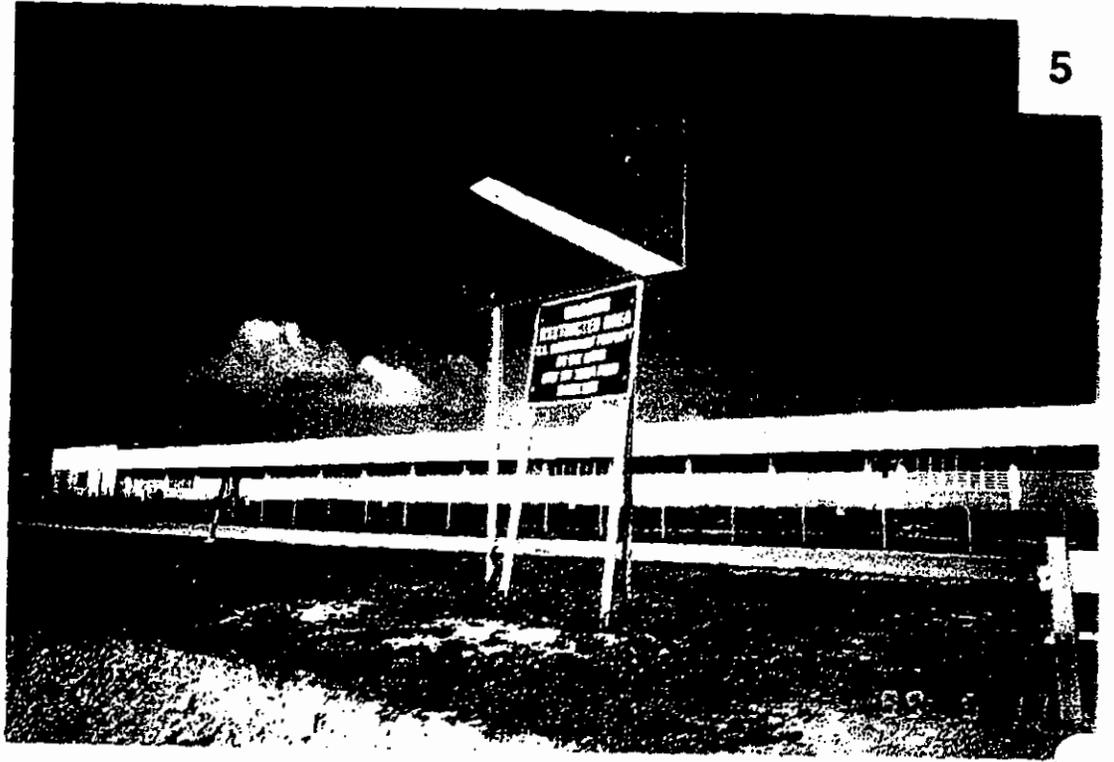
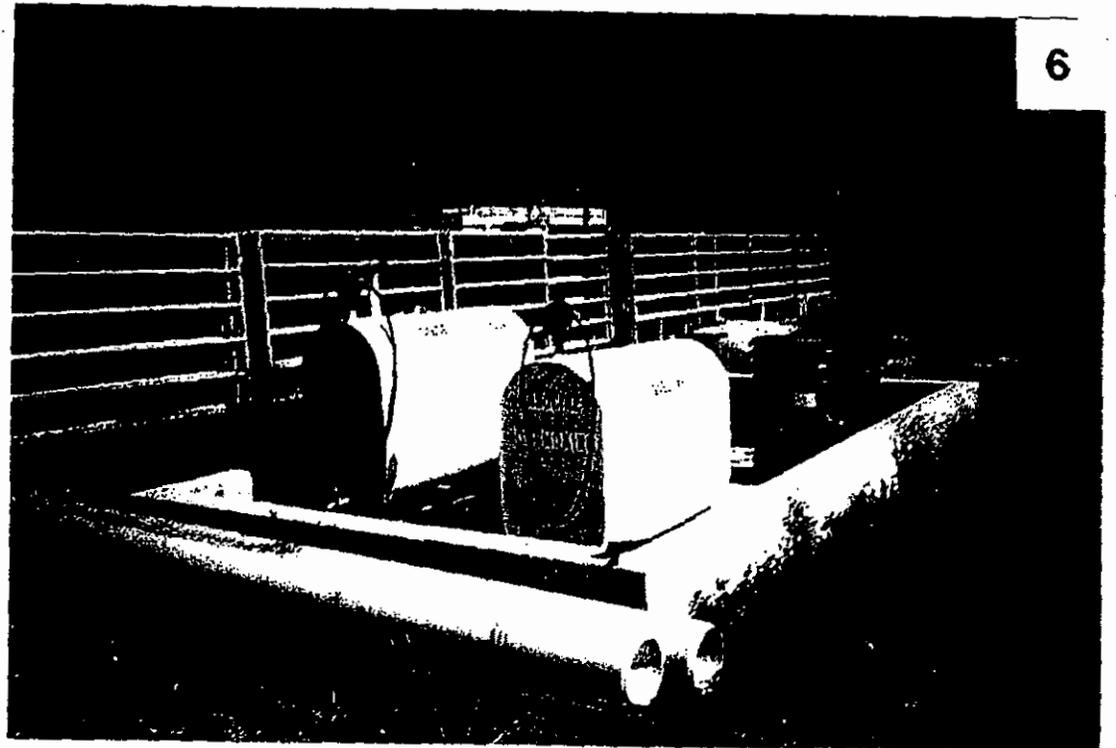
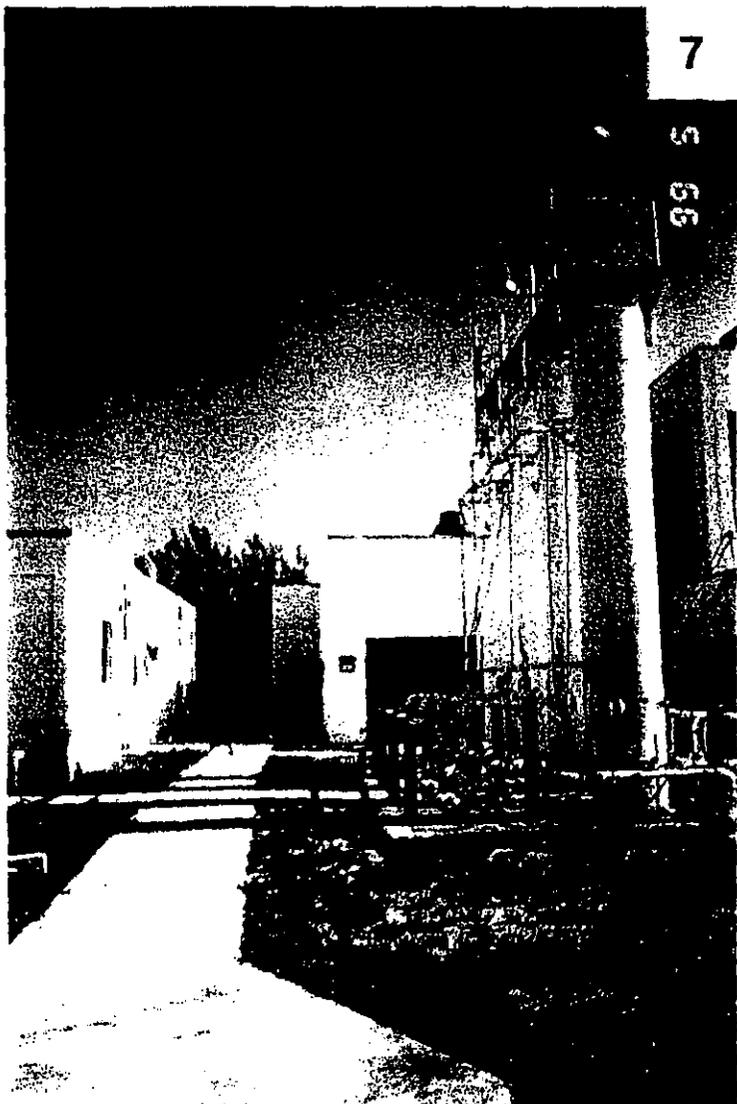
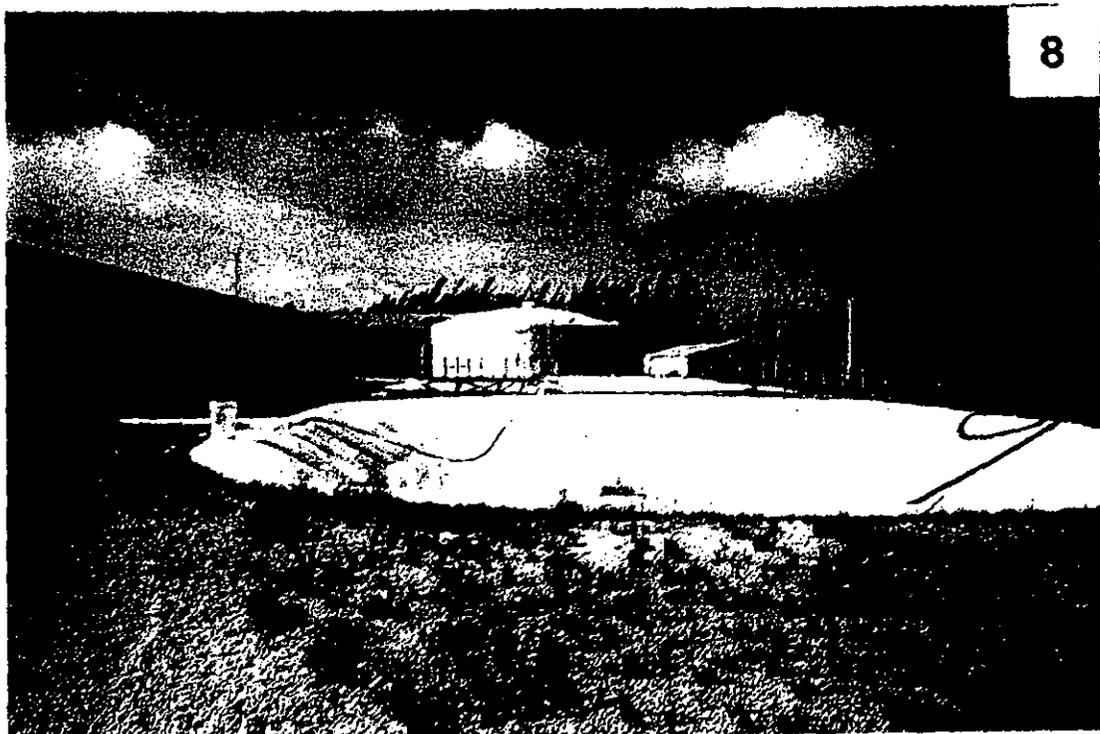
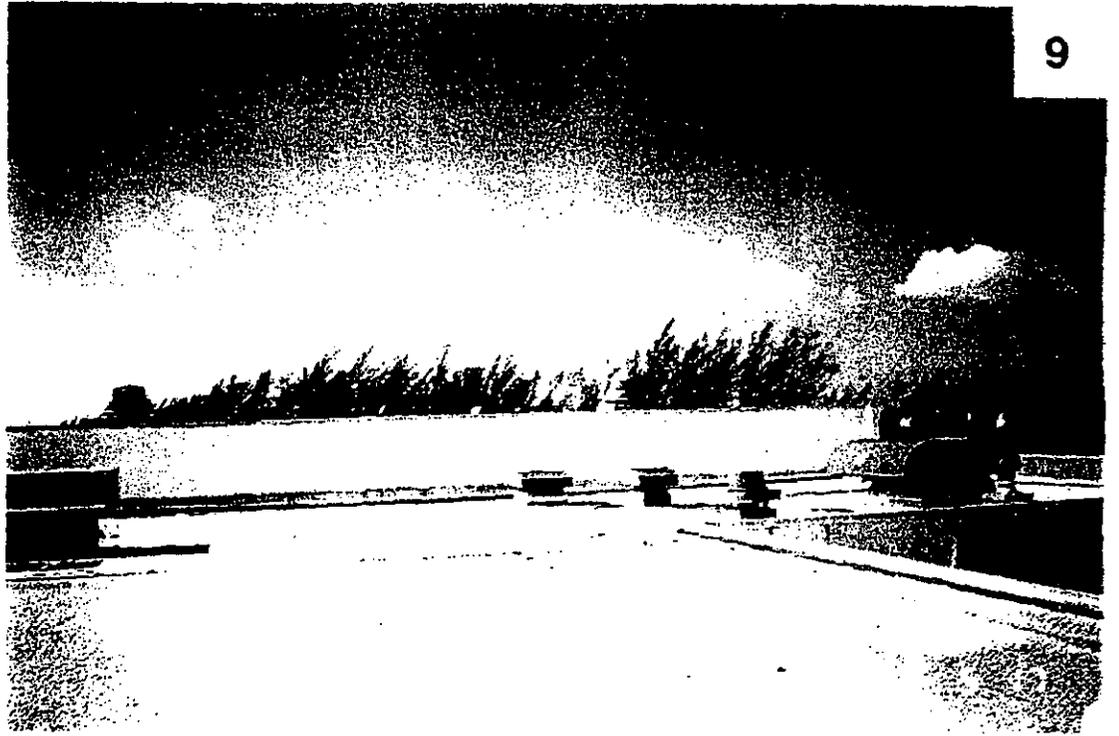
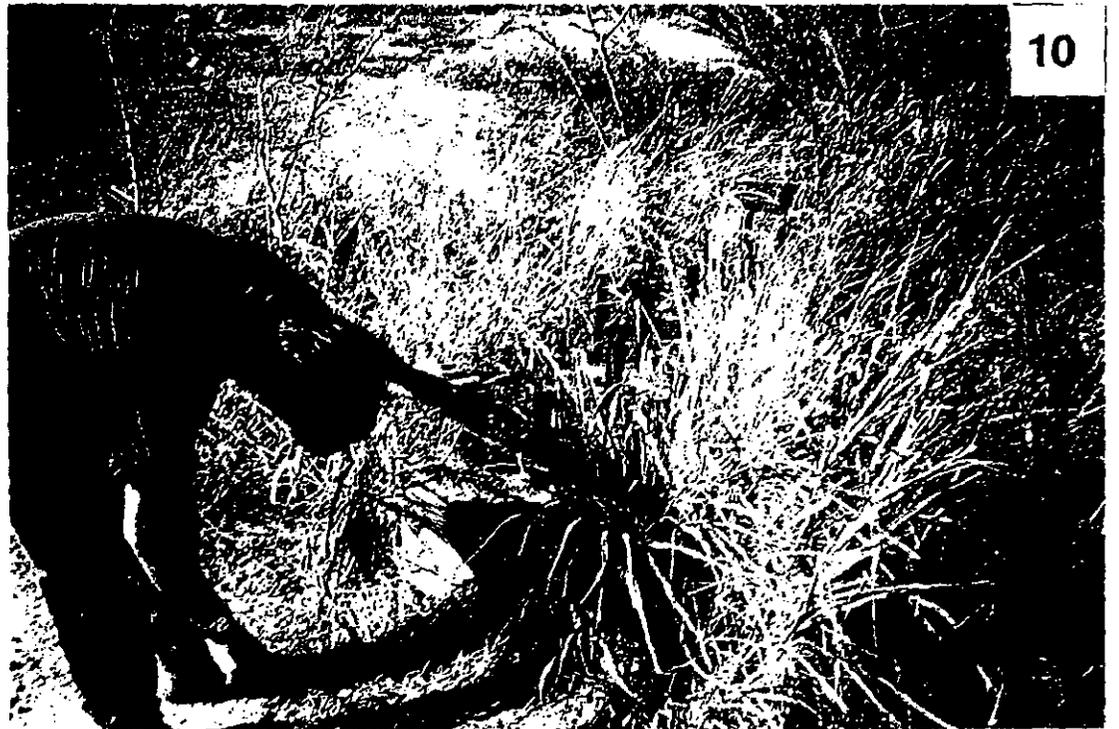
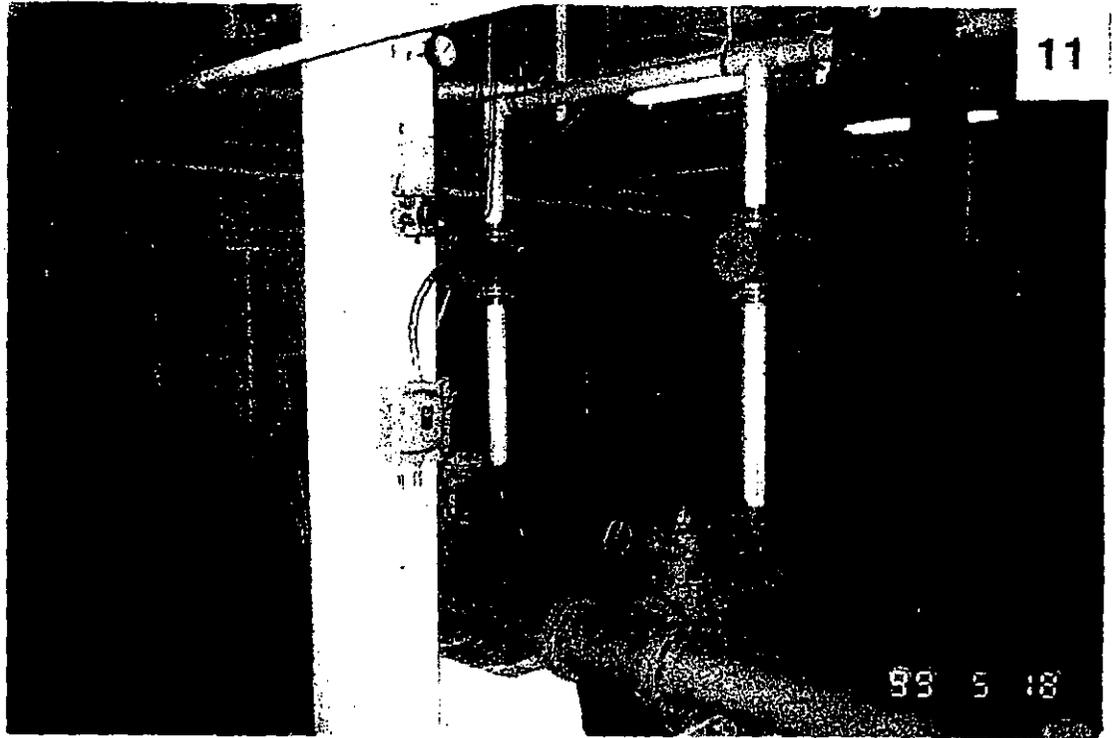
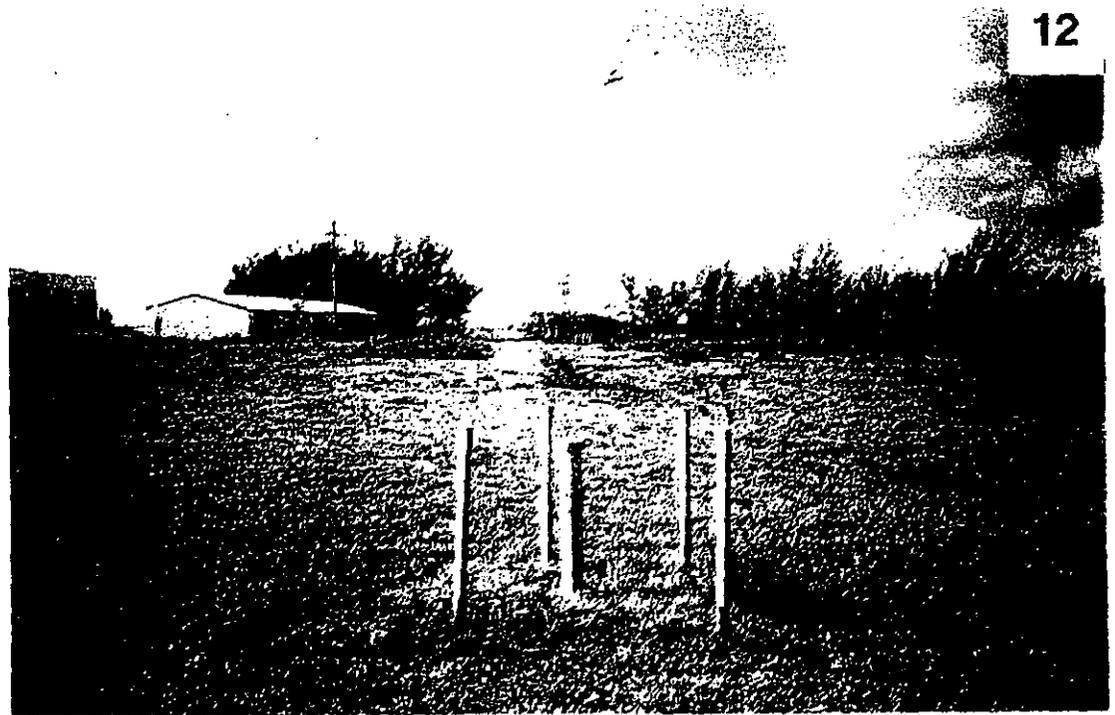
## PHOTOGRAPH LOG

<u>Photograph Number</u>	<u>Description</u>
1	View of HSTAIC front sign.
2	View of parking area tire bumper strip.
3	View of well and well protective poles.
4	View of garage exterior.
5	View of shoreline warning sign.
6	View of gasoline and diesel storage area.
7	View of wastewater treatment area.
8	View of wastewater treatment lagoon.
9	View of roof top vents and fan housings.
10	View of fence post imbedded in concrete on northwest property.
11	View of water treatment pump house.
12	View of well casing and well protective poles.
