RESOURCE CONSERVATION AND RECOVERY ACT FACILITY ASSESSMENT OF NS
MAYPORT FL
9/1/1989
A T KEARNEY

RCRA FACILITY ASSESSMENT
OF THE
NAVAL STATION MAYPORT
JACKSONVILLE, FLORIDA
EPA I.D. NO. FL9170024260

September 1989

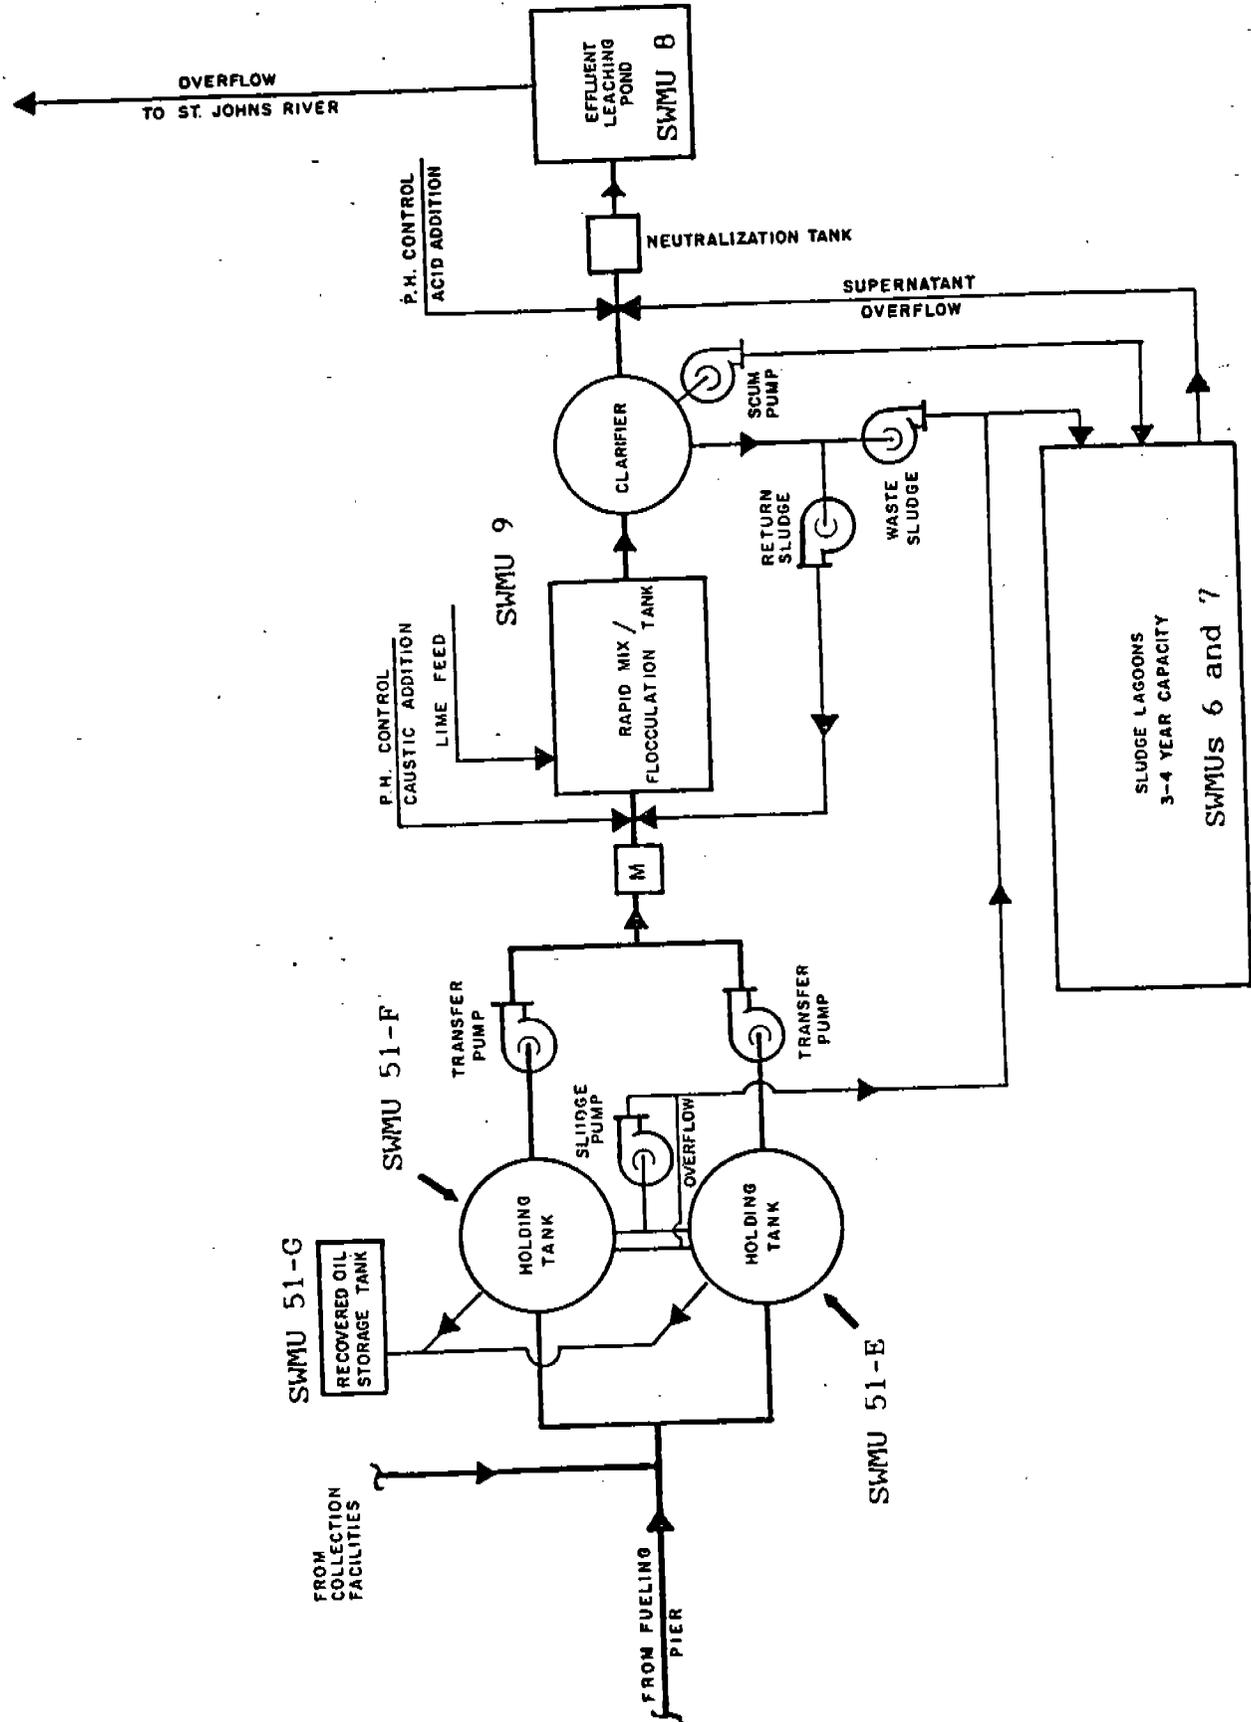
FIGURE II-4: PROCESS FLOW DIAGRAM, OILY WASTE TREATMENT PLANT (SWMUS 7-9, 51-E, F, and G) (REFERENCE 92)

The OWTP system consists of three 210,000-gallon holding tanks (SWMUs 5I-E, F, and G), a physical/chemical treatment system (SWMU 9), a percolation pond (SWMU 8) and four drying beds (SWMUs 6 and 7). Figure II-4 presents a flow diagram for the OWTP system. Oil separated from the bilge water is burned in on-site boilers or the Carbonaceous Fuel Boiler (SWMU 17). Effluent from the OWTP is discharged into the Saint Johns River in the NSC fuels farm area. The discharge is regulated under NPDES Permit No. FL0033308.

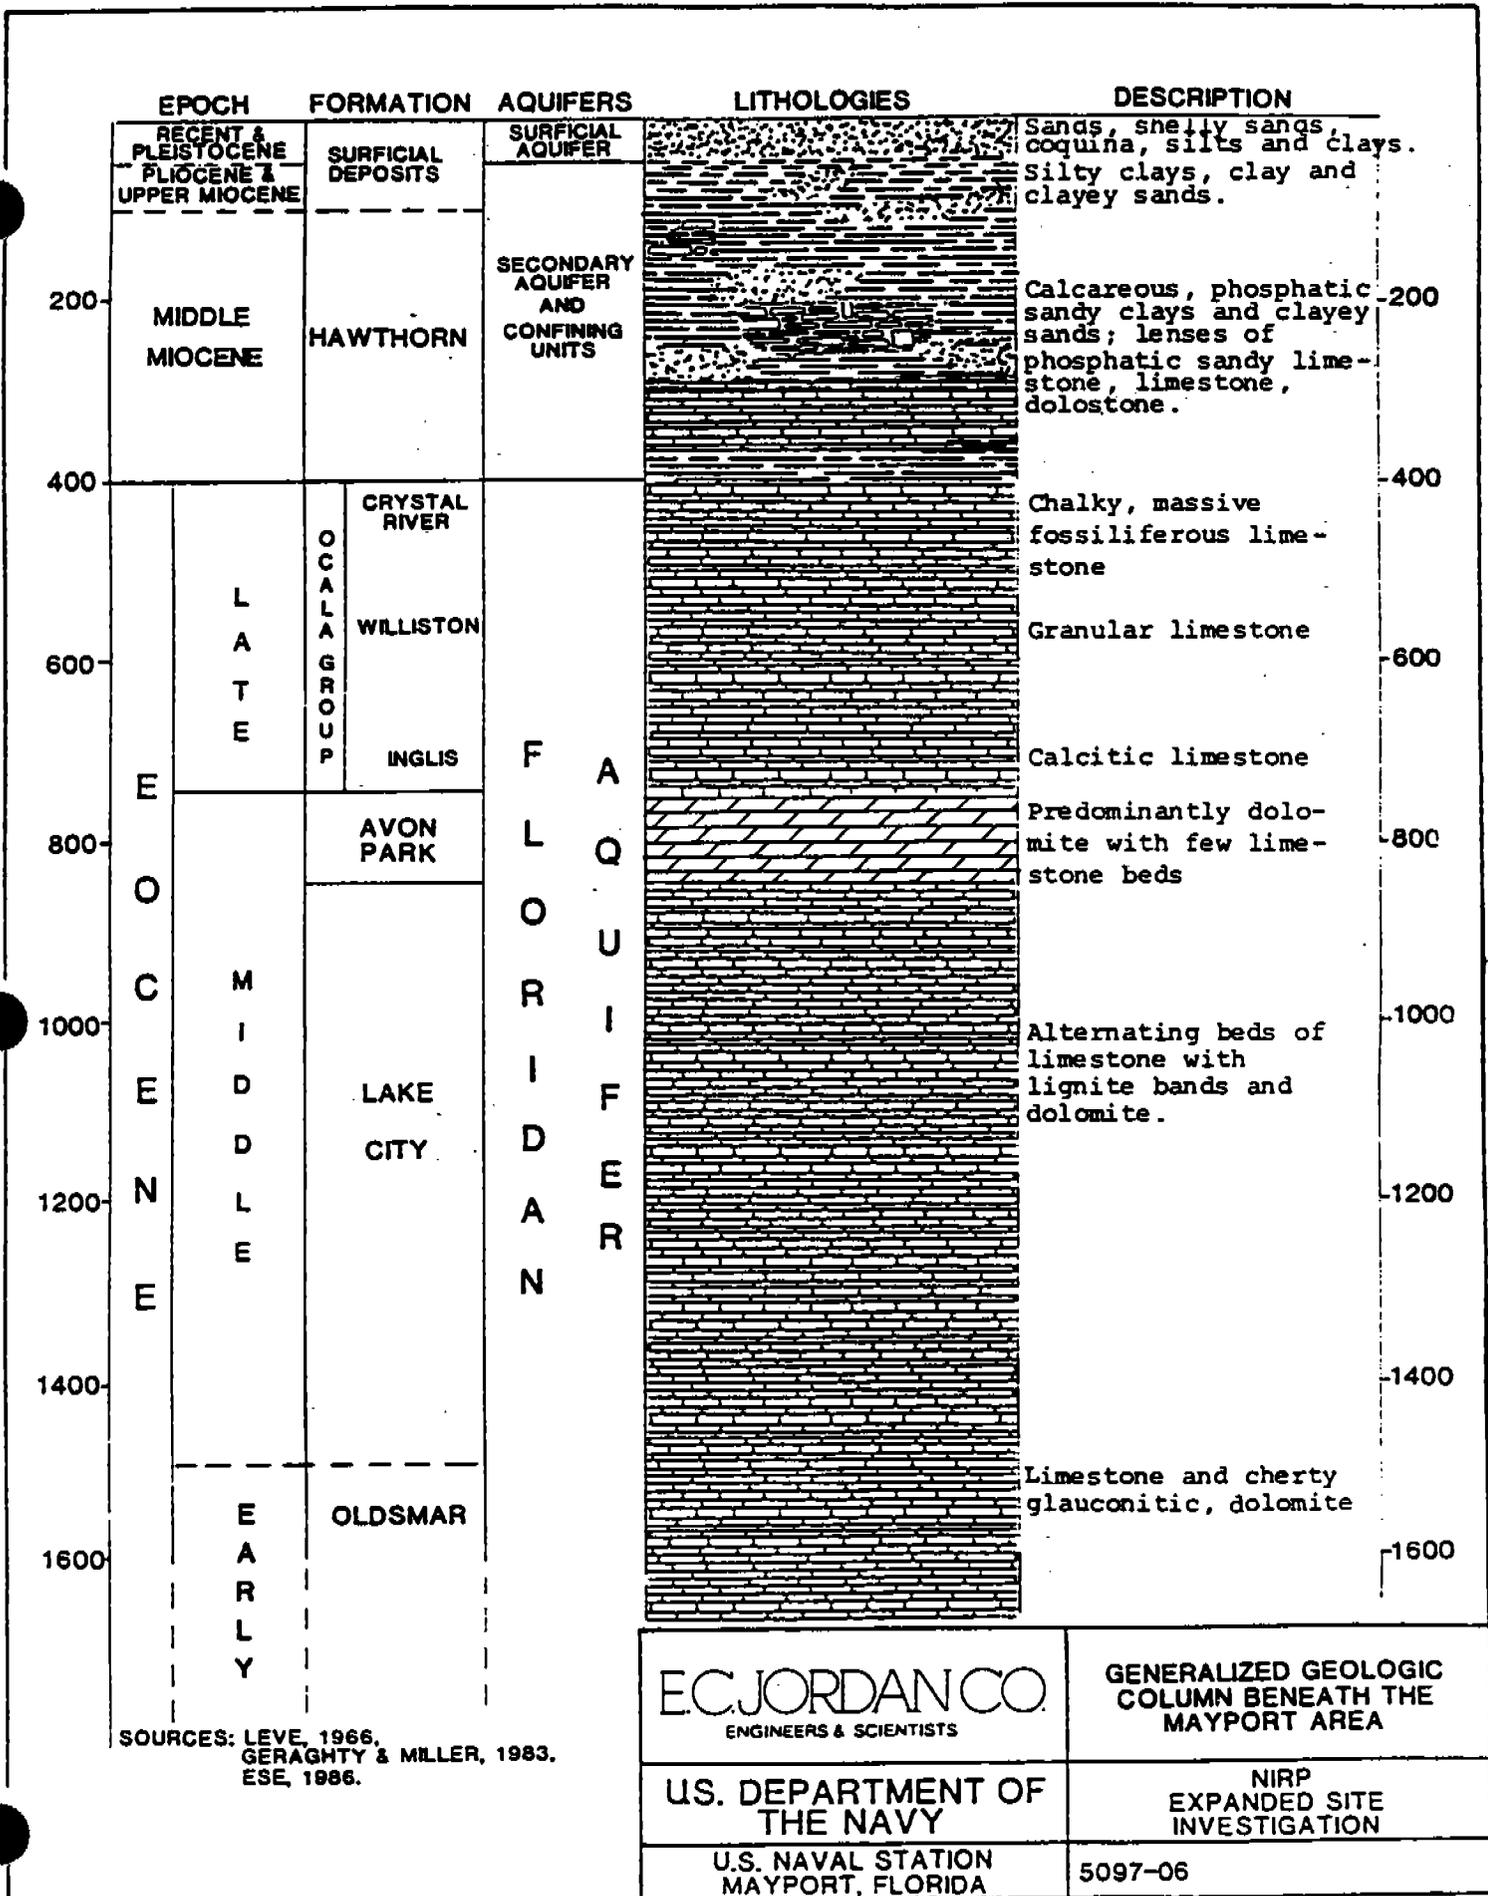
FIGURE II-7: GENERALIZED GEOLOGIC COLUMN BENEATH THE MAYPORT AREA (REFERENCE 34) II-23

- 1) Late Miocene to Recent surficial deposits, approximately 100 feet thick;
- 2) Middle Miocene Hawthorn formation, approximately 300 feet thick;
- 3) Eocene marine carbonate sequences of the Floridan aquifer, more than 1,000 feet thick (Reference 19).

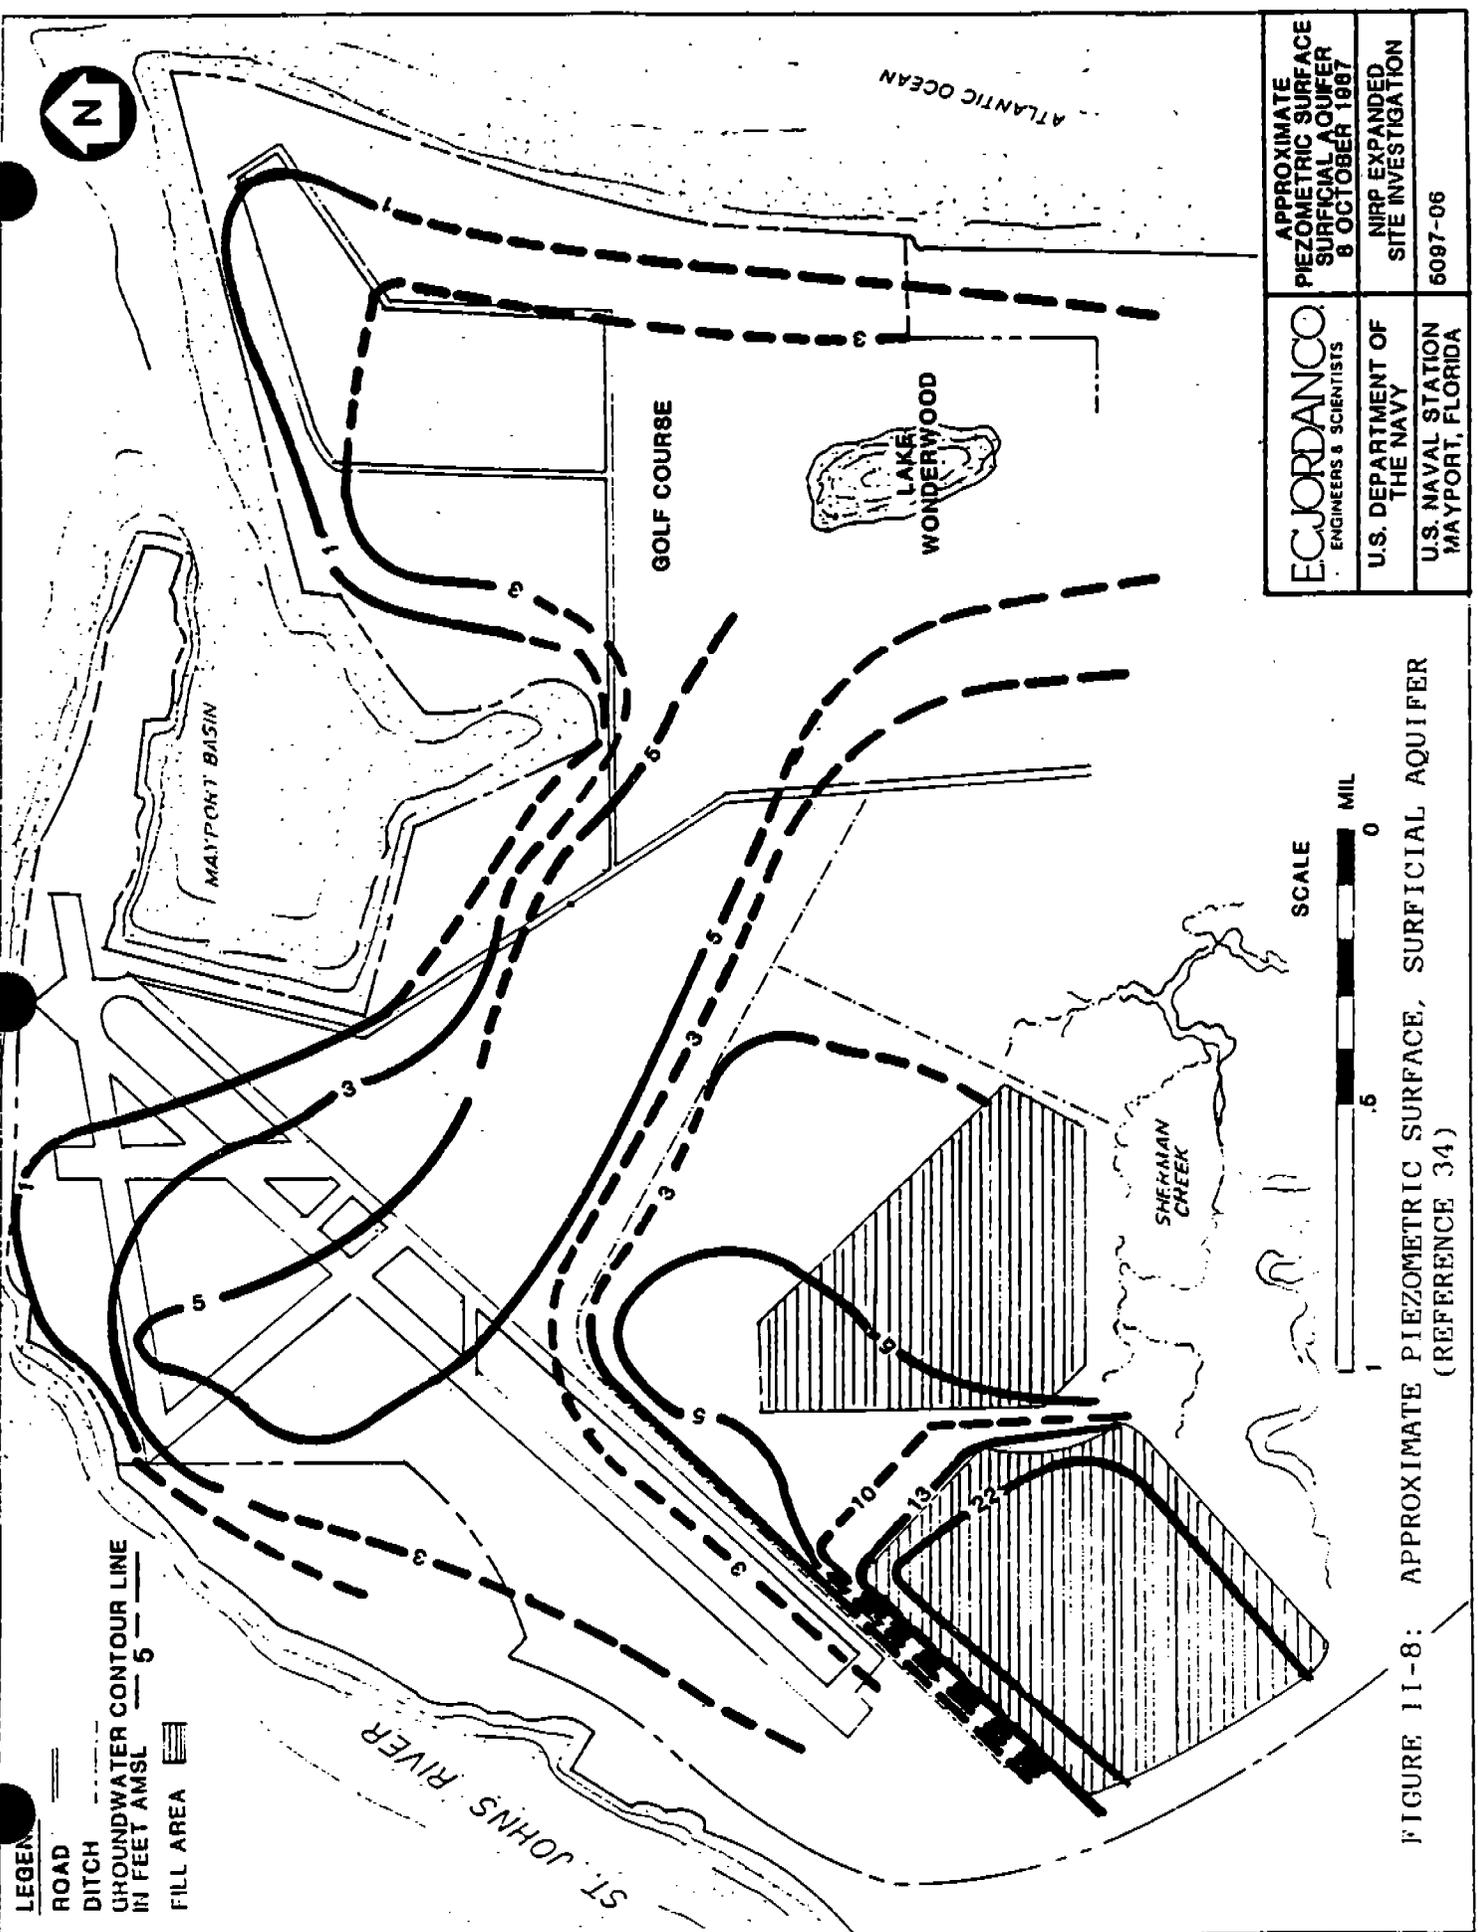
FIGURE 11-8: APPROXIMATE PIEZOMETRIC SURFACE, SURFICIAL AQUIFER (REFERENCE 34)

Below the surficial aquifer lies the Hawthorn formation, which consists of clayey sands and sandy clays. Interbedded with these lithologies are lenses of sand and limestone which are described as a secondary artesian aquifer. Water levels measured in the Hawthorn formation indicate that groundwater flow

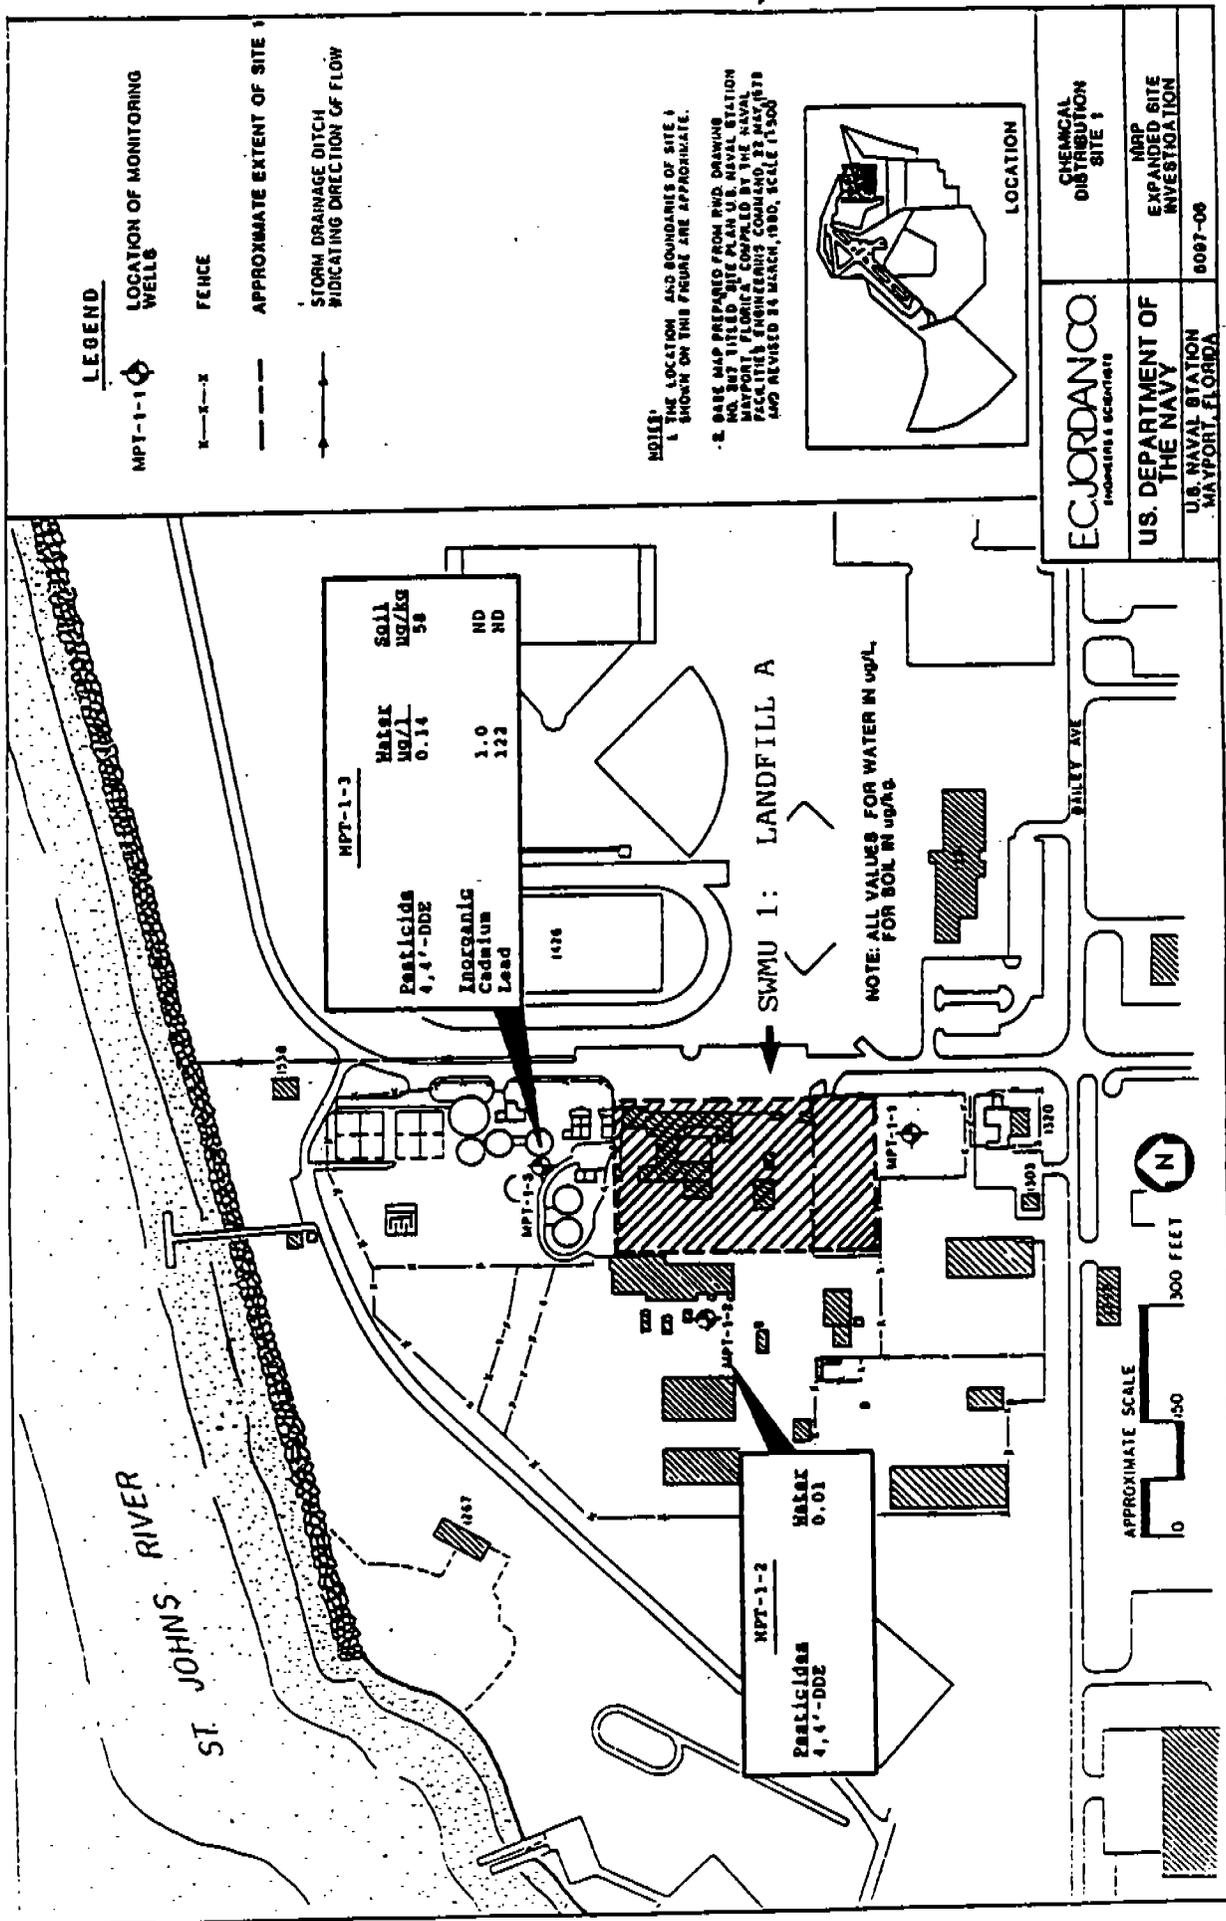
FIGURE IV-1: LOCATION OF SWMU 1 AND CHEMICAL DISTRIBUTION (REFERENCE 34)

The concentrations of 4,4'-DDE found in groundwater, 0.01 and 0.14 ug/l, exceed the U.S. EPA ambient water quality criteria for chronic exposure in saltwater environments, which is 0.001 ug/l. The concentrations of total lead detected in groundwater, 122 ug/l and 26 ug/l, also exceed the U.S. EPA ambient water quality criteria for chronic exposure in marine environments, 5.6 ug/l. The concentration of cadmium found in groundwater, 2.0 ug/l, does not exceed the U.S. EPA ambient water quality criteria for chronic exposure in saltwater environments, which is 9.3 ug/l (Reference 34).

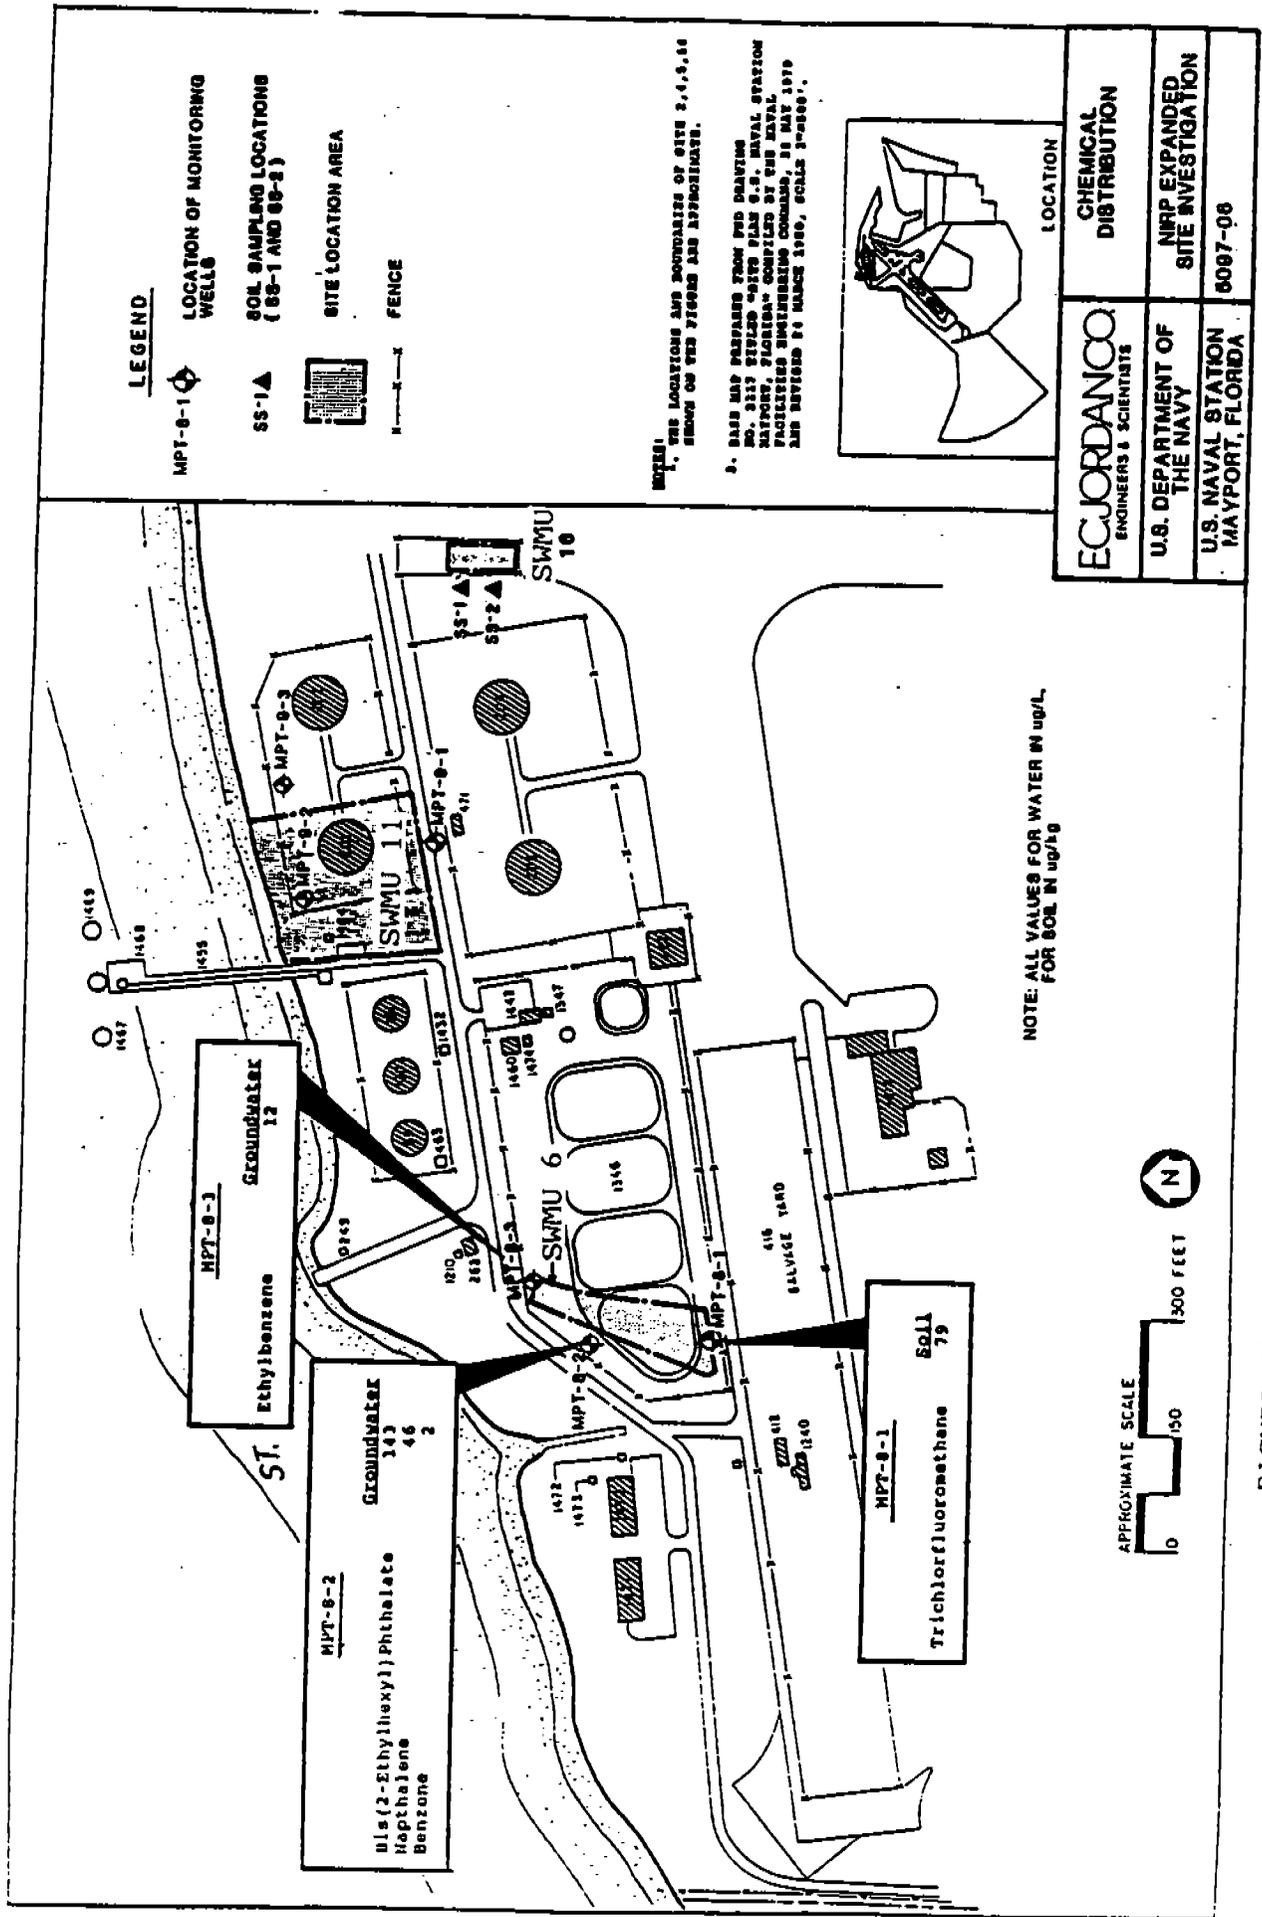
FIGURE IV-6: CHEMICAL DISTRIBUTION FOR SWMU 6 (REFERENCE 34)

conducted and a final report completed in May 1988 (Reference 34). In the ESI, it was estimated that the preliminary HRS score for the Waste Oil Pit was 6.73 and it was recommended that an environmental risk assessment be conducted for the area. Under the ESI, soil and groundwater samples were collected in the area of the waste oil pit and groundwater monitoring wells were installed. Figure IV-6 illustrates the sample collection and monitoring well installation locations. The results of analytical analysis of the soil and groundwater samples are also illustrated on Figure IV-6. Constituents detected in groundwater include bis(2-ethylhexyl)phthalate, naphthalene, benzene, ethylbenzene, endrine aldehyde, G-BHC, and lead. Freon was detected in soil samples. The concentration of endrine aldehyde (0.05 ug/l) found in groundwater exceeds the U.S. EPA ambient water quality criteria for chronic exposure in marine environments.

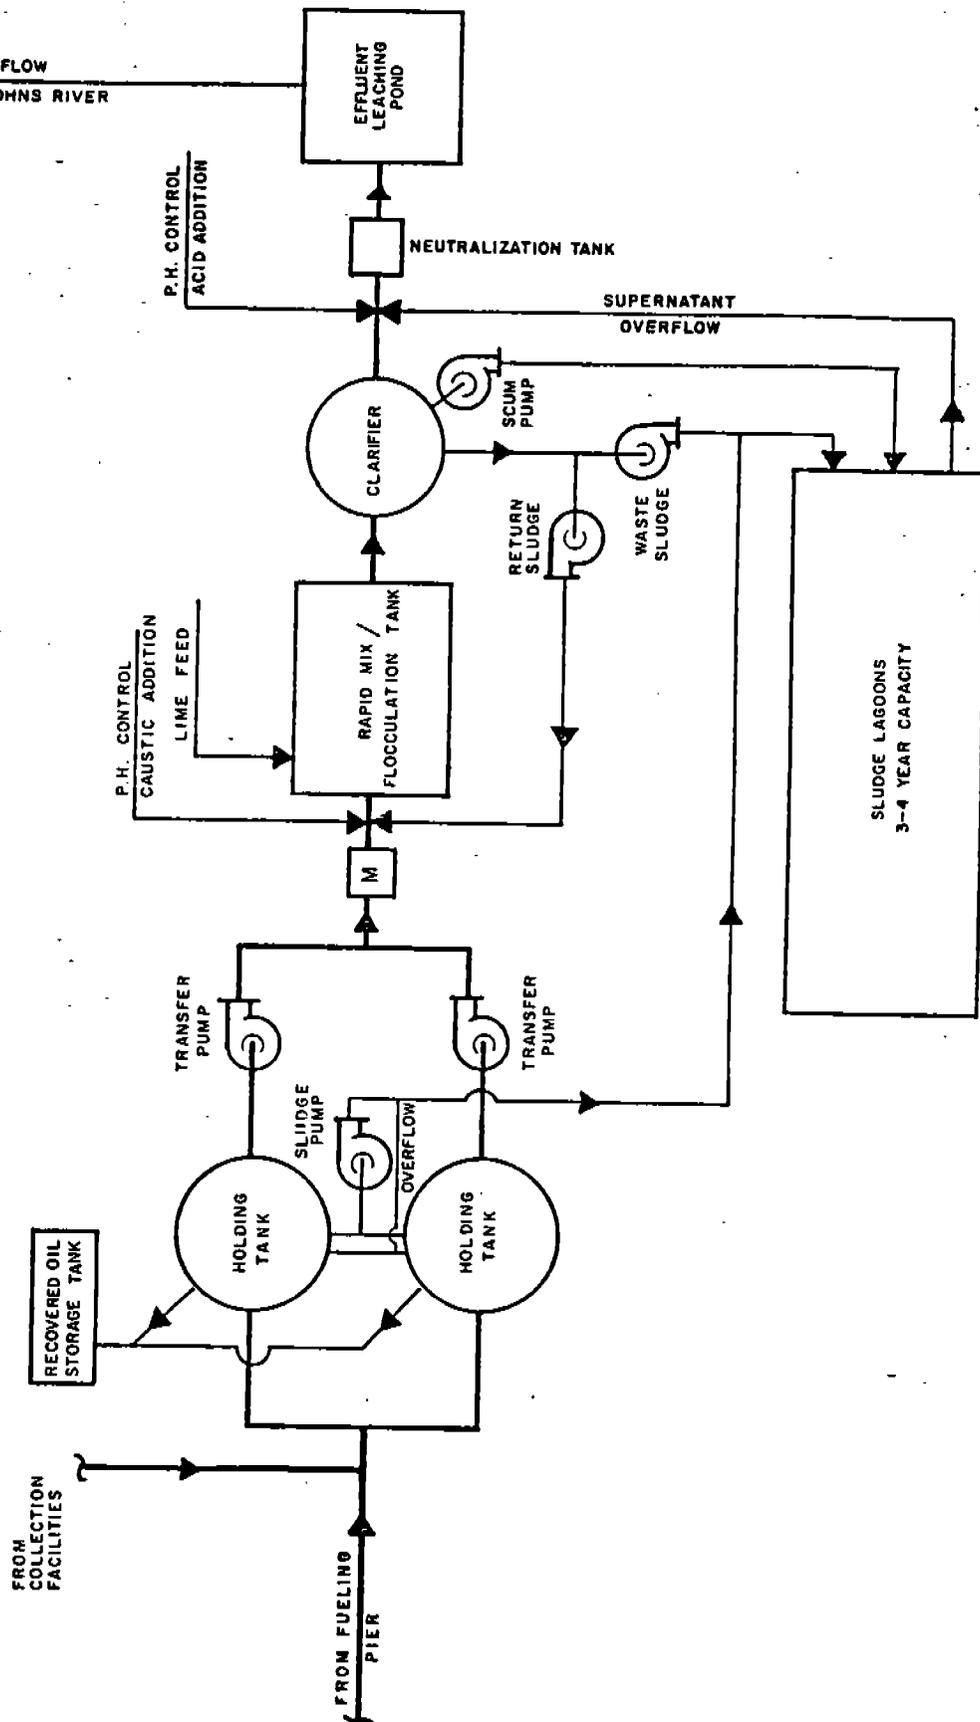
FIGURE IV-11: PROCESS FLOW DIAGRAM: OILY WASTE TREATMENT PLANT (SWMU 9)
(REFERENCE 92)

In the rapid mix/flocculation tank, bags of hydrated lime are added by hand to assist in the flocculation process. The system was designed to be semi-automatic using a lime feeder, but this feeder is not currently used.

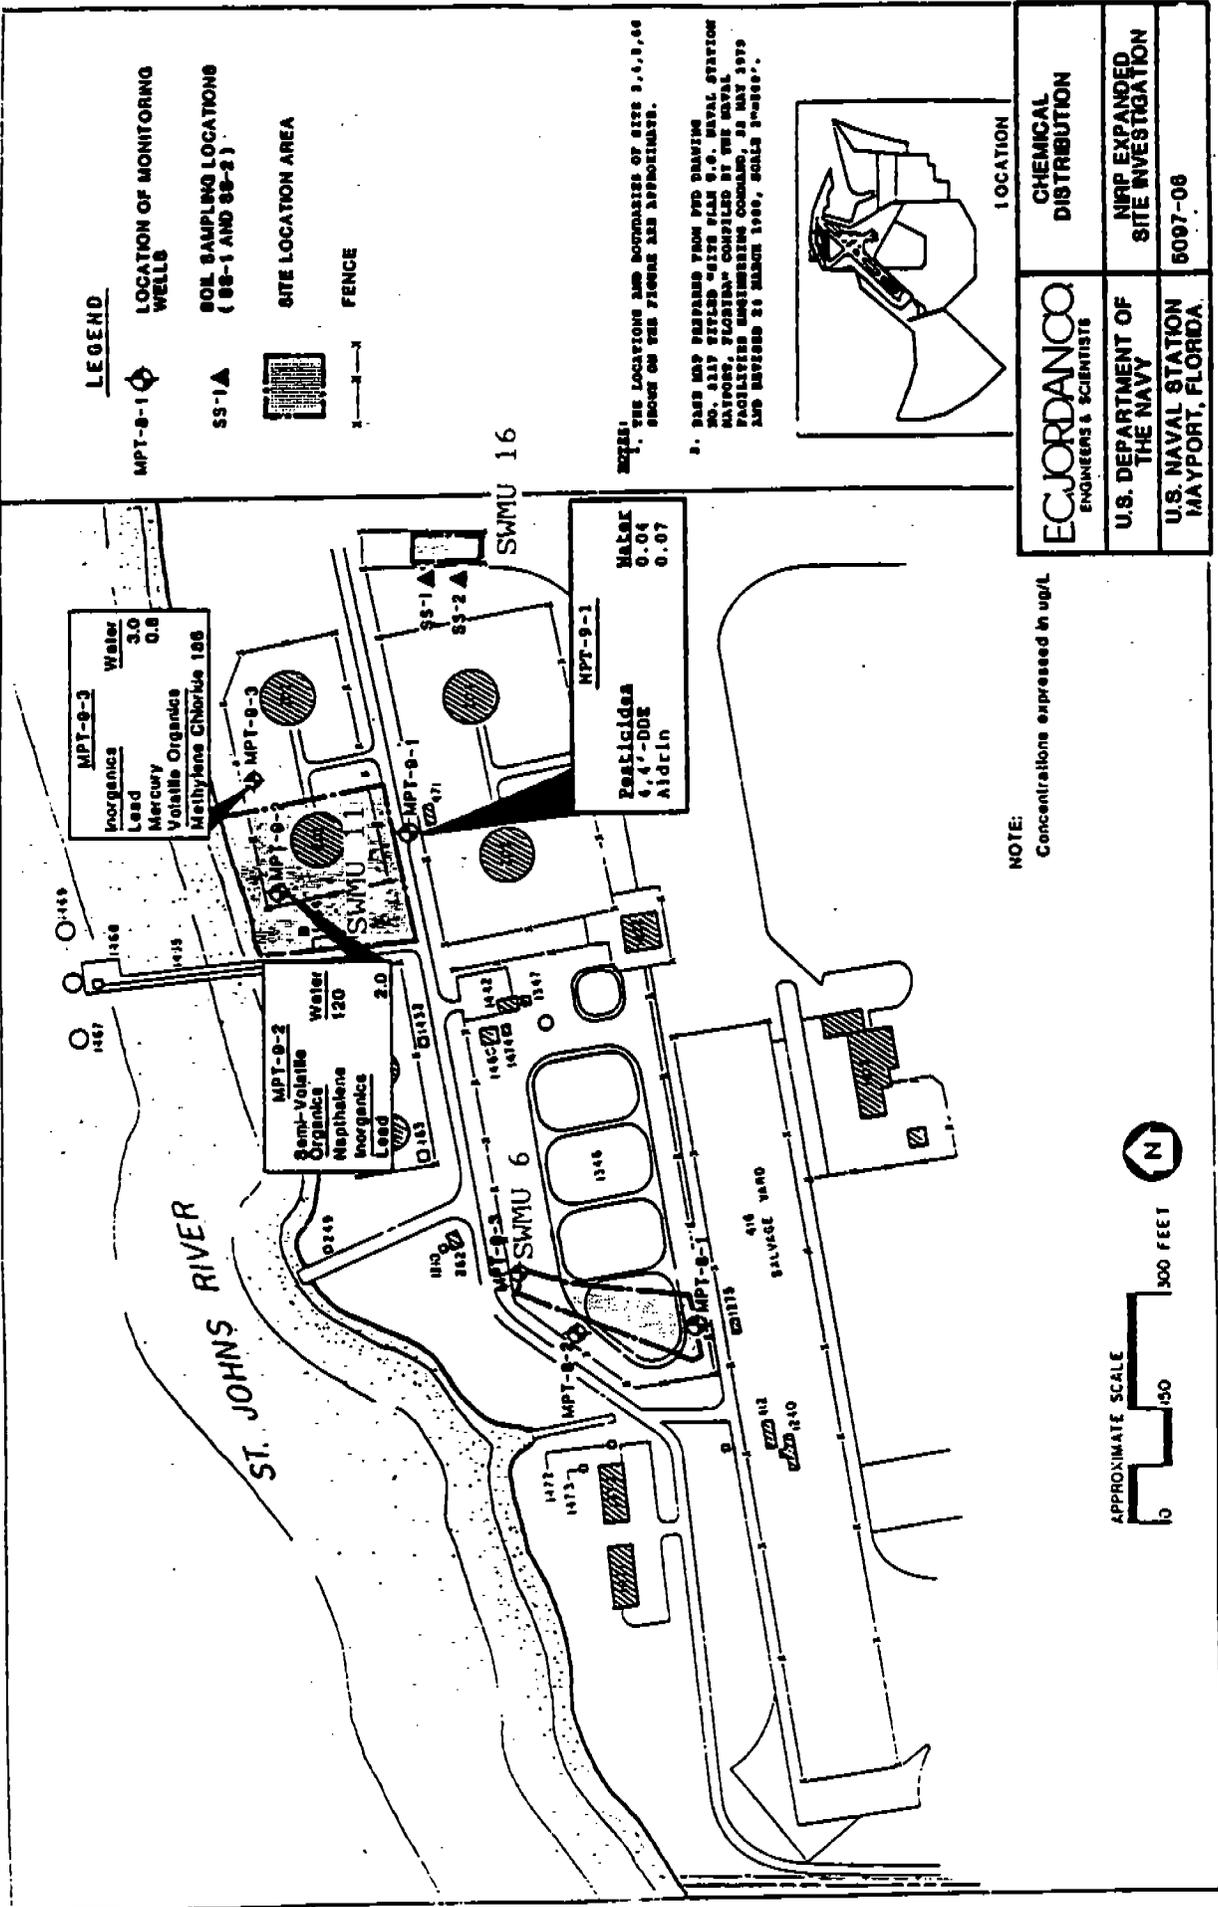
FIGURE IV-12: CHEMICAL DISTRIBUTION FOR THE FUEL SPILL AREA (SWMU 11) (REFERENCE 34)

Since releases of hazardous constituents have been documented in the ESI, an RFI is warranted for this area. An RFI has been required through the mechanism of the HSWA permit. An evaluation of whether the work conducted under the ESI will be accepted in place of some of the requisite RFI work has yet to be made.

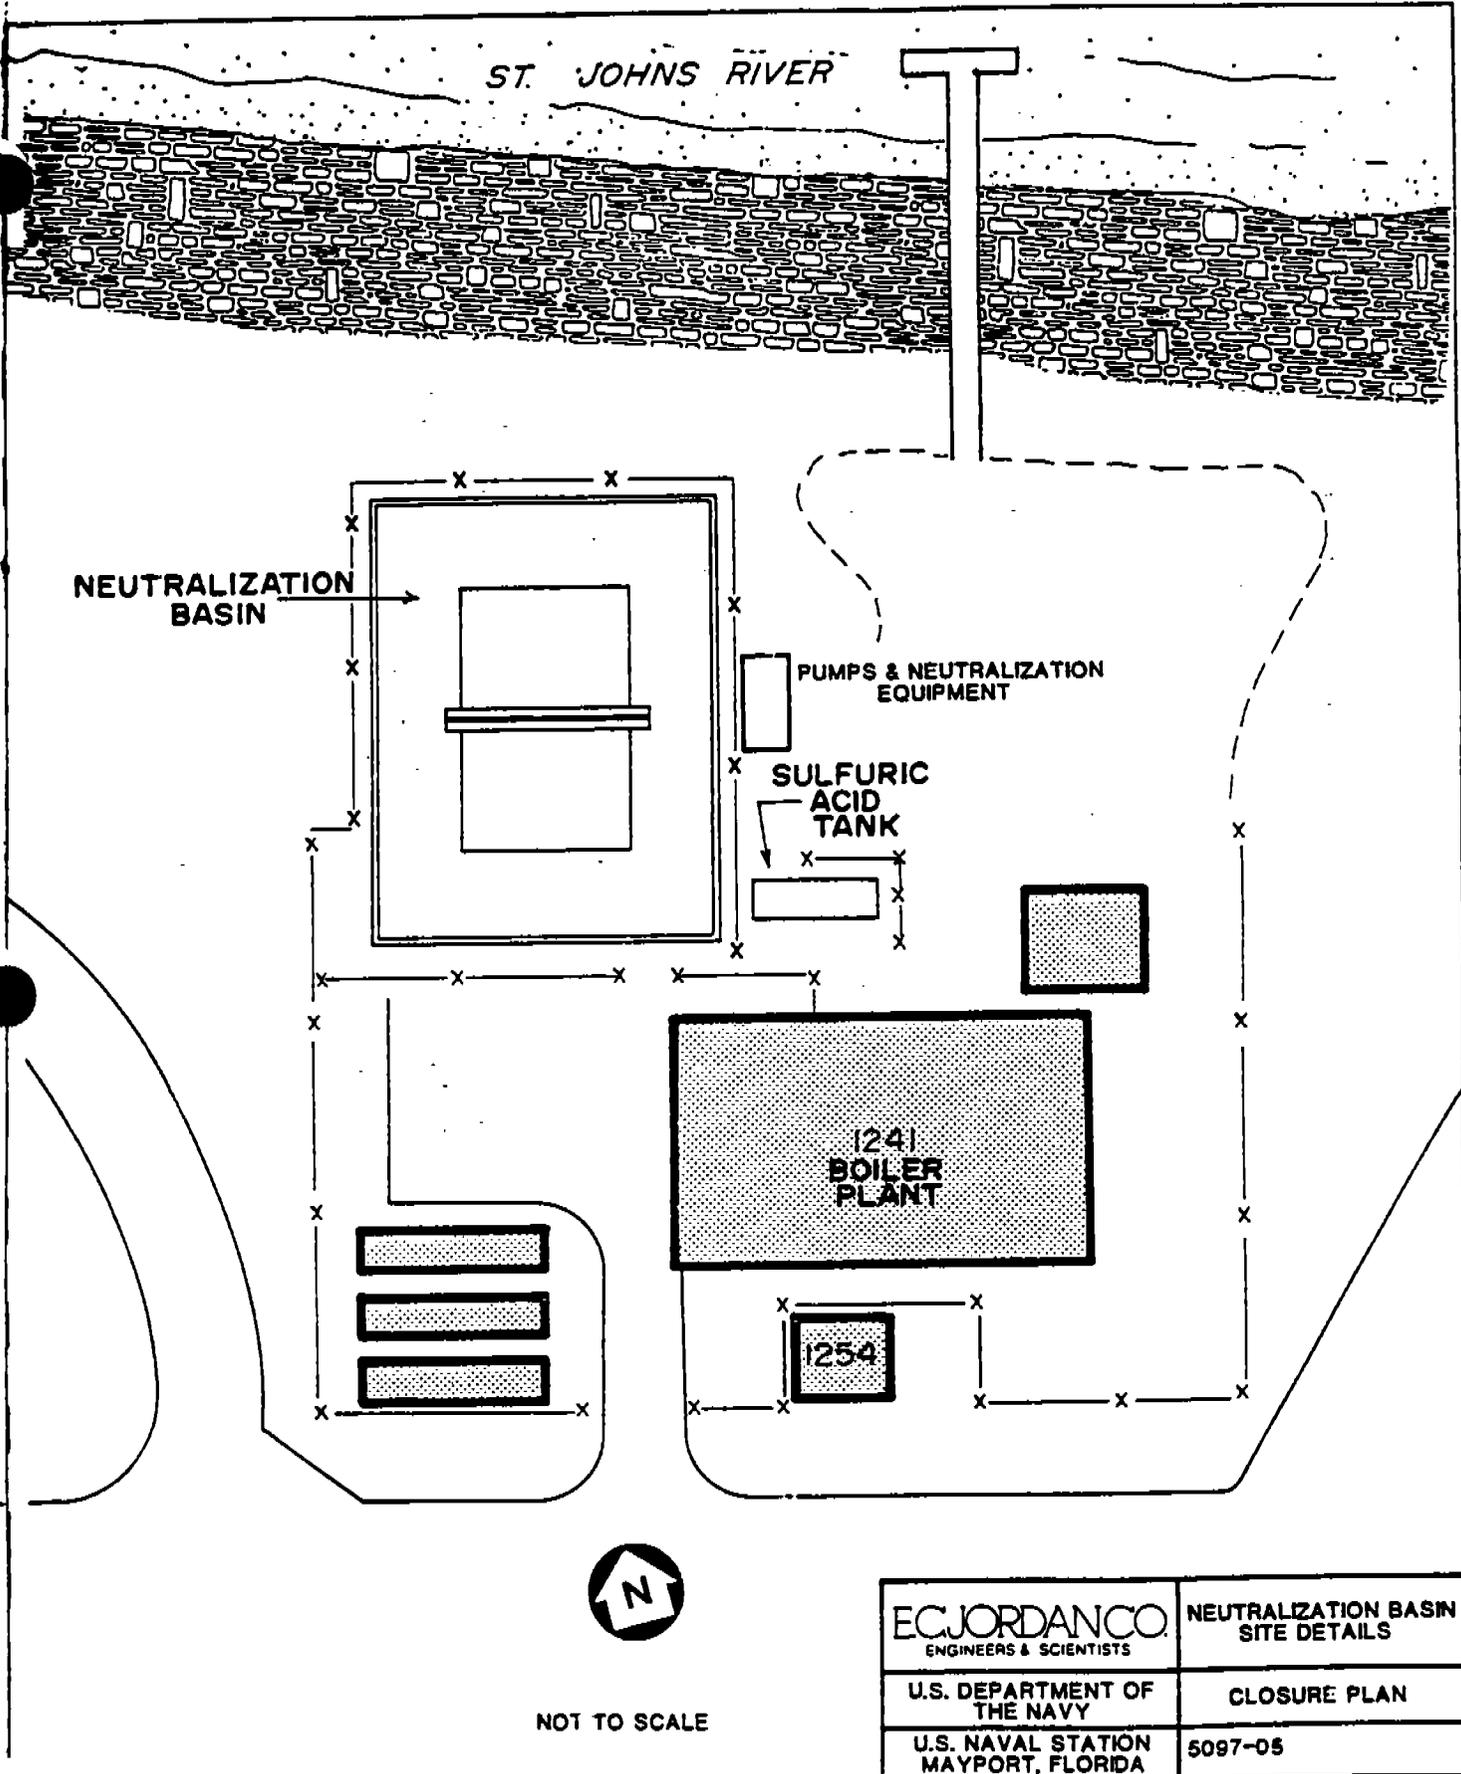
FIGURE IV-13: LOCATION OF THE NEUTRALIZATION BASIN (SWMU 12)
(REFERENCE 18)

A new basin was constructed to replace the old Basin in 1986 and was first operated in January of 1987. The new Basin, which is currently in use, is constructed of 6-inch-thick concrete on top of 12 inches of compacted soil. The concrete is covered with a Hypalon liner. The Basin is six feet deep, 59 feet wide, and 78 feet long. Influent from the Boiler Building enters the Basin through a 6-inch underground pipeline. The Basin is divided into two cells, and the effluent is discharged through sewer pipes to the Wastewater Treatment Facility (SWMUs 43-45). Release controls for the unit include six-foot-high berms on all sides of the Basin and flow rate controls in the regenerant system.

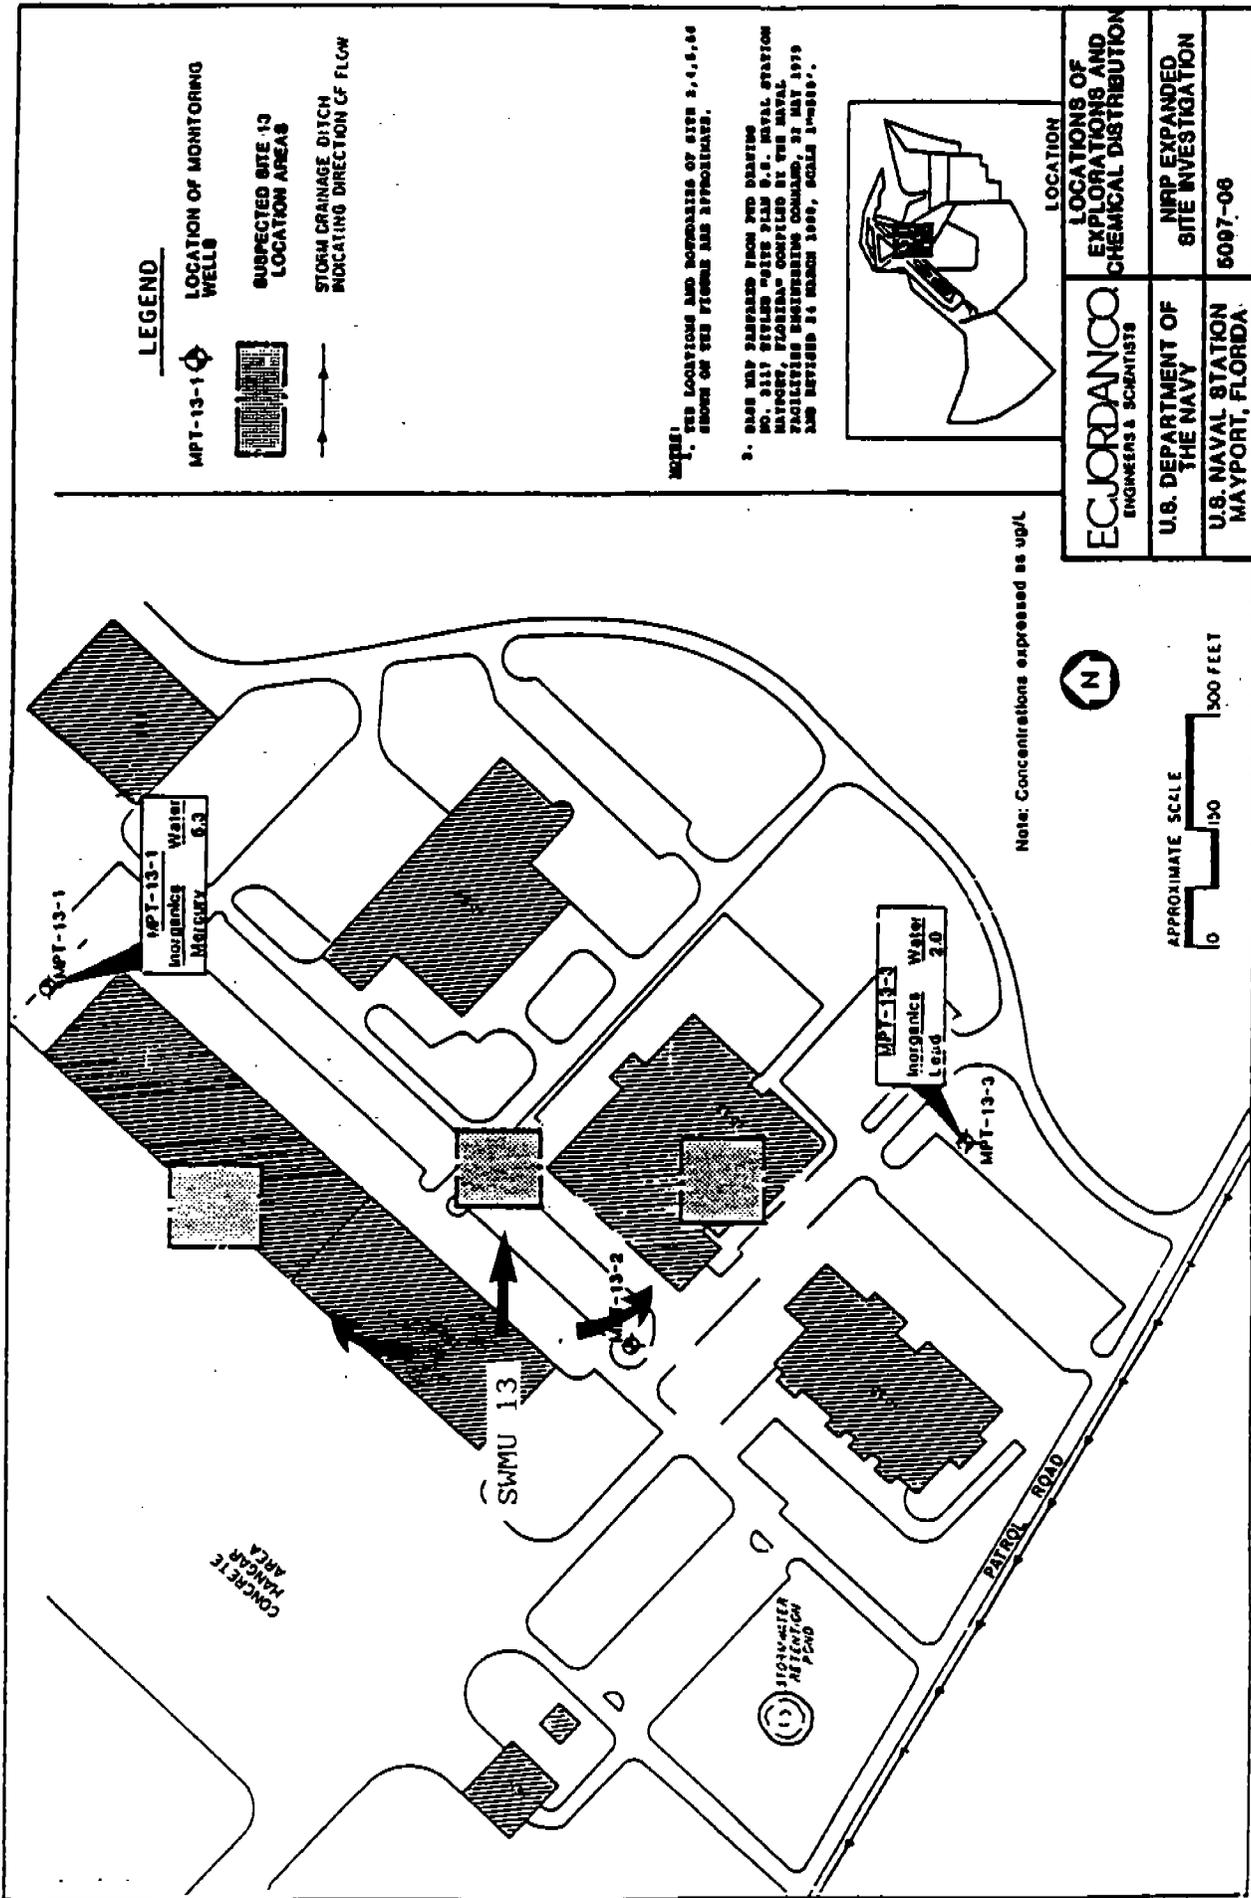
FIGURE IV-14: LOCATION AND CHEMICAL DISTRIBUTION FOR OLD FIREFIGHTING AREA (SWMU 13) (REFERENCE 34)

As part of the ESI, soil and groundwater samples were collected from three locations where monitoring wells were installed. No hazardous constituents were detected in the soil samples, but lead and mercury were each detected in one groundwater sample. Figure IV-14 illustrates the locations of the samples collected and the constituents detected. Due to the lack of sufficient information concerning groundwater flow directions in the area, it was recommended in the ESI that further investigation of the area be conducted under a Phase II ESI. It was recommended that the Phase II include installation of five piezometers to establish groundwater flow directions, and three groundwater monitoring wells to verify the presence or absence of hazardous constituents in the groundwater (Reference 34).
