RESOURCE CONSERVATION AND RECOVERY ACT FACILITY ASSESSMENT OF NS
MAYPORT FL
9/1/1989
A T KEARNEY

RCRA FACILITY ASSESSMENT
OF THE
NAVAL STATION MAYPORT
JACKSONVILLE, FLORIDA
EPA I.D. NO. FL9170024260

September 1989

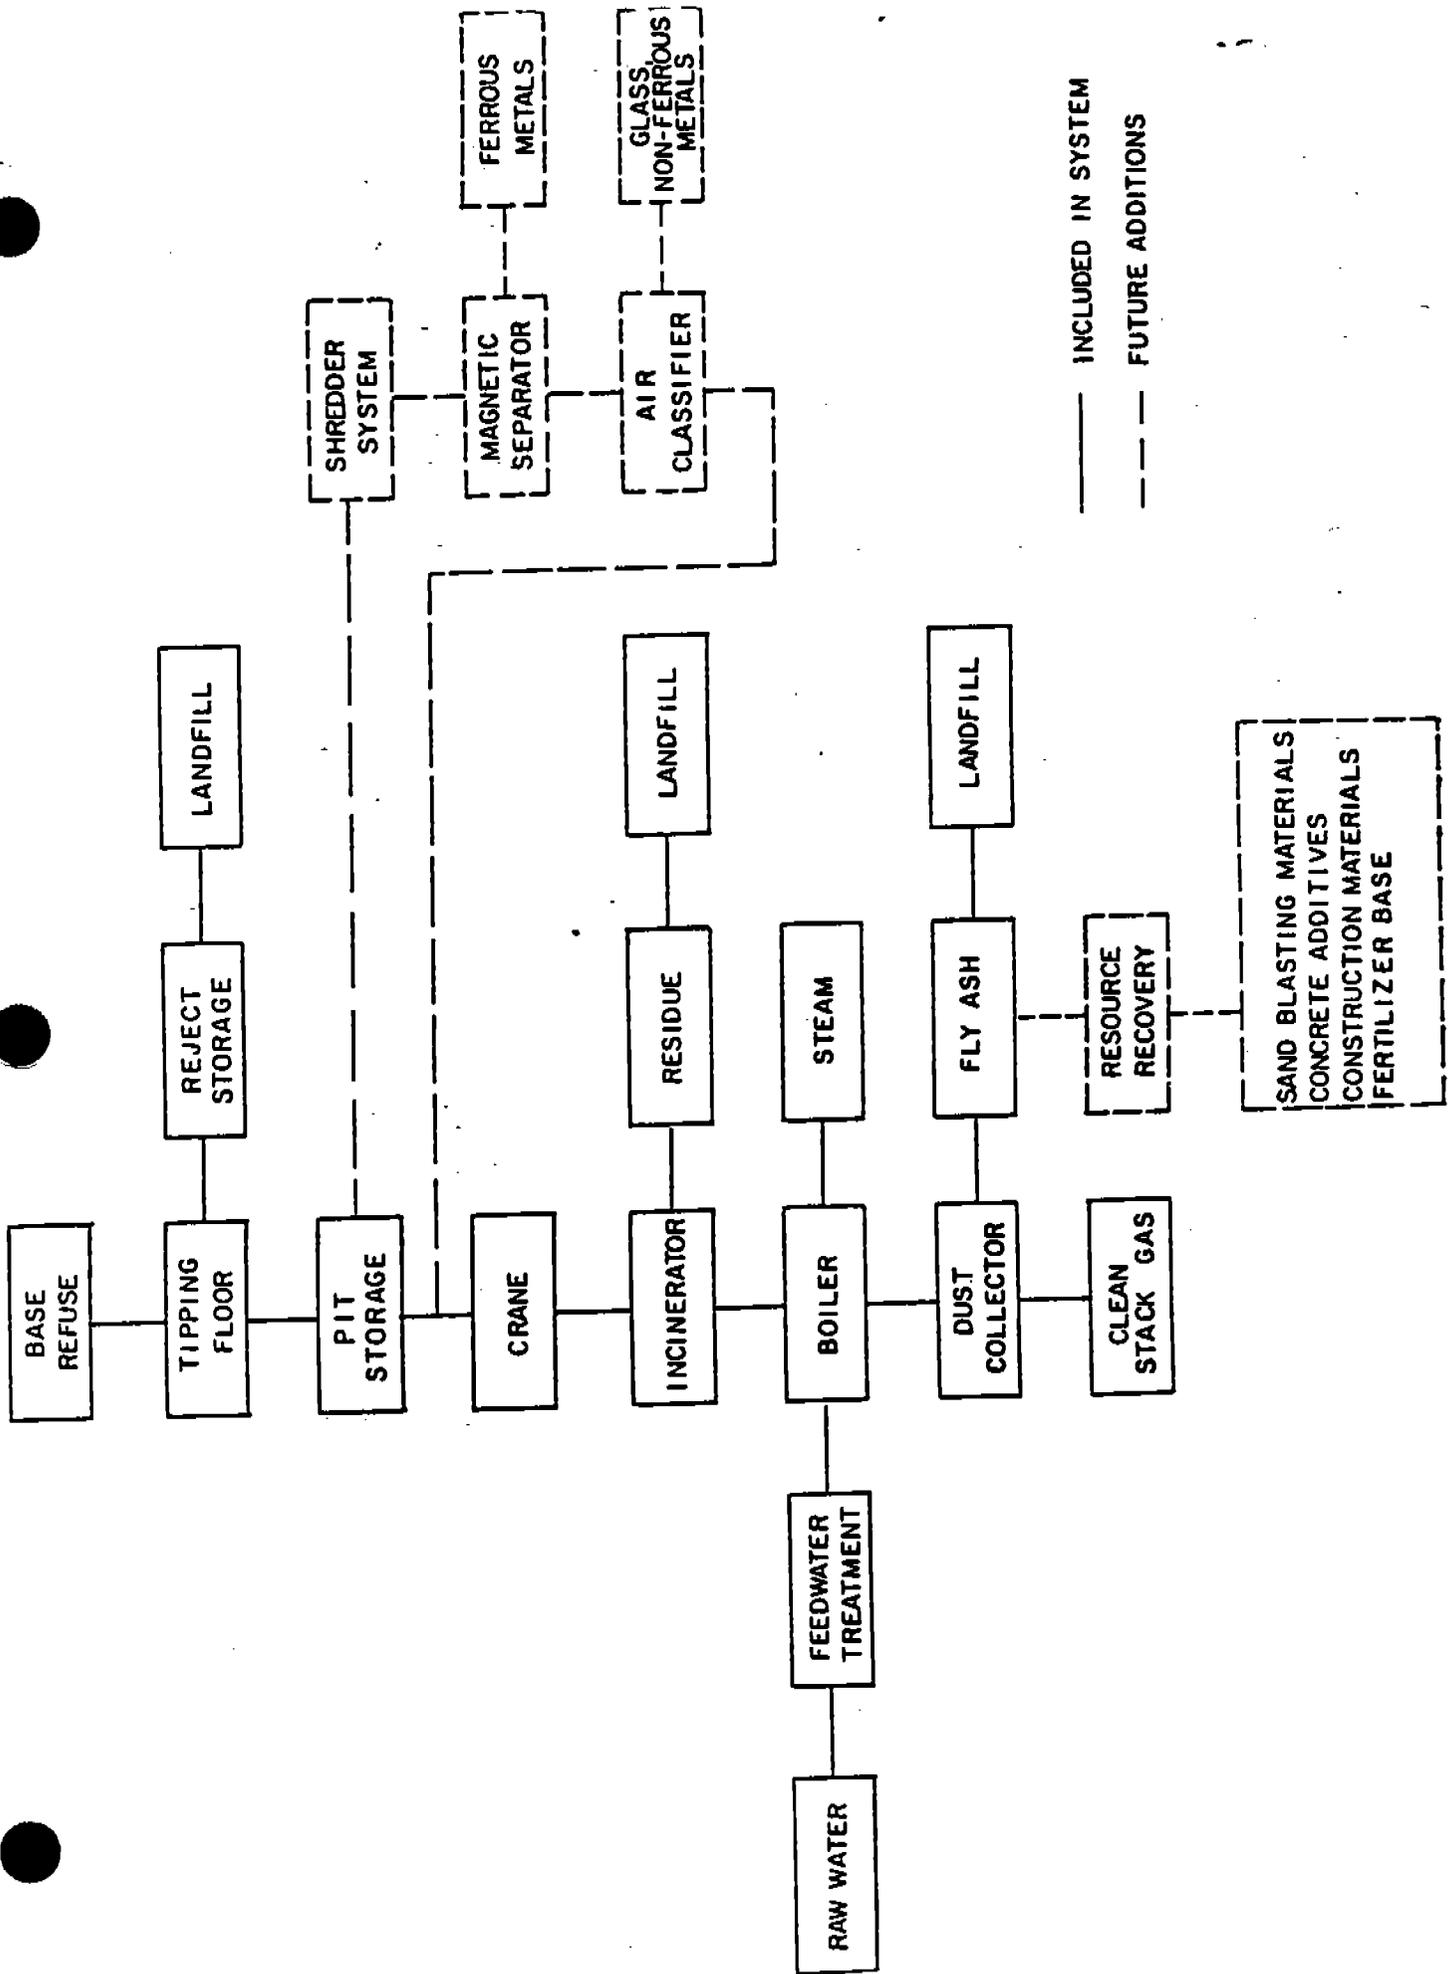
FIGURE IV-17: PLANT FLOW DIAGRAM; CARBONACEOUS FUEL BOILER (SWMU 17)
(REFERENCE 94)

The Carbonaceous Fuel Boiler (CFB) (SWMU 17) is located near the southwestern corner of the Destroyer slip in Building 1430. The CFB is similar to a municipal solid waste incinerator and has been used since 1979 to dispose of all refuse and burnable garbage generated at Mayport. The plant operates 24 hours a day, six days a week, and can burn approximately two tons per hour of solid waste refuse and up to 50 gallons per hour of reclaimed oil. Figures IV-17, IV-18 and IV-19 present a plant flow diagram, plant plan, and a cut-away plant control diagram for the CFB. The plant can generate up to 10,000 pounds per hour of saturated steam at 200 p.s.i.g. which is delivered through an underground conduit to the steam header in Building 250 (Reference 94).

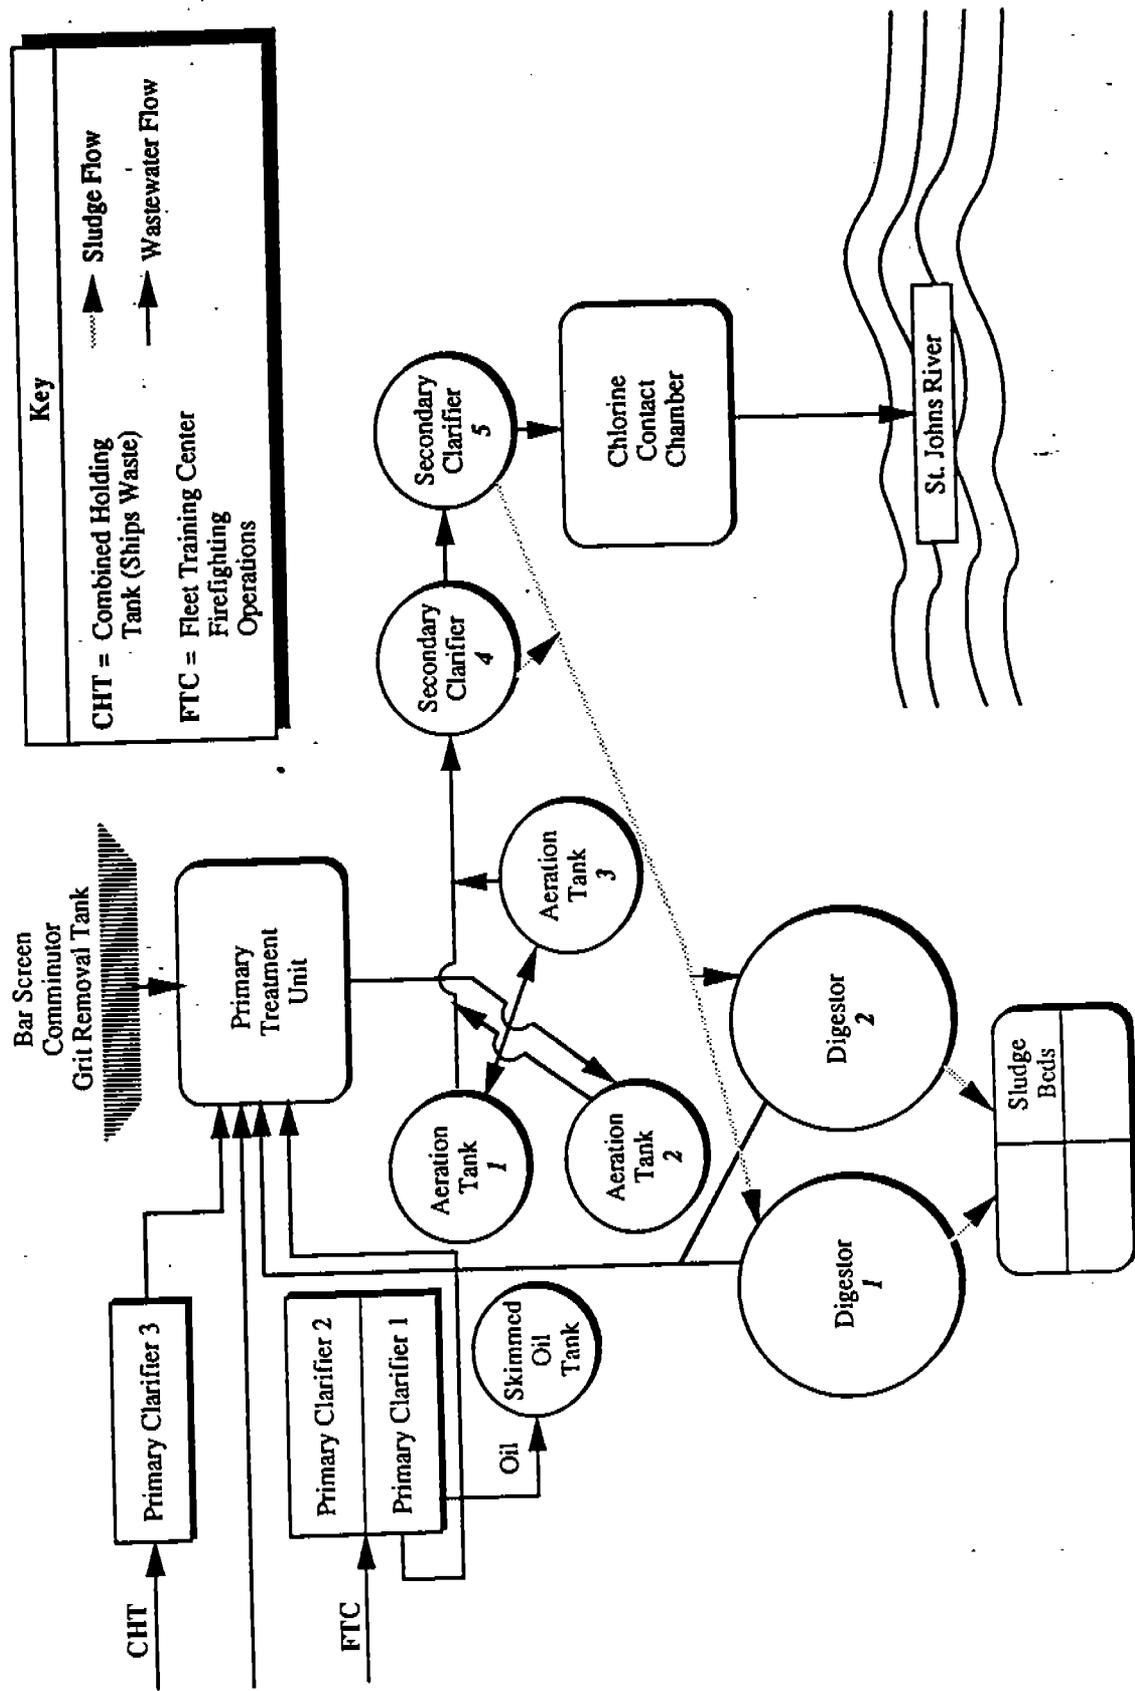
Figure IV-22: Process Flow Diagram, Wastewater Treatment Facility (SWMUs 43-45)

In the aeration tanks, the wastewater and recirculated solids are mixed in the presence of dissolved oxygen with activated sludge. The mixture overflows a weir and is conveyed by cast iron gravity lines to the Secondary Clarifiers Nos. 4 and 5 (Reference 75).

The Secondary Clarifiers are 45 feet in diameter by 12 feet 6 inches deep. The activated sludge is separated by gravity from the treated wastewater. A portion of the sludge is recirculated to the aeration tanks through the primary treatment unit. The remainder of the sludge is removed from hoppers in the clarifier bottom.

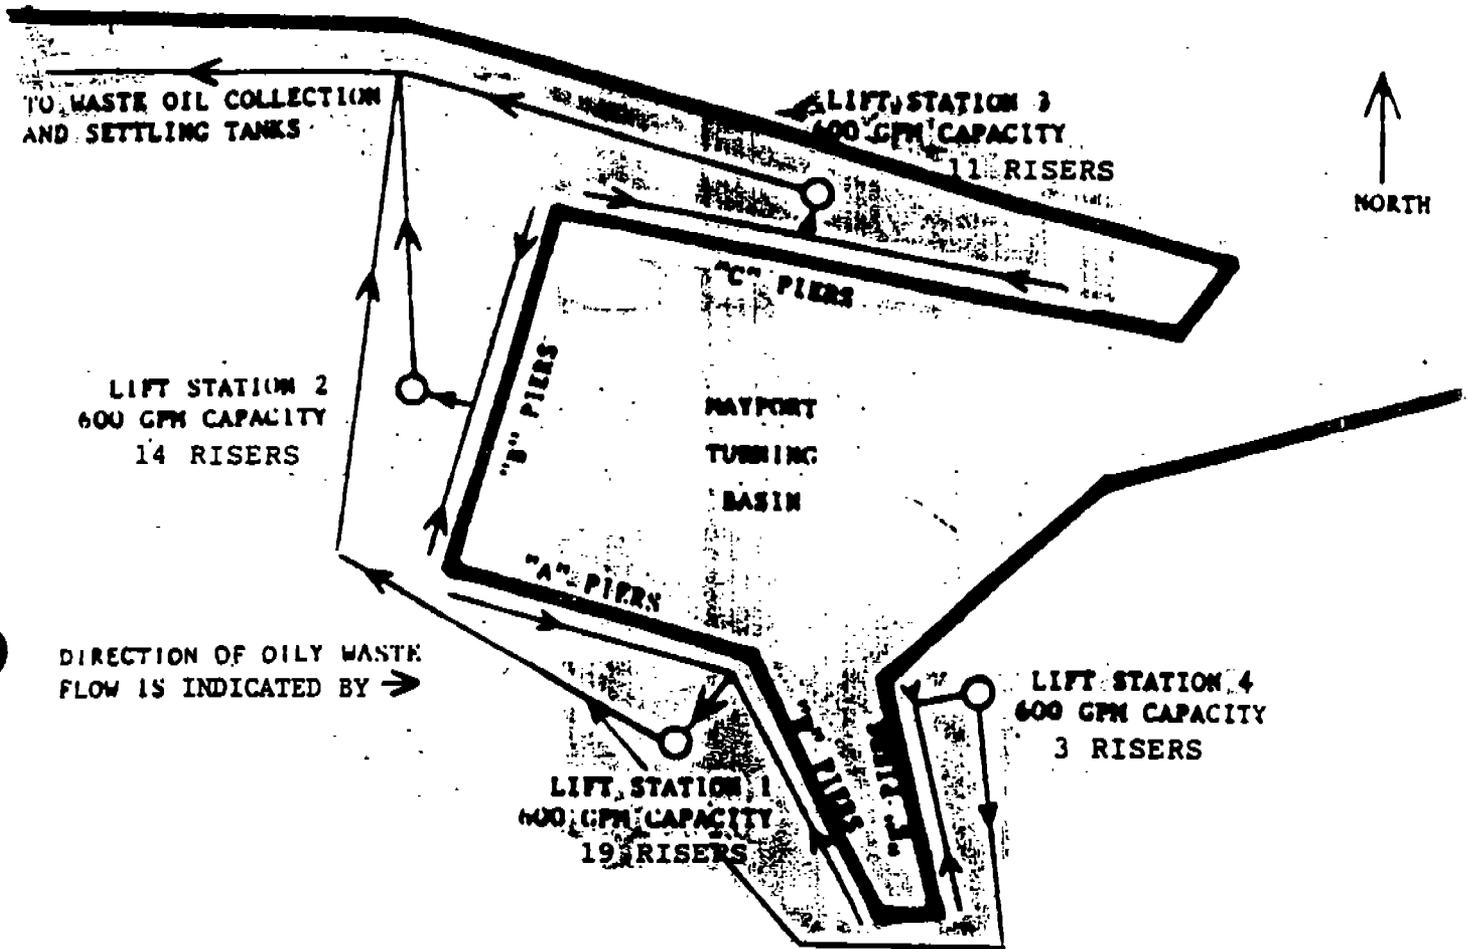
FIGURE IV-23: OILY WASTE COLLECTION SYSTEM (SWMU 47)
(REFERENCE 103)

According to facility representatives, the integrity of the Oily Waste Collection System has not been leak tested because the appropriate methods are not currently available to Station personnel (Reference 103). However, it is suspected that leaks may have occurred or be occurring. Evidence of a release from the Oily Waste Collection System has been found at the intersection of Alpha and Bravo piers (see SWMU 28), and during an excavation project

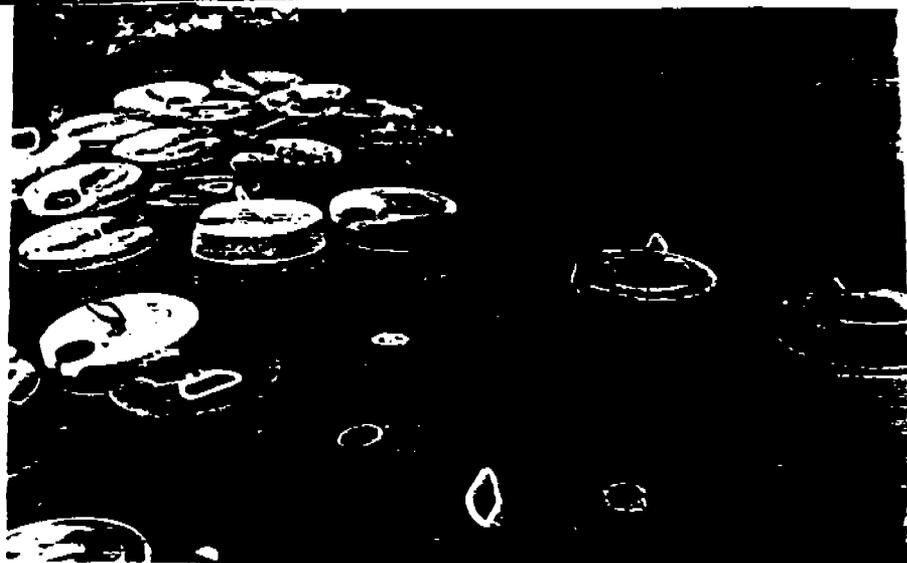
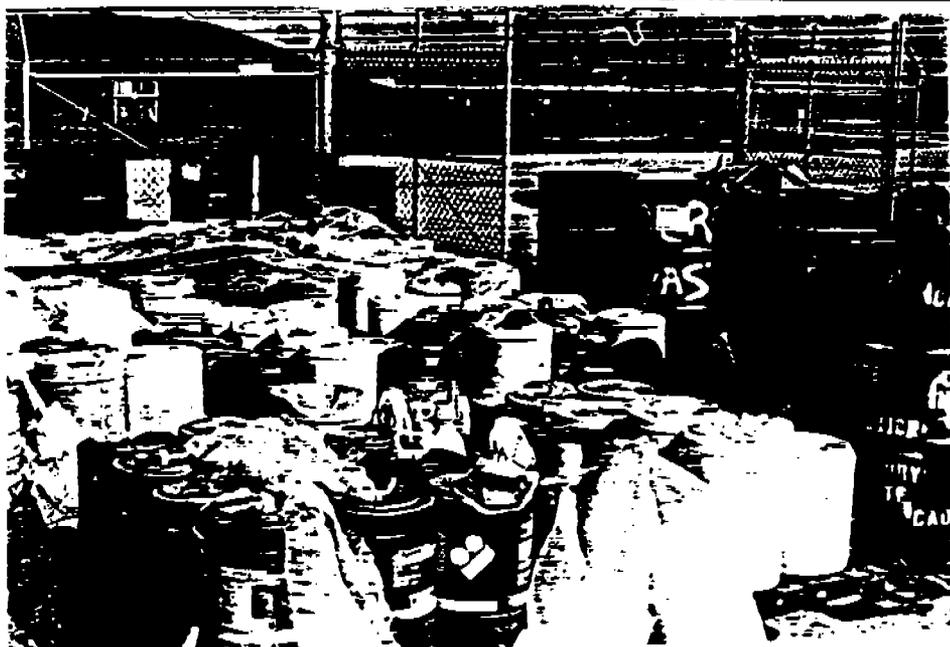
FIGURE IV-24: FDER FILE PHOTOGRAPHS; FORMER CHEMISTRY LAB ACCUMULATION AREA (SWMU 48) (REFERENCE 84)

The Former Chemistry Lab Accumulation Area (SWMU 48) was identified after the VSI from photographs obtained from FDER files (Reference 84). Copies of the photographs are presented as Figures IV-24 and IV-25. The photographs show numerous plastic and steel containers, many of which are labeled "Mercury Waste," stored outside in a grassy field near a fence. There appear to be at least ten 55-gallon drums and over fifty smaller plastic containers. The half-buried tank (SWMU 51-S) is visible in one photograph with an underground, above-grade tank behind it and a road and fence line in front. Other

Due to the permeability of the soils in the area, the shallow water table, the proximity of the Saint Johns River, the photographic and descriptive evidence of long-term storage in poorly maintained containers, and the relative toxicity of the wastes reportedly stored in the area (mercury and plating wastes), further investigation of this site appears warranted to verify whether releases of hazardous constituents have occurred. It is suggested that the location and extent of the area in which these wastes were stored be

verified. It is further suggested that shallow soil and groundwater samples be collected from the identified area and that they be analyzed for mercury and other heavy metals, to verify whether releases of these hazardous constituents have occurred and to characterize the nature and extent of any releases.

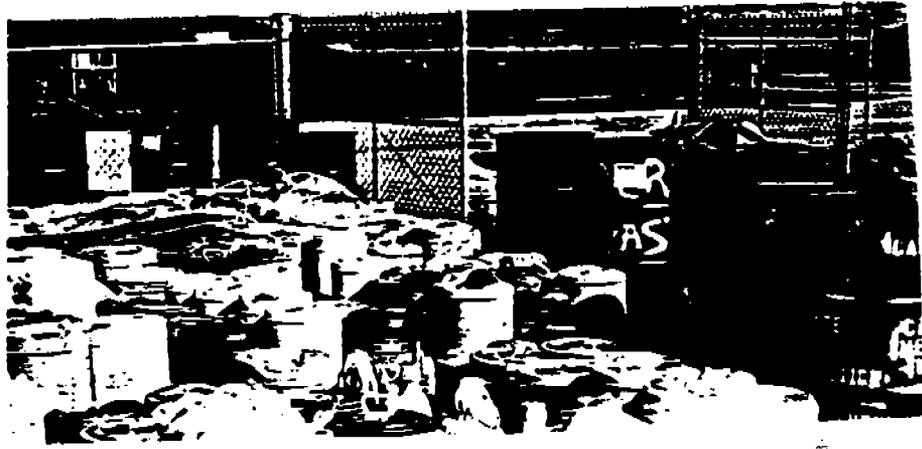
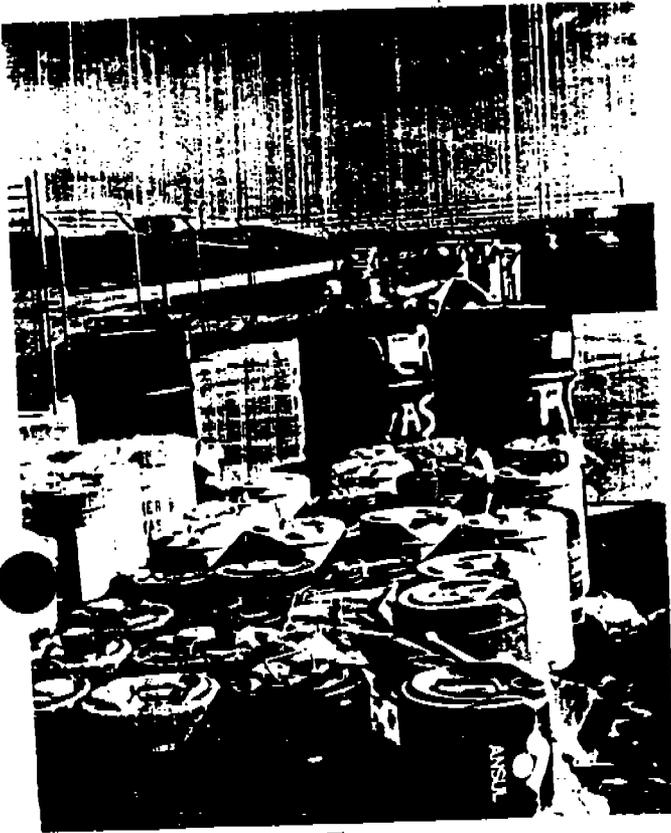
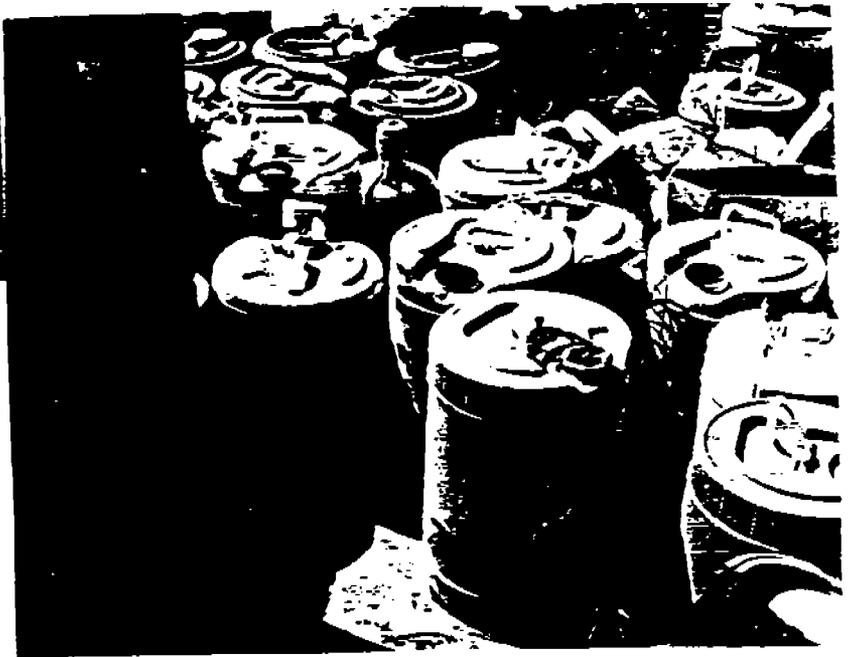
FIGURE IV-25: FDER FILE PHOTOGRAPHS: FORMER CHEMISTRY LAB ACCUMULATION AREA (SWMU 48) (REFERENCE 84)

photographs show drums stored near a cinder block wall. Some of the smaller plastic drums appear to be on pallets. At least one 55-gallon steel drum is shown lying on its side.

An FDER letter to the Mayport Public Works Officer dated December 4, 1981, mentions mercuric nitrate wastes and plating wastes stored outdoors, in plastic containers in varying conditions, many without lids (Reference 82). It appears likely that the letter is referring to the Former Chemistry Lab Accumulation Area because the letter mentions plans to conduct a follow-up inspection of the area in March 1981, which is very close in time to the April 1981 dates on the photographs. The letter also mentions that the area is in an open field and close to surface water, which is consistent with the location behind Building 1442 (Reference 82).
