LETTER REPORT REGARDING COMPLETION OF INTERIM MEASURE FOR THE
EXCAVATION, TRANSPORTATION AND DISPOSAL OF SOIL CONTAINING PCB AT SOLID
WASTE MANAGEMENT UNIT 2 NS MAYPORT FL
7/26/1996
ABB ENVIRONMENTAL SERVICES

**SUBJECT: Completion of Interim Measure at SWMU 2 PCB Area
Resource Conservation and Recovery Act
Corrective Action Program
U.S. Naval Station, Mayport, Florida
Contract No. N62467-87-D-0317 CTO#028**

ATTACHMENT B
PHOTOGRAPHS

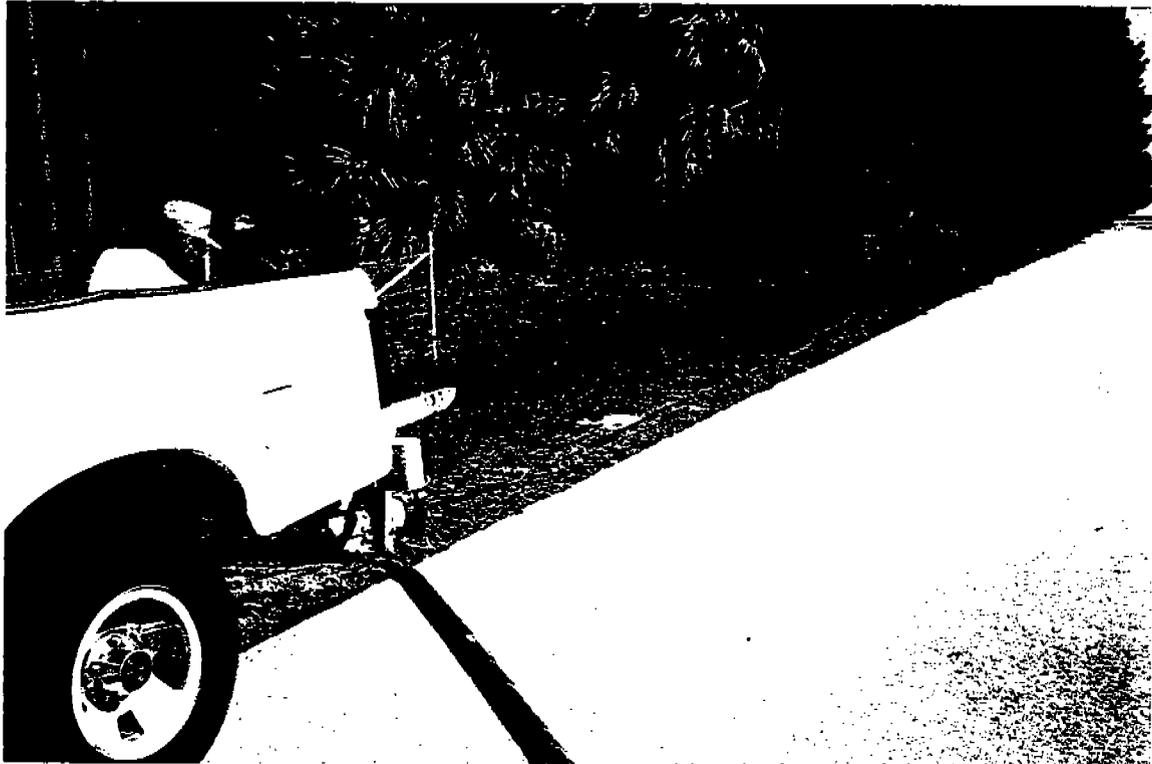
Photos 3 and 4: A Bechtel employee is pumping water from drainage ditches after a period of heavy rainfall. The water was discharged to drainage ditches on the other side of the road from the SWMU 2 PCB area. This occurred prior to the excavation activities.

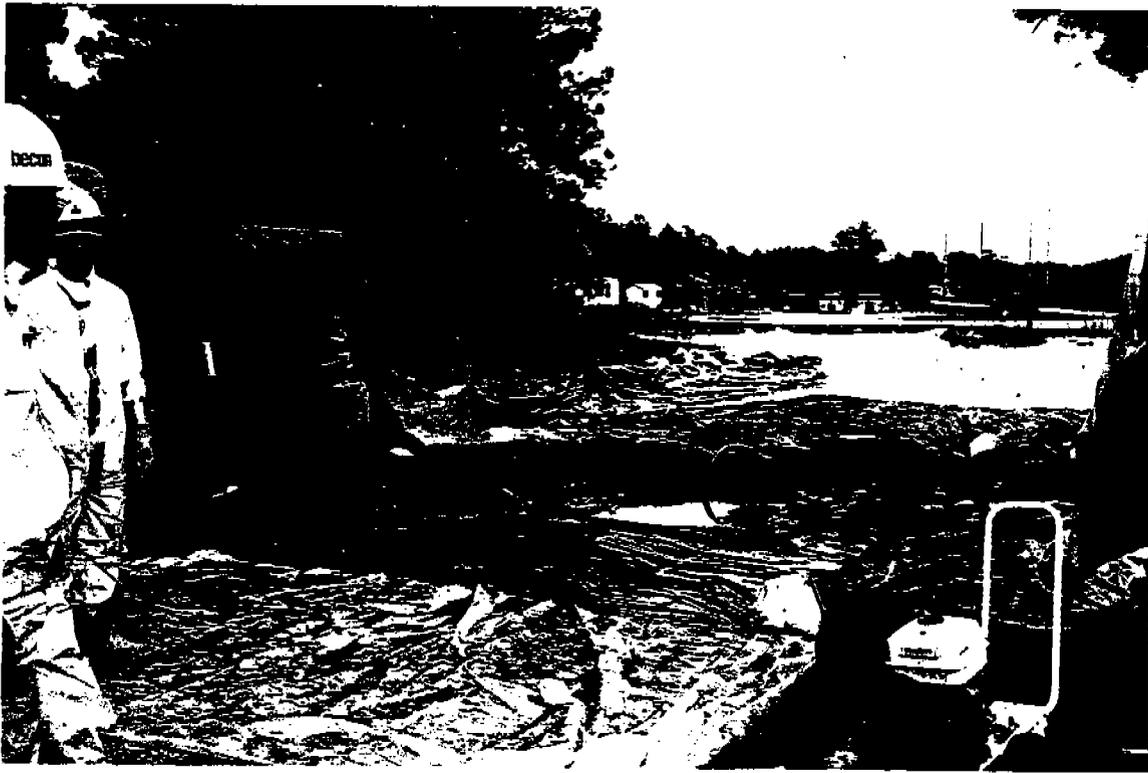
Photo 5: View looking east of the decontamination pit.

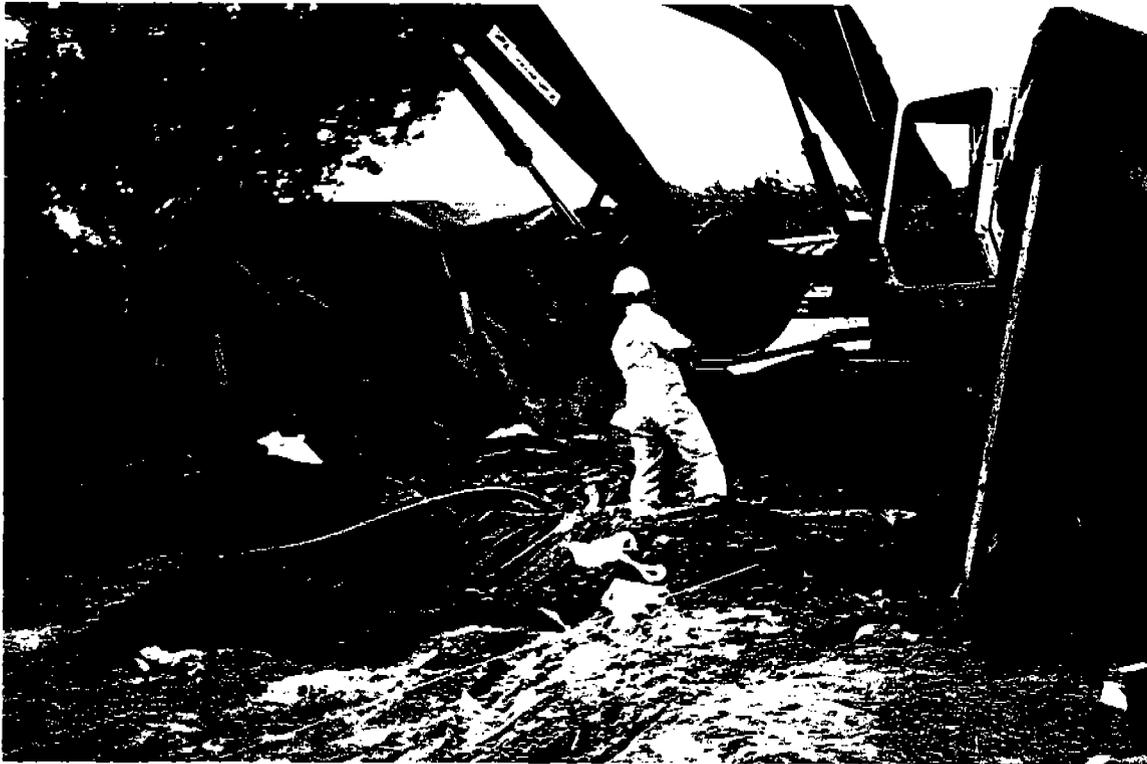
Photo 6: Decontamination of the trackhoe.

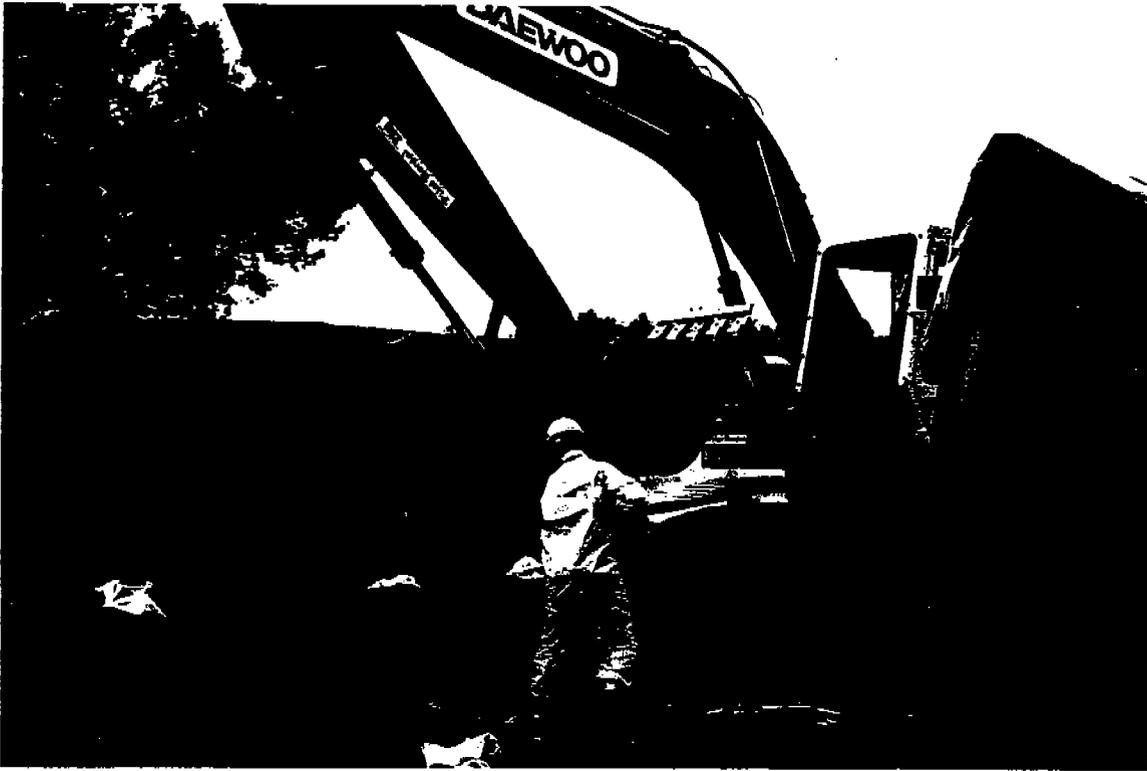
Photo 7: Decontamination of the trackhoe.

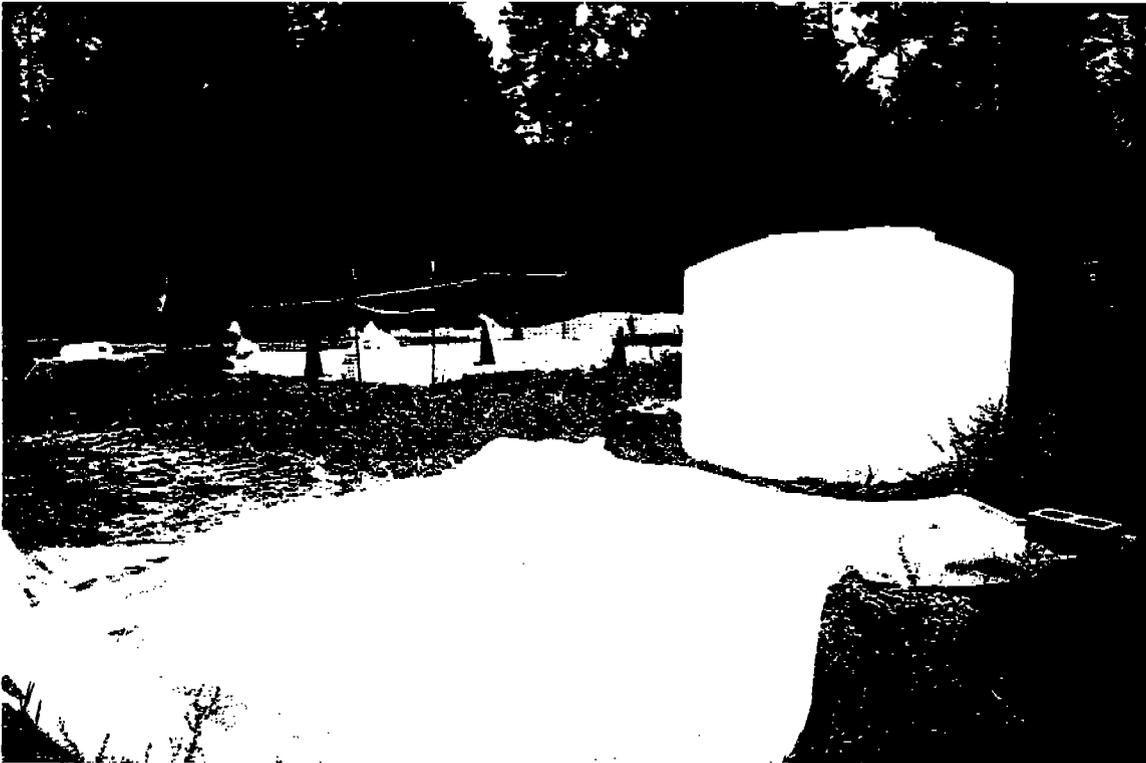
Photo 8: Storage tank OU1, decontaminated water

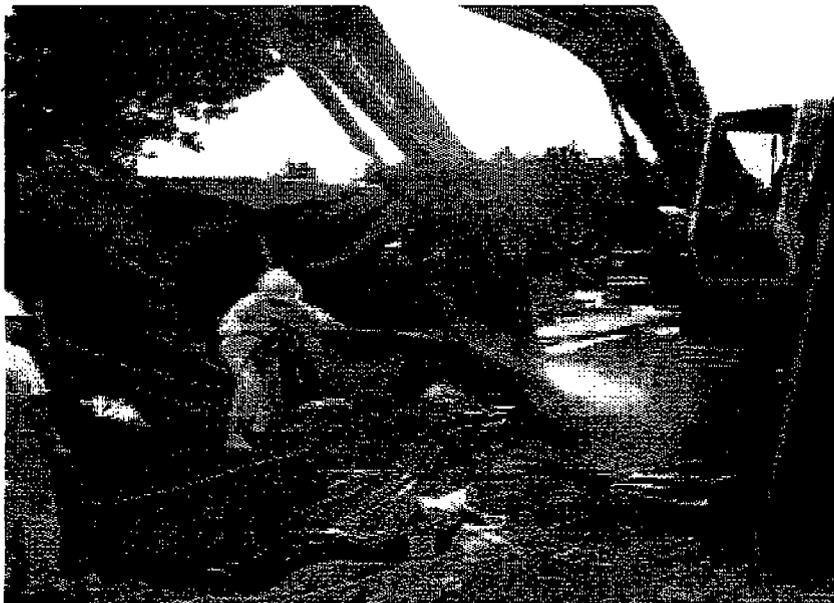
Photo 10: Decontamination of the trackhoe.

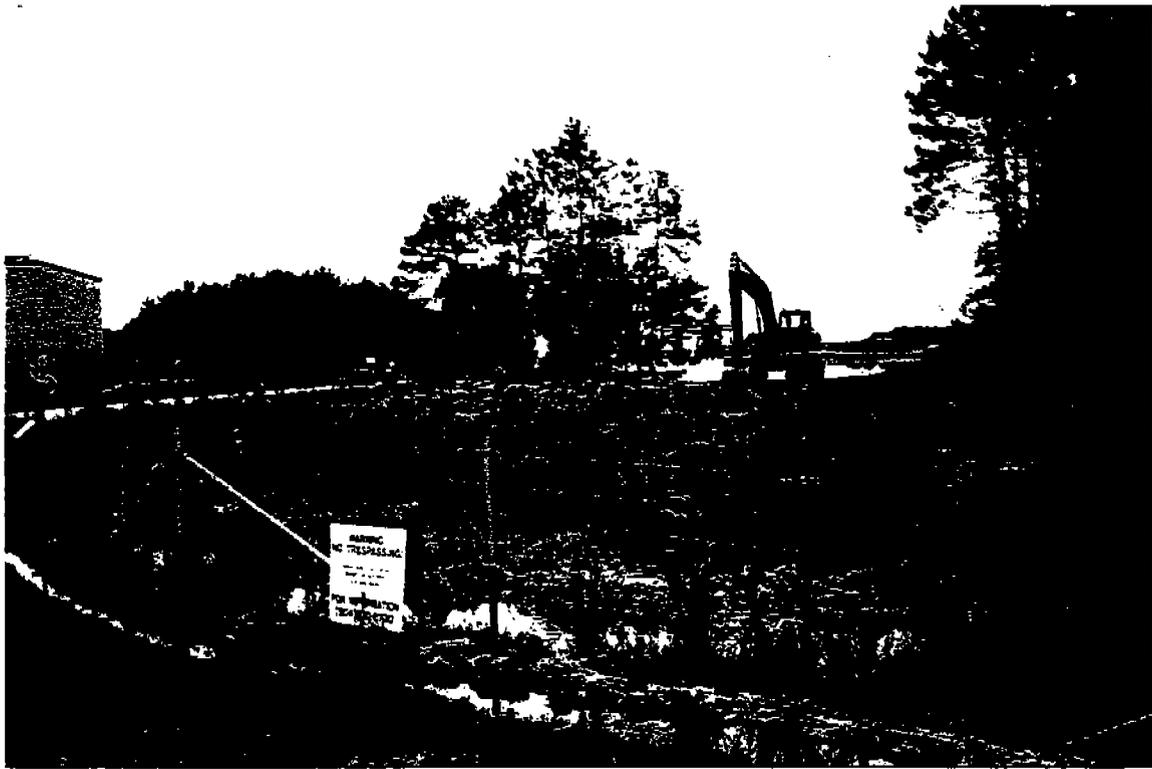
Photo 11: View looking west of the SWMU 2 PCB area. The stakes mark the grid used to determine the areas requiring excavation (ABB-ES, 1994) (Bechtel, 1995) and are reference points for confirmatory sampling activities.

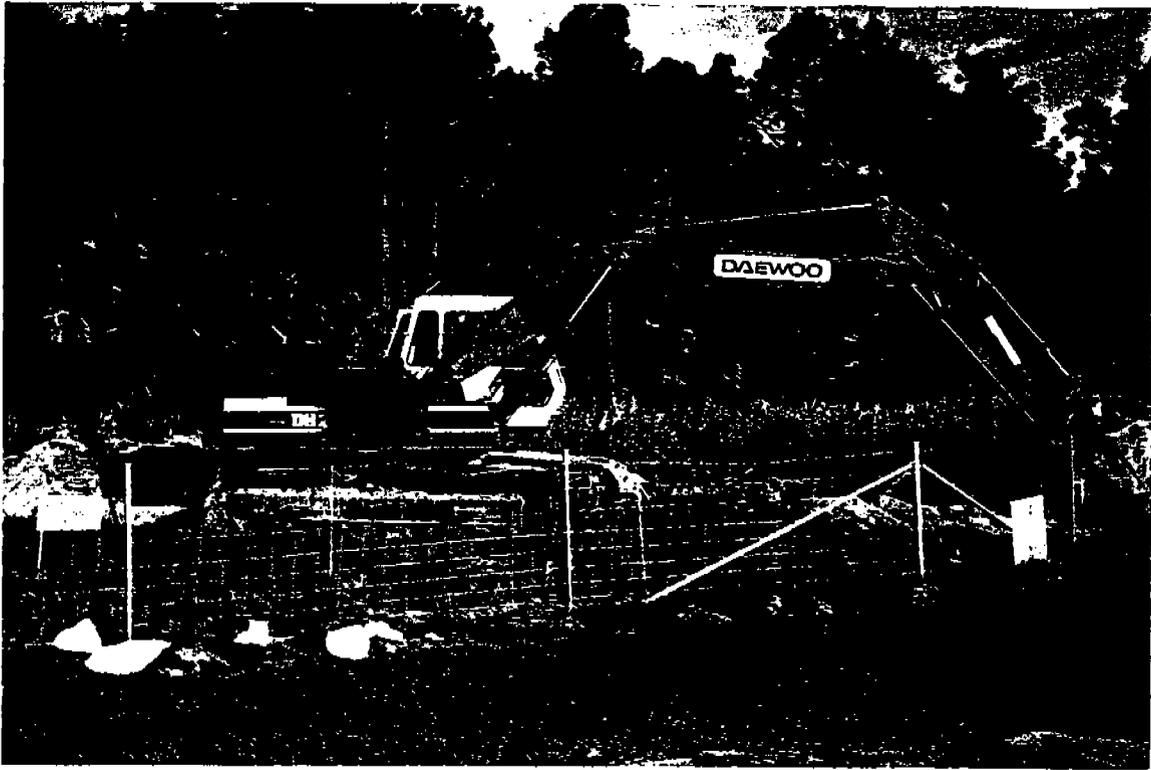
Photo 13: Trackhoe excavating soil.

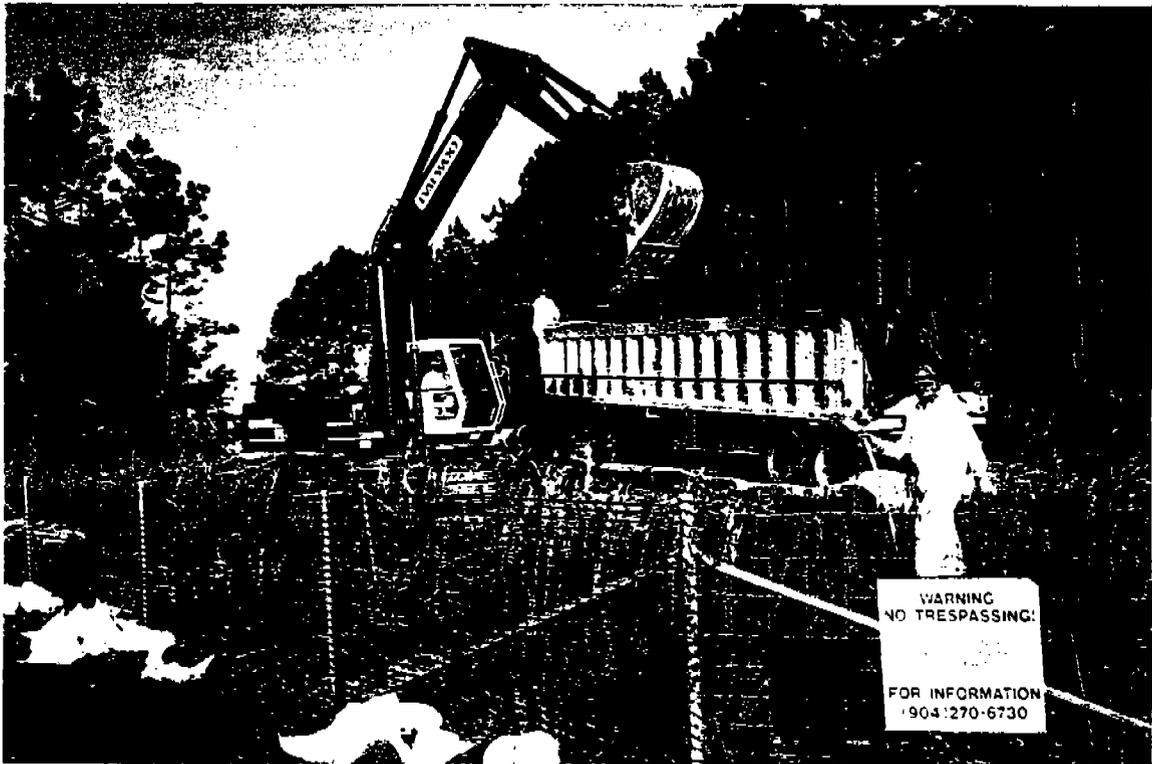
Photo 14: Loading excavated soil into a 20-cubic-yard trailer.

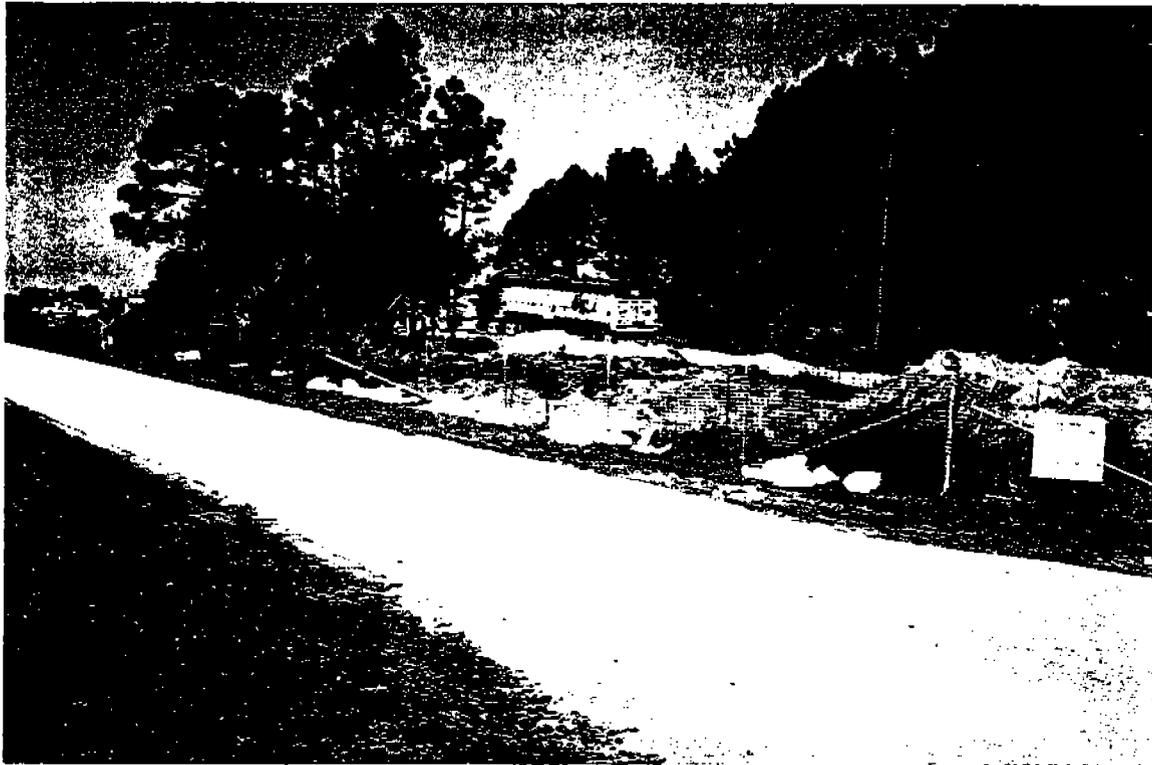
Photo 16: Loaded 20-cubic-yard trailer covered and ready for transport.

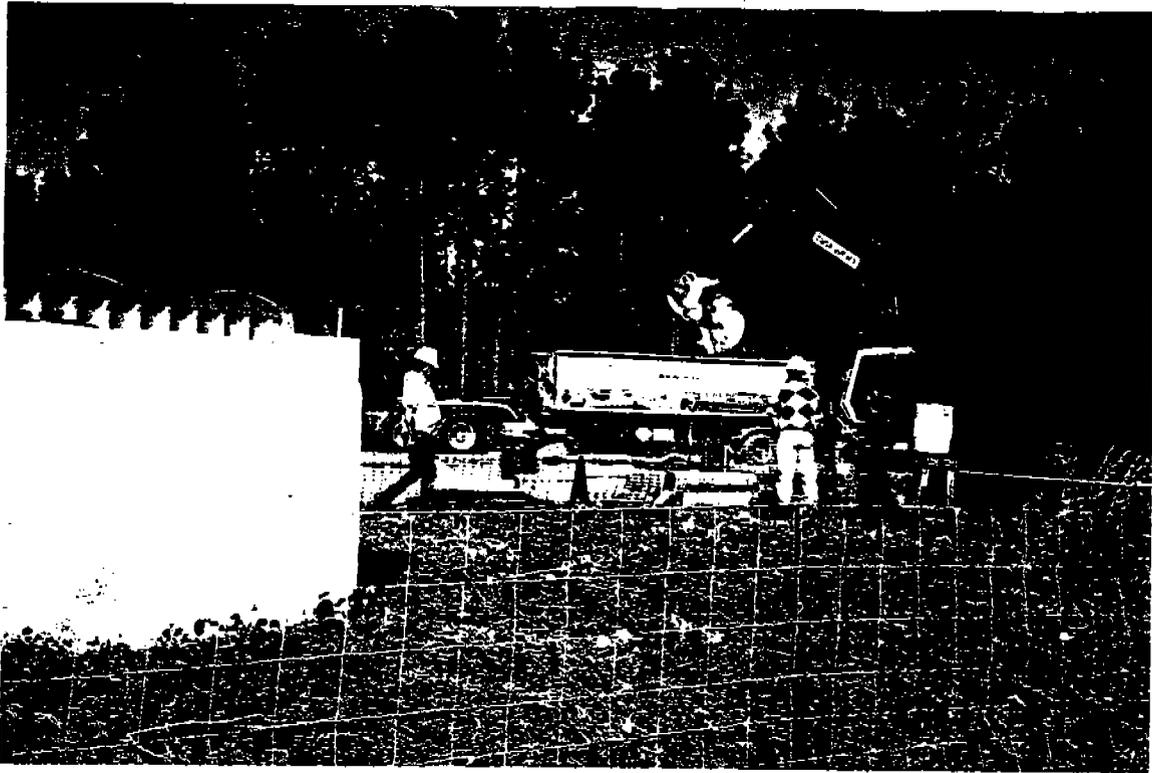
Photo 17: Excavated soil being placed in a 20-cubic-yard roll-off container.

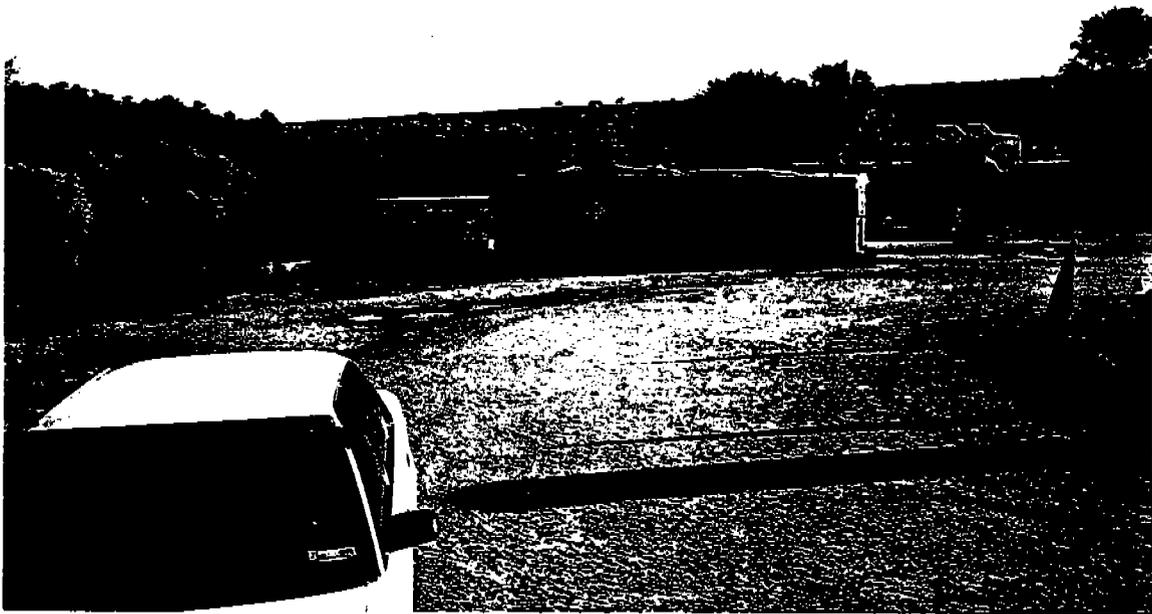
Photo 18: Twenty-cubic-yard roll-off container that has been filled, covered, and awaits transport. The container was temporarily stored in a parking lot across the street (east) of the SWMU 2 PCB site.

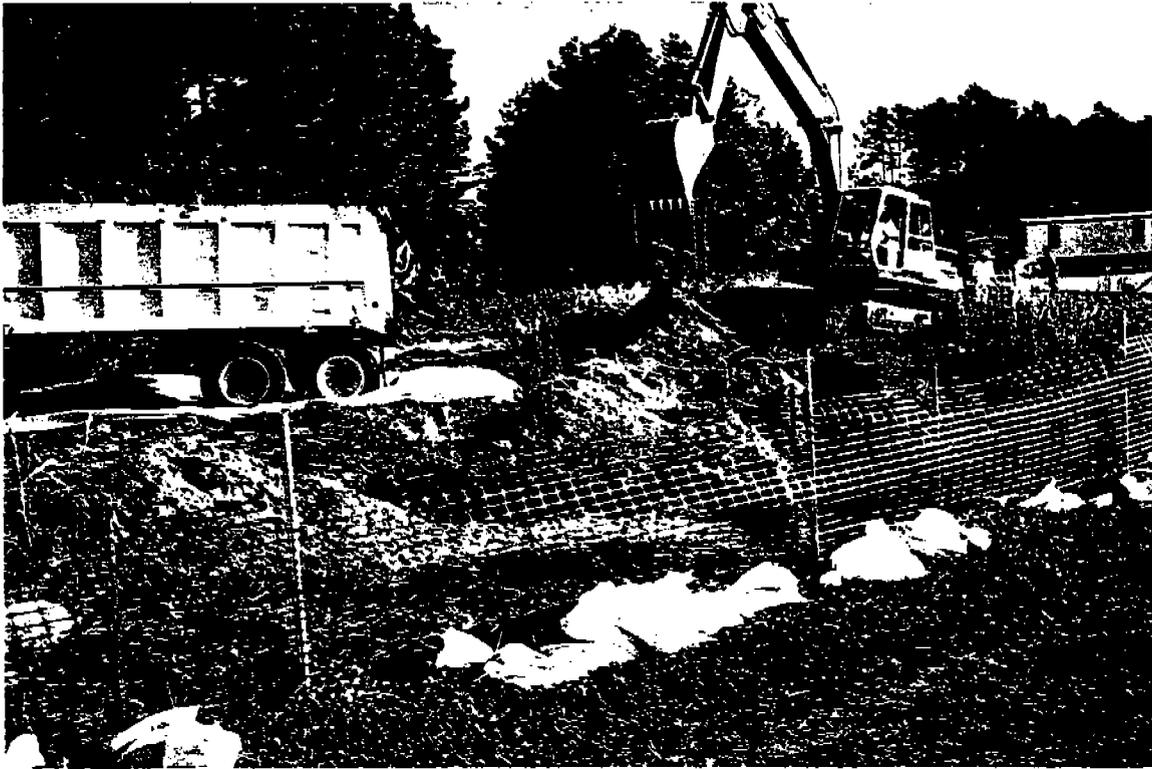
Photo 19: Excavating soil at the SWMU 2 PCB area.

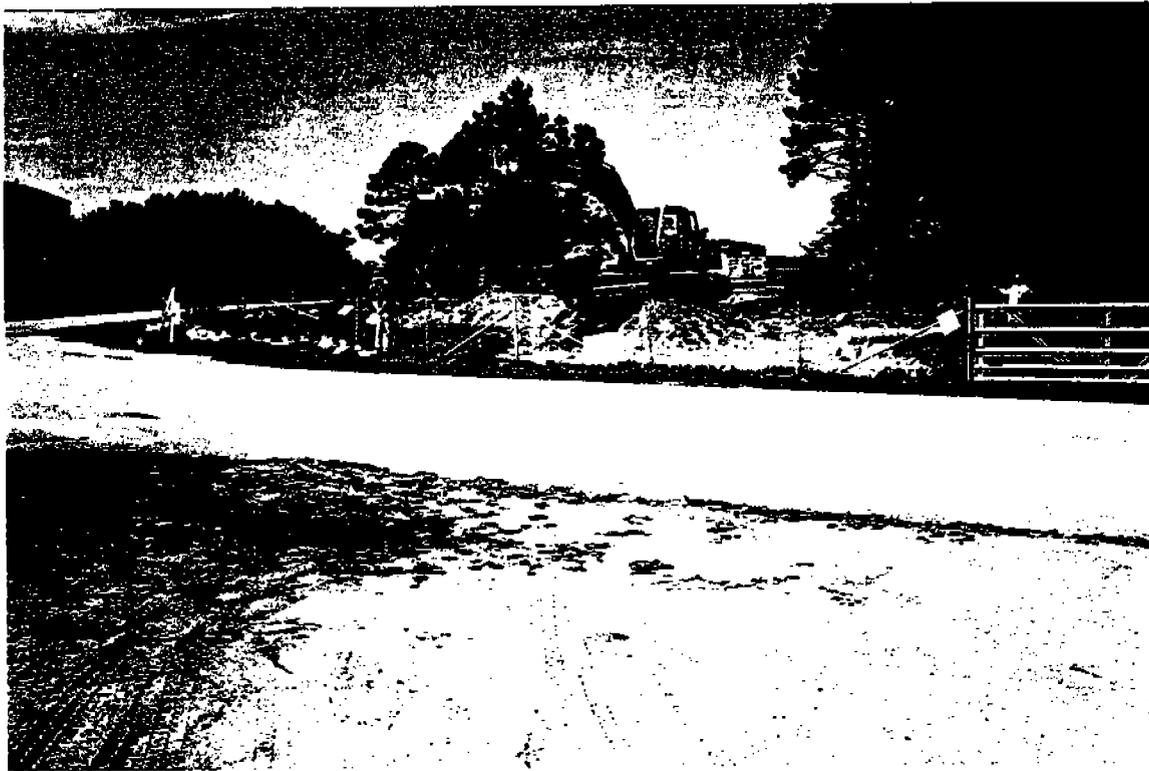
Photo 20: Excavating soil at the SWMU 2 PCB area.

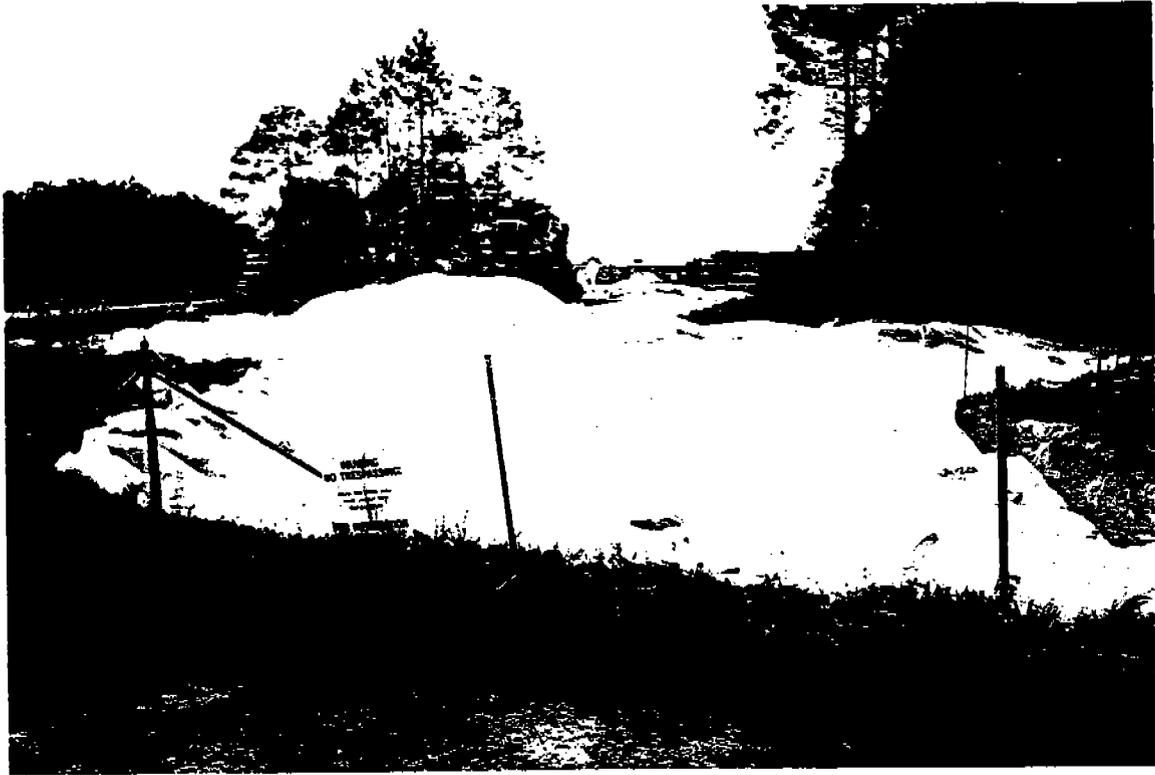
Photo 21: Excavated areas and soil stockpiles covered with polyethylene sheeting.

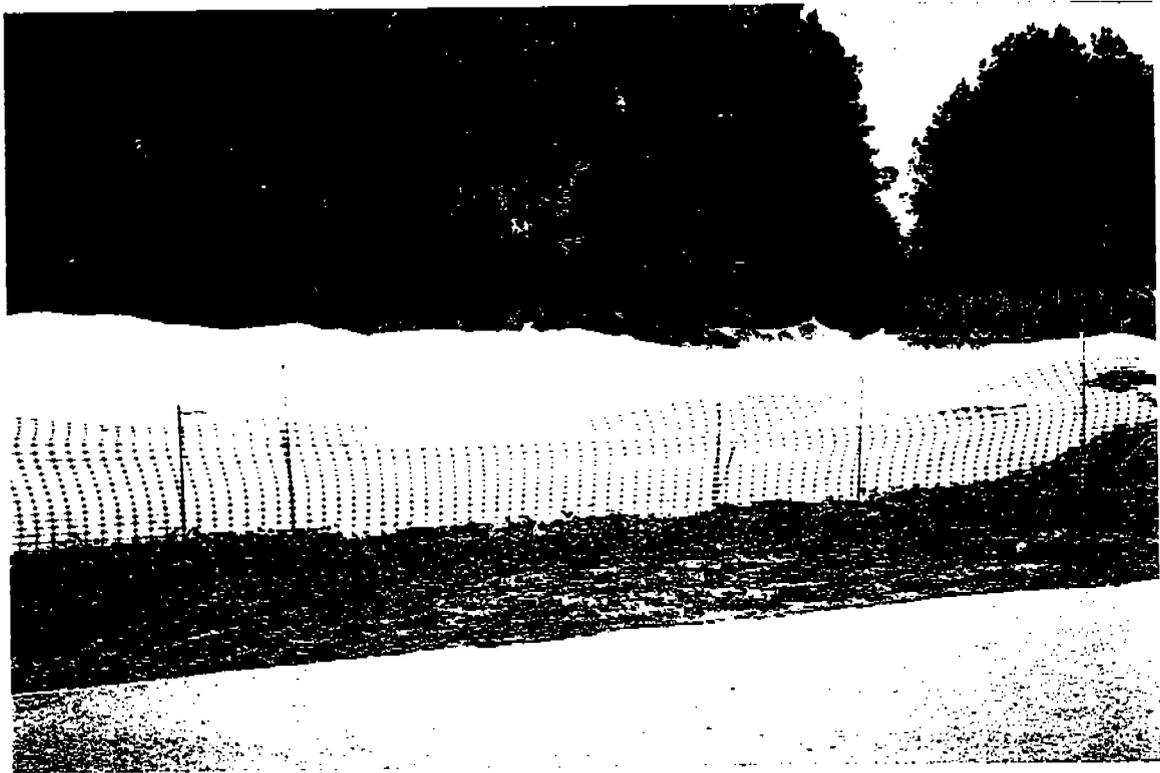
Photo 22: Excavated areas and soil stockpiles covered with polyethylene sheeting.

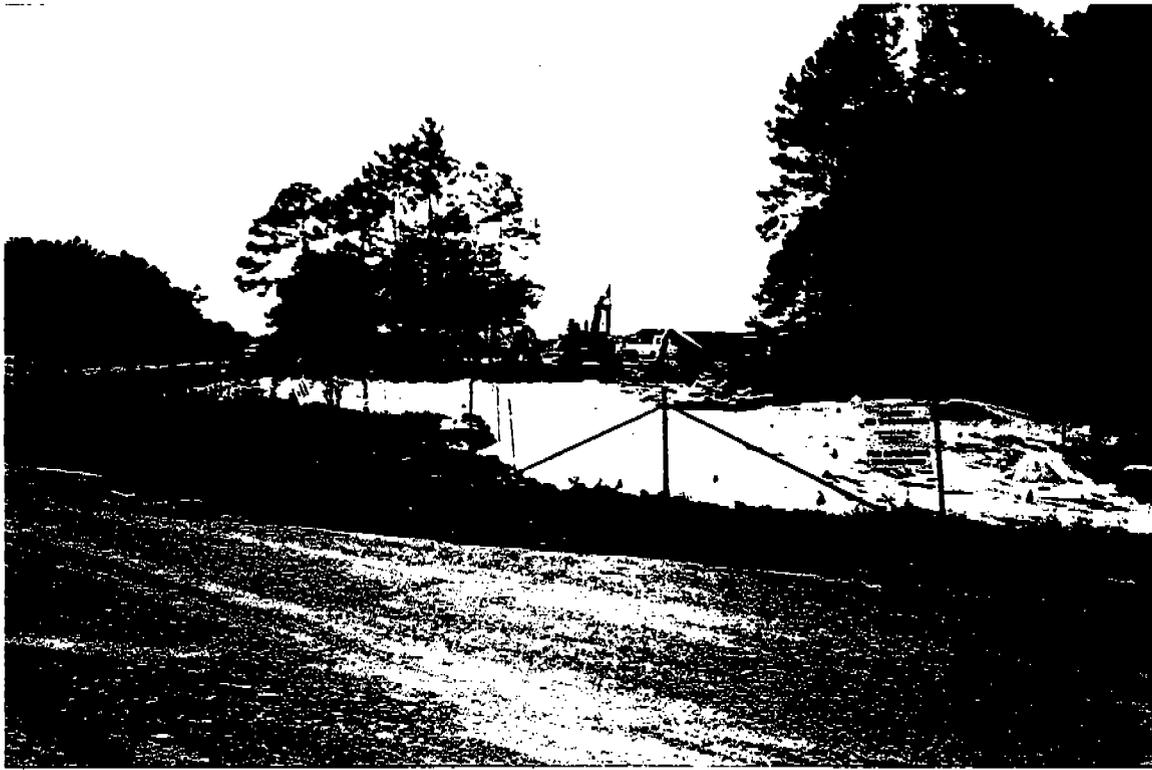
Photo 23: Excavated area covered with polyethylene sheeting.

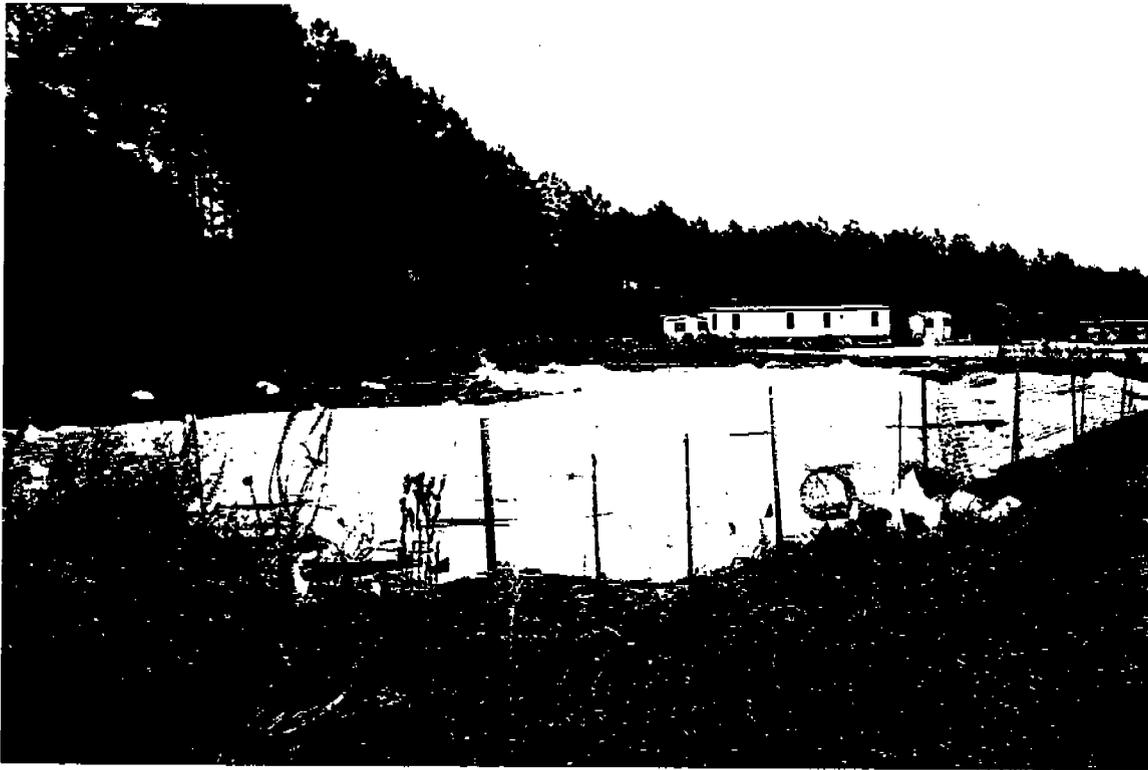
Photo 24: Excavated area covered with polyethylene sheeting.

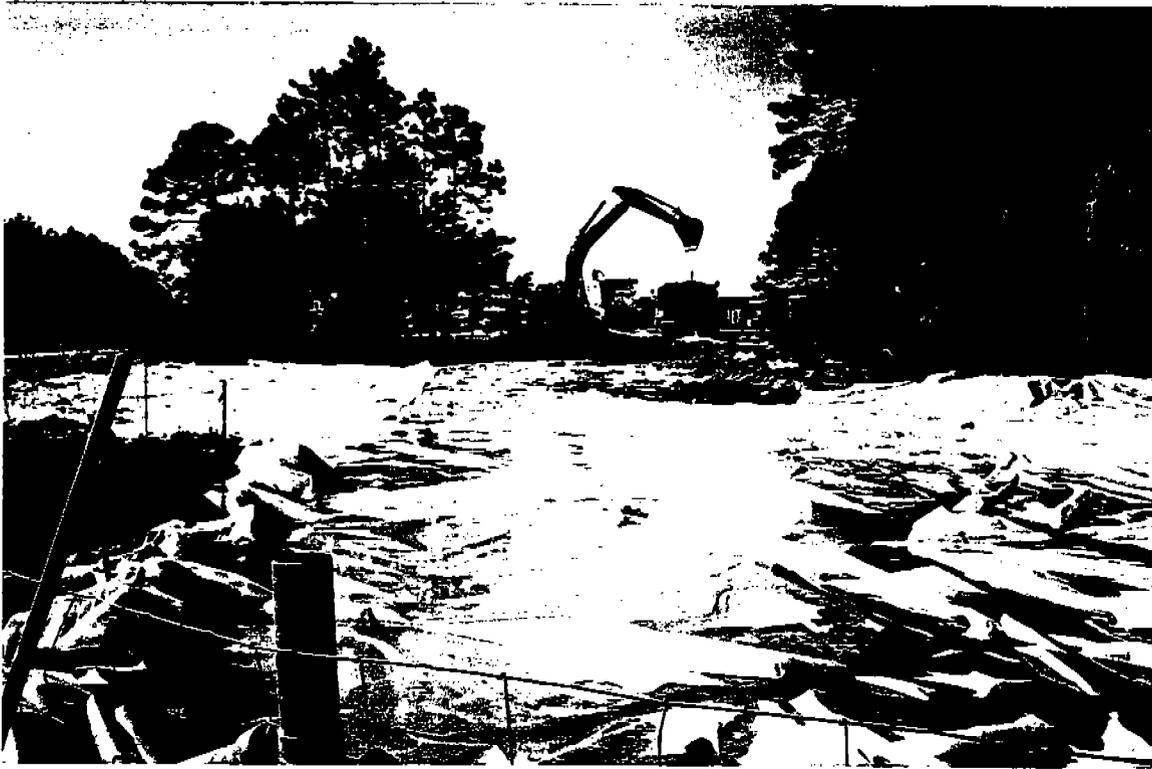
Photo 25: Excavating the western part of the SWMU 2 PCB site. Water from recent precipitation is contained by the polyethylene sheeting.

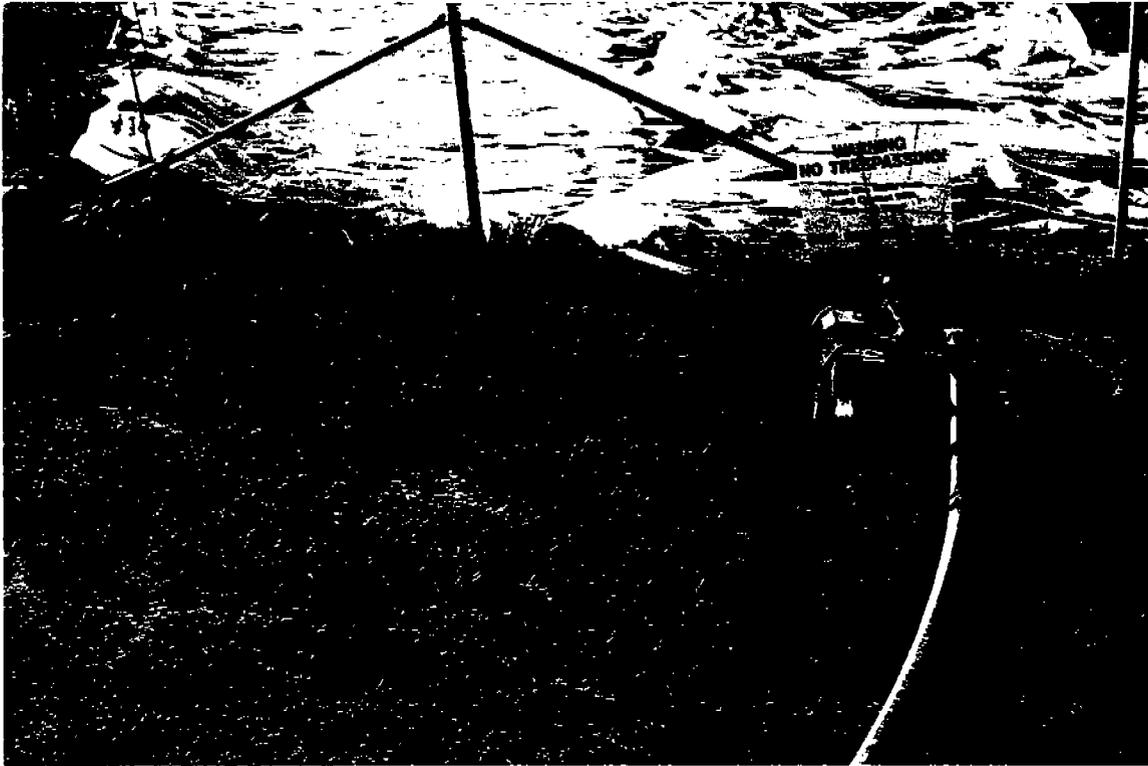
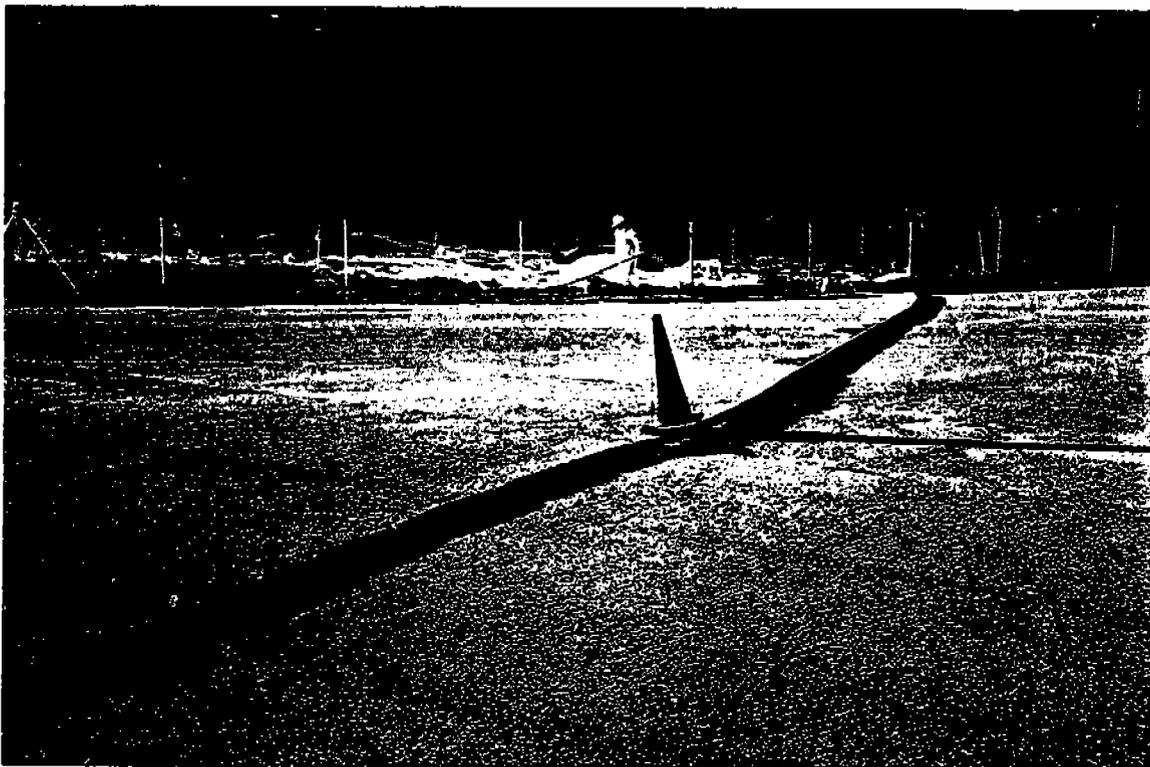
Photos 27 and 28: A trash pump was used to remove rainwater that collected on polyethylene sheeting during precipitation. The water was pumped to a parking lot located across the street (east) of the site.

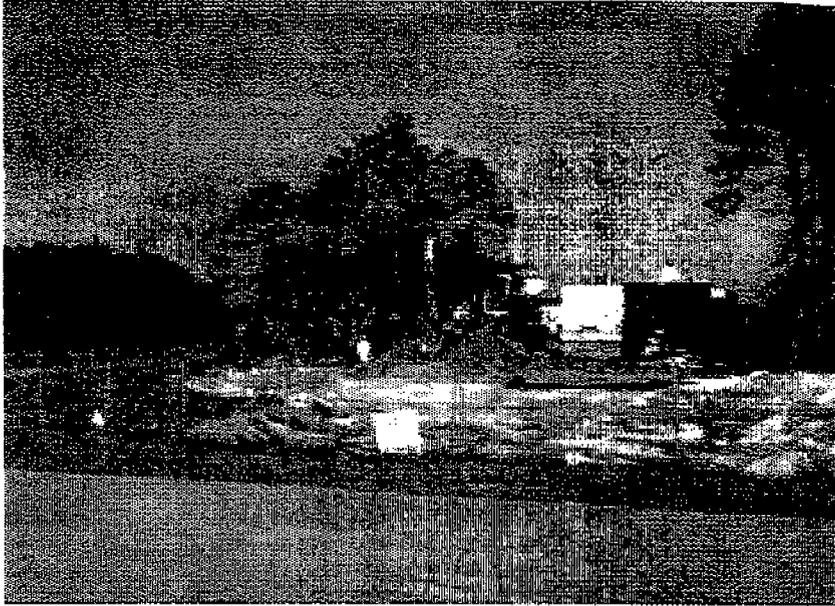
Photo 29: Excavating soil and loading a 20-cubic-yard trailer.

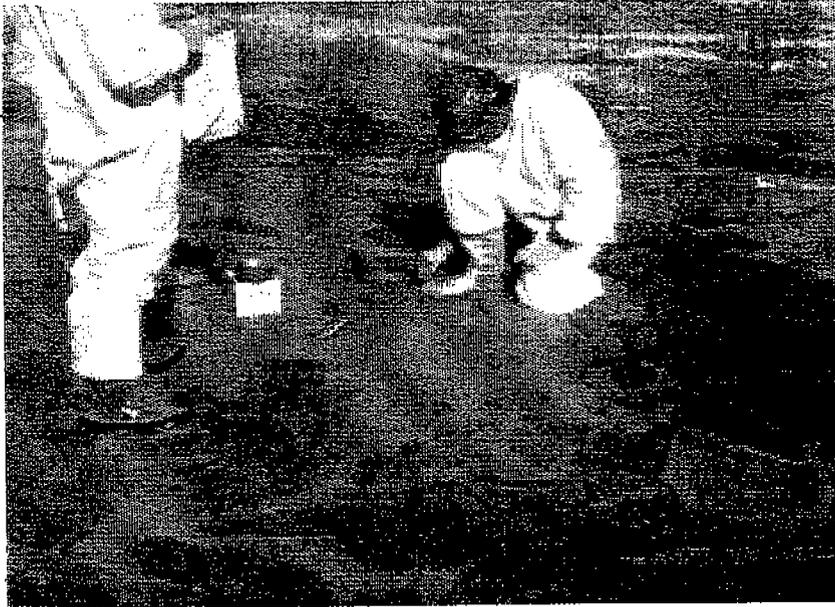
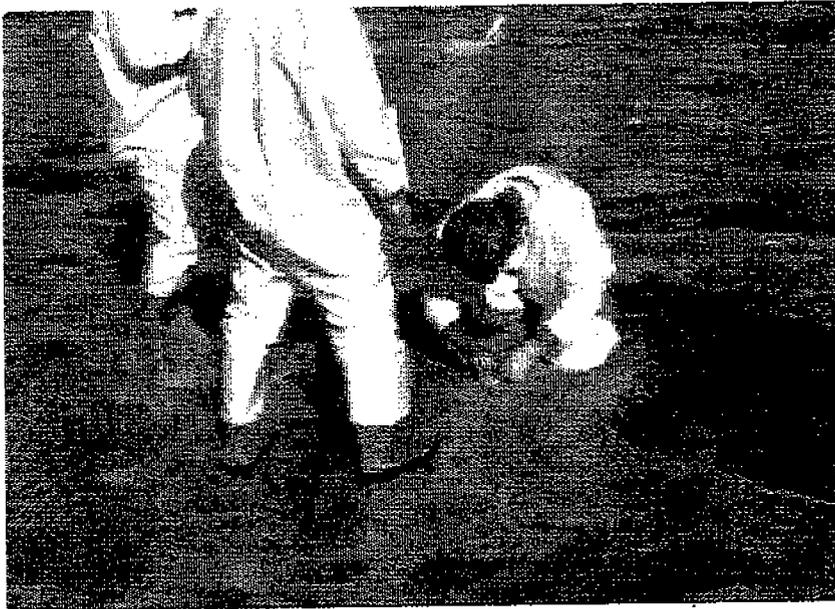
Photos 31 and 32: Collecting a soil sample for field screening analysis.

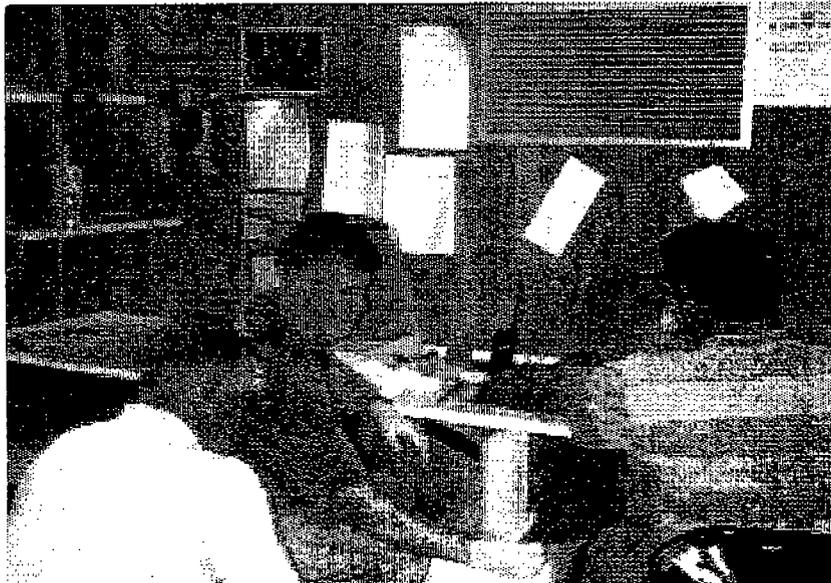
Photos 33 and 34: Analyzing a soil sample using the immunoassay testing kit (ENSYS PCB RIS[®] test kit)

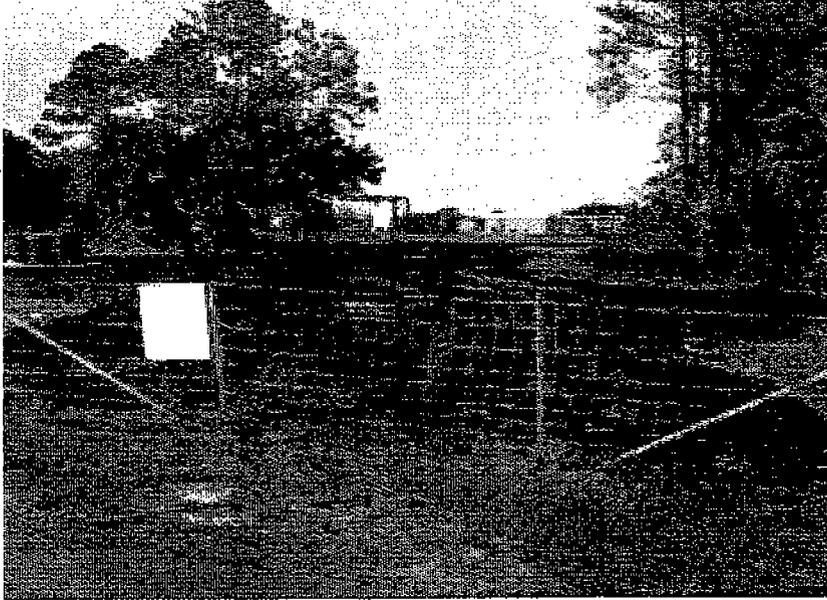
Photo 35: View looking west of backfill material (dark soil) placed at the SWMU 2 PCB site.
