FINAL ENVIRONMENTAL CONDITION OF PROPERTY REPORT FOR NAVAL AIR STATION  
MAYPORT BACHELOR ENLISTED QUARTERS NAS MAYPORT FL  
02/01/2009  
NAVFAC SOUTHERN

ENVIRONMENTAL CONDITION  
OF PROPERTY REPORT

NAVAL AIR STATION MAYPORT  
BACHELOR ENLISTED QUARTERS  
JACKSONVILLE, FLORIDA

February 2009

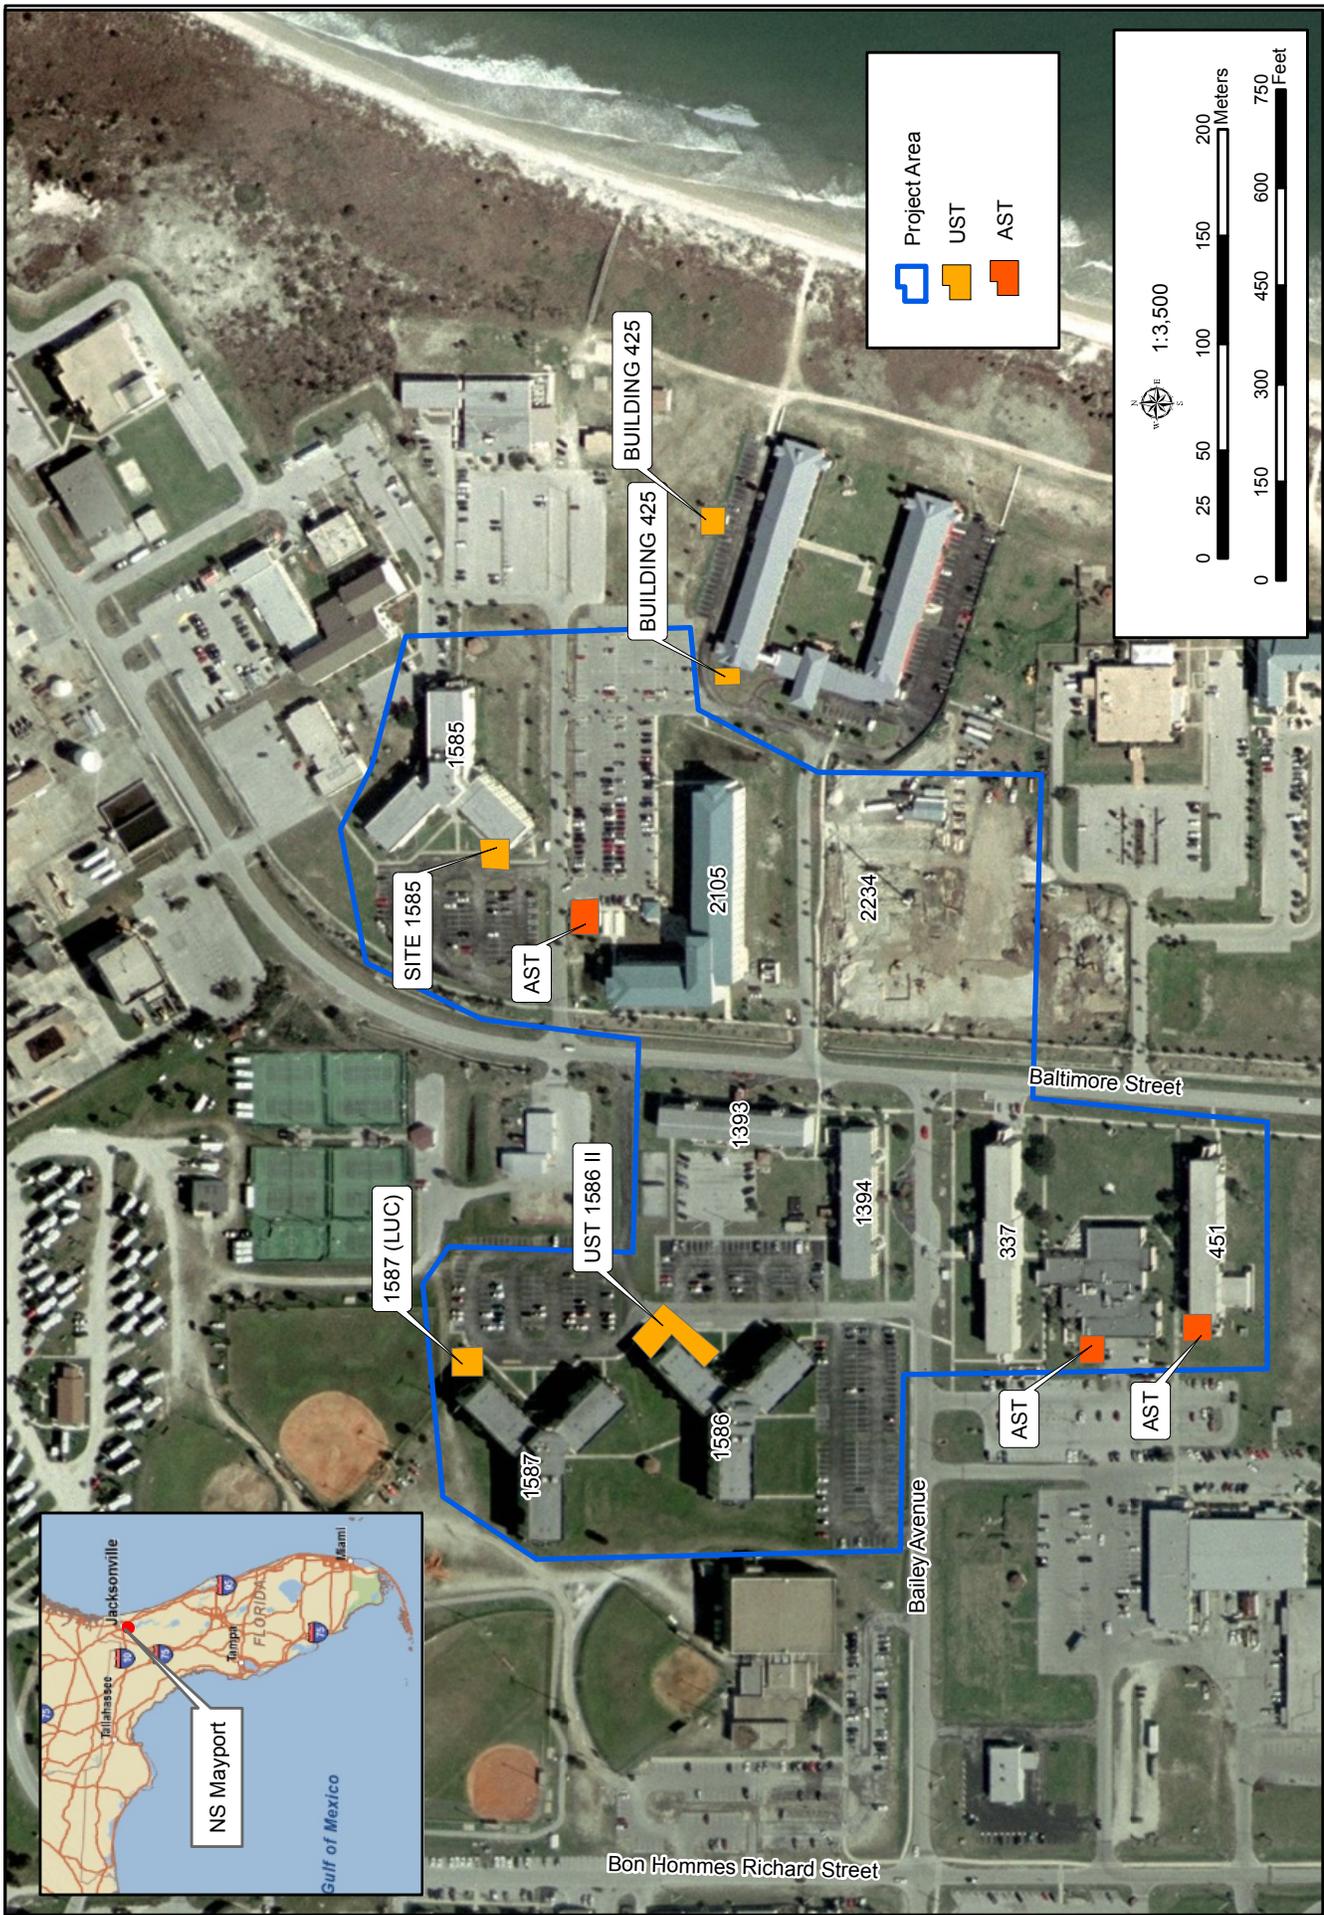
Figure 4: Subject Property UST and AST

According to the NS Mayport map of environmental remediation sites, there are USTs containing fuel oil located adjacent to Buildings 1585, 1586 and 1587 (Figure 4). All of these USTs have leaked tank contents to soil and groundwater in the past.

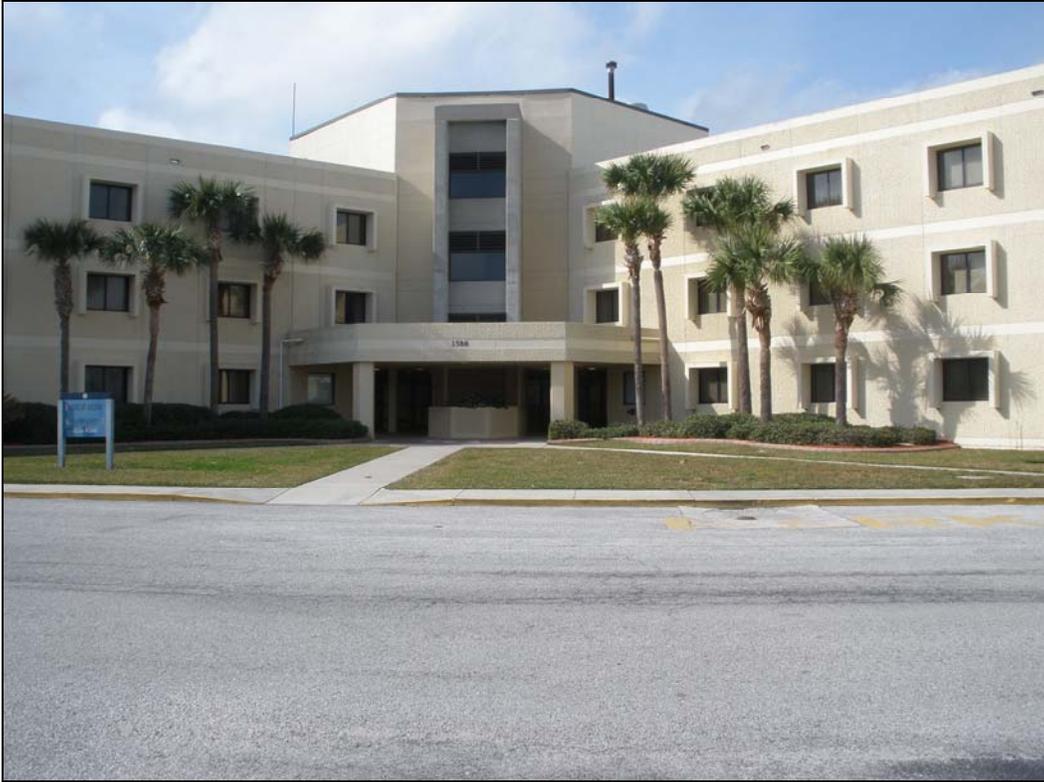
Photograph 1. Building 1586, front (W) view of building entrance

**Building 1586** is essentially identical to Building 1585, with three radiating wings (Photograph 1, Appendix C). There is a 5,000 gallon fuel oil UST located at the end of the northeast wing of the building (Photographs 2 and 3, Appendix C) with numerous monitoring wells around it. No visible evidence of the prior UST release was found. The bottom of the concrete fuel oil pump house did have stains around the base, indicating leaks in the past.

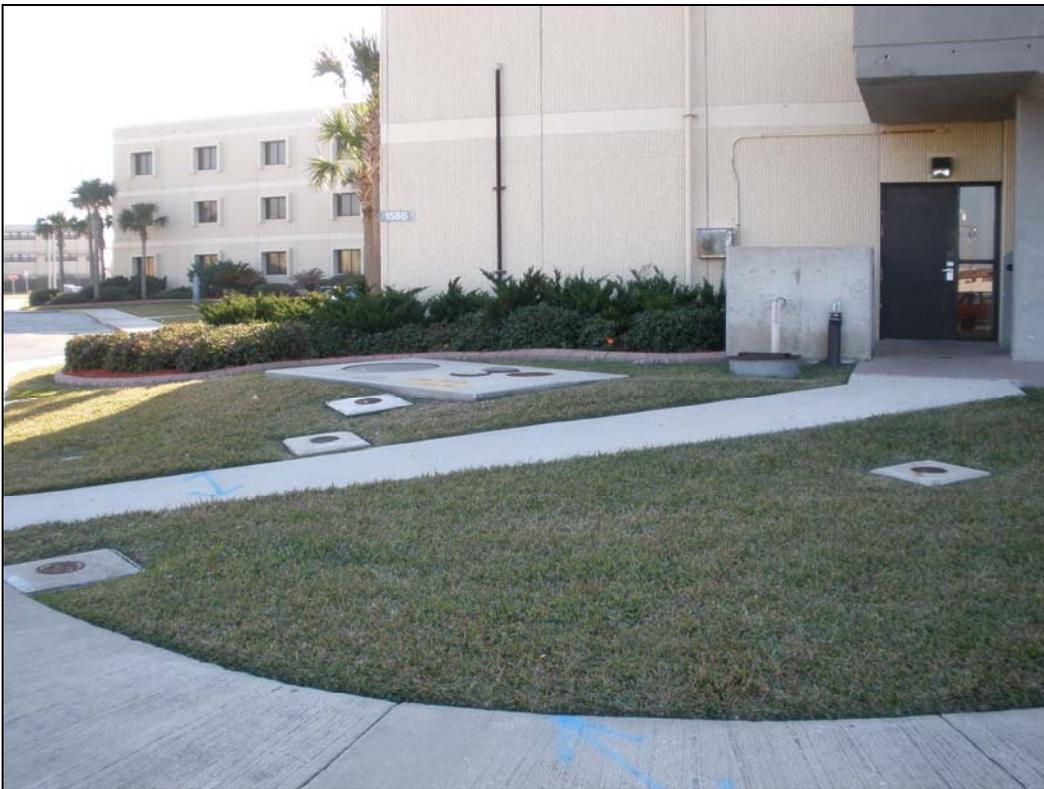
Photograph 2. Building 1586, UST and monitoring wells

Building 1586 has a 5,000 gallon fuel oil UST located at the end of the northeast wing of the building (Photographs 2 and 3, Appendix C). The tank previously leaked contents to soil and groundwater, and the spill was remediated. The UST was replaced, but a recent tank fill error resulted in a 1,400 gallon fuel oil spill in the tank pit and gravel bedding materials. Monitoring wells are in place, and it has been determined that free product contamination is confined to the immediate area of the UST. A preliminary remediation assessment has been prepared, and a formal remediation plan is expected to be filed with FDEP in 2009. Remediation is proposed to include installation of bioremediation socks in the monitoring wells to treat the spill. This site would be classified as *contaminated* until a NFA determination is issued by FDEP.

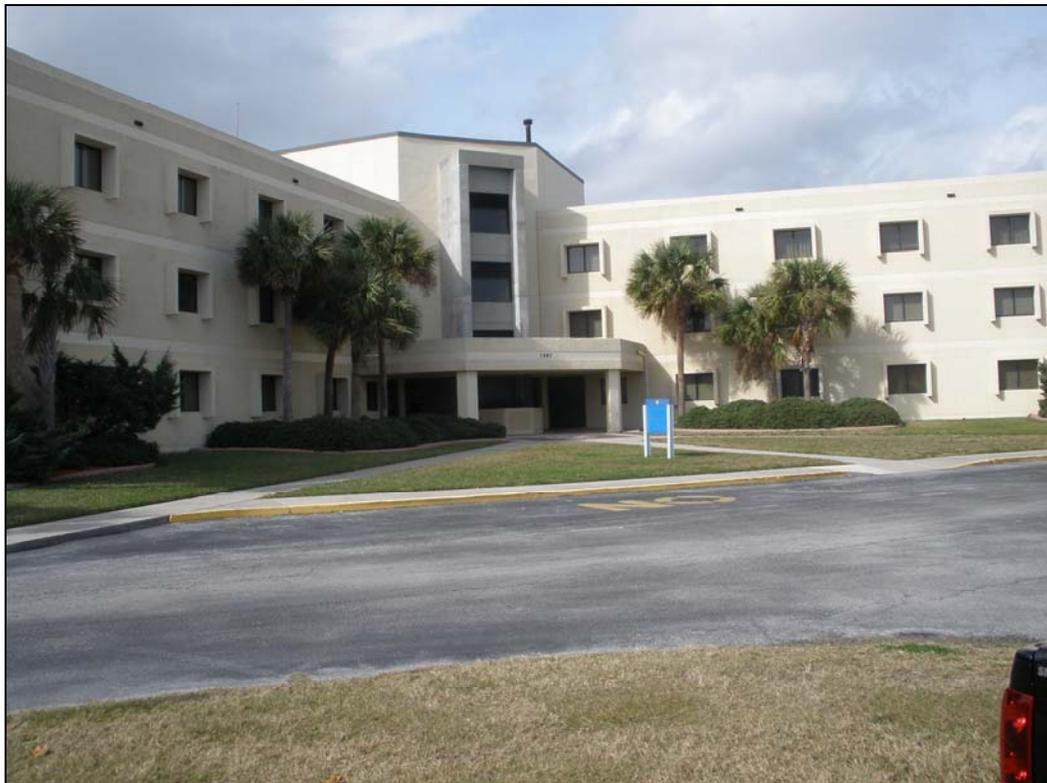
Photograph 4. Building 1587, front (W) view of building entrance

**Building 1587** is essentially identical to Buildings 1585 and 1586 (Photograph 4, Appendix C). There is a 4,000 gallon fuel oil UST located at the end of the northeast wing of the building with numerous monitoring wells around it (Photographs 5 and 6, Appendix C). No visible evidence of the prior UST release was found.

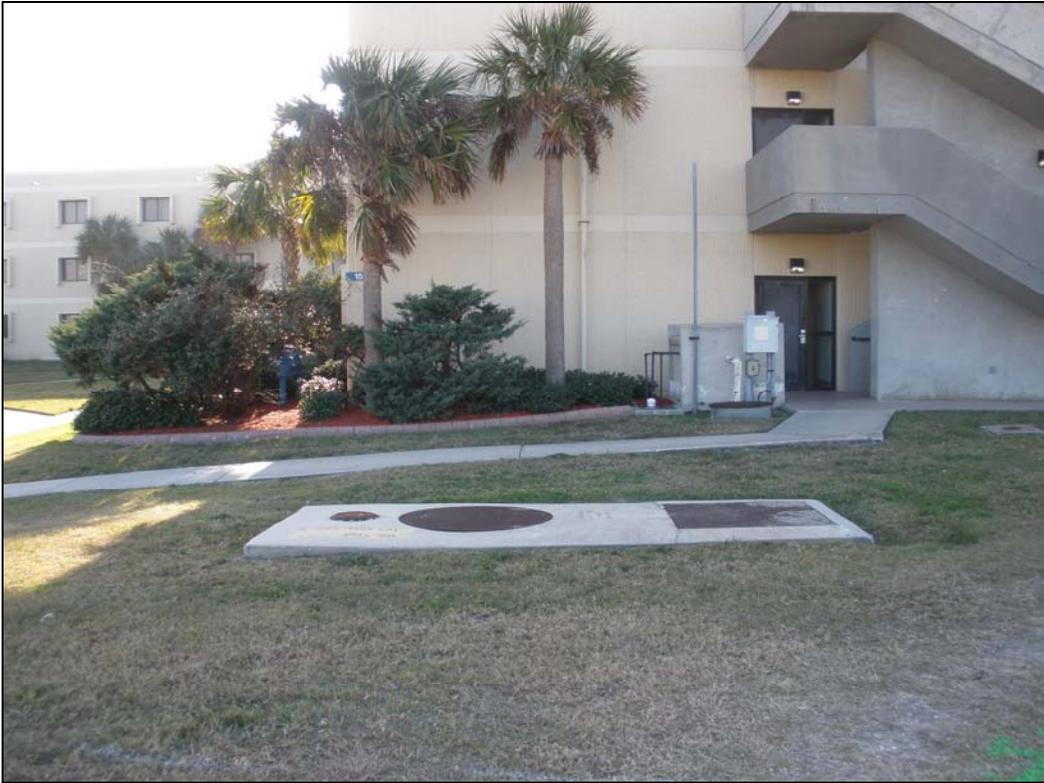
Photograph 5. Building 1587, UST and monitoring wells

Building 1587 has a 4,000 gallon fuel oil UST located at the end of the northeast wing of the building (Photographs 5 and 6, Appendix C). The UST previously leaked tank contents to soil and groundwater, and the spill was remediated by removing the tank and soil and replacing the tank. Due to the presence of contaminated soil beneath the building foundation and the exterior stairwell, contaminated soil remains in place at the site. FDEP issued a NFA determination, which included land use controls (LUC) that require notification and additional soil removal

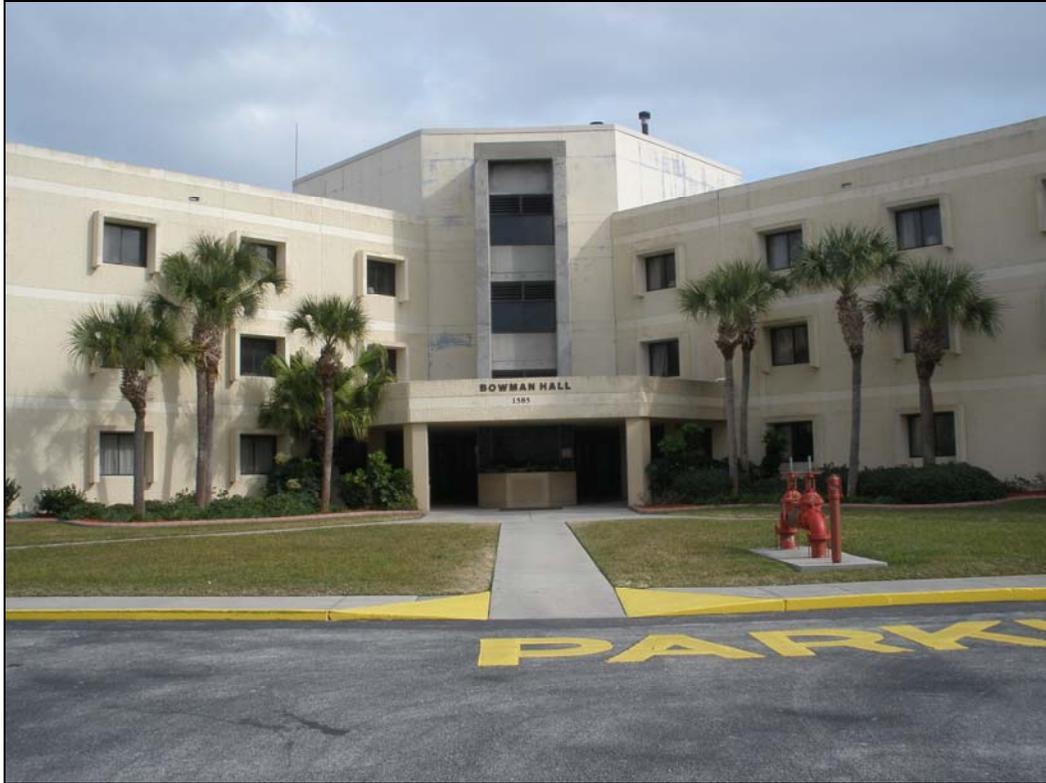
Photograph 7. Building 1585, front (E) view of building entrance

**Building 1585** consists of a three story building with three radiating wings (Photograph 7, appendix C). There is a 5,000 gallon fuel oil UST located adjacent to the southwest wing of the building with numerous monitoring wells around it (Photographs 8 and 9, Appendix C). No visible evidence of the prior UST release was found. The building is constructed of concrete panel outer walls and conventional stud and drywall interior walls. Building 1585 has a recurring problem with rain water intrusion above the entrance porticos on the second floor due to insufficient gutter capacity. All water intrusion problems are repaired as they occur on an as-needed basis.

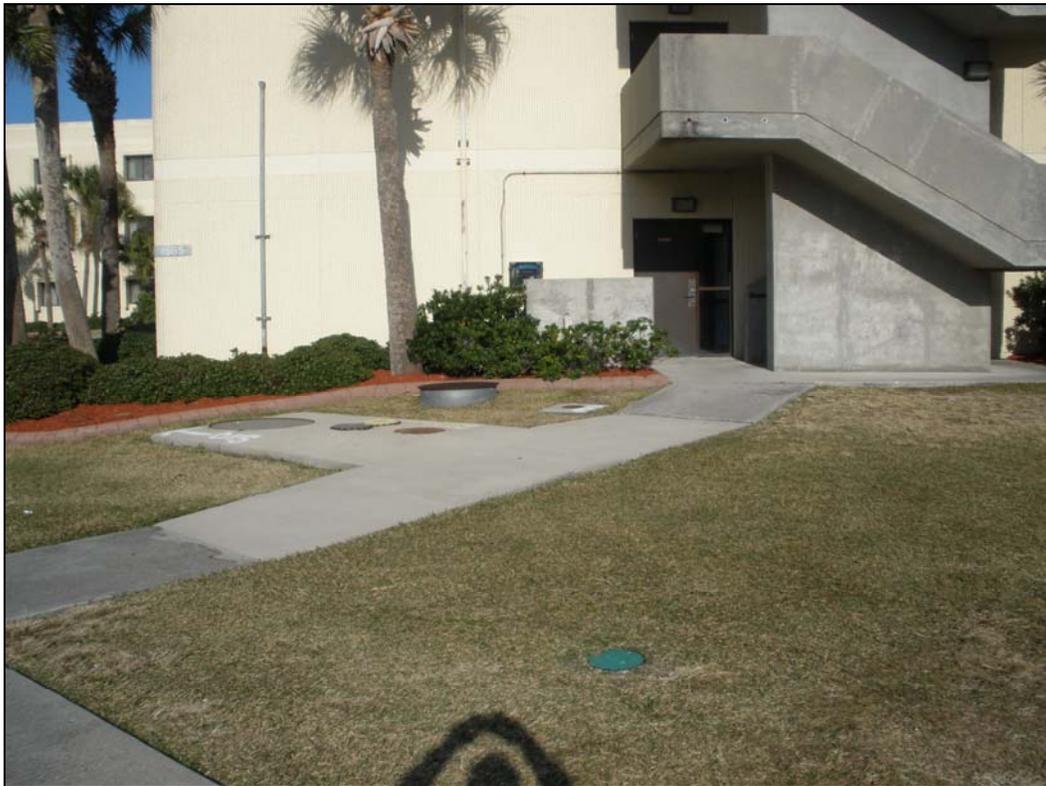
Photograph 8. Building 1585, UST and monitoring wells

Building 1585 has a 5,000 gallon fuel oil UST located at the end of the southwest wing of the building (Photographs 8 and 9, Appendix C). The tank leaked fuel oil to soil and groundwater in 2004, and monitoring wells were installed to define the limits of the contamination. According to monitoring well reports in 2008, the remediation of the site by pumping the soil and groundwater has been successful, and a no further action (NFA) request to FDEP will be filed in 2009. This site would be classified as *contaminated* until a NFA determination is issued by FDEP.

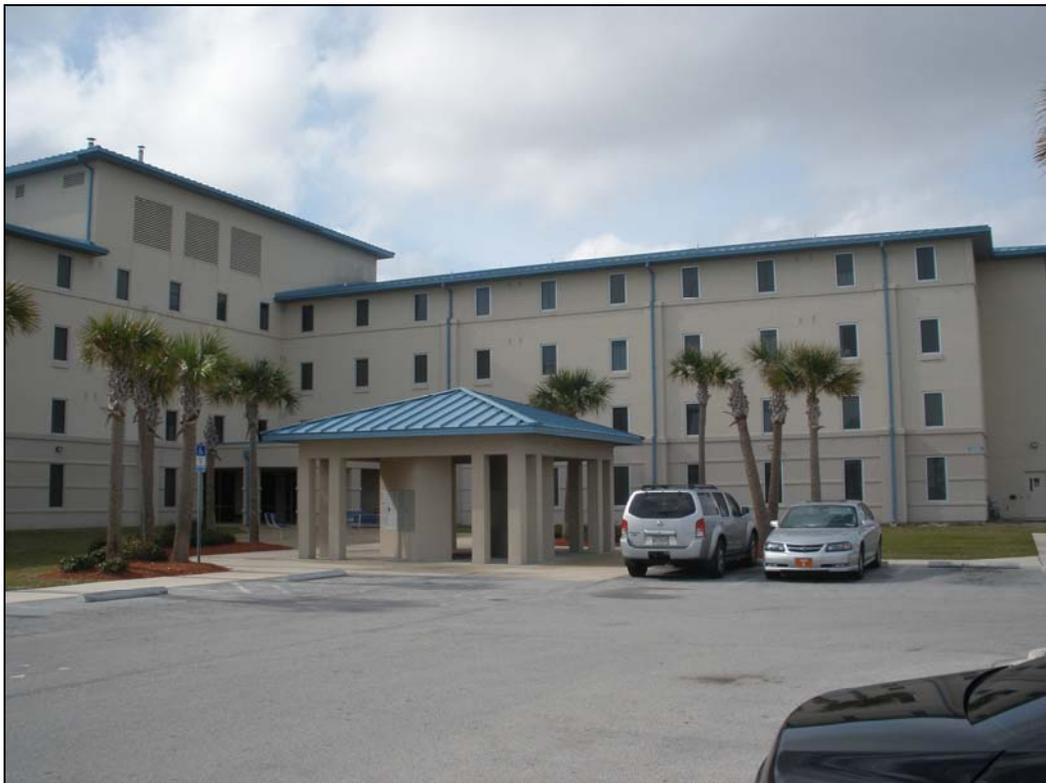
Photograph 10. Building 2105, front (SW) view of building entrance

**Building 2105** houses the main offices for NS Mayport BEQ. It is a four story building with a fifth floor penthouse which contains the main mechanical room for the building (Photograph 10, Appendix C). The mechanical room is clean and free of any hazardous materials (Photographs 14 and 15, Appendix C). The apartments are relatively new, and were in excellent condition (Photographs 16, 17 and 18, Appendix C). There is a fuel oil AST located north of the building adjacent to the parking lot (Photograph 13, Appendix C), but no leaks or spills were found. Several ground-mounted transformers are located around the building, and no PCB is present in the transformers (interview with Diane Racine).

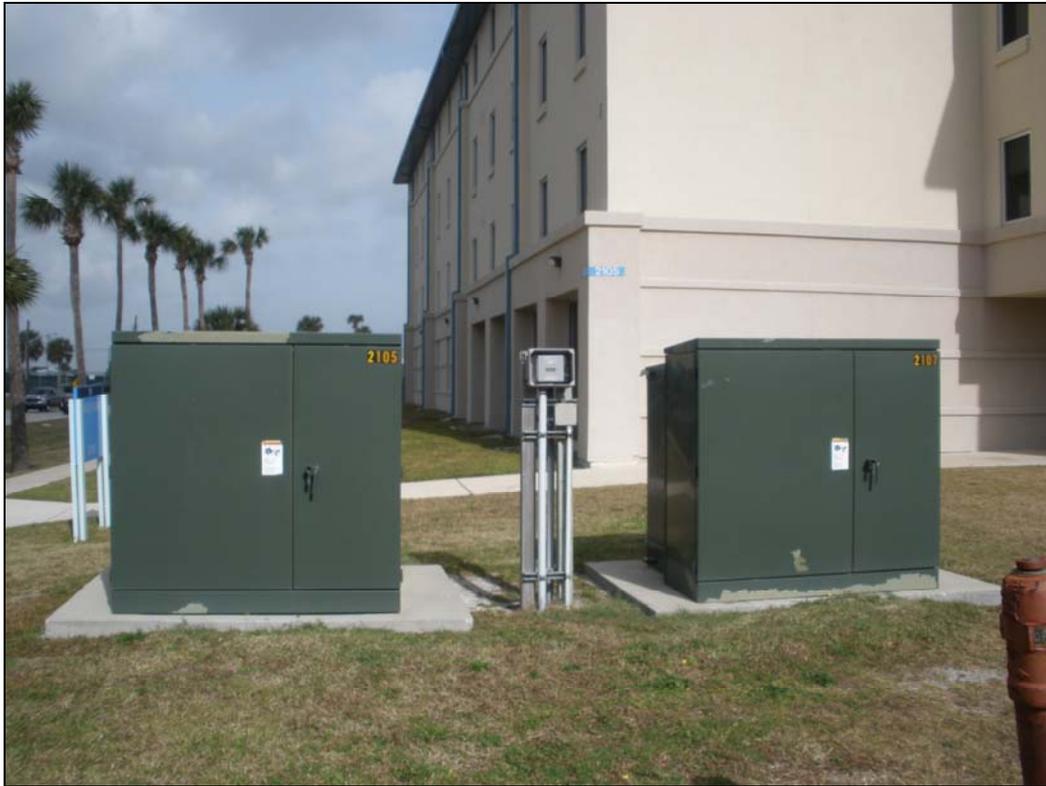
Photograph 11. Building 2105, transformers outside building

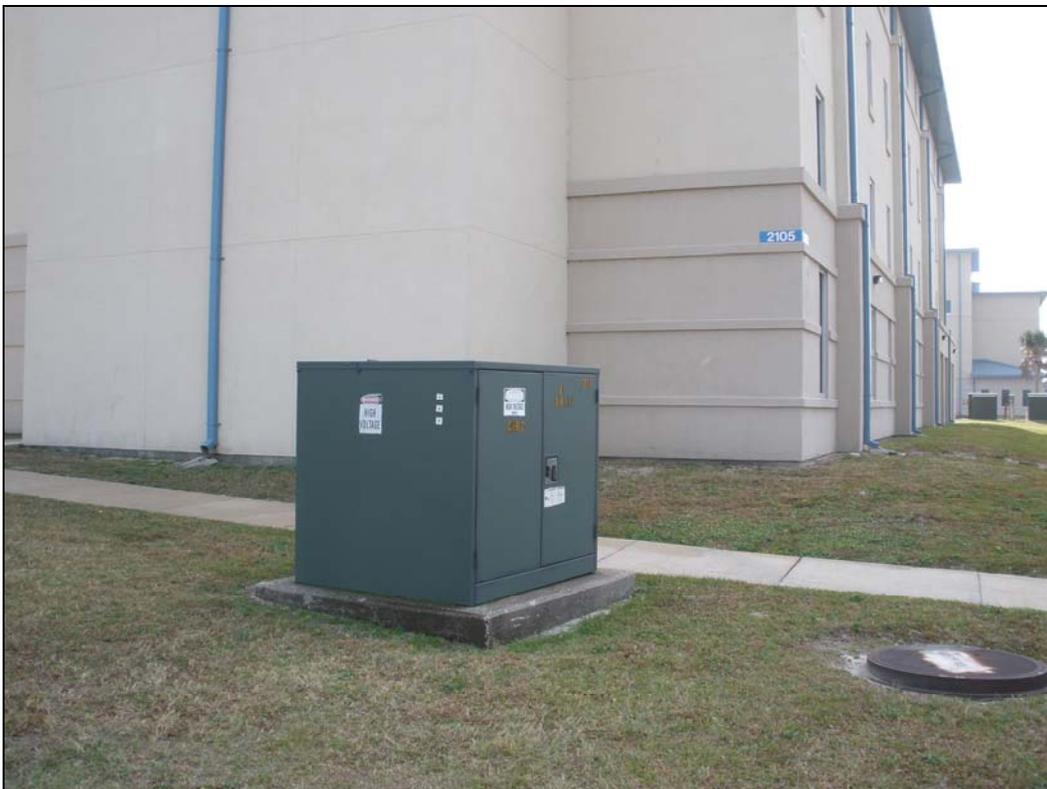
Photograph 12. Building 2105, transformer and sewer access outside building

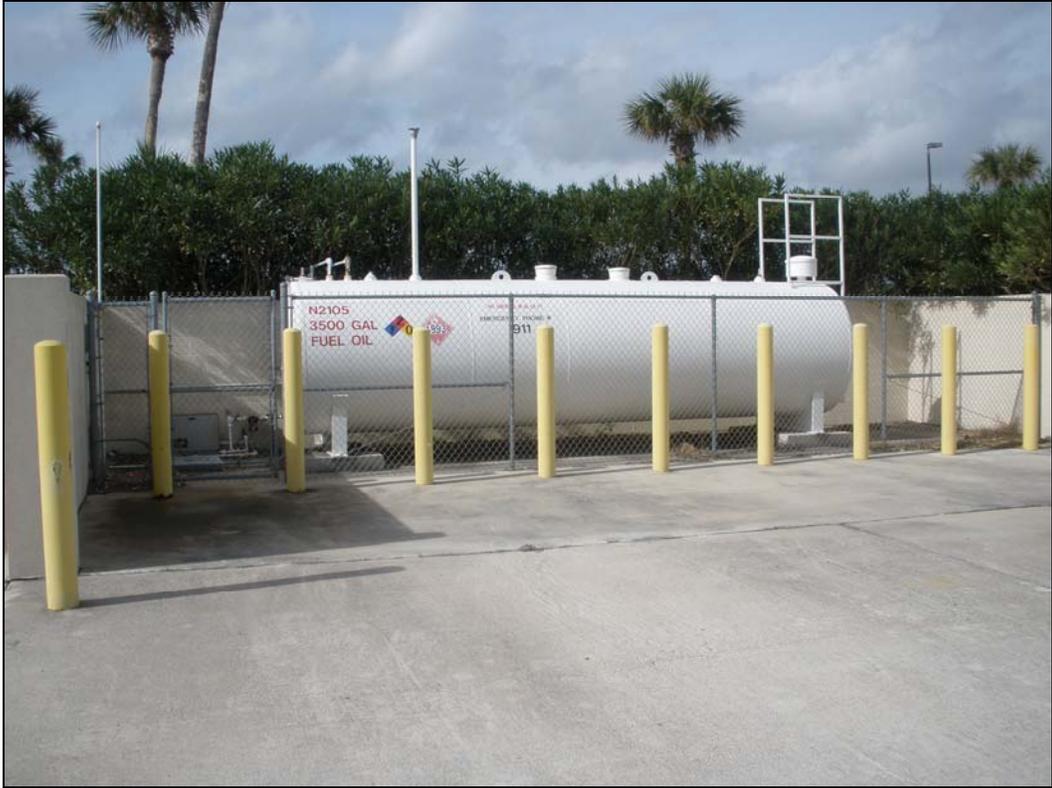
Photograph 13. Building 2105, fuel oil tank outside building

Building 2105 has a 3,500 gallon above ground storage tank (AST) containing fuel oil located in the parking lot north of the building (Photograph 13, Appendix C). The tank is new, and showed no indication of any leaks or spills, but there is no containment basin around the tank. The AST would be a *recognized environmental condition* for Building 2105, but no environmental risk was present at the time of this site assessment. The site would be classified as *uncontaminated*. There are two fuel oil UST spill sites located near Building 425, east of Building 2105, but the sites are remediated, and constitute *historical recognized environmental conditions* with no risk to the subject property.

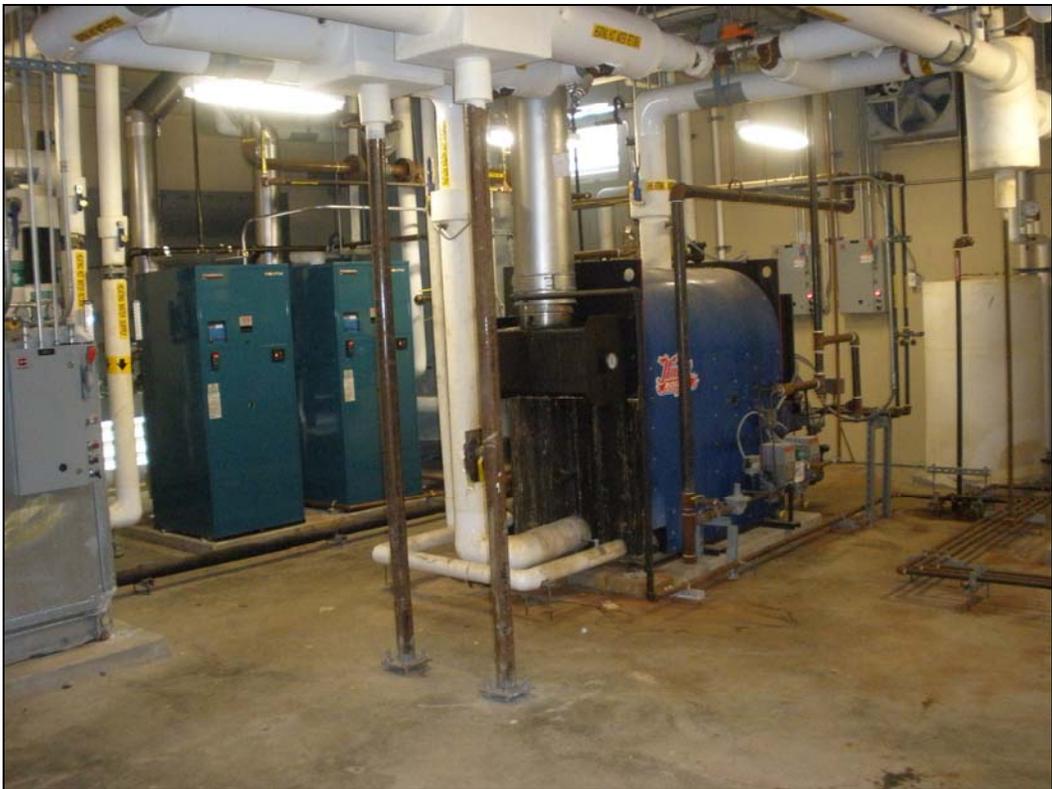
Photograph 14. Building 2105, mechanical/boiler room on fifth floor

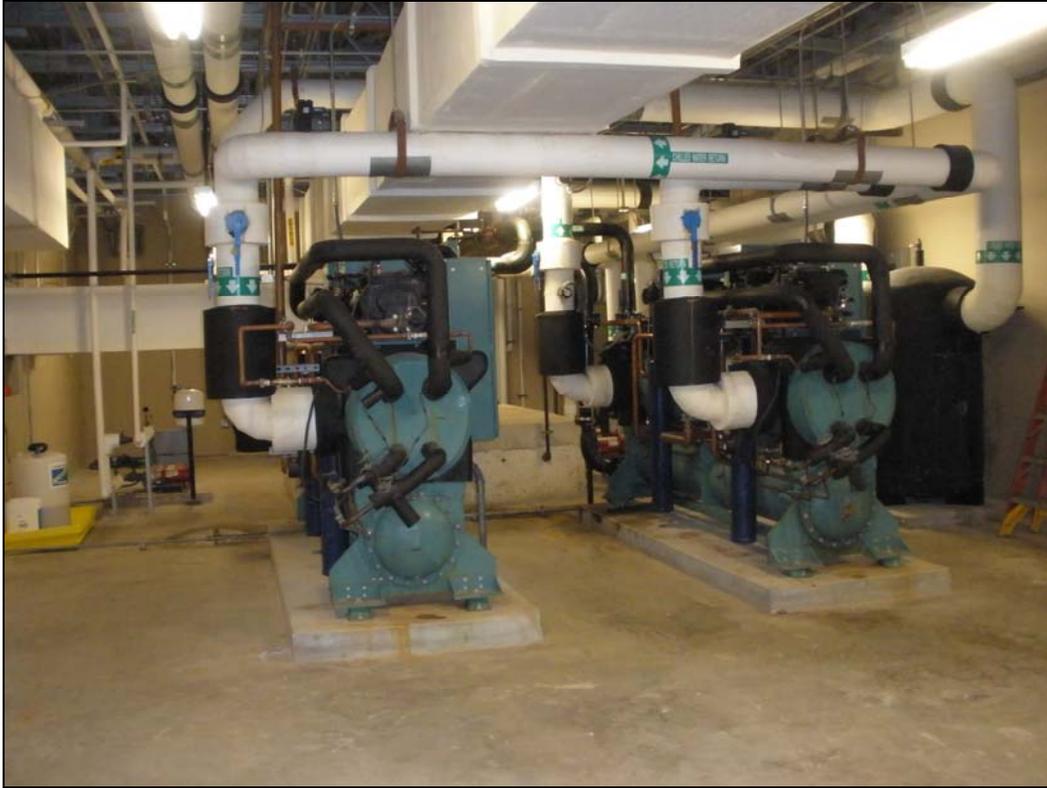
Photograph 15. Building 2105, mechanical/boiler room on fifth floor

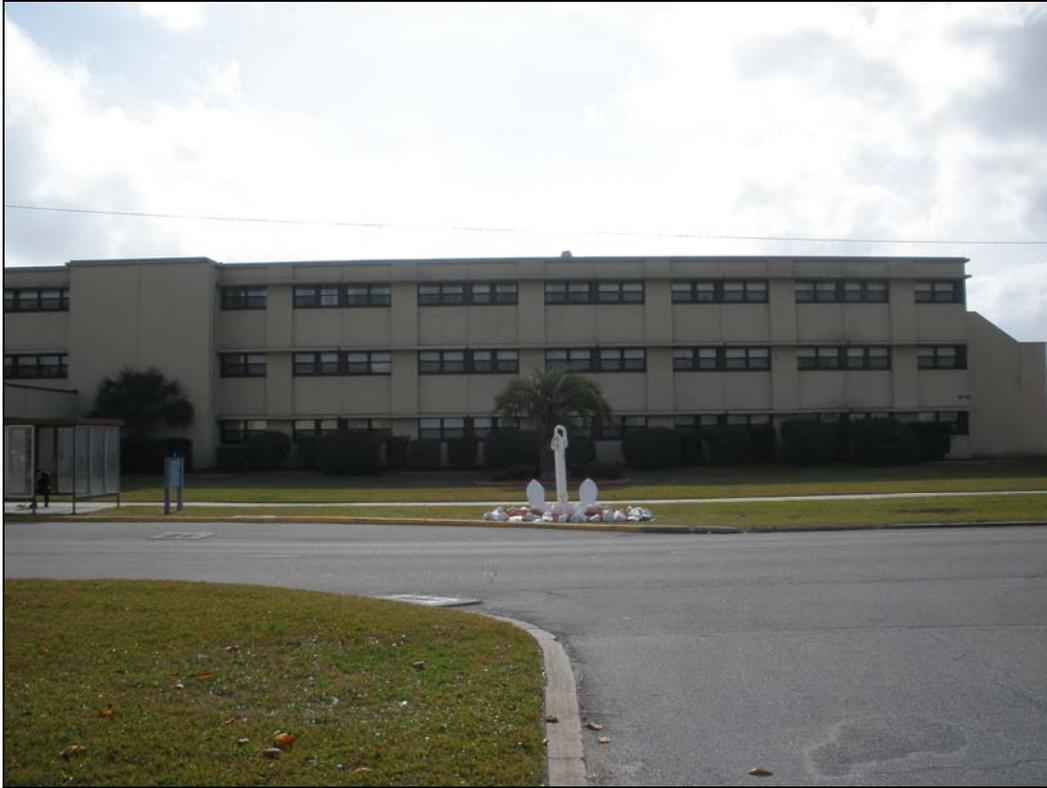
Photograph 19. Building 337, front (S) view of building entrance

**Building 337** is a three story building fronting Bailey Avenue with stud and stucco exterior walls and stud and drywall interior walls (Photograph 19, Appendix C). There are ground-mounted transformers located around Building 337 (Photograph 20, Appendix C), as well as Building 451, but no PCB is present. Fuel oil supply for Building 337 is shared with the mess hall, from an AST located behind the mess hall.

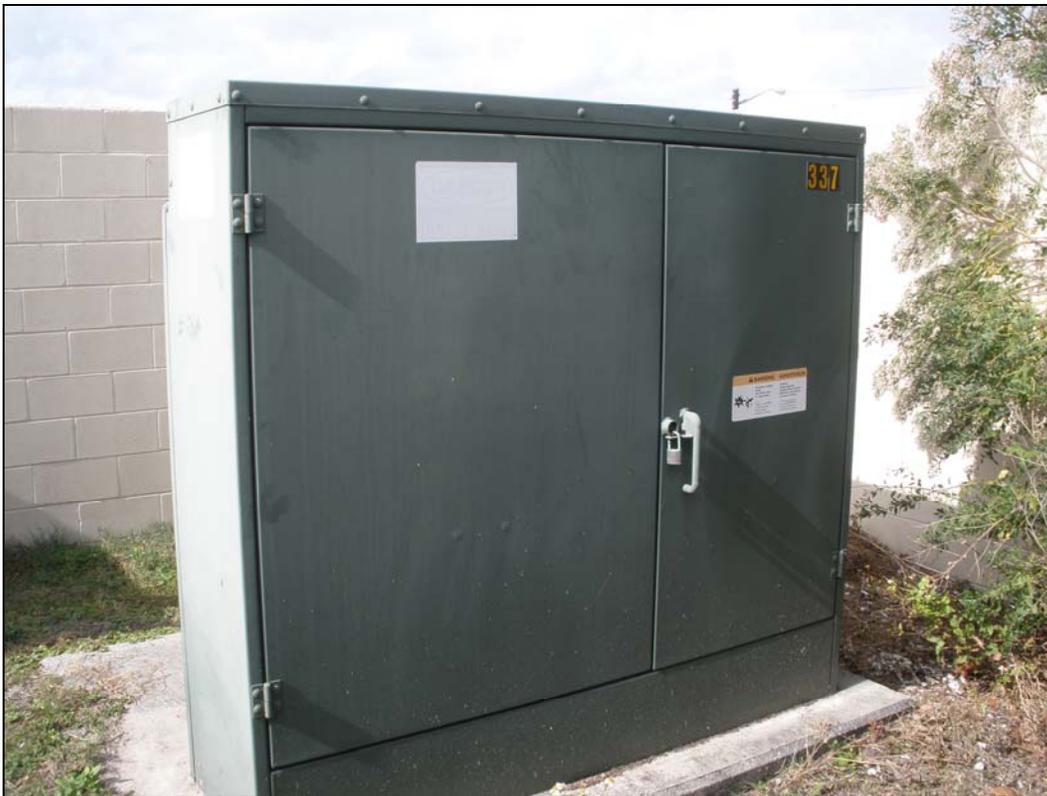
Photograph 20. Building 337, transformer outside building

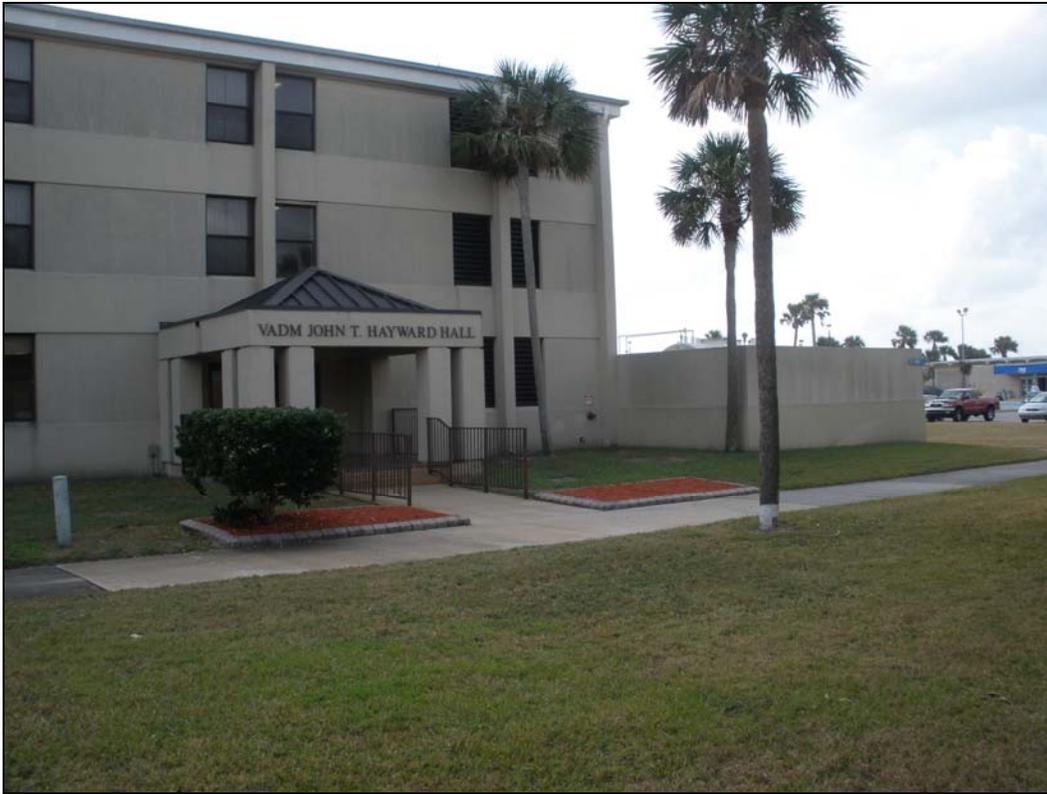
Photograph 21. Building 451, view (SW) of building entrance from mess hall

**Building 451** is a three story building which faces the mess hall to the north (Photograph 21, Appendix C). The construction details are the same as Building 337. there is a 4,000 gallon fuel oil AST located at the west end of Building 451 (Photograph 22, Appendix C), but no leaks or spills were observed around the tank. In the mechanical/boiler room of Building 451, located

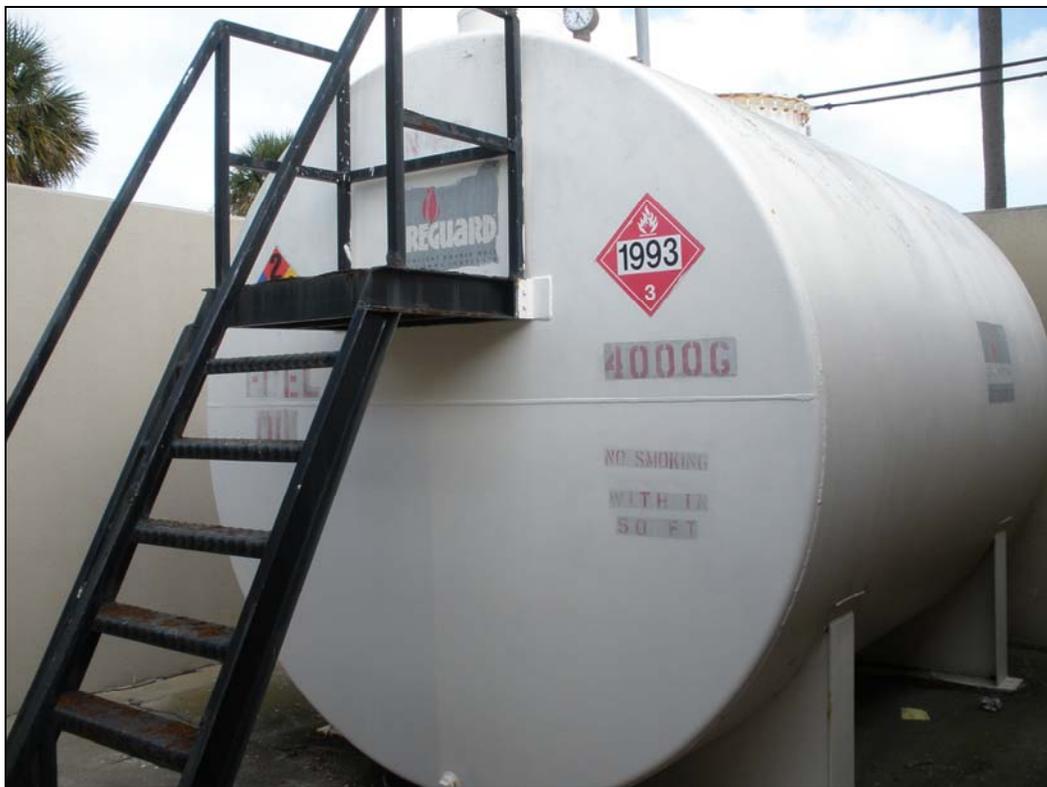
Photograph 22. Building 451, fuel oil tank adjacent to the building

Building 451 has a 4,000 gallon fuel oil AST located at the west end of the building (Photograph 22, Appendix C). The tank has no history of leaks or spills, and no indications were found during the site visit of any spills or leaks. The boiler/mechanical room in Building 451 showed indications of prior and continuing leaks of fuel oil from piping in the building (Photographs 23 and 24, Appendix C). The spills were confined to the concrete floor of the building, but would constitute a *recognized environmental condition* for the site. Building 451 would be classified as *contaminated* due to the fuel oil spills in that room, and the piping should be repaired and the spills cleaned up prior to any real estate action for the building. The adjacent AST would also be classified as a *recognized environmental condition*, but with no immediate risk to Building 451.

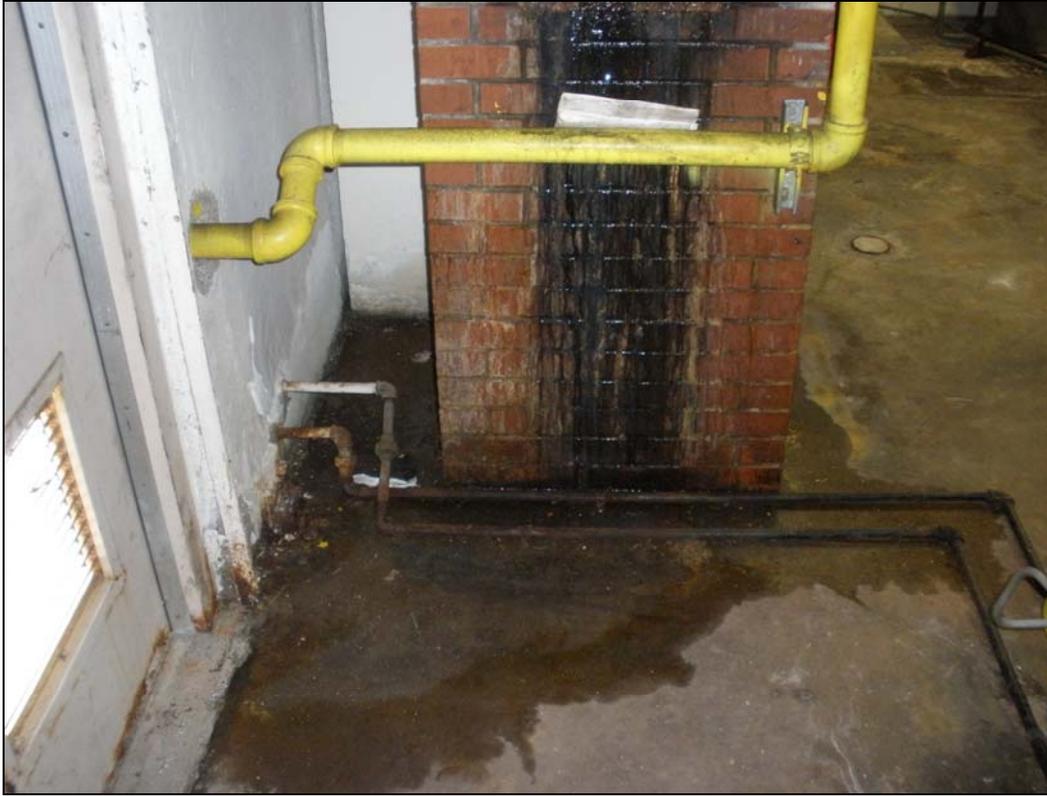
- Building 451 – the boiler/mechanical room of the building is classified as *contaminated* due to current leaks and spills of fuel oil on the walls and floor of the building.

adjacent to the AST, there is visible evidence of ongoing leaks of fuel oil from supply pipes on the walls and concrete floor of the building (Photographs 23 and 24, Appendix C).

Photograph 23. Building 451, oil spills in the boiler room

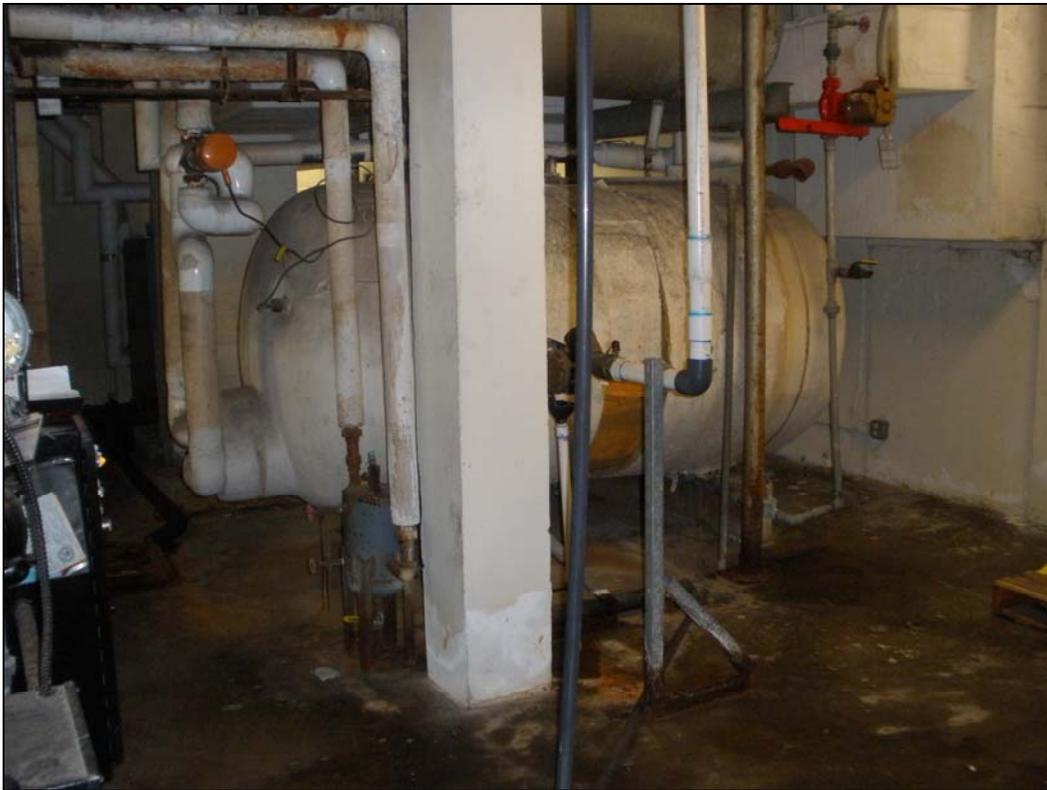
Photograph 24, Building 451, oil stained floor in the boiler room

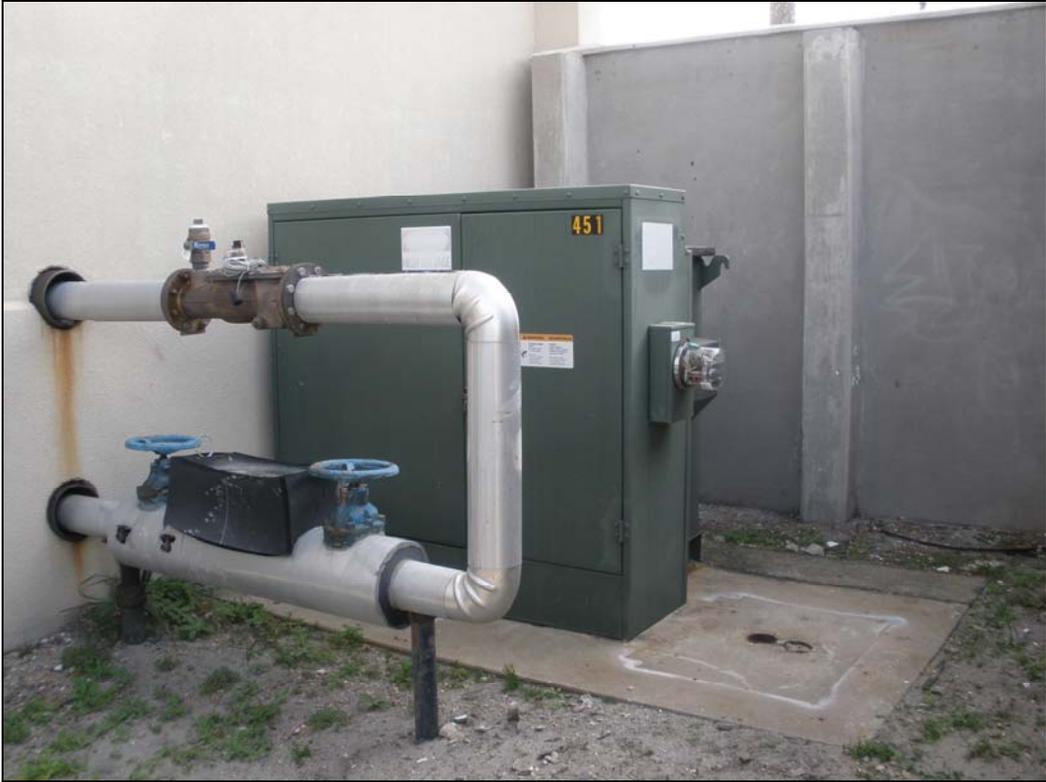
Photograph 25. Building 451, typical transformer and steam piping adjacent to building

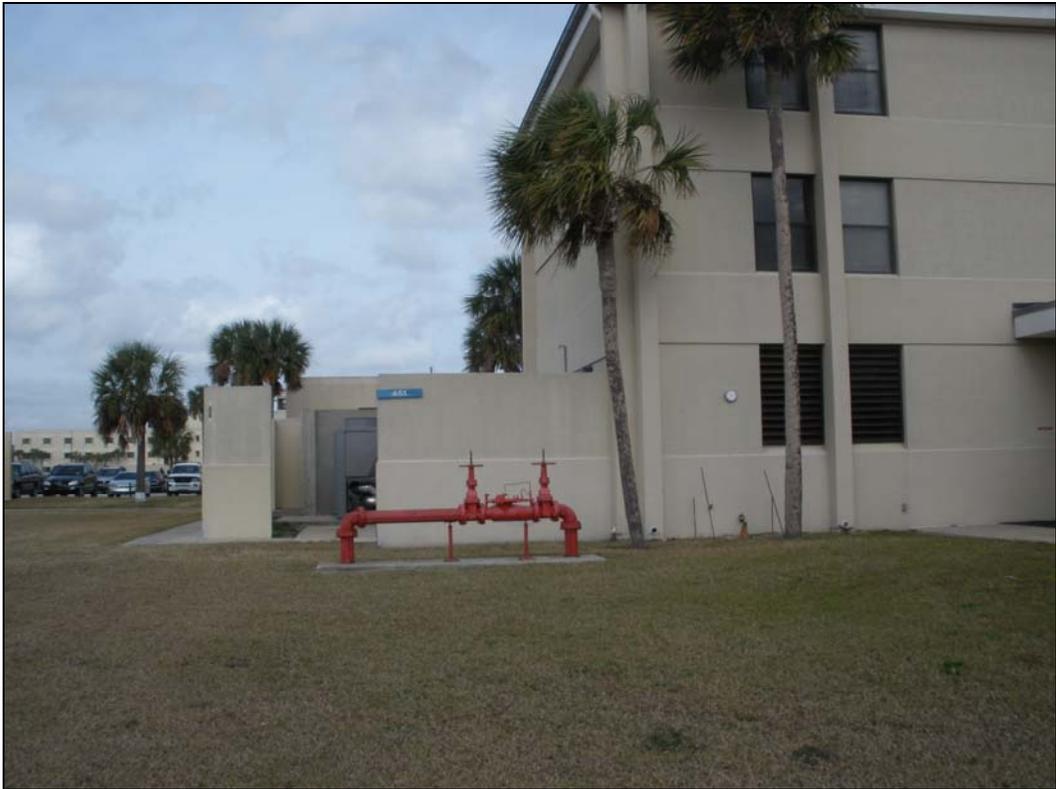
Photograph 26. Building 451, backflow preventers and mechanical adjacent to building

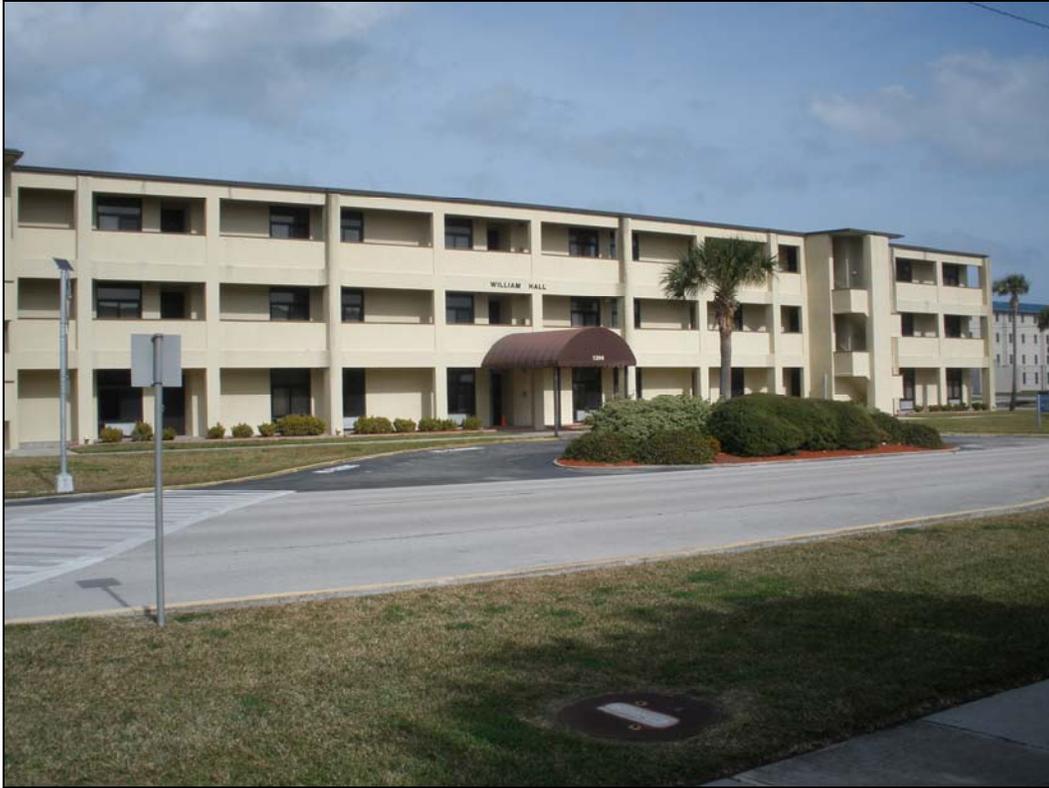
Photograph 27. Building 1394, front (N) view of building entrance

**Building 1394** is also a three story building fronting Bailey Avenue with the same manner of construction as Building 1393 (Photograph 27, Appendix C). There is an old AST concrete pad located at the rear of Building 1394 (Photograph 28, Appendix C), but no visible evidence of prior spills was observed.
