FINAL ENVIRONMENTAL CONDITION OF PROPERTY REPORT FOR NAVAL AIR STATION  
MAYPORT BACHELOR ENLISTED QUARTERS NAS MAYPORT FL  
02/01/2009  
NAVFAC SOUTHERN

ENVIRONMENTAL CONDITION  
OF PROPERTY REPORT

NAVAL AIR STATION MAYPORT  
BACHELOR ENLISTED QUARTERS  
JACKSONVILLE, FLORIDA

February 2009

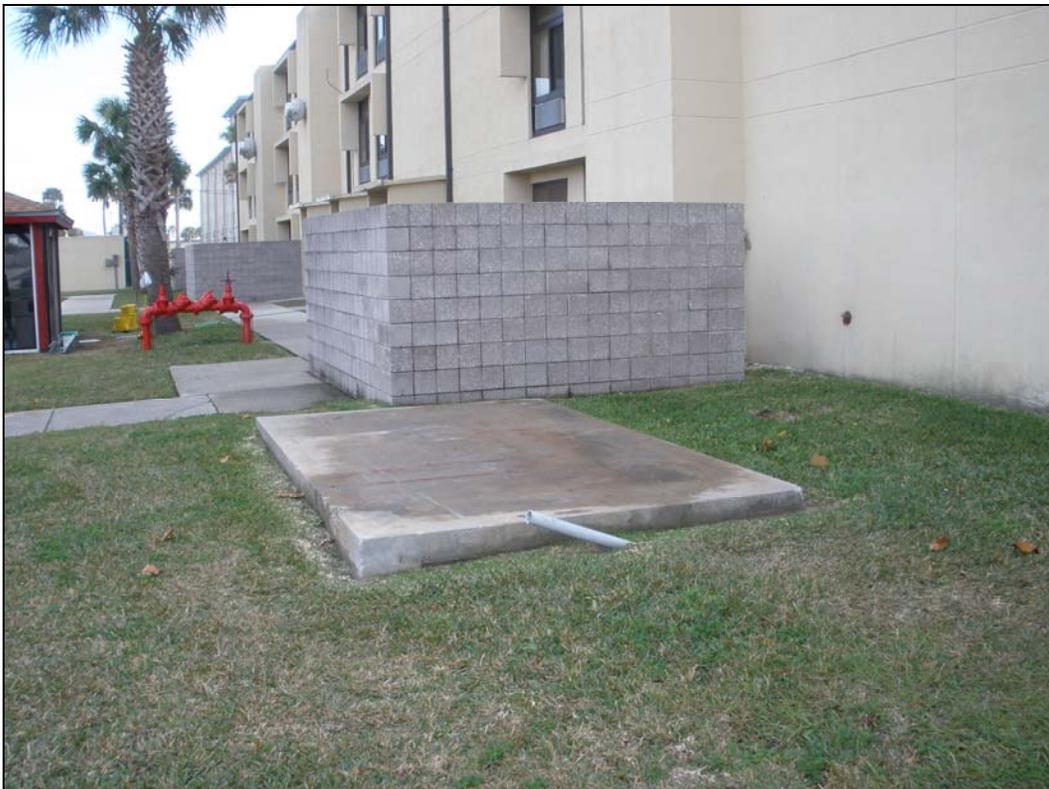
Photograph 28. Building 1394, old AST pad adjacent to building

Buildings 1393 and 1394 did not have backup fuel tanks associated with them. A former AST concrete pad was located adjacent to Building 1394 (Photograph 28, Appendix C), but no contamination was found associated with the former AST. The darker area visible on the pad in Photograph 28 is water staining due to recent cleaning activities in the area.

**Building 1394** is also a three story building fronting Bailey Avenue with the same manner of construction as Building 1393 (Photograph 27, Appendix C). There is an old AST concrete pad located at the rear of Building 1394 (Photograph 28, Appendix C), but no visible evidence of prior spills was observed.

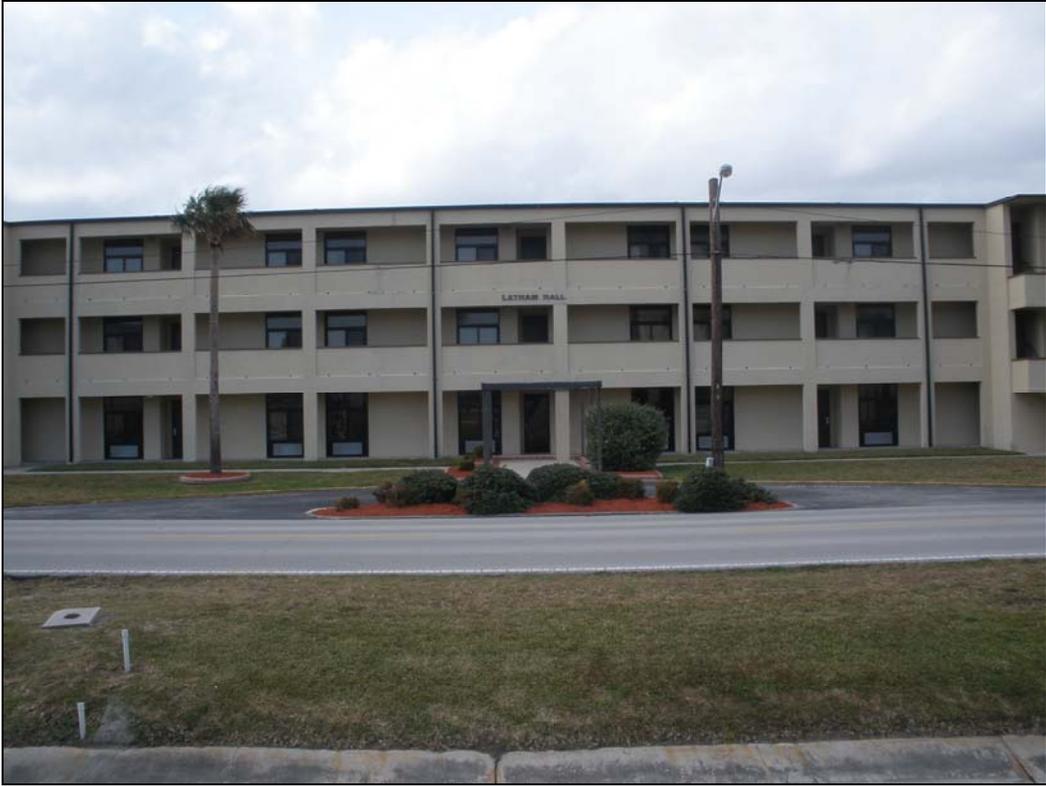
Photograph 29. Building 1393, front (E) view of building entrance

**Building 1393** is a three story building fronting on Baltimore Street, constructed of conventional studs and stucco exterior walls with stud and drywall interior walls (Photograph 29, Appendix C). No recognized environmental conditions were found around or in Building 1393.

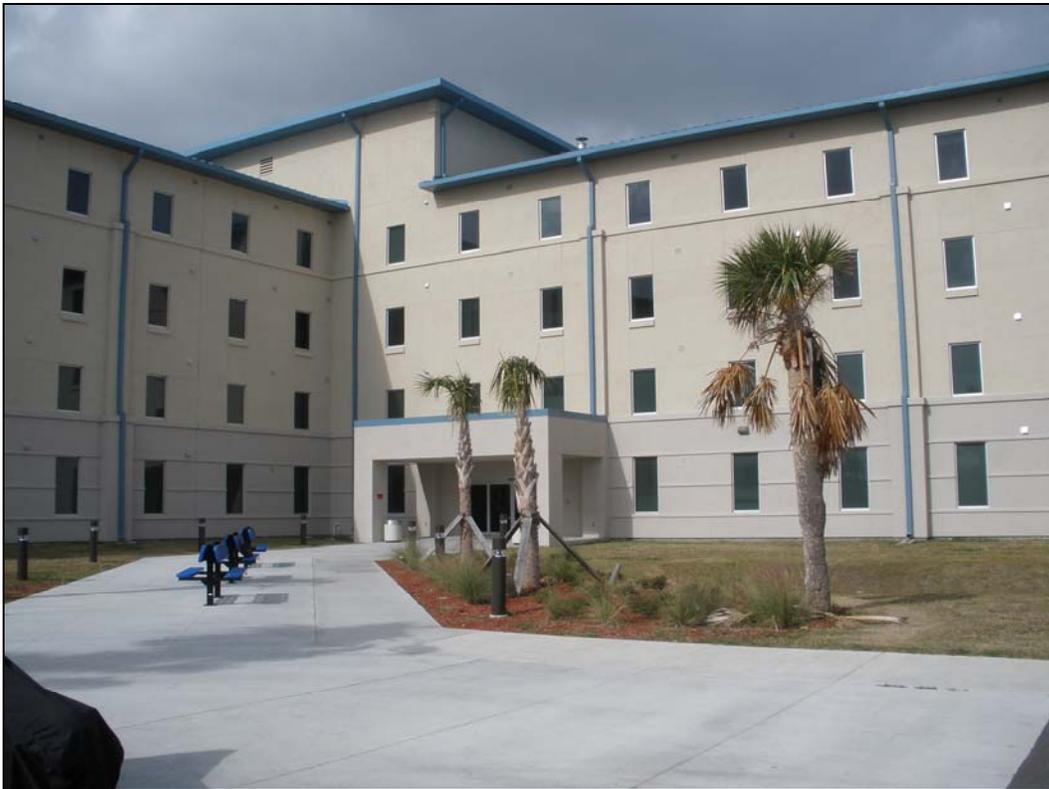
Photograph 30. Building 2234, front (NW) view of building entrance

**Building 2234** is the newest BEQ building at NS Mayport, with construction finished in July 2008. The entrance to the building faces the parking lot to the southeast (Photograph 30, Appendix C). It is constructed like Building 2105, with four stories of apartments and a fifth floor penthouse containing the boiler/mechanical room (Photographs 31 and 32, Appendix C). There were no hazardous conditions observed in or around Building 2234.

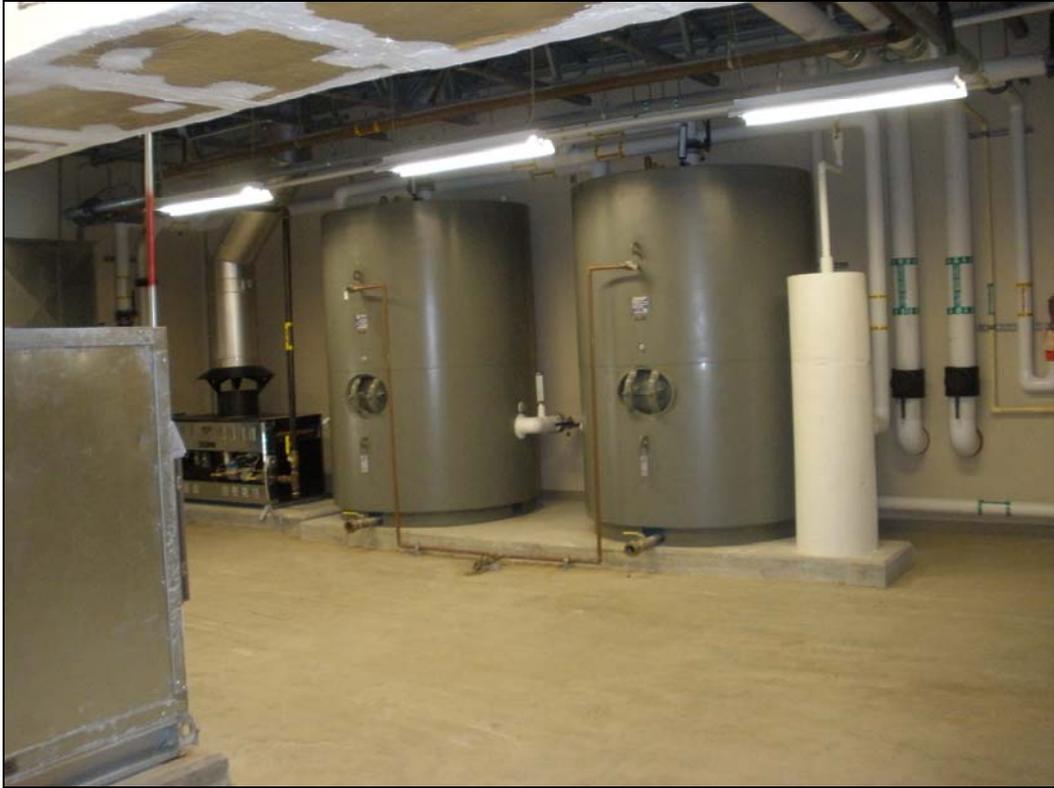
Photograph 31. Building 2234, boiler/mechanical room on fifth floor

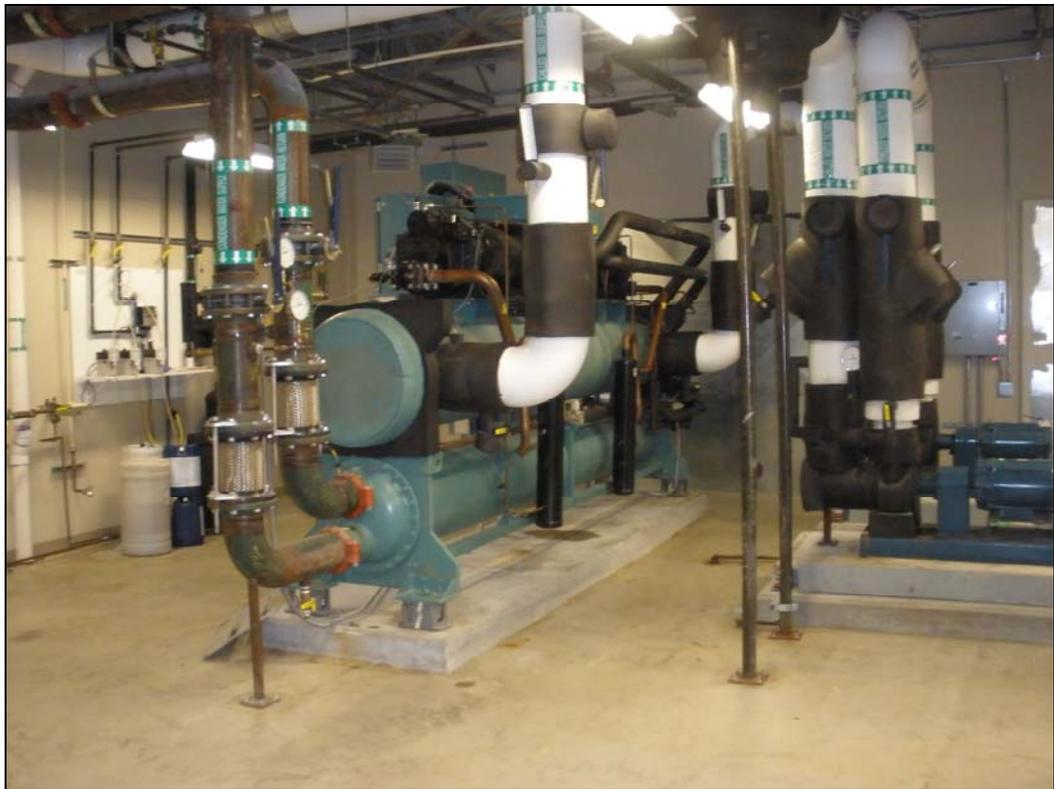
Photograph 32. Building 2234, boiler/mechanical room on fifth floor
