**TANK CLOSURE ASSESSMENT REPORT
BUILDING NO. 131
MAIN BASE**

**NAVAL TRAINING CENTER
ORLANDO, FLORIDA**

**UNIT IDENTIFICATION CODE: N65928
CONTRACT NO. N62467-89-D-0317/107**

SEPTEMBER 1995

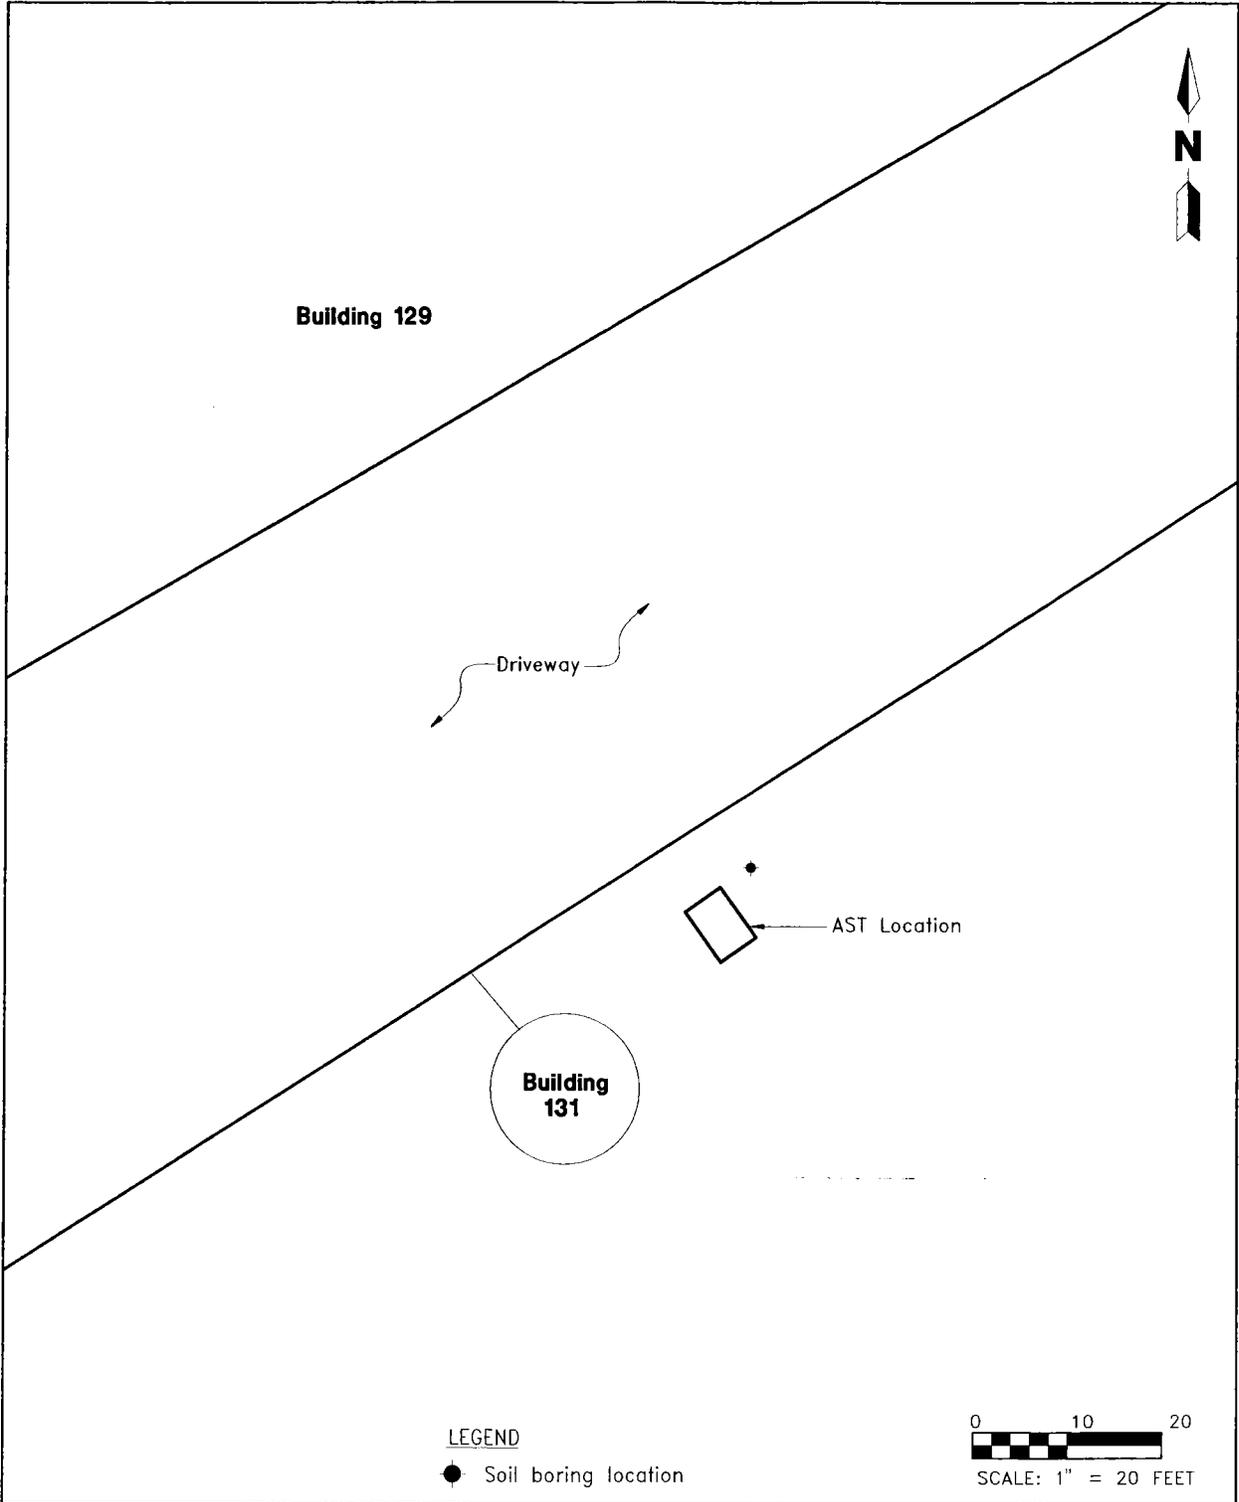
**FIGURE 2
SITE PLAN**

The tank area is approximately 4 feet by 6 feet (Figure 2).

- The soil screening was conducted following criteria for headspace method in Chapter 62-770, Florida Administrative Code (FAC), and ABB Environmental Services, Inc.'s (ABB-ES's) Comprehensive Quality Assurance Plan (CompQAP).
- The OVA data have been summarized in Table 1. Figure 2 shows the location where the soil samples were collected.

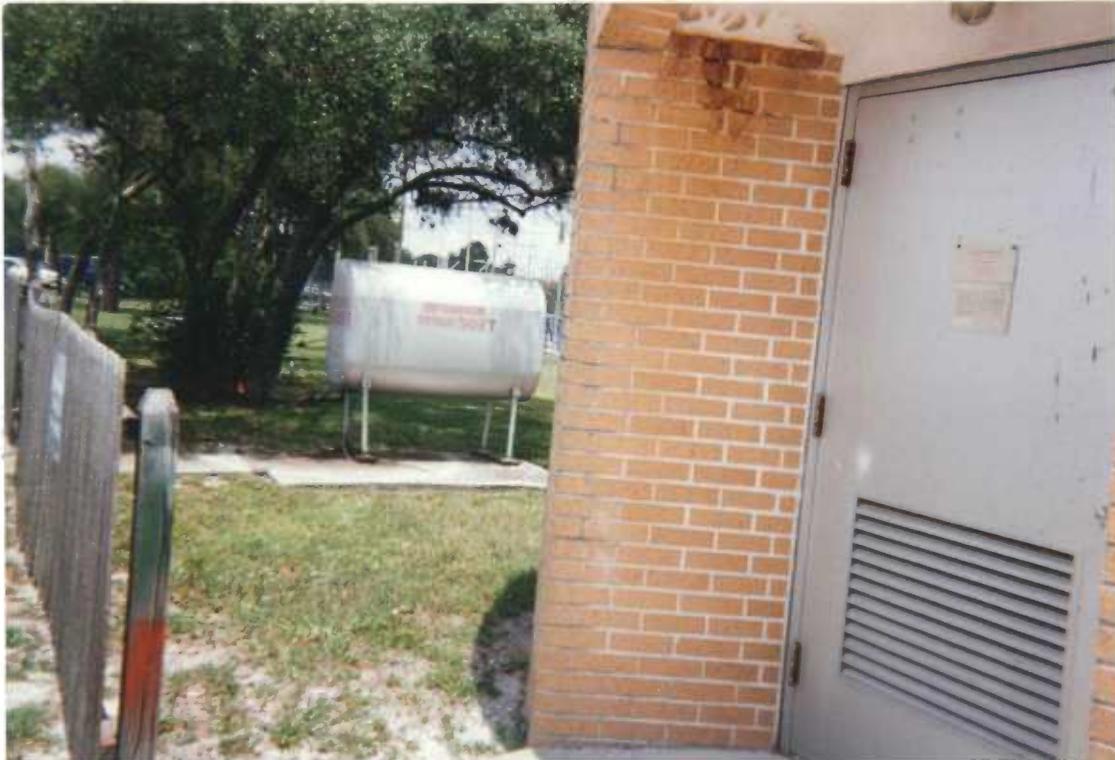
ABB-ES has screened the soil from the former tank area where the AST was located. Petroleum-impacted soil has been found only at the surface in the form of surface staining in the concrete pad. The soil-boring data and soil samples reveal that contamination does not extend below the surface.

Photograph 1: View of AST site, Building No. 131, facing southeast. Red flag indicates soil boring location.

ABB-ES recommends that during tank removal, Bechtel Environmental, Inc., removes the surface-impacted concrete and soil. After petroleum-impacted soil is removed, a groundwater sample will be collected prior to issuing a final tank closure report.

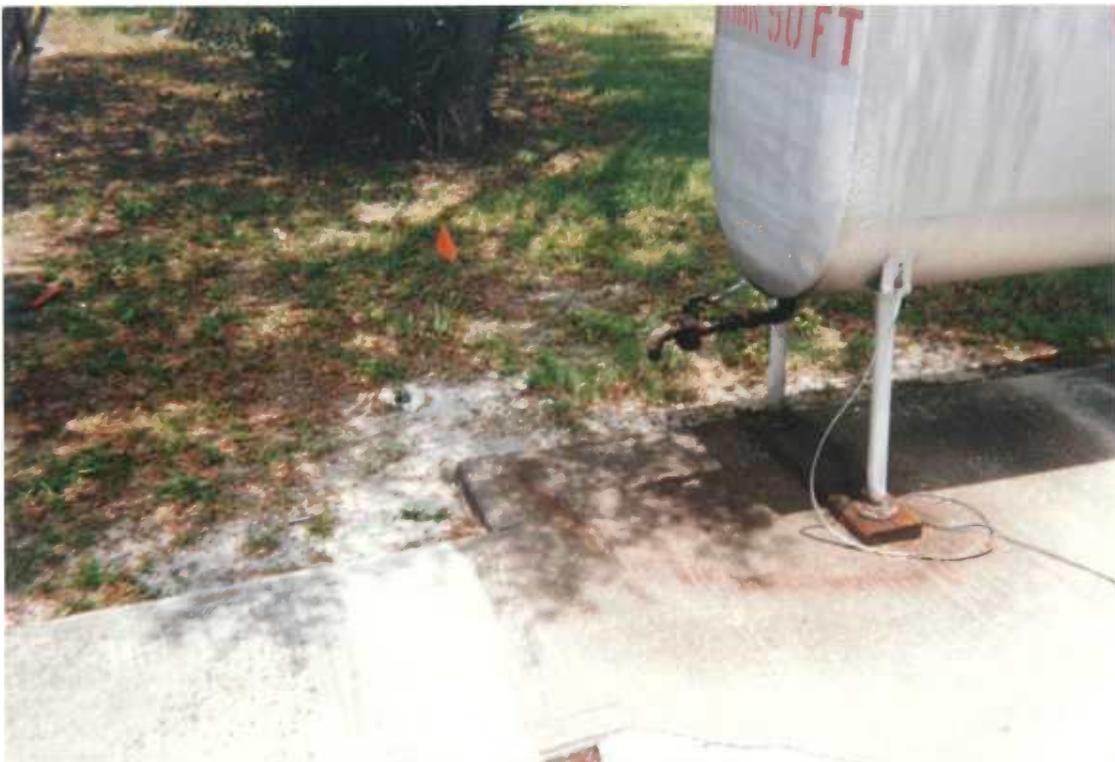
A photo of the existing tank is shown in Attachment A.

Photograph 2: Closeup view of AST site, Building No. 131, facing southeast. Red flag indicates soil boring location.
