RESPONSE TO FLORIDA DEPARTMENT OF ENVIRONMENTAL PROTECTION COMMENTS
ON SITE ASSESSMENT REPORT ADDENDUM II UNDERGROUND STORAGE TANK SITE
22 INSTALLATION RESTORATION SITE 21 NAS PENSACOLA FL
08/19/2011
NAVFAC SOUTHERN

**NAVAL AIR STATION PENSACOLA
PENSACOLA, FLORIDA
SITE ASSESSMENT REPORT ADDENDUM II
UNDERGROUND STORAGE TANK SITE 22 (IR SITE 21)**

**RESPONSE TO FDEP COMMENTS
Dated August 19, 2011**

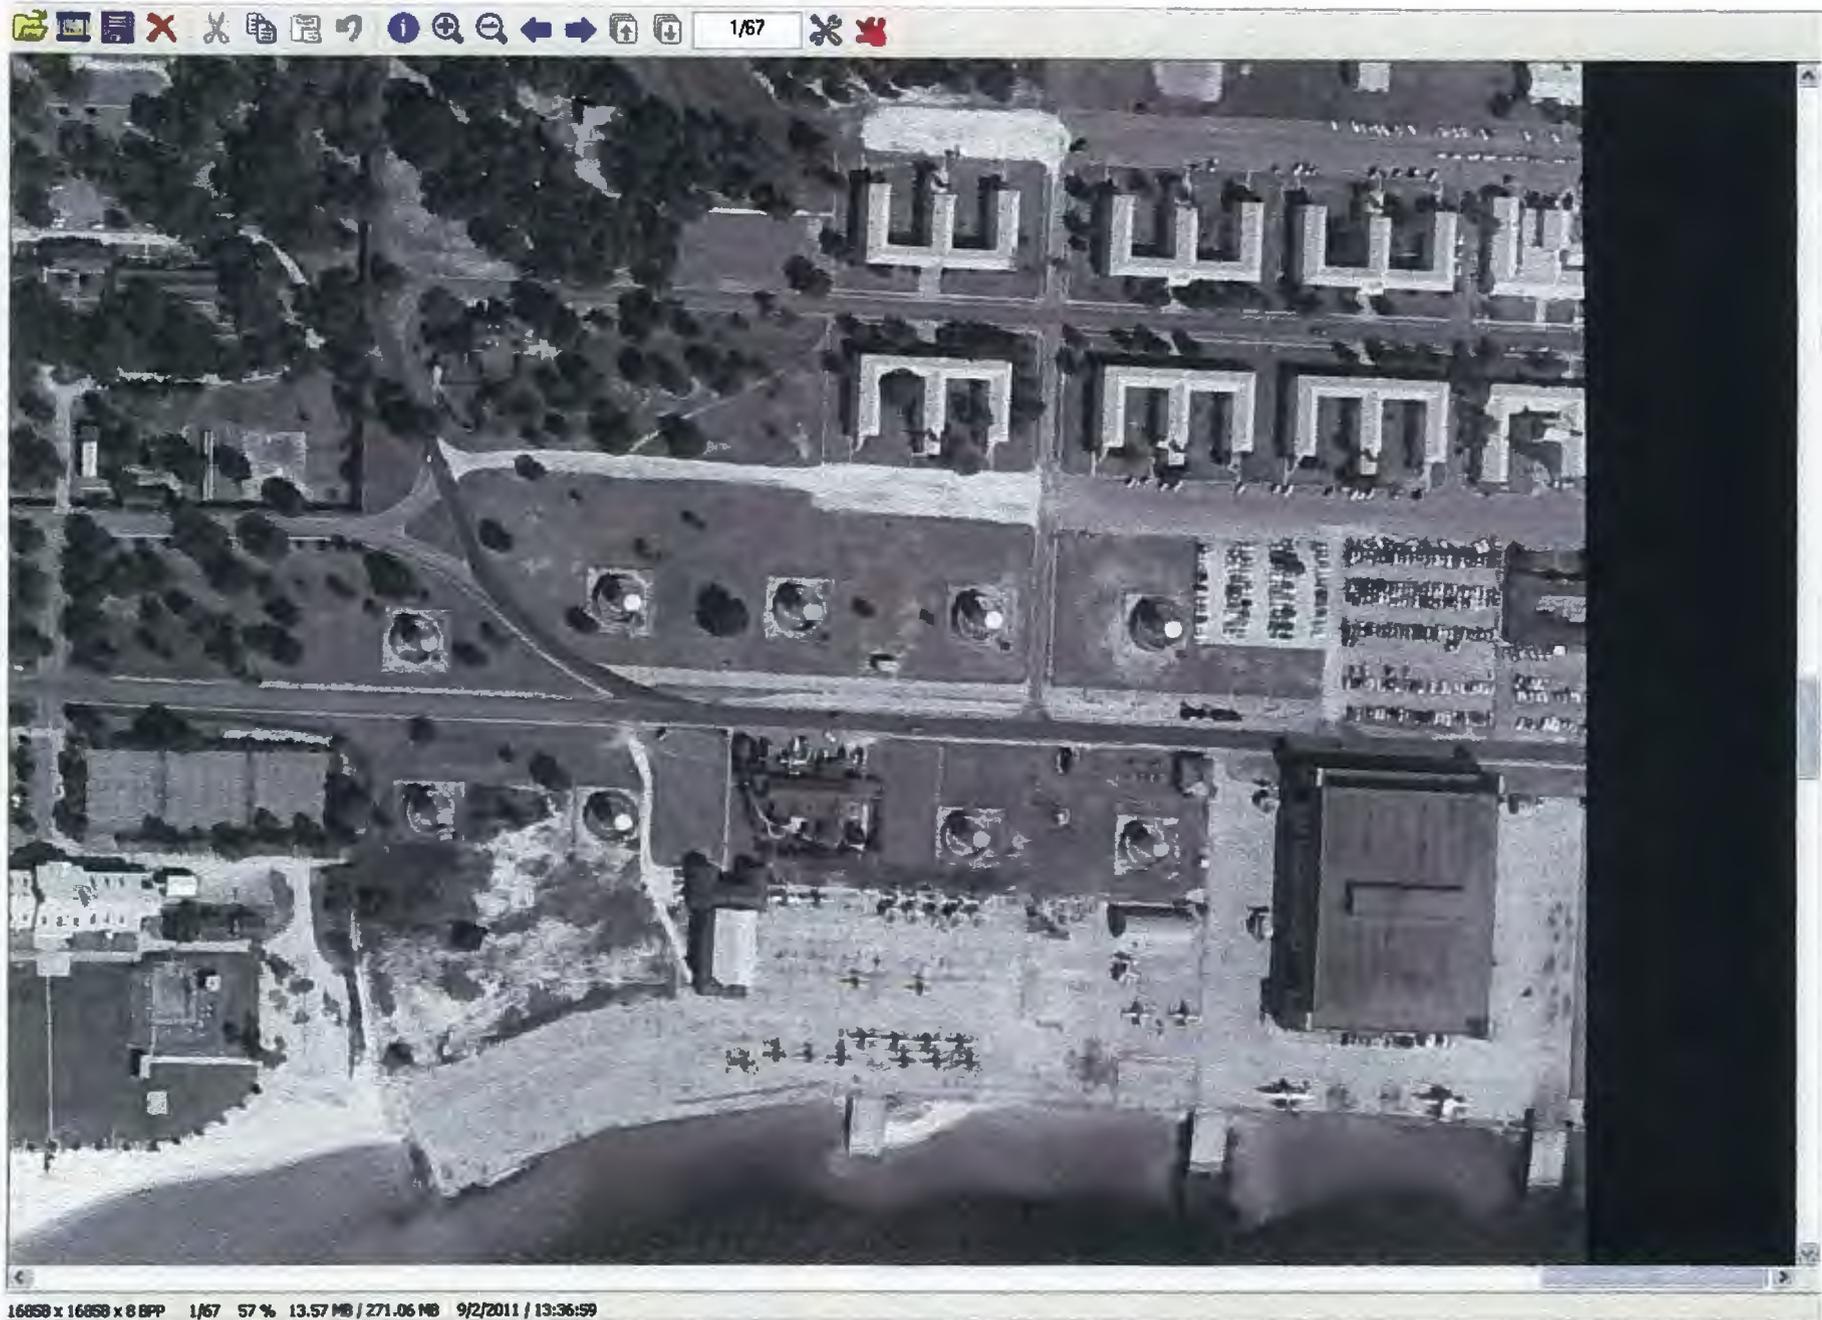
Aerial Photograph 1: Florida Department of Transportation, December 1961

apparent. The aerial photographs reviewed were from 1961, 1970, 1973, 1981, 1983, 1989, 1992, 1993, 1997, 2000, 2004, 2007, and 2010 (Please refer to Attachment 1, for Aerial Photographs 1 through 13). The majority of the aerial photographs show the locations of the 5 ASTs north of Radford Blvd. and 4 ASTs south of Radford Blvd. The two northwestern most AST locations were not visible in all of the aerial photographs. One of the northwestern ASTs is within the intersection of Radford Blvd and the newly constructed (~ 1989) Duncan St., (Aerial Photograph 6). The other northwestern AST location was obscured during the construction of a building on the northeast corner of Radford Blvd Duncan St., (Aerial Photographs 12 and 13). The northern ASTs and containment structures (north of Radford Blvd) appeared in aerial photographs from 1961 to 1973 (Aerial Photographs 1 through 3), but appear to have been removed prior to 1981 (Aerial Photograph 4). The southern ASTs and containment structures (south of Radford Blvd) appeared in aerial photographs from 1961 to 1993 (Aerial Photographs 1 through 8) but appear to have been removed prior to 1997 (Aerial Photograph 9). Based on the aerial photograph review, the areas around the tanks appeared to be maintained lawns that were impacted at various time by nearby construction activities. None of the aerial photographs appear to show an area(s) of staining or stressed vegetation that potentially would indicate the placing of tank bottoms on the maintained lawns.
