Site Characterization Site 731

United States Navy
Roosevelt Roads Naval Station
Ceiba, Puerto Rico

March 1998

Re: **Site Characterization Reports - Sites 731 and 734**
Roosevelt Roads Naval Station
Ceiba, Puerto Rico
Contract Number: N62470-93-D-4021
Project #: 399.33

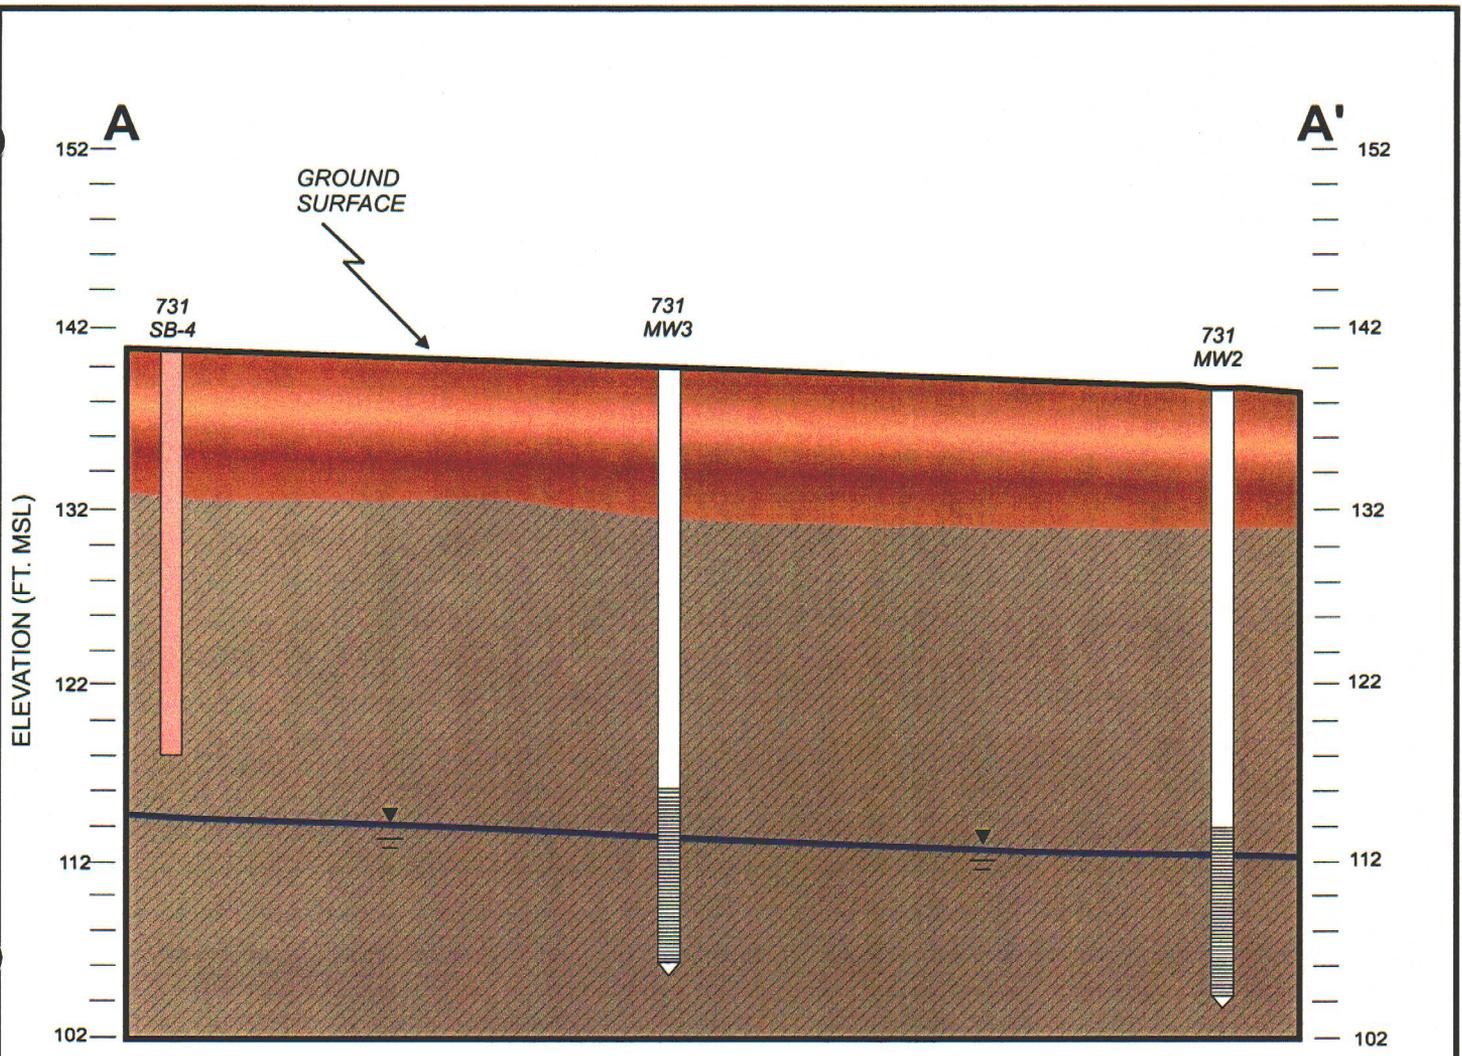
BLASLAND, BOUCK & LEE, INC. engineers & scientists
FIGURE 2-2

Site 731 lies on a small hill (approximately 40 feet above MSL) underlain by the Daguoa Formation that slopes downward to the south. Beneath Site 731, silt and clay, from highly weathered volcanic rock are encountered. The colors of the clays are primarily light to dark yellowish brown, light greenish gray/black, light olive brown, and pale green. The colors of the silt and clays were determined with the Munsell soil color system. The clay-rich material beneath this zone is saprolite, a thoroughly decomposed rock formed in place by chemical weathering of igneous and metamorphic rocks. The saprolite is encountered at approximately 6 to 8 feet below land surface (BLS). The formation of saprolite usually takes place in tropical or subtropical climates with high humidity. The brown coloring of the weathered volcanic rock is due to iron oxidation. These sediments possess high plasticity and are not easily crumbled under hand pressure. The locations of monitoring wells and soil borings are provided as figure 2-1. North-south and east-west geologic cross-sections are presented respectively in Figures 2-2 and 2-3. These cross-sections are based on the lithology observed during the installation of soil borings and monitoring wells for the SC.

ROOSEVELT ROADS U.S. NAVAL STATION CEIBA, PUERTO RICO SITE CHARACTERIZATION- SITE 731
GEOLOGIC CROSS SECTION A-A'

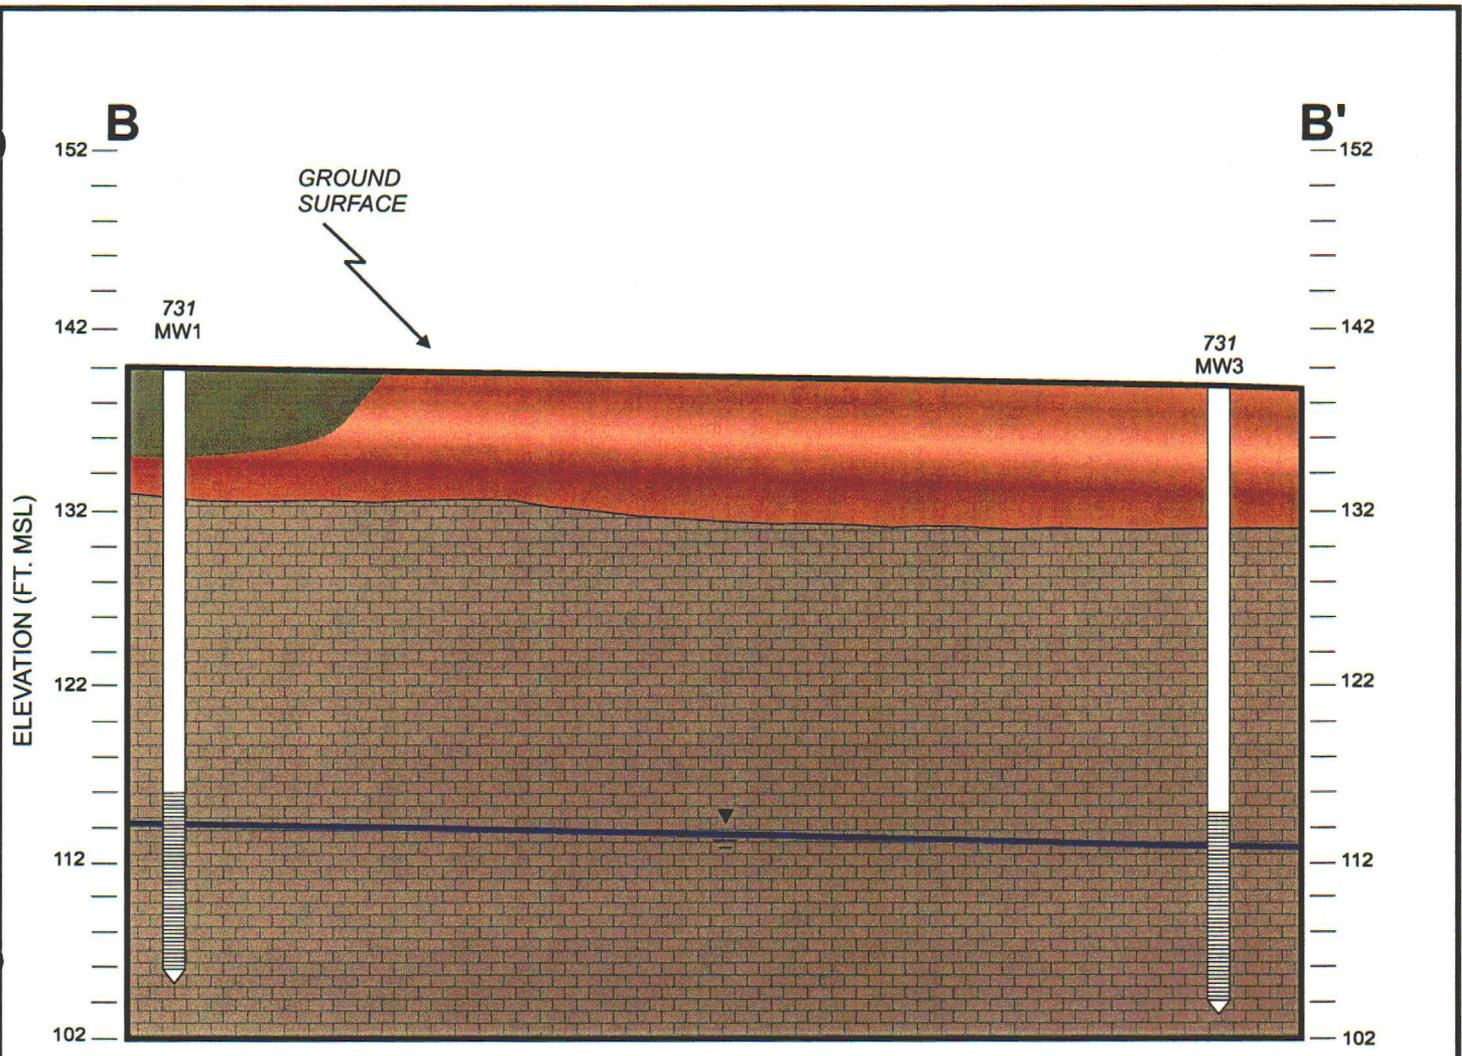
**FIGURE
2-3**

GEOLOGIC CROSS SECTION B-B'

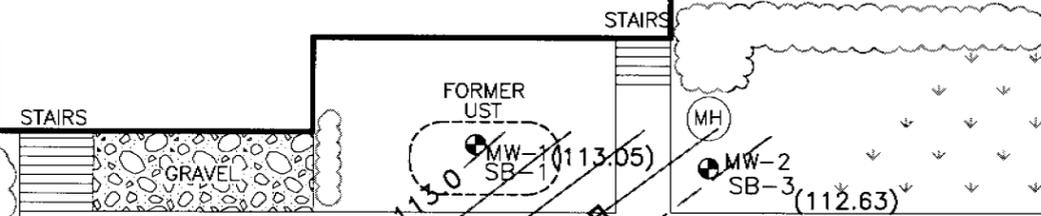
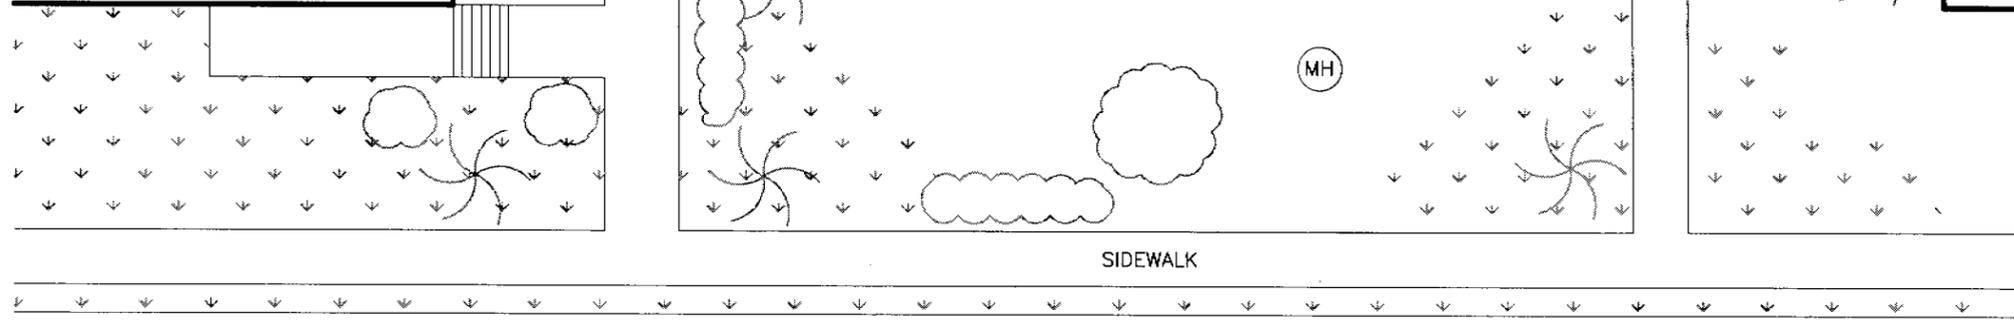
FIGURE
3-1

Groundwater flow at the site is controlled by elevation differences between adjacent hills. Groundwater flow across the site is to the southeast. Site 731 is underlain by an unconfined surficial aquifer system, which is composed of plastic clays (saprolite). The high plasticity of the subsurface material indicates that water is present in the pore spaces, however, the specific yield (ratio of the volume of water that drains from a sample under gravity to the total volume of the sample) is very low. The high specific retention (ratio of the volume of water that a sample retains against the pull of gravity to the total volume of the sample) observed in the samples is due to the ionic attraction between positively charged hydrogen bonds in the water molecules and the net negative charges on clay particle surfaces. As a result, the subsurface material displays low hydraulic conductivity in all directions of the flow field. Additionally, results from the slug tests display evidence of a slow rate of return to static conditions in the monitoring well. A summary of the slug test results and hydraulic conductivity values are presented in Appendix C.

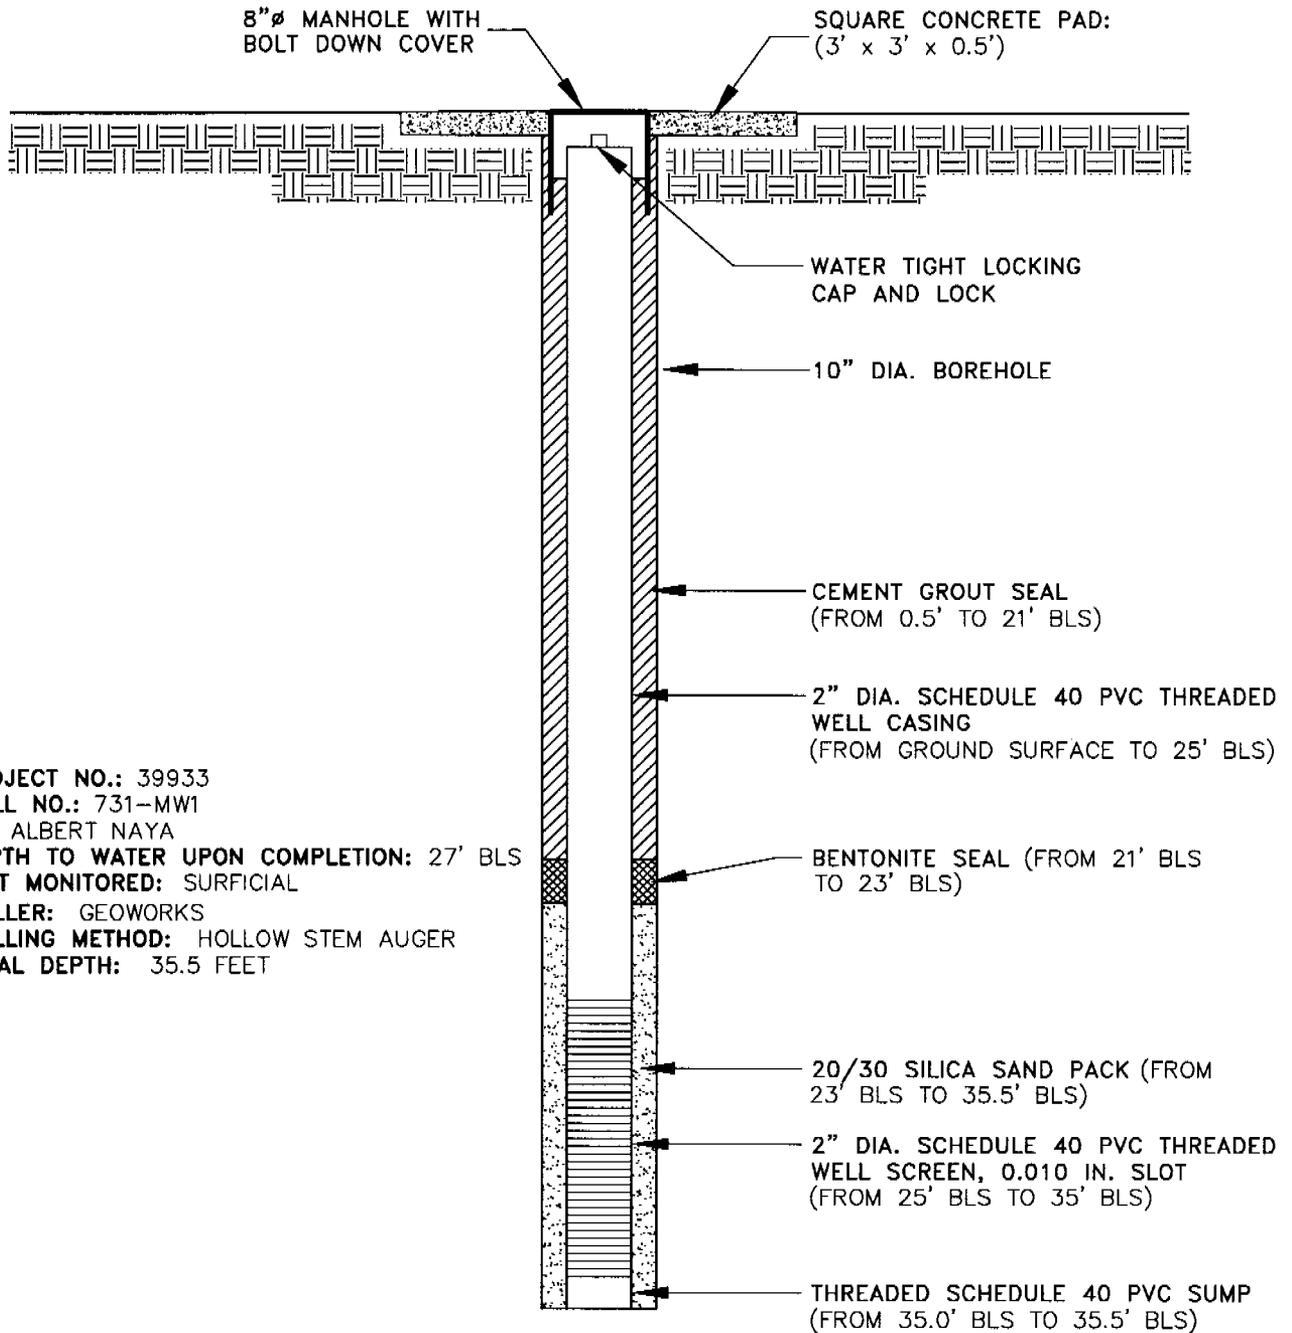
731 - MW1

PROJECT NO.: 39933
 WELL NO.: 731-MW1
 BY: ALBERT NAYA
 DEPTH TO WATER UPON COMPLETION: 27' BLS
 UNIT MONITORED: SURFICIAL
 DRILLER: GEOWORKS
 DRILLING METHOD: HOLLOW STEM AUGER
 TOTAL DEPTH: 35.5 FEET

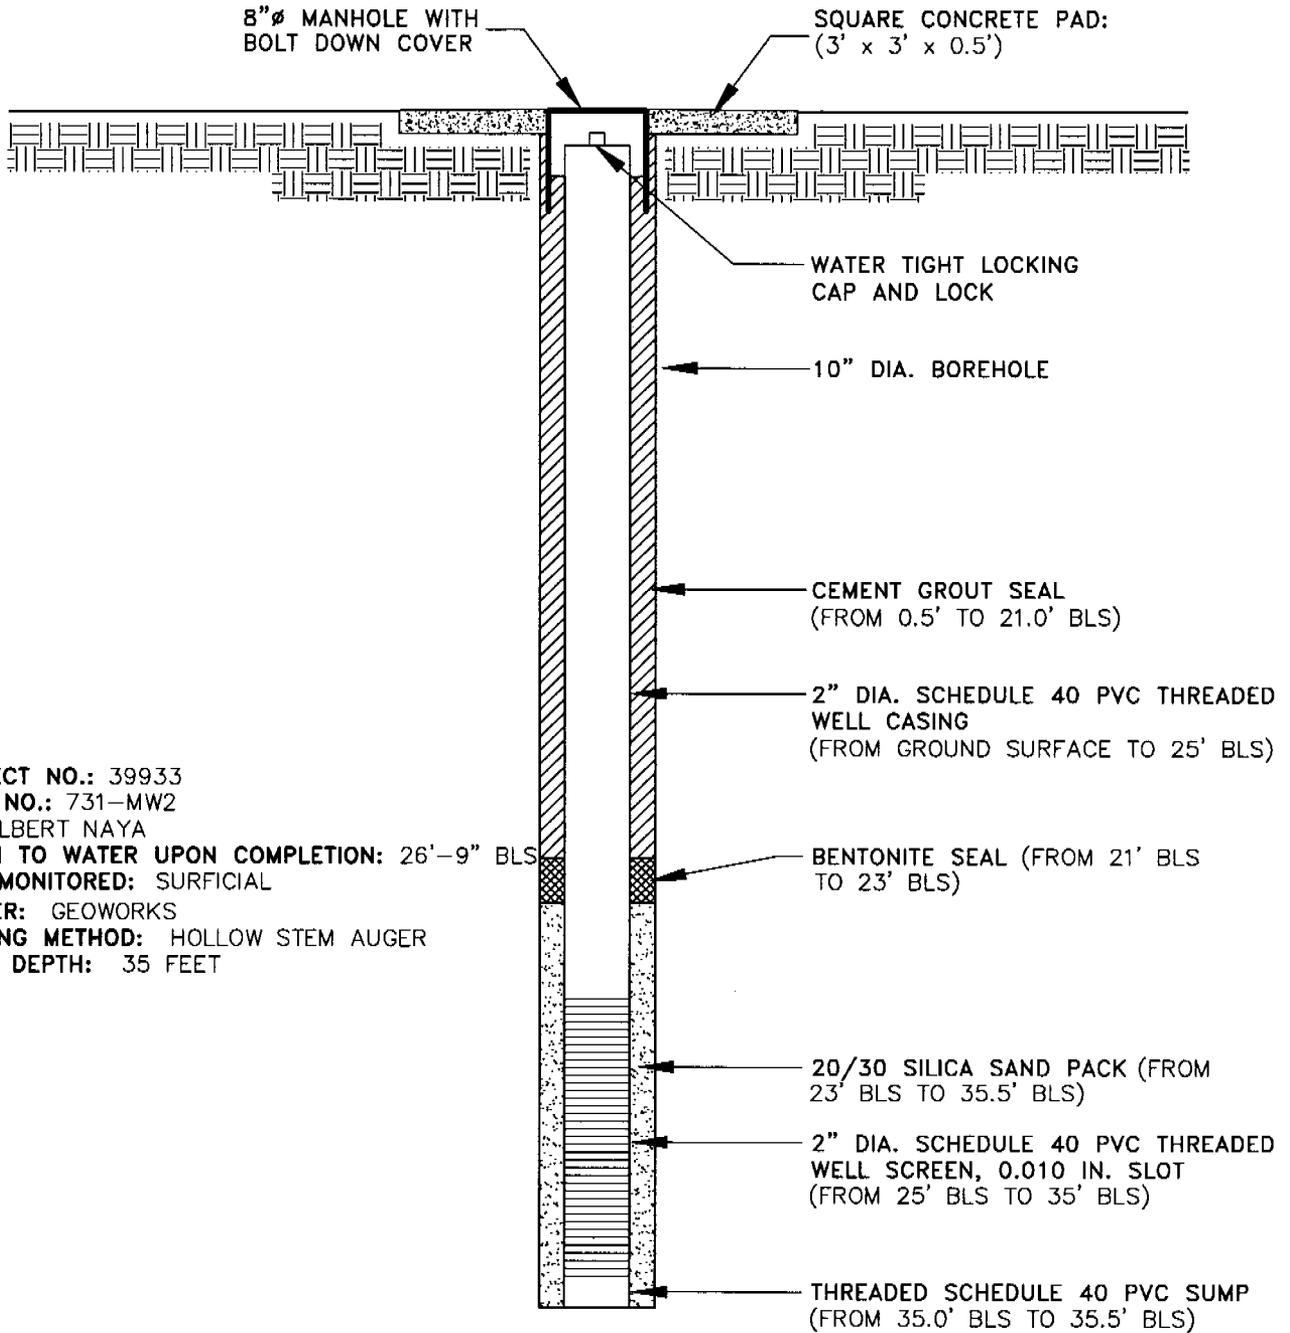
731 - MW2

PROJECT NO.: 39933
 WELL NO.: 731-MW2
 BY: ALBERT NAYA
 DEPTH TO WATER UPON COMPLETION: 26'-9" BLS
 UNIT MONITORED: SURFICIAL
 DRILLER: GEOWORKS
 DRILLING METHOD: HOLLOW STEM AUGER
 TOTAL DEPTH: 35 FEET

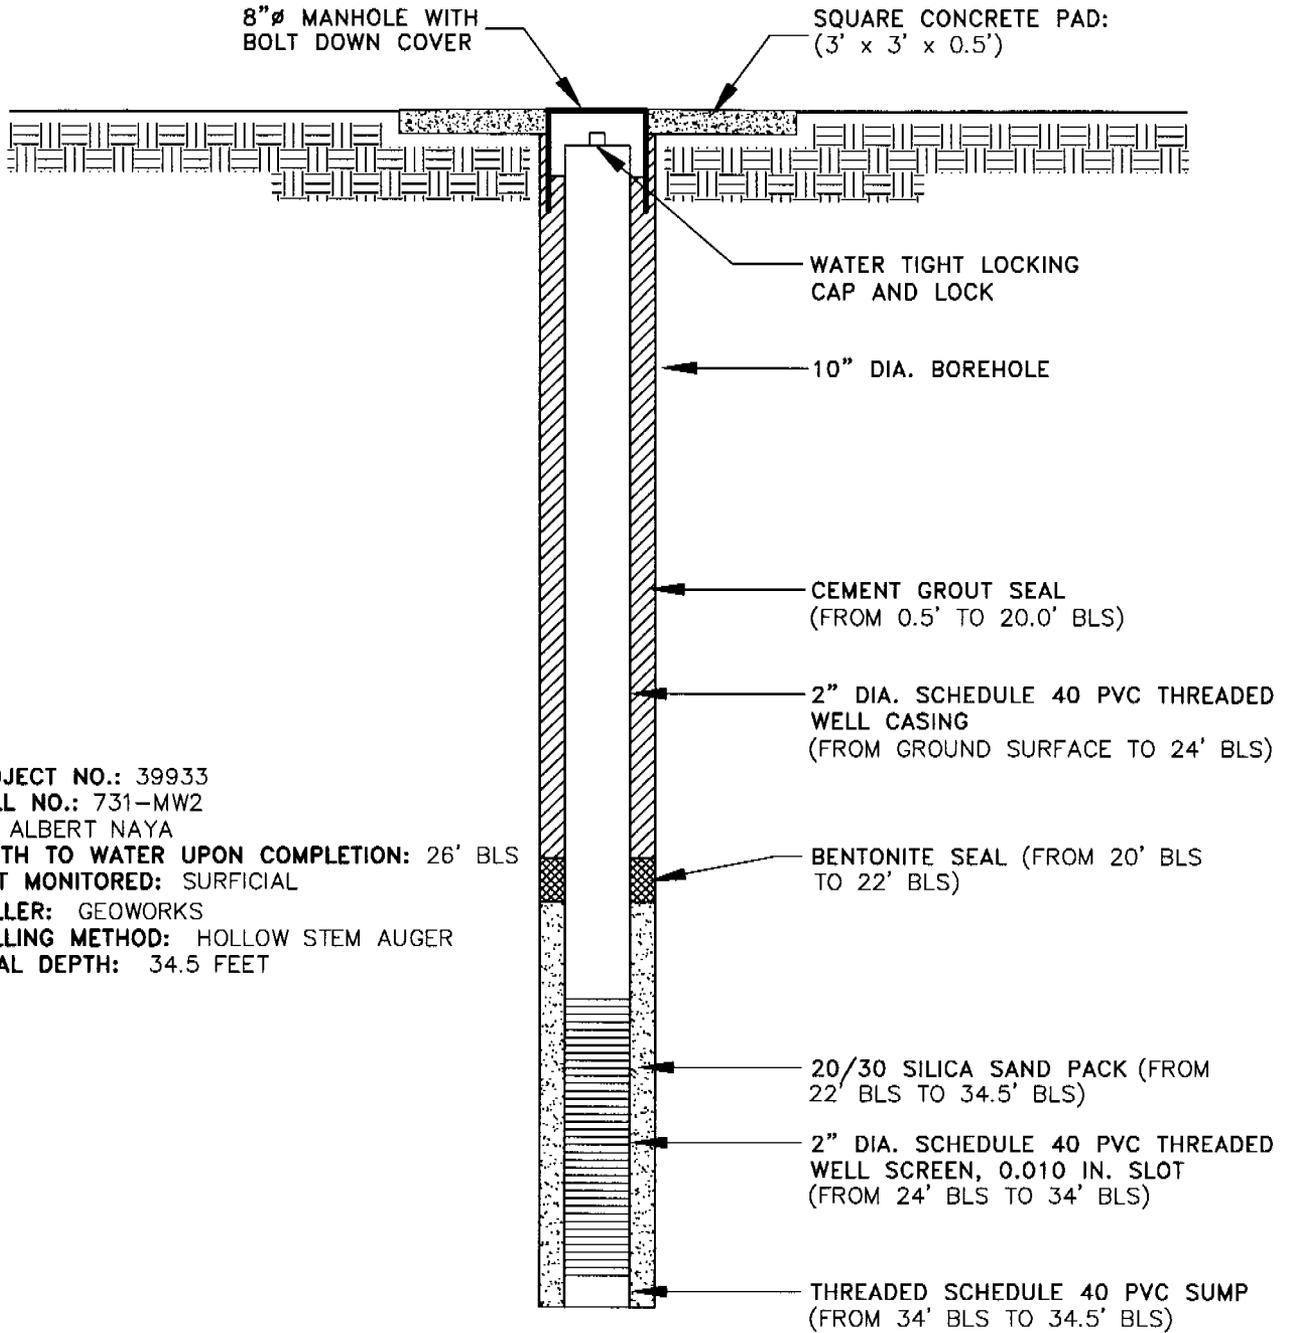
731 - MW3

PROJECT NO.: 39933
 WELL NO.: 731-MW2
 BY: ALBERT NAYA
 DEPTH TO WATER UPON COMPLETION: 26' BLS
 UNIT MONITORED: SURFICIAL
 DRILLER: GEOWORKS
 DRILLING METHOD: HOLLOW STEM AUGER
 TOTAL DEPTH: 34.5 FEET

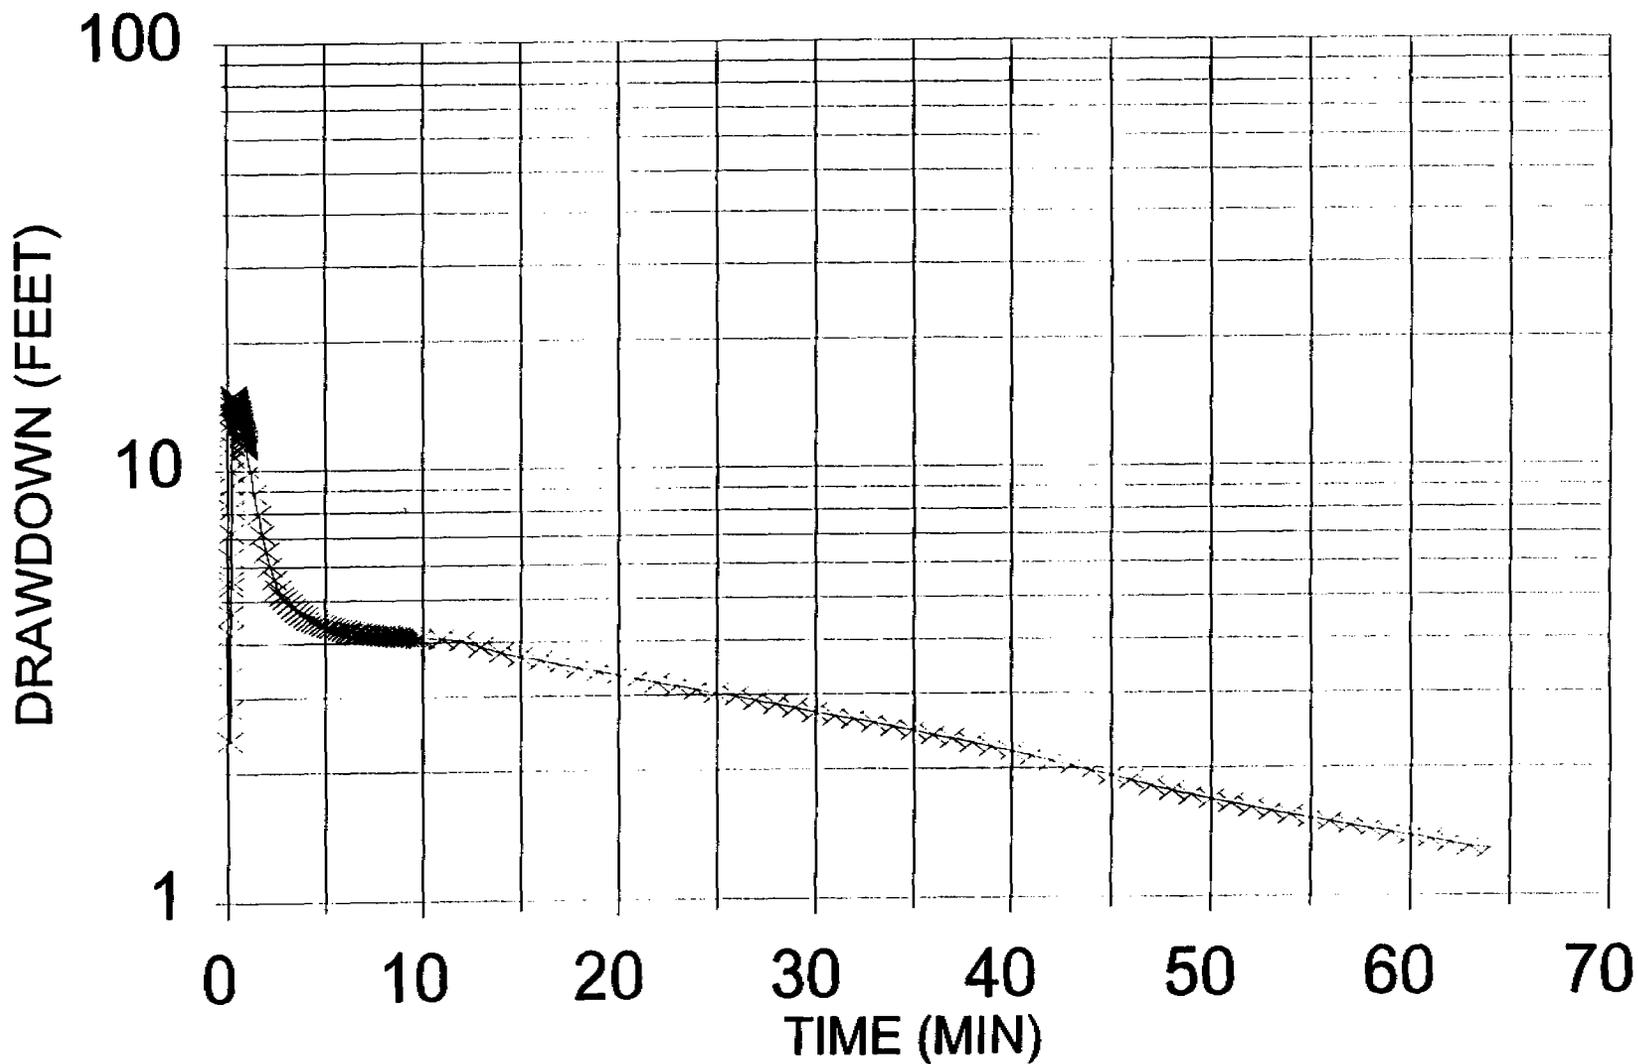
Slug Test Recovery Curve For 731-MW-2

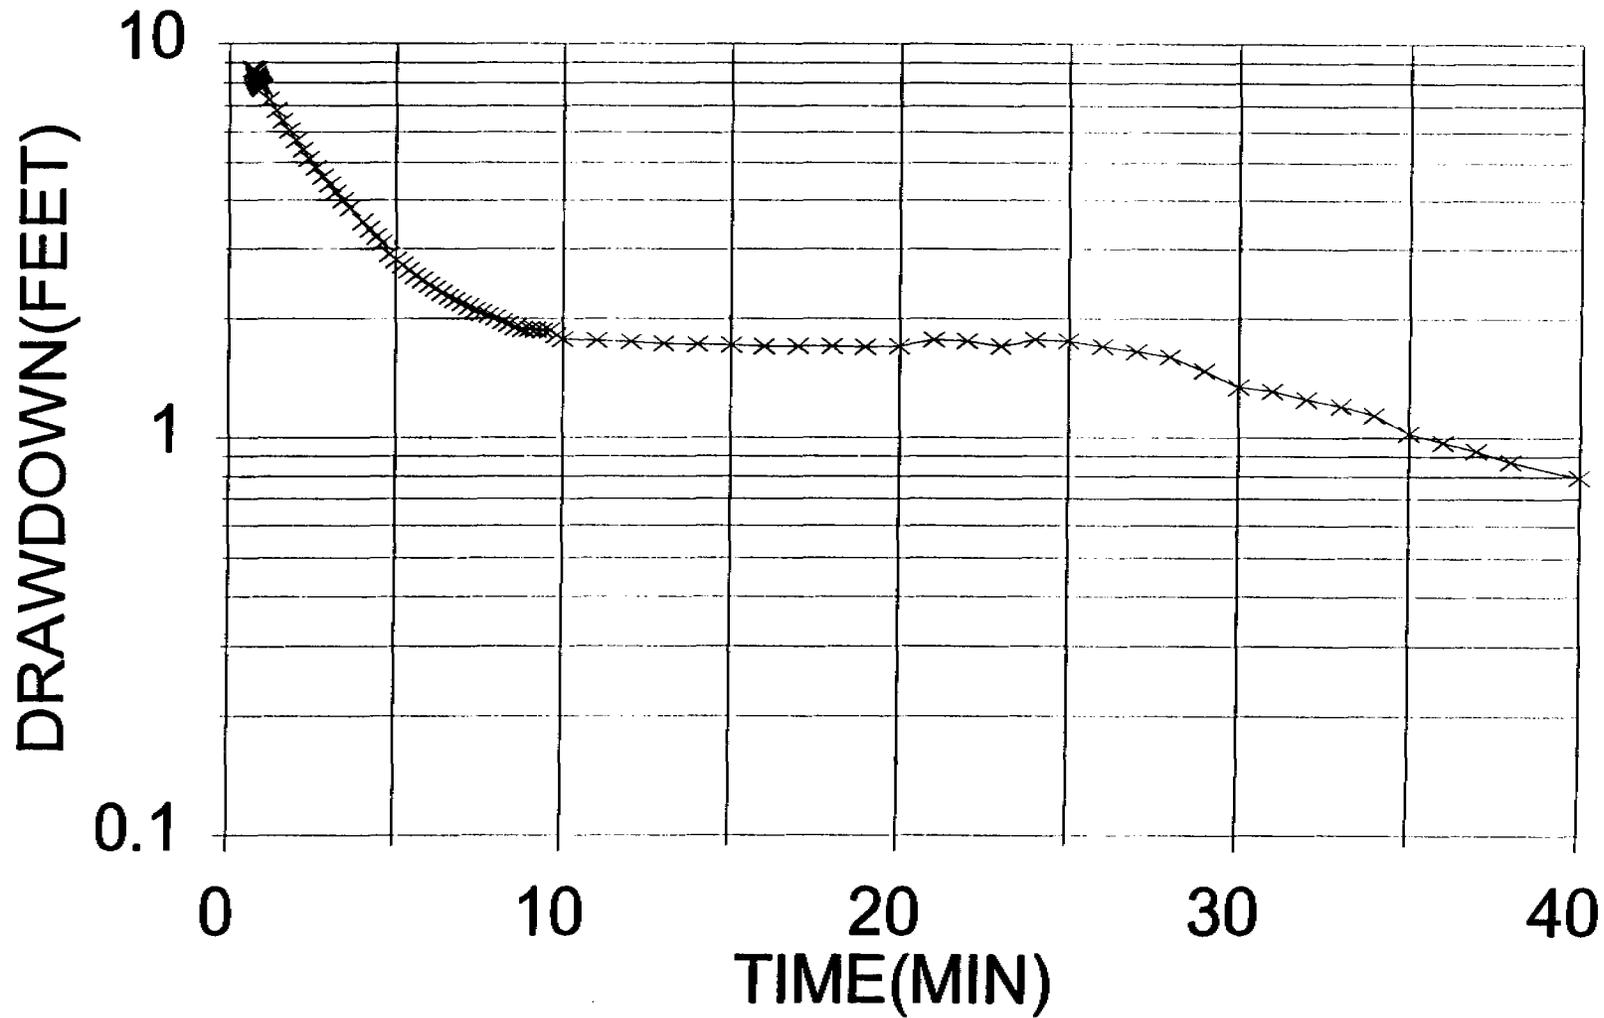
Slug Test Recovery Curve For 731-MW3
