PERFLUOROALKYL AND POLYFLUOROALKYL SUBSANCES ASSESSMENT FOR
SOLID WASTE MANAGEMENT UNIT (SWMU) 68 FORMER FIRE TRAINING AREA
NAVAL ACTIVITY PUERTO RICO
9/3/2010
CH2M HILL

Per- and Polyfluoroalkyl Substances Assessment for Solid Waste Management Unit 68, Former Southern Fire Training Area, Naval Activity Puerto Rico, Ceiba, Puerto Rico

PREPARED BY: CH2M HILL, Inc. on behalf of the Department of the Navy, Naval Facilities Engineering Command Southeast

DATE: September 2016

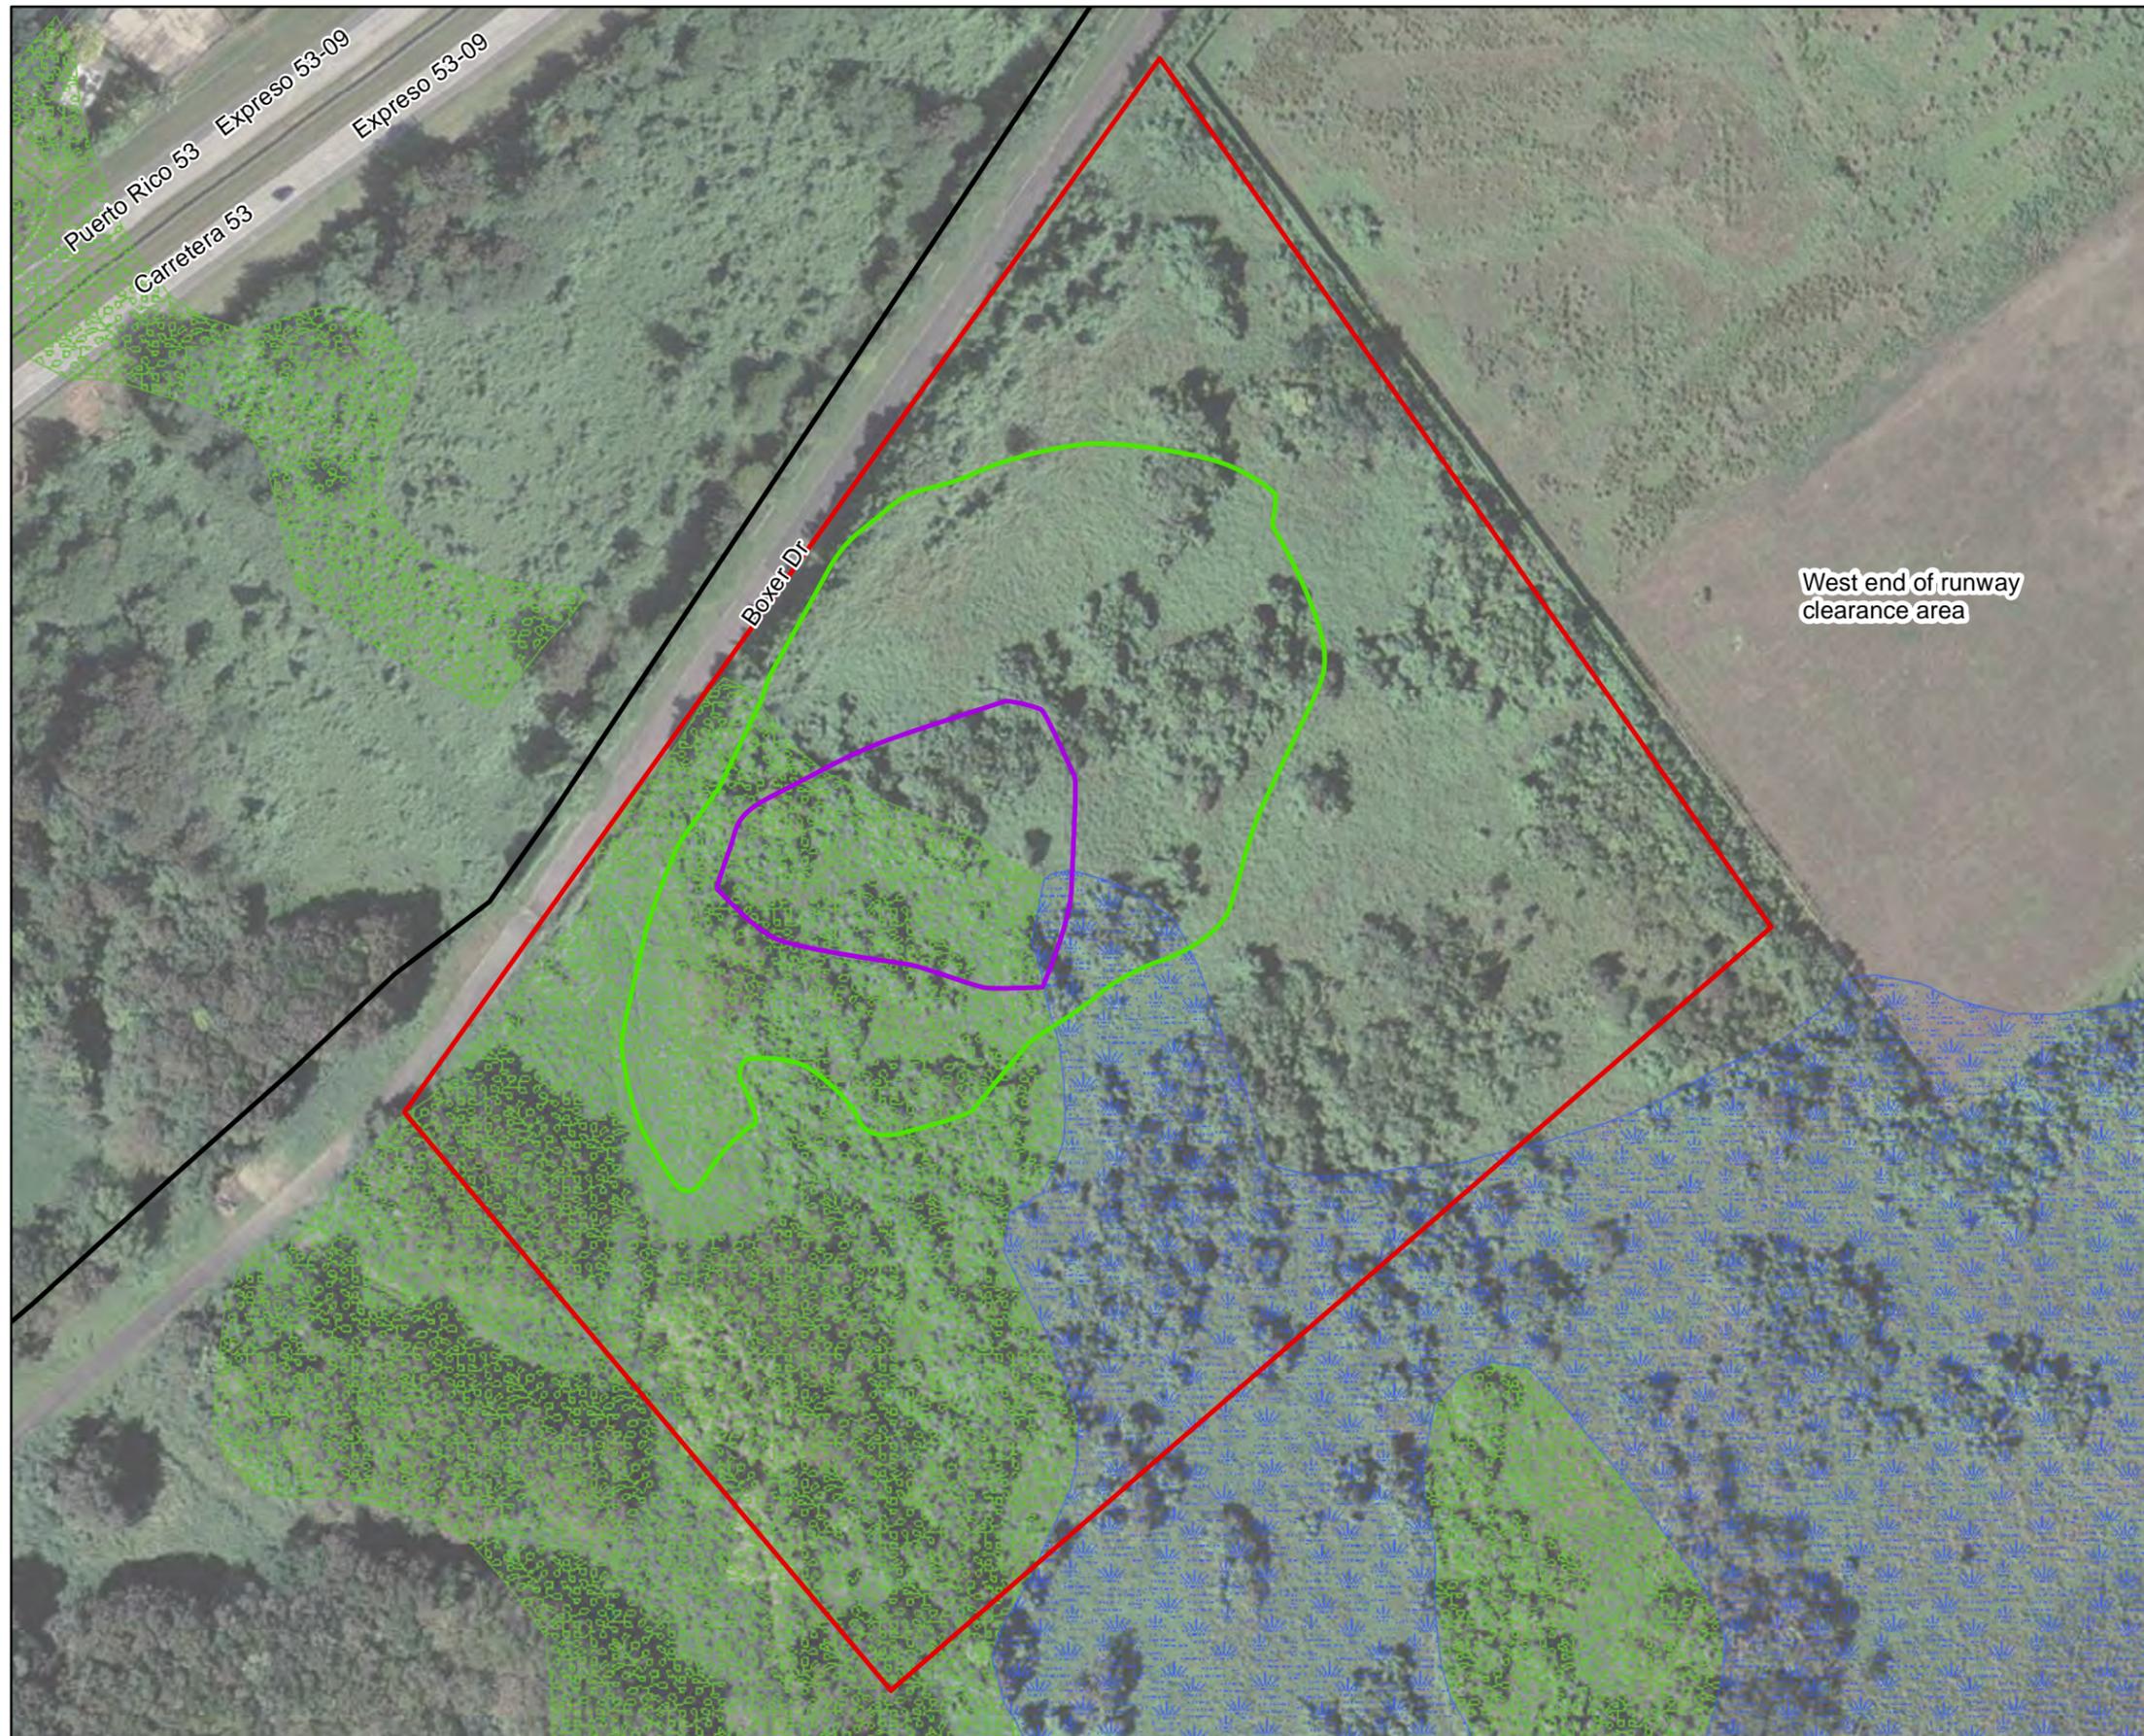
FIGURE 2
SWMU 68 Vicinity
Naval Activity Puerto Rico
(Former Roosevelt Roads Facility)
Ceiba, Puerto Rico

Note:
 Green and Purple boundaries are based on an evaluation of historical aerial photographs showing the portions of SWMU 68 that were clear of vegetation in the respective years

SWMU 68 is located at the southwest end of the former Ofstie Airfield within a flat-lying open area surrounded by secondary growth vegetation (**Figure 1**). The SWMU covers approximately 18 acres and includes portions of a freshwater wetland (**Figure 2**). SWMU 68 was originally identified in 2004 during the Aerial Photography Analysis portion of the ECP. Aerial photographs taken in 1961 and 1964 revealed a circular, graded area free of vegetation with an aircraft fuselage and two stained areas consistent with a fire training area. Interviews conducted with
