FINAL SITE INSPECTION REPORT FOR SITE 3 PISTOL RANGE MUNITIONS RESPONSE
SITE UXO 001 OUTLYING LANDING FIELD NAS SAUFLEY FIELD FL
5/1/2014
TETRA TECH

**Final
Site Inspection Report
for
Site 3 Pistol Range
Munitions Response Site (UXO 001)
Outlying Landing Field Saufley**

**Naval Air Station Pensacola
Pensacola, Florida**

May 2014

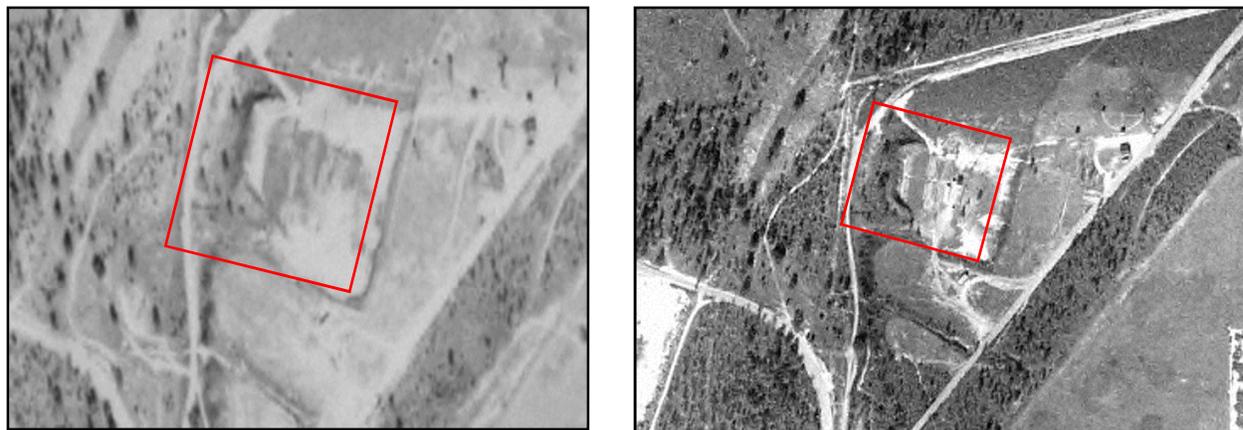
Figure 2-4 – Historical Aerial Photos of Site 3.
The left figure is from 1958 and the right figure is dated 1951.

Historic aerial photographs were used to estimate the site layout and design of the Site 3 Pistol Range (Figure 2-4). Munitions most likely to be found at the site are limited to small arms ammunition and from 12, 16, and 20 gauge and .410 caliber shotguns. Information used to define the general layout of pistol ranges and areas that may be impacted with MC was gathered from the Interstate Technical and Regulatory Council (ITRC) Guidance document titled "Characterization and Remediation of Soils at Closed Small Arms Firing Ranges" (IRTC, 2003) and site visits. The Site 3 - Pistol Range most likely included a primary impact berm, a range floor, and side berms.

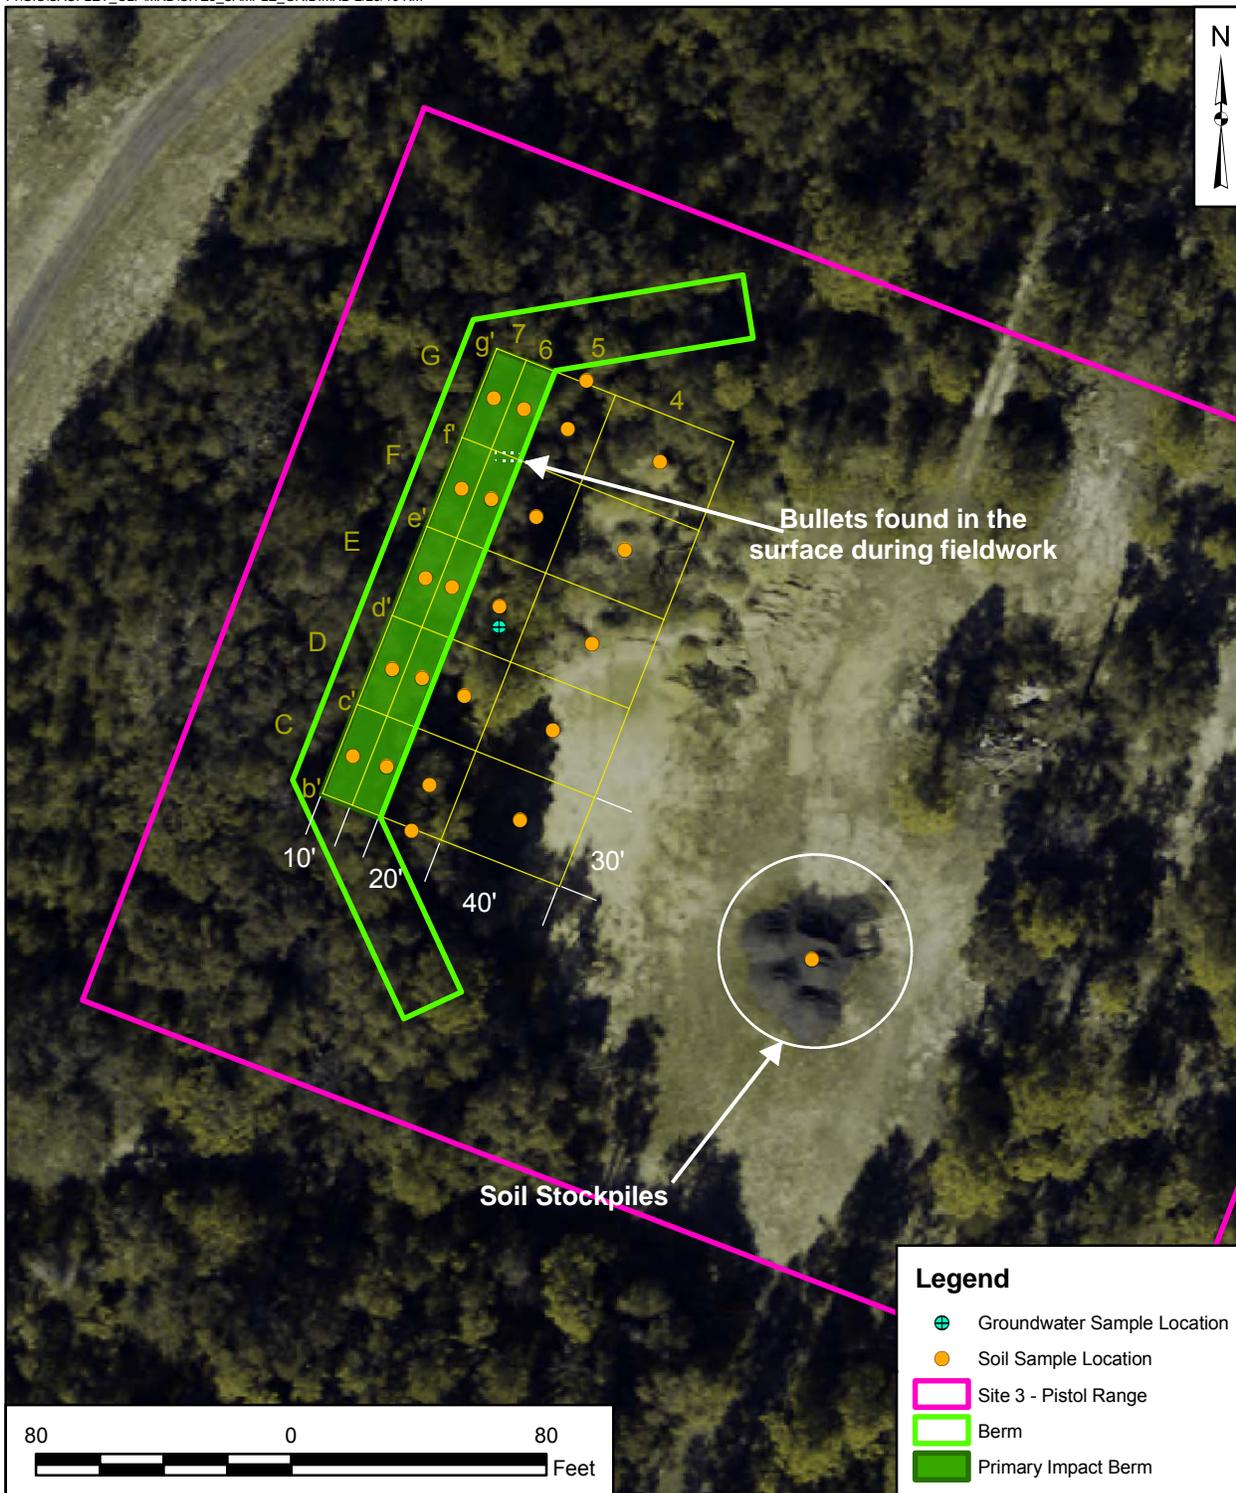
During sample collection activities, the soil material was visually inspected in the field for the presence of bullets or bullet fragments. The soil material was again visually monitored in the field laboratory during processing for XRF analysis. Bullets or bullet fragments were not observed in any of the sample material at the Site 3 Pistol Range. However, bullet fragments were observed on the ground surface in the central portion of the site near grids F6 and G6, as shown on Figure 3-1.

A total of 47 discrete surface and subsurface soil samples were collected from 23 locations at the Site 3 - Pistol Range (Figure 3-1). Two intervals of interest were collected from each soil boring location (0 to 0.5 foot and 0.5 to 2 feet bgs). Soil samples were collected at each grid location in accordance with SOP 05 and SOP-06 (TtNUS, 2009). A clean decontaminated stainless steel hand auger was used to conduct each soil boring and collect a soil sample from each sample interval. Each soil sample was placed in a Ziploc® bag and thoroughly homogenized.

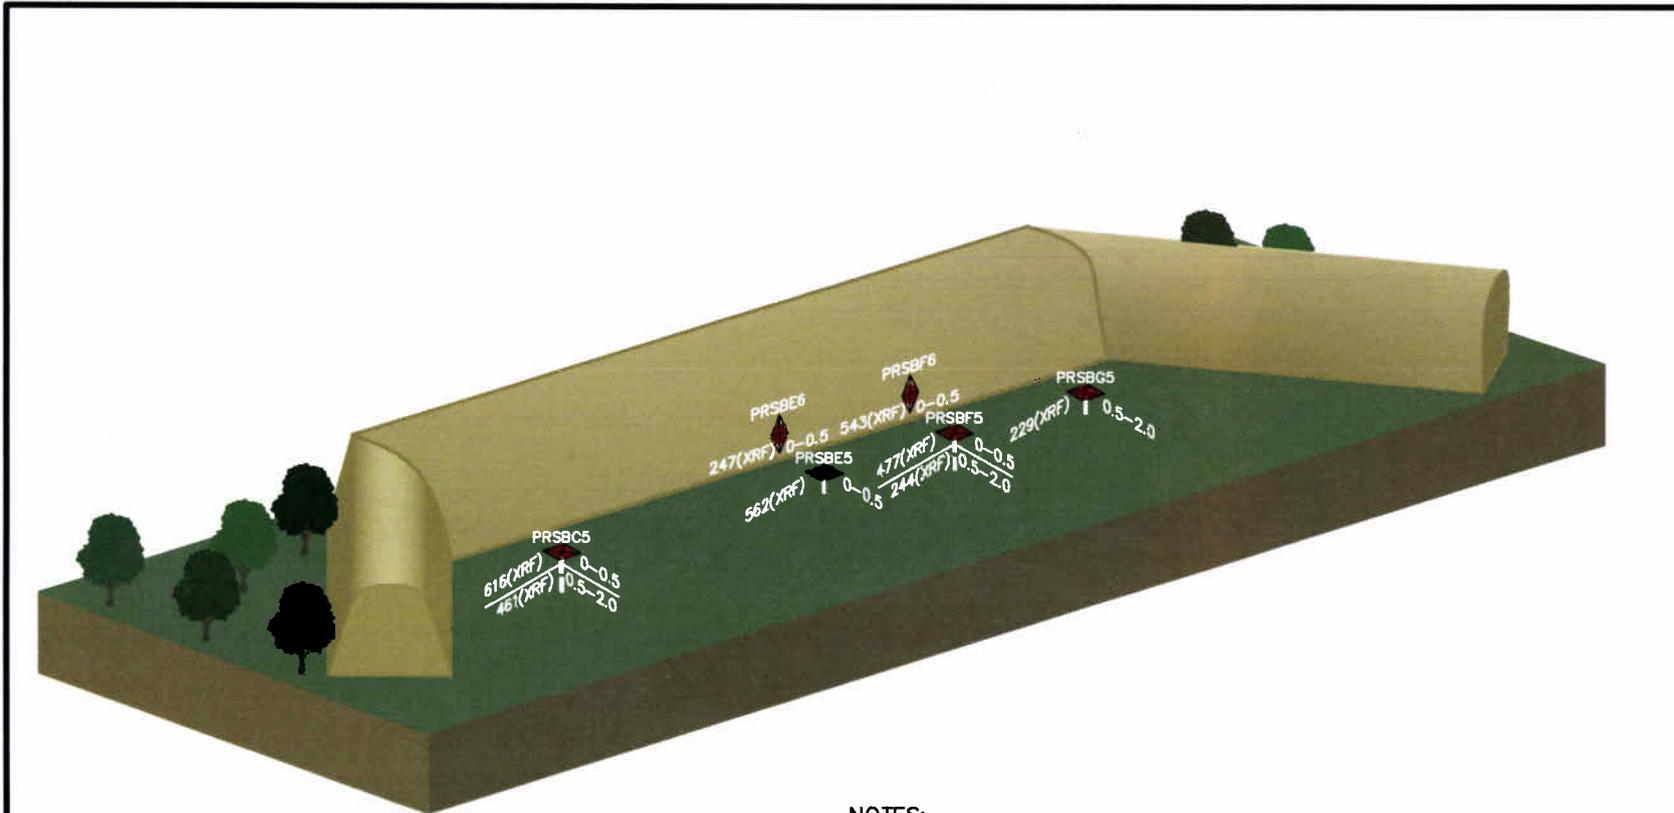
CONTRACT NO. 2352	
OWNER NO.	
APPROVED BY	DATE
DRAWING NO. FIGURE 4-1	REV. 0

**XRF LEAD FIELD SCREENING
EXCEEDANCES IN SURFACE SOIL
SITE 3 - PISTOL RANGE
OLF SAUFLEY
PENSACOLA, FLORIDA**

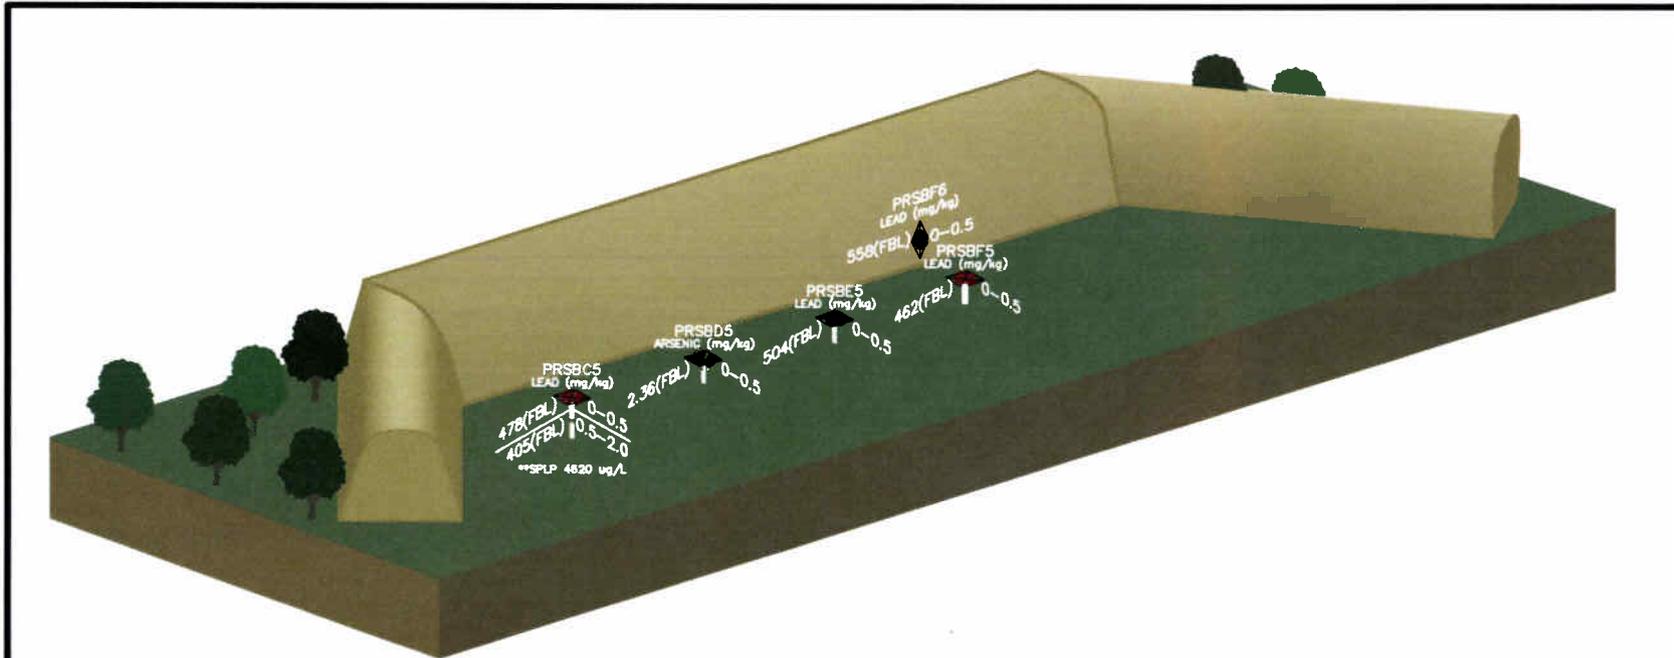
FDEP = FLORIDA DEPARTMENT OF ENVIRONMENTAL PROTECTION
 SCTL = RESIDENTIAL SOIL CLEANUP TARGET LEVEL, CHAPTER 62-777
 FLORIDA ADMINISTRATION CODE (FAC)
 GCTL = GROUNDWATER CLEANUP TARGET LEVEL, CHAPTER 62-777, FAC
 PRSB## = PISTOL RANGE SOIL BORING AND SAMPLE NUMBER
 FBL = FIXED-BASE LAB
 **SPLP = SYNTHETIC PRECIPITATION LEACHING PROCEDURE
 FDEP RESIDENTIAL SCTL FOR ARSENIC = 2.1 MILLIGRAMS PER KILOGRAM (mg/kg)
 FDEP RESIDENTIAL SCTL FOR LEAD = 400 mg/kg
 FDEP GCTL FOR SPLP LEAD = 15 MICROGRAMS PER LITER (ug/L)

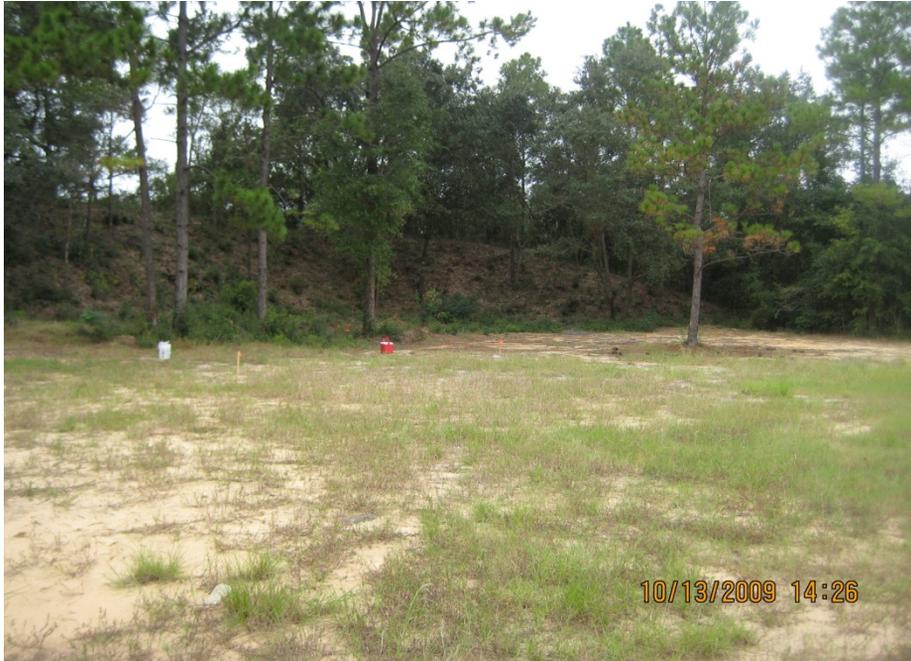
1
10/13/09

DESCRIPTION: Overall view of the pistol range berm
(in photo background).

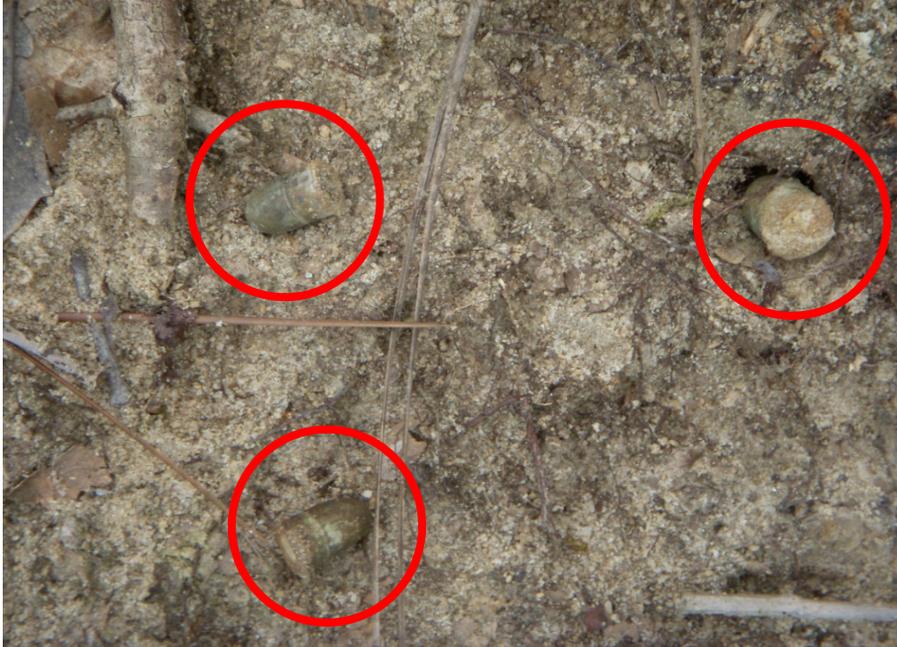
3
10/13/09

DESCRIPTION: Bullets within the range berm.

- The bullets/bullet fragments observed at the site serve as a potential source of lead in soil; therefore, removal of the bullets/bullet fragments was completed.

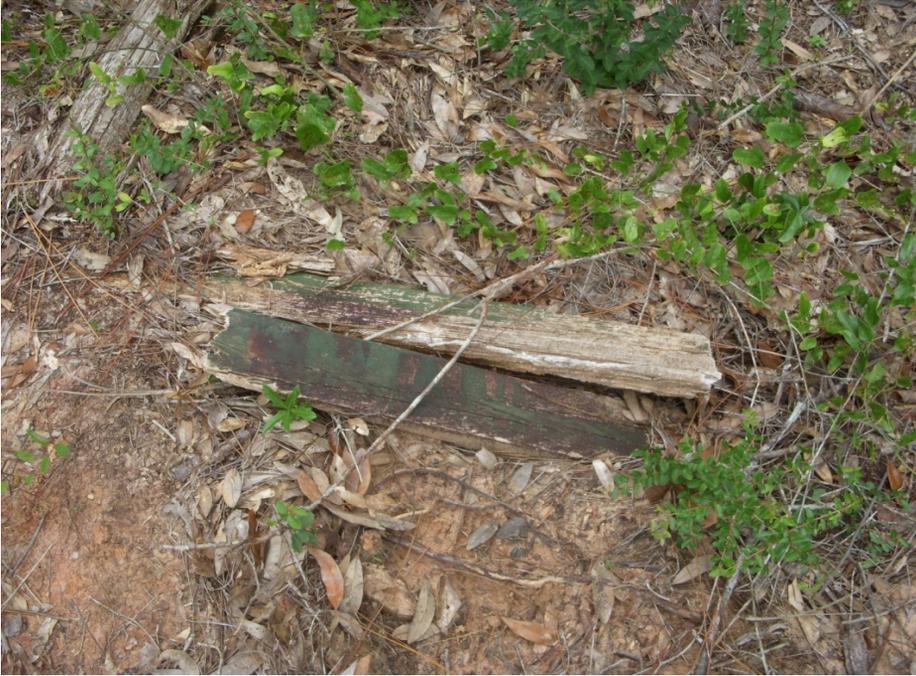
5
10/13/09

DESCRIPTION: Wooden remnants of pistol range target holders.

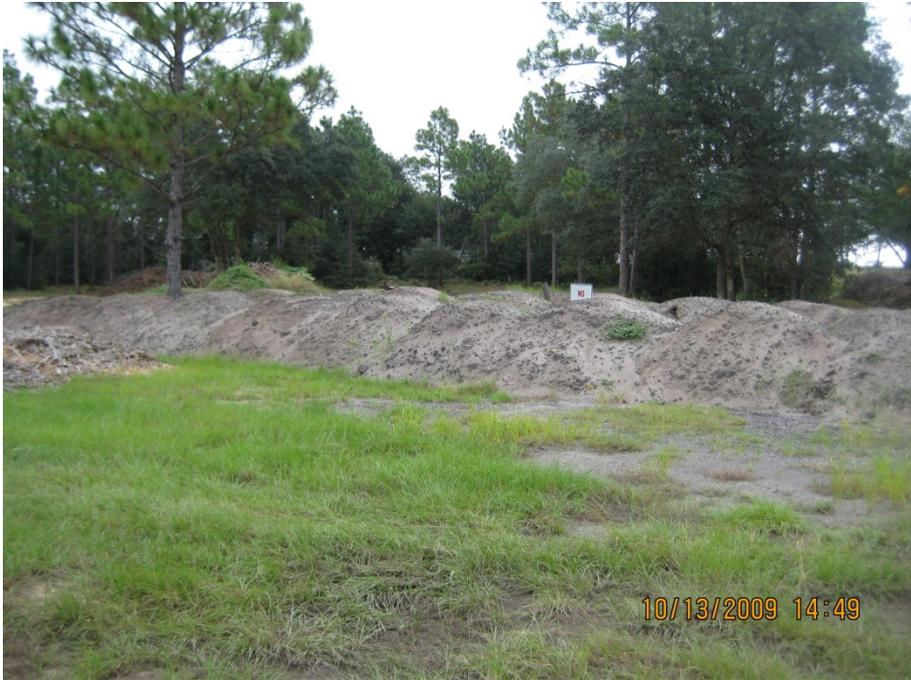
7
10/13/09

DESCRIPTION: Soil stockpiles located just east of site.

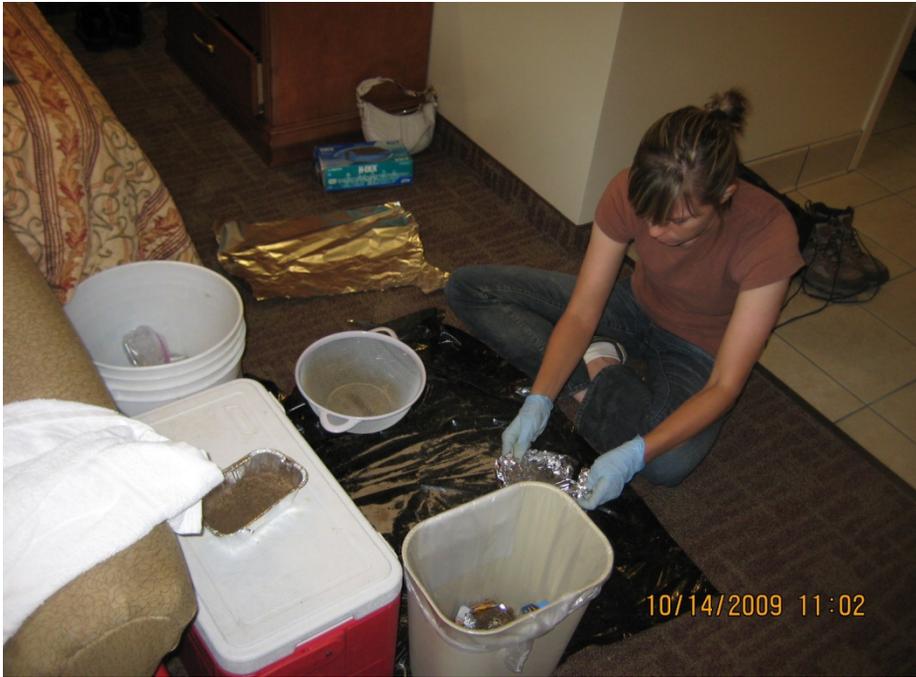
9
10/14/09

DESCRIPTION: Sieving of soil samples.

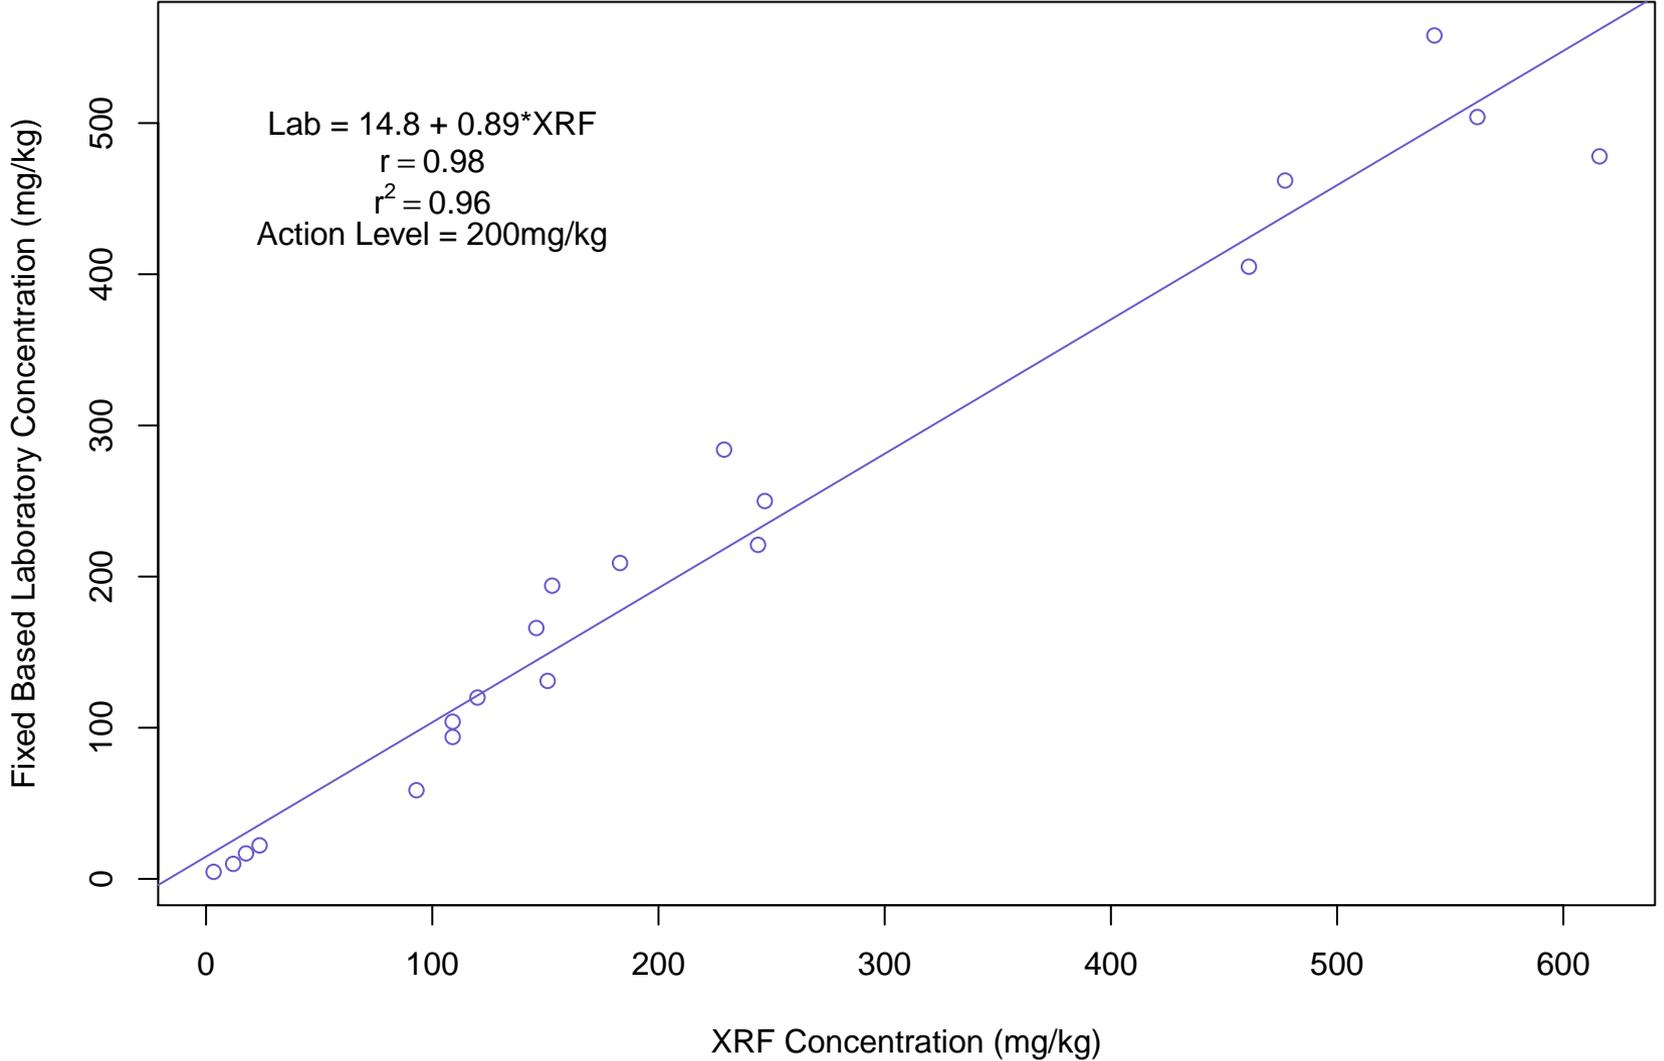
Figure 1 is a scatterplot of the Average XRF Lead results and the Laboratory lead results for each sample. From the scatterplot, a strong positive linear trend is evident. The correlation between the fixed based laboratory concentrations and the XRF is 0.98. The correlation always falls between -1 and 1. Values of r near 0 indicate a very weak linear relationship. The strength of the linear relationship increases as r moves away from 0 toward either -1 or 1. Values of r close to -1 and 1 indicate that the points lie close to a straight line. The extreme values -1 and 1 occur only in the case of a perfect linear relationship. So the correlation indicates a strong linear trend. The R-squared value is 96 percent. This value represents the percent of variation in laboratory lead concentrations that can be explained by the lead XRF concentration. An R-Squared value greater than about 80 percent is considered to indicate a very strong relationship between the two measurement methods. The maximum possible value is 100 percent.

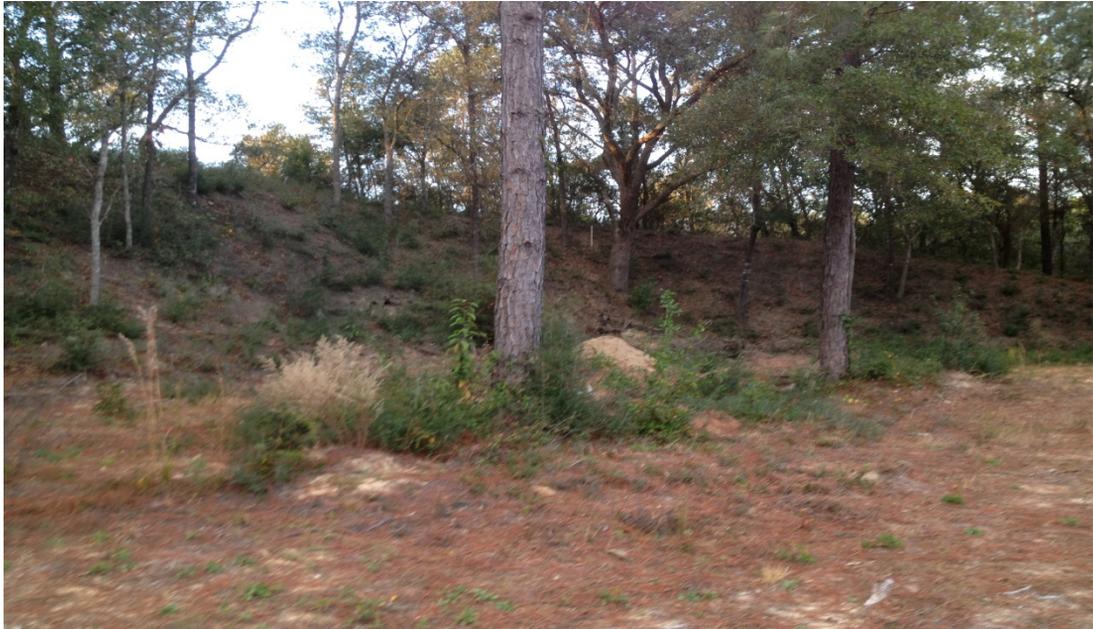
SITE: Saufley Field - Pistol Range Berm	PHOTOGRAPHER: J. Goerd VIEW: North	DESCRIPTION: Northern edge of excavation area prior to initiating excavation of impact berm.	Photo #1 12/4/12
--	--	---	---------------------

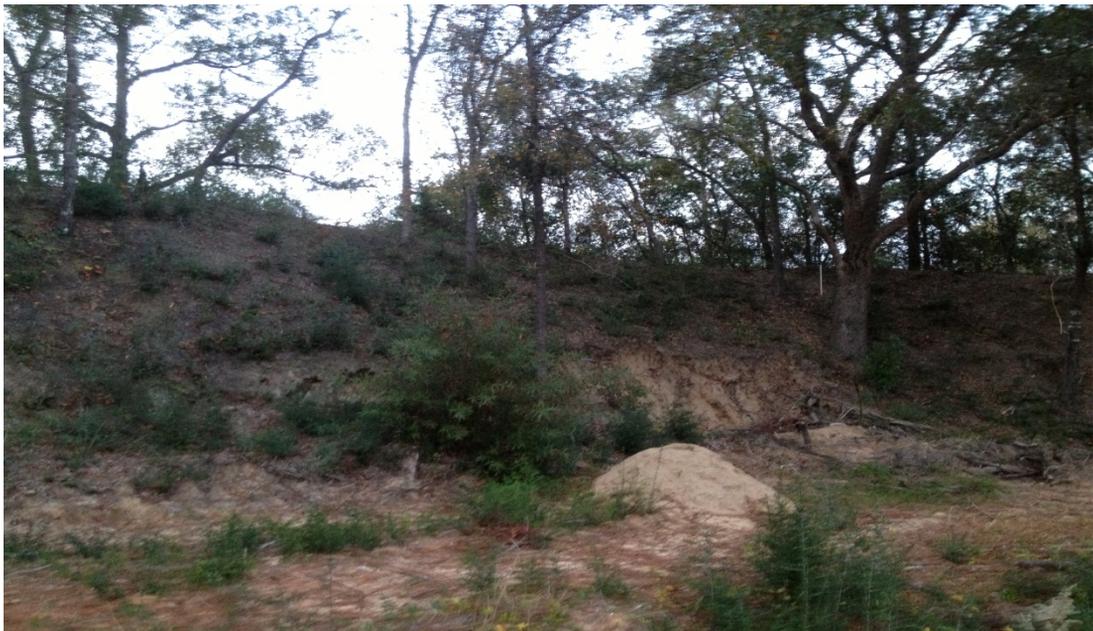
SITE: Saufley Field - Pistol Range Berm	PHOTOGRAPHER: J. Goerd VIEW: North	DESCRIPTION: Close-up view of photo #1. Some sloughing has occurred in this area. Large tree (center right) marks northern-most edge of excavation area.	Photo #2 12/4/12
--	--	---	---------------------

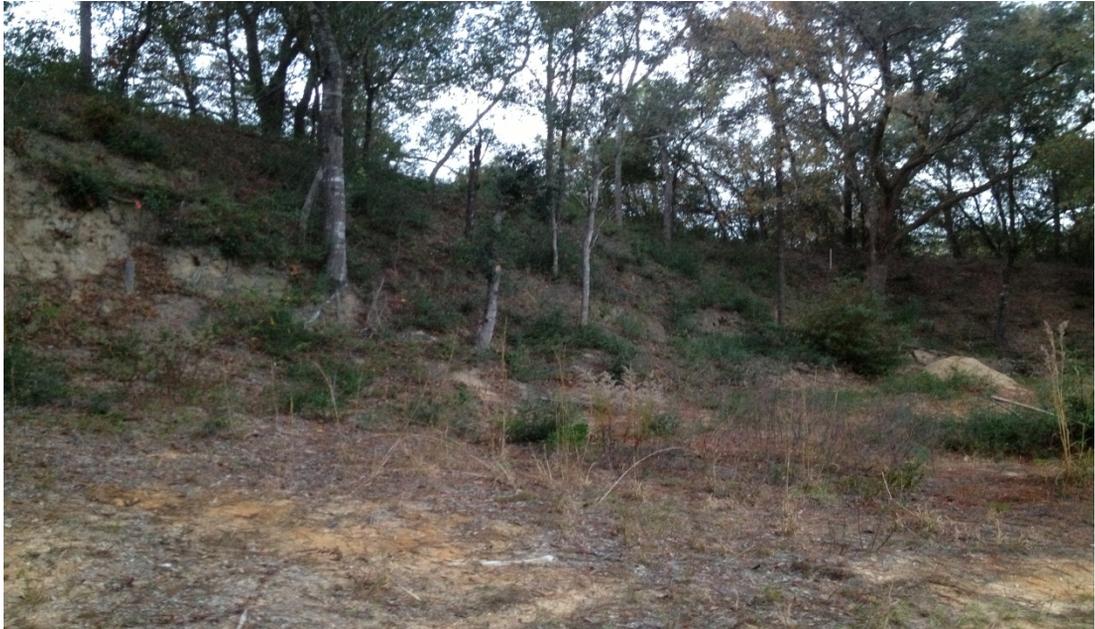
Photo #3
12/4/12

DESCRIPTION: Central and southern edge of excavation area.
Sloughing of berm on left side of photograph.

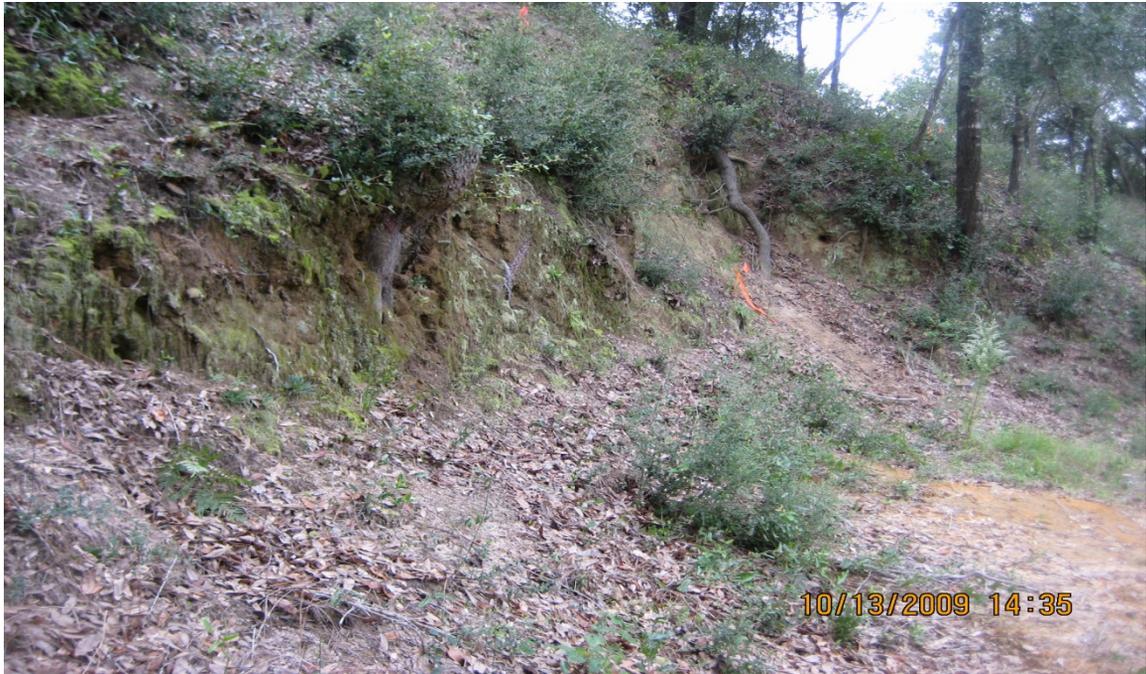
Photo #5
10/13/09

DESCRIPTION: Sloughing along southern edge of berm face.

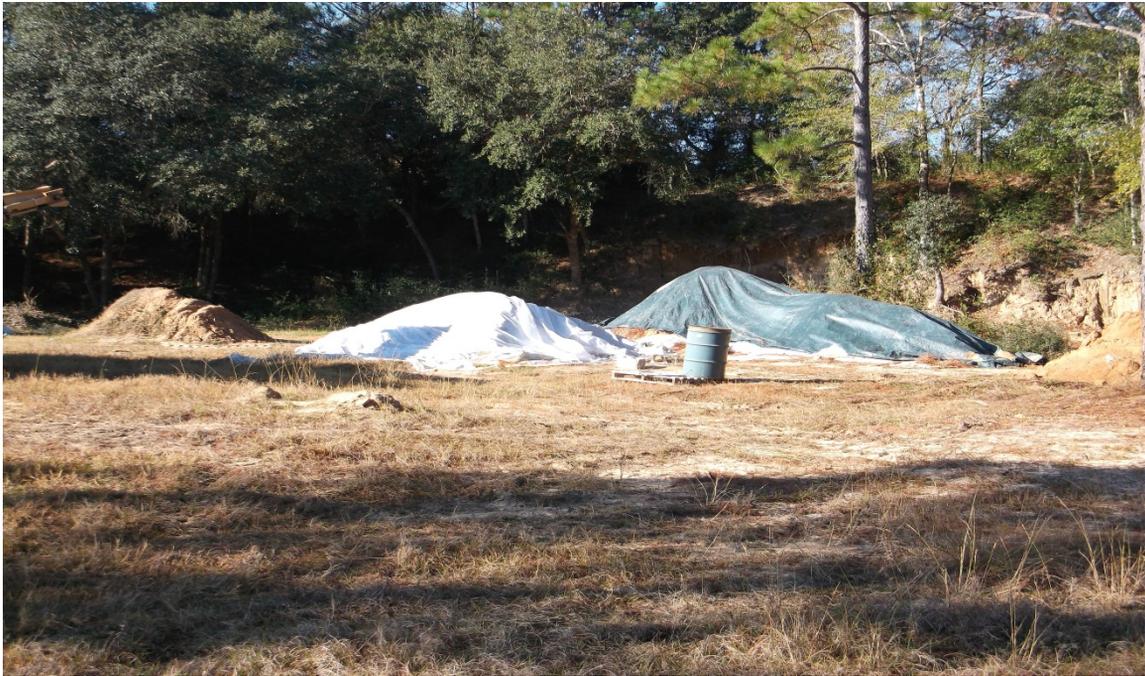
Photo #7
12/19/13

DESCRIPTION: Stockpiled soil excavated from the berm and covered with plastic.

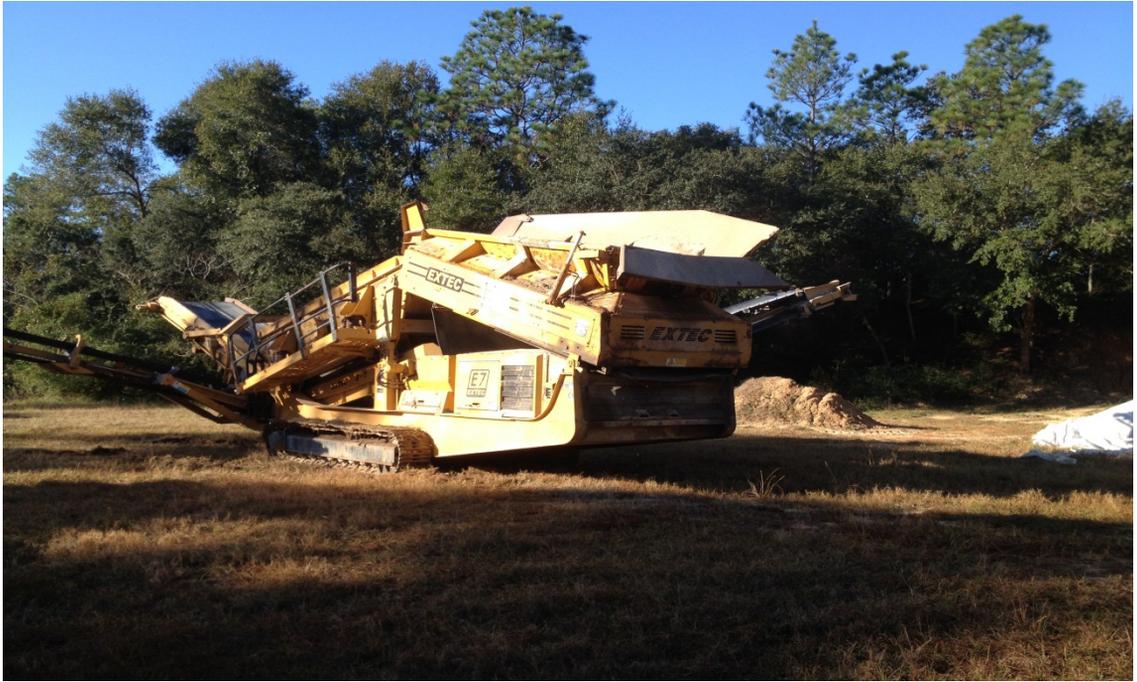
Photo #9
12/19/13

DESCRIPTION: Large soil screener.

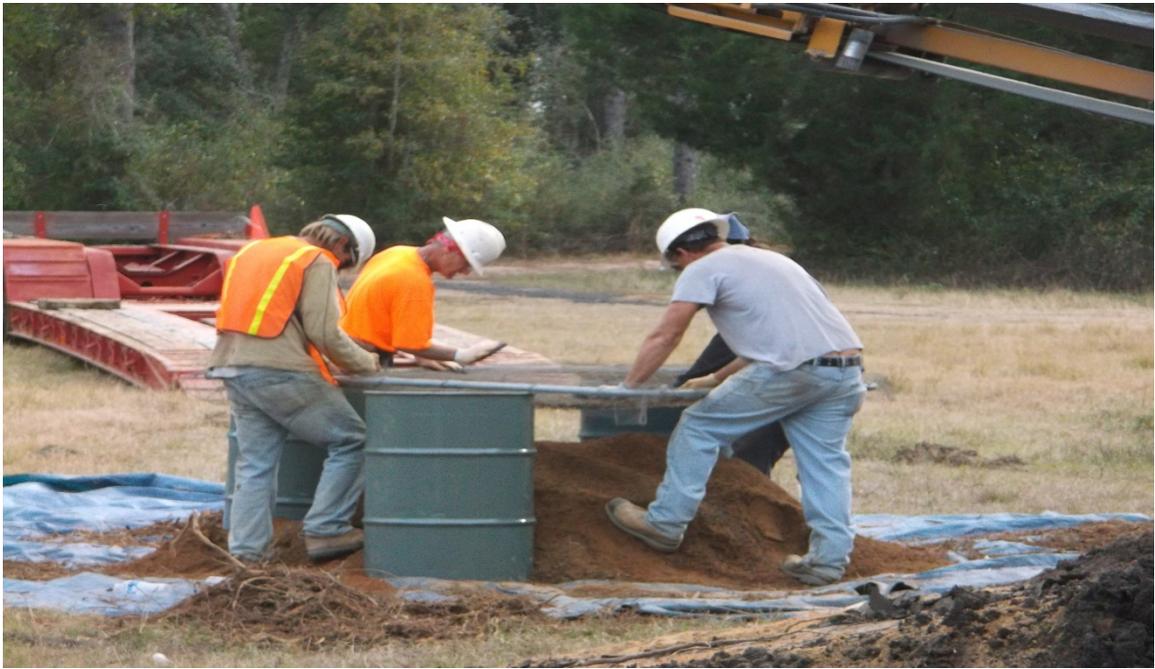
Photo #11
12/19/13

DESCRIPTION: Final hand screening to ensure all bullets, bullet fragments, and casings are removed from soil.

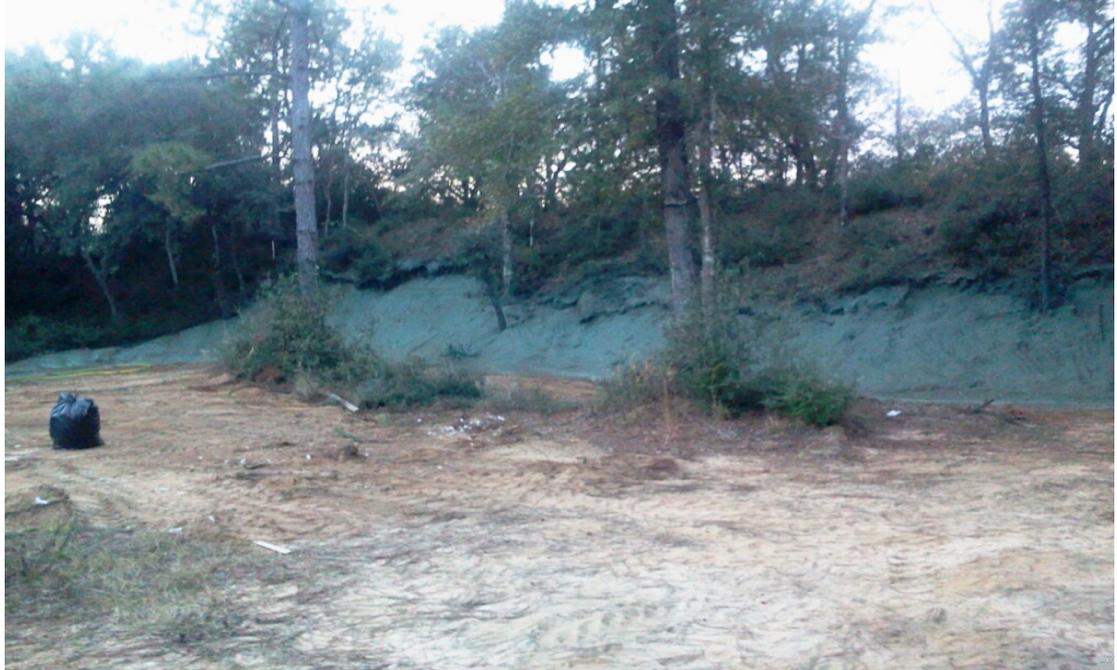
Photo
#13
12/20/13

DESCRIPTION: Geo blanket and hydro seeding of southern
berm face.
