CLOSURE REPORT LUBE OIL TANKS, FUELING PITS, AND FAST FUEL LINES LOCATED  
AT SITE 20B BARIN NAS WHITING FIELD FL  
5/1/1997  
ABB ENVIRONMENTAL

**CLOSURE REPORT**

**LUBE OIL TANKS, FUELING PITS, AND FAST FUEL LINES  
LOCATED AT SITE 20B,  
ABANDONED UNDERGROUND STORAGE TANKS AND  
FUEL PIT AREA**

**OUTLYING LANDING FIELD BARIN  
FOLEY, ALABAMA**

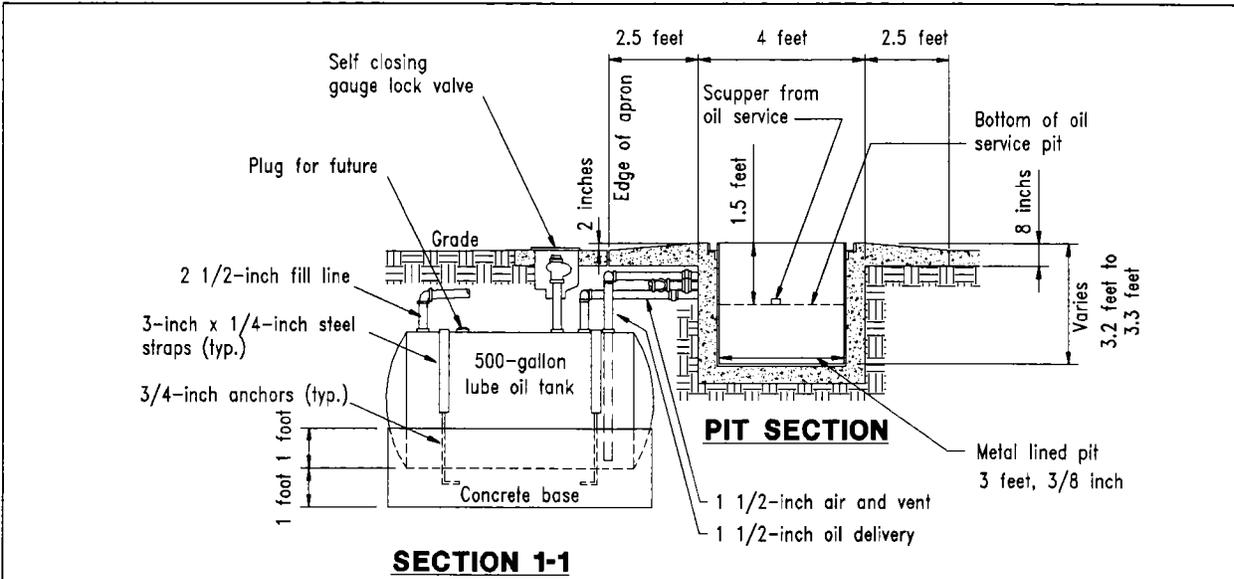
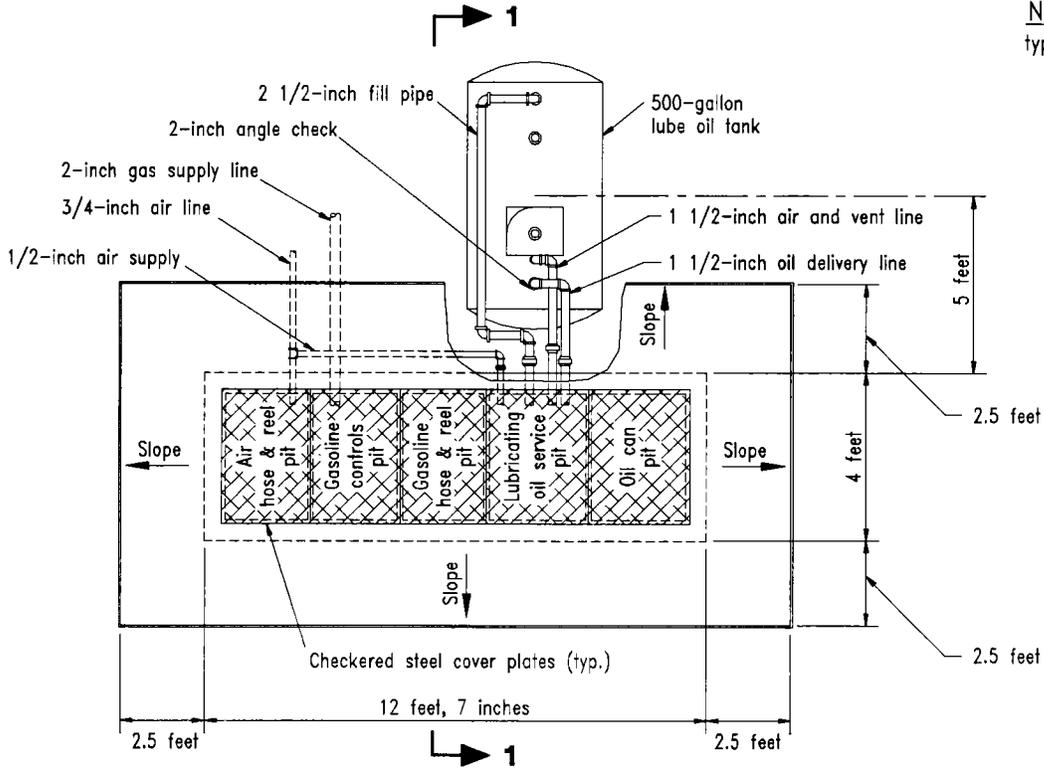
**PLAN OF FUELING PIT AND LUBE OIL TANK**

Because of the number of tanks, length of fuel line, and the elapsed time since they were last used (1950s) it was agreed at the November 1996 meeting that an abbreviated sampling program designed to be representative of site conditions would be implemented. At each of the 30 lube oil tank locations one soil sample was collected from the bottom third of the tank diameter and one soil sample was collected approximately 5 feet below the bottom of the tank. Samples were collected on the east side of the tanks using direct push technology (TerraProbe<sup>SM</sup>). Soil sample locations are shown on Figure 3-1. Figure 3-2 shows typical plan and profile views of a lube oil tank and fueling pit.

**SECTION 1-1**

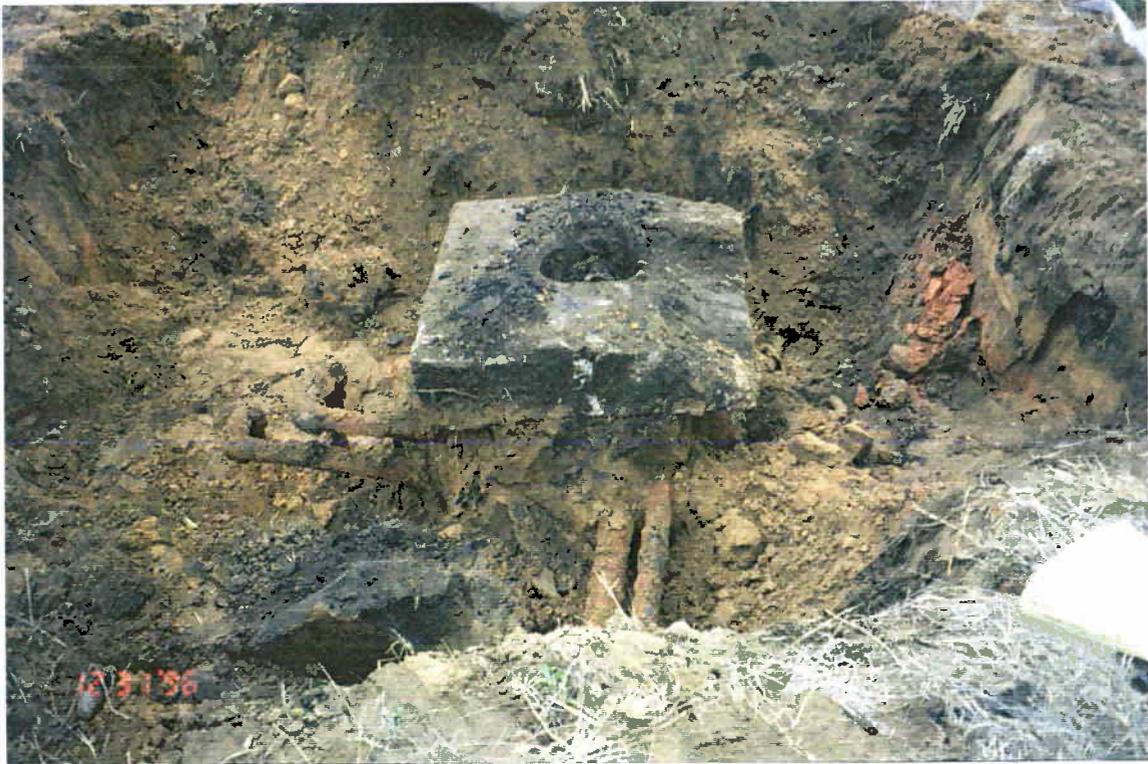
**Photo 1, December 31, 1996  
Piping and Fill Port at Top of Lube Oil Tank**

Thirty LOST were located approximately three feet north of the bowser pits and approximately two feet bgs (Figure 2-3). Each of the 500 gallon capacity LOST were found to contain oily liquids. The soil on top of the LOST was excavated and staged on plastic adjacent to each LOST for sampling. Stockpiles were covered at the end of each day (Appendix A, Photographs 1,2,4).

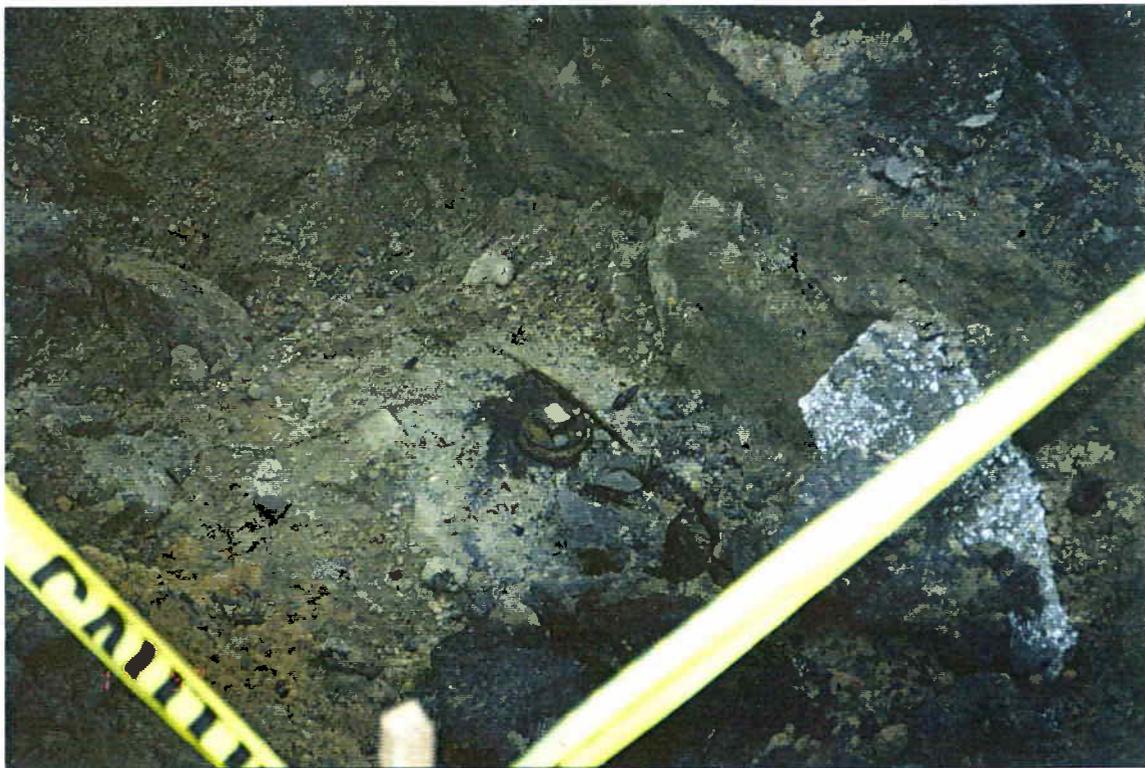
**Photo 2, January 2, 1997  
Plug at End of Lube Oil Tank to be  
Used for Content Removal**

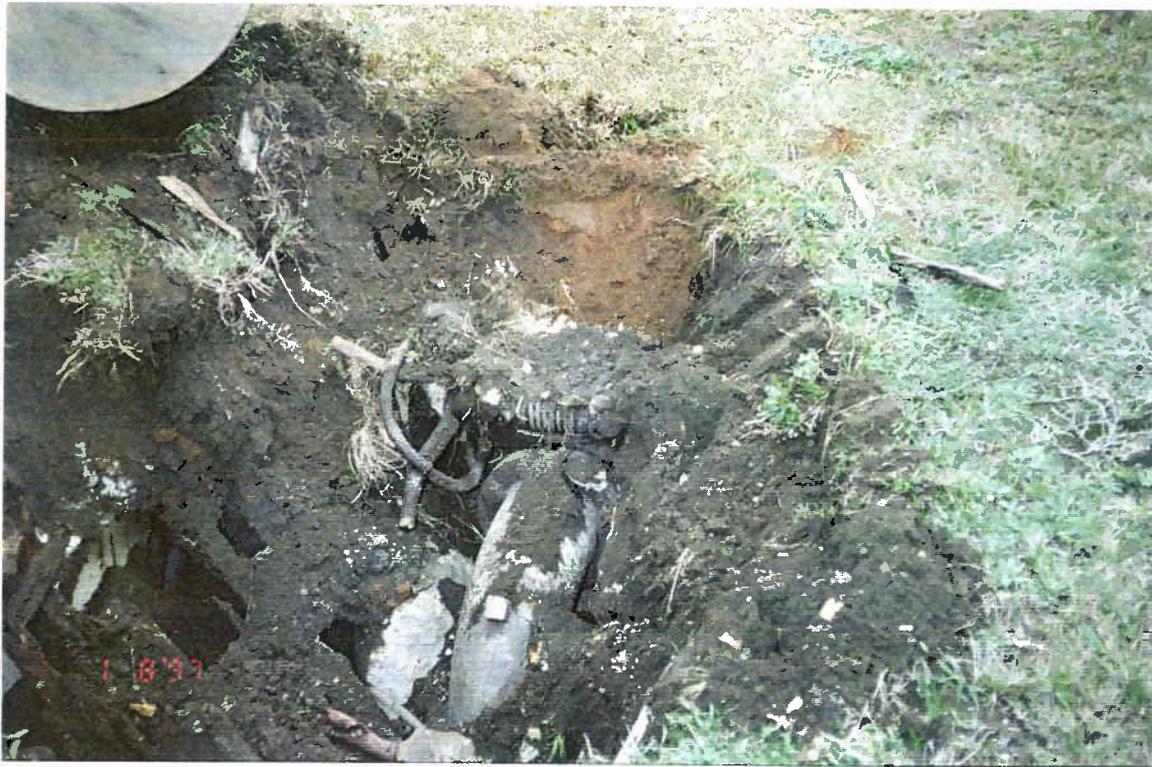
**Photo 3, January 8, 1997**  
**Valve Pit for Fast Fuel Header Backfilled**  
**with Concrete Pipe and Soil**

All bowser pits were covered with metal plate covers and some were filled with soil. All soil was removed and stockpiled on plastic sheeting adjacent to each pit. The bowser pit valves needed to be in the closed position before the FFL could be drained and cleaned so each bowser pit was inspected to ensure that the valve to the FFL was operable. The valve in pit #1 was not operable and was replaced with a two inch pipe cap. Appendix A, photographs 3, 6, 9 and 10 show some of these activities.

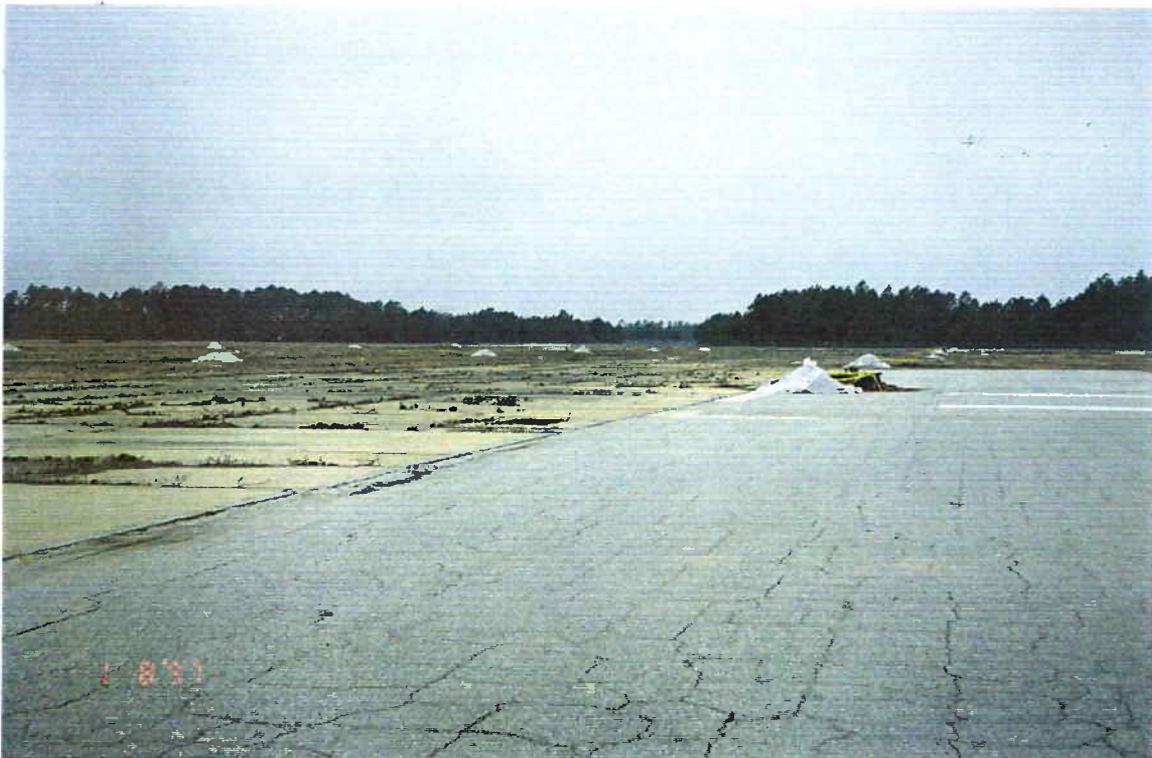
**Photo 4, January 8, 1997**  
**Overview of Area where Top of Lube Oil Tanks**  
**was Uncovered**

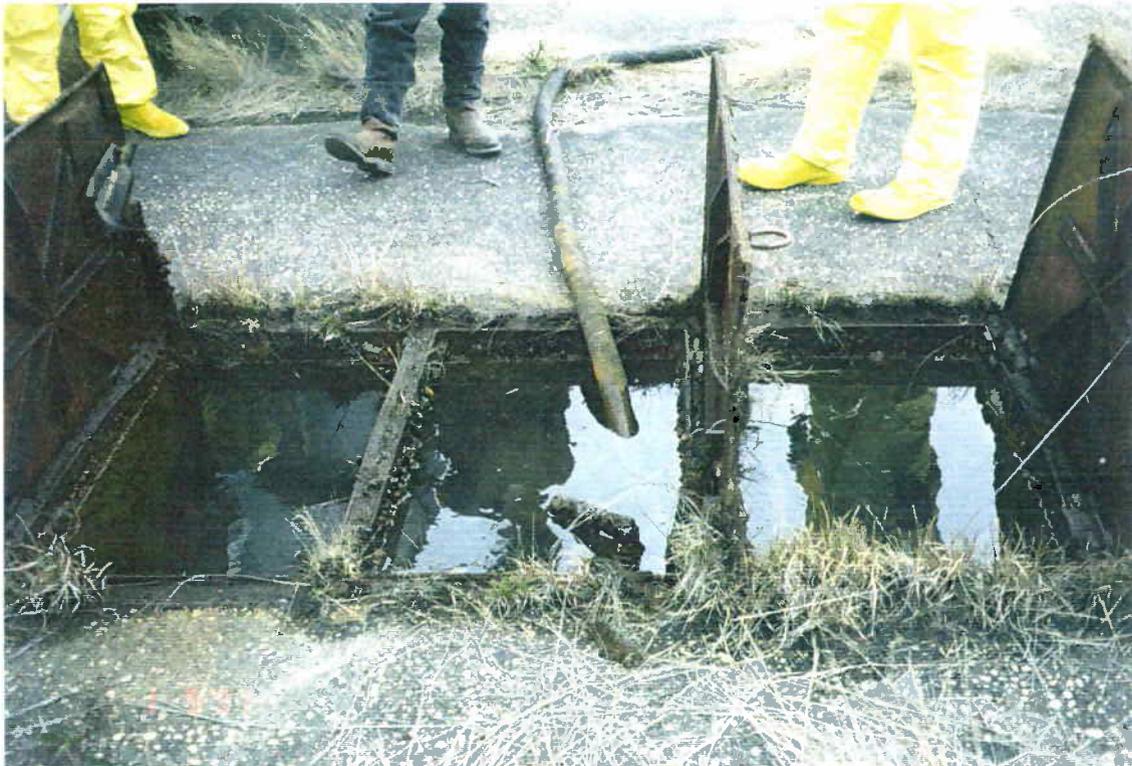
**Photo 5, January 9, 1997  
Vacuum Truck Removing Liquids from  
Bowser Pits**

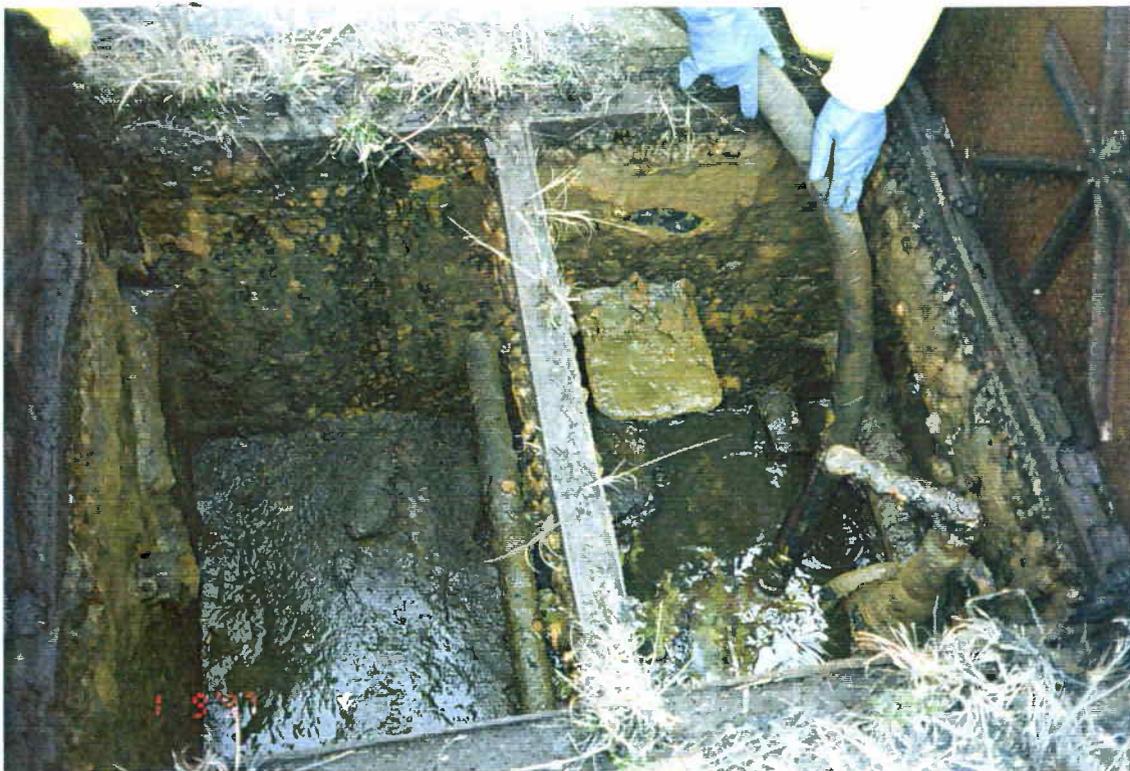
**Photo 6, January 9, 1997  
Bowser Pit after being Pumped out**

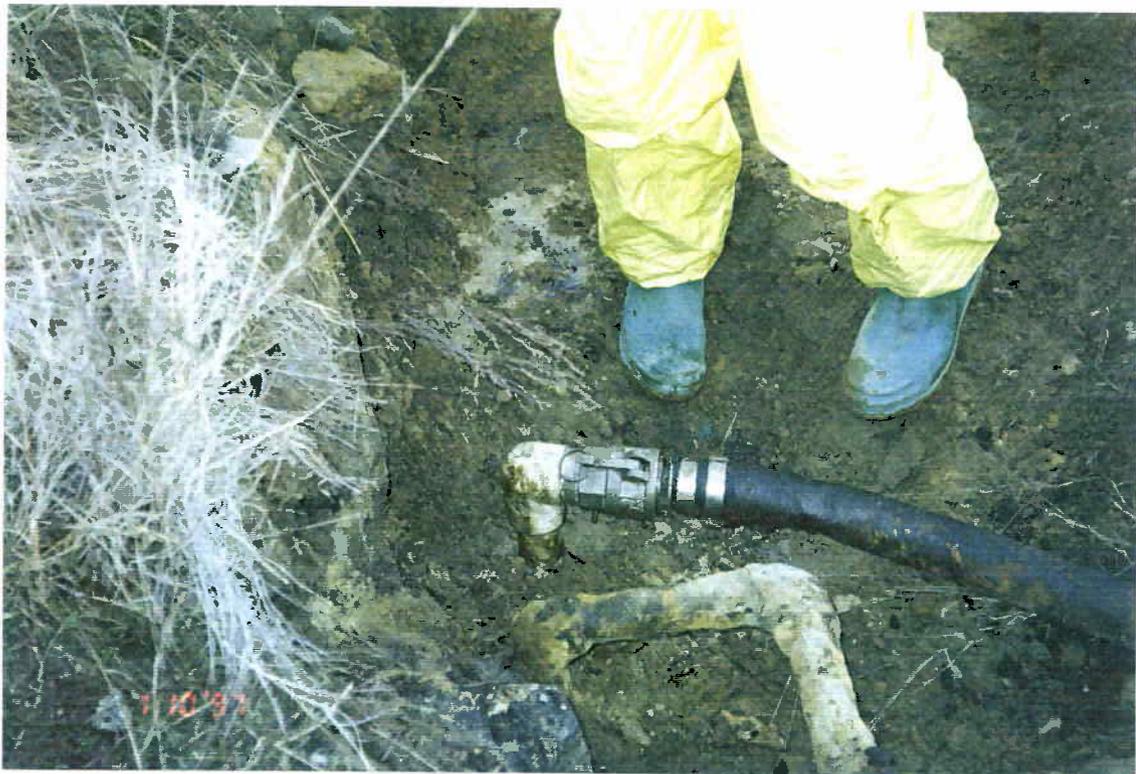
**Photo 7, January 10, 1997  
Lube Oil Tank Contents being Removed by  
Vacuum Truck**

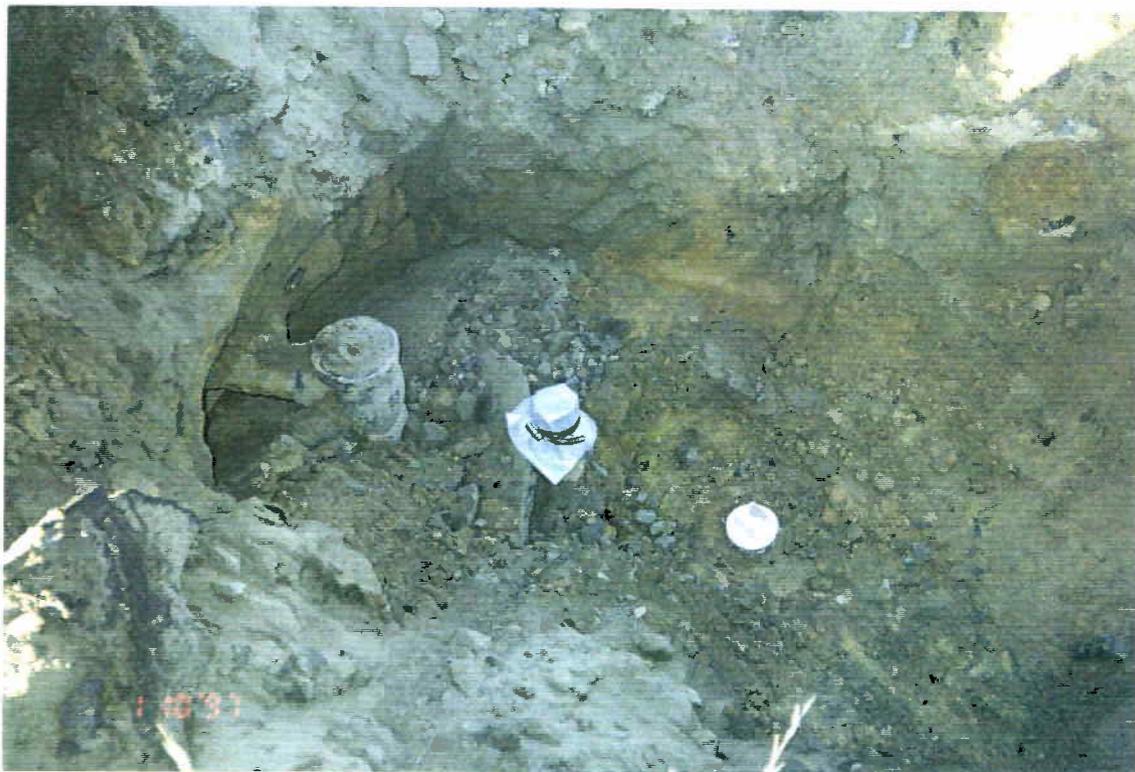
**Photo 8, January 10, 1997  
Capped and Plugged Lube Oil Tank after  
Contents Removed**

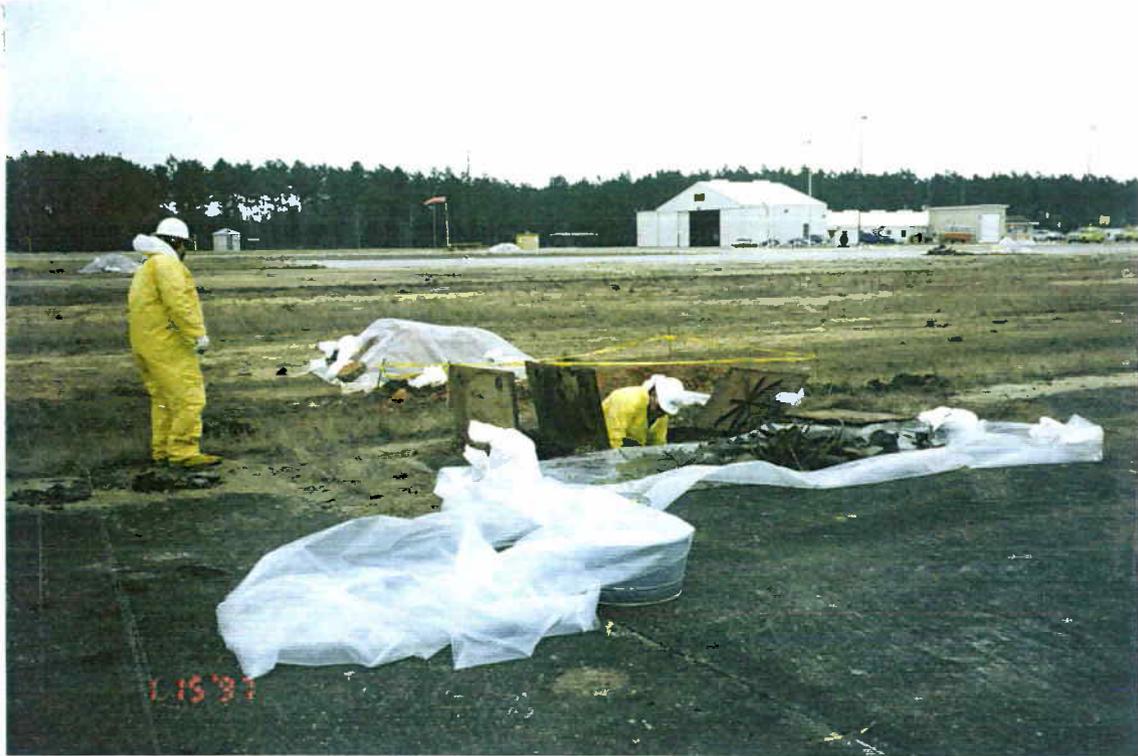
**Photo 9, January 15, 1997  
Kemron Employees Removing Material from  
a Bowser Pit**

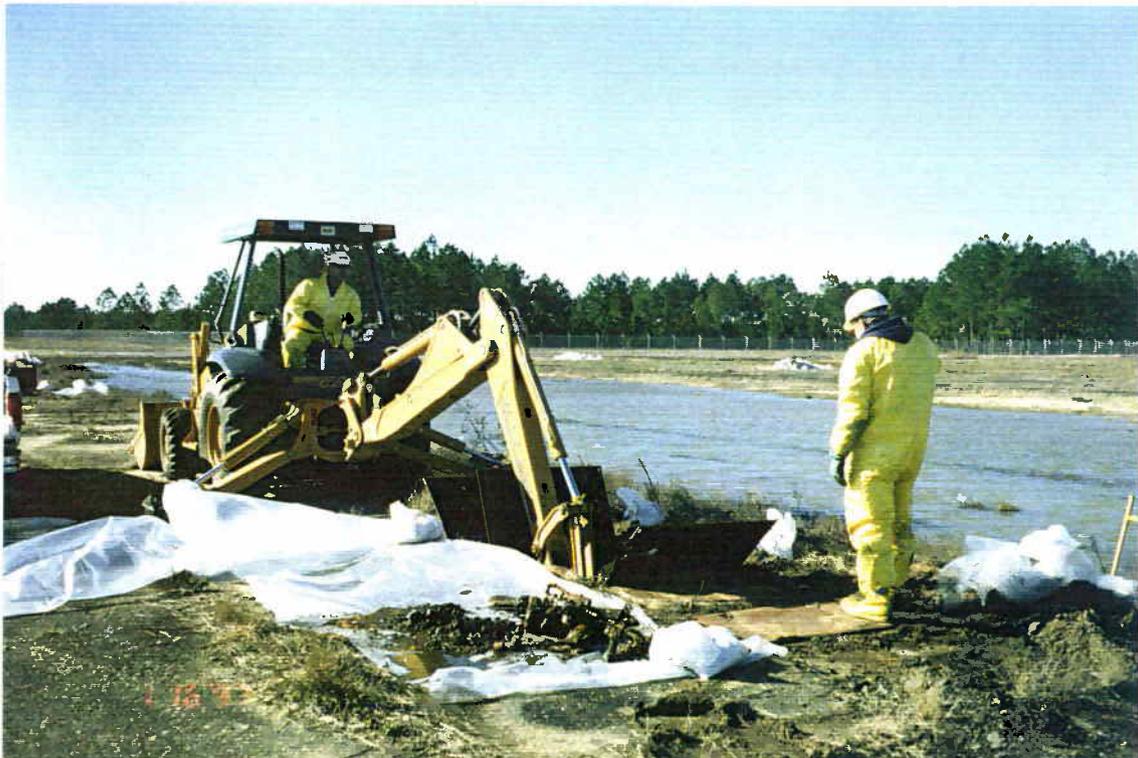
**Photo 10, January 16, 1997  
Case Backhoe Removed Material from  
Bowser Pit # 48**

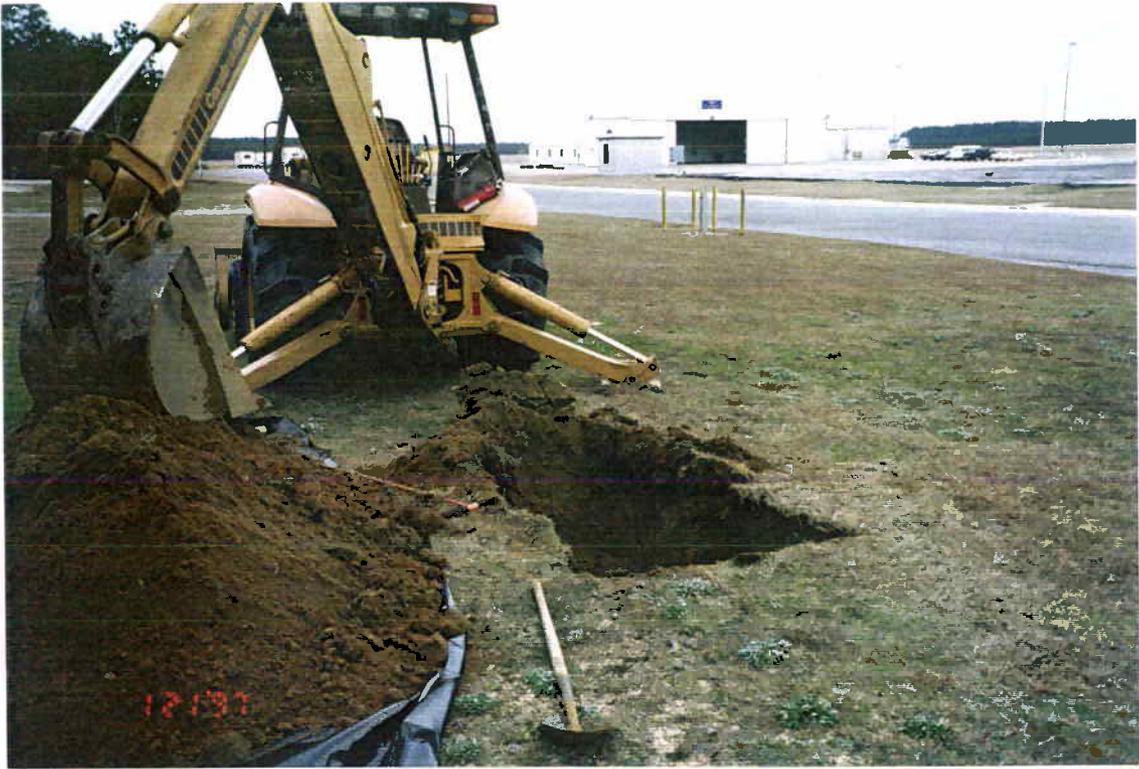
Photo 11, January 21, 1997  
4th Excavation North of Guadalcanal Rd. NE of  
Gasoline Filling Pit

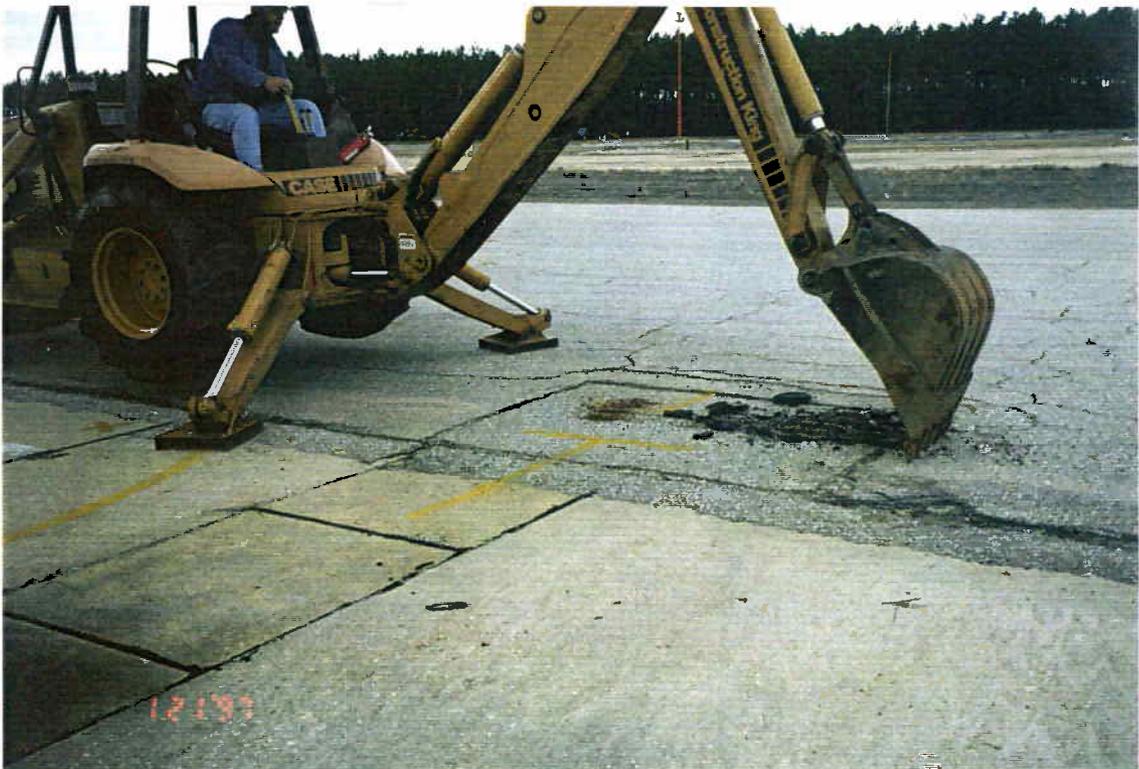
Photo 12, January 21, 1997  
5th Excavation, Break in Line Indicated with Yellow  
Paint, Backhoe Begins to Break Asphalt at 23 & 24

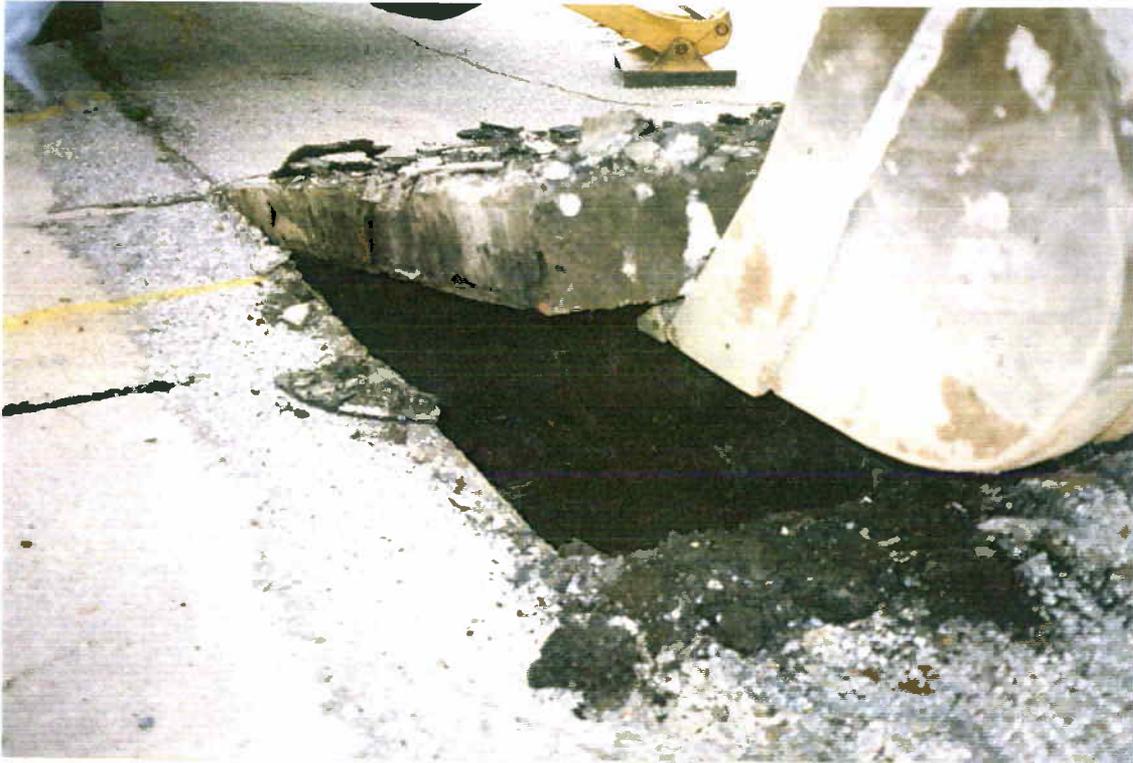
Photo 13, January 21, 1997  
Inside of Concrete Pit. During 5th Exploratory  
Excavation between Stations 23 &24

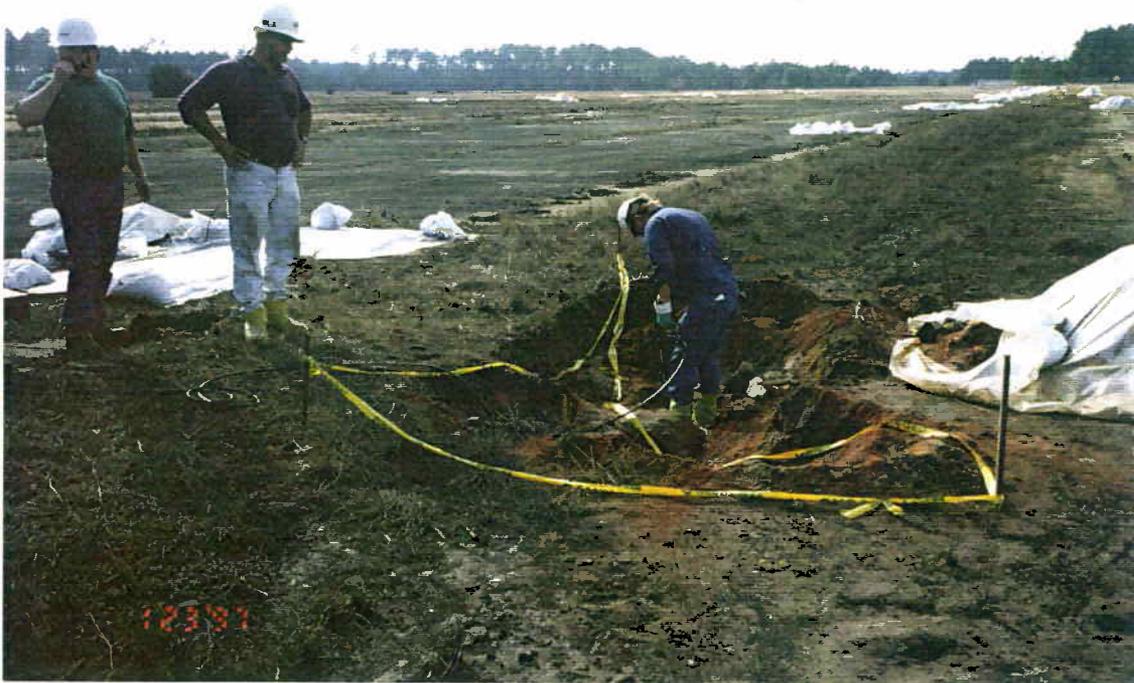
Photo 14, January 23, 1997  
Tank Cleaning Process

Once the LOSTs were emptied, a pressure washer with a biodegradable detergent solution, Simple Green™, was used to remove residual product from the interior of the tank. The rinse water was pumped into the frac tank. The LOSTs were cleaned as described in the MK Work Plan Section 4.2.3, until the interior atmosphere had a lower explosive level (LEL) less than 10%, an oxygen level between 19.5% and 23.5%, an organic vapor concentration less than 10 parts per million (ppm) [by photo ionization detector (PID)], and a visually clean interior [MK, 1996]. Photograph 14 in Appendix A shows the tank cleaning activity.

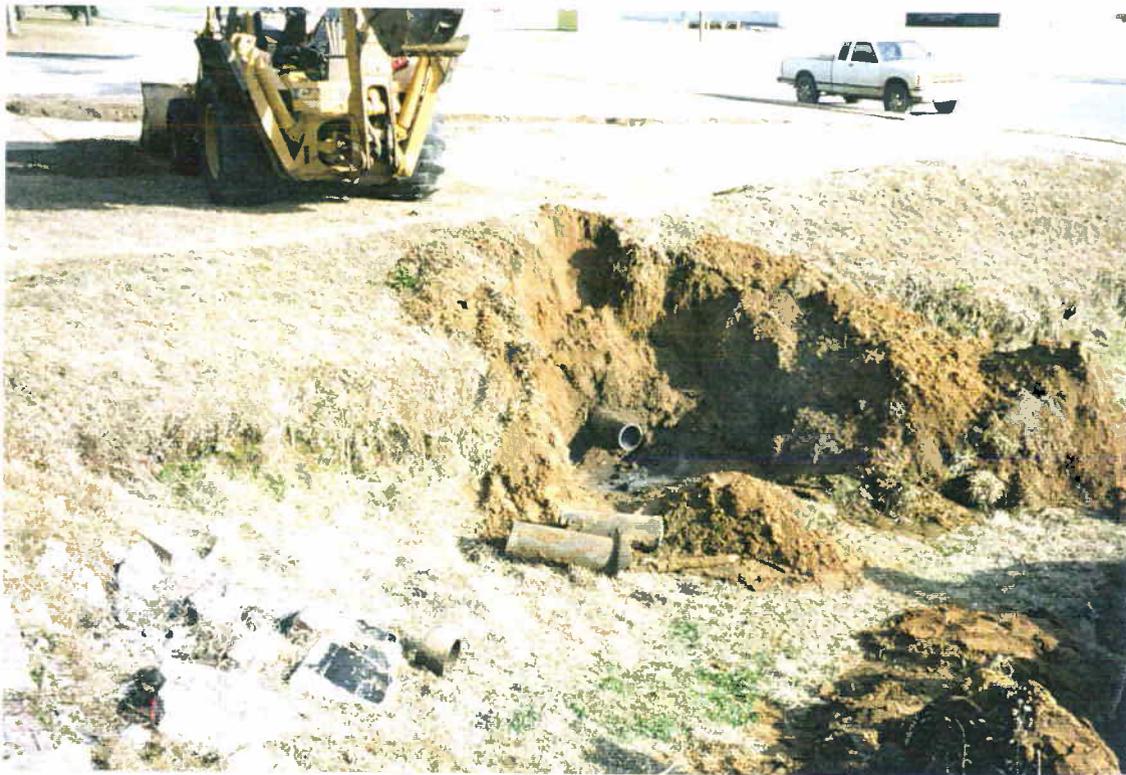
**Photo 15, January 24, 1997**  
**Fast Fueline Pipe after Cut is Complete**

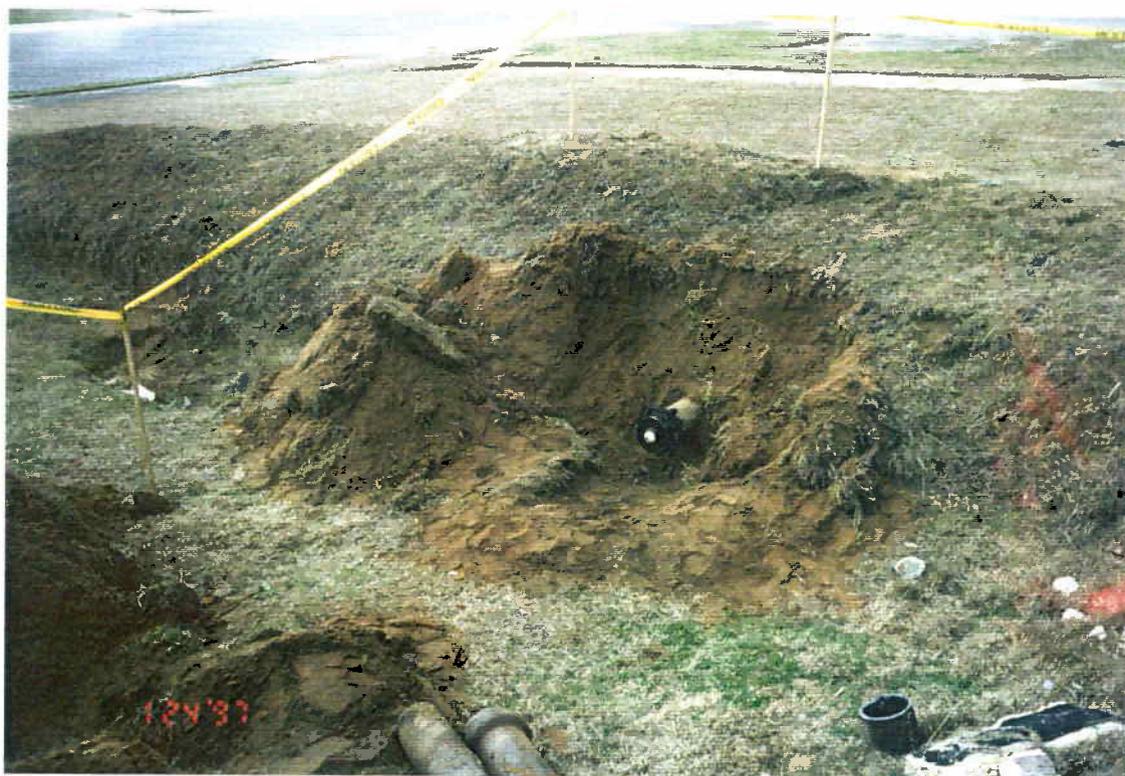
**Photo 16, January 24, 1997**  
**Kemron Finishes Putting Fittings on End of Pipes**

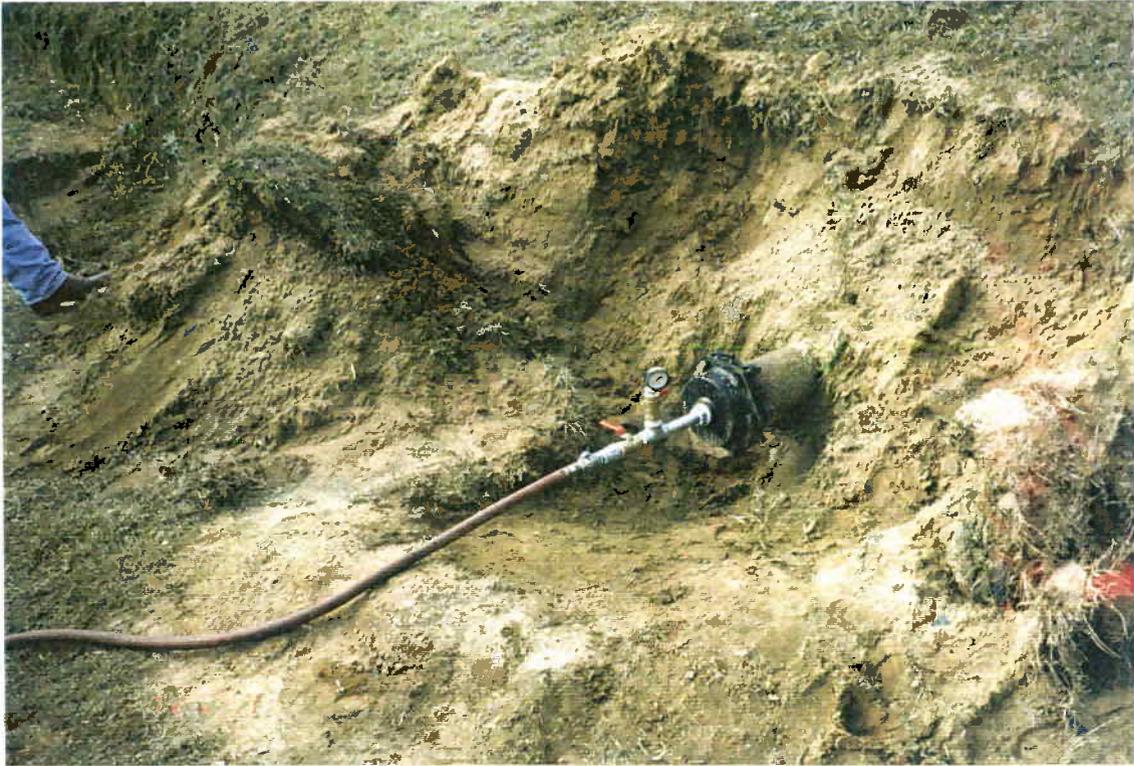
**Photo 17, January 27, 1997  
Apparatus Attached to Conduct Air Test  
of Fast Fuel Line**

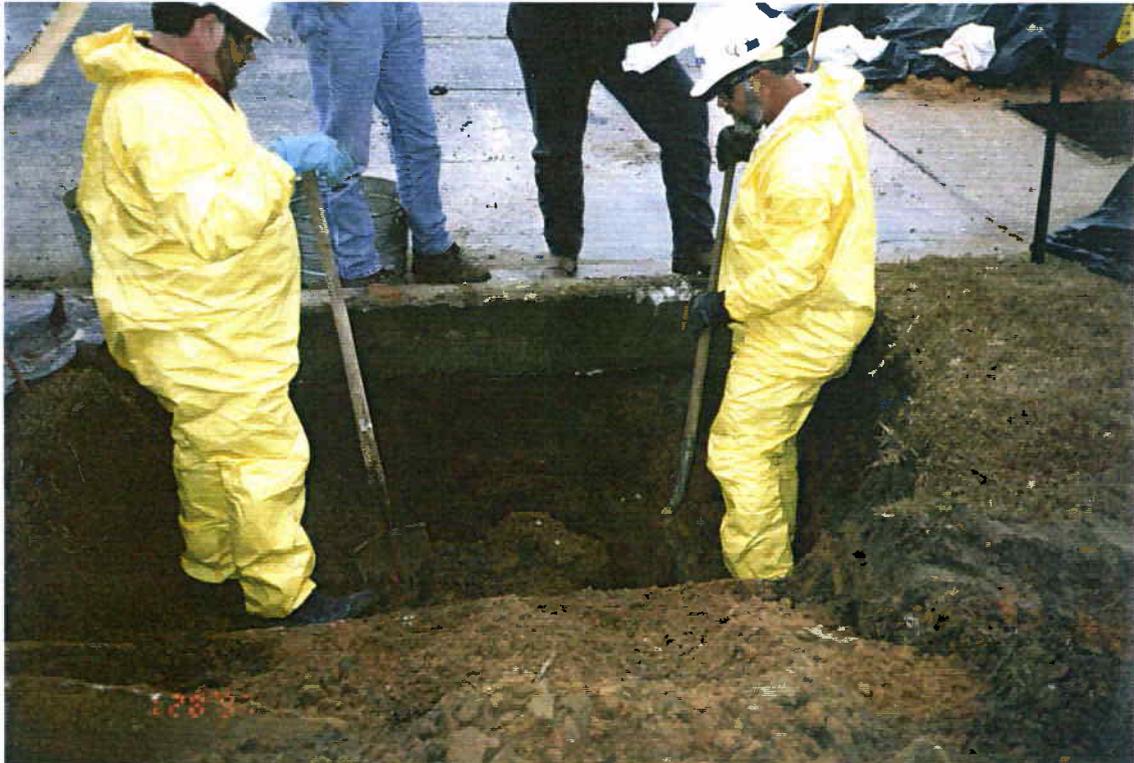
**Photo 18, January 28, 1997  
Excavation Located N. of Pit #9, Kemron Uncovered  
Fast Fuel Line Bypass Piping**

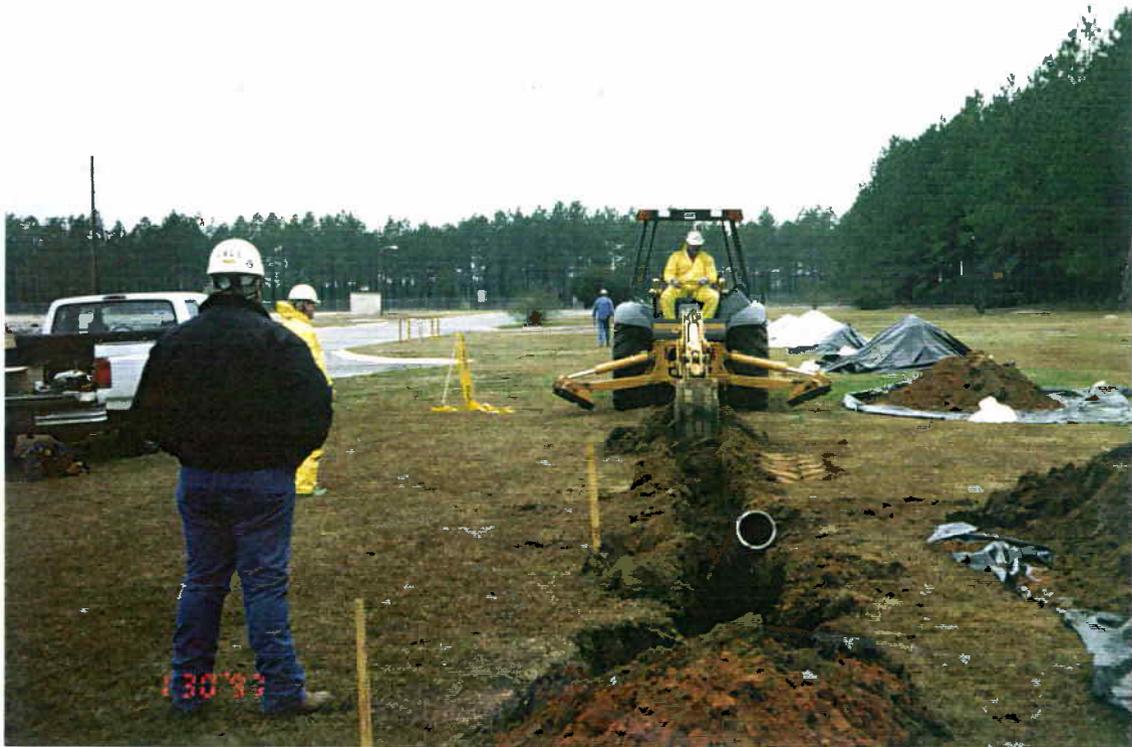
Photo 20, January 30, 1997  
Excavation and Removal of 6" Fast Fuel Line

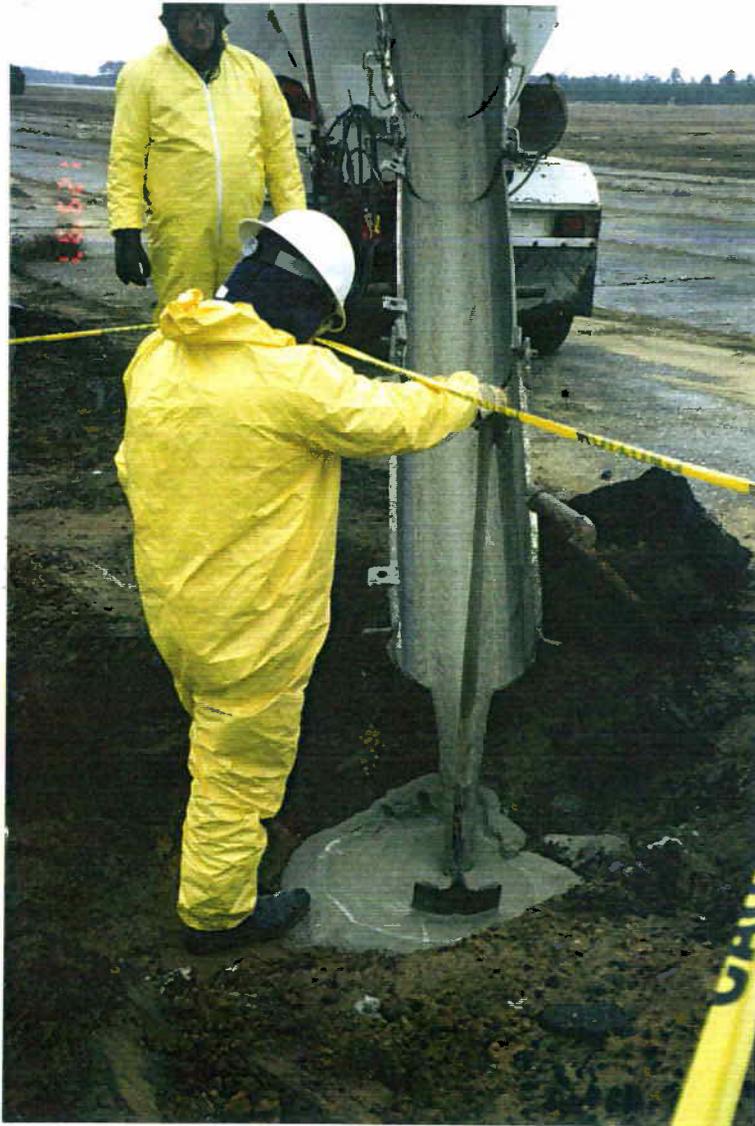
Photo 21, January 29, 1997  
Grouting Process, Concrete Poured into Tank  
at Station #46

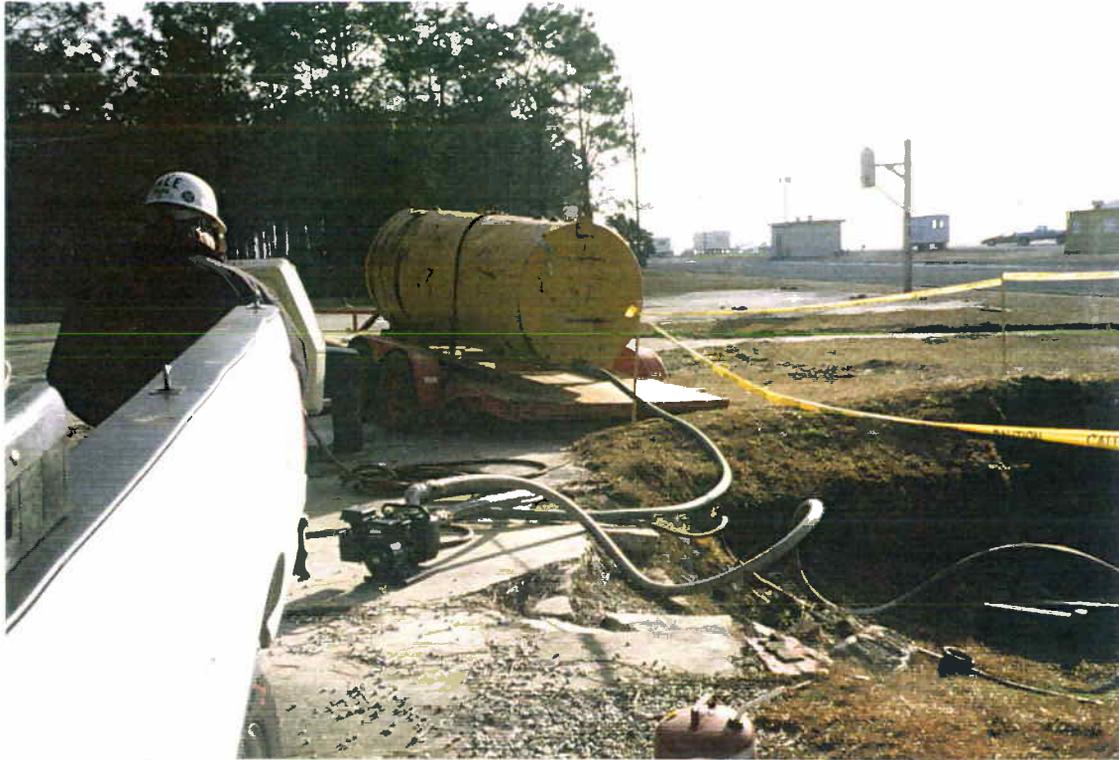
Photo 22, January 31, 1997  
Fast Fuel Line Cleaning Set-Up

Following testing, the liquid in the FFL was removed and placed into the frac tanks. A solution of water and Simple Green™ was pumped into the drained FFL and left to soak overnight. Simple Green™ is a biodegradable detergent. The overnight soaking was used to remove any materials that had collected in the interior of the FFL and hardened during the time that the FFL was not in use. After soaking, the lines were drained to the end bowser pit of each row (Figure 2-3 and Appendix A, photographs 22, 23, 24, 25, and 27) and the liquid was transferred to the frac tanks. The lines were then rinsed with water to remove residual materials. Over 9,100 linear feet of pipe was rinsed. The rinse water was also placed in the frac tanks. PID readings were taken from the end pit valves, and at randomly selected pit locations in the

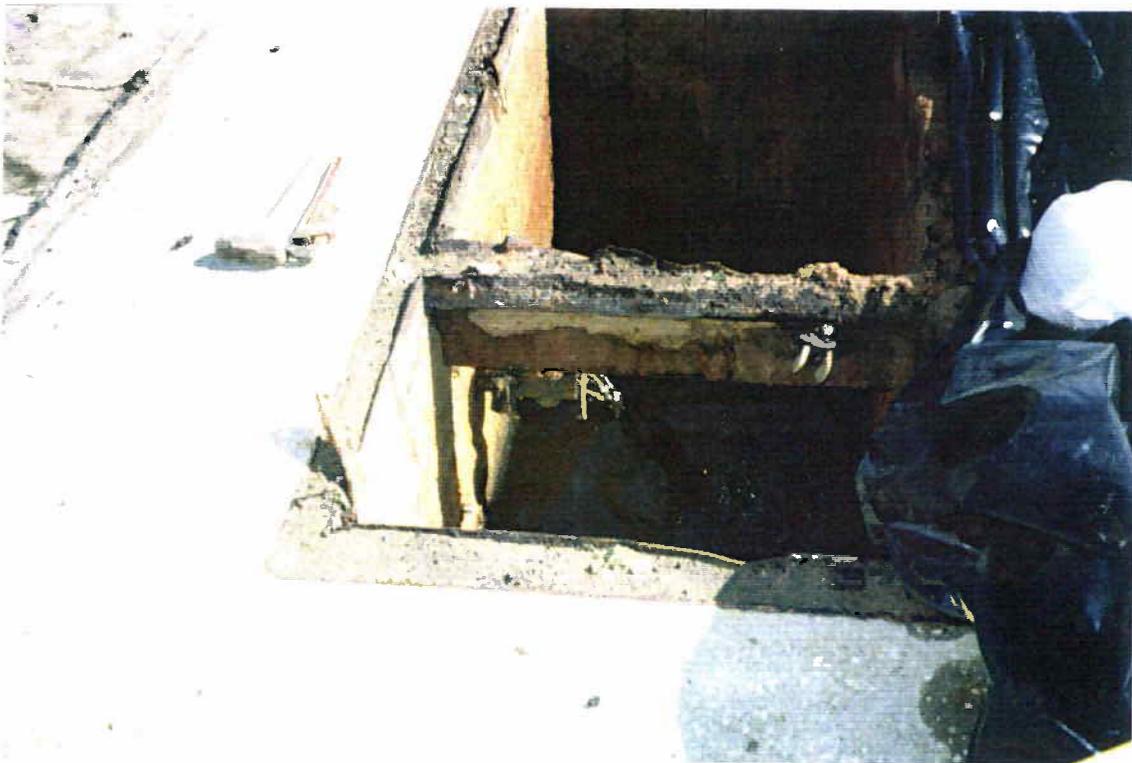
Photo 23, January 31, 1997  
Water Flow at Station #11. View is Facing East

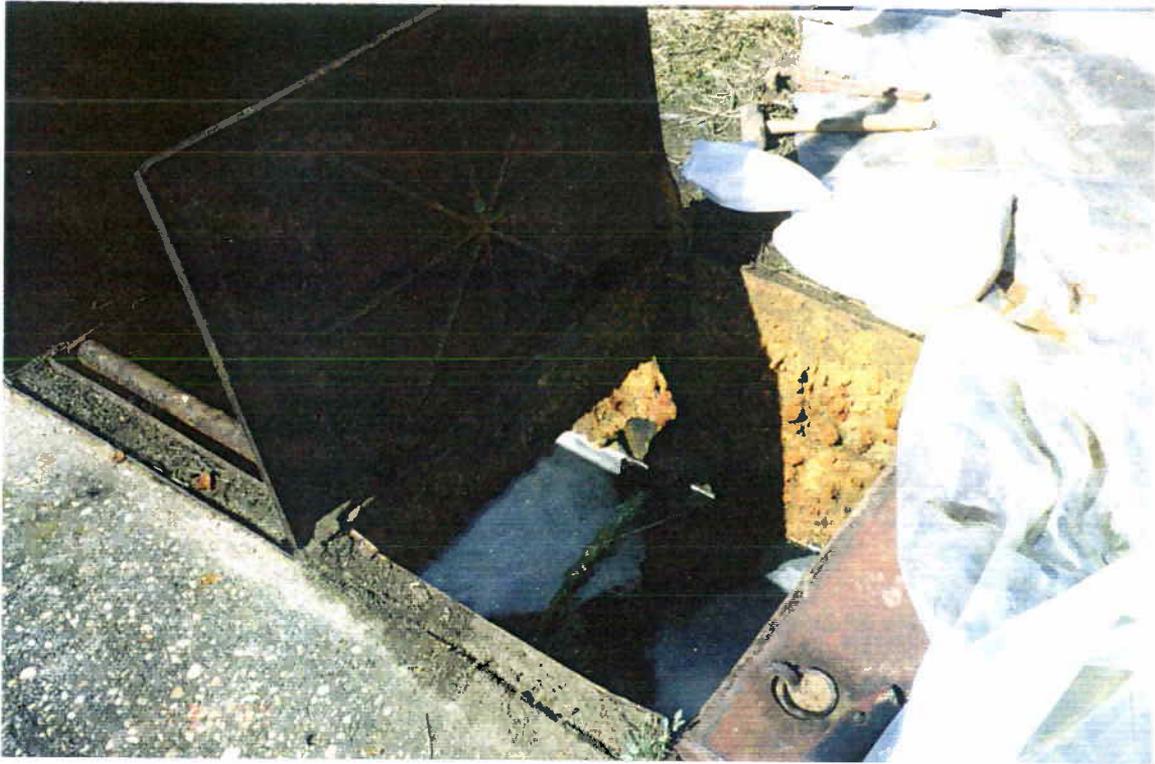
Photo 24, January 31, 1997  
Beginning of Fast Fuel Line Flushing Process at  
Pit #45 - Dark Water Flowing out of Open Valve
