CLOSURE REPORT LUBE OIL TANKS, FUELING PITS, AND FAST FUEL LINES LOCATED  
AT SITE 20B BARIN NAS WHITING FIELD FL  
5/1/1997  
ABB ENVIRONMENTAL

**CLOSURE REPORT**

**LUBE OIL TANKS, FUELING PITS, AND FAST FUEL LINES  
LOCATED AT SITE 20B,  
ABANDONED UNDERGROUND STORAGE TANKS AND  
FUEL PIT AREA**

**OUTLYING LANDING FIELD BARIN  
FOLEY, ALABAMA**

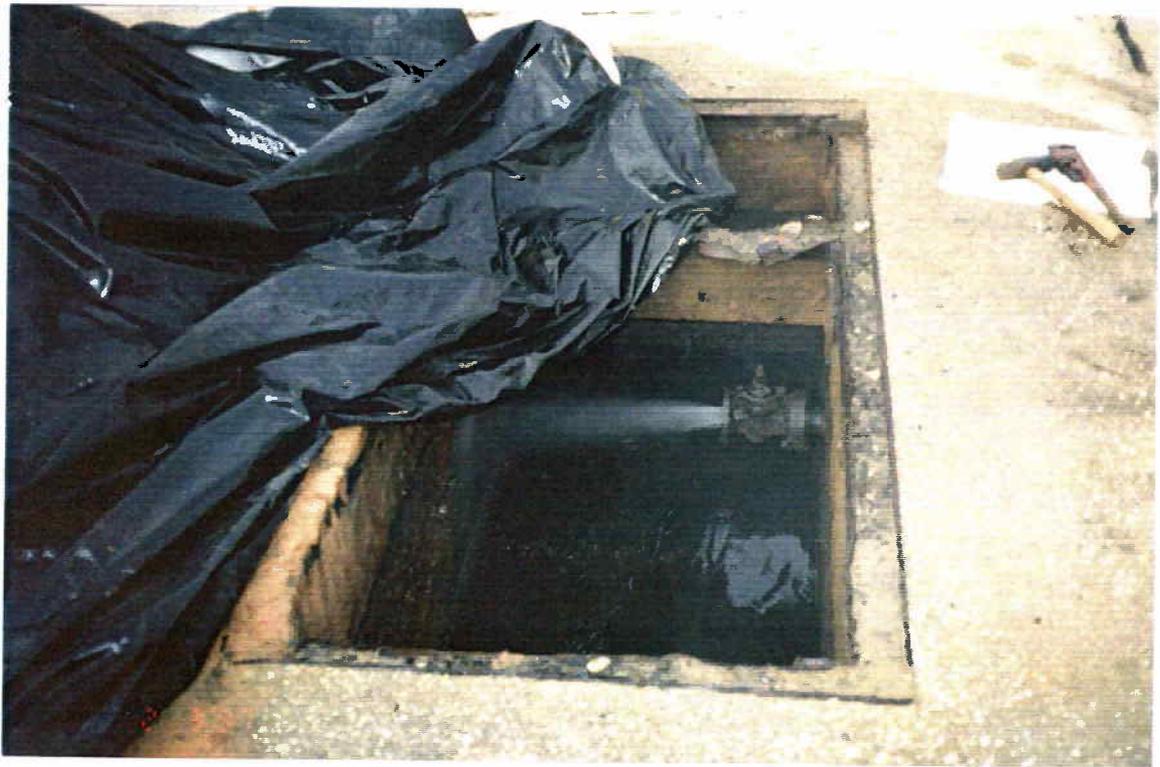
Photo 25, February 3, 1997  
Flushing Procedures in Fast Fuel Pit #11  
Water Flowing out of Open Valve

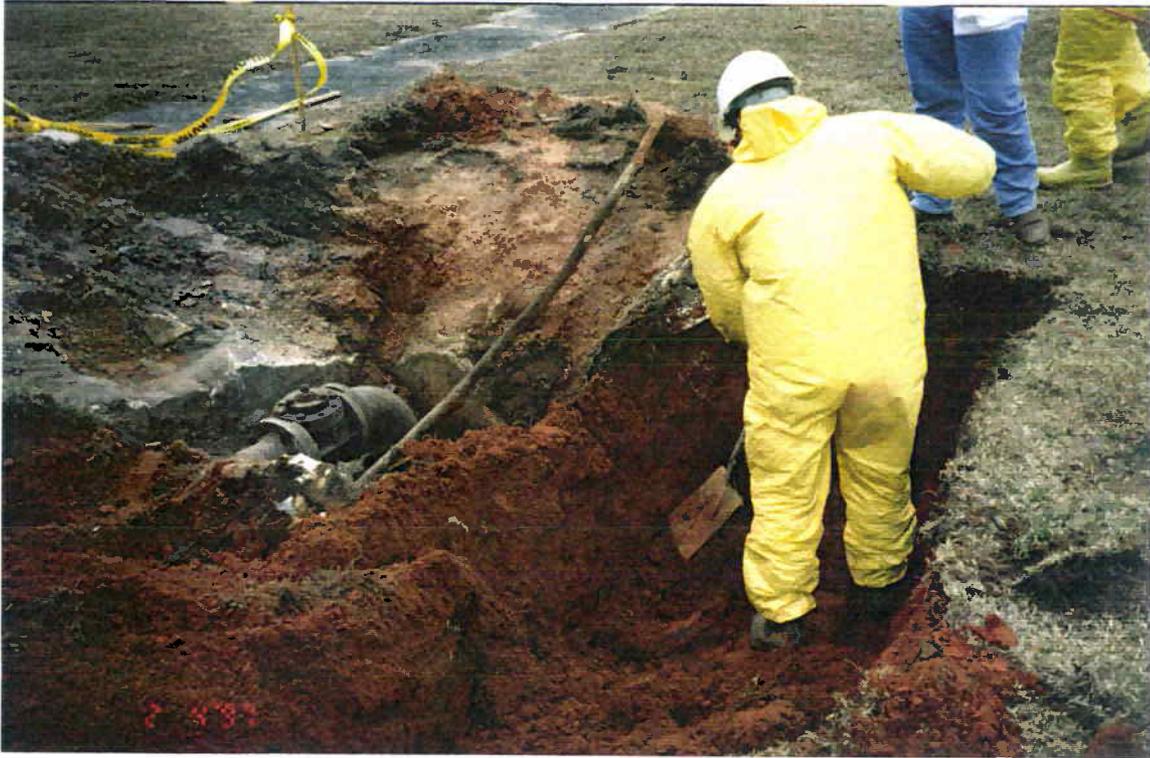
Photo 26, February 4, 1997  
Freshly Exposed 4" Line North of Grassy Area.  
Kemron Excavates Soil around Pipe

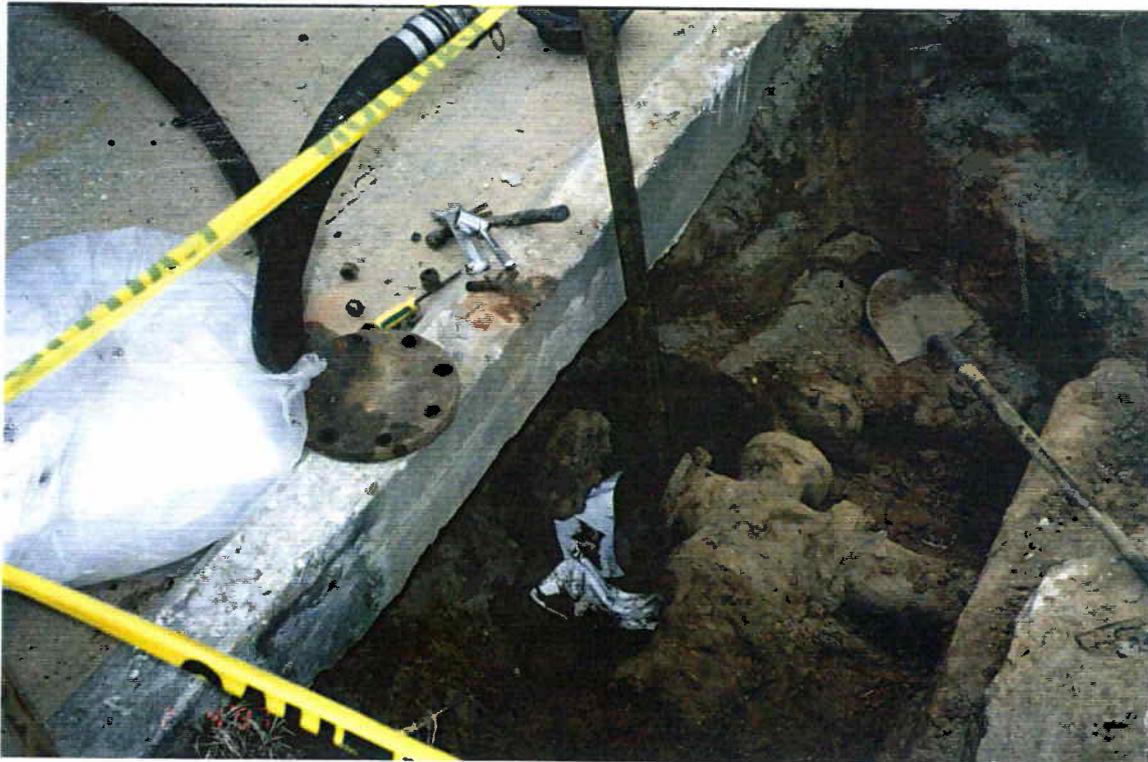
Photo 27, February 4, 1997  
Pit Where "T" in Fuel Line Exists - Vacuum Truck Removing  
Liquids from 6" Line

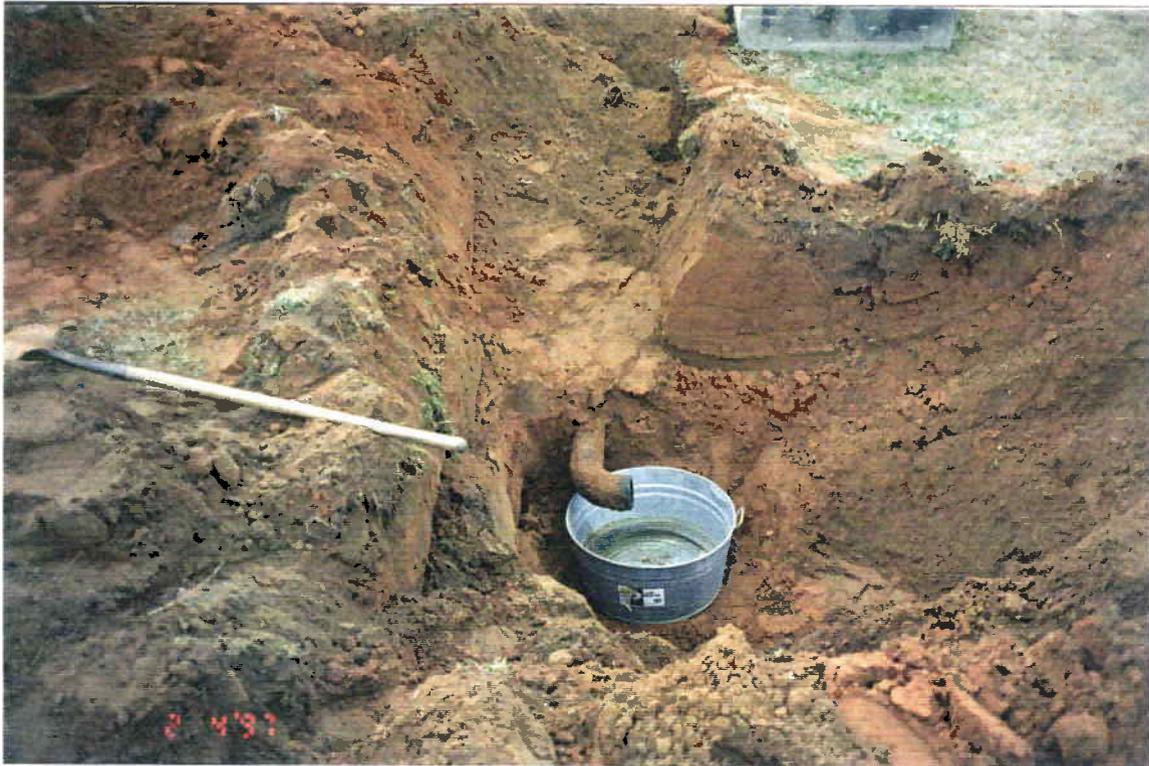
**Photo 30, February 4, 1997**  
**View of 4" Line and Bucket Used to Catch Water**  
**Facing West**

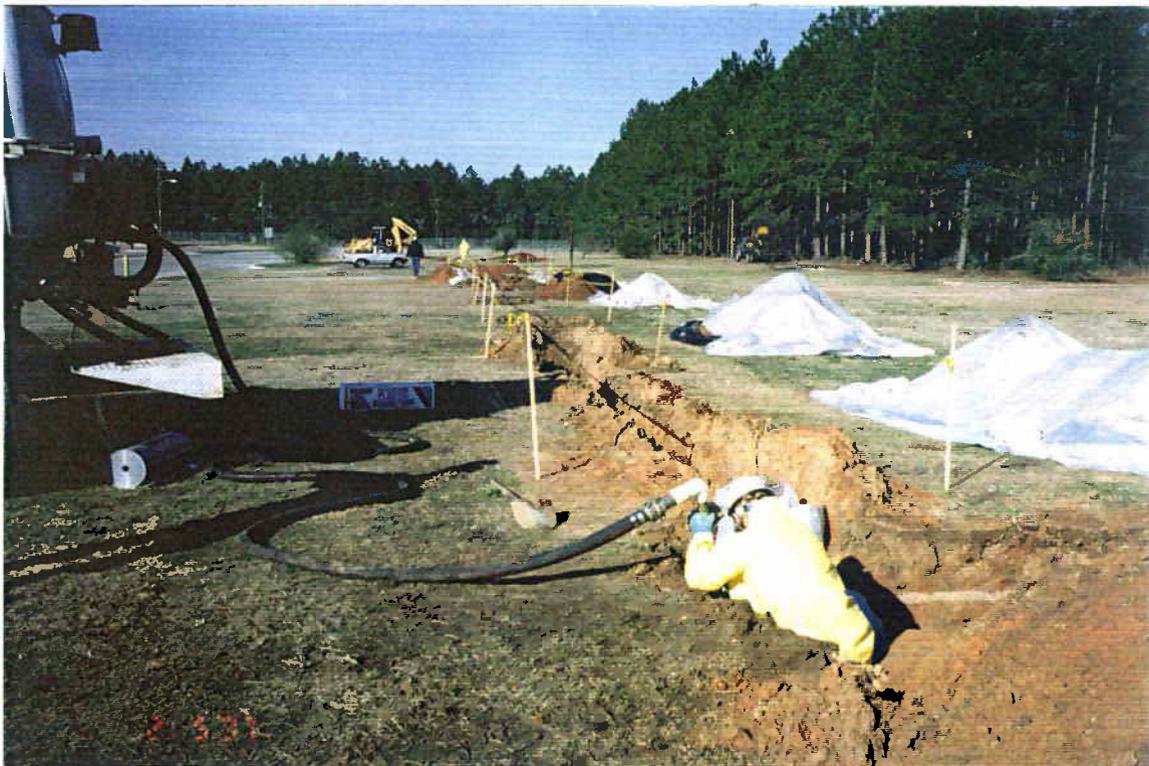
**Photo 31, February 5, 1997**  
**6" Line Flushing Procedure - Drawing Fluids From**  
**Flushed Line via Vacuum Truck - View Facing West**

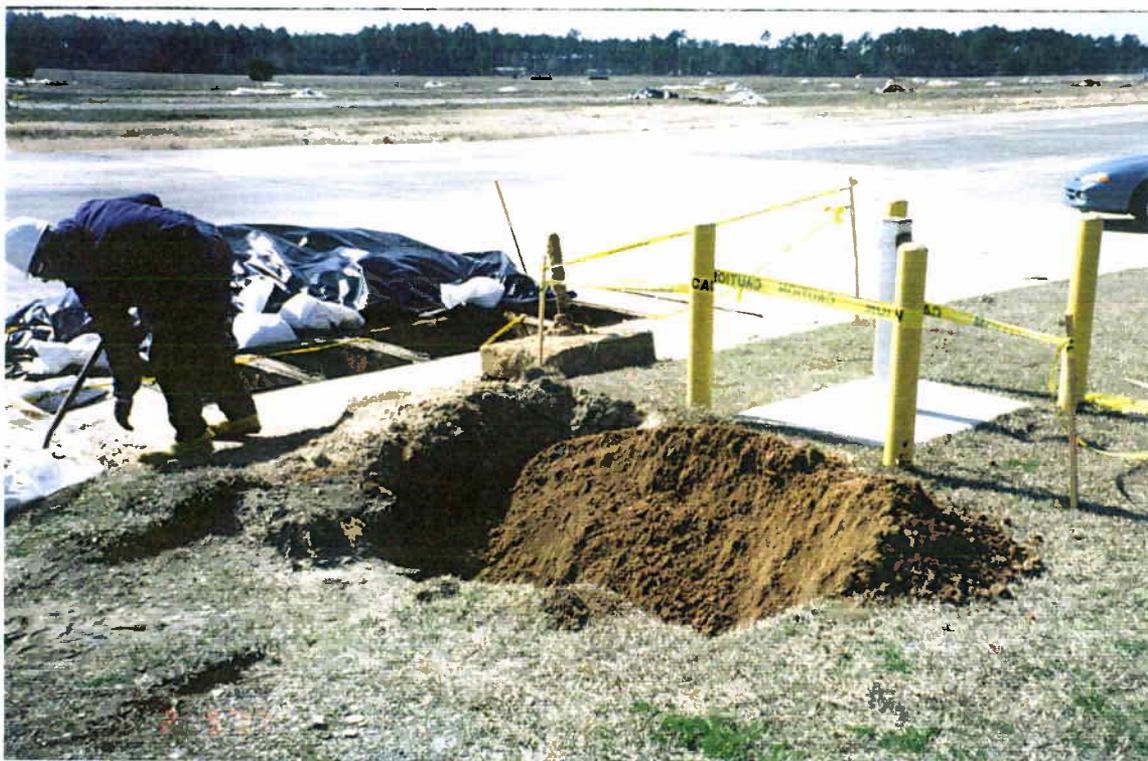
**Photo 32, February 5, 1997  
Backfilling Process on Tops of Lube Oil  
Tank #6 Facing SW**

All areas of the site were restored to pre-existing conditions after all activities were completed. Appendix A, photographs 37 through 43 show backfilling and final conditions of the site. Appendix F contains the as-built drawings of the activities.

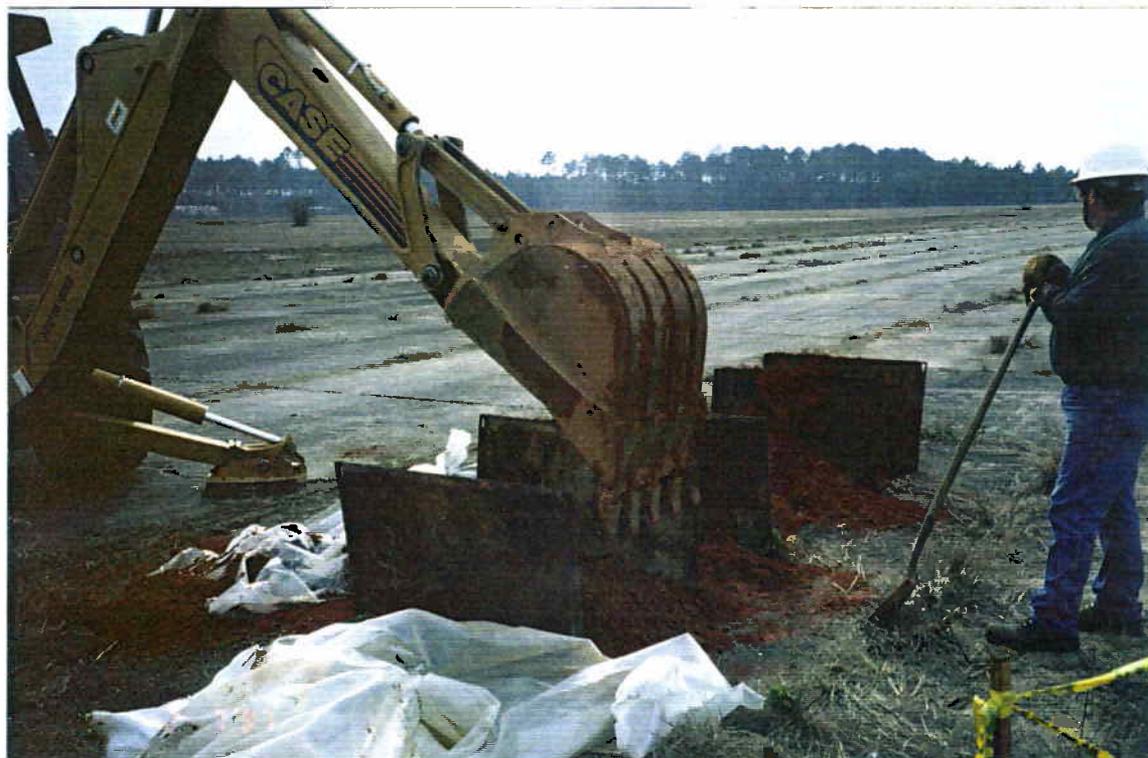
**Photo 33, February 7, 1997  
Bowser Pit Backfilling Procedure at Pit #50  
View Facing SW**

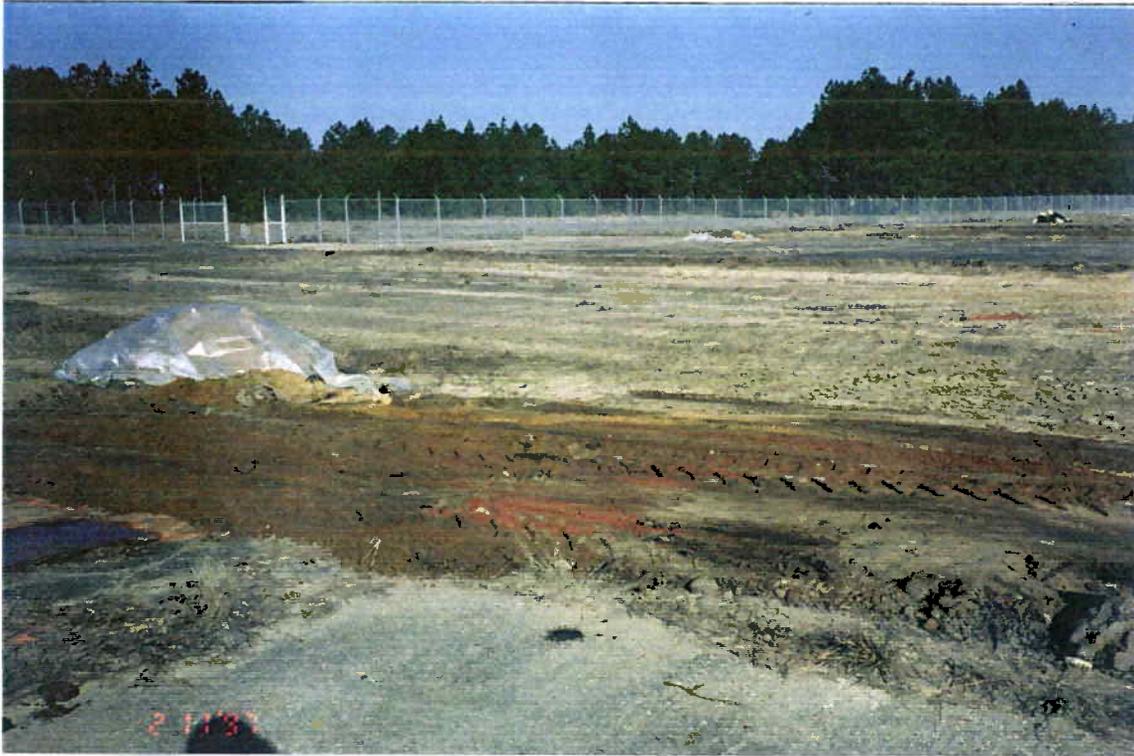
Photo 34, February 11, 1997  
Freshly Backfilled Tank Excavation at Station #46  
View Facing NW - Stockpiled Contaminated Soil

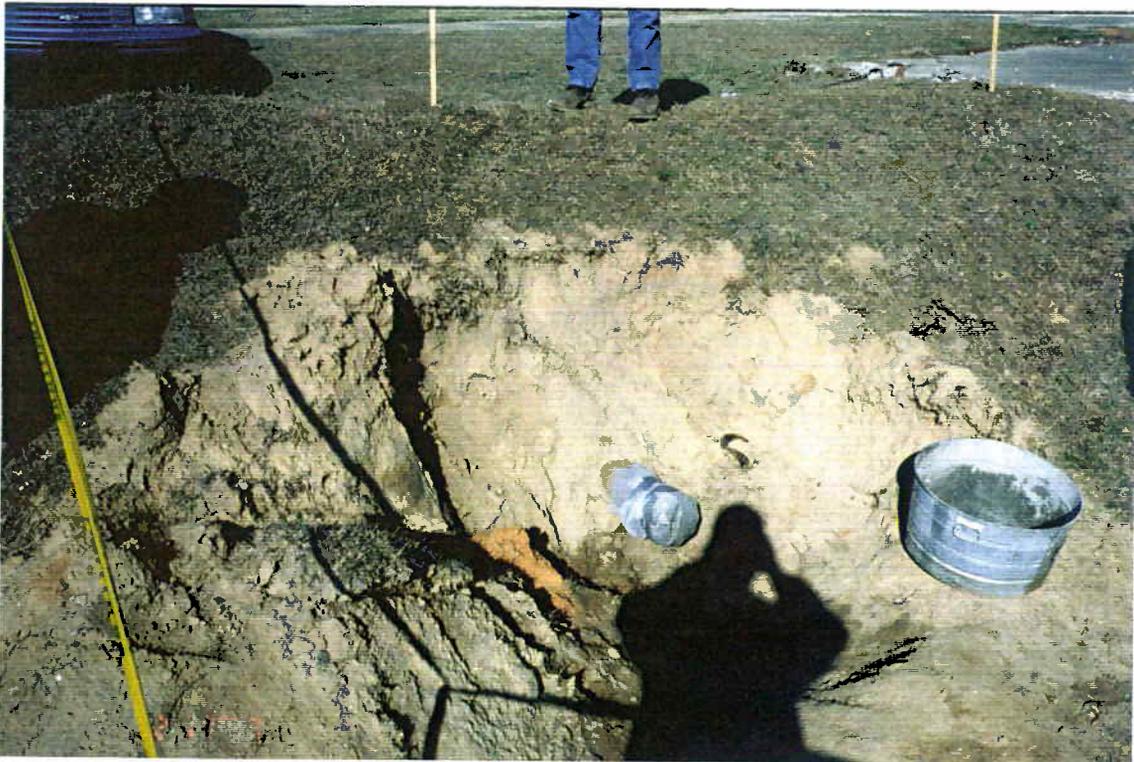
Photo 35, February 11, 1997  
Grouted Ends of FFL Where Air Pressure Test  
was Conducted - Facing NW

After the valves were closed, all open ends to the FFL were plugged and grouted with non-shrinking grout. The bowser pits were backfilled with stockpiled soil containing less than 100 ppm total petroleum hydrocarbons (TPH) and compacted using the excavator buckets. Soil sample results are provided in Tables 4-1 and 4-2. The metal covers were replaced on all pits.

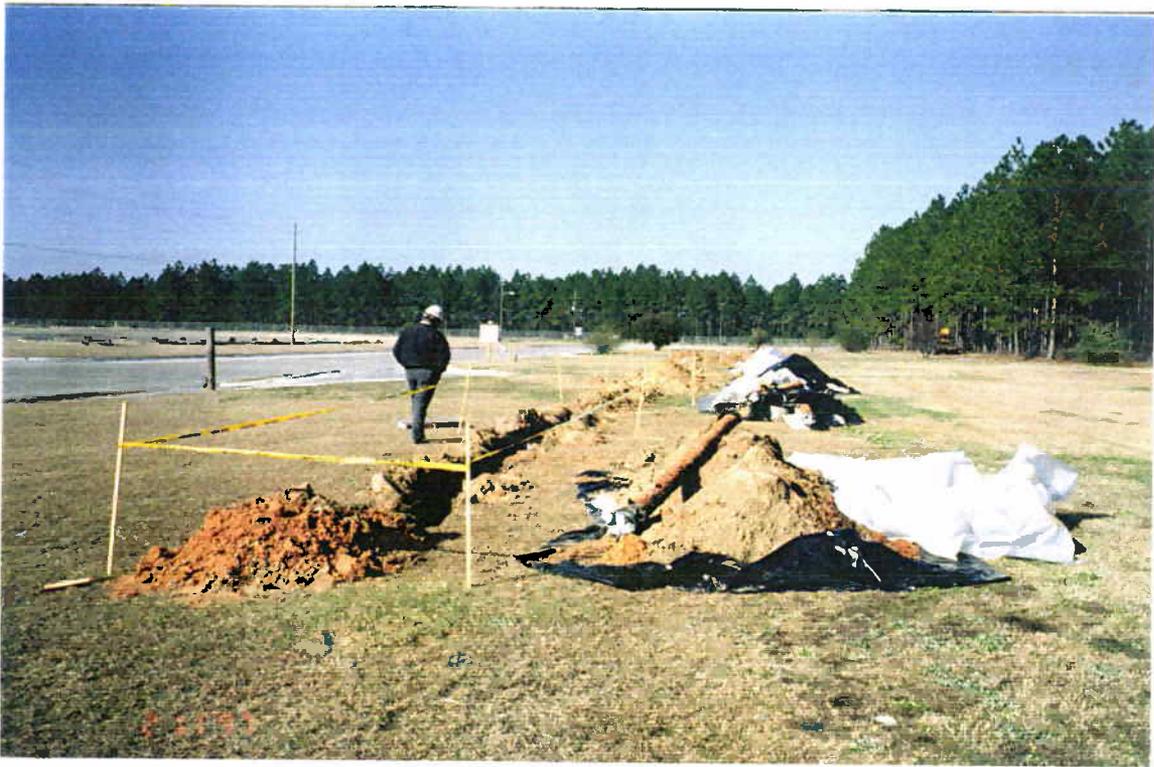
**Photo 36, February 11, 1997  
Excavated FFL, Stockpiled Material, Grouted Piping  
Stockpiled Prior to Backfilling Area - D. Allen  
Inspects Excavation - Facing West**

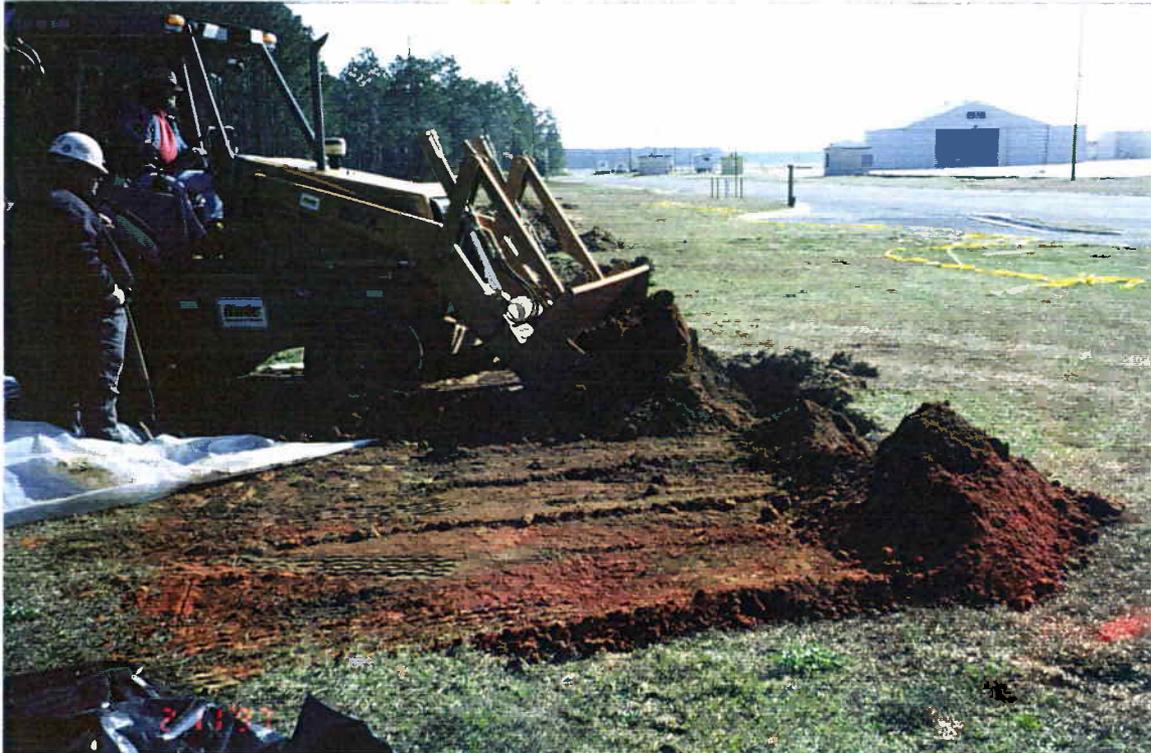
**Photo 37, February 11, 1997  
Backfilling Process in Grassy Area Along FFL,  
Case Backhoe Pushing Material into Excavation - Facing East**

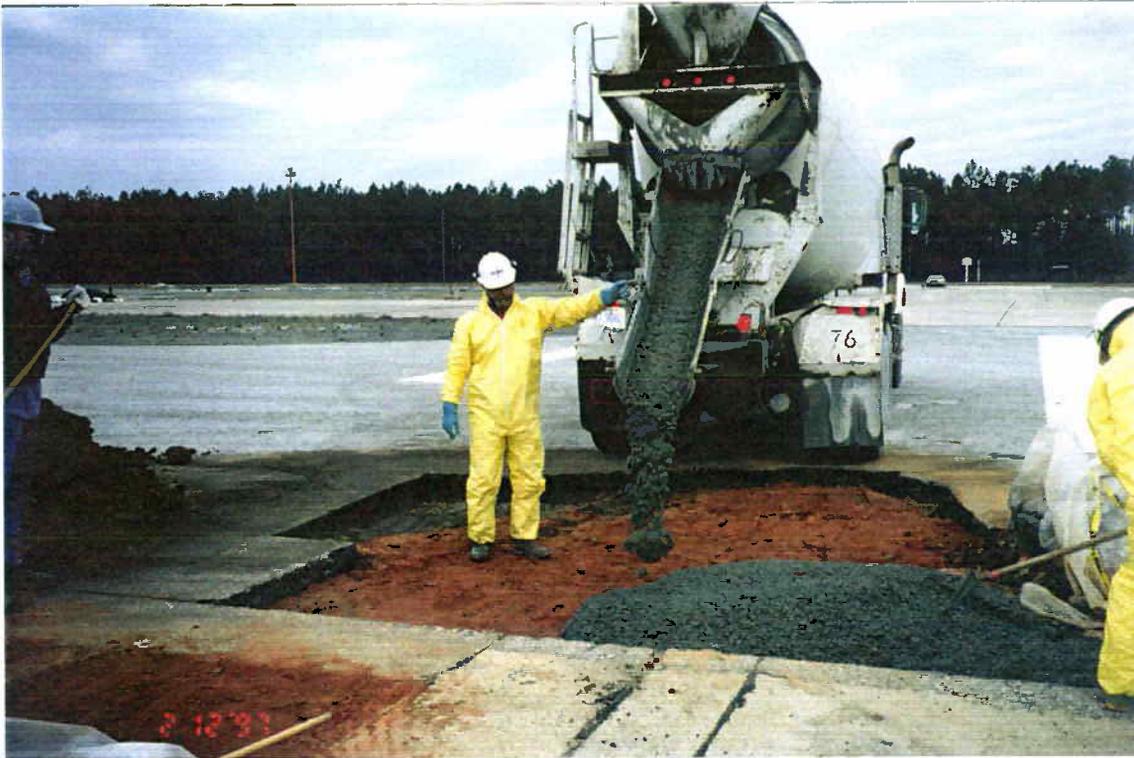
Photo 38, February 12, 1997  
Concrete Pour at Station #24  
Facing North

Masonry work was required to replace the curbing and paving that was removed during excavation. Damaged concrete and asphalt was saw-cut and removed. A 4,000 psi mix was used for both the curb and pavement repair.

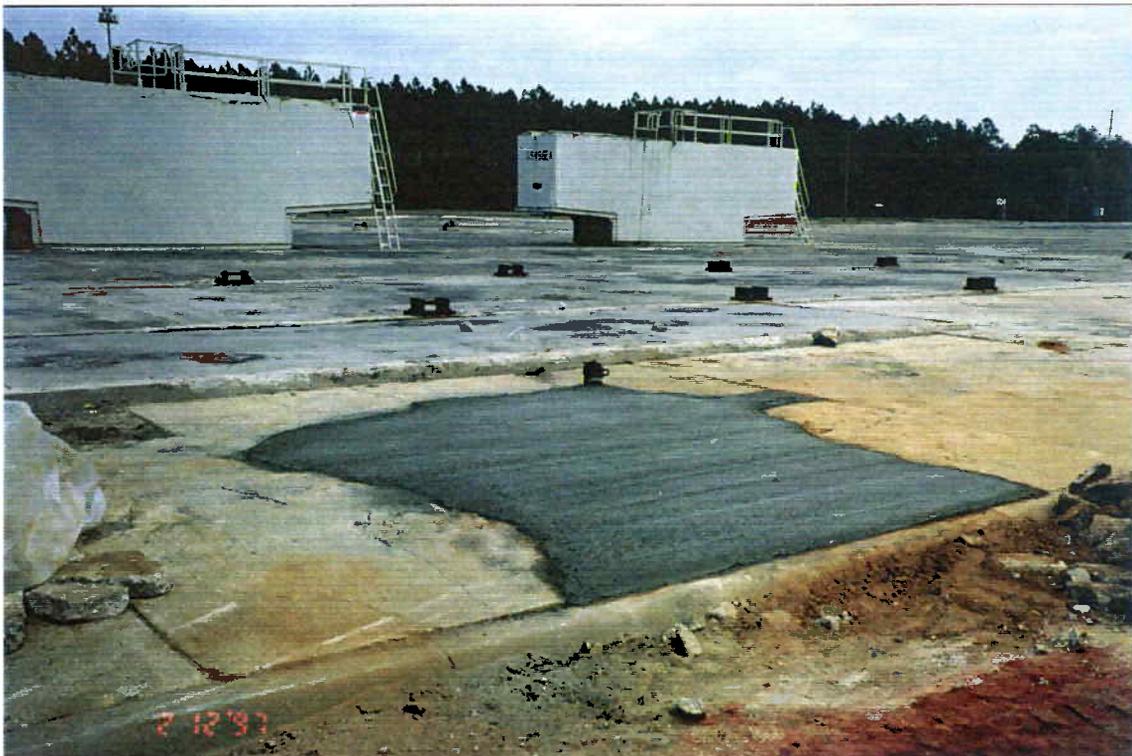
Photo 39, February 12, 1997  
Finished Concrete Pour at Tank #8  
Facing NE

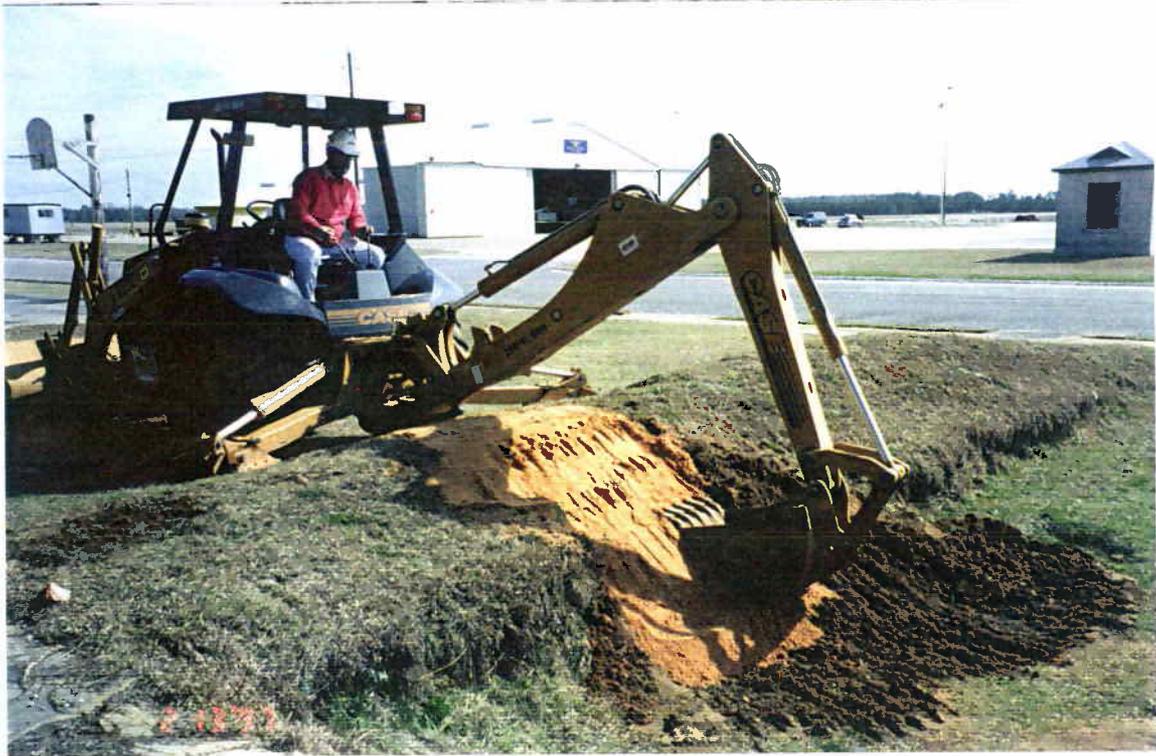
**Photo 40, February 13, 1997**  
**Backfilling on Bank Where FFL Air Testing was Conducted**  
**Facing East**

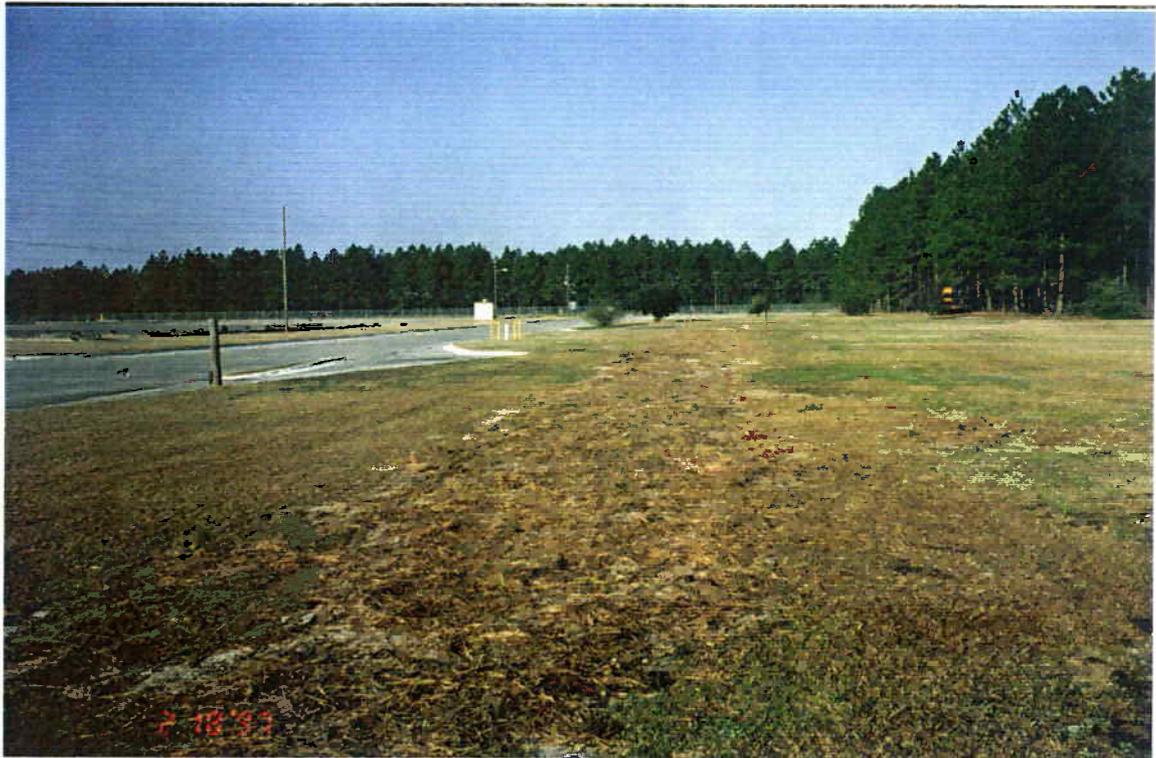
**Photo 41, February 18, 1997**  
**Backfilled Header Area at Completion**  
**Facing West**

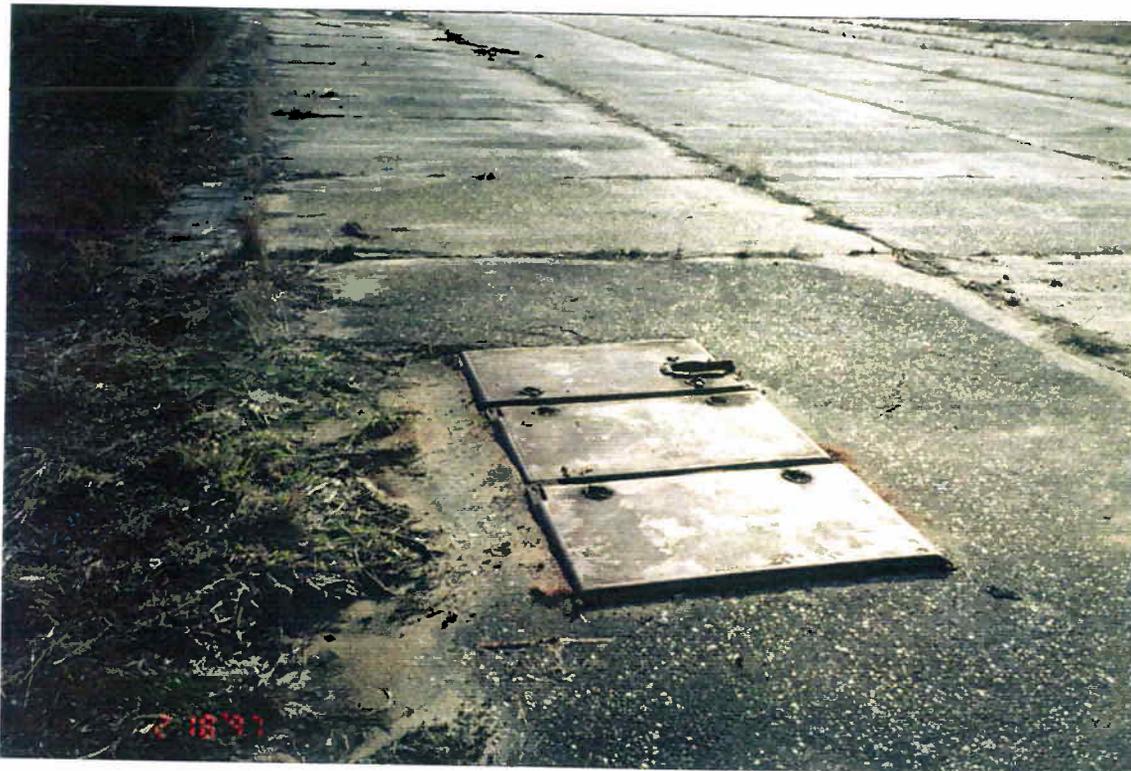
**Photo 42, February 18, 1997  
Fast Fuel Pit in Its Final State  
Facing SE**

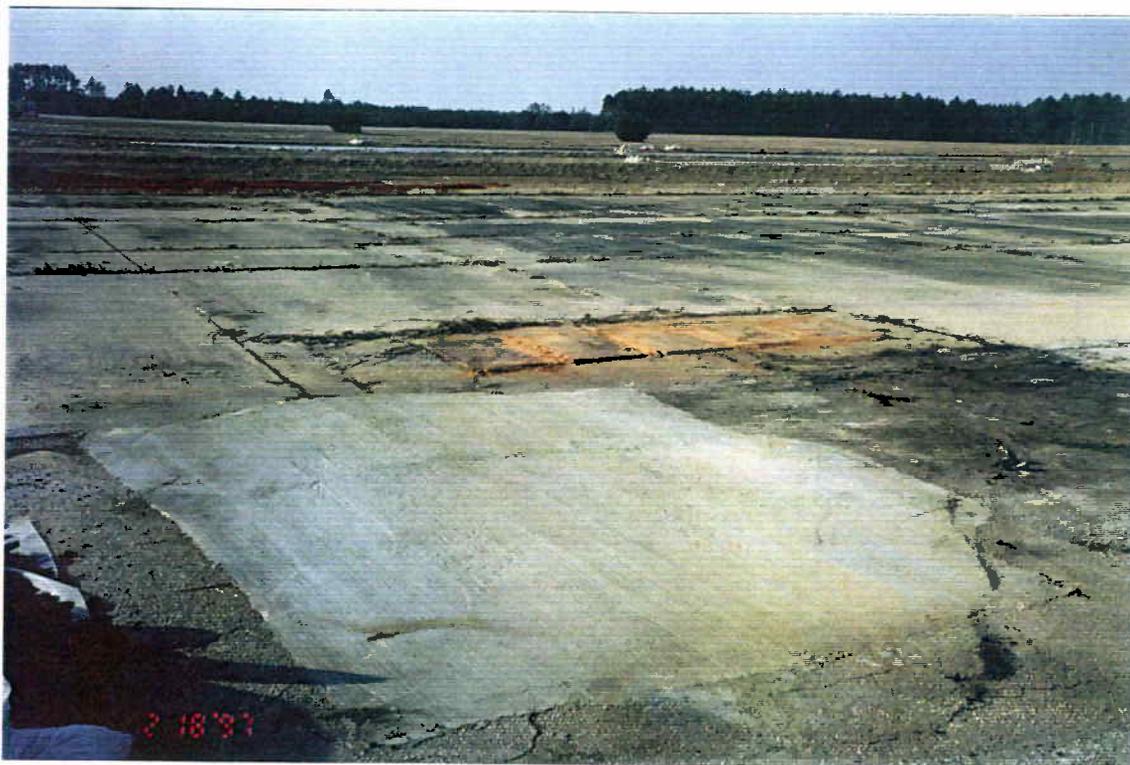
**Photo 43, February 18, 1997  
Completed Lube Oil Storage Tank, Backfilled and  
Filled with Concrete, and Completed FFL Pit - Facing SE**

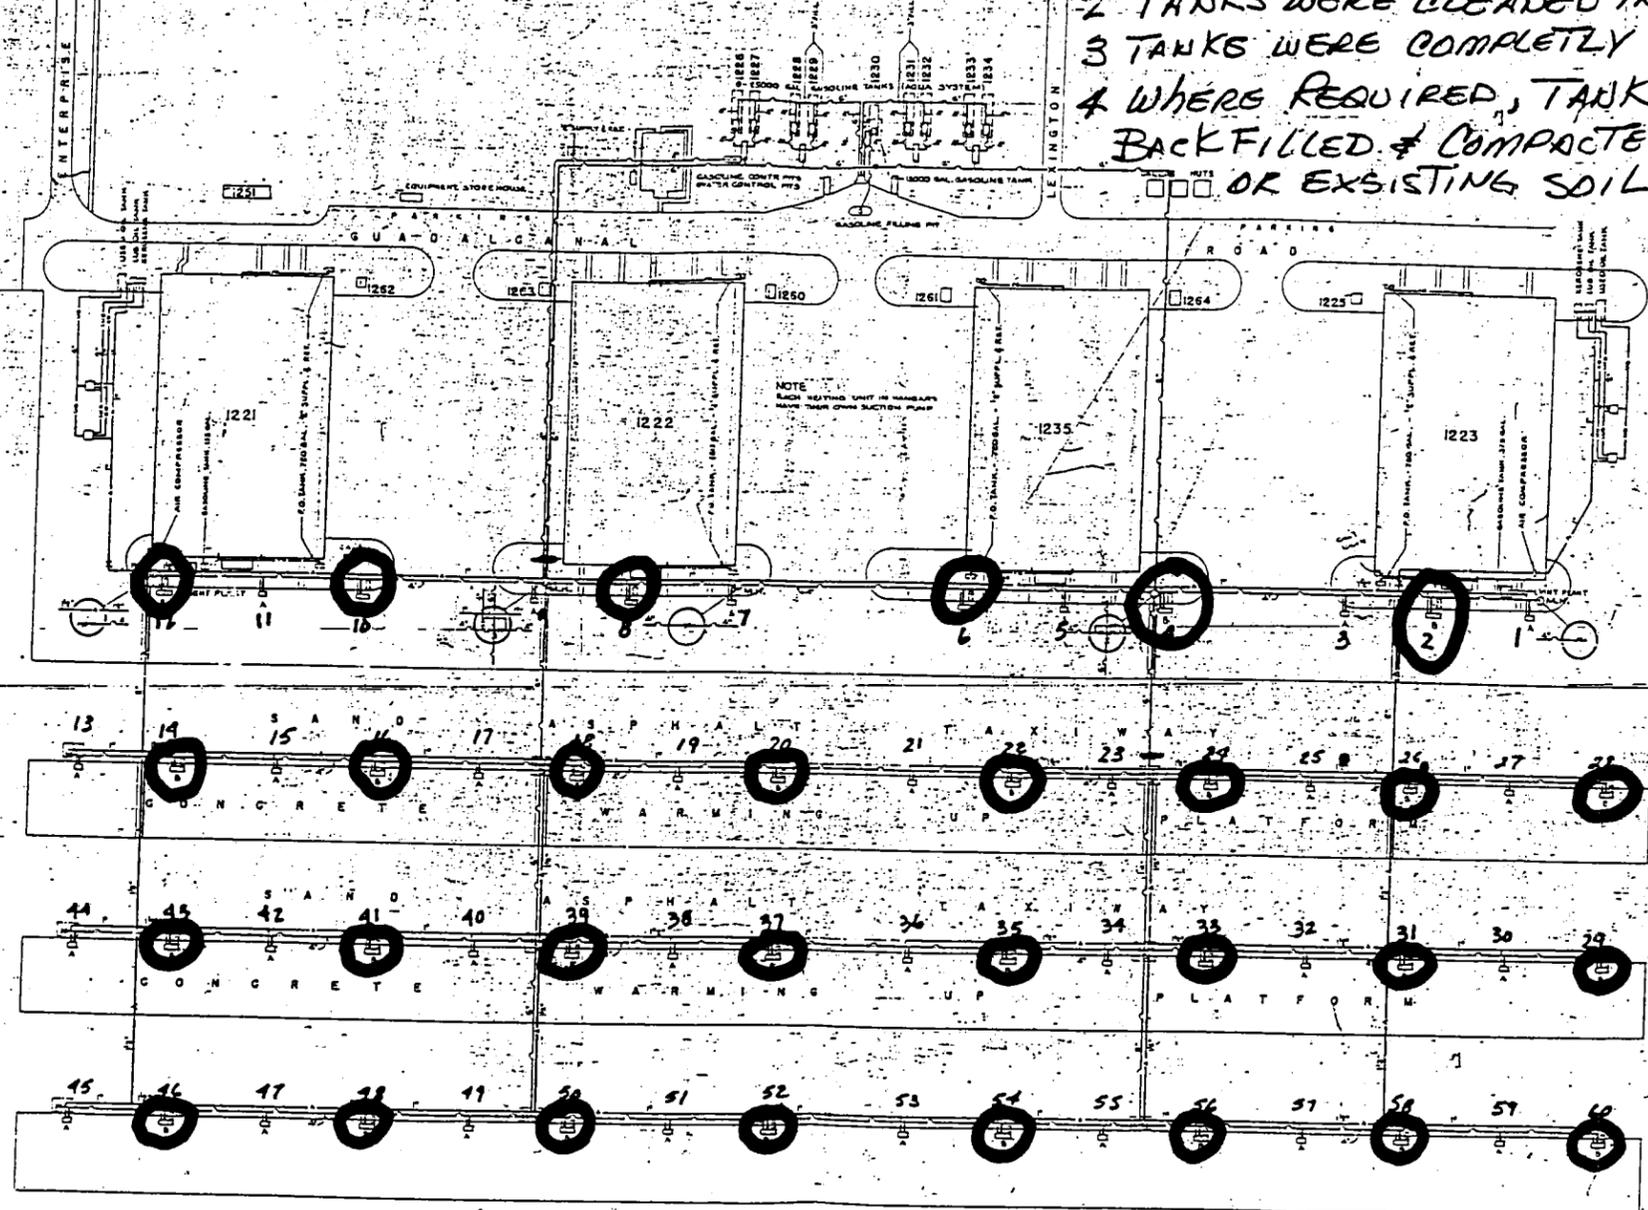
- 1 ALL EXISTING PRODUCT WAS EVACUATED
- 2 TANKS WERE CLEANED IN AN APPROVED MANNER
- 3 TANKS WERE COMPLETELY FILLED WITH GROUT
- 4 WHERE REQUIRED, TANK EXCAVATIONS WERE BACKFILLED & COMPACTED WITH NEW SOIL OR EXISTING SOIL.

NOTE  
TANKS OF GASOLINE PIPES EXCEPT  
WARMING UP SYSTEM ARE ALL WELDED PIPES  
TANKS NOT UNDER REMOVAL LINES  
ARE OTHER ALL WELDED PIPES  
APPROVED PRESSURE IS APPROX. 20 LBS.  
USED IN OPERATION.

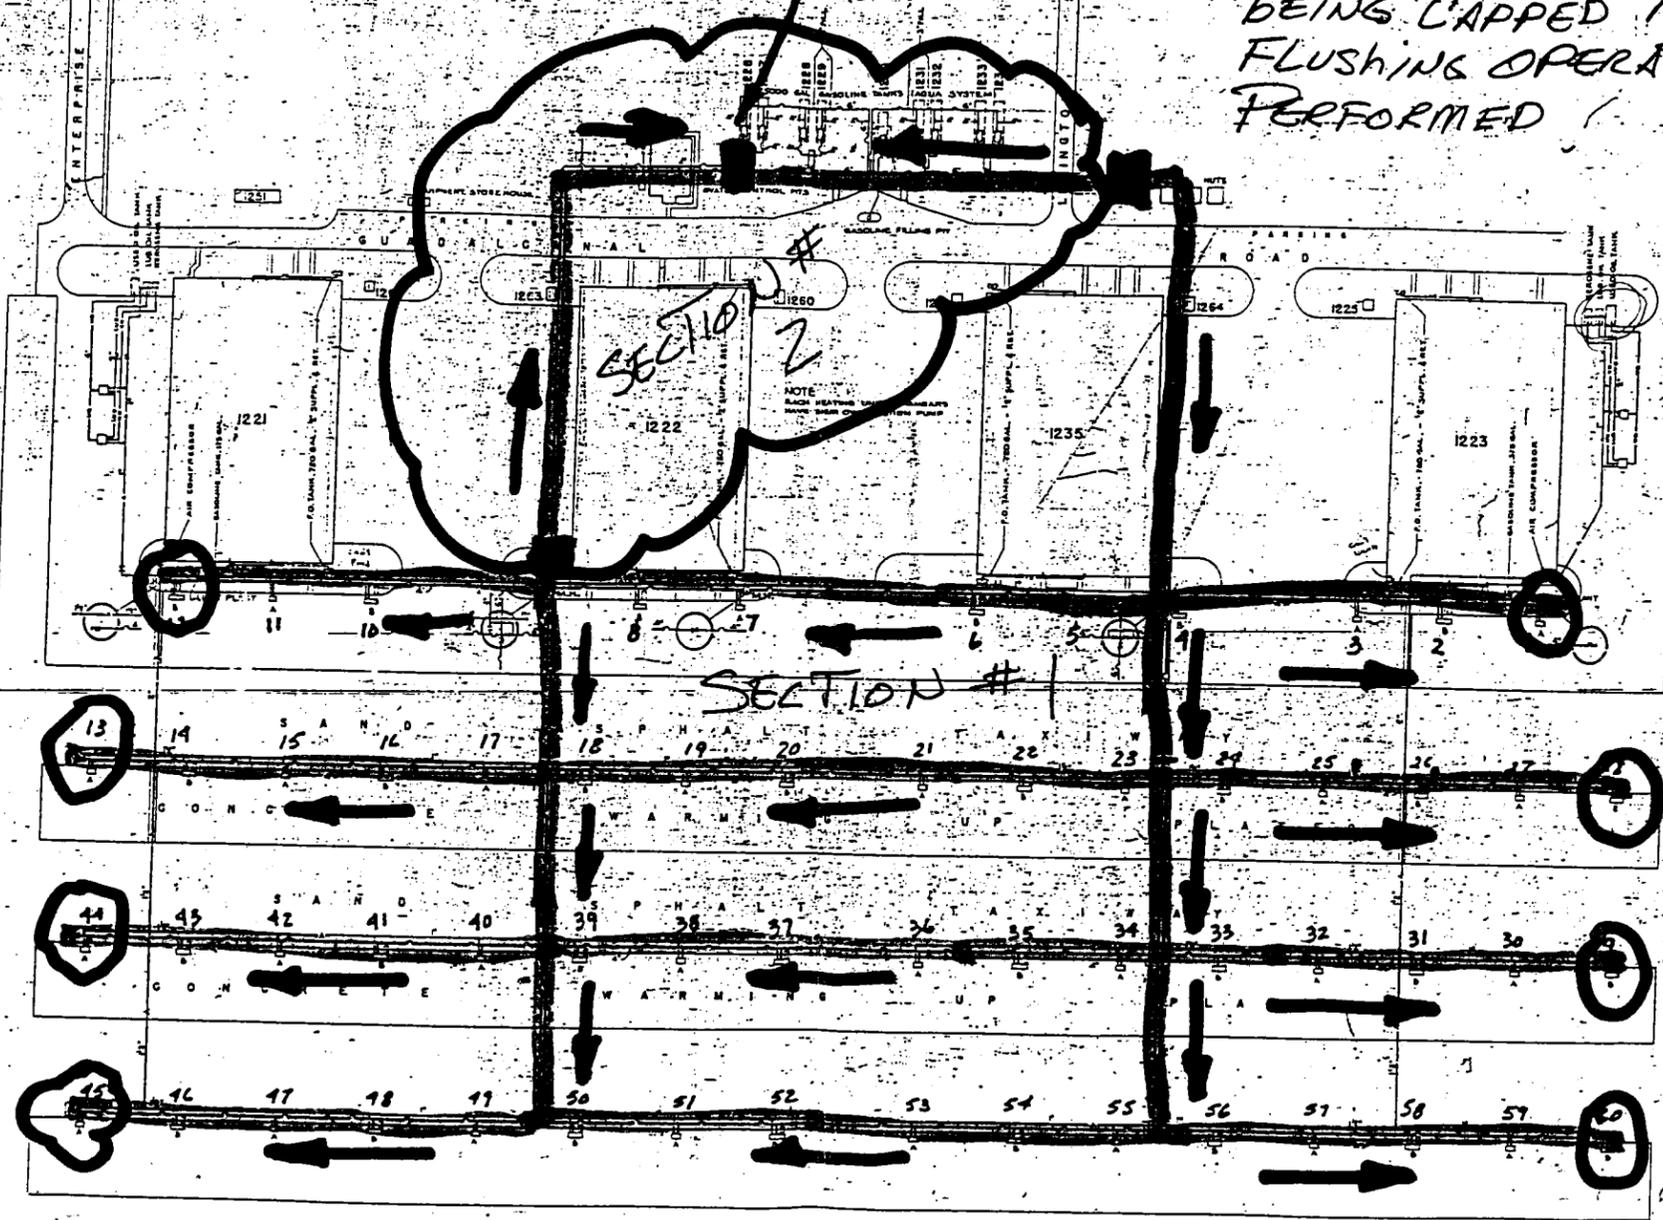
DUE TO SECTIONS OF PIPING BEING CAPPED TWO SEPERATE FLUSHING OPERATIONS WERE PERFORMED

NOTE  
 ALL GASOLINE PIPES EXCEPT  
 IN AREA SYSTEM ARE ALL WELDED PIPES  
 1" AND 1 1/2" DIAMETER PIPES  
 ARE BUTTER FLAME CUT PIPES  
 ALL OTHERS ARE APPROX. SOLID  
 WELDED IN PLACE
