**Final
Bioventing Pilot Study Report
Site 4 - North AVGAS Tank Sludge Disposal Area**

**Naval Air Station Whiting Field
Milton, Florida**

**Contract No. N624670-08-D-1006
Task Order No. JM19**

September 2015

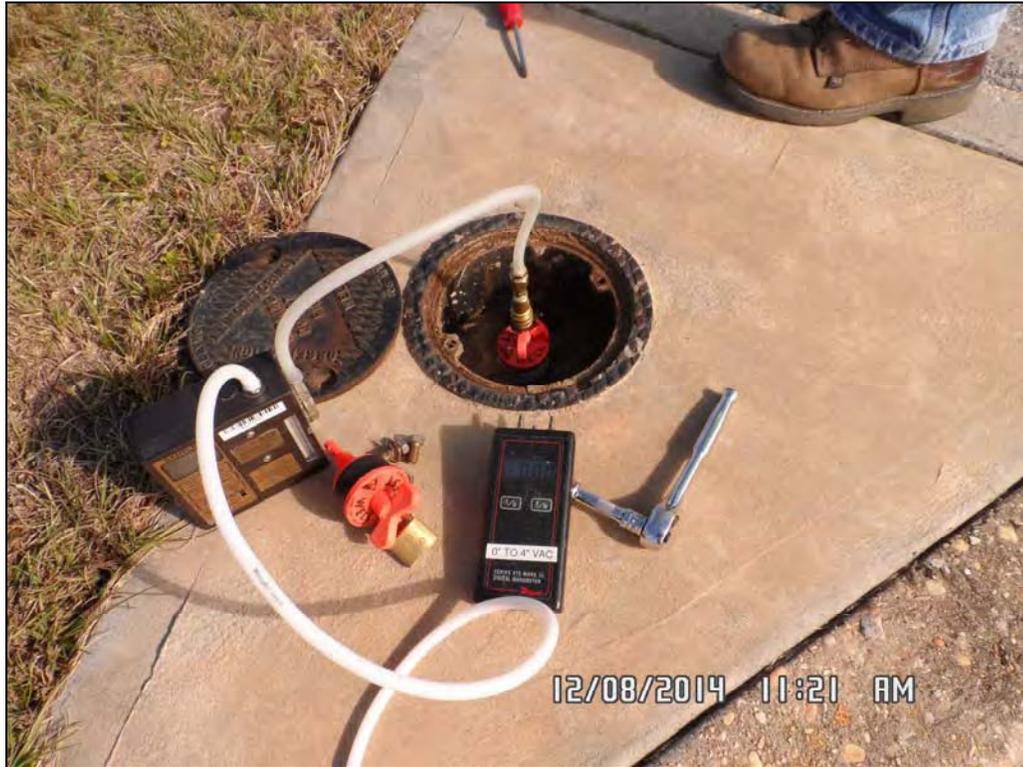
Photo #3 - Typical 2" Sample Port

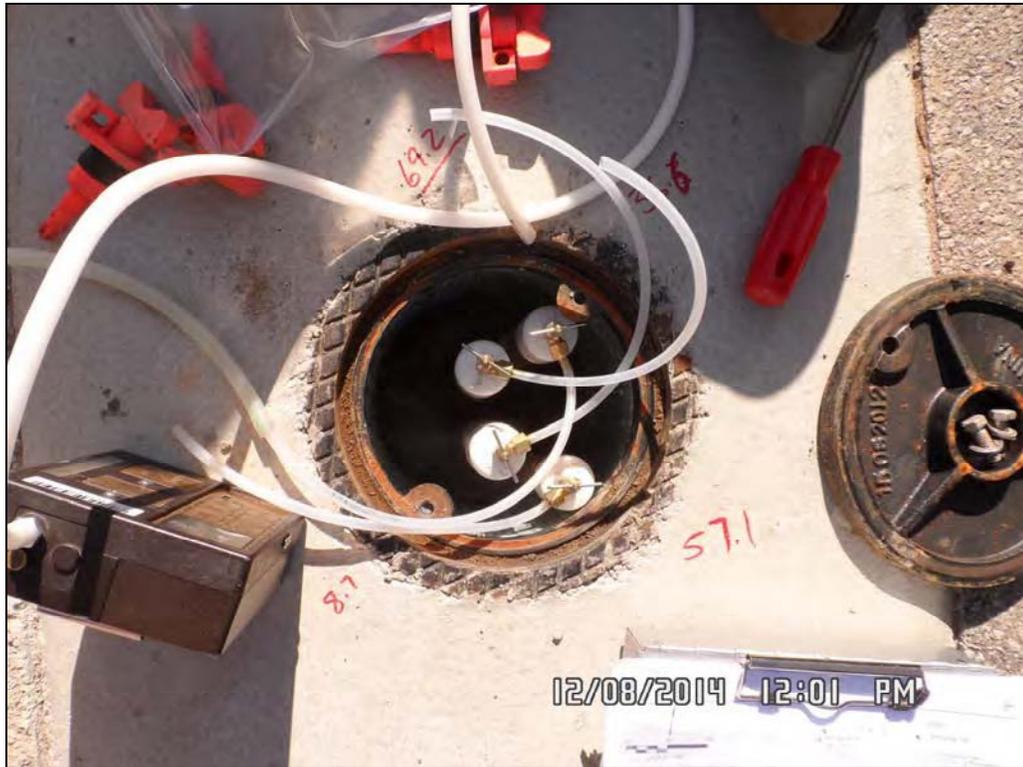
Photo #4 - Typical 1" Sample Ports

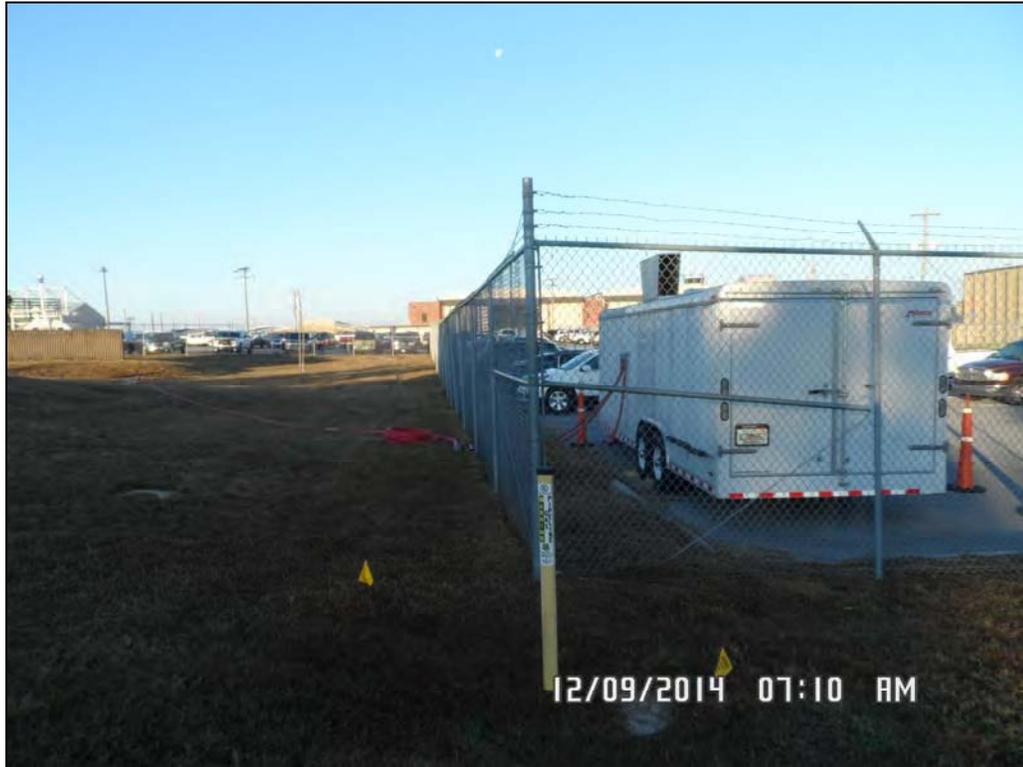
Photo #3 - Facing West, System Piping to MC-10

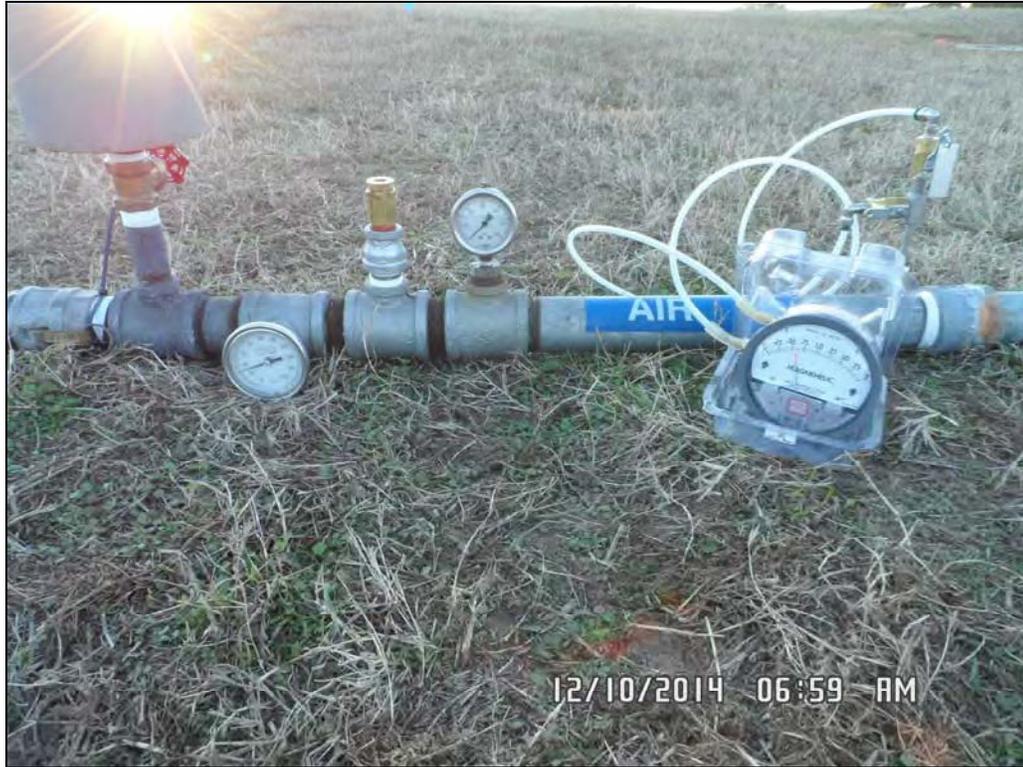
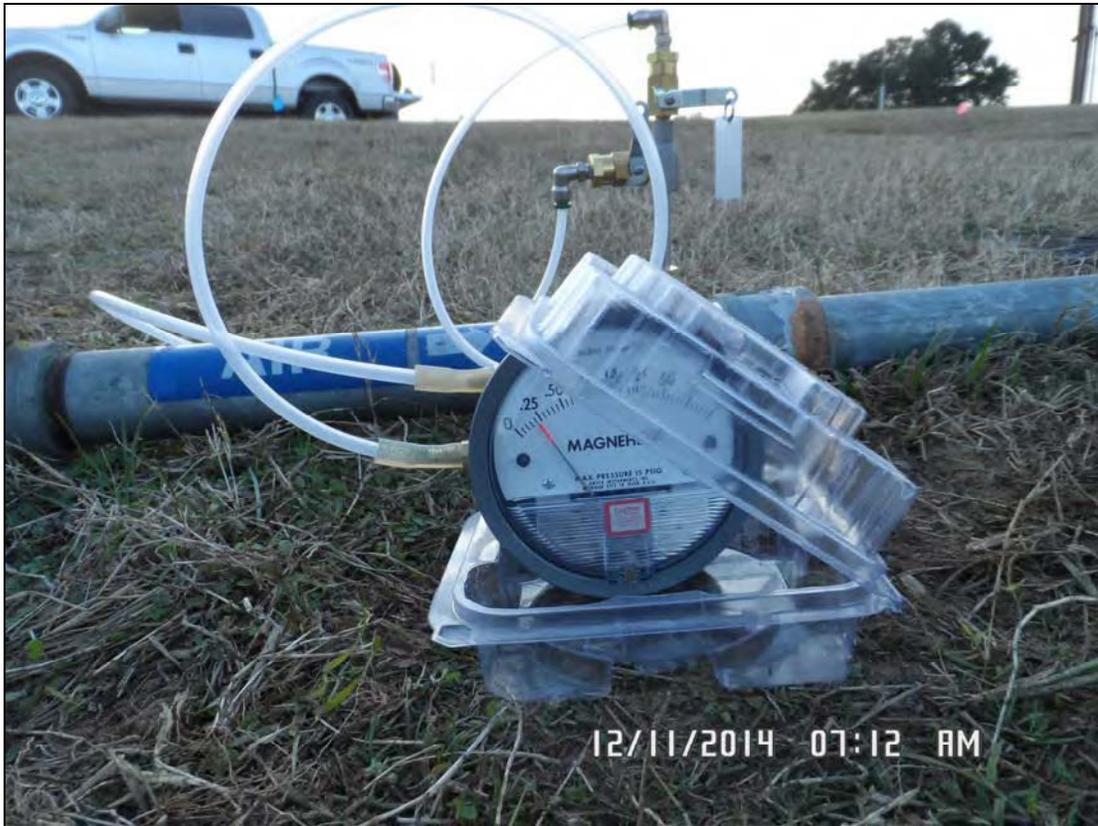
Photo #1 - Air Flow Gauges Upstream of the Air Injection Point MC-10

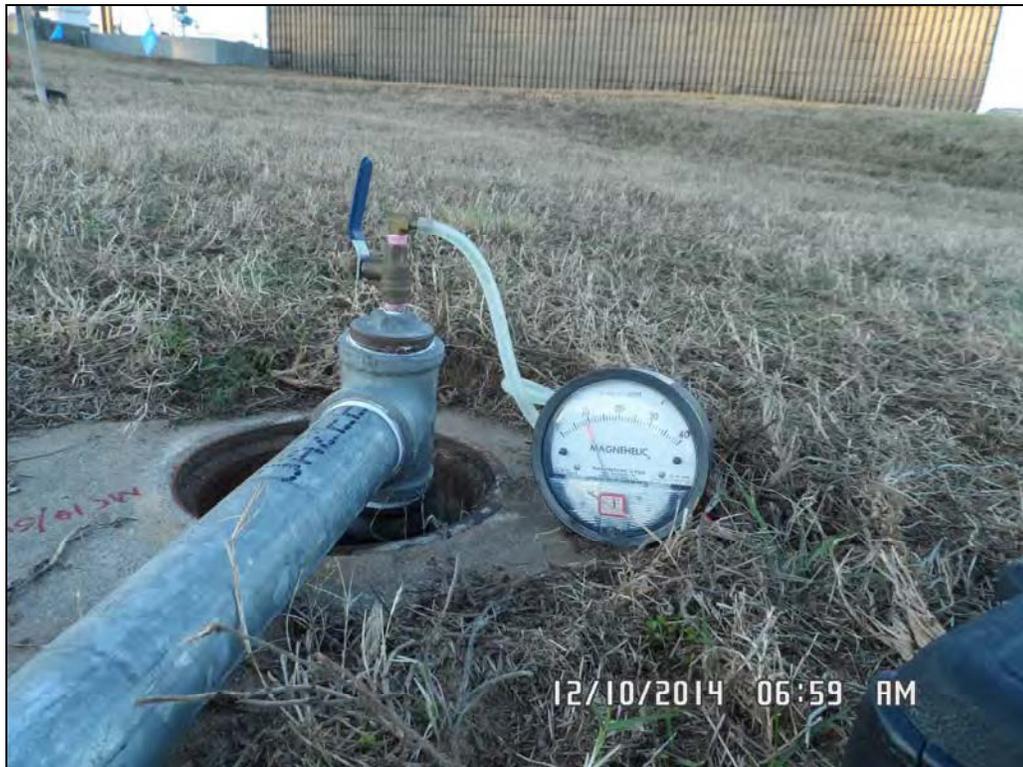
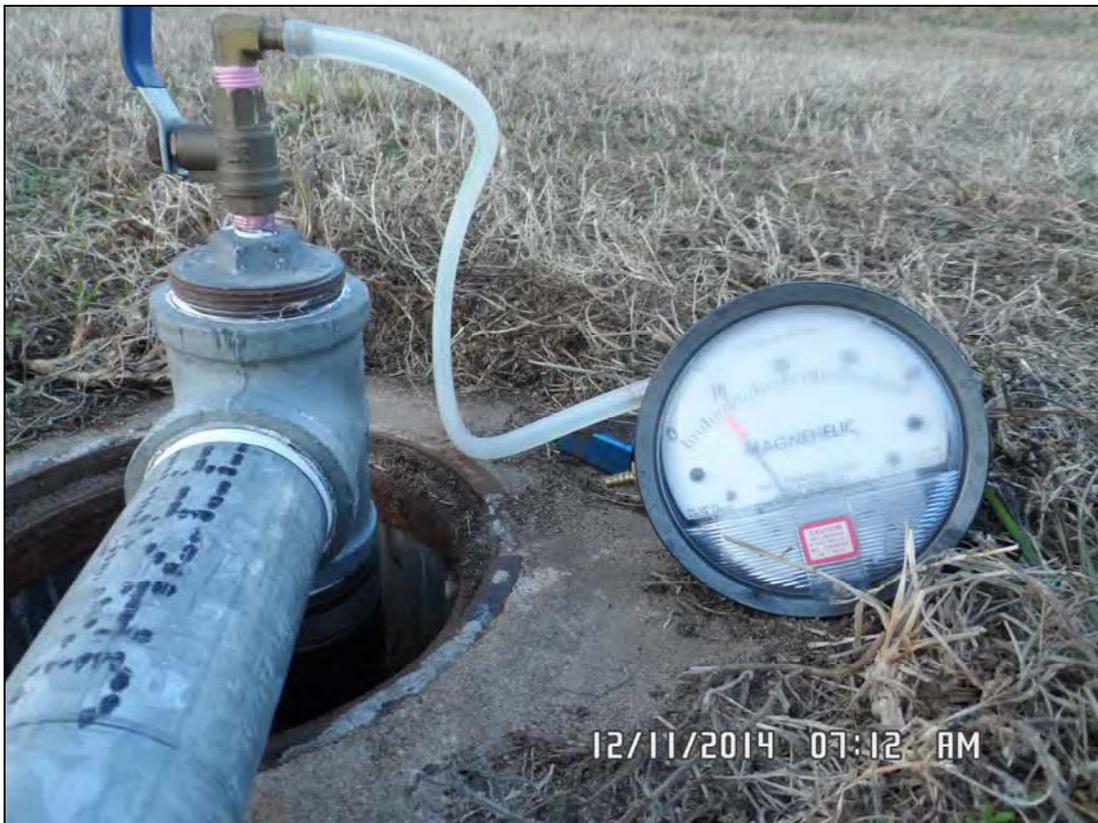
Photo #2 - Pressure at Air Injection Point MC-10

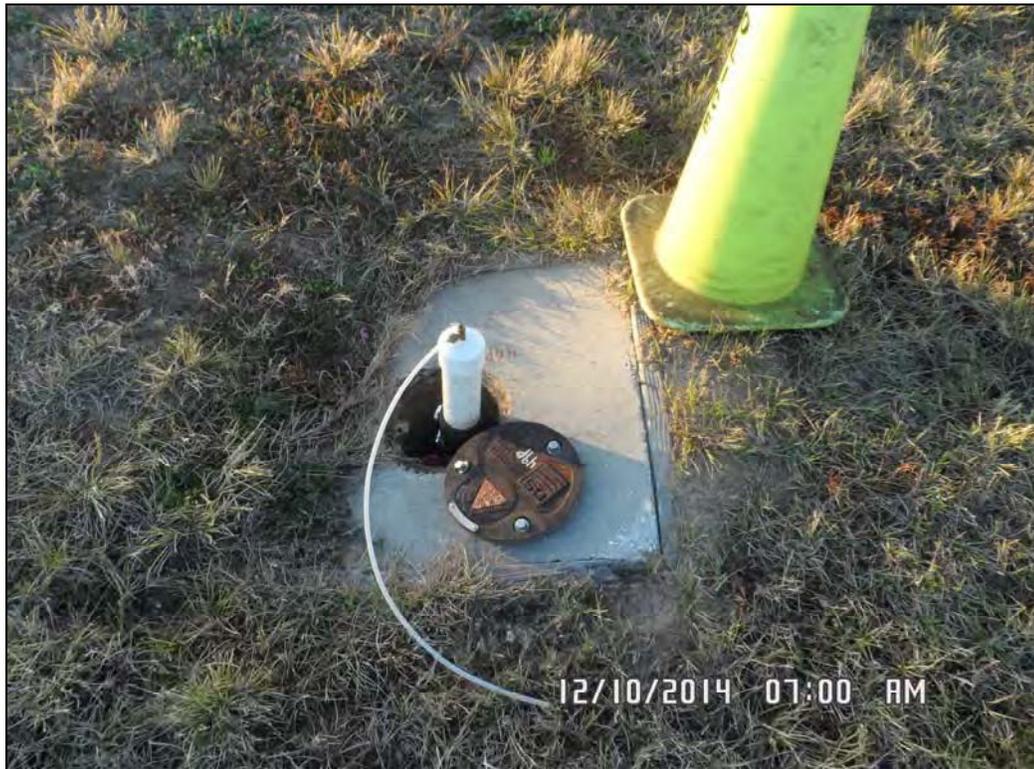
Photo #3 - Damaged MW-49P, Existing Condition

Monitoring well WHF-1467-MW-49P was damaged before the pilot study started, apparently by a heavy truck that ran over the well vault and forced it down onto the well casing. The casing was broken at the cap. The field team installed a rubber sleeve between the casing and the pressure valve extension. When pressure changes readings were not observed in this well, the data from this well was disregarded in estimating the ROI as it could have also been damaged below land surface.

As noted in the previous section, the well casing of monitoring well WHF-1467-MW-49P was damaged and the compromised casing may have extended below the surface, making it impossible for the field team to observe the full extent of the damage. Consequently, data from this well are suspect and were discarded in the evaluation of the oxygen ROI.
