<p>Alameda Point U.S. Navy NFECS Southwest, San Diego, CA</p>
<p>Figure A-2-2 SOLID WASTE MANAGEMENT UNIT INTEGRATION APPROACH RCRA Hazardous Waste Facility Permit EPA ID CA 2170023236 NAS Alameda, Alameda, CA</p>
<p>SWMU Evaluation Report for Economic Development Conveyance Parcel 5</p>

FIGURE A-3-1
SWMUs LOCATED WITHIN
EDC PARCEL 5

COMPILATION OF SOLID WASTE MANAGEMENT
UNIT EVALUATION REPORTS PREVIOUSLY
SUBMITTED WITH CERCLA DOCUMENTS
HAZARDOUS WASTE PERMIT
EPA ID NUMBER CA 2170023236

**ATTACHMENT A
SOLID WASTE MANAGEMENT UNIT
EVALUATION REPORT FOR PUBLIC
BENEFIT CONVEYANCE PARCEL 1A
Hazardous Waste Permit
EPA ID Number CA 2170023236**

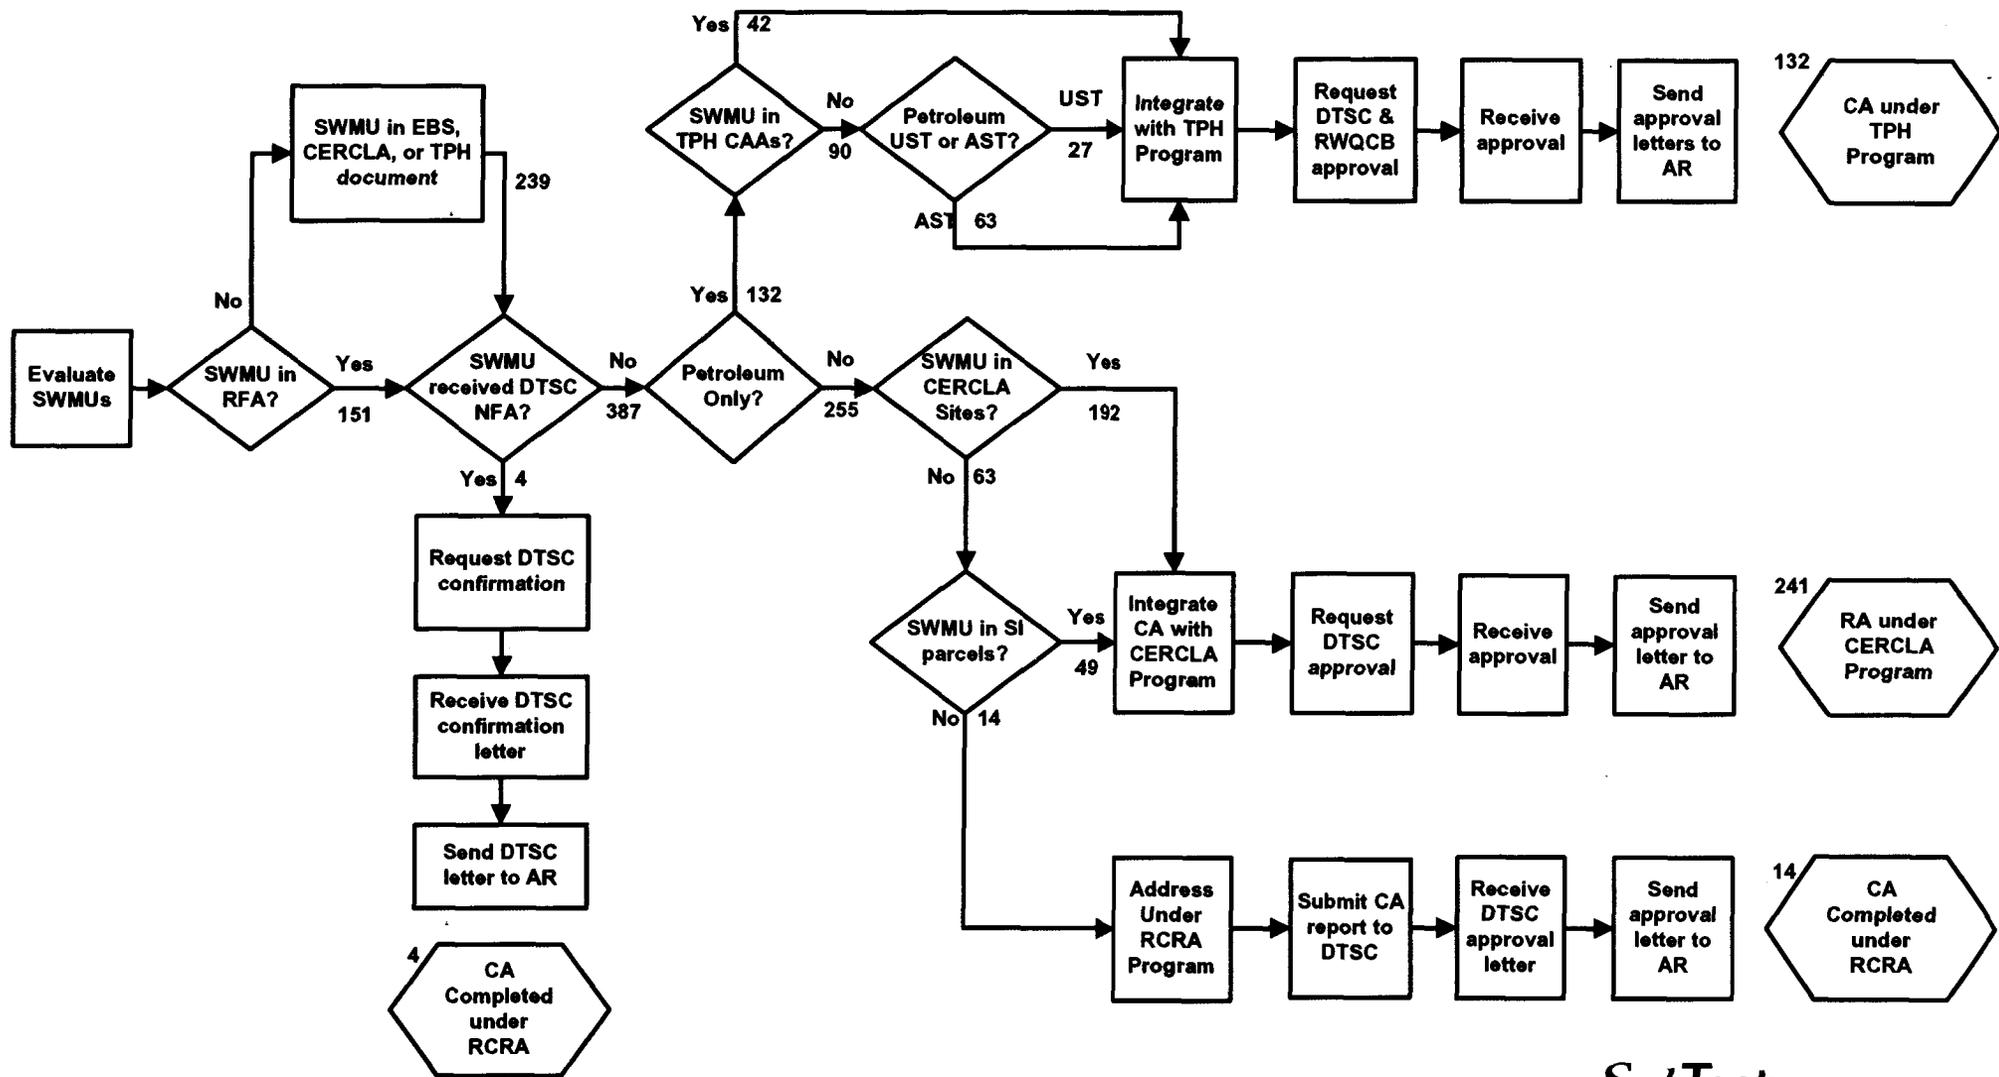
1. SWMUs include CERCLA sites, USTs, ASTs, oil-water separators, washdown areas and underground fuel pipelines but exclude RCRA regulated units
2. Numbers indicate number of SWMUs

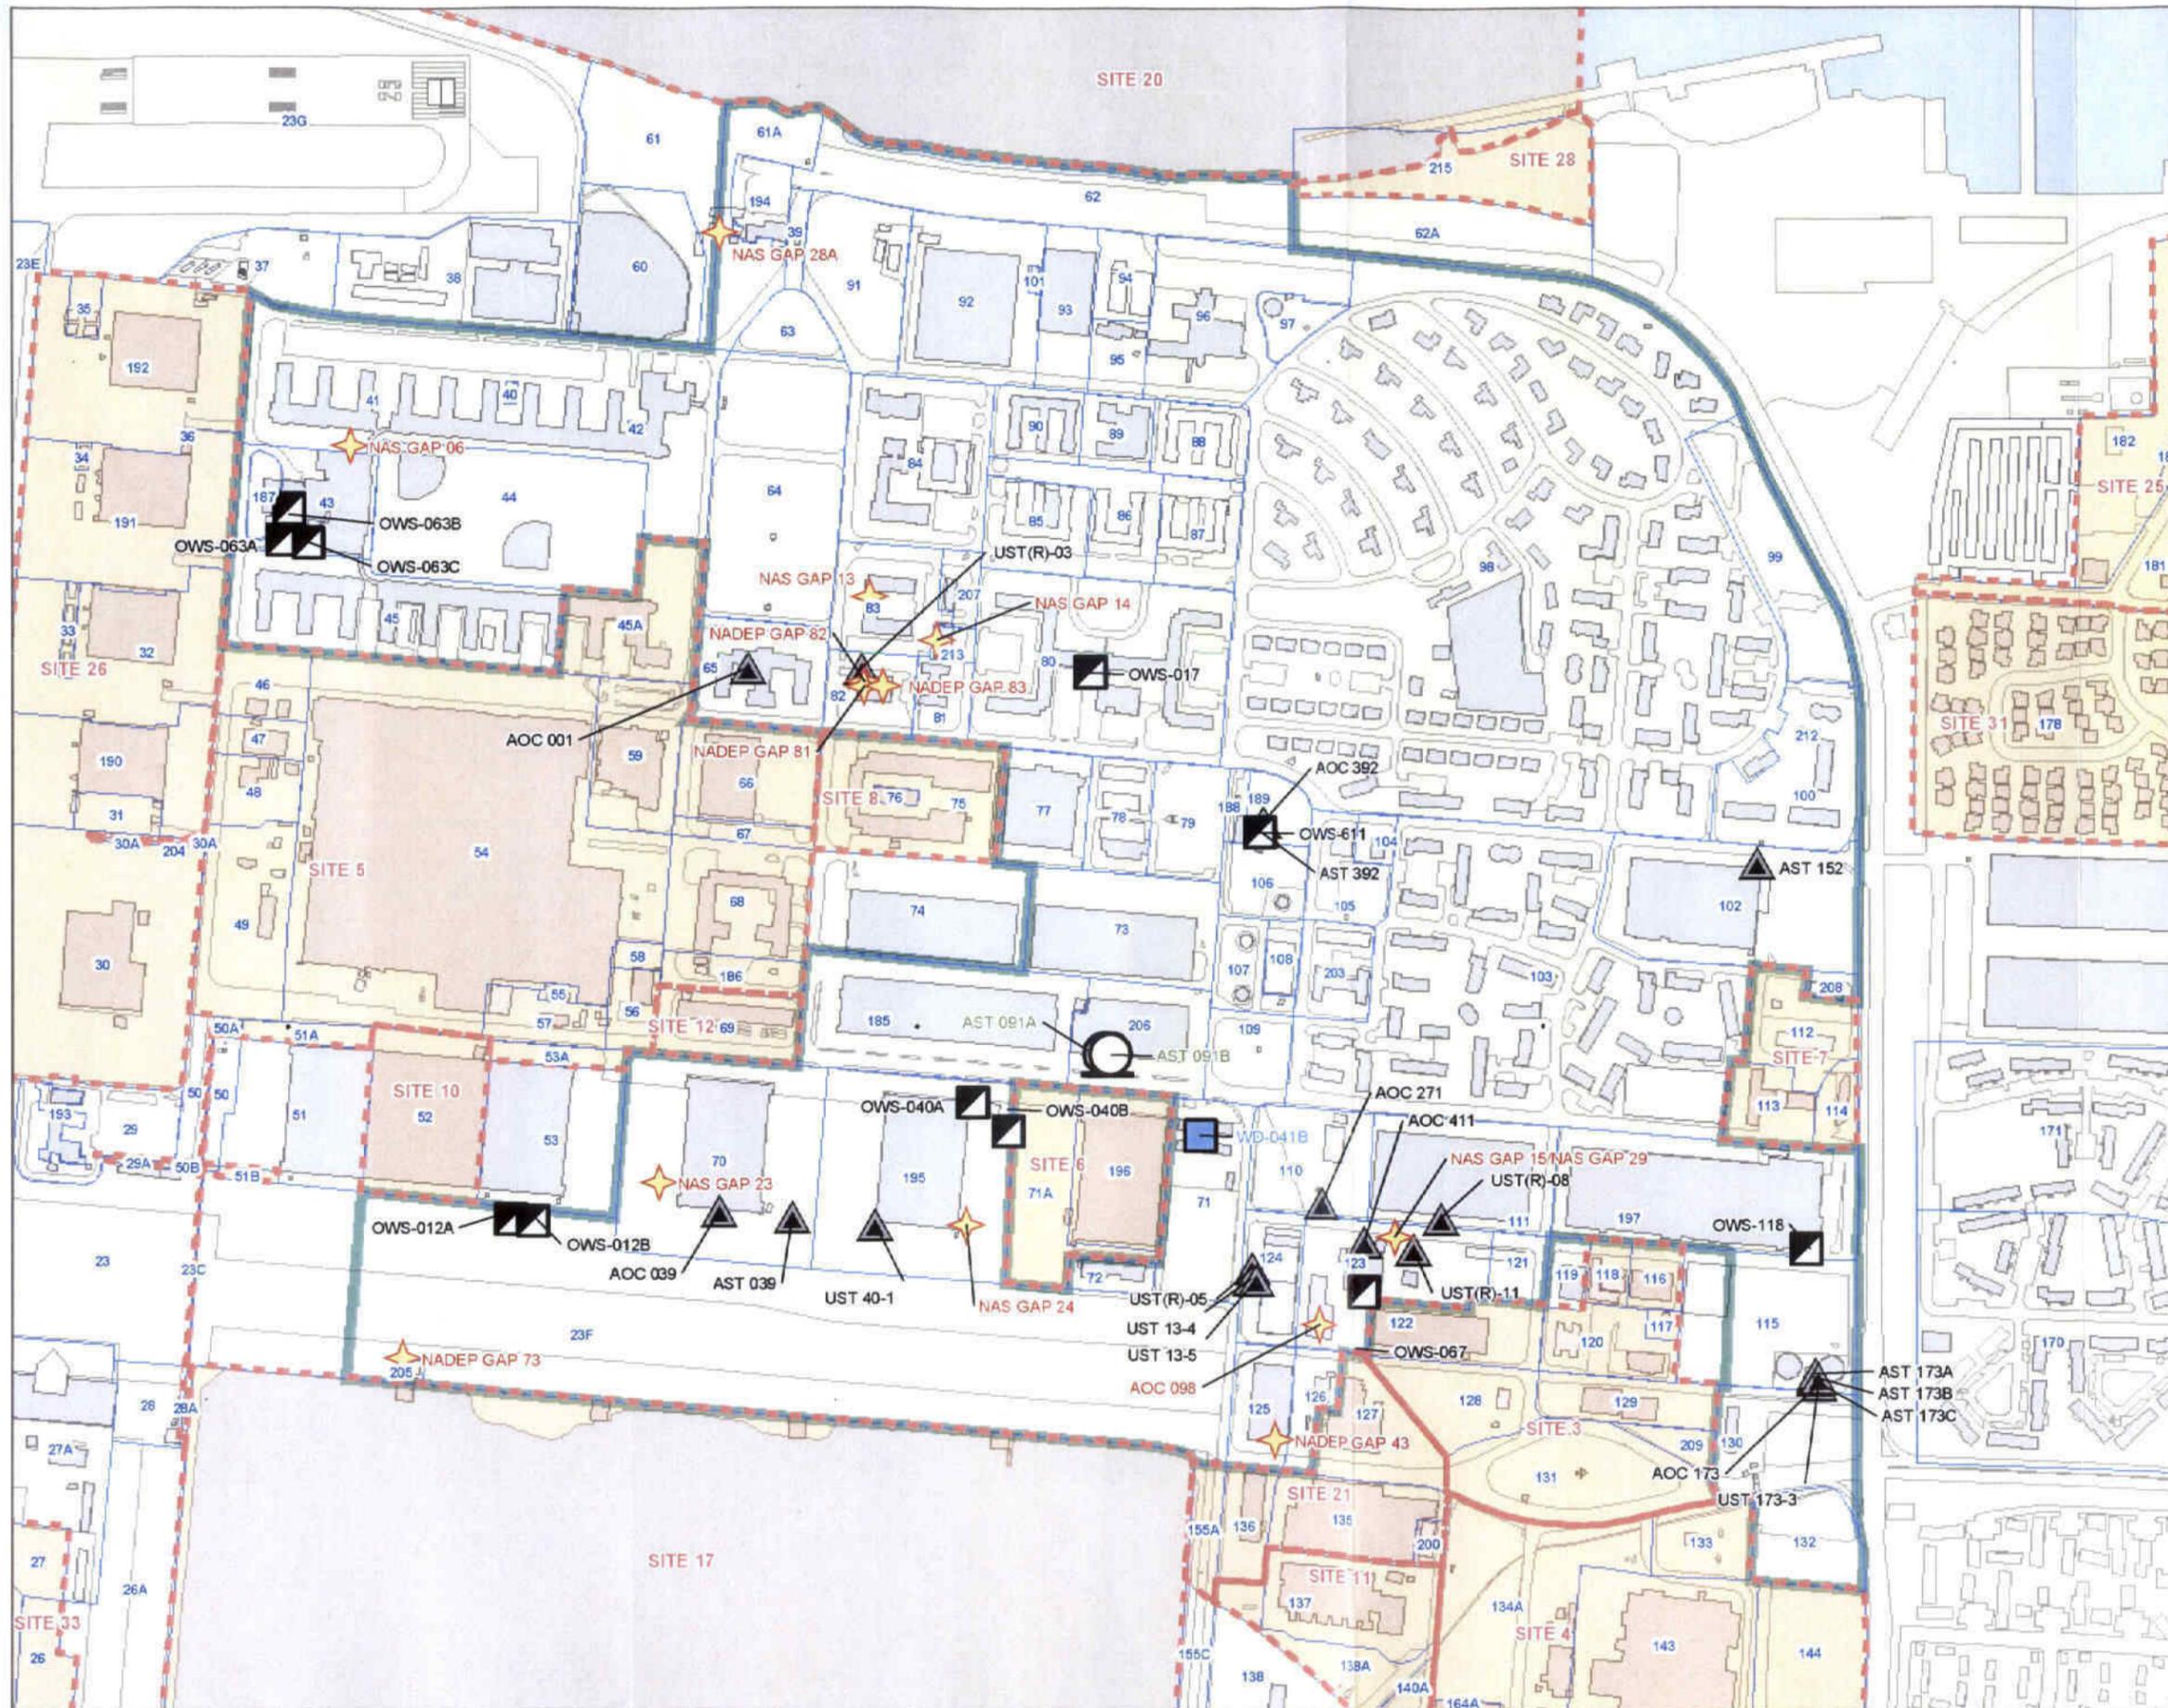
- DISPOSAL PARCEL EDC-05
- CERCLA SITE
- ENVIRONMENTAL BASELINE SURVEY (EBS) PARCEL
- GENERATION ACCUMULATION POINT (GAP)
- OIL-WATER SEPARATOR (OWS)
- WASHDOWN (WD) AREA
- ABOVEGROUND STORAGE TANK (AST), REMOVED
- SWMUs INTEGRATED WITH THE TPH PROGRAM
- LAND COVER
- BUILDING
- Present
- Removed

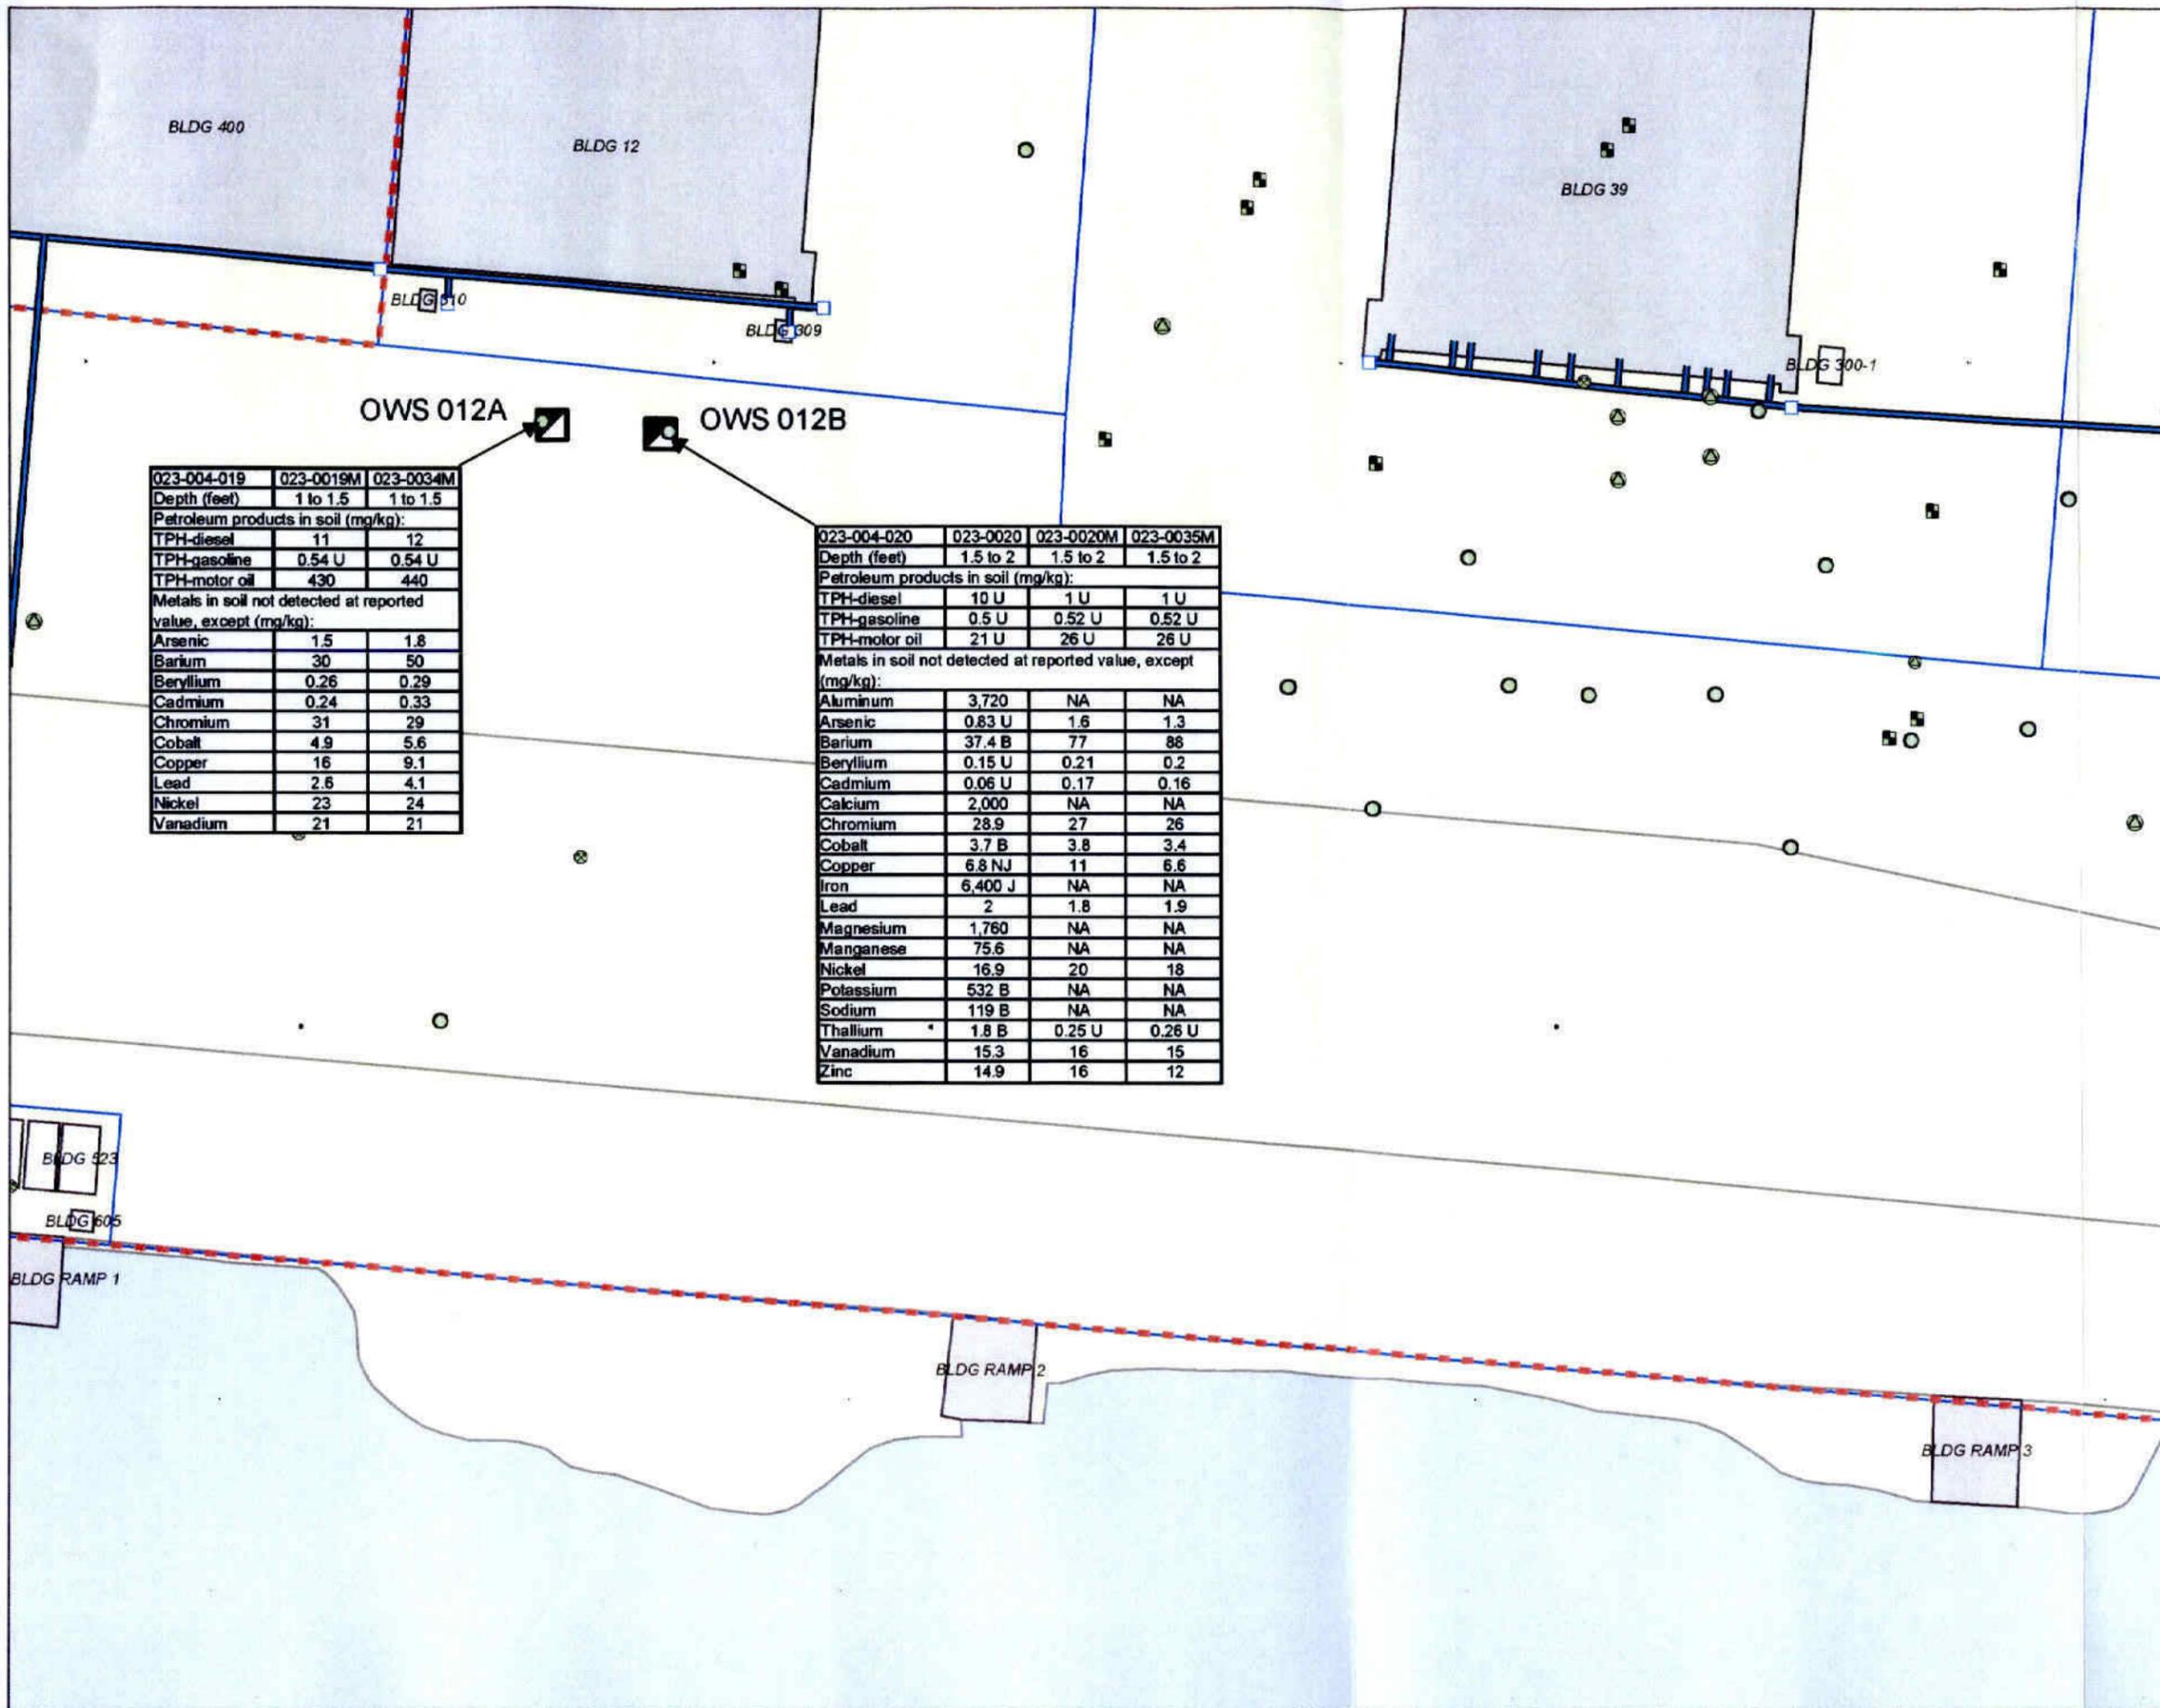
FIGURE A-3-2
EBS PARCEL 23F
OWS-012A & OWS-012B SAMPLE RESULTS

- SAMPLING LOCATIONS**
- ⊗ Direct-Push
 - Soil Boring
 - ⊗ Excavation
 - Surface Location
- OIL-WATER SEPARATOR (OWS)**
- ▣ Catch Basin
 - Manhole
 - Storm Sewer Line
- CERCLA SITE**
- ▭ Environmental Baseline Survey (EBS) Parcel
 - ▭ Land Cover
- BUILDING**
- ▭ Present
 - ▭ Removed

EBS Subparcel	Identification	Navy Recommendation/ Closure Status	Refer to Figure for Sample Results
23F	OWS 012A	NFA recommended	Figure A-3-2
23F	OWS 012B	NFA Recommended	Figure A-3-2
41	NAS GAP 06	NFA Recommended by DTSC (2004)	Figure A-3-3
43	OWS 063A	NFA Recommended	Figure A-3-4
43	OWS 063B	Further Action Recommended	Figure A-3-4
43	OWS 063C	NFA Recommended	Figure A-3-4
61A	NAS GAP 28A	NFA Recommended by DTSC (2004)	Figure A-3-5
70	NAS GAP 23	NFA Recommended by DTSC (2004)	Figure A-3-6
71	WD 041B	NFA Recommended	Figure A-3-7
80	OWS 017	NFA Recommended	NA
82	NADEP GAP 81	NFA Recommended by DTSC (2004)	NA
82	NADEP GAP 82	NFA Recommended by DTSC (2004)	NA
82	NADEP GAP 83	NFA Recommended by DTSC (2004)	NA
83	NAS GAP 13	NFA Recommended by DTSC (2004)	NA
123	AOC 098	NFA Recommended	Figure A-3-8
123	NAS GAP 15/NAS GAP 29	NFA Recommended	Figure A-3-9
123	OWS 067	Further Action Recommended	Figure A-3-8
125	NADEP GAP 43	NFA Recommended by DTSC (2004)	Figure A-3-10

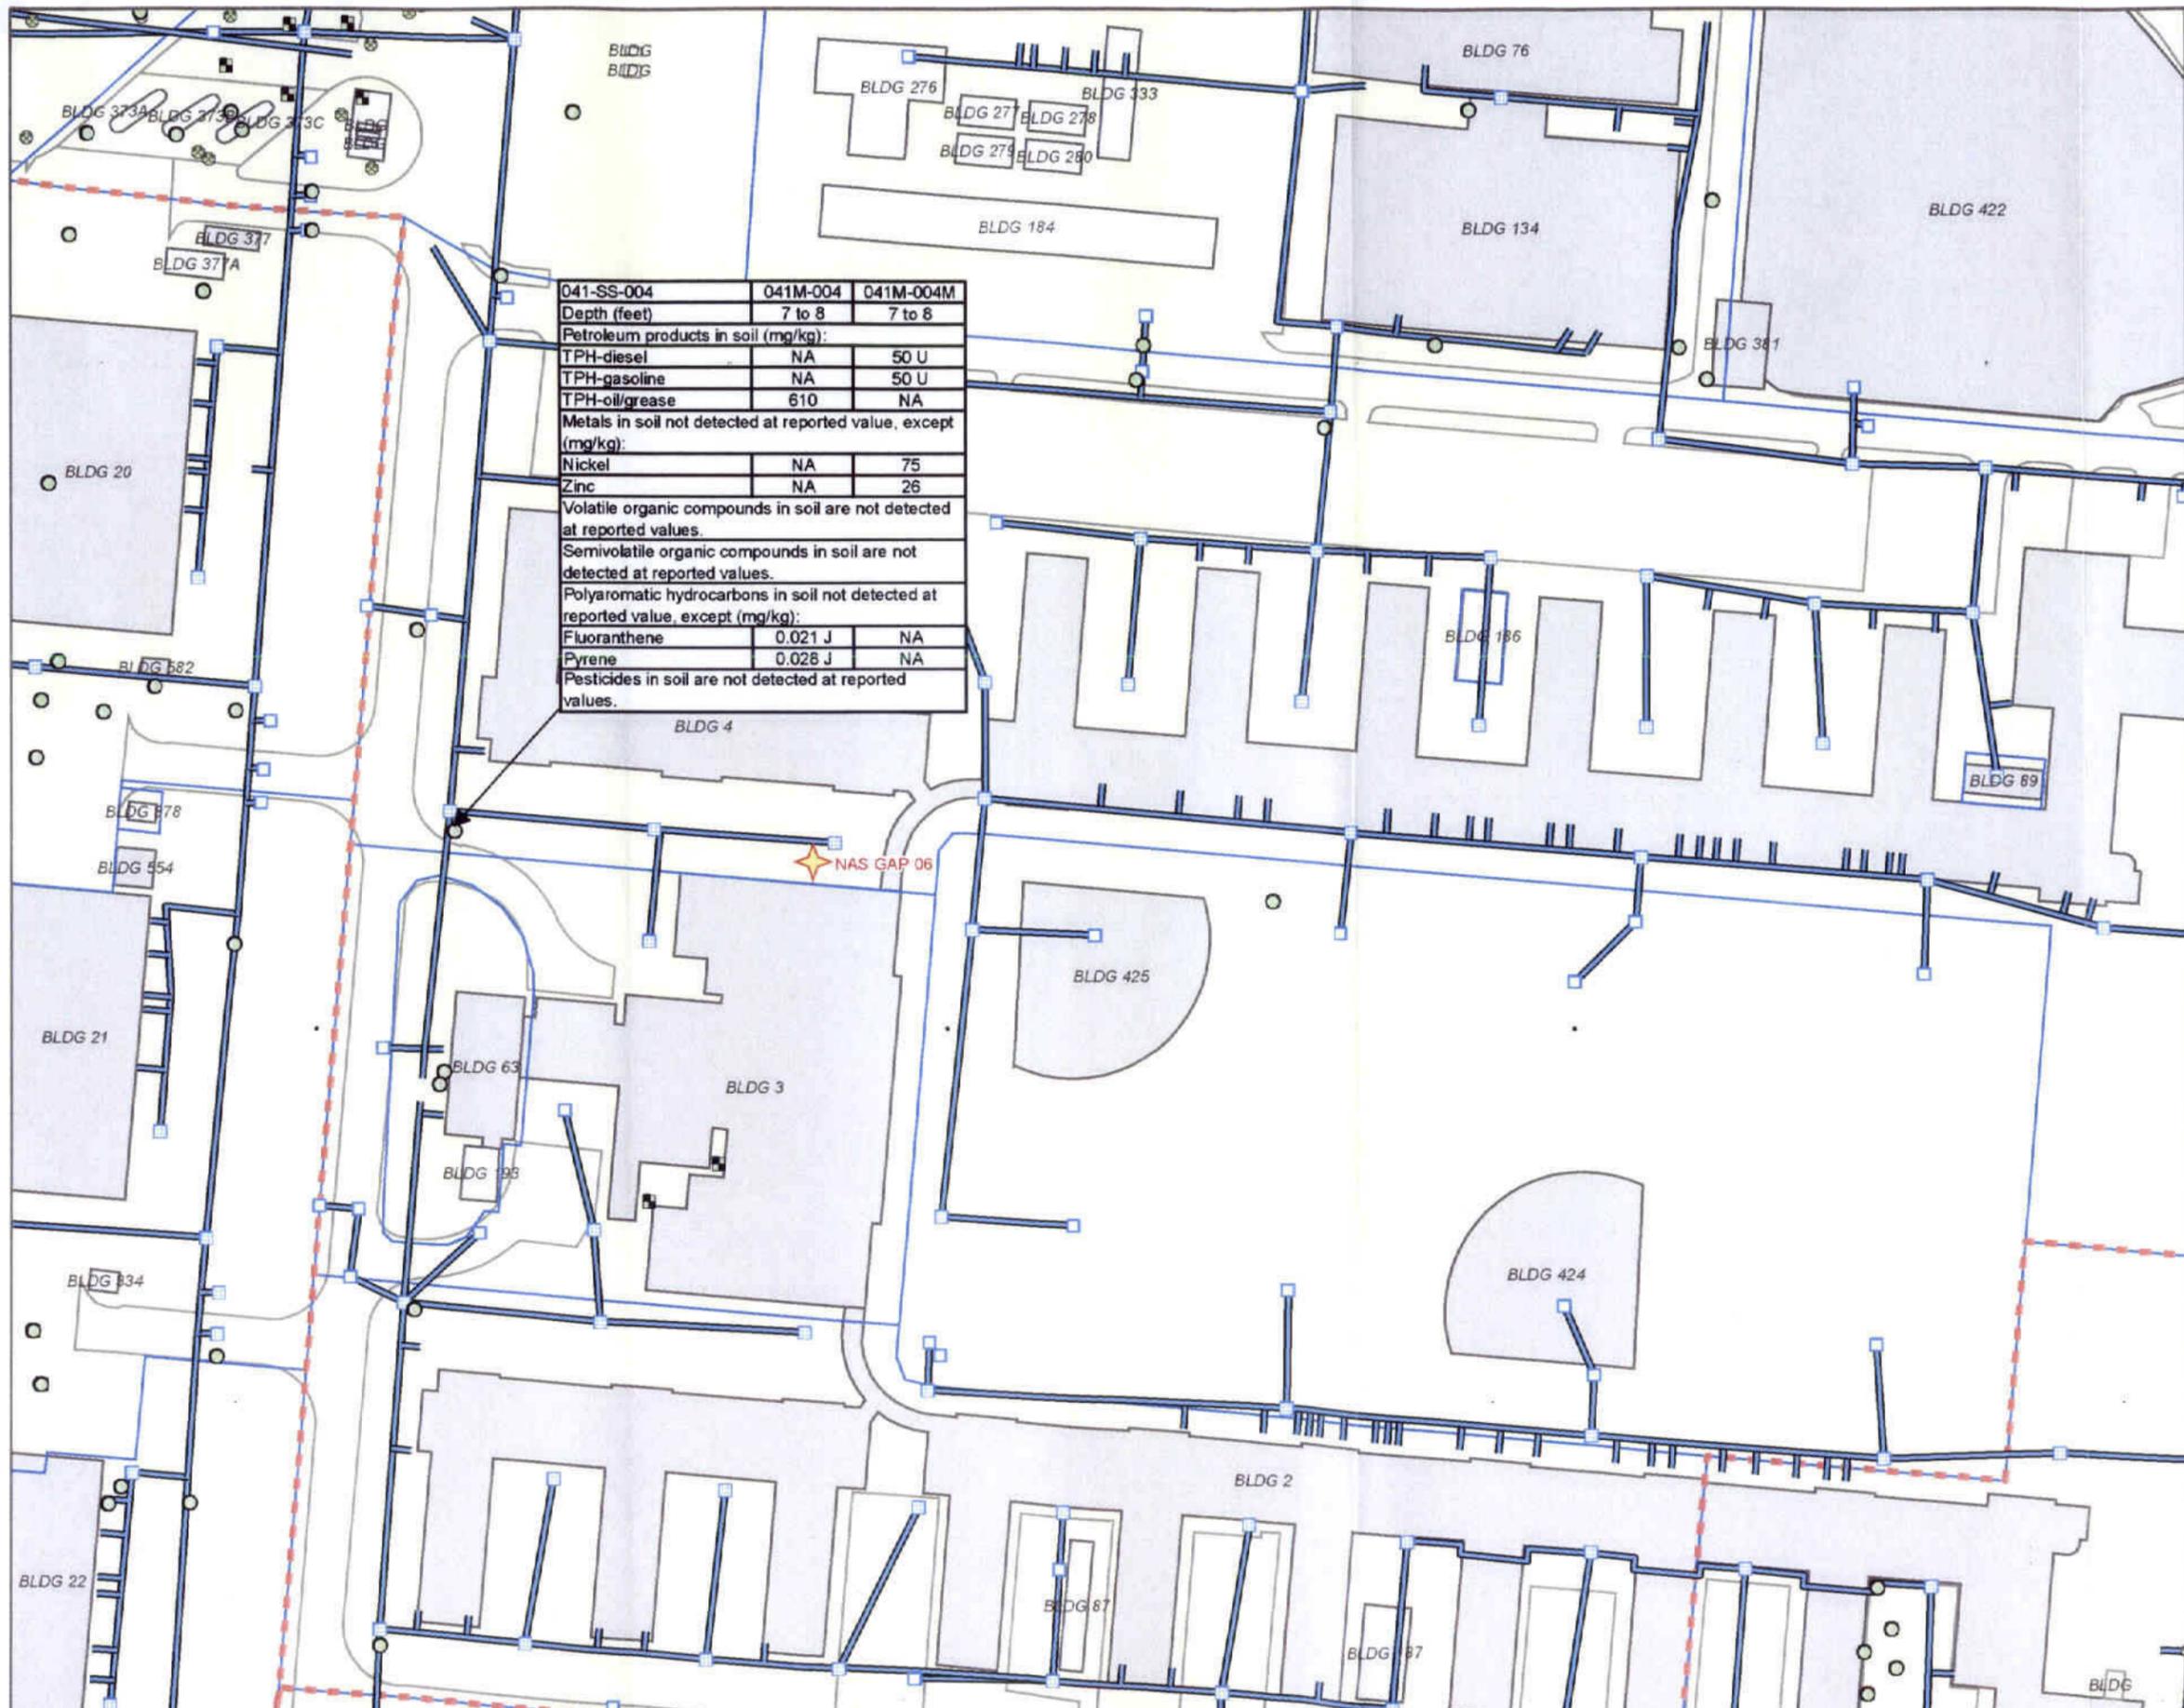
FIGURE A-3-3
EBS PARCEL 41
NAS GAP 06 SAMPLE RESULTS

- SAMPLING LOCATIONS**
- ⊗ Excavation
 - Soil Boring
 - Surface Location
 - ★ GENERATION ACCUMULATION POINT (GAP)
 - CATCH BASIN
 - MANHOLE
 - STORM SEWER LINE
 - ⋯ CERCLA SITE
 - ▭ ENVIRONMENTAL BASELINE SURVEY (EBS) PARCEL
 - ▭ LAND COVER
- BUILDING**
- ▭ Present
 - ▭ Removed

SWMU Identifier **NAS GAP 06** **Refer to Figure #** Figure A-3-3
Navy Recommendation/Closure Status **NFA Recommended by DTSC (2004)**

NAS GAP 06 was located between Buildings 3 and 4 east of First Street in parcel 41, which is included in Zone 09 of the EBS. This SWMU consisted of three metal cabinets or sheds used to store various size containers of paint and paint thinners. The RCRA Part B Corrective Action Schedule of Compliance required further investigation for this SWMU. NAS GAP 06 was evaluated under Phase 1 of the EBS (site inspection activities), and further investigation was not recommended. A letter from DTSC dated November 4, 1999 recommended NFA for this SWMU (DTSC 1999). As shown on the parcel 41 figure, the nearest sample (041-SS-004) to NAS GAP 06 with applicable data is approximately 200 feet from the SWMU. Analytes detected at this sample point are below residential PRCs and EPA 2002 PRGs (EPA 2002). NFA is recommended for NAS GAP 06.

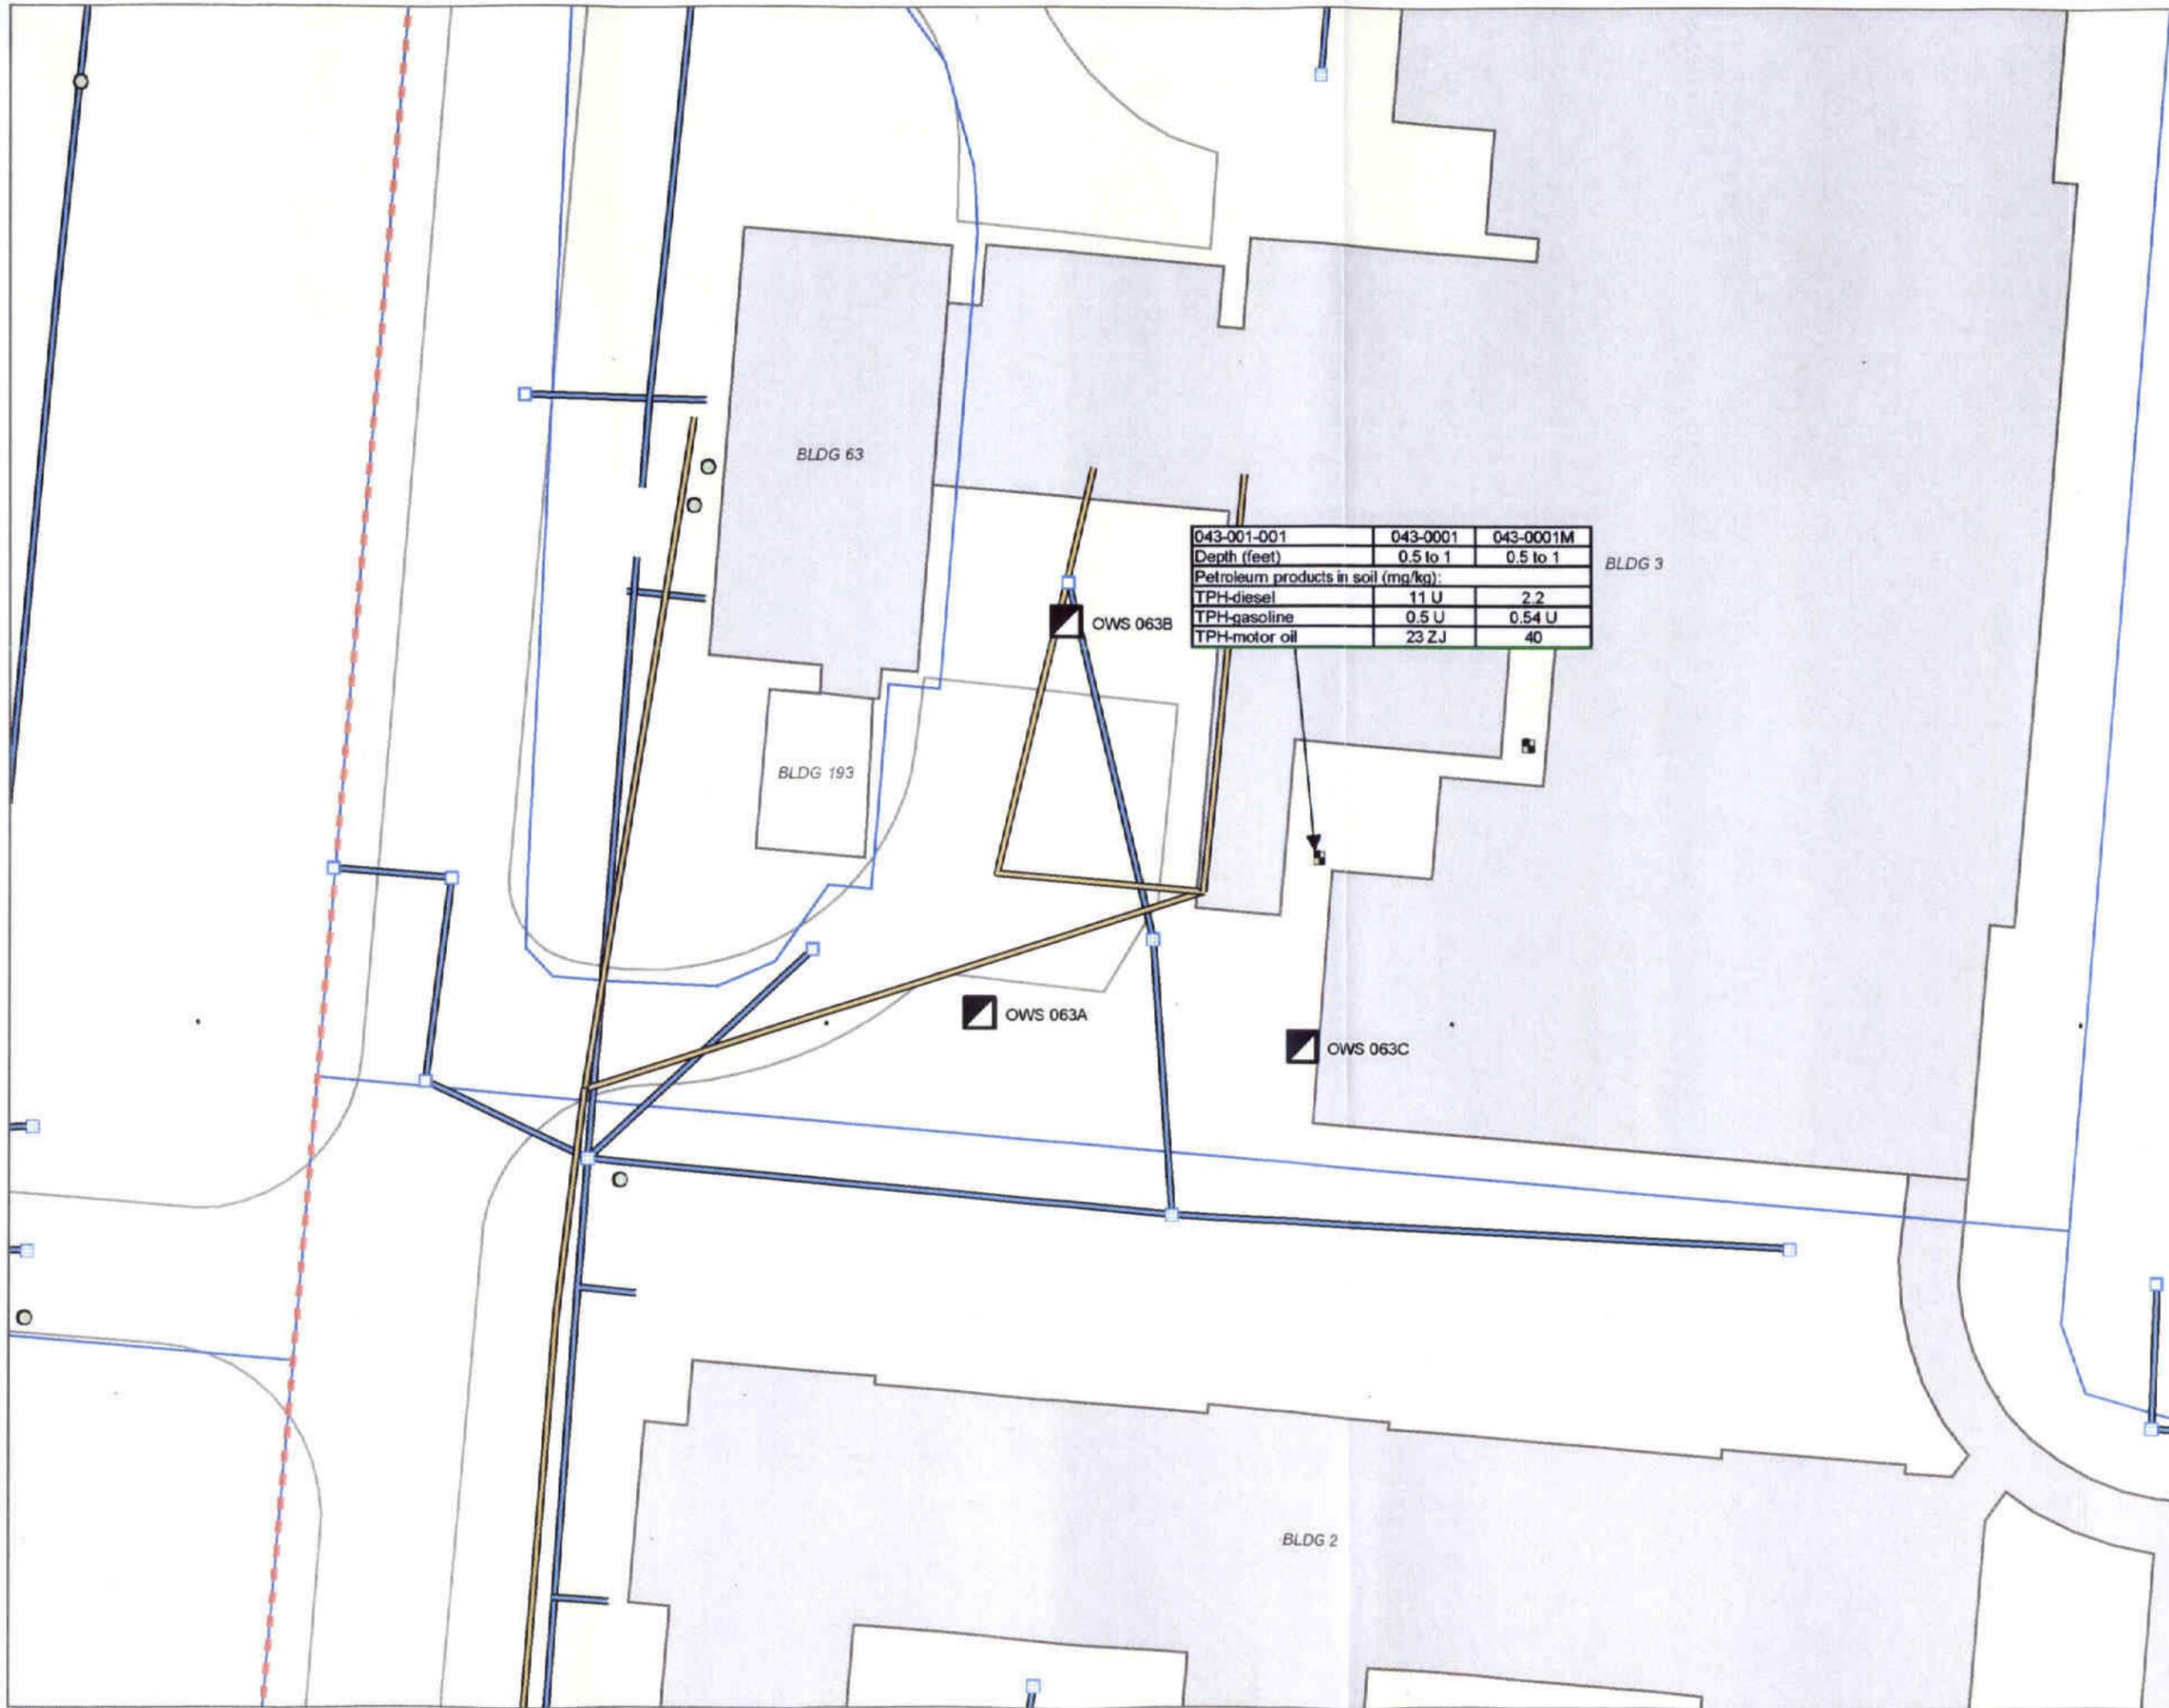
FIGURE A-3-4
EBS PARCEL 43
OWS-063A & OWS-063B & OWS-063C
SAMPLE RESULTS

- SAMPLING LOCATIONS**
- Soil Boring
 - Surface Location
 - ▣ OIL-WATER SEPARATOR (OWS)
 - CATCH BASIN
 - MANHOLE
 - SANITARY SEWER LINE
 - STORM SEWER LINE
 - ⋯ CERCLA SITE
 - ENVIRONMENTAL BASELINE SURVEY (EBS) PARCEL
 - LAND COVER
- BUILDING**
- Present
 - Removed

OWS 063A is located at the southern end of the courtyard east of Building 63, which is part of parcel 43 in Zone 09 of the EBS. OWS 063A was a grease pit for the rear kitchen located in Building 3 and no hazardous materials were managed in the SWMU. No target area was established to investigate the OWS during the EBS. As shown on the parcel 43 figure, the closest soil sample analyzed for petroleum products (043-001-001) is located approximately 80 feet northeast of the OWS. This location reported TPH concentrations of diesel and motor oil detected below residential PRCs (IT 2001). NFA is recommended for OWS 063A.

OWS was observed during the 2002 site visit; it was inactive.

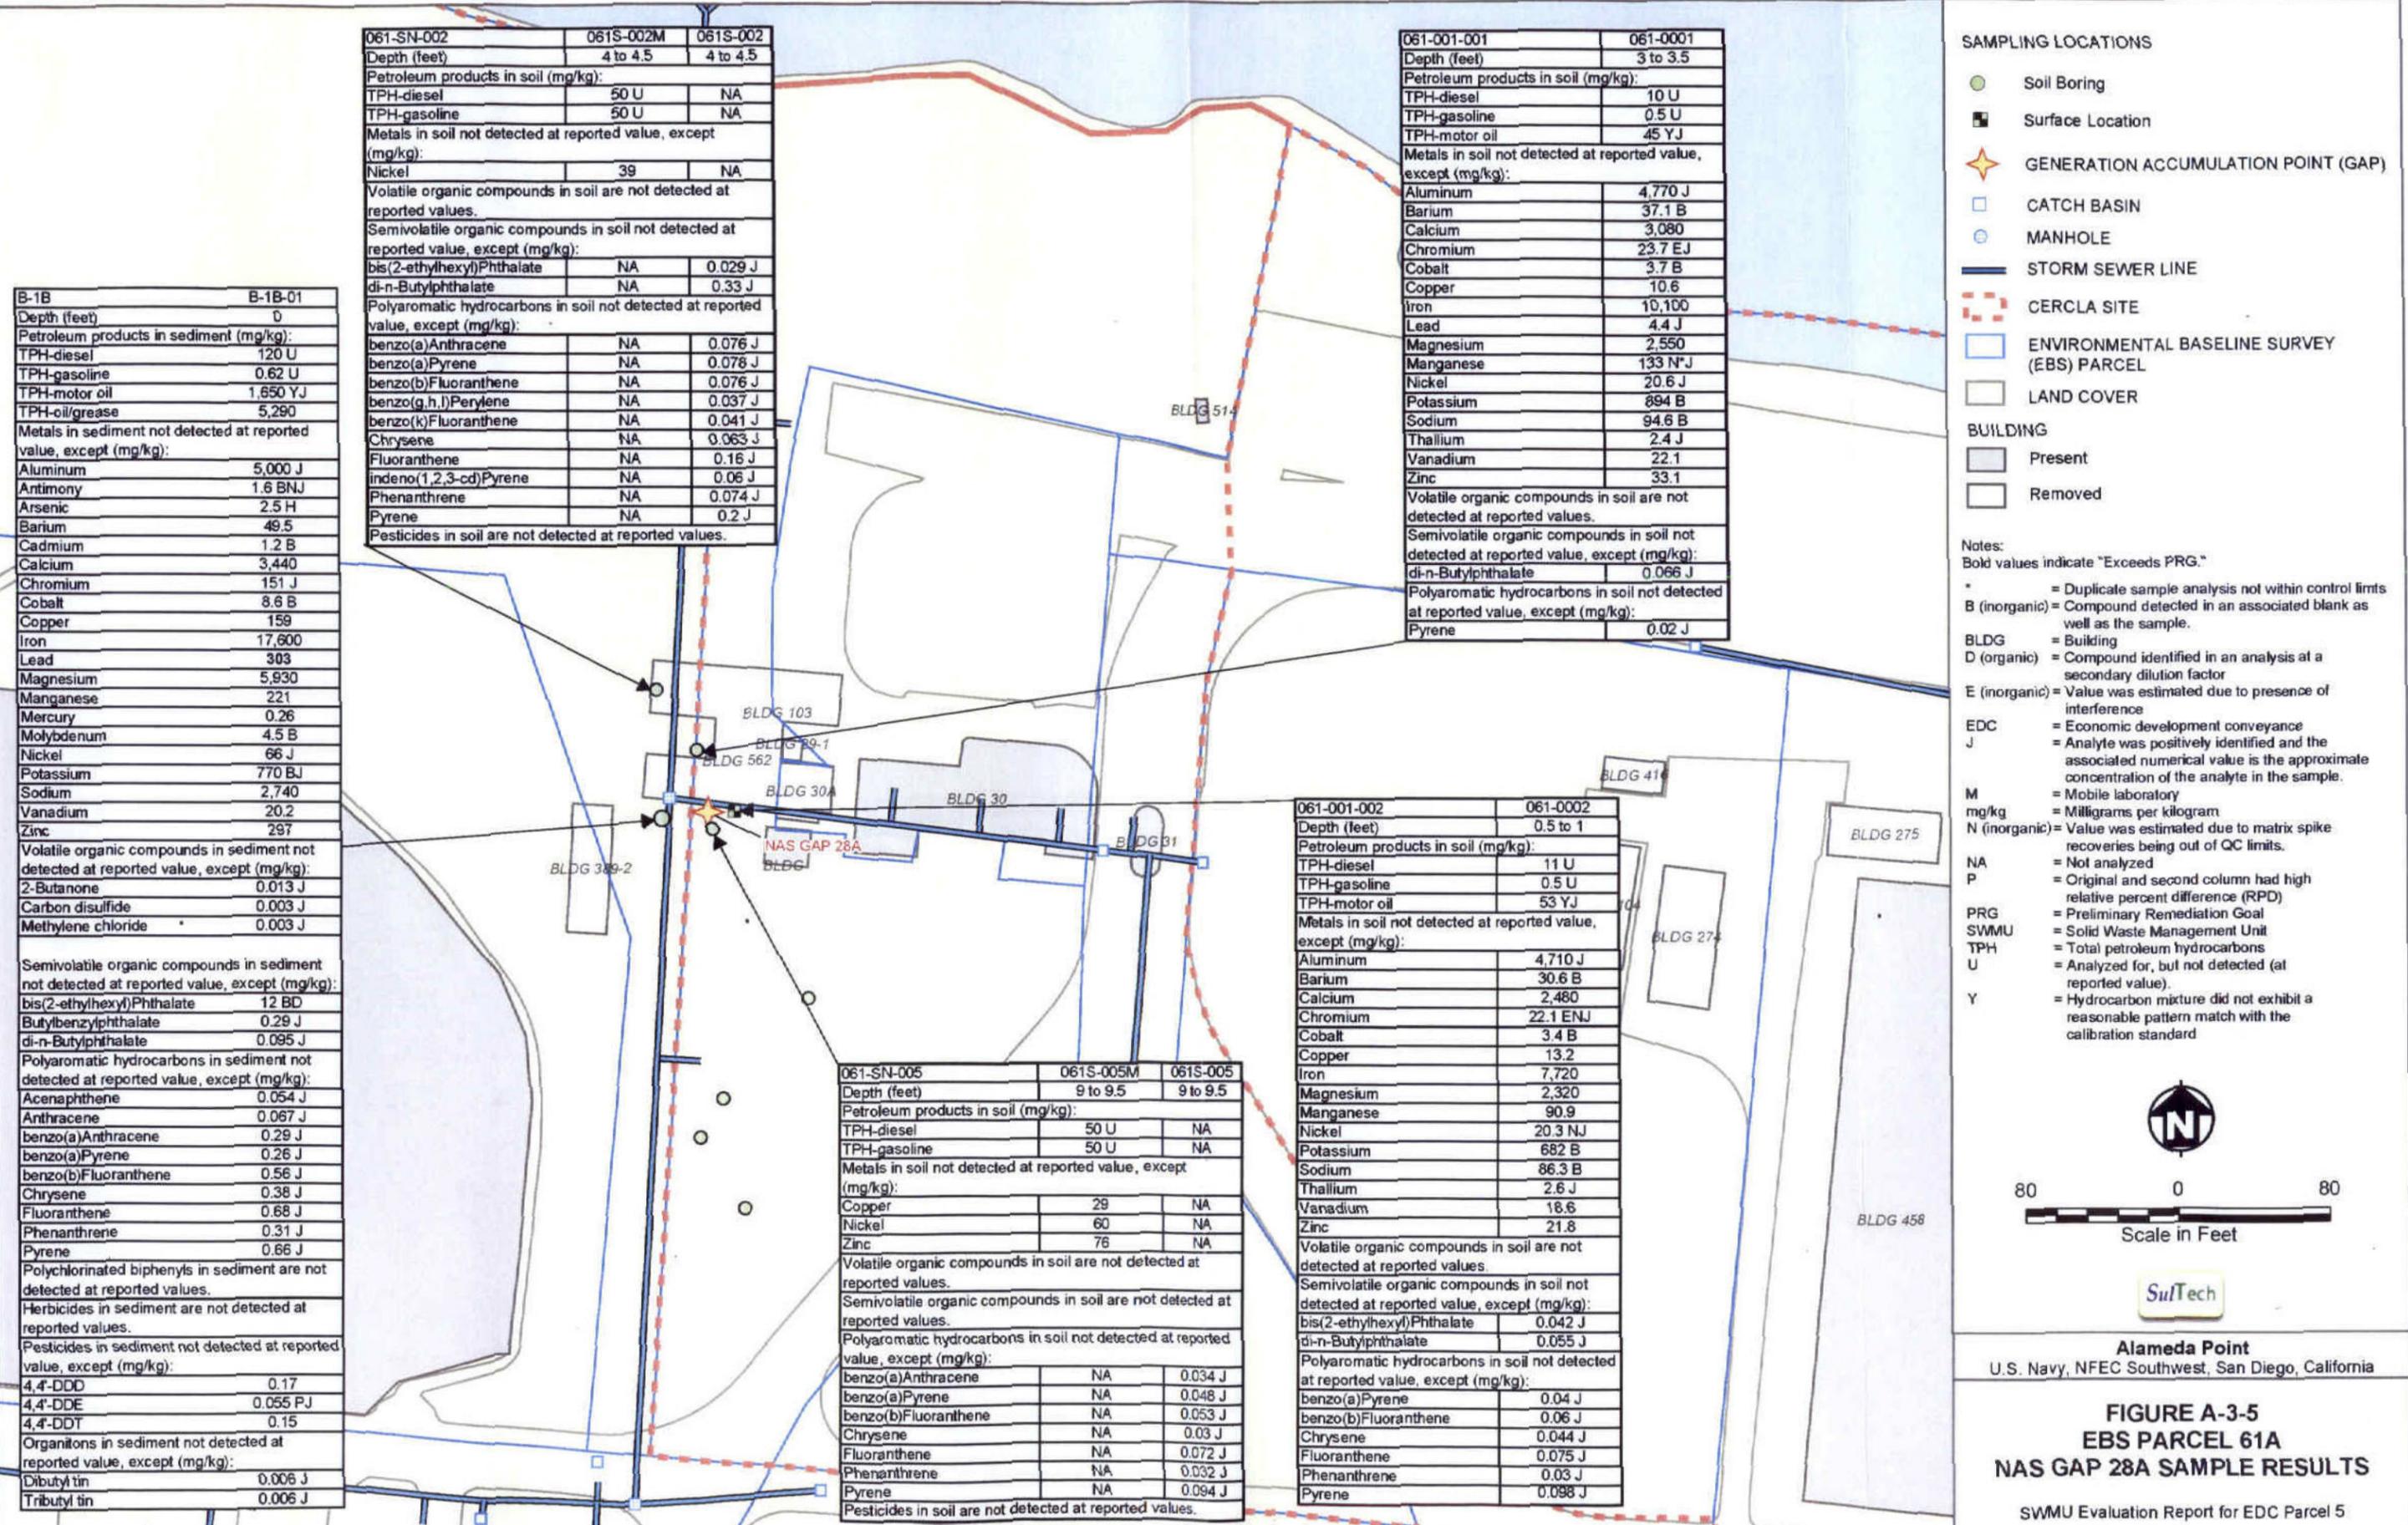
Alameda Point
 U.S. Navy, NFEC Southwest, San Diego, California
FIGURE A-3-5
EBS PARCEL 61A
NAS GAP 28A SAMPLE RESULTS
 SWMU Evaluation Report for EDC Parcel 5

061-SN-002	061S-002M	061S-002
Depth (feet)	4 to 4.5	4 to 4.5
Petroleum products in soil (mg/kg):		
TPH-diesel	50 U	NA
TPH-gasoline	50 U	NA
Metals in soil not detected at reported value, except (mg/kg):		
Nickel	39	NA
Volatile organic compounds in soil are not detected at reported values.		
Semivolatile organic compounds in soil not detected at reported value, except (mg/kg):		
bis(2-ethylhexyl)Phthalate	NA	0.029 J
di-n-Butylphthalate	NA	0.33 J
Polyaromatic hydrocarbons in soil not detected at reported value, except (mg/kg):		
benzo(a)Anthracene	NA	0.076 J
benzo(a)Pyrene	NA	0.078 J
benzo(b)Fluoranthene	NA	0.076 J
benzo(g,h,i)Perylene	NA	0.037 J
benzo(k)Fluoranthene	NA	0.041 J
Chrysene	NA	0.063 J
Fluoranthene	NA	0.16 J
indeno(1,2,3-cd)Pyrene	NA	0.06 J
Phenanthrene	NA	0.074 J
Pyrene	NA	0.2 J
Pesticides in soil are not detected at reported values.

061-001-001	061-0001
Depth (feet)	3 to 3.5
Petroleum products in soil (mg/kg):	
TPH-diesel	10 U
TPH-gasoline	0.5 U
TPH-motor oil	45 YJ
Metals in soil not detected at reported value, except (mg/kg):	
Aluminum	4,770 J
Barium	37.1 B
Calcium	3,080
Chromium	23.7 EJ
Cobalt	3.7 B
Copper	10.6
Iron	10,100
Lead	4.4 J
Magnesium	2,550
Manganese	133 N*J
Nickel	20.6 J
Potassium	894 B
Sodium	94.6 B
Thallium	2.4 J
Vanadium	22.1
Zinc	33.1
Volatile organic compounds in soil are not detected at reported values.	
Semivolatile organic compounds in soil not detected at reported value, except (mg/kg):	
di-n-Butylphthalate	0.066 J
Polyaromatic hydrocarbons in soil not detected at reported value, except (mg/kg):	
Pyrene	0.02 J

SWMU Identifier **NAS GAP 28A** **Refer to Figure #** Figure A-3-5
Navy Recommendation/Closure Status **NFA Recommended by DTSC (2004)**

Disposal Parcel EDC 05 **CERCLA Site** 35
EBS Subparcel 61A **TPH CAA** NA
Associated Building 562 **Building Status** Present **Leasing Status** Not leased by ARRA
Building Name Sewage Industrial Waste Pump Station LS #1
Additional Information Building 562; hazardous material storage surrounding the building; approximate location shown on figure
