<p>Alameda Point U.S. Navy NFECS Southwest, San Diego, CA</p>
<p>Figure A-2-2 SOLID WASTE MANAGEMENT UNIT INTEGRATION APPROACH RCRA Hazardous Waste Facility Permit EPA ID CA 2170023236 NAS Alameda, Alameda, CA</p>
<p>SWMU Evaluation Report for Economic Development Conveyance Parcel 5</p>

FIGURE A-3-1
SWMUs LOCATED WITHIN
EDC PARCEL 5

COMPILATION OF SOLID WASTE MANAGEMENT
UNIT EVALUATION REPORTS PREVIOUSLY
SUBMITTED WITH CERCLA DOCUMENTS
HAZARDOUS WASTE PERMIT
EPA ID NUMBER CA 2170023236

**ATTACHMENT A
SOLID WASTE MANAGEMENT UNIT
EVALUATION REPORT FOR PUBLIC
BENEFIT CONVEYANCE PARCEL 1A
Hazardous Waste Permit
EPA ID Number CA 2170023236**

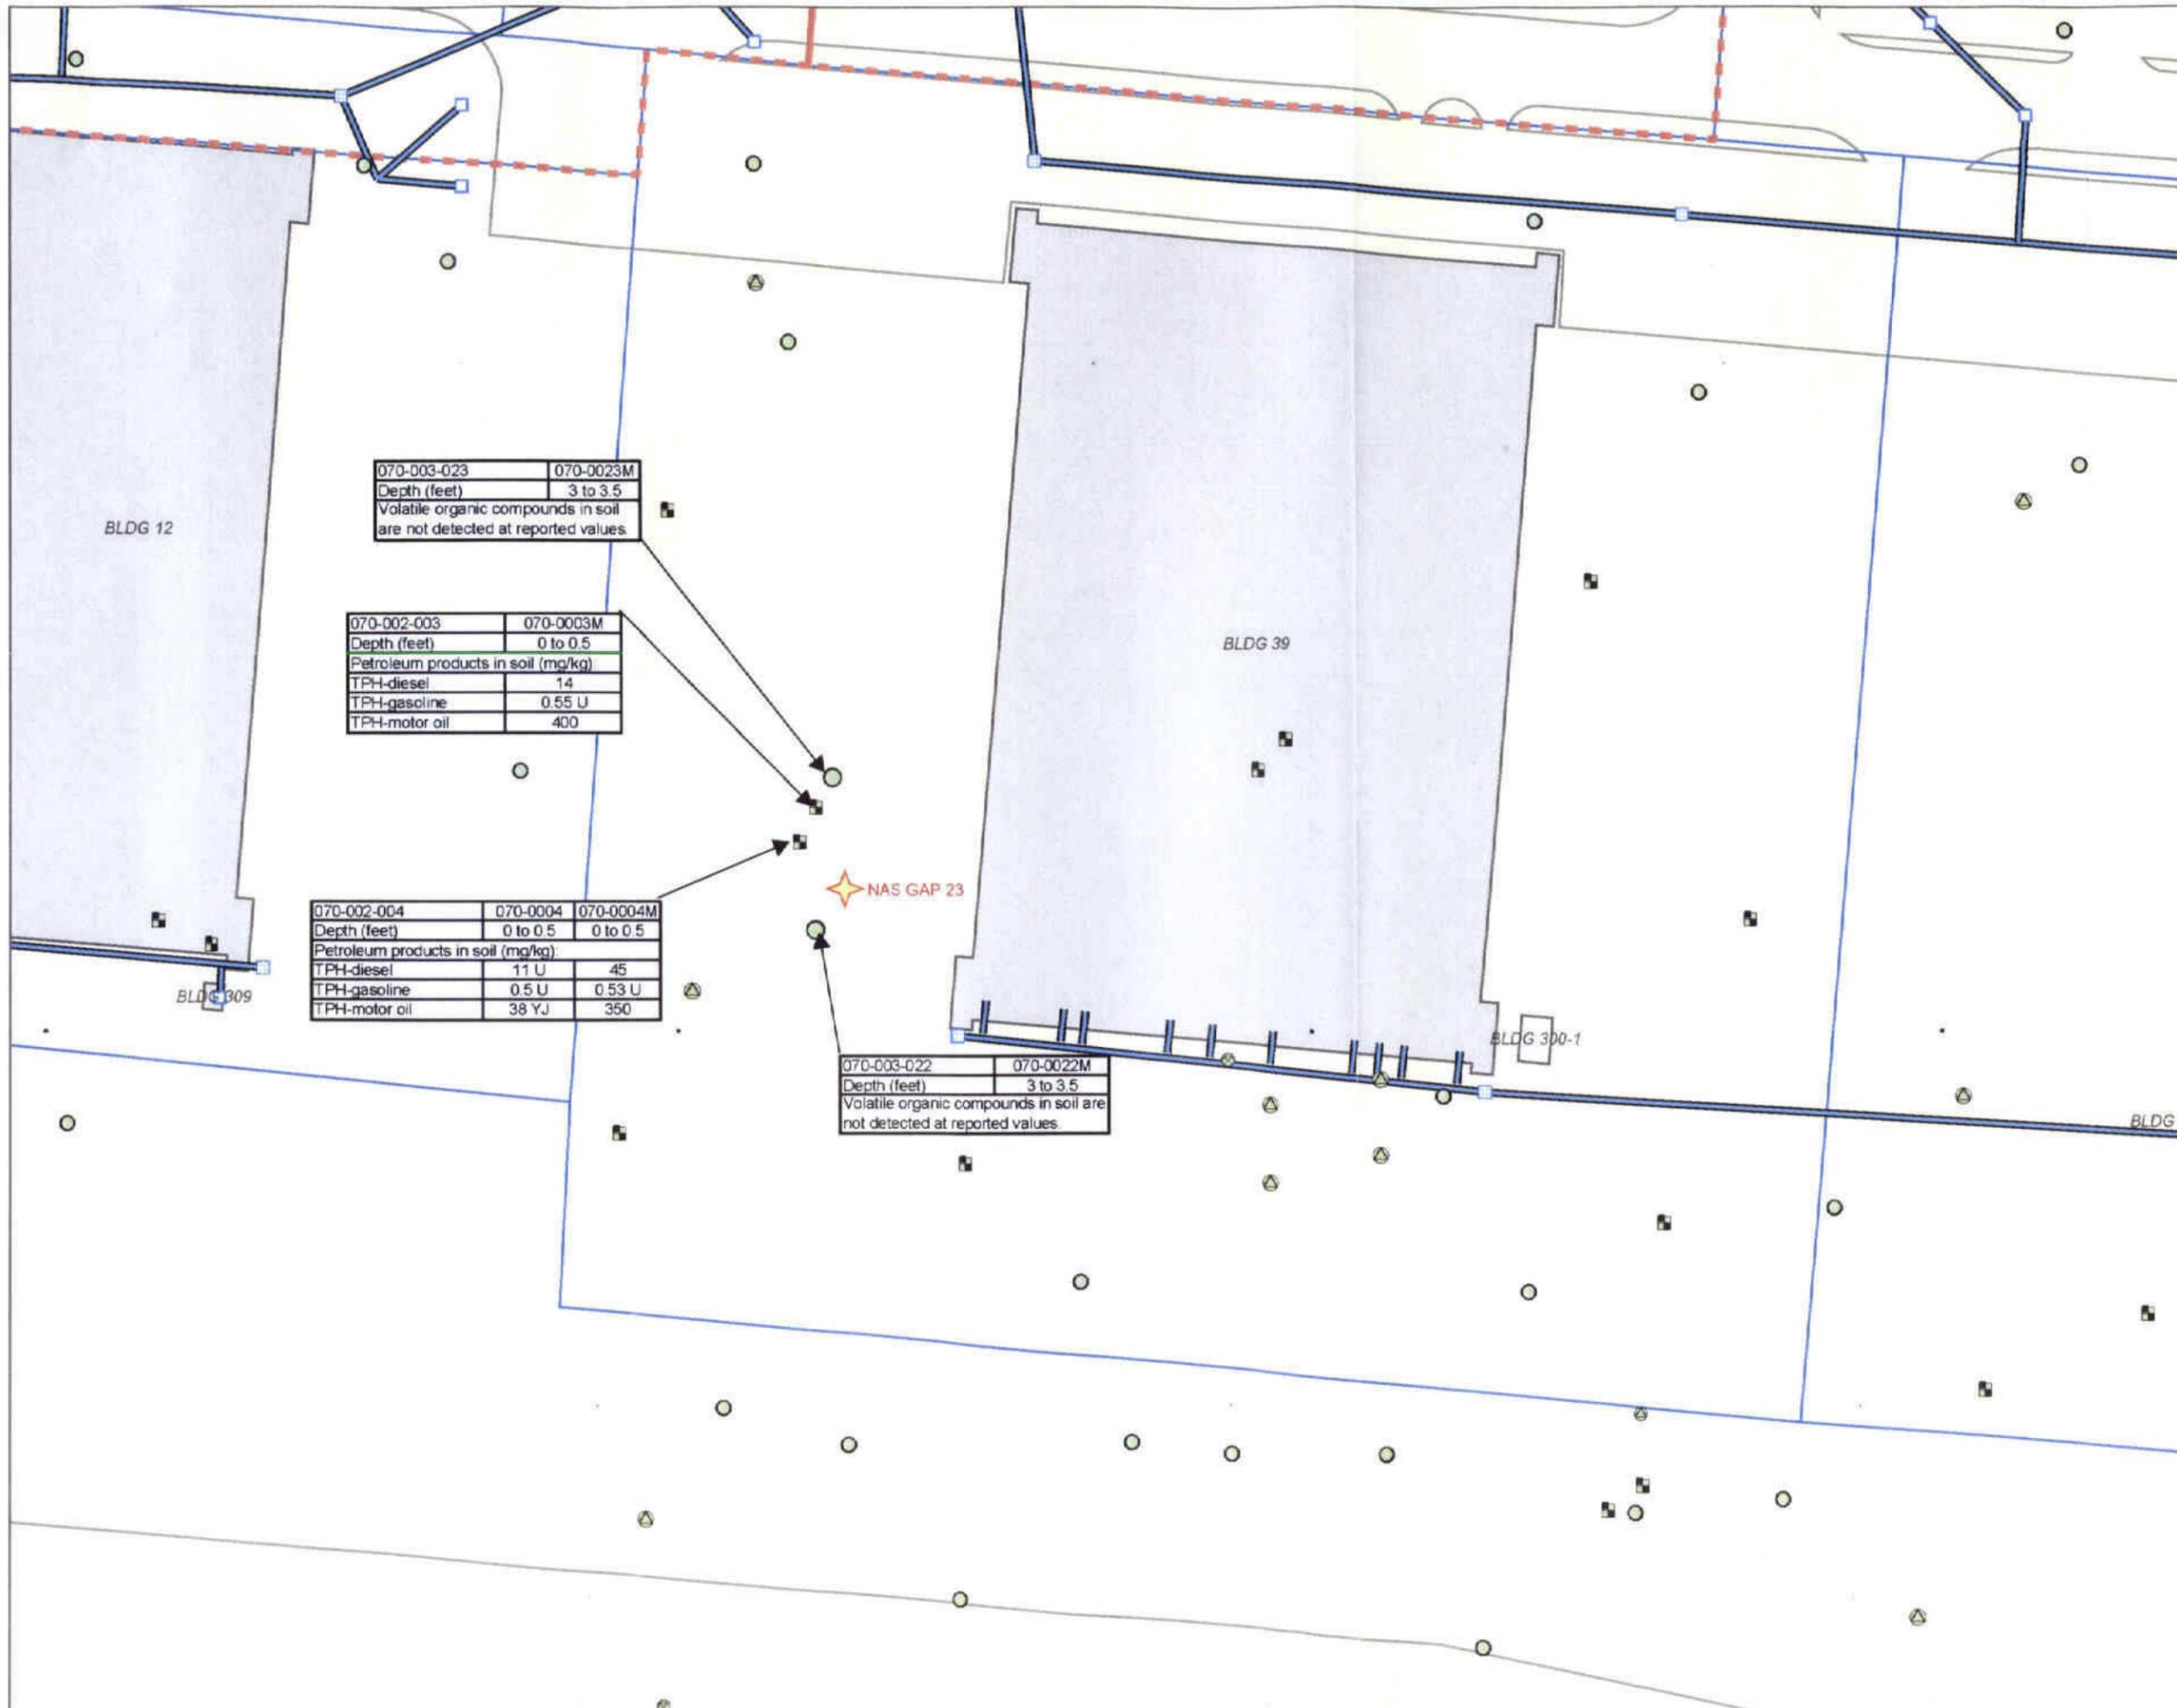
FIGURE A-3-6
EBS PARCEL 70
NAS GAP 23 SAMPLE RESULTS

070-003-023	070-0023M
Depth (feet)	3 to 3.5
Volatile organic compounds in soil are not detected at reported values.

070-002-003	070-0003M
Depth (feet)	0 to 0.5
Petroleum products in soil (mg/kg)	
TPH-diesel	14
TPH-gasoline	0.55 U
TPH-motor oil	400

SWMU Identifier **NAS GAP 23** Refer to Figure # **Figure A-3-6**
Navy Recommendation/Closure Status **NFA Recommended by DTSC (2004)**

NAS GAP 23 (west of Building 39) was investigated as Target Area 2 for parcel 70 in Zone 11 of the EBS. This SWMU consisted of storage lockers surrounded by 55-gallon drums. VOCs and TPH are the specified compounds of concern for this GAP. Analytical data, as shown on the parcel 70 figure, show TPH concentrations below residential PRCs. Further EBS sample data in parcel 70 suggest that TPH detected at NAS GAP 23 is the result of parcel-wide activities, rather than spills or leaks from the SWMU. VOCs were not detected at reported values near this GAP. Since NAS GAP 23 did not appear to represent a significant source of contamination at parcel 70, no additional sampling was recommended (IT 2001). According to the RFA, NAS GAP 23 exhibited a low potential for releases (none known) into soil and groundwater because the GAP was located on concrete (DTSC 1992). A letter from DTSC dated November 4, 1999 recommended NFA for this SWMU (DTSC 1999). NFA is recommended for NAS GAP 23.

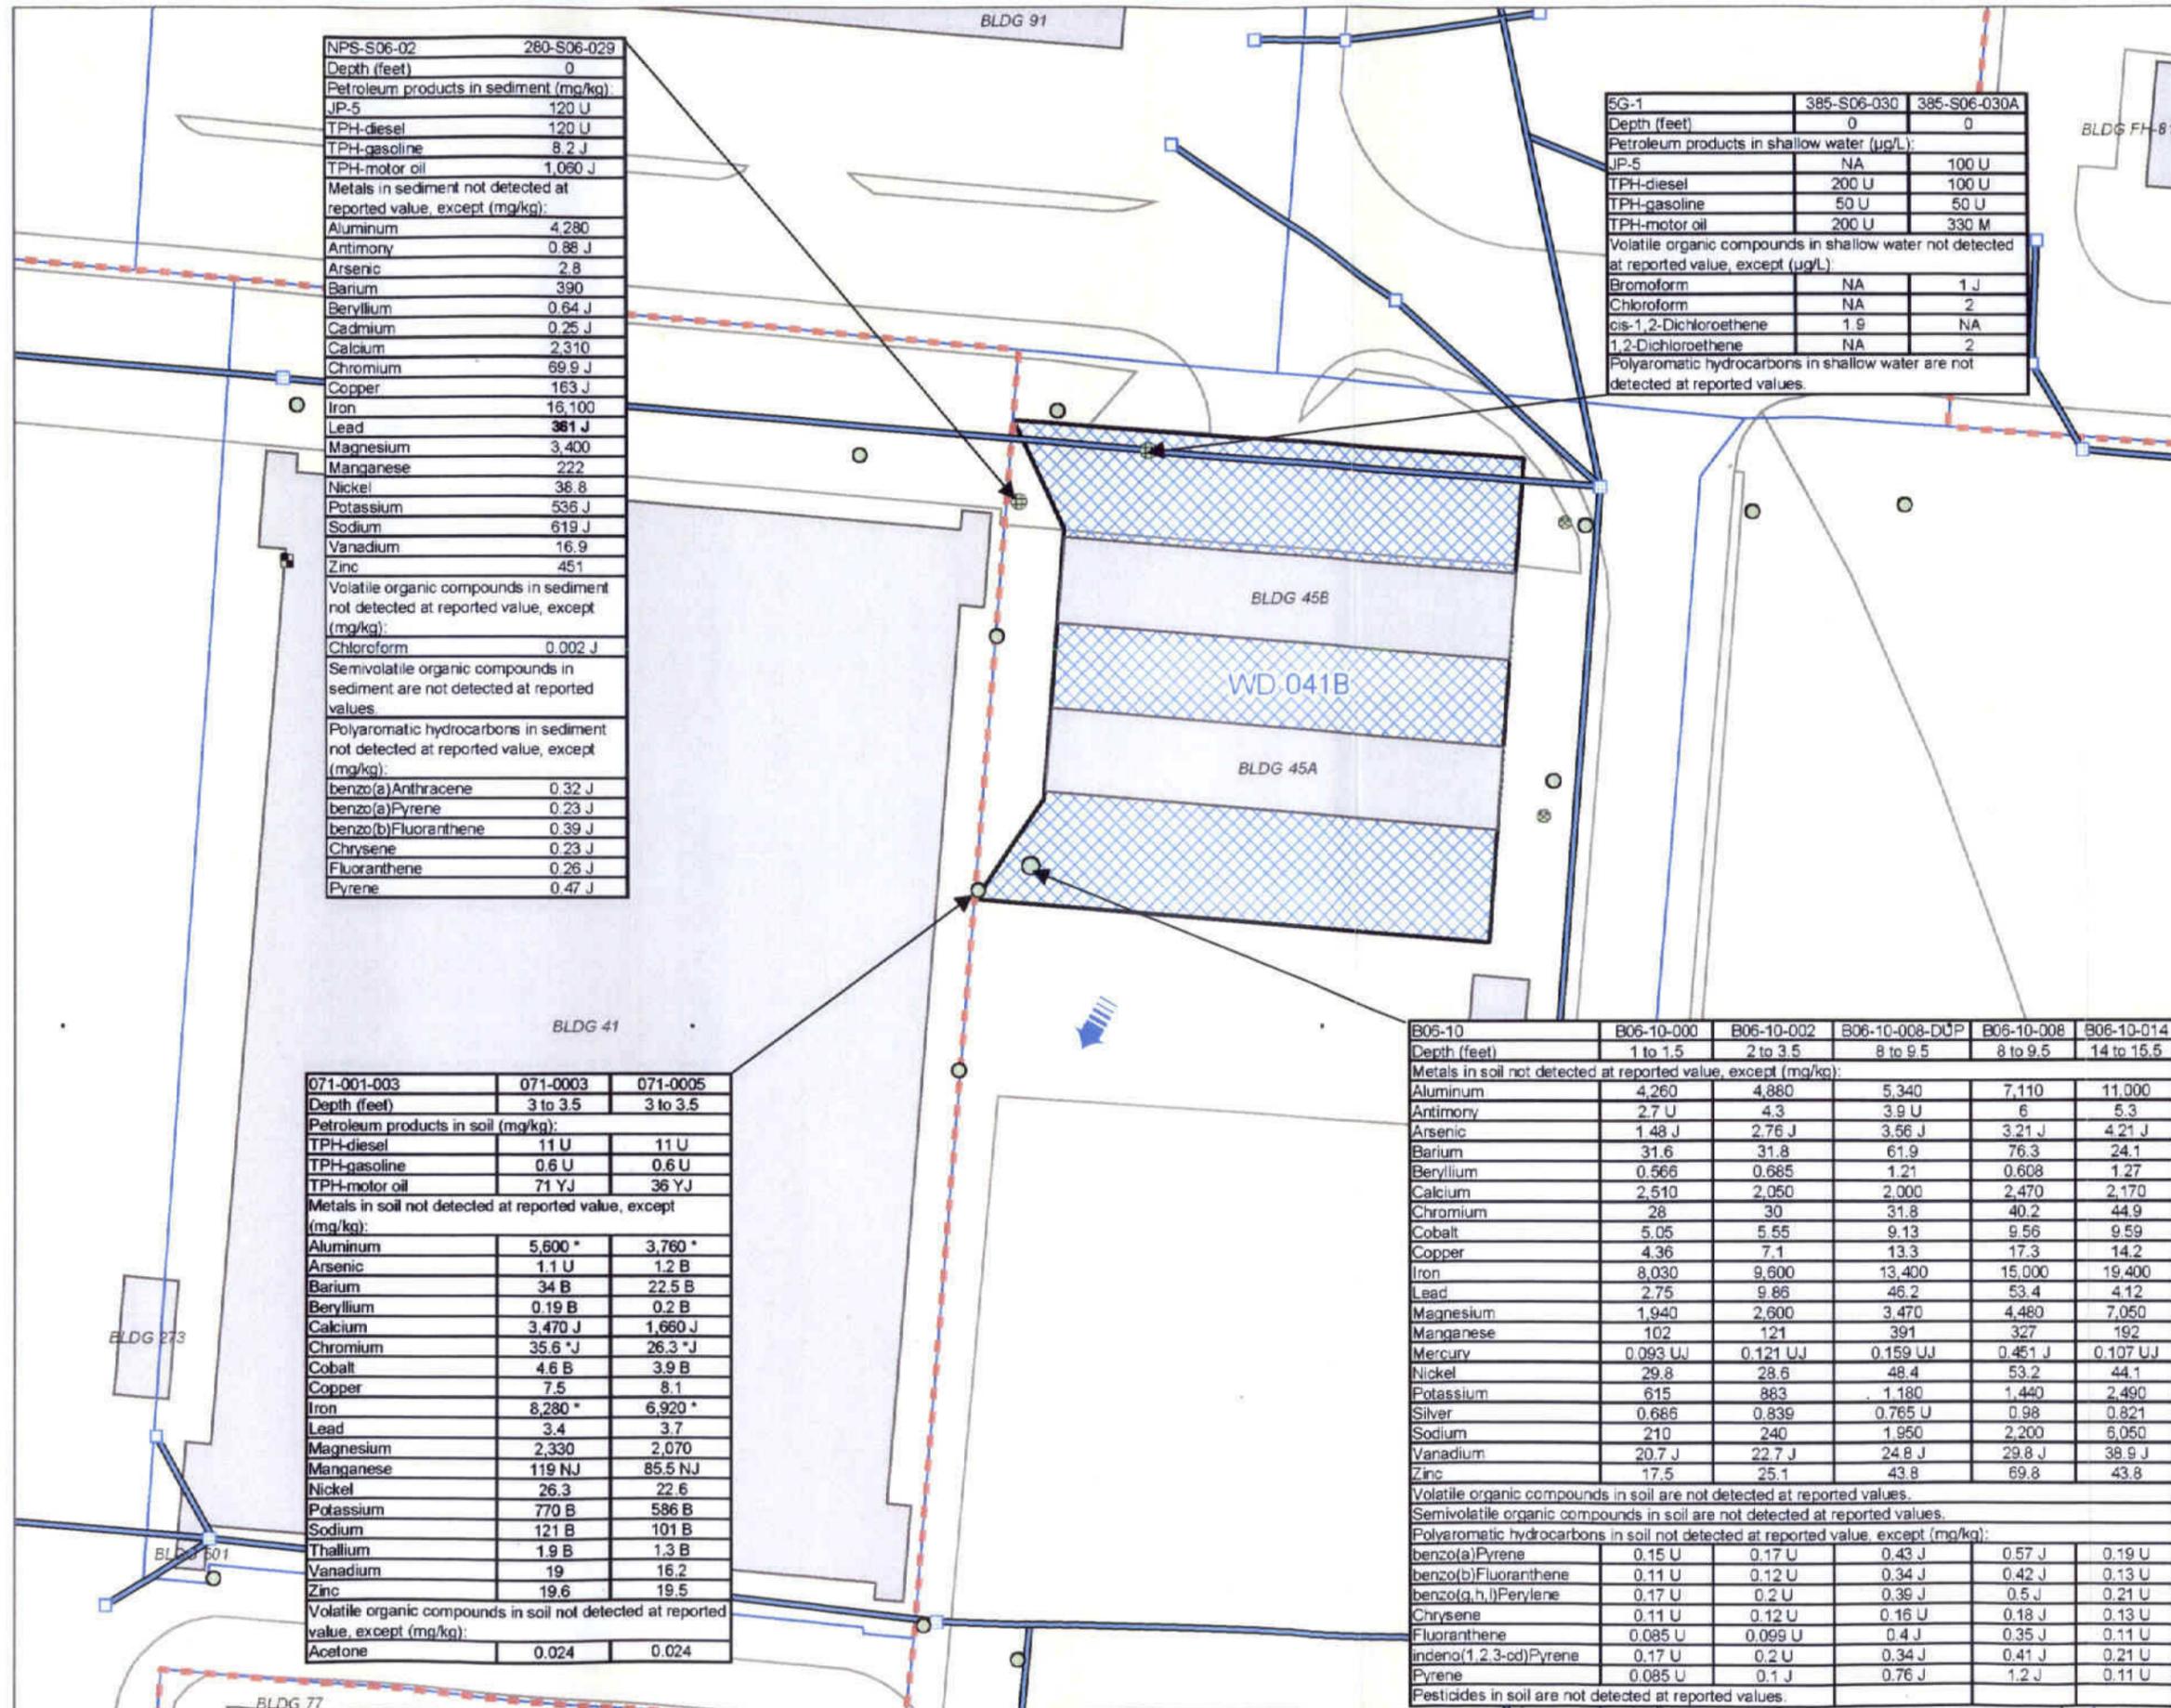
FIGURE A-3-7
EBS PARCEL 71
WD 041B SAMPLE RESULTS

- SAMPLING LOCATIONS**
- ⊗ Excavation
 - ⊕ Manhole/Stormdrain
 - Soil Boring
 - Surface Location
 - CATCH BASIN
 - MANHOLE
 - STORM SEWER LINE
 - ➔ APPROXIMATE DIRECTION OF GROUNDWATER FLOW
 - ▨ WASHDOWN (WD) AREA
 - ⋯ CERCLA SITE
 - ENVIRONMENTAL BASELINE SURVEY (EBS) PARCEL
 - LAND COVER
 - BUILDING**
 - Present
 - Removed

WD 041B (east of Building 41) was located within the equipment storage area investigated as Target Area 1 for parcel 71 in Zone 11 of the EBS. Because of the nature of activities within a washdown area and the absence of an OWS near this location, potential contaminants released from WD 041B were channeled into the adjacent storm sewer system as well as soil and groundwater. As shown on the figure for parcel 71, concentrations of VOCs, TPH, and metals were noted in soil and groundwater samples collected at the perimeter of the equipment storage area. Sediment samples associated with the storm sewer line nearest to WD 041B also showed concentrations of VOCs, TPH, and metals. Lead was detected above the residential PRC and Cal-modified residential PRG at sampling location (NPS-S06-02); however, the concentration did not exceed the nonresidential PRC. All other detected concentrations of analytes were below residential PRCs, MCLs, EPA 2002 PRGs and/or background levels for Alameda Point (Tetra Tech 2001b); therefore, no additional sampling was recommended (IT 2001). The Storm Sewer Study Report at Alameda Point addresses contaminants released into the storm sewer system (Tetra Tech 2000a). NFA is recommended for WD 041B.

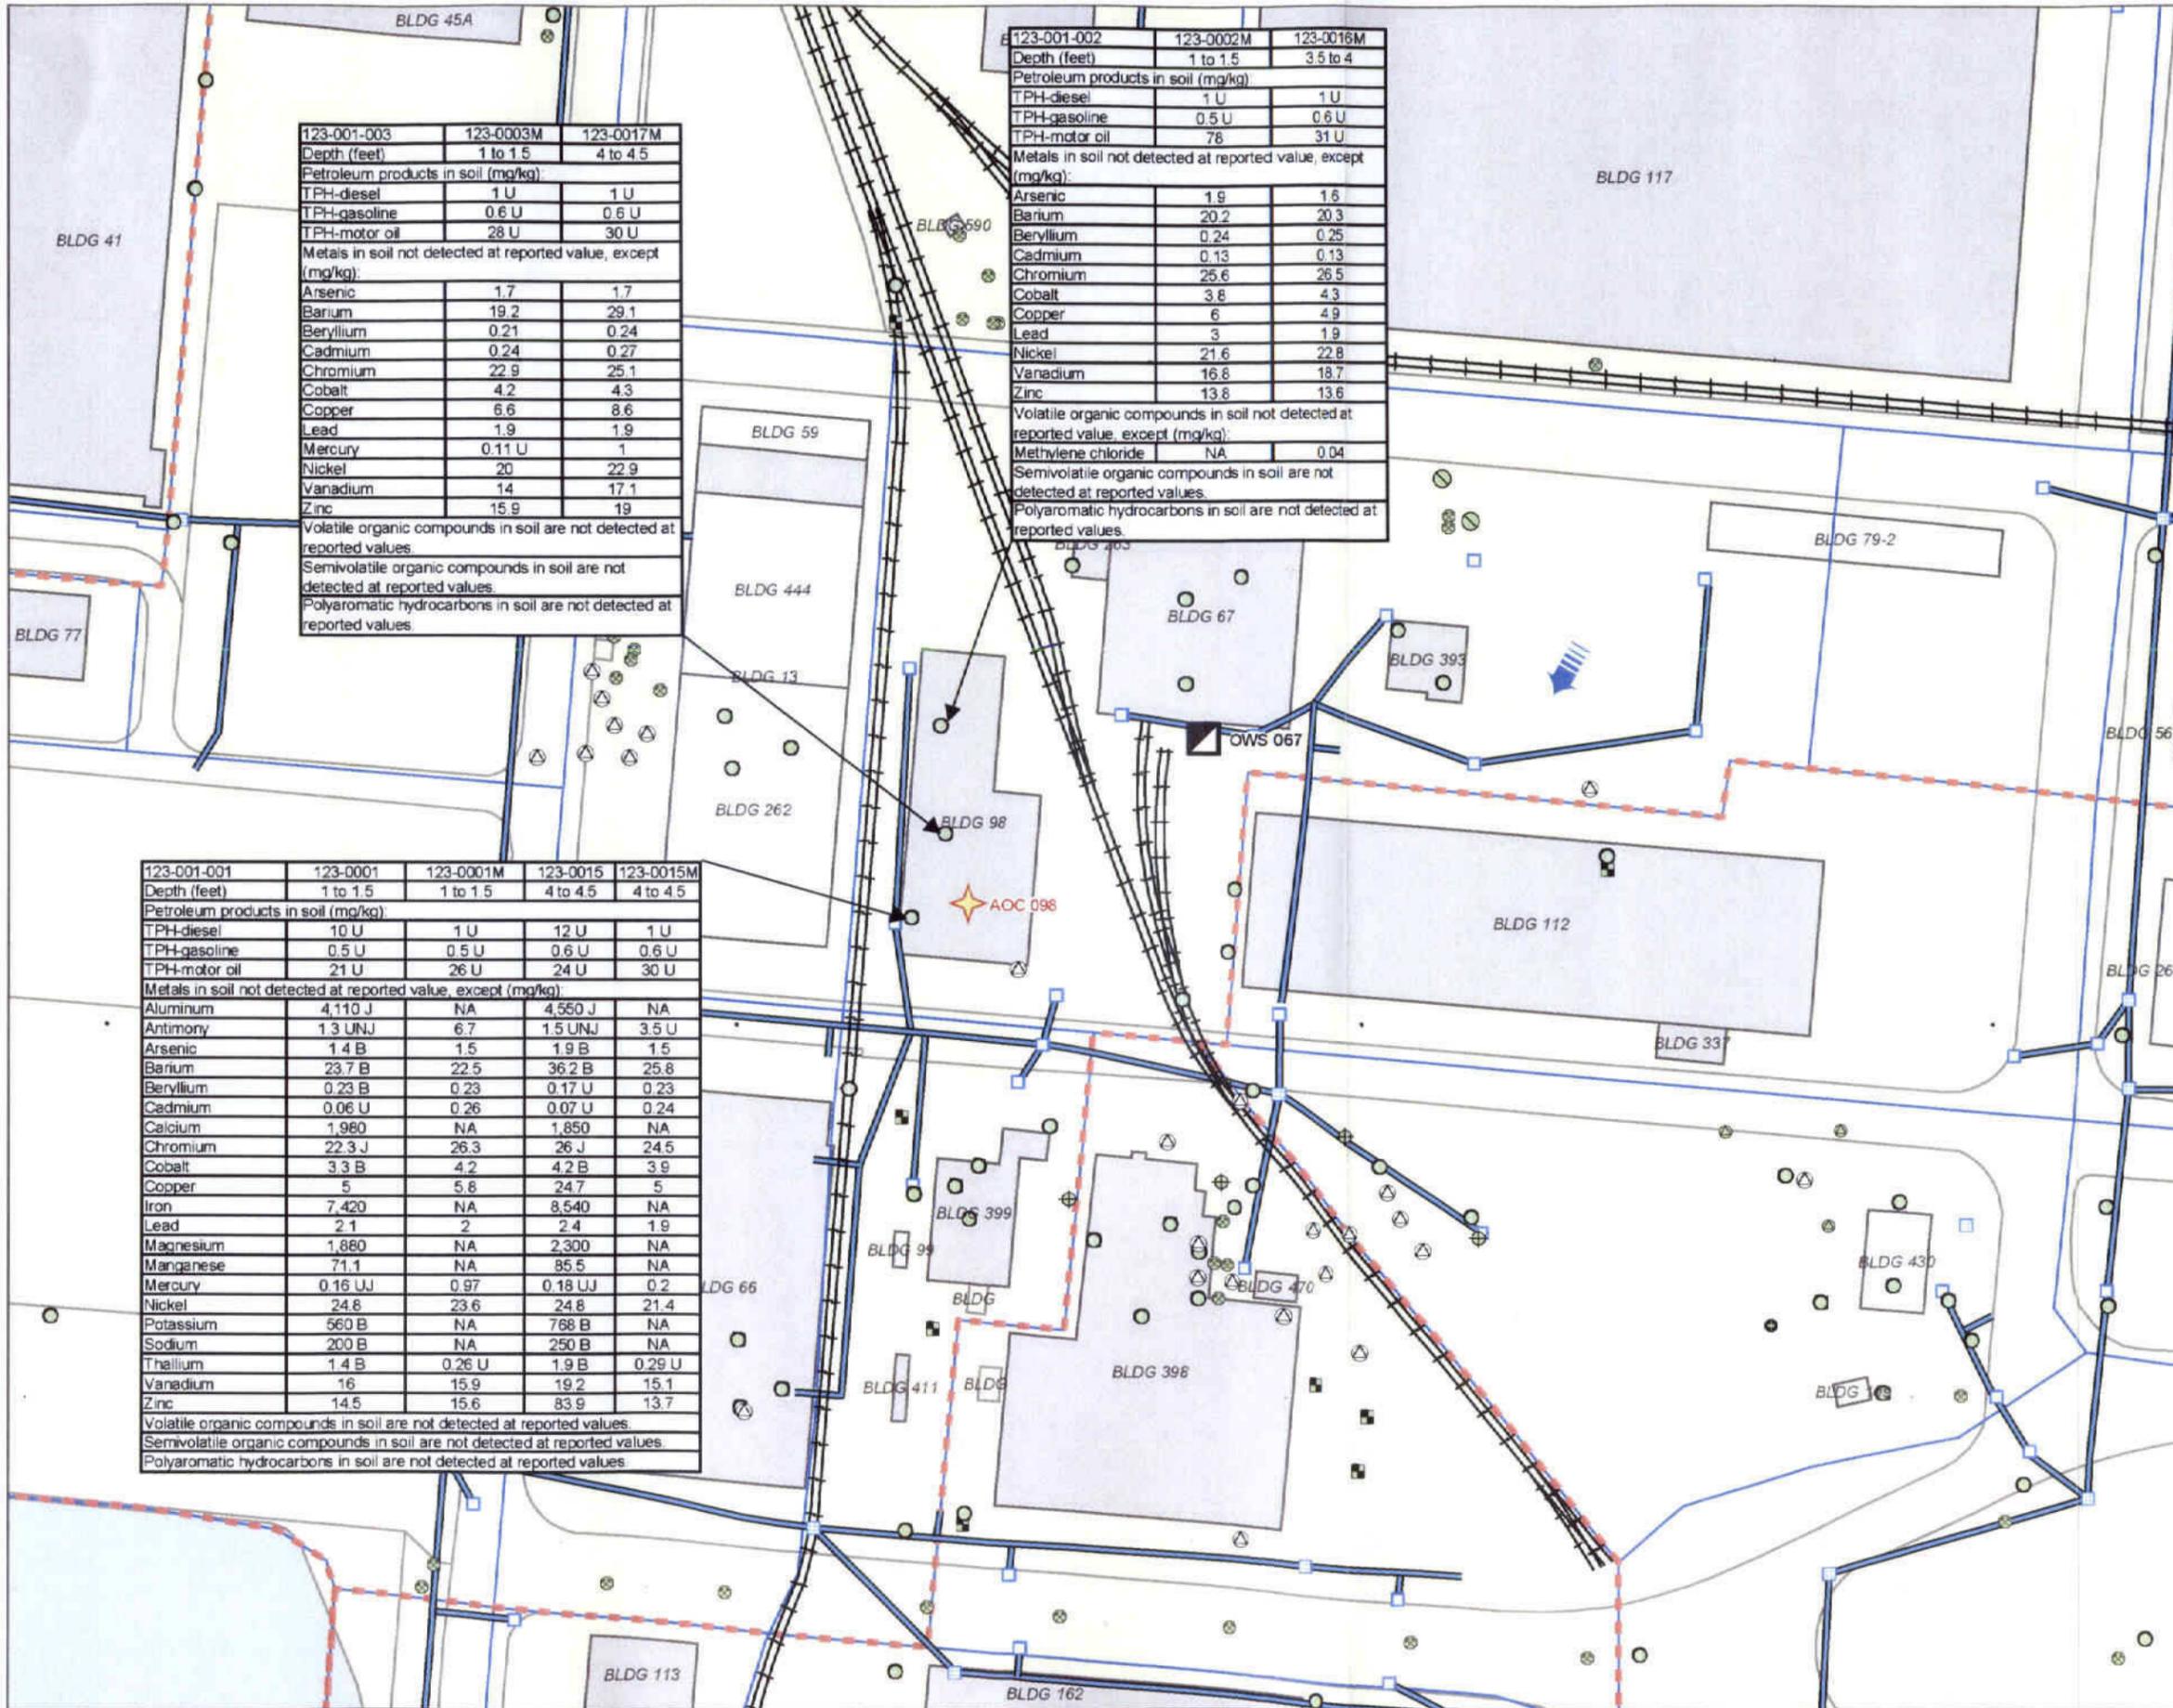
FIGURE A-3-8
EBS PARCEL 123
AOC 098 & OWS-067 SAMPLE RESULTS

123-001-003	123-0003M	123-0017M
Depth (feet)	1 to 1.5	4 to 4.5
Petroleum products in soil (mg/kg):		
TPH-diesel	1 U	1 U
TPH-gasoline	0.6 U	0.6 U
TPH-motor oil	28 U	30 U
Metals in soil not detected at reported value, except (mg/kg):		
Arsenic	1.7	1.7
Barium	19.2	29.1
Beryllium	0.21	0.24
Cadmium	0.24	0.27
Chromium	22.9	25.1
Cobalt	4.2	4.3
Copper	6.6	8.6
Lead	1.9	1.9
Mercury	0.11 U	1
Nickel	20	22.9
Vanadium	14	17.1
Zinc	15.9	19
Volatile organic compounds in soil are not detected at reported values.		
Semivolatile organic compounds in soil are not detected at reported values.		
Polyaromatic hydrocarbons in soil are not detected at reported values.

123-001-002	123-0002M	123-0016M
Depth (feet)	1 to 1.5	3.5 to 4
Petroleum products in soil (mg/kg):		
TPH-diesel	1 U	1 U
TPH-gasoline	0.5 U	0.6 U
TPH-motor oil	78	31 U
Metals in soil not detected at reported value, except (mg/kg):		
Arsenic	1.9	1.6
Barium	20.2	20.3
Beryllium	0.24	0.25
Cadmium	0.13	0.13
Chromium	25.6	25.5
Cobalt	3.8	4.3
Copper	6	4.9
Lead	3	1.9
Nickel	21.6	22.8
Vanadium	16.8	18.7
Zinc	13.8	13.6
Volatile organic compounds in soil not detected at reported value, except (mg/kg):		
Methylene chloride	NA	0.04
Semivolatile organic compounds in soil are not detected at reported values.		
Polyaromatic hydrocarbons in soil are not detected at reported values.

AOC 098 (Building 098) was investigated as Target Area 1 for parcel 123 in Zone 17 of the EBS. As shown in the parcel 123 figure, three sampling locations were analyzed from the most heavily stained areas within the building. All detected analyte concentrations were below residential PRCs, MCLs, EPA 2002 PRGs, and/or Alameda Point background concentrations. Nondetect values were compared to screening levels and found not to be a problem. The lack of impacted soil strongly indicates no impact to groundwater. Based on these data, the EBS stated that there appeared to be no demonstrable impact to soil below the stained areas; therefore, because of the low concentrations of detected analytes in surface soil beneath the concrete floor, no additional sampling was recommended (IT 2001). NFA is recommended for AOC 098.

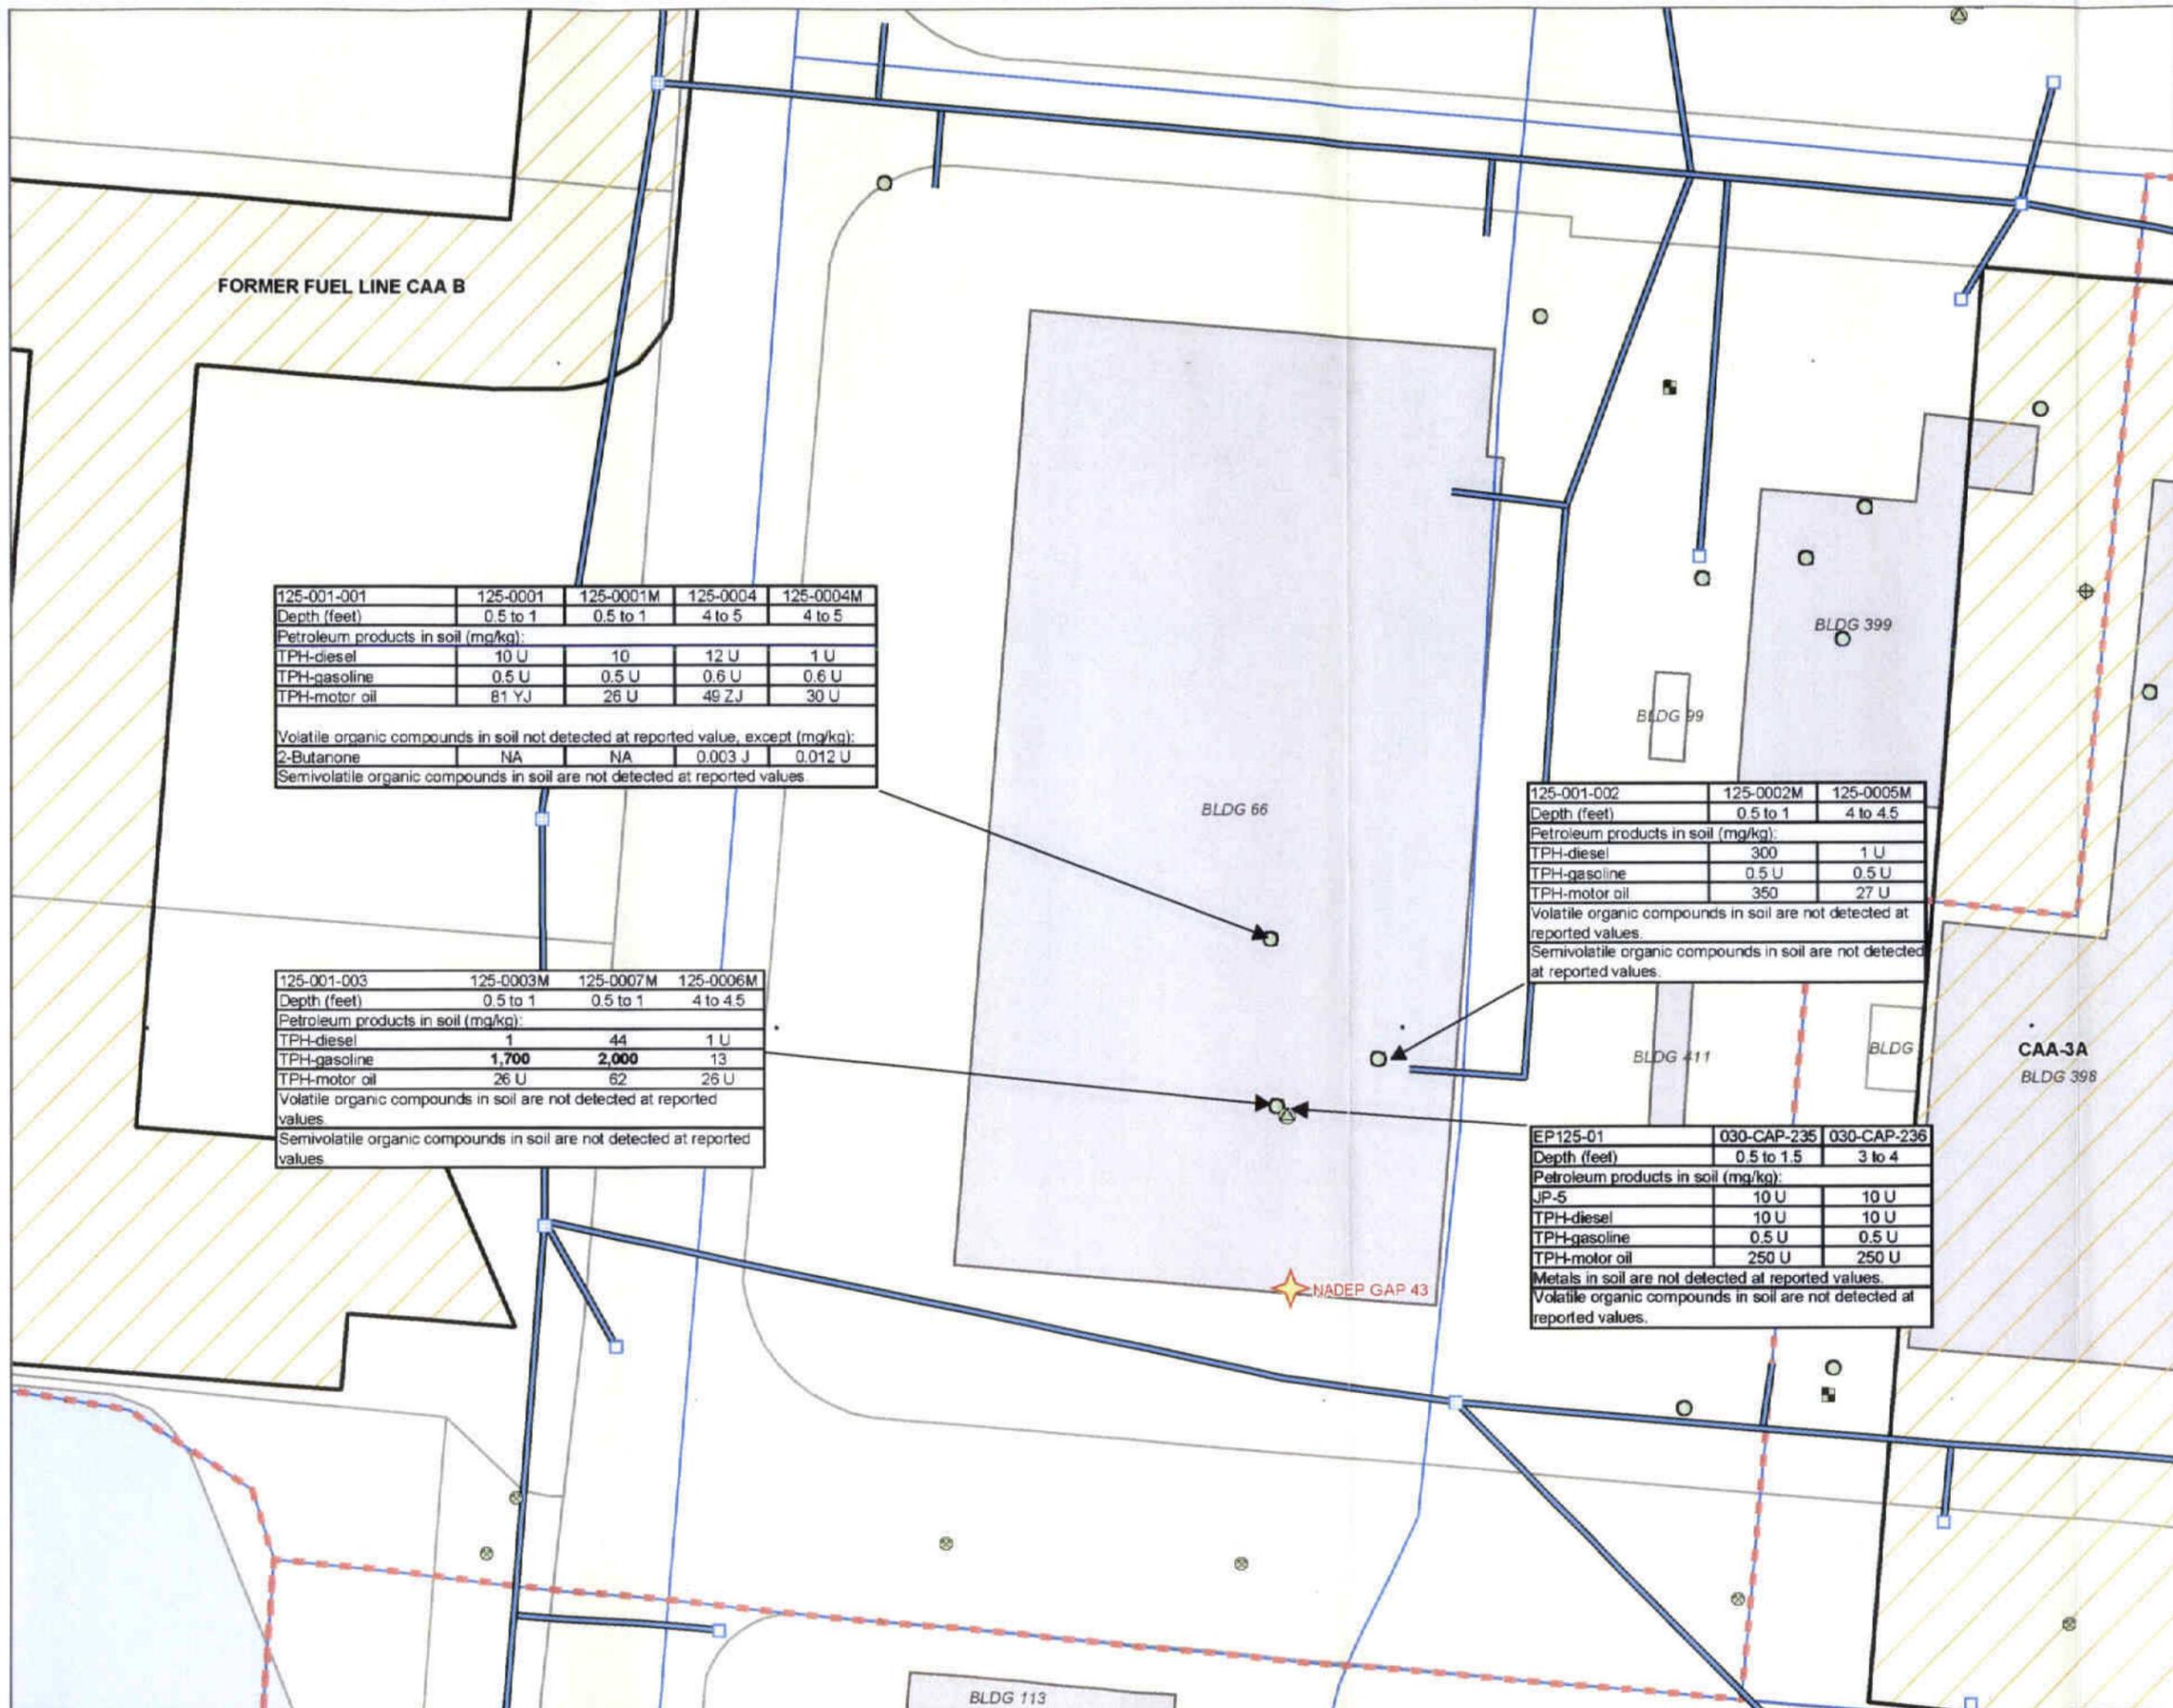
FIGURE A-3-10
EBS PARCEL 125
NADEP GAP 43 SAMPLE RESULTS

125-001-001	125-0001	125-0001M	125-0004	125-0004M
Depth (feet)	0.5 to 1	0.5 to 1	4 to 5	4 to 5
Petroleum products in soil (mg/kg):				
TPH-diesel	10 U	10	12 U	1 U
TPH-gasoline	0.5 U	0.5 U	0.6 U	0.6 U
TPH-motor oil	81 YJ	26 U	49 ZJ	30 U
Volatile organic compounds in soil not detected at reported value, except (mg/kg):				
2-Butanone	NA	NA	0.003 J	0.012 U
Semivolatile organic compounds in soil are not detected at reported values

125-001-003	125-0003M	125-0007M	125-0006M
Depth (feet)	0.5 to 1	0.5 to 1	4 to 4.5
Petroleum products in soil (mg/kg):			
TPH-diesel	1	44	1 U
TPH-gasoline	1,700	2,000	13
TPH-motor oil	26 U	62	26 U
Volatile organic compounds in soil are not detected at reported values			
Semivolatile organic compounds in soil are not detected at reported values

SWMU Identifier **NADEP GAP 43** **Refer to Figure #** Figure A-3-10
Navy Recommendation/Closure Status **NFA Recommended by DTSC (2004)**

NADEP GAP 43 (in Building 066) was investigated as Target Area 1 for parcel 125 in Zone 17 of the EBS. According to the RFA, NADEP GAP 43 exhibited a low potential for releases (none known) into soil and groundwater because the GAP was located indoors atop a concrete floor (DTSC 1992). As shown on the parcel 125 figure, four sampling locations were analyzed in this area, which was designated as a worst-case scenario for possible releases because of the extensive floor staining noted within Building 66. One sampling location showed elevated concentrations of TPH as gasoline exceeding residential PRC, but less than nonresidential PRC. All other detected analyte concentrations were below residential PRCs and EPA 2002 PRGs. The concentrations of gasoline and other petroleum products appeared to be restricted to near surface soils below the building floor and did not suggest extensive transport of petroleum to the subsurface; therefore, no further investigation was recommended for this SWMU (IT 2001). NFA is recommended for NADAP GAP 43.

Metal racks and machine parts are currently placed on former NADEP GAP 43 and surrounding areas. The current tenant of building 066 was unaware of any staining within or around the GAP upon leasing the building.

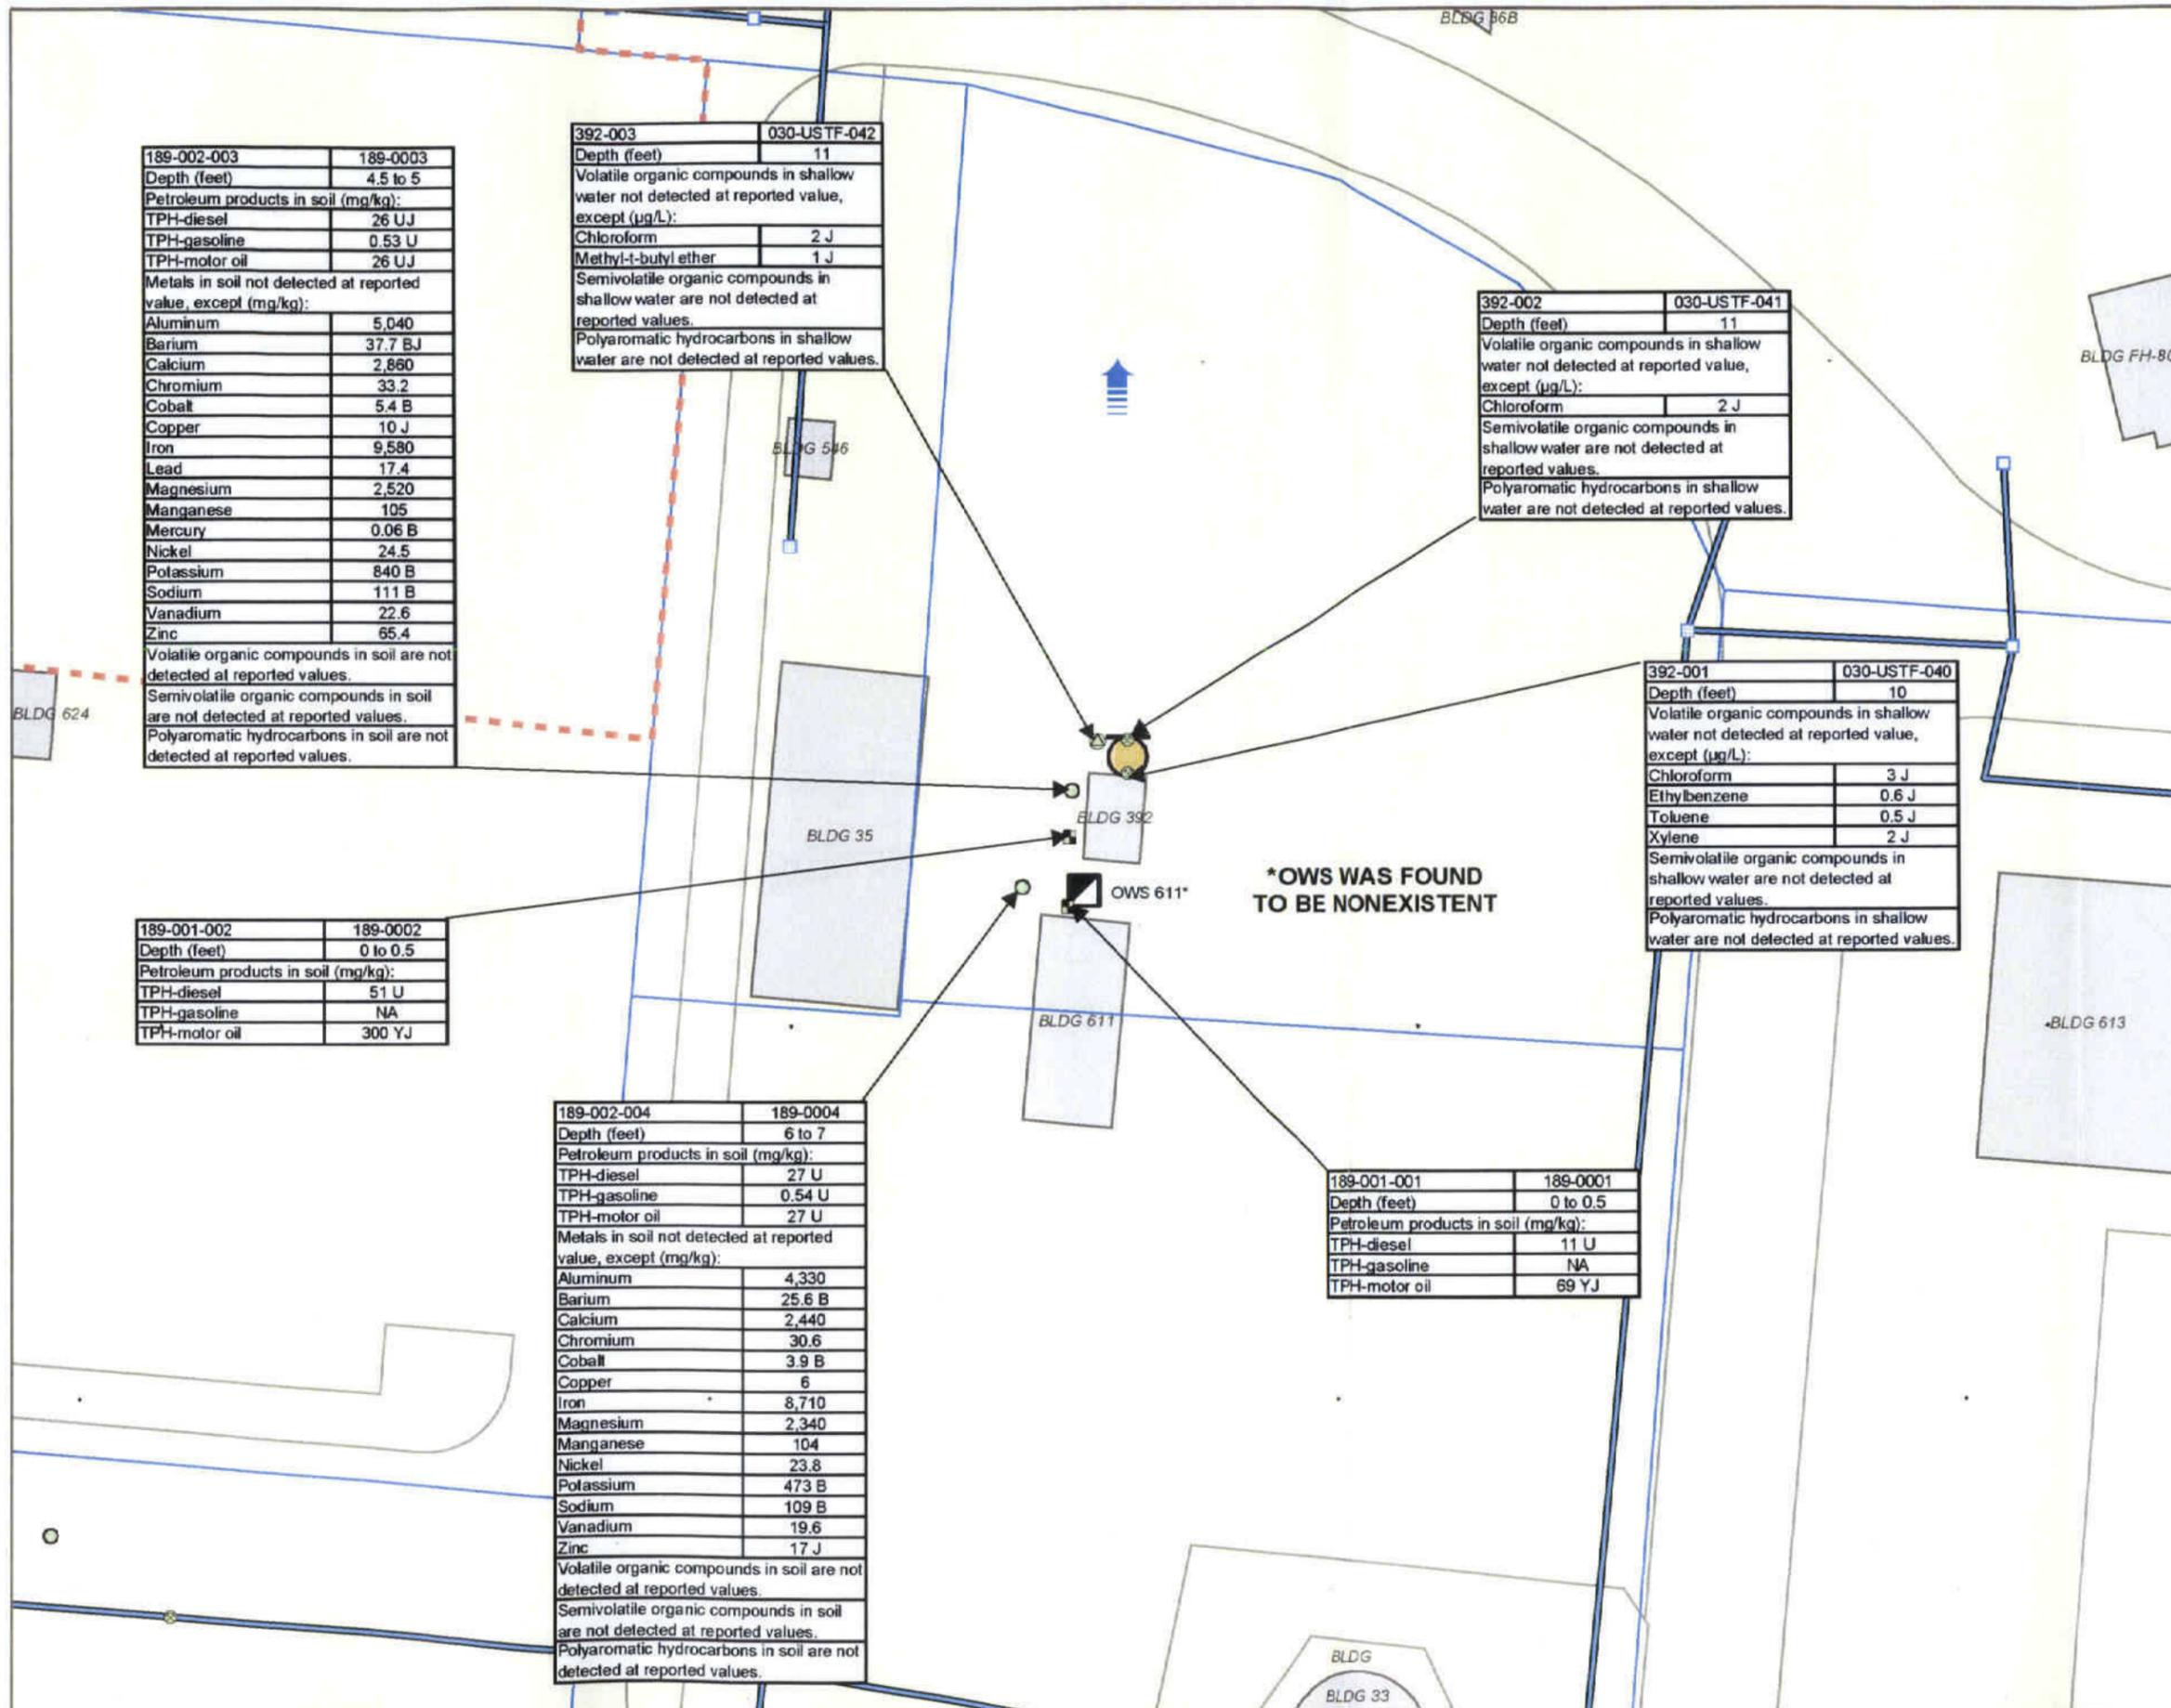
FIGURE A-3-11
EBS PARCEL 189
OWS 611 SAMPLE RESULTS

SAMPLE LOCATION

- Direct-Push
- Excavation
- Soil Boring
- Surface Location

OWS 611 does not exist. It was incorrectly identified as being located between Building 611 and Building 392, within parcel 189 in Zone 13 of the EBS. The only features observed between the two buildings during a site visit on January 13, 2005 was a bermed pad for a former portable diesel generator and an electrical vault. EBS parcel 189 also had an underground storage tank (UST 392-1; also called AOC 392) that contained unleaded gasoline and was located adjacent to the north wall of Building 392 and an aboveground storage tank (AST 392) that contained diesel and was located south of Building 392. The Navy recommends removing OWS 611 from the SWMU list as it was identified in error and it never existed.
